Reflective Cracking between Precast Prestressed Box Girders

This brief summarizes Project 0092-14-01,
“Reflective Cracking between Precast Prestressed Box Girders”
Wisconsin Highway Research Program

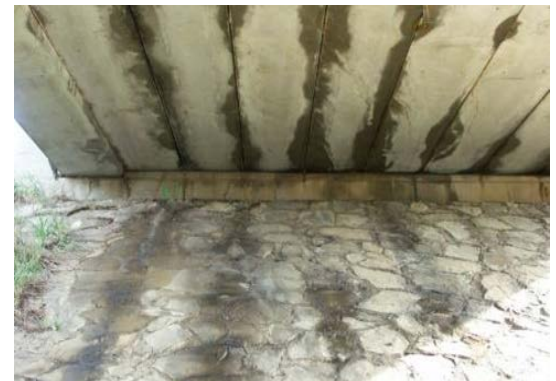
Moisture ingress through cracks and shear keys.
