1. Report No. CA15-2560	2. Government Accession No.	3. Recipient's Catalog No.	
4. Title and Subtitle Development Length for Headed Bars in Slab-Column Joints of RC Slab Bridges		5. Report Date 12/4/2015

Report No.
SSRP-15/10

**Development Length for Headed Bars in
Slab-Column Joints of RC Slab Bridges**

Report Submitted to the California Department of Transportation
under Contract No. 65A0498

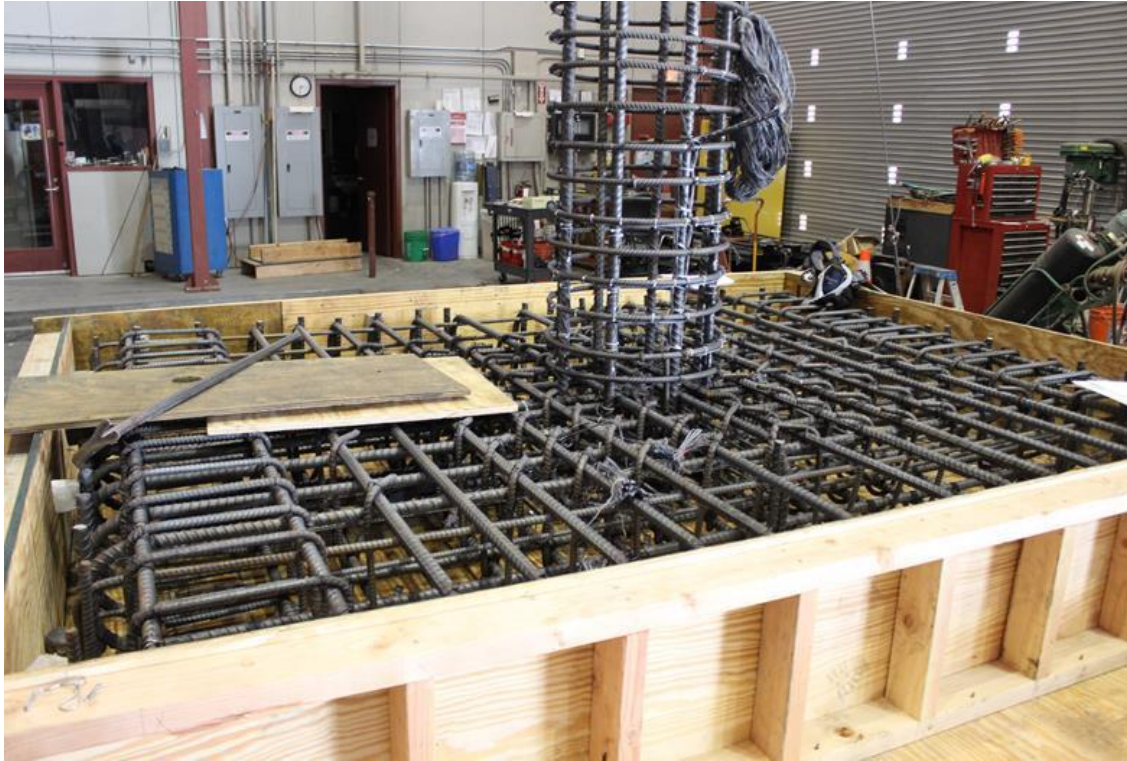
Figure 3.9 – Picture of the slab and column reinforcement of Specimen #1 prior to cast

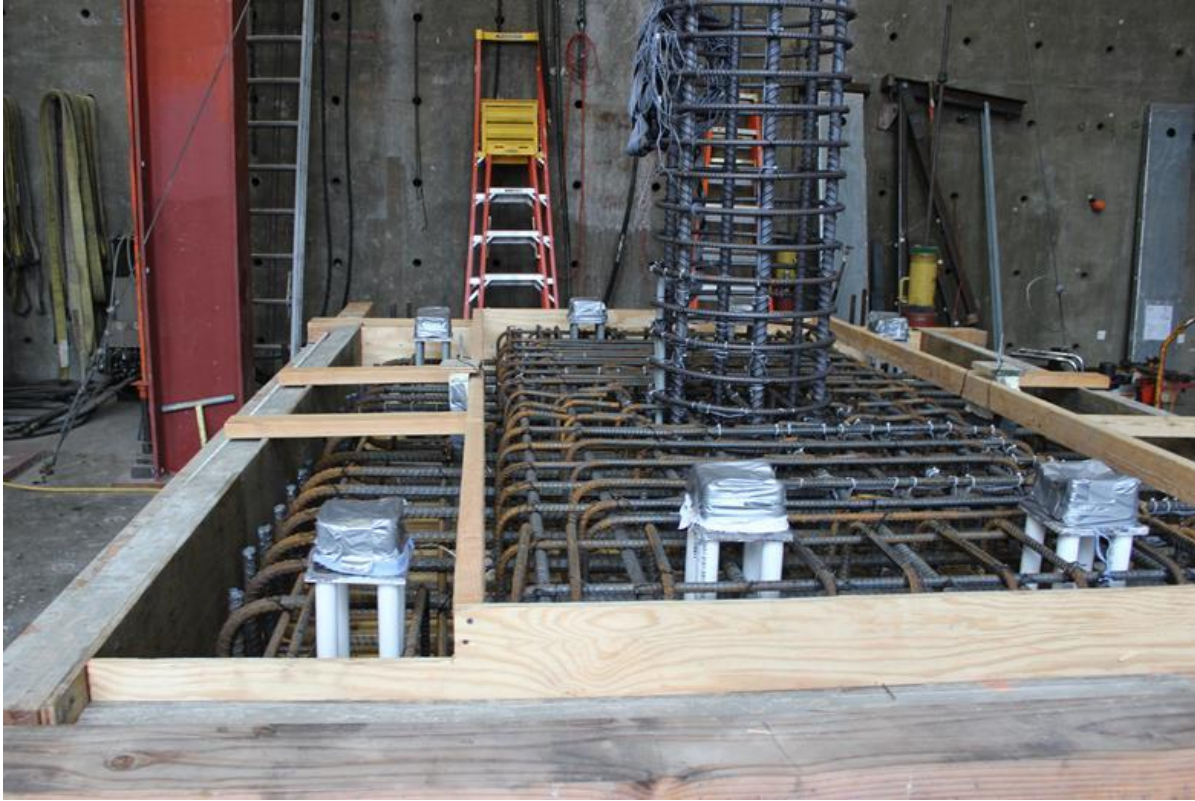
Figure 3.15 – Picture of slab and column reinforcement of Specimen #3 prior to casting

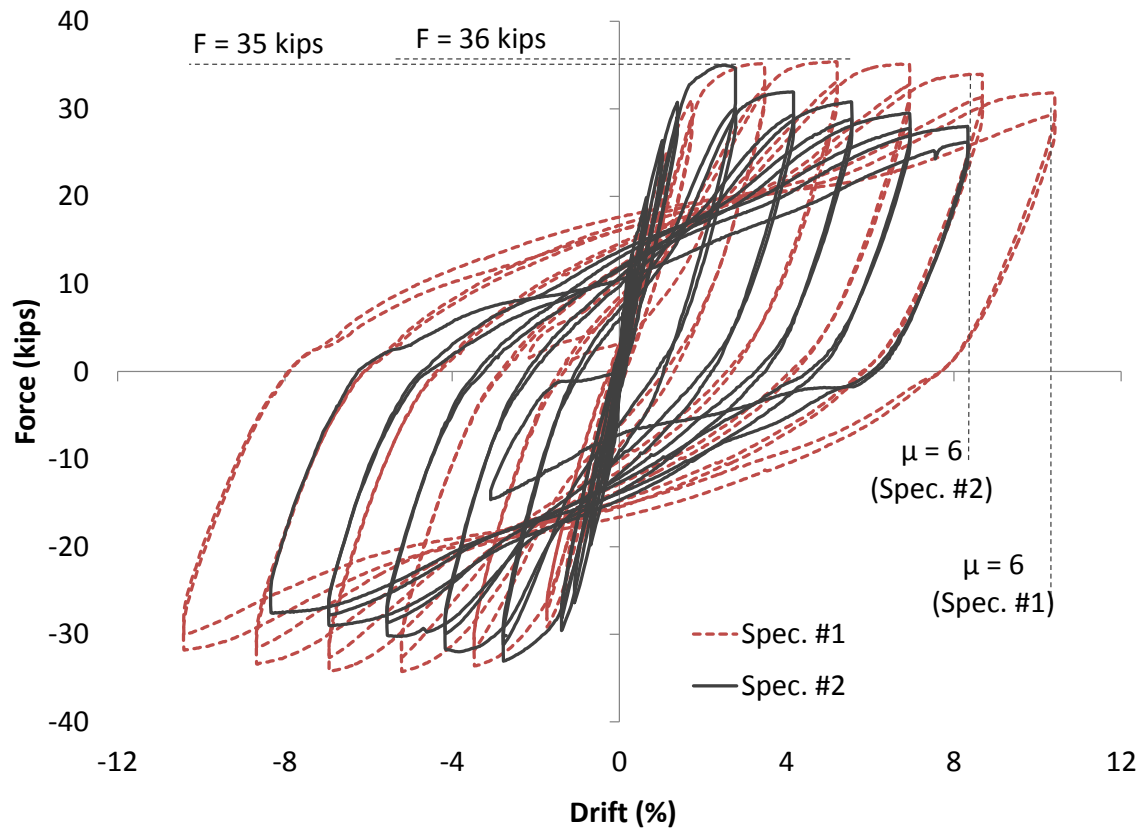
Figure 4.1 – Lateral force-vs.-drift ratio for Specimens #1 and #2

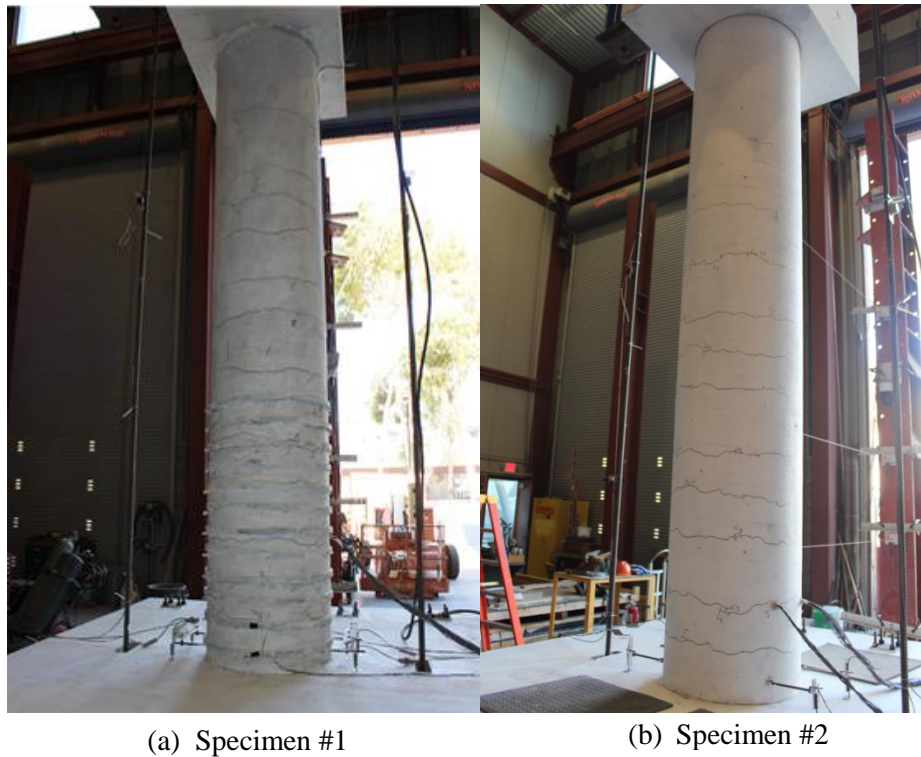
Figure 4.4 – Flexural cracks at the south face of the columns of Specimens #1 and #2 at Cycle 4 (1st yield)

For all three specimens, flexural cracks started to be visible in the lower half of the columns, in the test configuration, during Cycle 2, at a lateral load that was about 50% of the force predicted by analysis to cause the first yield of the longitudinal bars. At Cycle 4, when the load approached the theoretical first yield, flexural cracks were formed almost along the whole height of the columns, as shown in Figure 4.4 for Specimens #1 and #2. The same observations also stand for Specimen #3. Up to Cycle 4, no cracks were observed in the slabs. Observations obtained in latter cycles are presented below. For all three specimens, plastic hinges eventually developed at the bottom of columns in the test configuration, which had the slab-column assembly in the upside-down position.

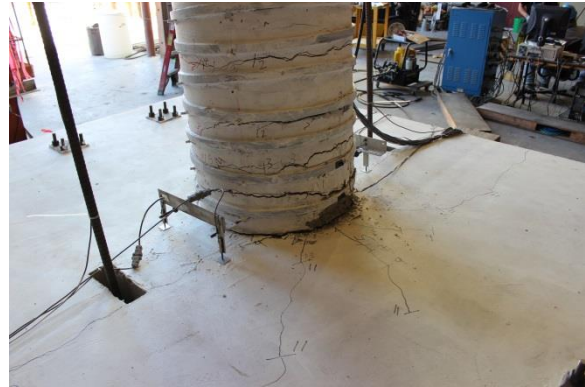
(a) north face at Cycle 6a ($\mu = 2$)

(d) south face at Cycle 9a ($\mu = 5$)

Figure 4.5 – Evolution of damage at the bottom of the column of Specimen #1

Figure 4.5 shows the evolution of damage near the bottom of the column in Specimen #1. Crushing of the concrete cover started in Cycle 6(a), which was the 1st cycle of ductility 2, as shown in Figure 4.5(a) and Figure 4.5(b). Concrete cover spalling and large flexural cracks were observed in the 1st cycle of ductility 5, as shown in Figure 4.5(c) and Figure 4.5(d). However, the spalling of concrete was not severe because of the external steel confinement. This is reflected in the small load degradation exhibited by the lateral load-vs.-drift ratio curve presented in Figure 4.1. Figure 4.6 shows the hoop strains in the two steel straps closest to the base of the column. The straps were located 4 in. and 8 in. away from the column base. As shown, the straps yielded in tension, with the lowest one experiencing larger strains. This shows that they were fully engaged in the confinement action.

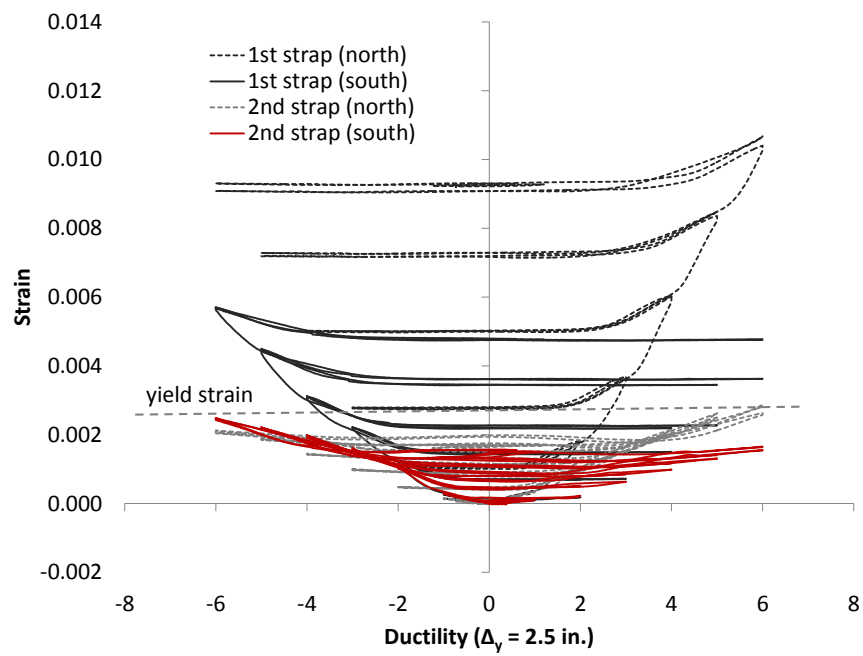
Figure 4.6 – Strains in confining steel straps around the column of Specimen #1

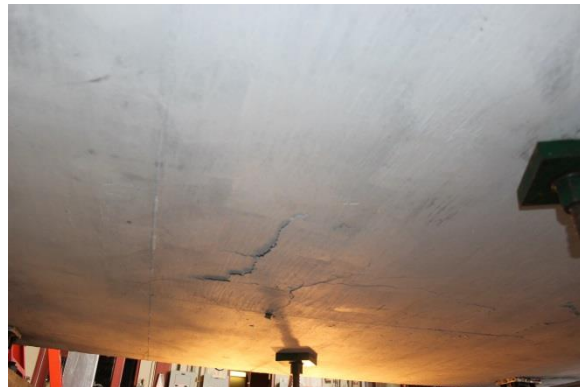
(d) Cycle 10a ($\mu = 6$)

Figure 4.7 – Evolution of damage in the slab of Specimen #1

Figure 4.7 shows the evolution of damage in the slab of Specimen #1. Flexural cracks were observed at the bottom face of the slab (top face in the specimen) in the 1st cycle of ductility 1. In Cycle 7a, corresponding to a ductility demand of 3, additional cracks, radiating from the column, appeared at the bottom face of the slab (top face in the specimen). These cracks extended towards the east and west edges of the slab, as the displacement applied to the column increased. The crack pattern at the bottom face of the slab (top face in the specimen), at the end of the test, is shown in Figure 4.8. At the top face of the slab (bottom face in the specimen), punching cracks could be observed in the 2nd cycle of ductility 3, as shown in Figure 4.7(c). The punching cracks were formed as the heads of the bars under compression pushed against concrete. The punching cracks were marked and measured after the end of the test. Relative vertical displacements were observed across punching cracks. After the end of the test, the residual punching crack displacements in the north and south region were 0.12 in. and 0.2 in., respectively. The punching crack displacement is defined as the differential vertical displacement of the slab surface across a punching crack measured with a micrometer. Figure 4.9 shows the crack pattern at the end of the test, with the locations of the column and the heads of the longitudinal bars marked. As shown in the figure, two large punching cracks were formed outside the column perimeter, at a maximum distance of 10 in. Cracks crossing the footprints of the column and the bar heads were also observed. After the test, concrete pieces between large punching cracks were removed with the use of mechanical tools, and some fracture surface was exposed, as shown in Figure 4.10. The average inclination of the fracture surface radiating from a bar head varies between 20° and 40°.

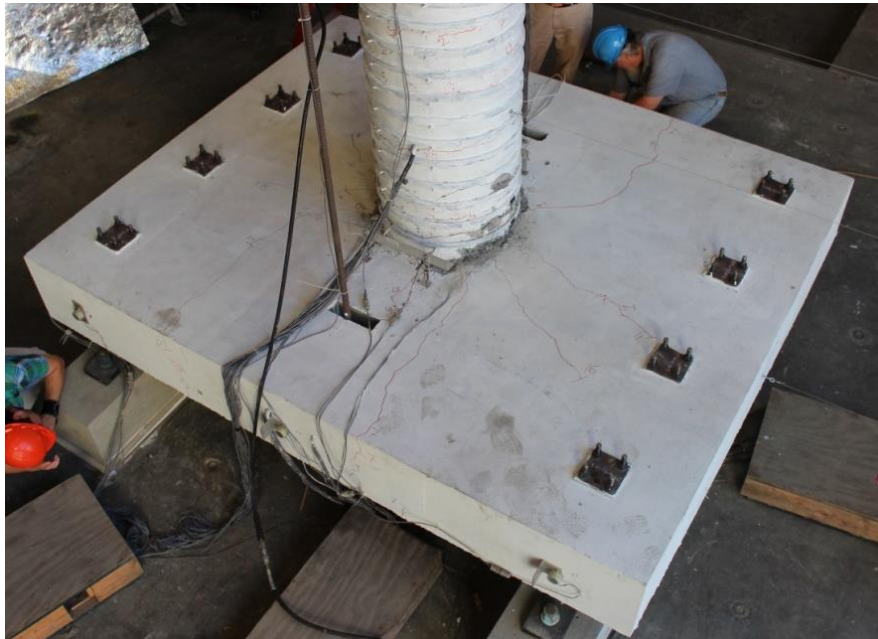
Figure 4.8 – Damage at the bottom face of the slab (top face in the specimen) of Specimen #1 at the end of testing

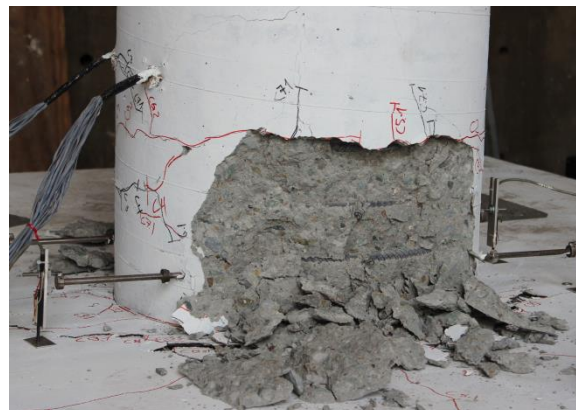
(a) north face at Cycle 6b ($\mu = 2$)

(d) north face at Cycle 10a ($\mu = 6$)

Figure 4.11 – Evolution of damage at the bottom of the column of Specimen #2

Crushing of concrete started near the base of the column of Specimen #2 in the 2nd cycle of ductility 2, as shown in Figure 4.11(a). This was followed by a noticeable drop of the lateral resistance of the column as shown in the lateral load-vs.-drift ratio curve in Figure 4.1. Figure 4.11(b) through Figure 4.11(d) show the evolution of damage near the base of the column, where severe concrete cover spalling

was observed. In the last cycle at ductility 6, the transverse reinforcement was exposed due to the cover spalling, as shown in Figure 4.11(d).

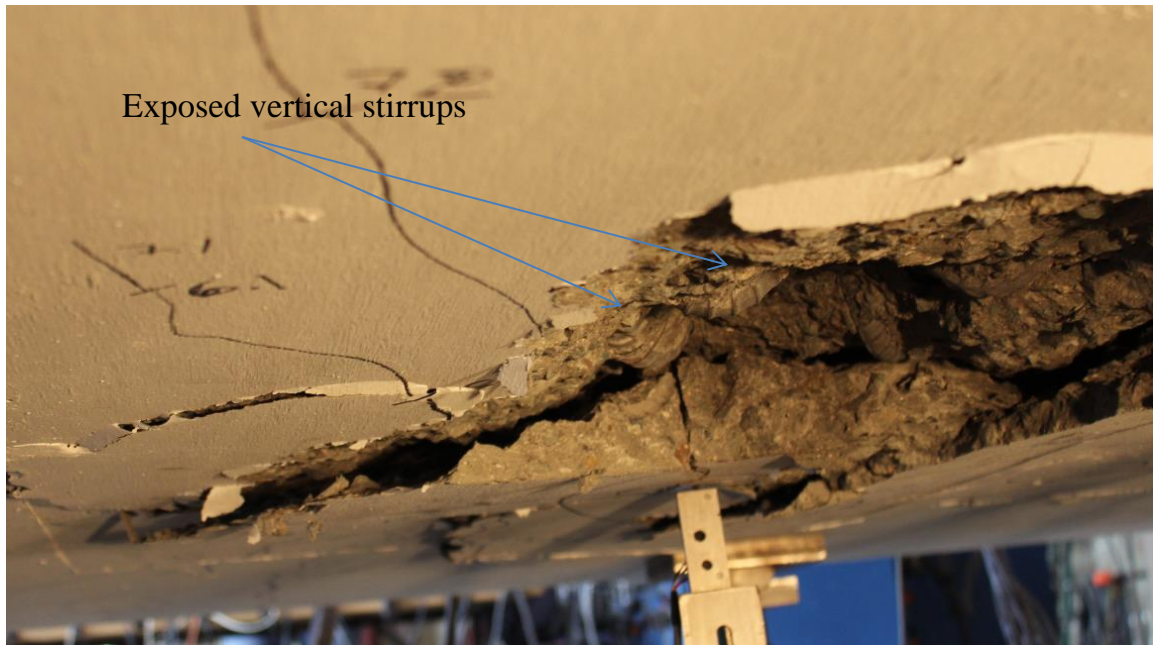
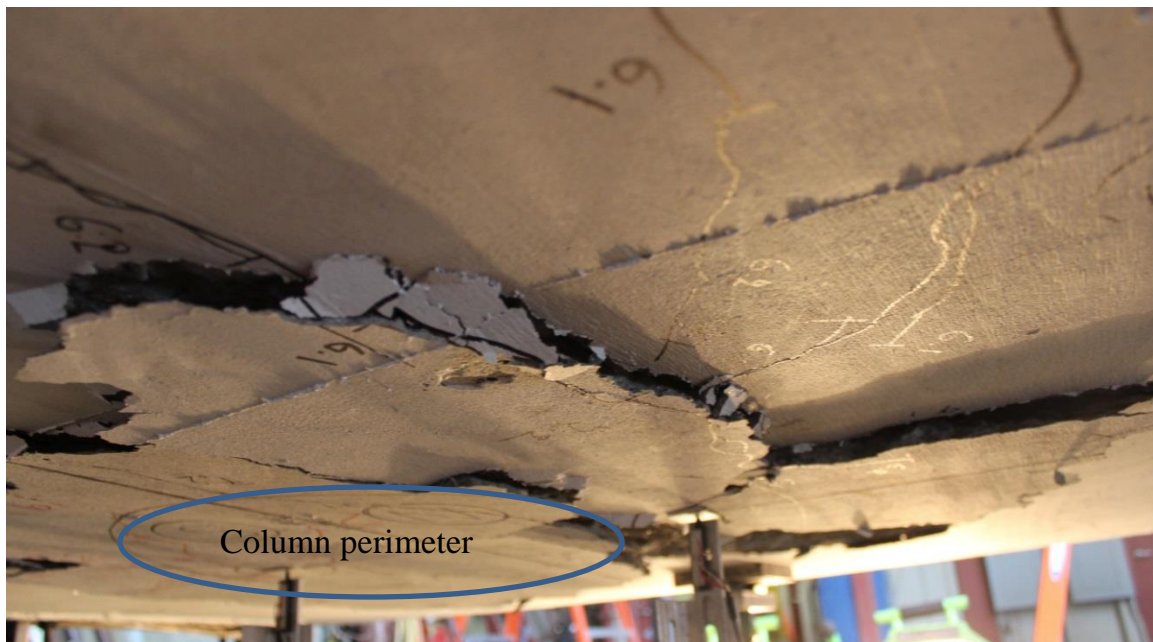
(a) North region

(b) South region

Figure 4.14 – Damage at the top face of the slab (bottom face in the specimen) of Specimen #2 at the end of testing

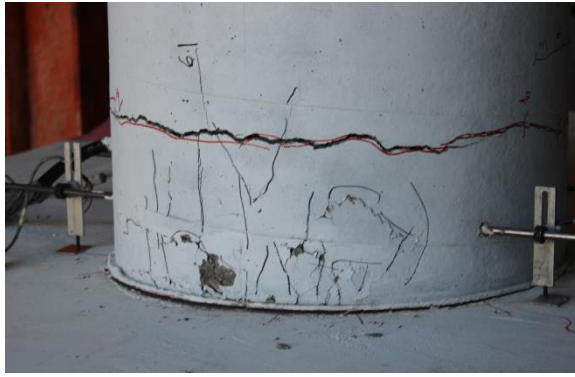
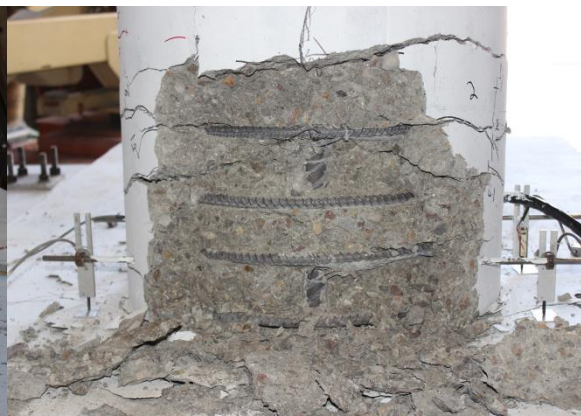
(a) north face at Cycle 6b ($\mu = 2$)

(d) south face at Cycle 11b ($\mu = 7$)

Figure 4.16 – Evolution of damage at the base of the column of Specimen #3

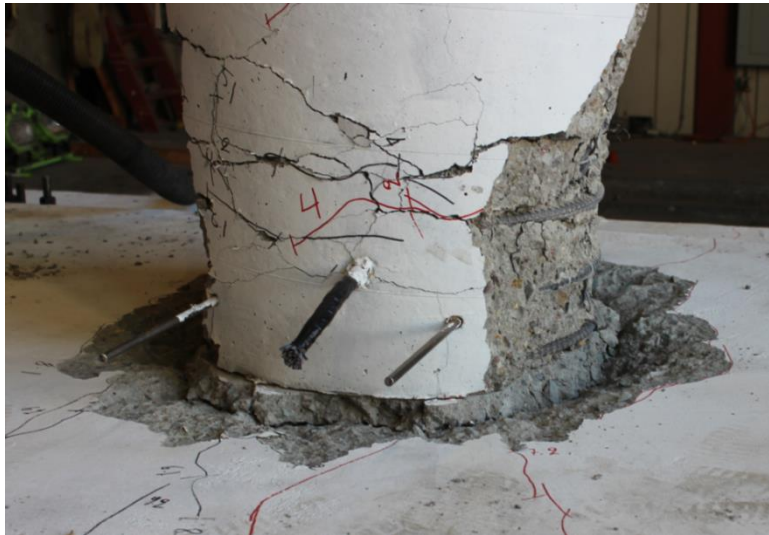
Figure 4.18 – Damage at the slab-column interface after the testing of Specimen #3
