EVALUATION OF LONGITUDINAL JOINTS OF HMA PAVEMENTS IN TENNESSEE

Submitted to the Tennessee Department of Transportation
Research Development and Technology Program

Project #: RES 1304

May 2010

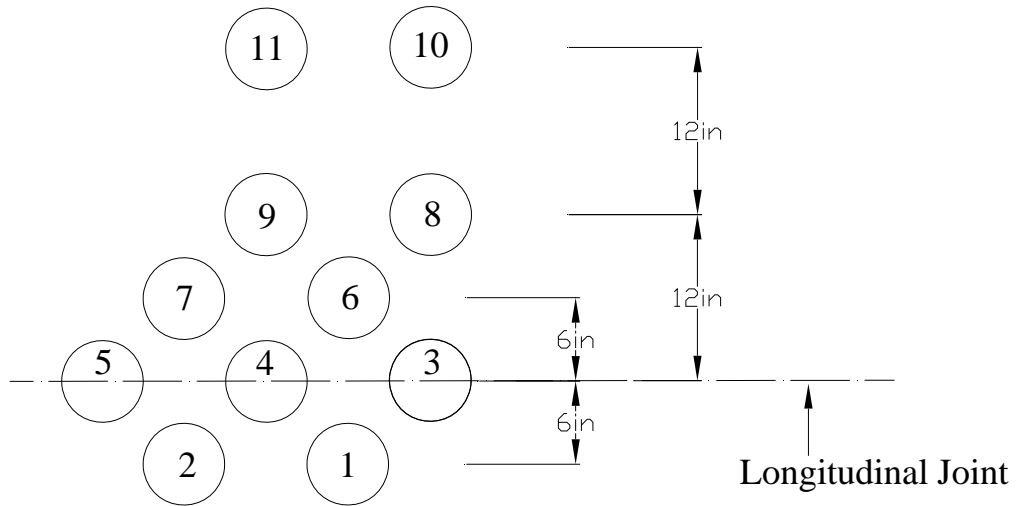
Figure 3-5 Coring Pattern (Note: Only seven cores, i.e., cores No. 3-5 and 8-11 were taken for the first time.)

Field cores were taken twice from the Project CNF923. Coring locations and pattern are shown in Figures 3-4 and 3-5. Seven cores (cores No. 3-5 and 8-11) were taken after compaction at one location for the first time on the same day of construction, Oct. 31, 2007. On Feb. 14, 2008, field cores were taken for the second time at three different locations (Figure 3-4). At each location, 11 cores were taken in the manner shown in Figure 3-5. Figure 3-6 shows the positions of field cores at one location before and after coring. Figure 3-7 shows the coring operation by TDOT engineers. Figure 3-8 shows the cores taken from the longitudinal joint and the neighboring area.

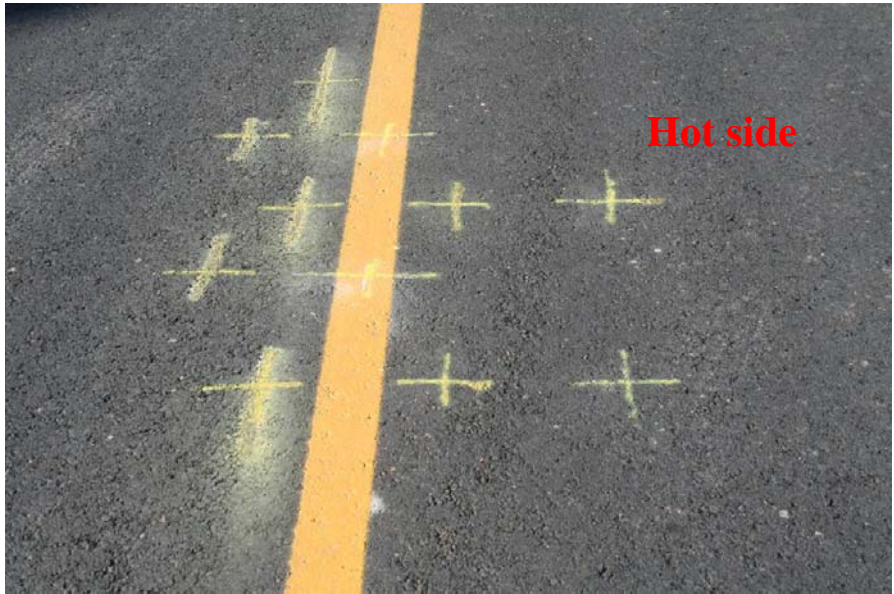
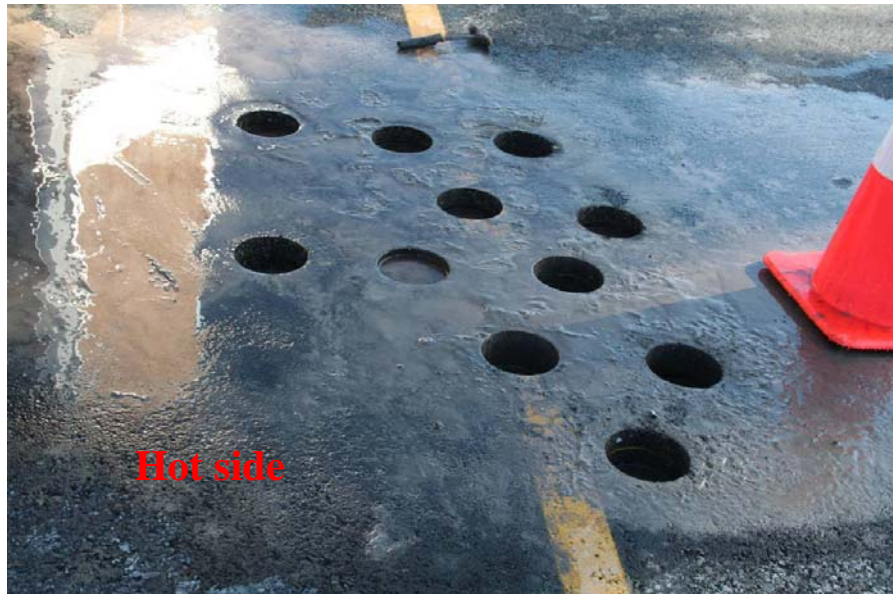
Figure 3-6 Core Positions at One Coring Location

(a) Before Coring

(b) After Coring

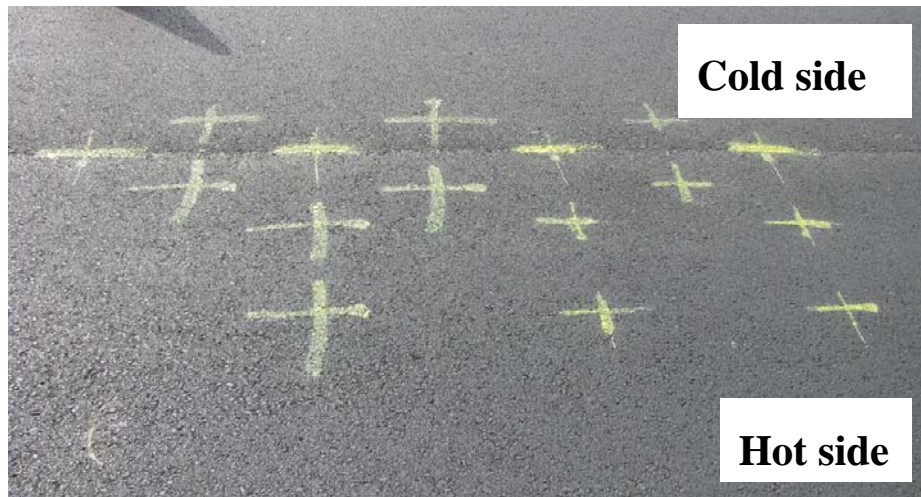
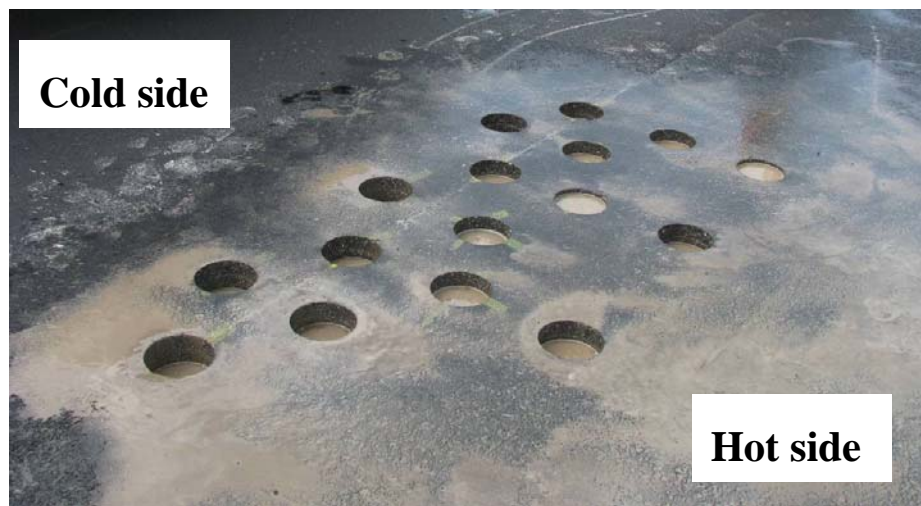
Figure 3-11 Core Positions at One Coring Location

(a) Before Coring

(b) After Coring

3-11 shows the coring positions at one location before and after coring. Figure 3-12 shows the coring operation by TDOT engineers. Figure 3-13 shows the cores taken at one location. The cores were 6 inches in diameter and varied in thickness.

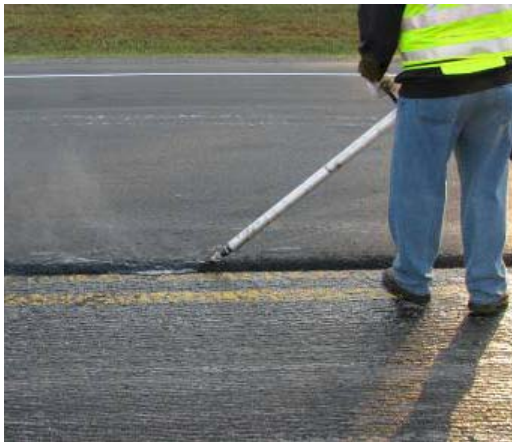
(a) Crafcro Joint Adhesive

Four joint adhesives were applied to the joint surface before placement and compaction of asphalt mixture, with the aim to improve the bonding between cold and hot lanes and to help prevent rainfall from penetrating into joint (Figure 3-15). They included two commercially available joint adhesives (Crafco and Pavon joint adhesives), and two emulsions commonly used by TDOT as tack coat. Crafco joint adhesive is a hot-applied high-polymer (SBS) asphalt containing rubber typically applied at 0.25-0.37 kg/m (4-6 ft/lb), see Figure 3-15(a). Figure 3-15(b) shows that the temperature of Crafco

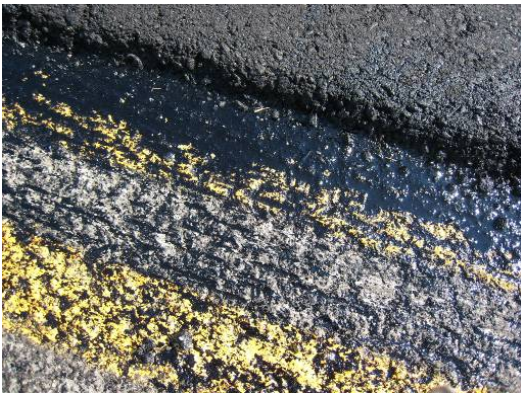
(c) Pavon Joint Adhesive

joint adhesive was tested to be around 182°C (360°F) immediately after application. Pavon joint adhesive is a highly polymerized emulsion containing SBR polymer and resins, see Figure 3-15(c). Its application rate is approximately 0.17 kg/m (73 gallon/mile) for ½” thick pavements and 0.094 kg/m (40 gallon/mile) for 1” thick pavements. The two emulsions used by TDOT as joint adhesive in this study were a polymer emulsion and a basic emulsion. The polymer emulsion was spray applied at a rate of 0.096-0.11 kg/m (0.07-0.08 gallon/yd²) along the longitudinal joint approximately 30.5 cm (12 in.) wide before placement of the adjacent lane, see Figure 3-15(d). The basic emulsion was manually applied along the longitudinal joint and its application rate was 0.124 kg/m (10 gallons/1000 ft), see Figure 3-15(e).

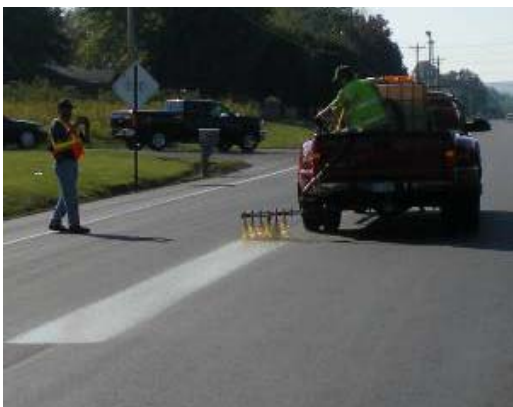
(a) Jointbond

Two joint sealers were employed (Jointbond and Replay joint sealers) to prevent rainfall from penetrating into asphalt pavement. Joint sealers were spray applied to the joint area after pavement compaction. Jointbond is a polymerized maltene emulsion and its application rate is usually 0.36 L/m^2 (0.08 gallon/yd^2), see Figure 3-16(a). Replay joint sealer is a liquid mixture of agricultural oil (soy bean oil) containing SBS polymer and its application rate is 0.14 L/m^2 (0.03 gallon/yd^2), see Figure 3-16(b).

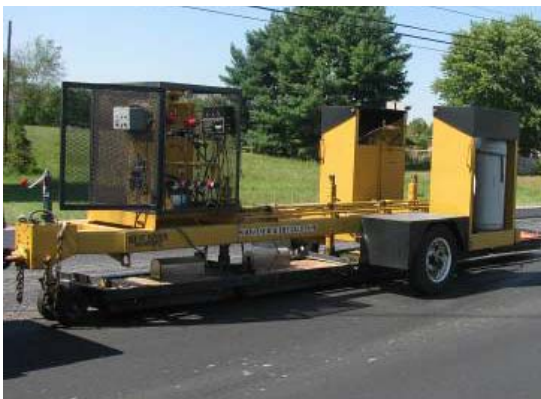
(a) Towed Infrared Heater

The infrared joint heater was used to preheat the cold edge of the previously compacted lane with infrared heat converted from a propane fired heater before placement of asphalt mixture. The purpose of the preheating is to improve the adhesion between cold and hot lanes and make pavement compaction easier. The joint heating system consists of several heaters towed by a tractor [Figure 3-17(a)] and one heater attached to the paver [Figure 3-17(b)]. Immediately after heating, the joint temperature could reach up to 250°F. The joint temperature dropped down to approximately 230°F before mixture placement [Figure 3-17(c)].

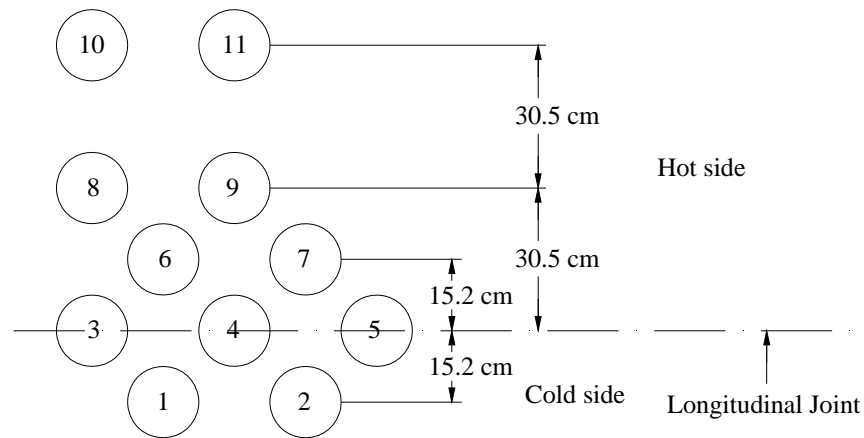
Figure 3-18 Coring Pattern (Cores No. 8 through 11 were taken only for the infrared joint heater and the second control sections)

Two coring patterns were used to take cores from the longitudinal joint and its neighboring area to investigate the joint quality. For the test sections of the infrared joint heater and the second control section, the coring pattern as shown in Figure 3-18 was used to take 11 field cores. For the rest of the test sections, only seven cores (No. 1 to 7) were taken to reduce the damage caused by the coring to the pavement. The field coring began the next day after construction and finished within three days.

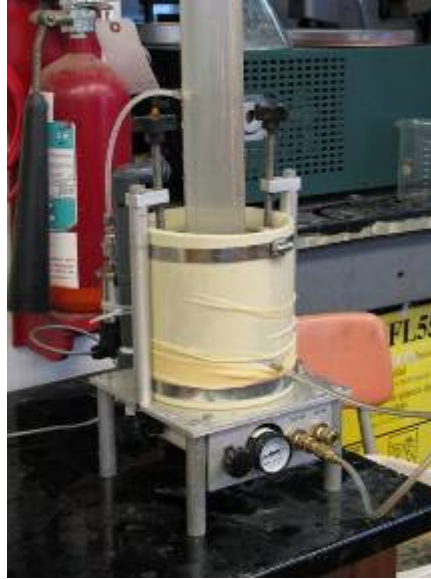
Figure 3-19 Water Permeameter

A falling head permeameter was used to determine the water permeability of the field cores (Figure 3-19). While water flows in the vertical direction through the test specimen, the time interval for the water head to drop from the initial reading to the final reading is recorded. Based on Darcy's law, the coefficient of permeability is expressed using the following equation:

$$k = \frac{aL}{At} \ln\left(\frac{h_1}{h_2}\right) \times t_c \quad (3-1)$$

where k = coefficient of permeability; a = inside cross-sectional area of standpipe; L = average thickness of the core; A = average cross-sectional area of the core; t = elapsed time between h_1 and h_2 ; h_1 = initial head across the core; h_2 = final head across the core; and t_c = temperature correction for viscosity of water.

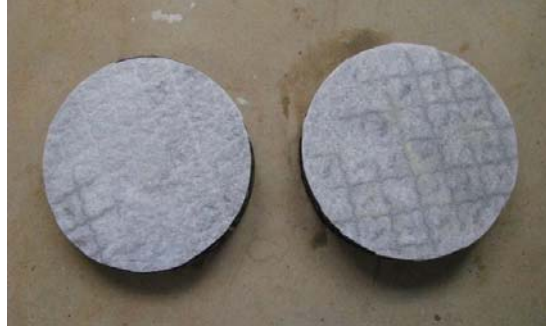
(a) Field Cores Covered with Paper Cloth

$$\text{Absorption Rate} = \frac{W_2 - W_1}{W_1} \times 100 \quad (3-2)$$

where Absorption Rate = water absorption rate, %; W_1 = initial dry weight of paper cloth; and W_2 = final weight of paper cloth.

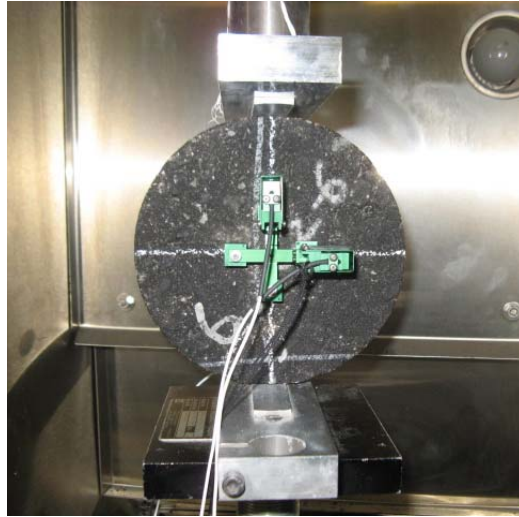
Figure 3-21 IDT Test Setup

The IDT strength test (Figure 3-21) was used to determine tensile strength of field cores, which could be an indicator of adhesion between cold and hot lanes for joint cores. In this test, field cores were monotonically loaded to failure along the vertical diametric axis at a constant rate of 76.2 mm/min. For joint cores, caution was taken to make sure that the specimens were loaded along the direction of the longitudinal joint so that failure could occur along the joint and the indirect tensile strength along the joint was measured. The indirect tensile strength can be calculated as follows:

$$S_t = \frac{2P}{\pi Dt} \quad (3-3)$$

where S_t = indirect tensile strength; P = failure load; D = diameter of specimen; and t = thickness of specimen.

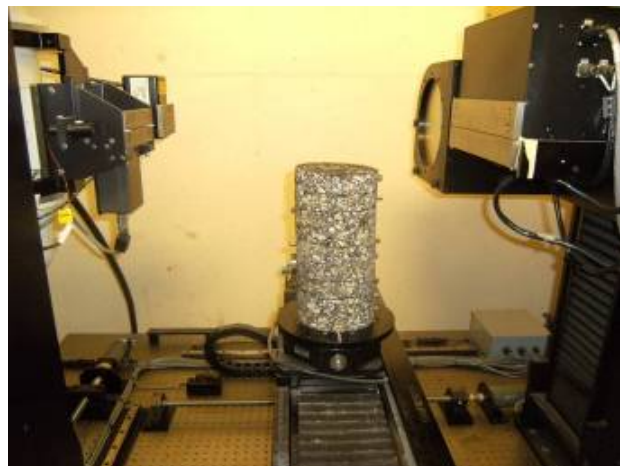
Figure 3-22 X-ray CT Machine

Some field cores were selected and scanned with the X-ray CT machine (Figure 3-22). X-ray particles emitted from the X-ray source penetrate through the core and are detected by an X-ray detector. Due to the difference in attenuation of X-ray particles penetrating through the individual components of asphalt mixtures, 2-D X-ray images are obtained from the detected X-ray intensity. In the study, 2-D images were acquired every 1 mm along the depth of field cores. The air voids distribution along the vertical direction was then obtained through image processing technique.

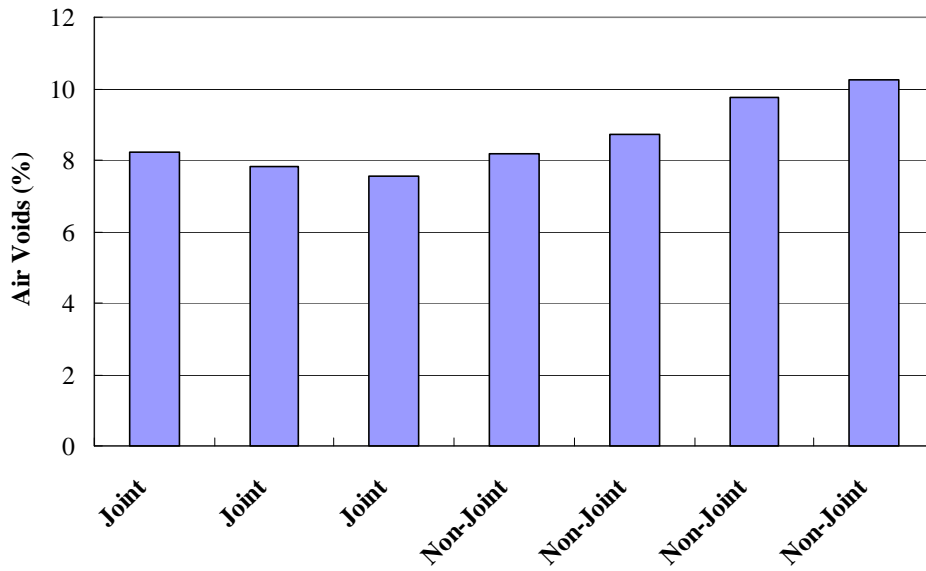
Figure 4-1 Air Voids Results

From Table 4-1 and Figures 4-1 to 4-3, it can be seen that the cores taken from the longitudinal joint exhibited lowest air void content, lowest water permeability, and

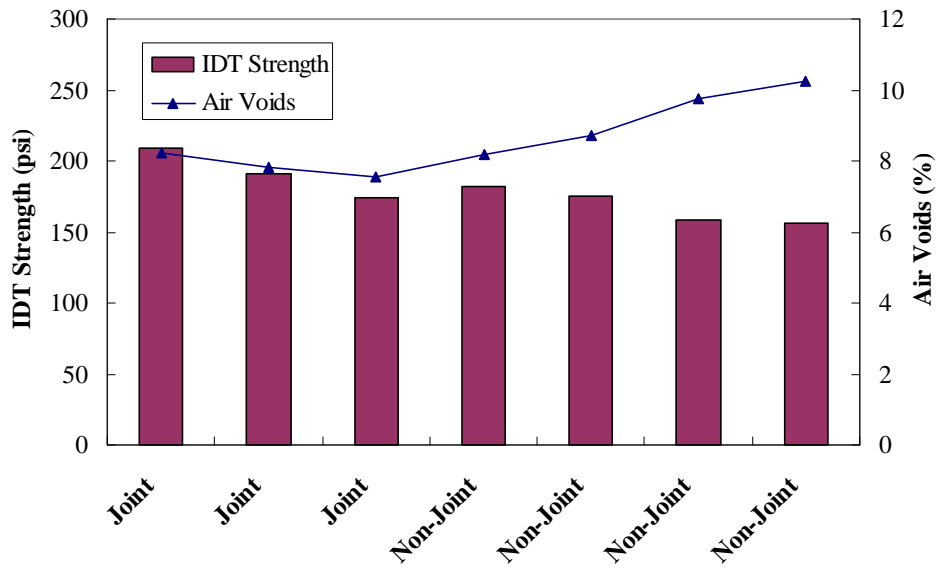
Figure 4-3 IDT Strength

highest IDT strength, which indicates that good joint construction quality could be achieved through the adoption of infrared heating technique. Figures 4-4 to 4-6 further clearly show that the closer the distance from the longitudinal joint, the better the joint construction quality, which can also be attributed to the joint heating technique. The results from the three laboratory tests were consistent with each other, i.e., the lower the air void content, the lower the water permeability, the higher the IDT strength, and the better the joint construction quality.

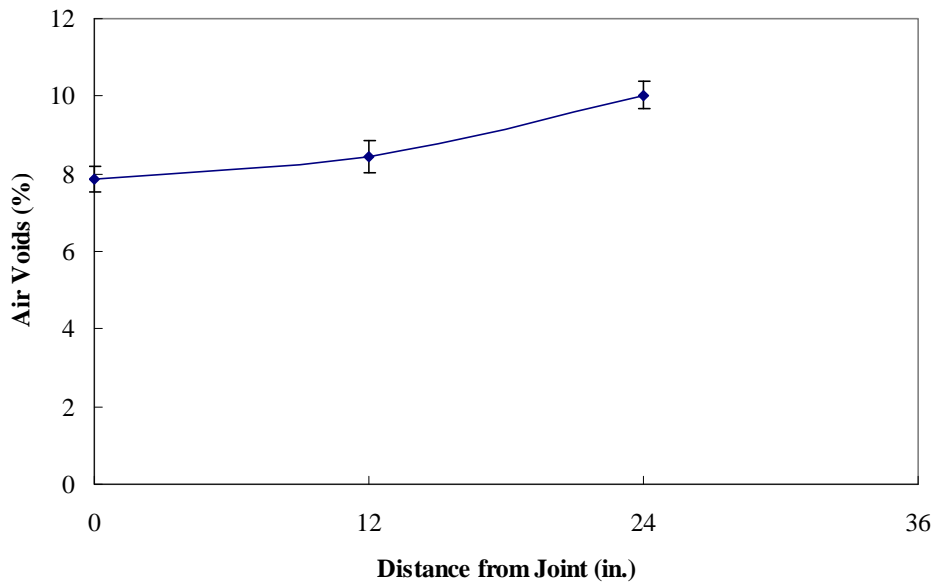
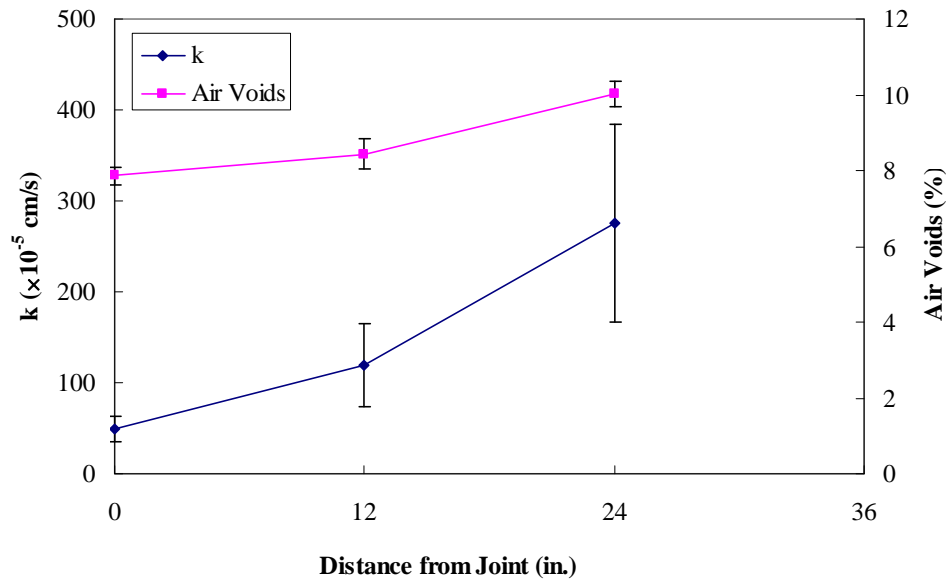
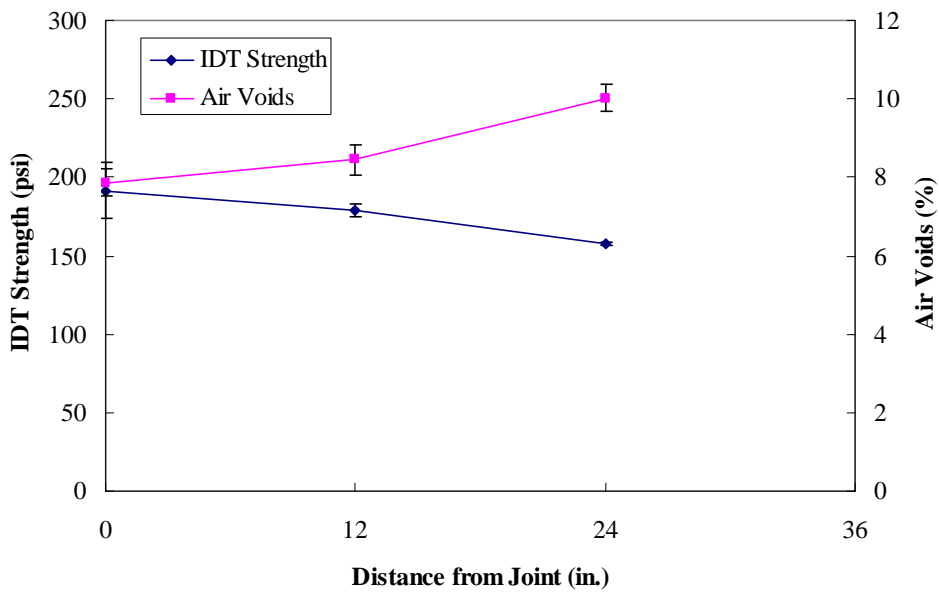
Figure 4-4 Change of Air Voids with Location

Figure 4-5 Change of Water Permeability with Location

Figure 4-6 Change of IDT Strength with Location

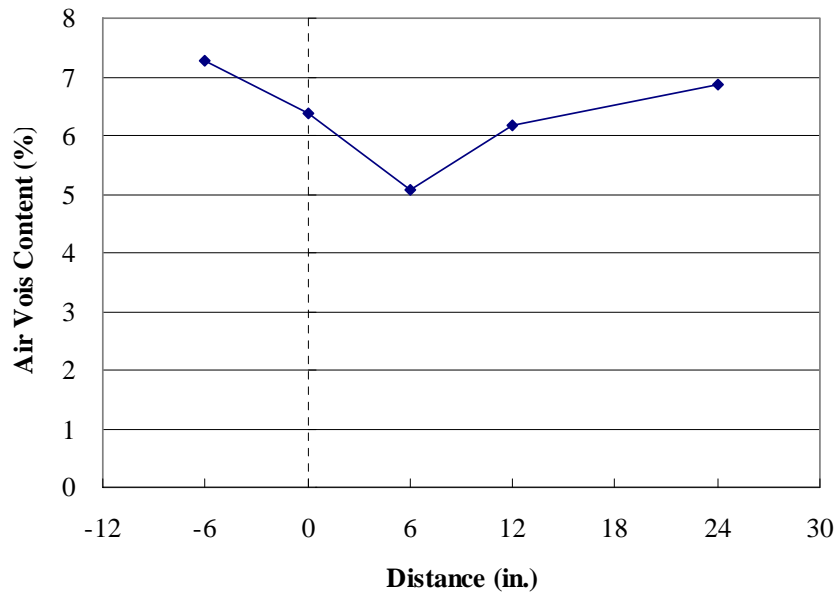
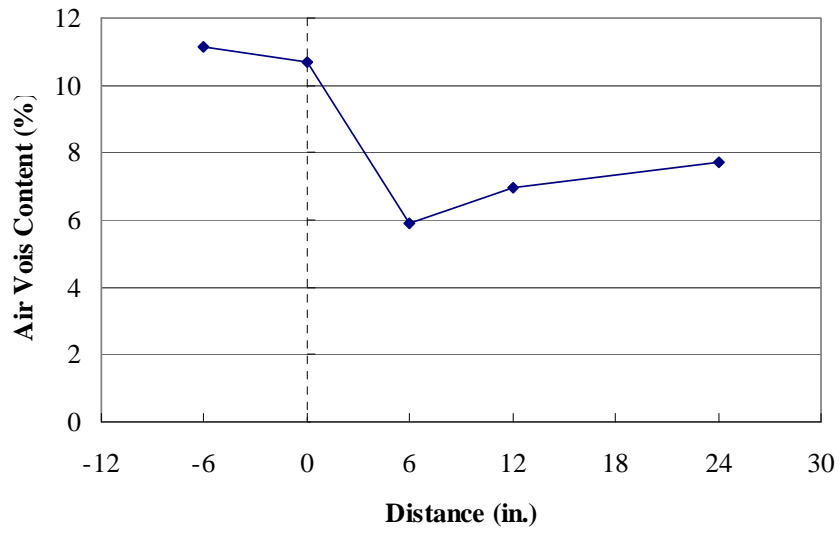
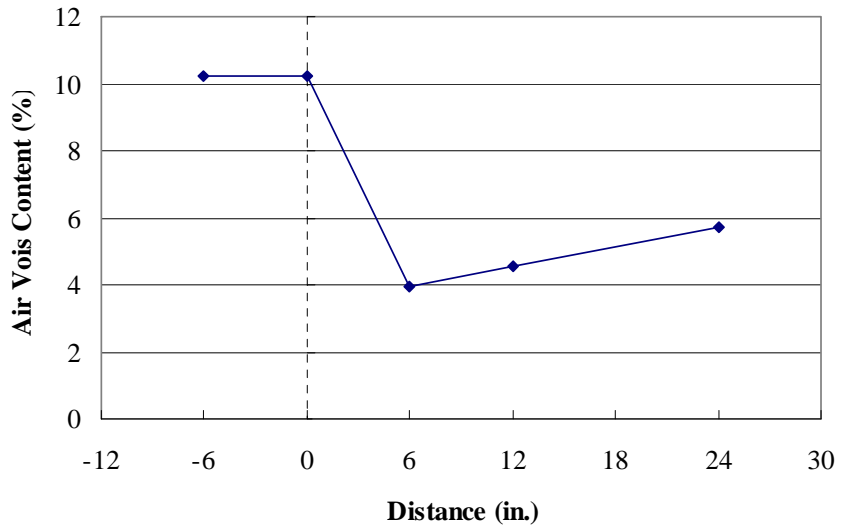
Figure 4-7 Air void content Results

Figures 4-7, 4-8, and 4-9 graphically present the test results for the cores taken on the second time. The results from the three tests were also found to be consistent with each other, which means that generally high air void content led to high permeability and low IDT strength. However, unlike the results for the first coring, the results for the second coring show that the best construction quality was achieved at an area near the longitudinal joint on the hot side, not on the longitudinal joint. Although the joint heating technique was applied for this project, the longitudinal joint and the cold side edge area still exhibited higher air void content, higher permeability, and lower IDT strength when compared to the hot side construction quality. The test results from the cores at three different coring locations generally follow the similar trend.

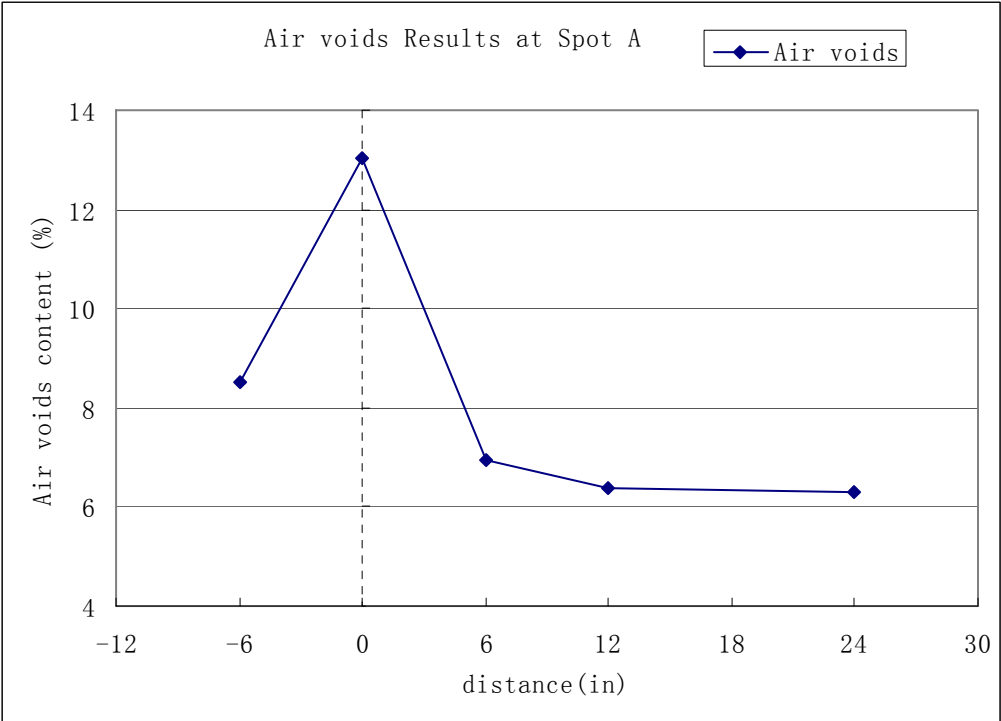
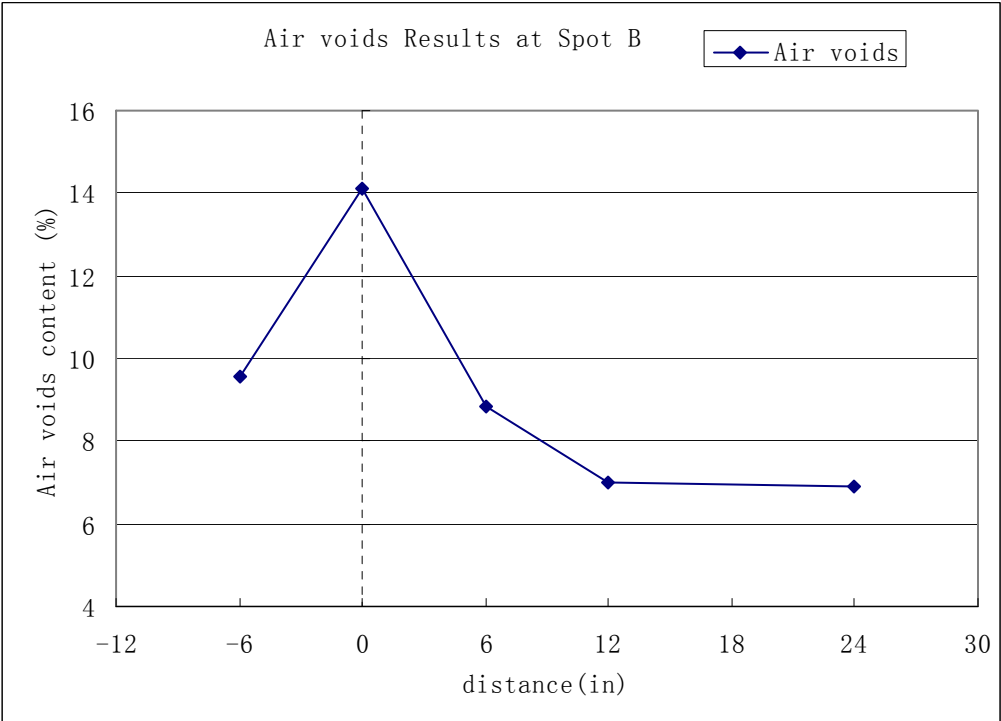
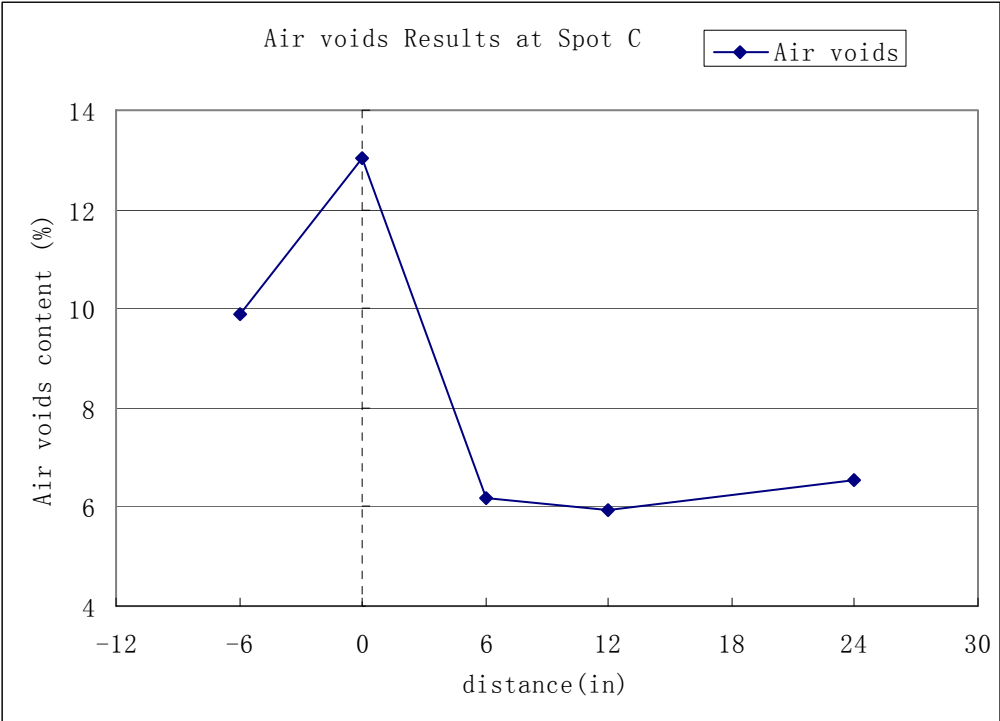
Figure 4-10 Air Voids Results

The air void content, permeability, and IDT strength tests were conducted on the field cores taken from the Project CNG072. Figures 4-10, 4-11, and 4-12 graphically present the test results. The results from the tests were consistent with each other, i.e., the higher the air void content, the higher the permeability, and the lower the IDT strength. It can be seen that without any special joint construction treatment and just using the conventional construction method as usually used in the state of Tennessee, the longitudinal joint exhibited much higher air void content and permeability and much lower IDT strength than its neighboring area on both cold and hot sides. This indicates that longitudinal joint construction quality may not be guaranteed with the conventional construction practice. To improve joint construction quality, special joint construction methods or compaction methods will be needed.

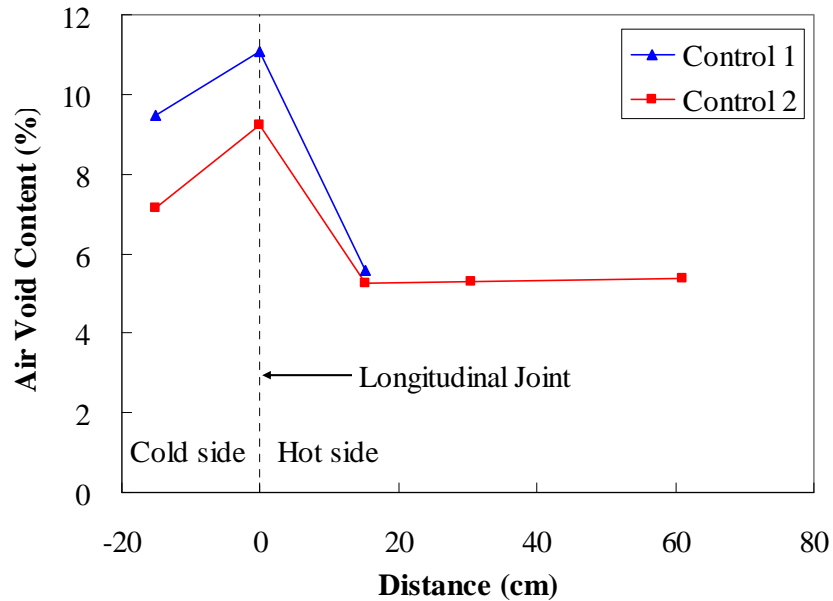
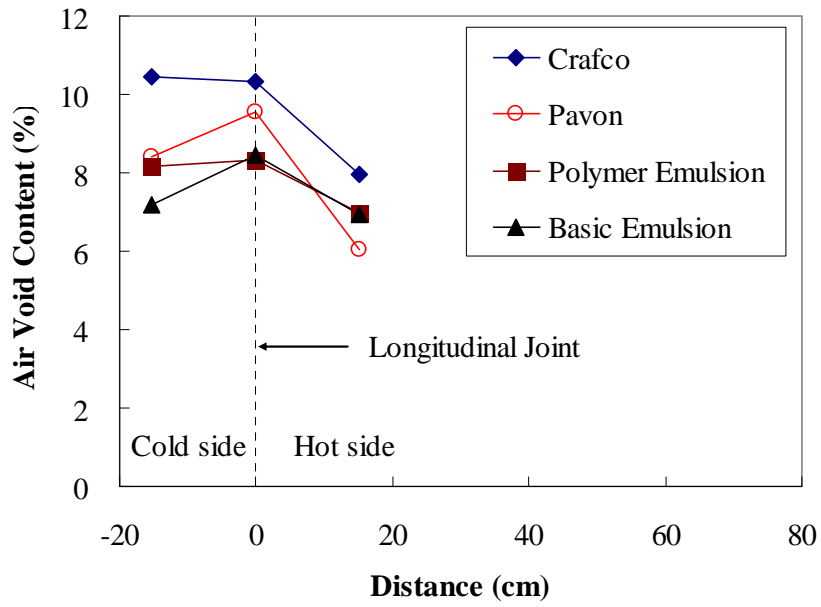
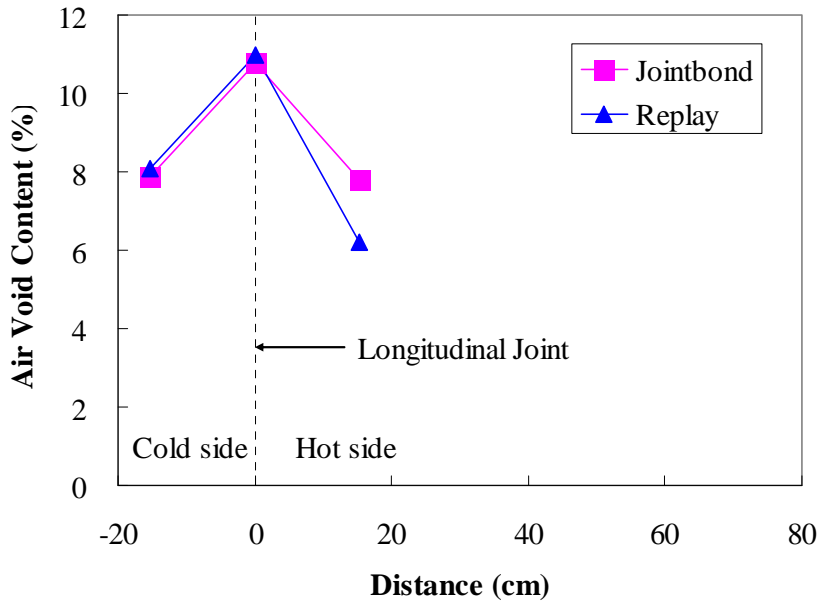
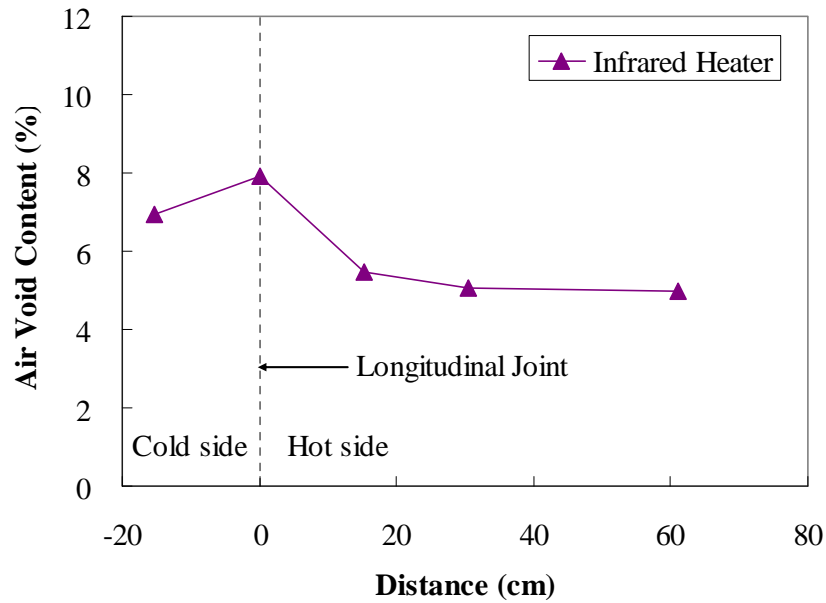
longitudinal joint area. This is consistent with the expected mechanisms for joint adhesive and sealer. The purpose of joint adhesive was to improve the adhesion between cold and hot lanes and the purpose of joint sealer was to seal pavement surface to protect it from water penetrating into it. They were not used to improve the longitudinal joint density.

Unlike joint adhesive and sealer, infrared heater was employed to heat the joint area, to make compaction easier, and thus to compact the joint denser. The effect of infrared heating is clearly shown in Figure 4-13(d). Compared to the test sections of control, joint adhesive, and joint sealer, the air void content of the infrared heat test section was greatly reduced through infrared heating and the longitudinal joint was the densest among all the test sections in this field project. In addition, the construction improvement was not limited to the narrow joint. Even the mat density of the cold side was also improved. As shown in Figure 3-17, a fairly wide area along the joint could be heated and affected by the infrared heater and the construction quality could be improved through the infrared heating.

Figure 4-13 Air Void Results for Project CNG155

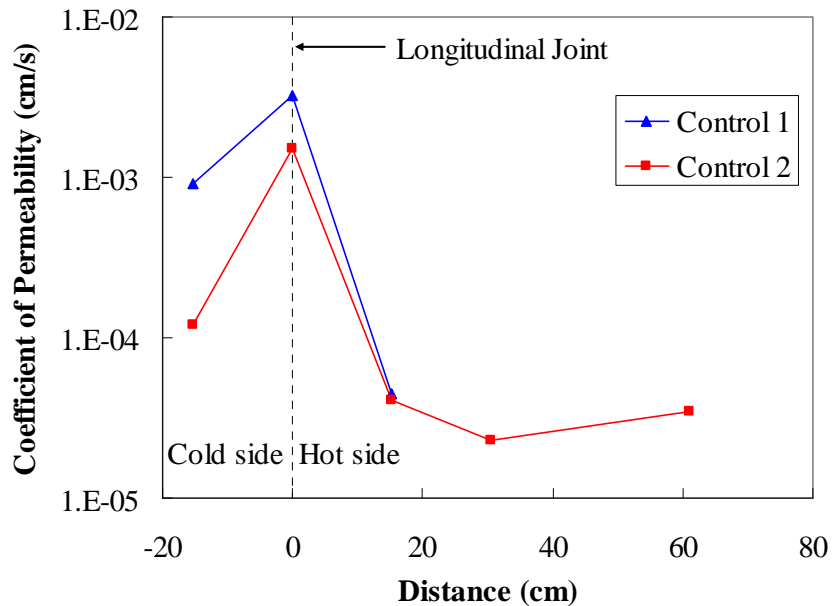
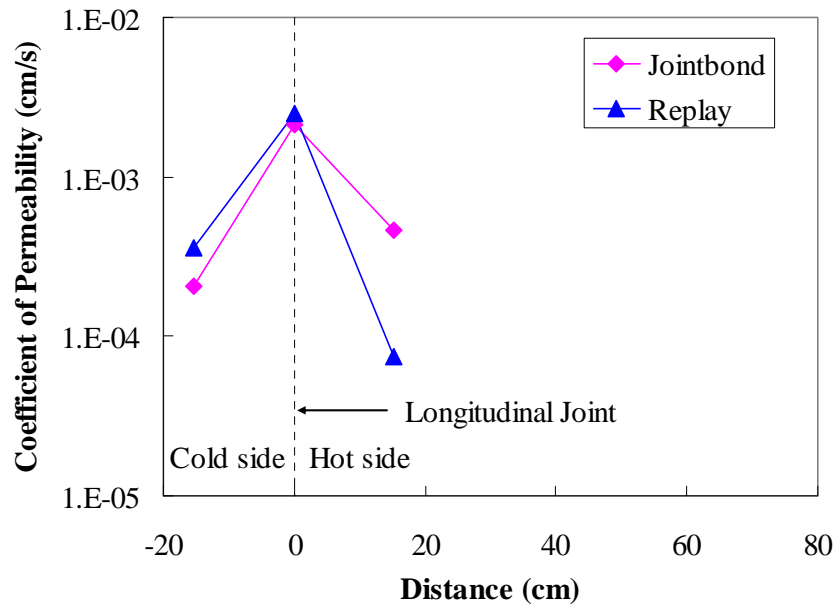
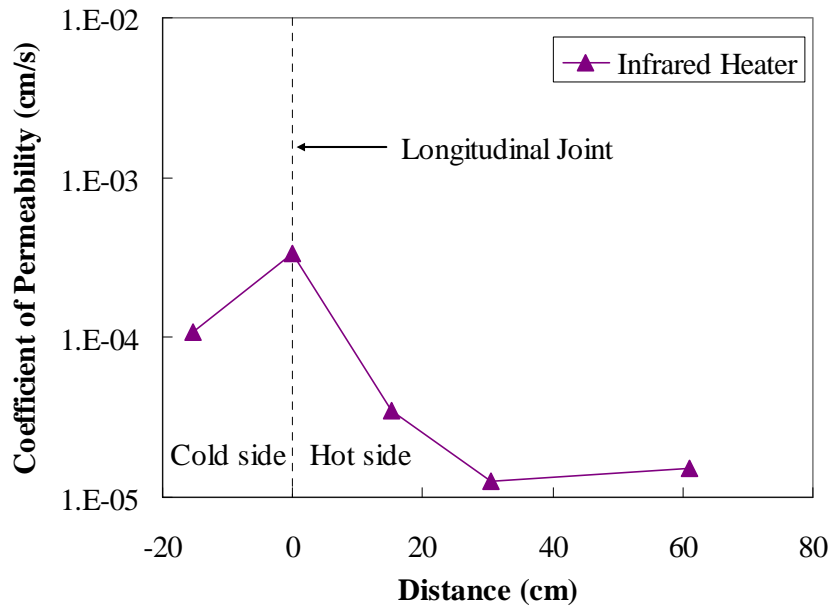
The coefficients of permeability of the field cores from the Project CNG155 are shown in Figure 4-14. It is observed that the distribution of permeability across the longitudinal joint is similar to that of air void content, i.e., the joint exhibited the highest permeability, followed by the mat on the cold side. The mat on the hot side exhibited the lowest permeability. The permeability results are consistent with those of the air void content because air void is generally directly related with permeability. A high air void content usually leads to a high permeability.

head in the falling head permeability test used in this study. However, the sealant membrane may be still effective in preventing water from penetrating into pavement during a regular rainfall, which was confirmed by the results from the water absorption test that will be discussed later.

Figure 4-14(d) shows that the infrared heater was very effective in reducing the permeability coefficient along the longitudinal joint and in its neighboring area. Compared to other test sections, the section of infrared heater exhibited much lower permeability coefficient around the joint area. Since water infiltrating into longitudinal joint plays a significant role in cracking or raveling failure of longitudinal joint, the lower permeability coefficient achieved through infrared heater would help longitudinal joint perform better and last longer.

Figure 4-14 Permeability Results for Project CNG155

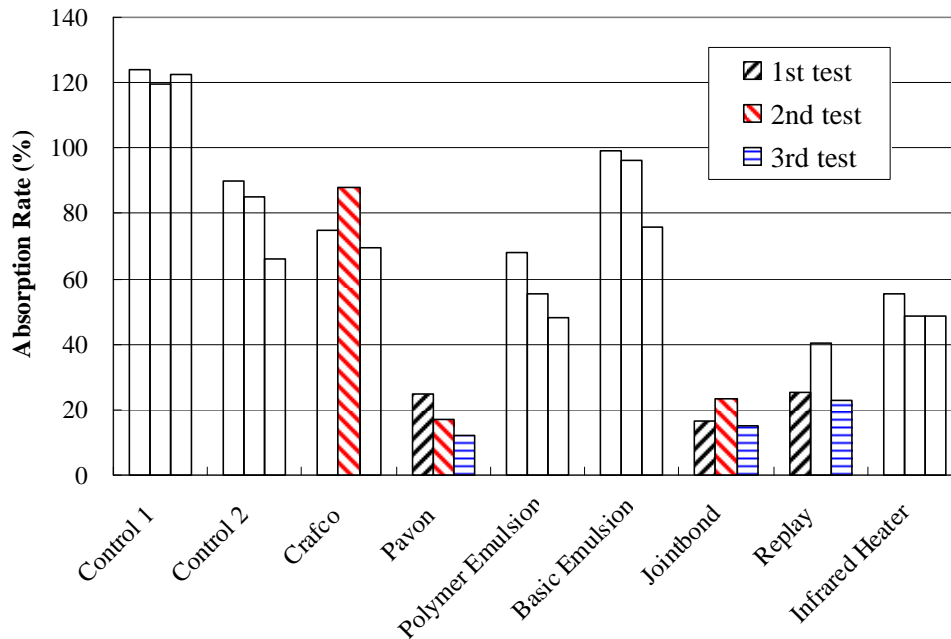
To evaluate the feasibility of the water absorption test, this test was conducted three times in this study. The average water absorption rates of replicate joint cores at each time are shown in Figure 4-15. It can be seen that the results from the three tests were consistent and repeatable. The joint cores taken from the two sealer sections (Jointbond and Replay) and the section with Pavon joint adhesive exhibited significantly lower absorption rates than the cores taken from other sections. The results indicate that joint sealers in this study were effective in preventing water from penetrating into longitudinal joint, which would help the longitudinal joint prevent moisture-related damage and make the joint perform better. One concern about joint sealer is that how long they can sustain the wear of vehicle tires. Considering that a longitudinal joint is much less often passed by vehicles than lane path, joint sealer is able to keep its effectiveness for a reasonably long period of time.

Figure 4-15 Water Absorption Rates for Project CNG155

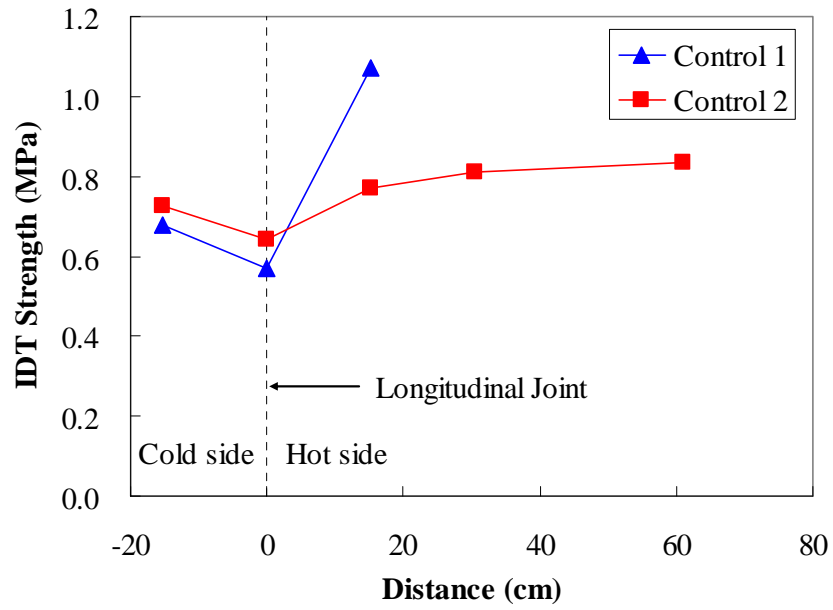
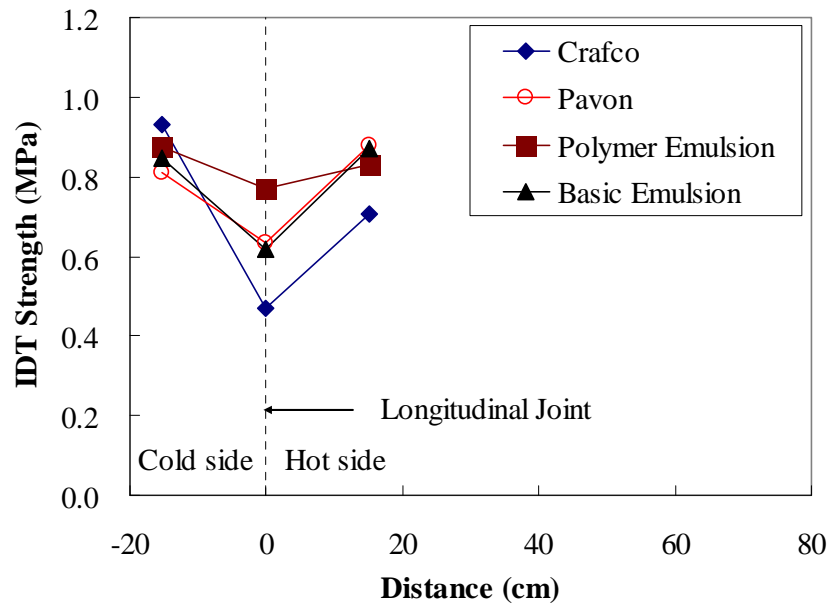
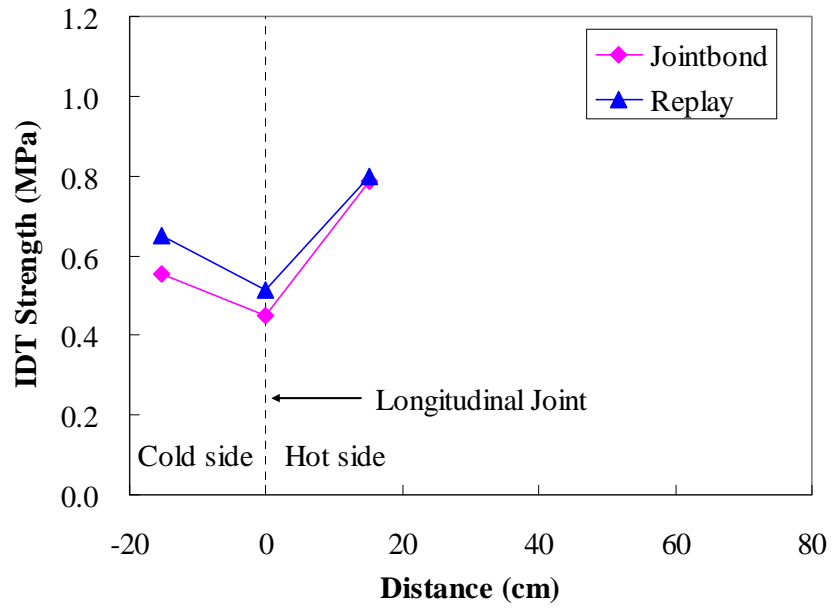
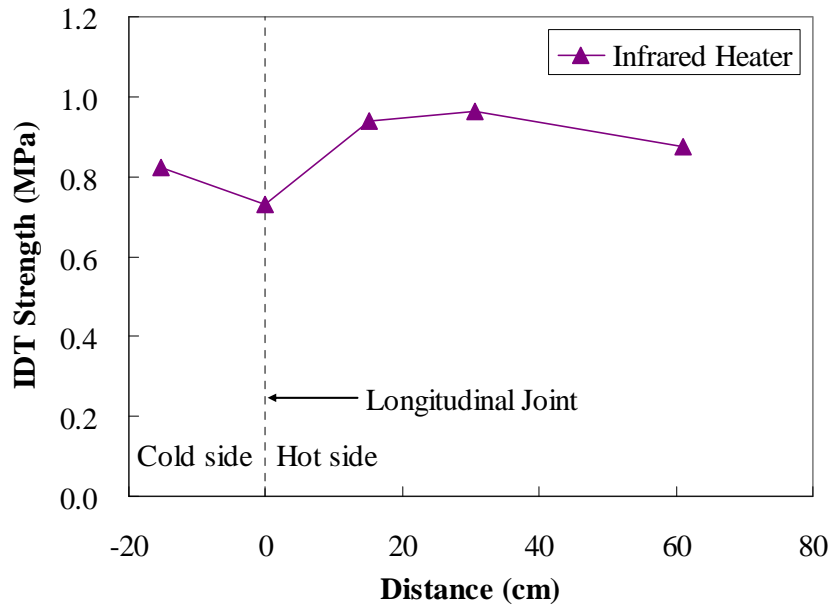
Figure 4-16 IDT Strength Results

Figure 4-16 shows the indirect tensile (IDT) strength results of the field cores for the Project CNG155. It can be seen from Figure 4-16(a) that the mat on the hot side exhibited the highest IDT strength, followed by the mat on the cold side. The longitudinal joint exhibited the lowest IDT strength. This is consistent with the air void content and permeability test results. From Figure 4-16(b), polymer emulsion significantly improved IDT strength. During the construction, it was observed that Crafcoc joint adhesive was often picked up by the tires of haul trucks leaving the paver, which could significantly compromise its efficacy. Compared to the control sections, the IDT strength of the test sections treated with joint sealers (Jointbond and Replay) did not seem to increase at all [Figure 4-16(c)]. From Figure 4-16(d), the infrared heater was very effective in

improving IDT strength, which could be attributed to the better compaction of longitudinal joint under the reheated condition.

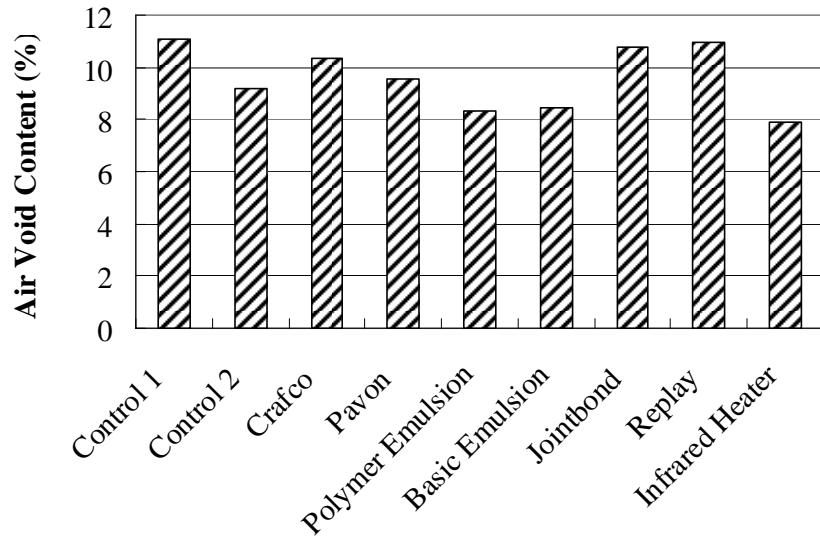
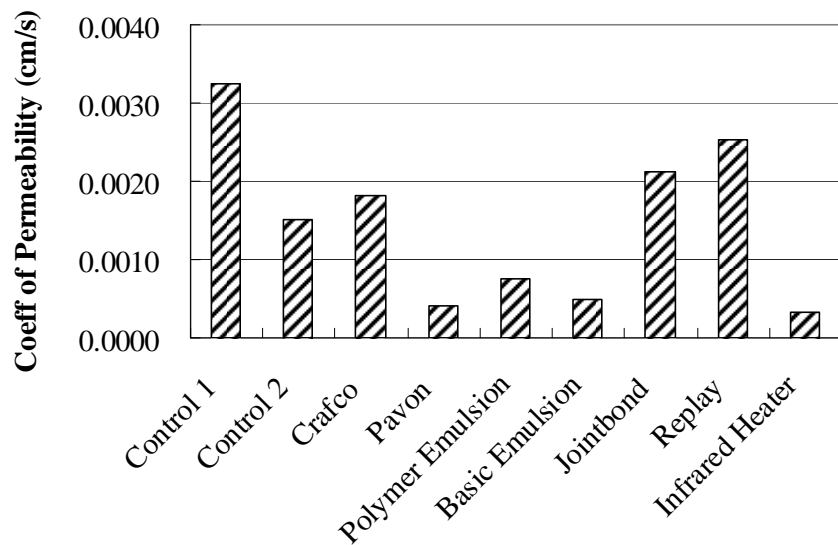
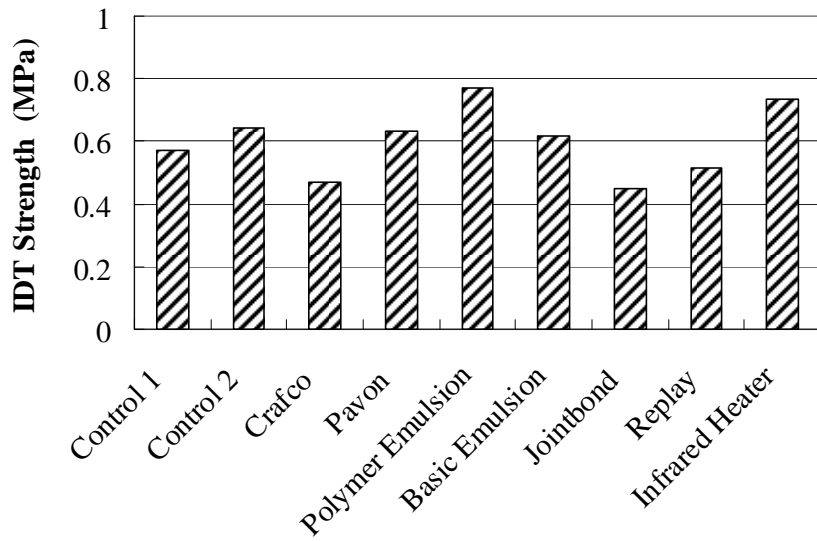
Figure 4-18 Comparison of Different Joint Construction Techniques

It should be noted that the overlay used in this study was 31.8 cm (1.25 in.) thick. The effectiveness of joint heater may be compromised with the increase in the layer thickness because infrared may not be able to penetrate through the thick layer to heat the

asphalt mixture at the bottom. Unlike infrared heater, joint adhesive is applied right along longitudinal joint and joint sealer is spray applied on pavement surface along longitudinal joint after construction, their effectiveness should have nothing to do with the thickness of pavement layer.
