EVALUATION OF LONGITUDINAL JOINTS OF HMA PAVEMENTS IN TENNESSEE

Submitted to the Tennessee Department of Transportation
Research Development and Technology Program

Project #: RES 1304

May 2010

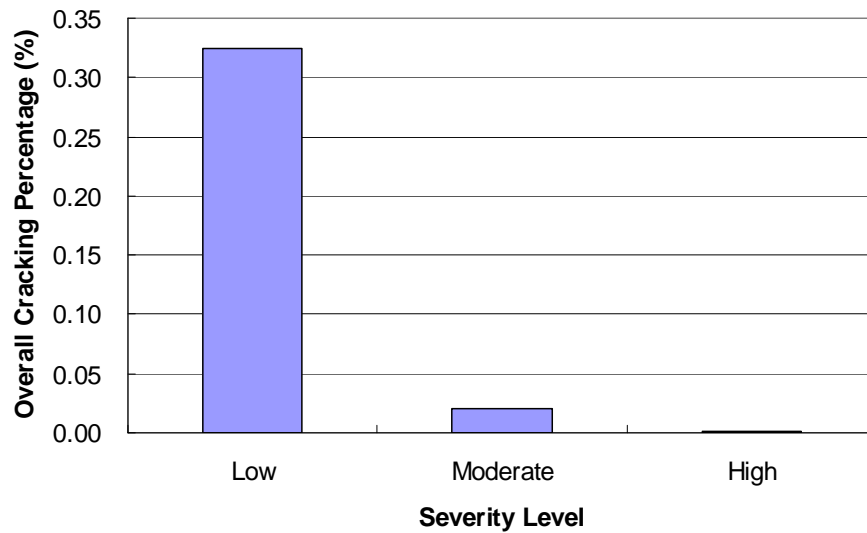
Table 5-1 and Figure 5-1 present the overall cracking performance of the interstates of Tennessee in 2007. The average cracking percentage of all thirteen interstates in Tennessee was less than 0.35% at low severity level, i.e. less than 5.6 meters out of 1 mile of interstate pavement exhibited the low level cracking. From Table 5-1 and Figure 5-1, it is also observed that much less of Tennessee interstates experienced the moderate and high level cracking. This indicates that the overall longitudinal joint on interstates performed well in Tennessee.

Figure 5-1 Cracking Performance of Interstates in Tennessee

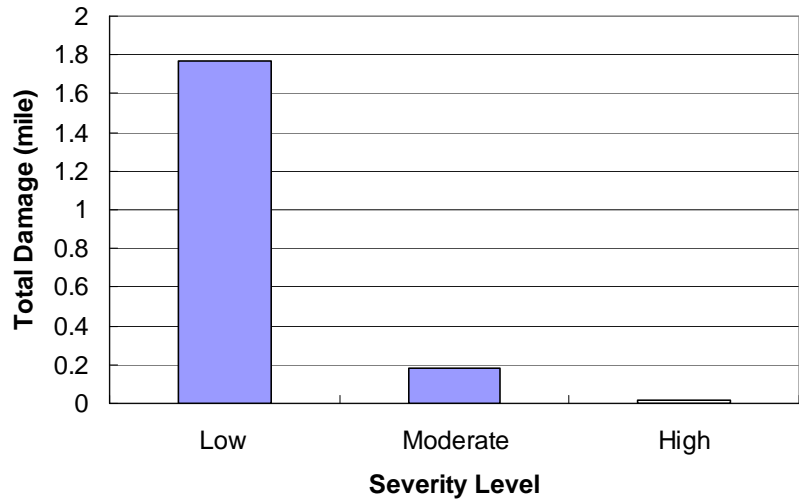
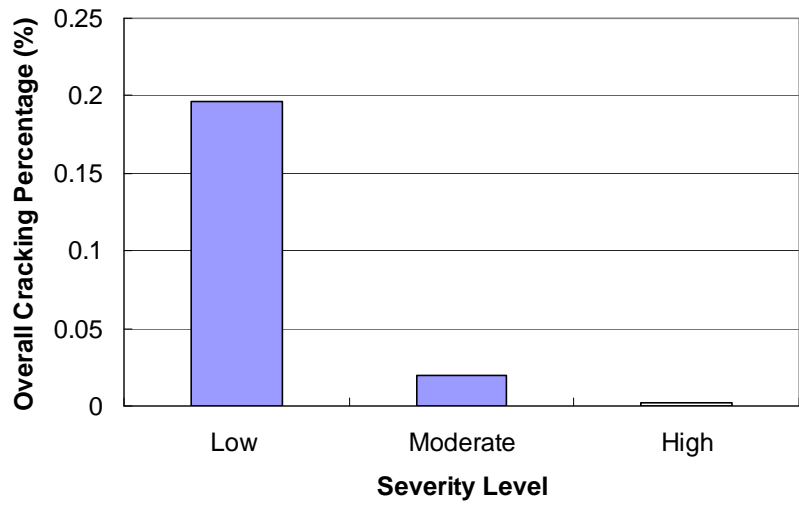
The Interstate 40 is a major interstate east-west route going through Tennessee. The cracking condition of I-40 is shown in Figure 5-2. The total cracking length at low severity level on I-40 was about 1.8 miles, less than 0.2% of its total length in Tennessee. The total length and overall percentage for moderate and severe cracking were much less compared to the low cracking level.

Figure 5-2 Longitudinal Joint Cracking on Interstate 40

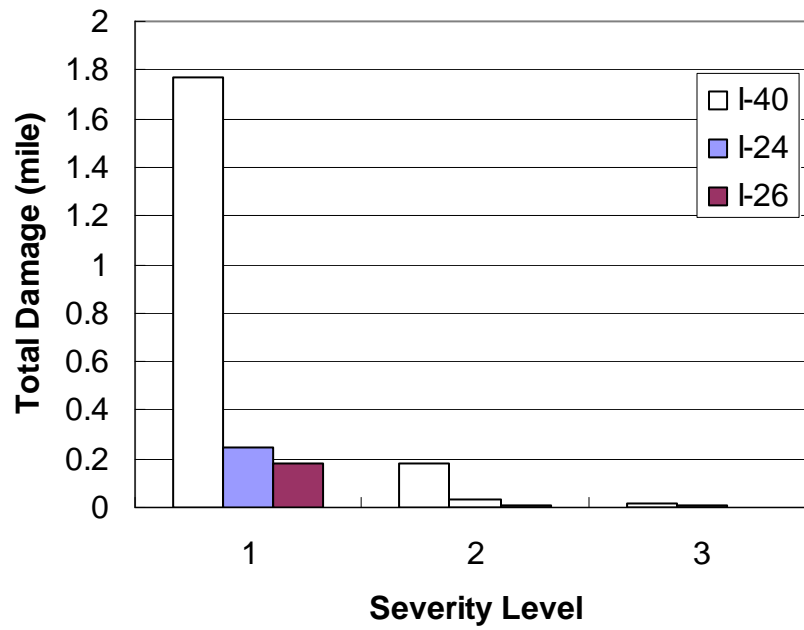
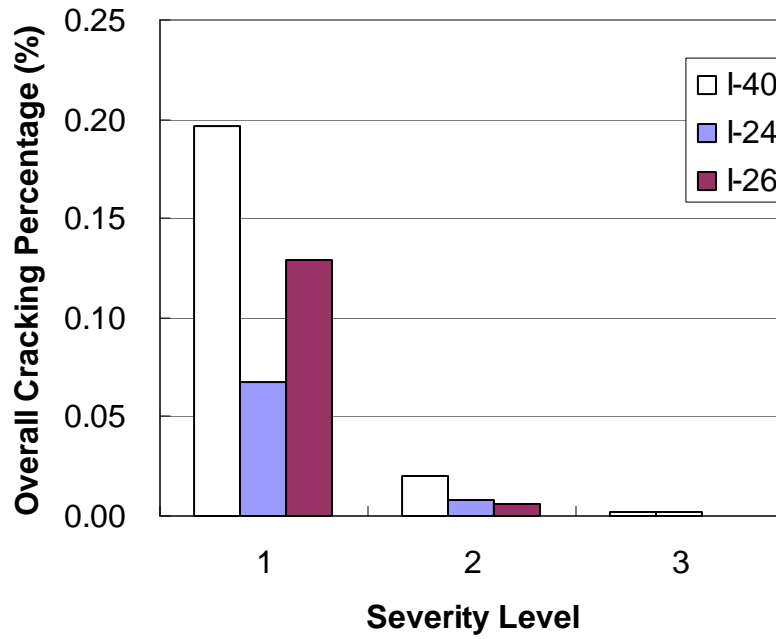
Figure 5-3 presents the comparison of three east-west interstate highway routes in Tennessee. It can be seen that I-40 had the longest total cracked longitudinal joint than the other two interstates (I-24 and I-26) because it has the longest mileage in Tennessee. In terms of overall cracking percentage, the longitudinal joint on I-40 performed worst among the three interstate routes.

Figure 5-3 Comparison of East-West Interstate Routes

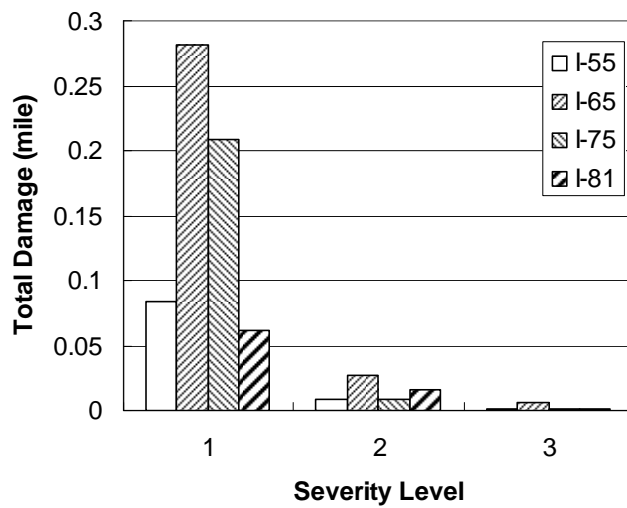
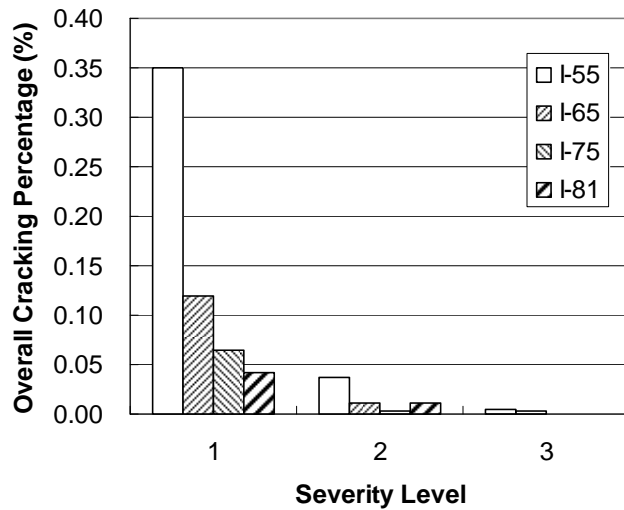
Figure 5-4 presents the comparison of four north-south interstate highway routes in Tennessee. It can be seen that the three major north-west interstate routes in Tennessee (I-65, I-75, and I-81) were subjected to similar longitudinal joint failure in terms of both total crack length and overall cracking percentage, among which I-81 performed the best and I-65 performed the worst.

Figure 5-4 Comparison of North-West Interstate Routes

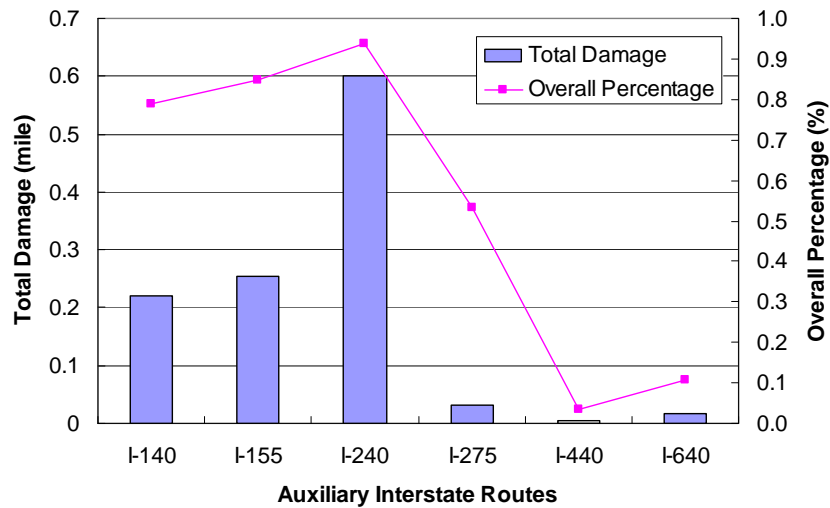
Figure 5-5 presents the longitudinal joint cracking on auxiliary interstate routes in Tennessee at the low severity level. It can be seen that the ranking of the longitudinal joint performance was similar based on total crack length and overall cracking performance.

Figure 5-5 Longitudinal Joint Cracking on Auxiliary Interstate Routes

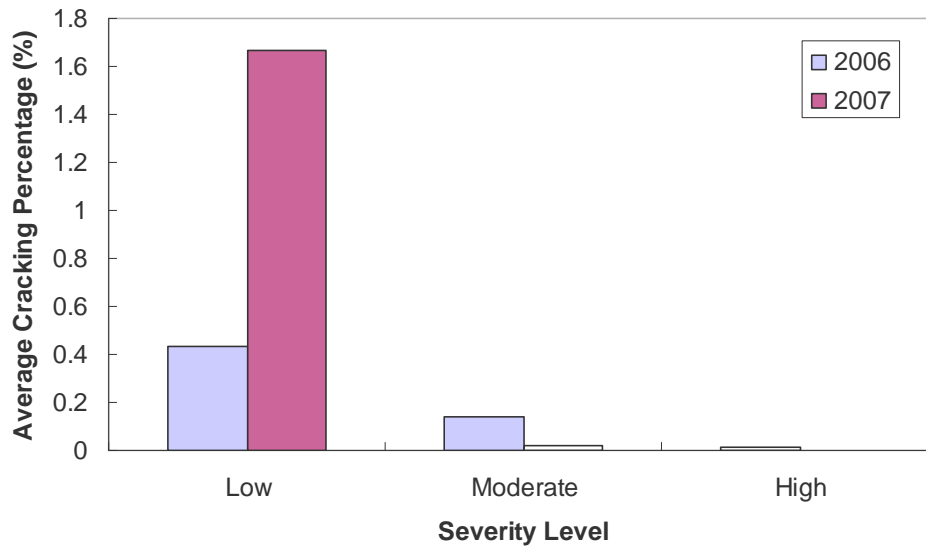
It is observed from Figure 5-6 that the state routes in Tennessee experienced more cracking in 2007 than in 2006. Major state routes with center-line length ≥ 10 miles were selected for the evaluation of the overall cracking performance of longitudinal joint on Tennessee state routes. Figure 5-7 shows that the cracking pattern of the major state routes at different severity levels similar to that in Figure 5-1 for the interstates in Tennessee. However, cracking percentage values show that the state routes exhibited much worse cracking than the interstates in Tennessee. At the low severity level, Tennessee Interstate highways exhibited less than 0.35% cracking, whereas state routes experienced 0.8% cracking. This indicated the longitudinal joints on the state routes in Tennessee did not perform so good as on the Interstate highways.

Figure 5-6 Comparison of Longitudinal Joint Cracking on Tennessee State Routes

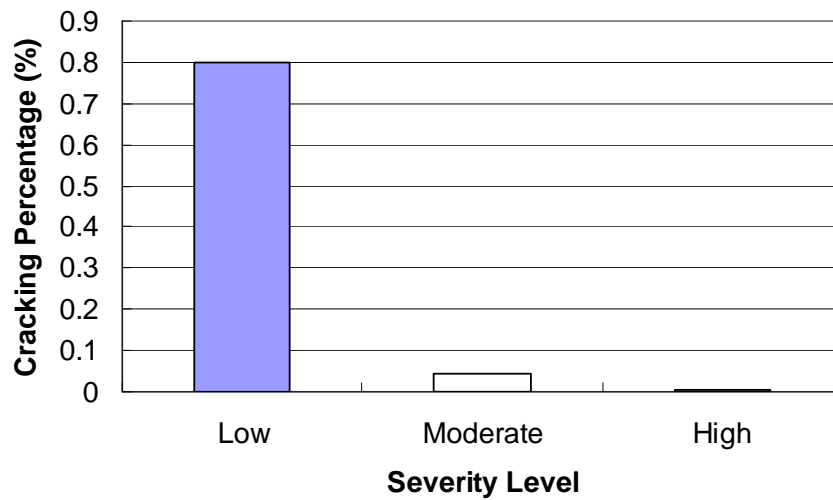
Figure 5-7 Cracking Performance of Major Tennessee State Routes
(Center-length ≥ 10 miles)

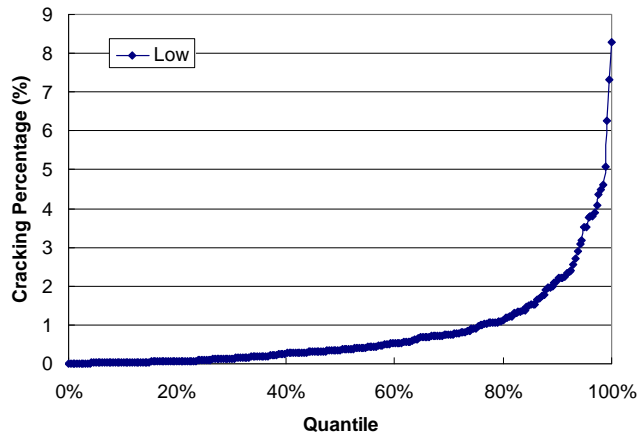
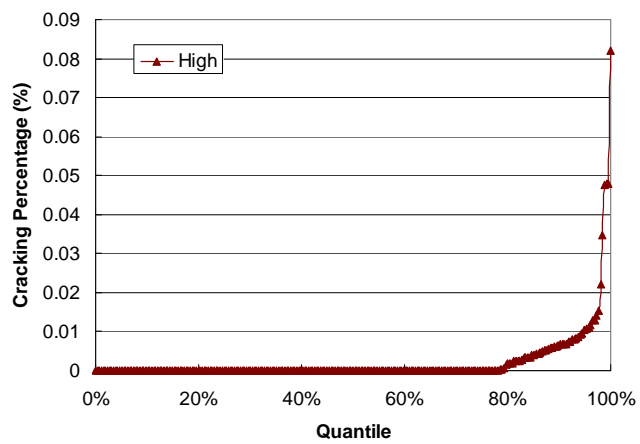
From Table 5-3 and Figure 5-8, it can be seen that almost 80% of the state routes in Tennessee experienced less than 1% cracking at the low severity level. At the moderate and high severity levels, almost 40% and 80% of the state routes experienced no cracking at all. Only a relatively small percentages of the state route experienced cracking at three different severity levels.

Figure 5-8 Distribution of Longitudinal Joint Cracking Percentage of Major Tennessee State Routes
