Report # MATC-UI: 371

Final Report

Automated Erosion System to Protect Highway Bridge Crossings at Abutments

June 2010

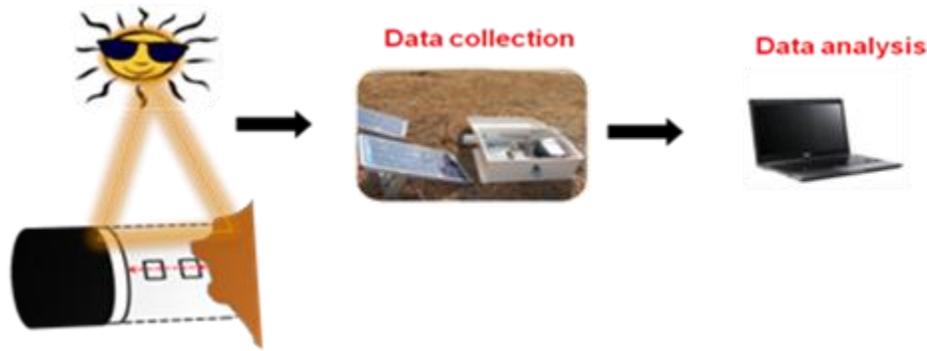
Figure 3.1 Illustration of the Principles of Operation of the PEEP

The Photo-Electronic Erosion Pin, which was originally described in Lawler (1991), provides automated and continuous monitoring of erosion and deposition. The PEEPs are essentially a series of photovoltaic/ photo-resistance cells (or diodes) encased in a transparent waterproofed acrylic tube (Lawler 1991, 1992); thus, the PEEPs are light dependent. The photovoltaic PEEP provides a voltage as light (e.g., from the sun) strikes the diodes. The voltage is sent along a cable and is recorded on a datalogger. With the photo-resistance PEEP, an external voltage is supplied to the PEEP but is stopped when reaching the photo-resistors. As light strikes the photo-resistors their resistance drops, which allows a higher voltage to pass through to the datalogger, where the value is recorded. Figure 3.1 illustrates the principle of the PEEP sensors.

Essentially for both PEEP models, an increase in the number of exposed diodes (i.e., struck by light) corresponds to a higher voltage sent to the datalogger. When the PEEPs are initially inserted into the bank face parallel to the water surface, all the diodes are covered by the bank sediment and the voltage received by the datalogger is low. However, as the bank face retreats, more diodes are exposed and the voltage received by the datalogger increases. This voltage is normalized against a reference value, which corresponds to the voltage if all PEEP diodes are exposed. This ratio is then related to an erosion length. The ratio between the reference voltage and the voltage received by the datalogger is considered to account for the fluctuations of sunlight or temporary shadows.

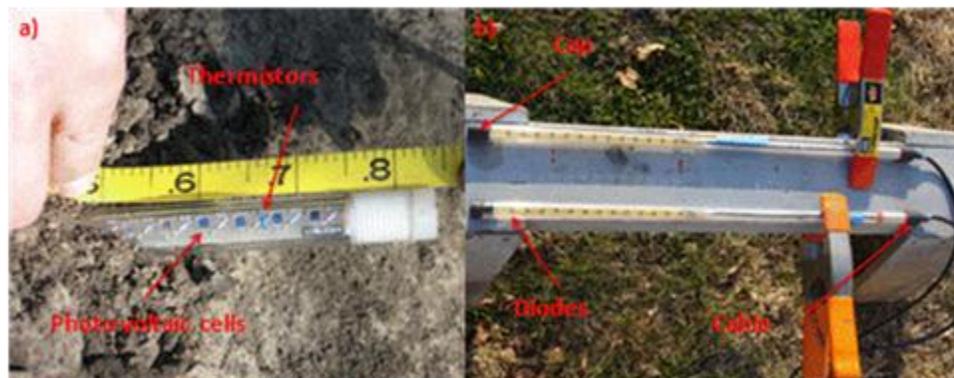
Figure 3.2 a) Picture of the PEEP Sensors (Lawler et al. 2001); b) Picture of the Rickly PEEP Series

For this study, two PEEP models were used: a photovoltaic PEEP and a photo-resistance PEEP. The photovoltaic PEEP is a PEEP 200 series by Hydro Scientific Limited, as shown in figure 3.2a. The model consists of 20 photovoltaic cells in series over a 20 cm section that constitutes the active length of the sensor. The diodes are encased in an acrylic tube. The whole instrument is 66 cm long and is terminated by a 15 m cable, which can be connected to a datalogger. The outer diameter of the protective acrylic tube is 16 mm. Two of the diodes located at either end of the active length are considered reference cells. The other eighteen diodes are

The second PEEP model is produced by Rickly Hydrological Company and is based on the principle proposed by Lawler (1991), however, these PEEPs use photo-resistors. In addition, these PEEPs are shorter: only containing 13 diodes as seen in figure 3.2 b. The diodes are encased in an acrylic tube. These PEEPs require an additional, fully exposed PEEP for the reference values. Ten PEEPs of this model were used in this study and identified as A1, A2, A3, A4, A5 and B1, B2, B3, B4, B5.

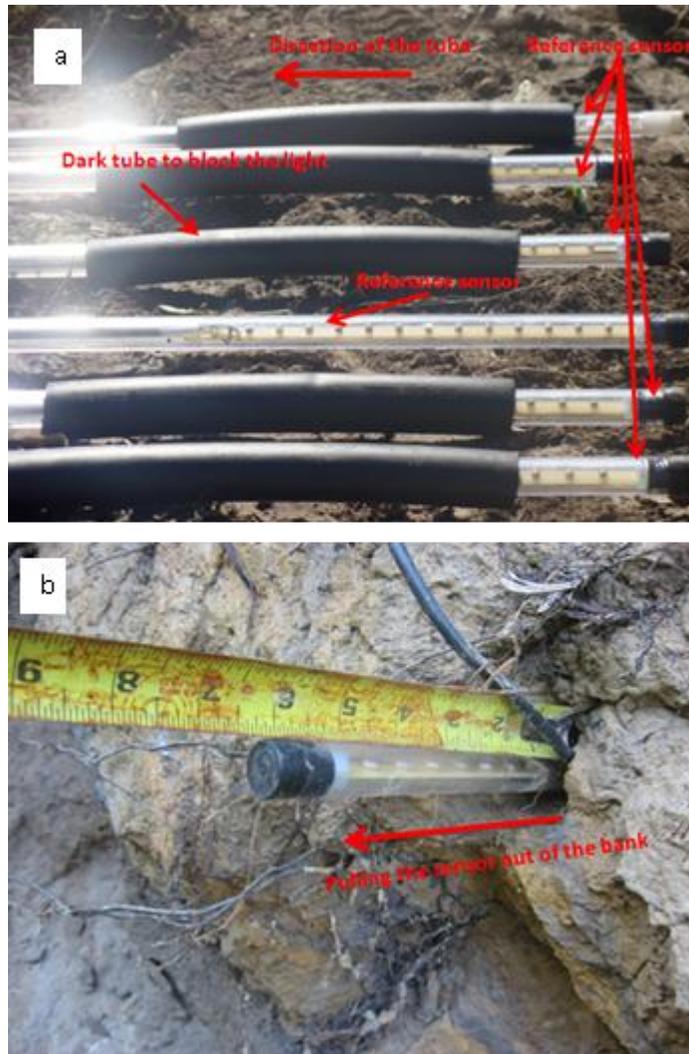
Figure 3.3 Calibration of the PEEPs: a) Floodplain; b) In-bank

calibration is recommended (Lawler, 1991); therefore, a field calibration was conducted at study sites for the PEEPs on a sunny day with some fluctuations in light intensity. Initially, the PEEPs were laid horizontally adjacent to one another on floodplain at each site in alignment with the sun, as demonstrated in figure 3.3 a. Steel wire stakes were used to fix the PEEPs to the ground to prevent tilting of the PEEPs, which would produce invalid data. A dark tube was placed over all the diodes of each PEEP. The tube was moved back at defined intervals exposing the diodes, which simulated bank erosion. The interval between the exposure of subsequent diodes was 4 minutes and the measurement window for each diode was every fifteen seconds. The calibration process lasted about 2 hours. The corresponding voltage recorded by the datalogger after each consecutive movement of the tube was correlated to the measured exposed length for the calibration. The exposed length was measured using a measure tape.

The modified procedure for installing the PEEPs required auguring a 16 mm hole parallel to the water surface only about 1 m into the bank face. The hole was carefully drilled to avoid significant disturbance to the surrounding bank soils (see fig. 3.6a). Moreover, the diameter of the hole was kept close to the outer diameter of the sensor itself (see fig. 3.3b).

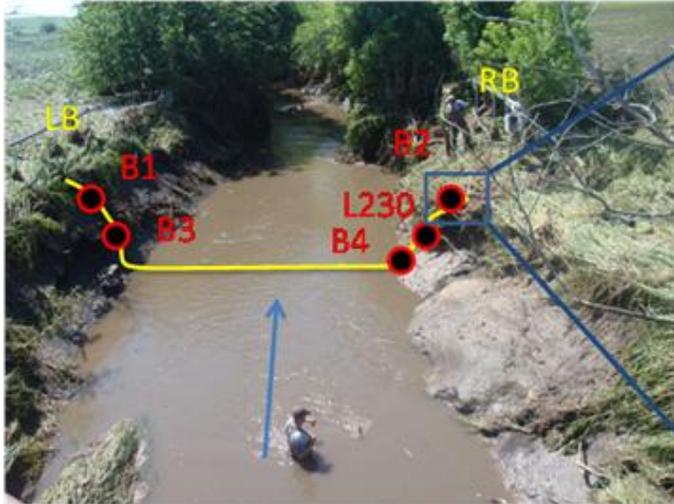
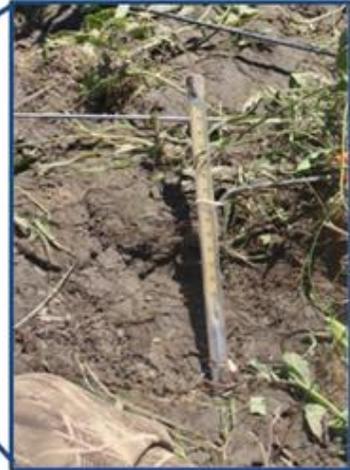
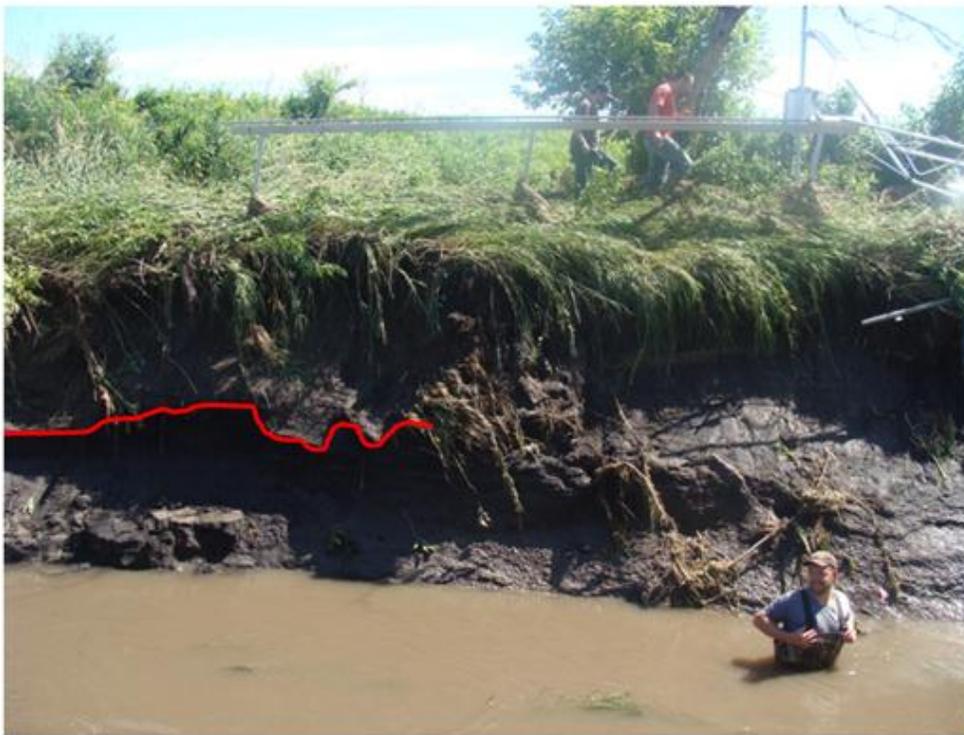
LB: Left bank RB: Right bank
● PEEPs — Cross-section
— Flow direction

**Top PEEP B2
 completely exposed**

— Slumping of materials at the left bank

Figure 3.4 Site 1 Study Reach Showing the Location of the Peeps

Two study sites at the Clear Creek Watershed (CCW), IA were selected based on evidence of previous bank erosion. The first site, hereafter referred to as “Site 1,” is located below an agricultural headwater of the CCW at the confluence of two 1st order streams

downstream of the 190th Street Bridge near U.S. Highway 151 in Iowa County. The reach drains a 26-km², agricultural sub-watershed of the CCW. The mean annual stream flow discharge for this reach is 5.9×10^6 m³/yr with an annual sediment discharge of 5×10^3 tons (Abaci and Papanicolaou, 2009). Six cross-sections were established every 15 m within the reach to determine the reach geometry and for extensive monitoring (see fig. 3.4). The average bank height of each cross section was 3.3 m and the average bank angle was 23°. It is expected that mass failure is the dominant erosion mechanism here due to the flashiness of the system.

At Site 1, five photo-resistance PEEPs (B1, B2, B3, B4, and B5) and one photovoltaic PEEP (L230) were installed on May 18, 2009. For the photo-resistance PEEPs, B5 was considered as the reference PEEP and secured at the flood plain as shown in figure 3.6d. On the right bank (looking downstream), PEEPs B2, L230, and B4 were respectively inserted into the bank face from the top of the bank to the toe, while on the left bank B1 and B3 were installed at the top and bank toe, respectively (see fig. 3.4). These PEEP sensors were removed shortly after the high event of June 19, 2009. The left bank experienced significant mass failure and PEEPs B1 and B3 were completely exposed. No data were recorded for these PEEPs due to a substantial battery drain. The PEEPs on the right bank remained in-place, but significant erosion had also occurred. The reference PEEP, B5, was moved from its original location due to over bank water flow.

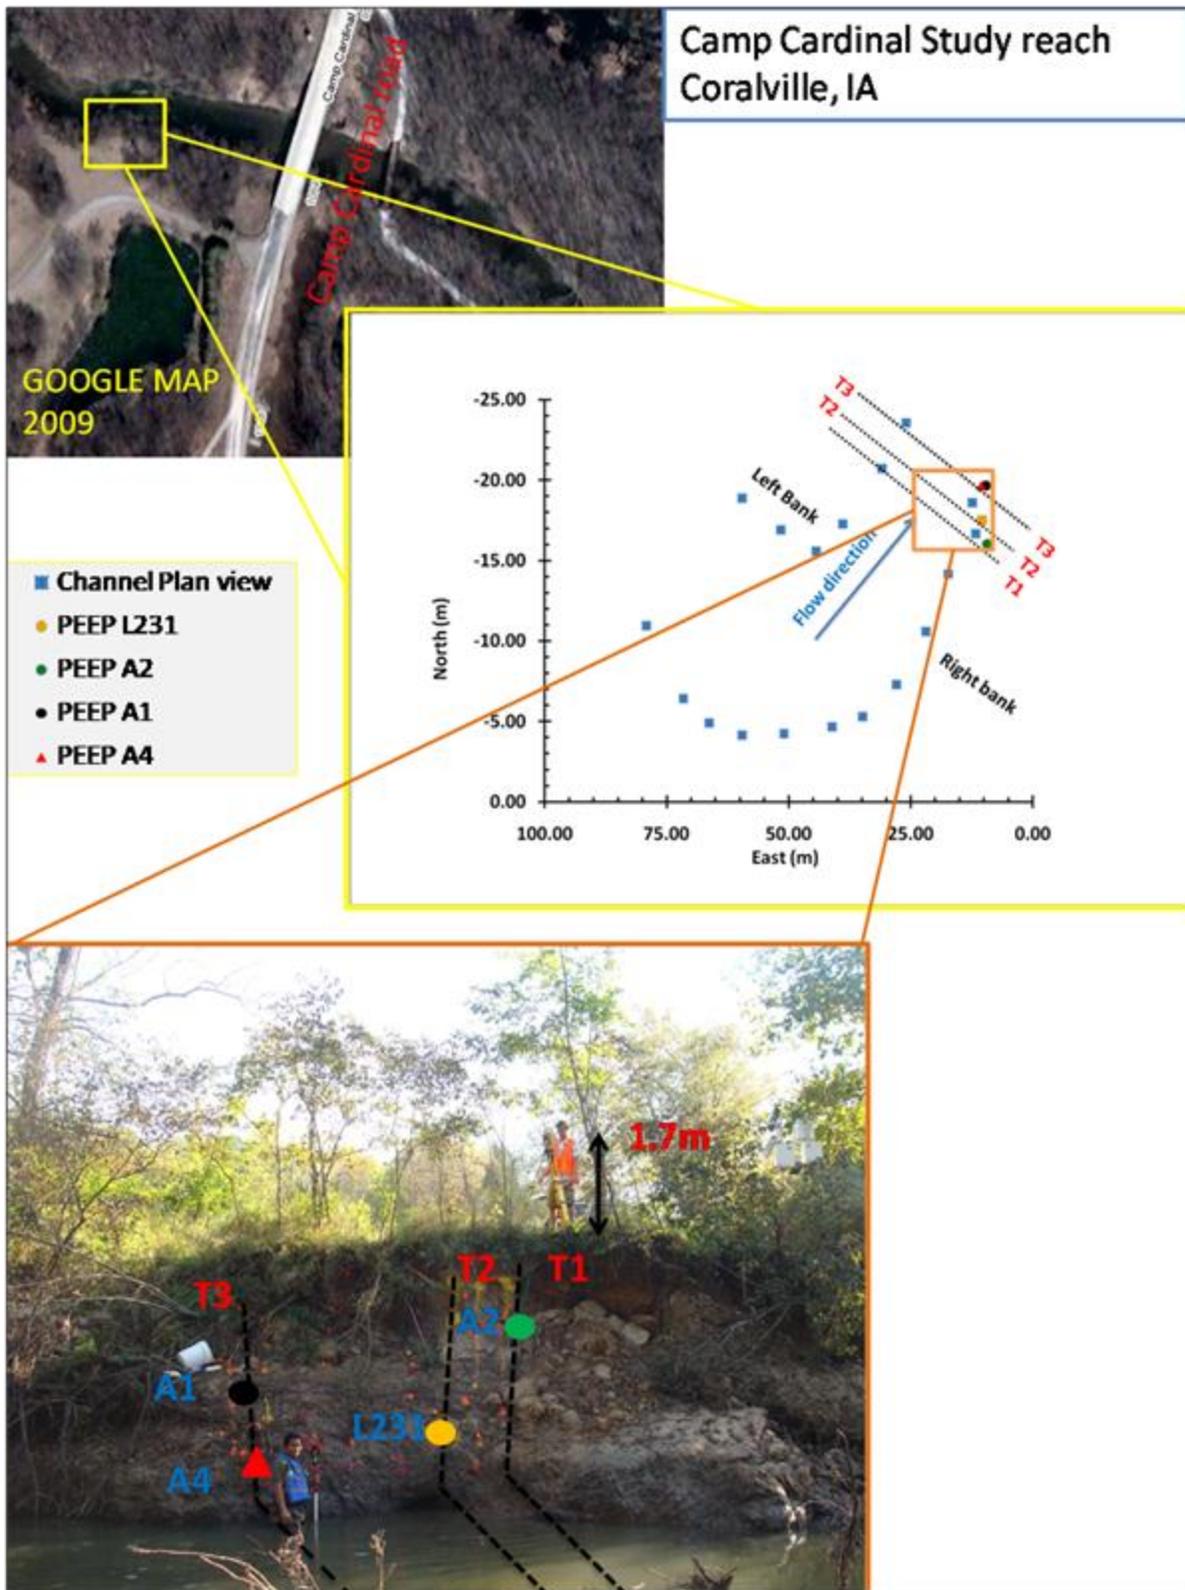
Figure 3.5 Site 2 Study Reach Showing the Location of the Peeps

The second site, hereafter referred to as “Site 2,” is located on a 4th order stream at Camp Cardinal Rd. in Coralville, Iowa near the CCW confluence (mouth) with the Iowa River (see fig. 3.5). The area surrounding this reach is mainly urbanized. Flow at Site 2 is less flashy than site 1 and the sustained high flows facilitate fluvial erosion. The average bank height was 5.8 m and the average bank angle was 47°. The reach is at a bend in the river, so the study was focused on the right bank (looking downstream), which receives the impinging flow. The average annual flow is 7.2×10^7 m³/ yr and the sediment discharge from this site is 7.8×10^4 tons. Figure 3.5 shows the bank height is steep and greater than 2 m. This bank had obvious signs of bank erosion. Fluvial erosion is expected to be the main erosion process at Site 2.

At Site 2, four photo-resistance PEEPs (A1, A2, A4, and A5) and 1 photovoltaic PEEP (L231) were installed. Three transects were established on only the right bank (looking downstream), which is the side that received the impinging flow around the bend. PEEP A2 was installed in Transect 1 (T1), PEEP L231 in Transect 2 (T2), and PEEPs A1 and A4 in Transect 3 (T3). T1 was the most upstream transect followed by T2 and T3 moving downstream. The sensors A4 and A1 were installed, respectively, at the toe and mid bank section. L231 and A1 were installed, respectively, at mid and top bank.

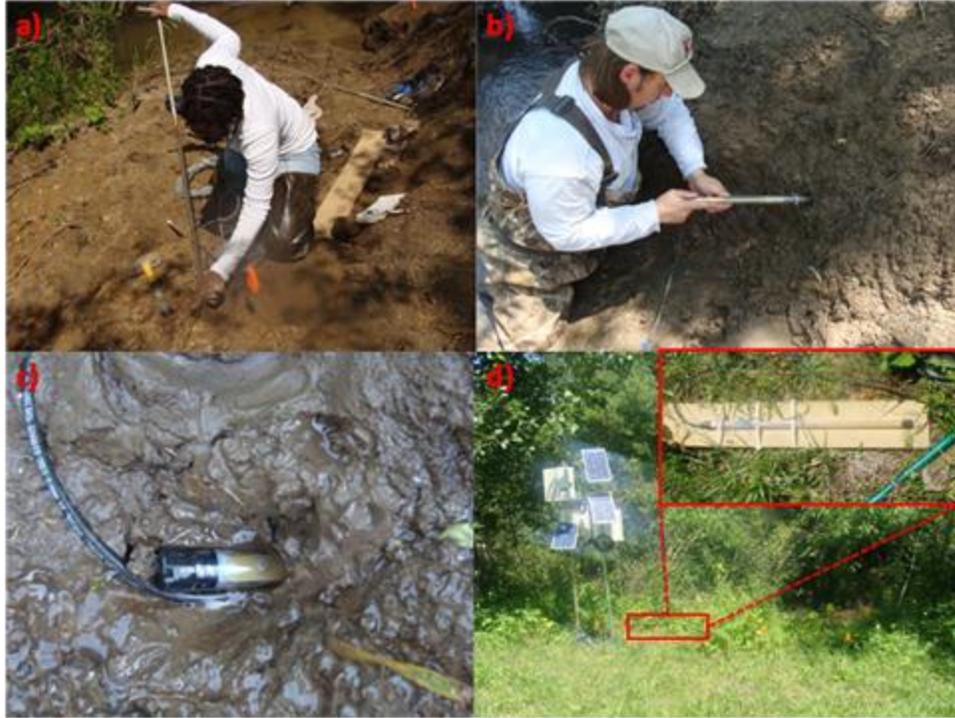
Figure 3.6 Installation Procedure of the Peeps

The recommended procedure for installing the PEEPs calls for drilling two 16 mm diameter holes. The first hole is into the bank face, parallel to the water surface. The second hole must be vertical from the top of bank some distance from the edge to avoid disturbing the bank. The two holes must intersect perfectly so that the PEEP cable can be passed through the holes. This technique proved difficult and was modified.

Before inserting the PEEP into the hole, the cable at the end of the sensor was attached to the side of acrylic tube using plastic cable ties. Care was taken not to cover the diodes with the cable. In addition, sufficient slack was maintained at the tube/ cable interface to avoid snapping the cable. The PEEP and attached cable were then inserted in the bank so that only one diode was initially exposed (see fig. 3.6b and c). This configuration allowed the cable to exit the front of the hole so that the cable may travel up the bank face to the datalogger. The cable along the bank face was inserted into a garden hose for additional protection and the hose was fixed to the bank surface using bent steel wire stakes.

The data loggers were attached to 3 m aluminum poles that were driven at least 1 m into the ground. These poles were positioned approximately 2 m from the bank edge to avoid slumping. The cables were wired into the dataloggers and the remaining slack wire was bound to these poles (see fig. 3.6d).

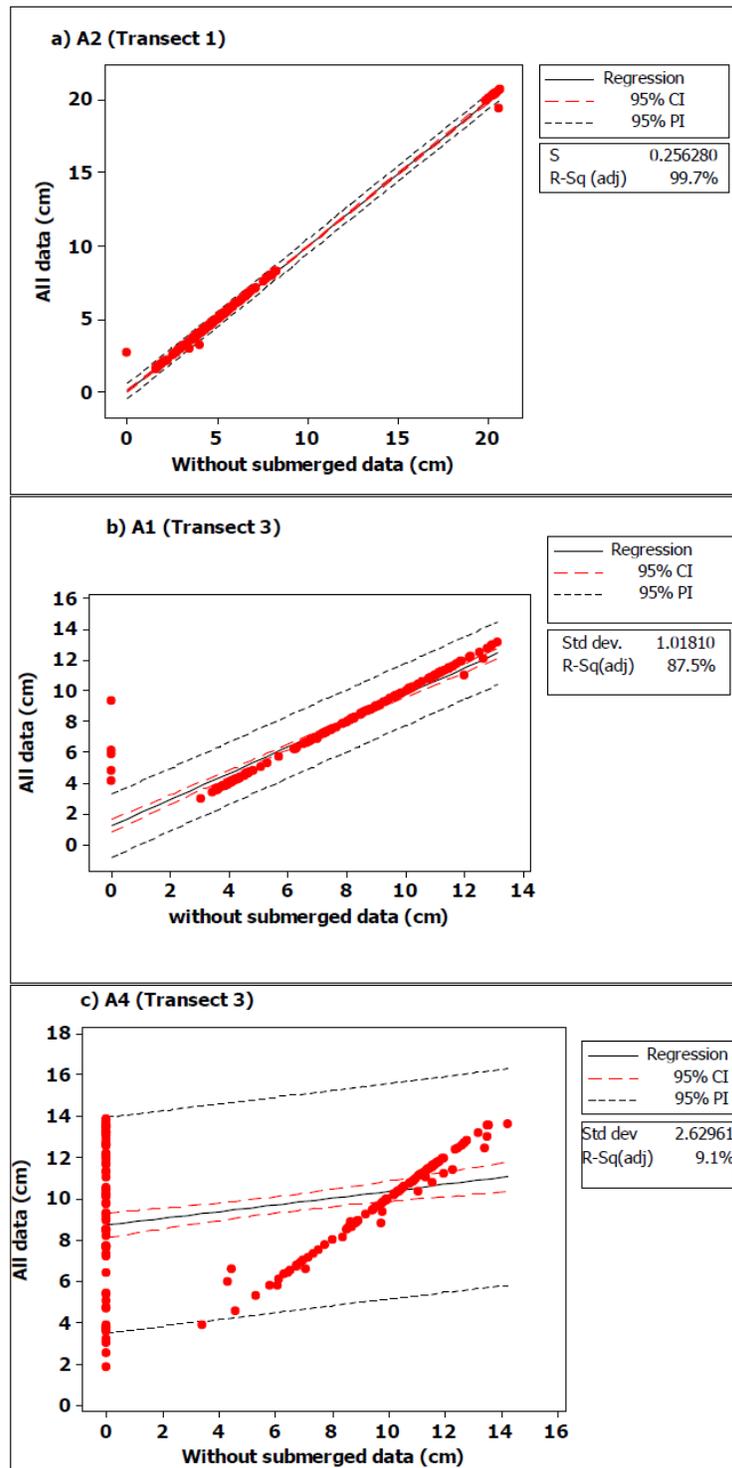
Figure 4.1 Examination of Peeps Performance for Periods that Peeps are Submerged to the Flow and Unsubmerged. The datasets are recorded from PEEPs: a) A2; b) A1; and c) A4 located at Camp Cardinal (Site 2) for summer and fall of 2009. The x-axis includes data when PEEPs A2, A1, and A4 are fully submerged. The y-axis includes all the data without removing the data when PEEPs A2, A1, and A4 are submerged.

The statistical tests performed to evaluate the performance of PEEPs A1, A2, and A4 located at the three transects at Site 2 are summarized in figure 4.1. On the vertical axis all the data were plotted, when the PEEPs were submerged and unsubmerged. To determine the impact of submergence on the instrument's performance, we correlated all data defined earlier with unsubmerged data. Figure 4.1 reveals that there is a positive correlation between unsubmerged condition and all data with the poorest performance exhibited by PEEP A4 located near the stream bed (see fig. 3.5). Figure 4.1 incorporates regression lines and confidence intervals for the best fit lines of the real data. The closer the PEEPs were to the free water surface, the poorer the performance of the PEEP. This was reflected with the correlation coefficient R^2 value recorded for the three PEEP transects. The higher the elevation of the sensor, the higher the R^2 obtained from the best fit analysis. We believe PEEPs located near the toe of the bank perform poorer than the remaining PEEPs for the following reasons: (1) light availability and penetration corresponding to the submergence period of the PEEPs, and (2) disturbance caused by the bank inundation and the formation of forbay areas in the proximity of the bank toe.

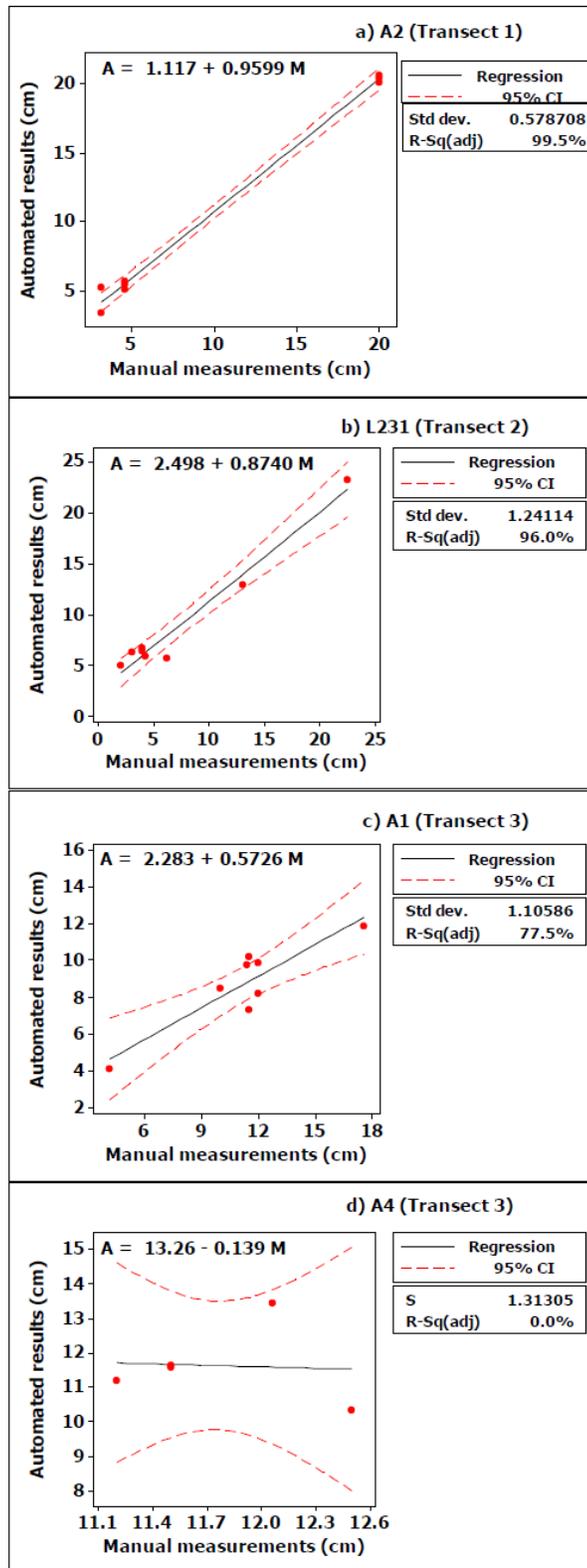
Figure 4.2 Regression Plot between the PEEP Results and Measuring Tape Measurements. On the x-axis are the manual measurements of the protruding length of the sensor and on the y-axis the results of the PEEP sensor: a) A2; b) L231; c) A1; and d) A4 for the same date.

Table 4.1 offers a comparison of the automated bank measurements with the traditional measurements (i.e., tape measure and surveys) at Site 2. The surveys were performed on July 30th and September 30th. There is an excellent agreement between the measurements for PEEP A2. The maximum error observed was about 20% and was recorded for PEEP L231. Figure 4.2 complements the results summarized in table 4.1, and demonstrates the performance of all PEEPS against the measuring tape measurements referred to in the horizontal axis as manual measurements. The closer to the bank toe, the higher the departure is between the automated and manual measurements. Several authors in the literature have attributed this trend to the intense inundation that takes place near the toe. Vibration caused by the potentially induced spiral motion of the impinging flow must also be considered (Couperthwaite et al. 1998; Lawler 1991; Lawler 1992; Lawler et al. 2001; Lawler 2005; Mitchell et al. 1999; Prosser et al. 2000).

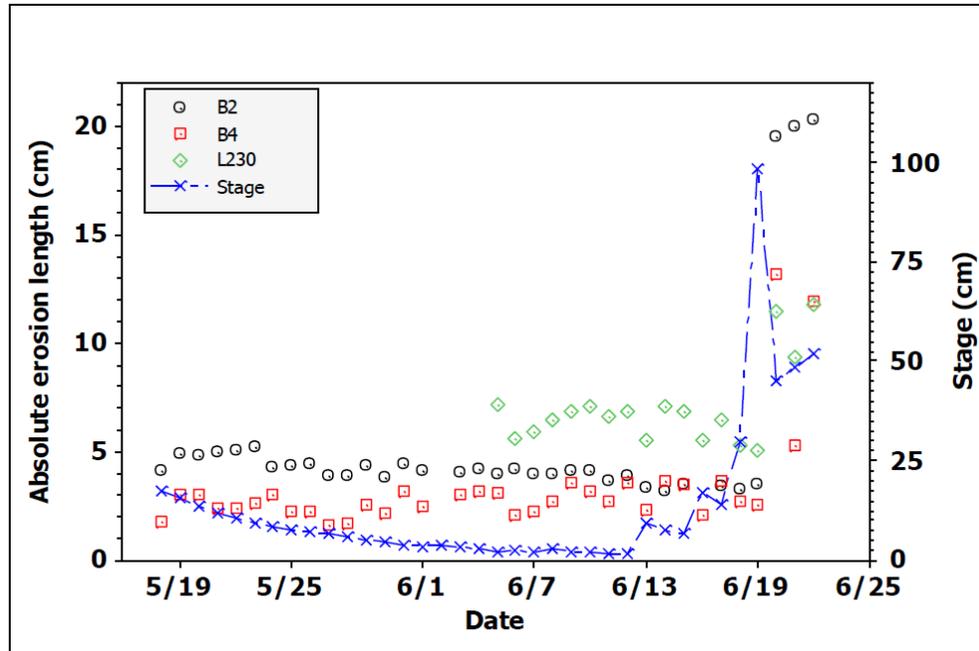
Figure 4.3 Times Series of Daily Interval, Stage and Bank Erosion Measurements Using the Sensors B2, B4, L230 at South Amana (Site 1)

The daily time series data for the PEEPs records are presented along with the stage measured in figure 4.3 for Site 1 during the period of May 18 to June 22, 2009. The figure shows continuous toe erosion activity for the period of observation. Bank toe erosion has been observed to occur on a continuous basis and presents high variability that is attributed to the variability in the stress exerted by the flow. According to Simon and Collison (2001), and Papanicolaou et al (2007), bank toe erosion is triggered due to significant excess or apparent shear stress, which can lead to bank undercutting near the toe region. Therefore, it is most probable that bank toe erosion at Site 1 is triggered by the fluvial shear stress.

As the stage increased and we approached closer to the June 19th event, the erosion rates increased at all locations. A maximum retreat of 20.5 cm was recorded along the bank face (see fig. 4.3). This was an indication that mass failure occurred during the rising and falling limbs of the hydrograph. In other words, the erosion process at the bank boundary lost its spatial randomness and occurred simultaneously at the same rate for all locations.

In addition, figure 4.3 provides unique information about the time lag between the peak of the hydrograph and the highest erosion rate for all locations. The maximum retreat was observed roughly 21 hours after the occurrence of the hydrograph peak. It was clear that swelling and subsurface flow within the bank soil have contributed to the delayed response of the bank to the June 19th event. Both subsurface flows and swelling are key components of subaerial processes confirming our earlier suggestion that mass erosion remains the controlling agent during and after the June 19th event at Site 1. A similar trend to the one observed at site 1 was also observed at Site 2.

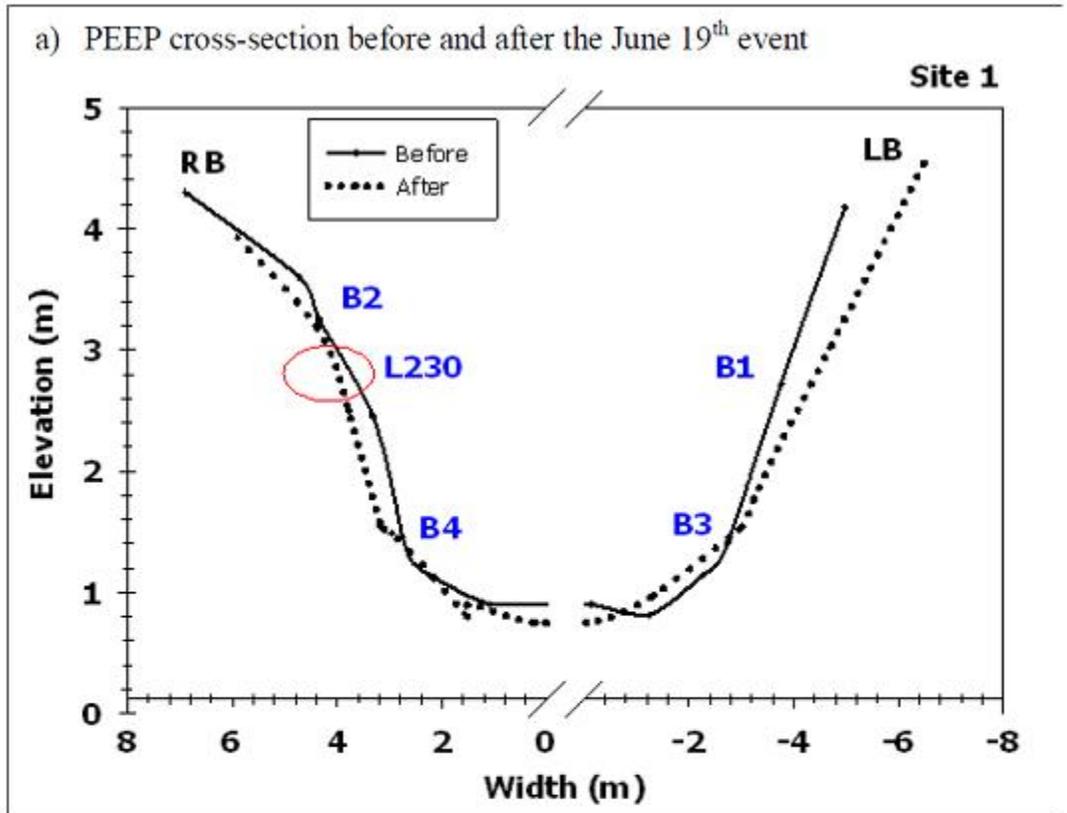
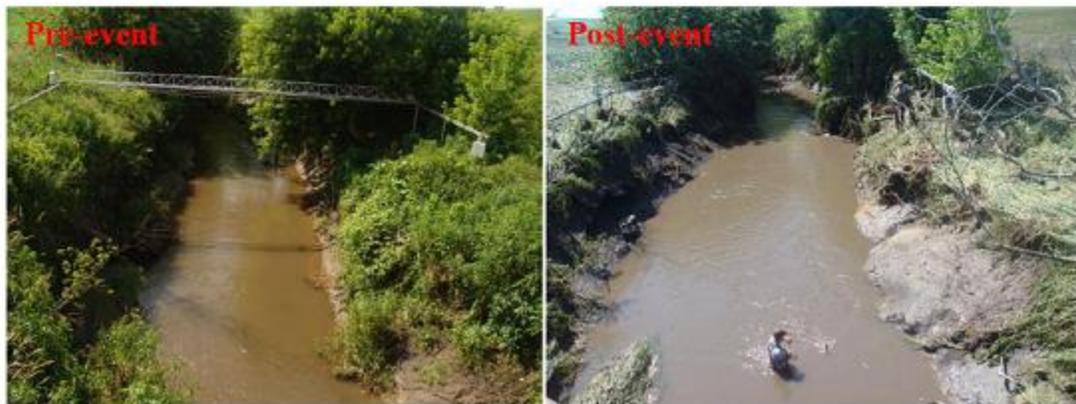
b) Picture of the PEEPs cross-section pre- and post-event

Figure 4.4 a) PEEP Cross-Section before and after the June 19th Event*; b) Plan View of the Study Reach Pre-event and Post-Event. If facing downstream, “RB” stands for Right bank and “LB” for left bank. The bank profile is delimited using the survey data of May 28th and June 23rd 2009.

The fluvial and mass erosion at Site 1 before and after the June 19th event is shown in figure 4.4. In general, the survey data (see fig. 4.4a) confirms the PEEPs observations. Figure 4.4b provides a plan view of the study reach before and after the June 19th event. There are discernable differences between the pre- and post-event cross-sectional areas in Site 1. The pictures strongly confirm the mass erosion triggered by the June 19th event with the widening of the channel and the removal of the pre-existing vegetation along the bank face. Note also that the pre-event picture was only taken 2 hours before the initiation of the June 19th event, while the post-event picture was taken the day after the event. Figure 4.5 shows the before and after conditions for two transects at Site 2. At Transect 1 the stream is active near the bed and the left bank where impingement of the incoming flow took place, whereas in Transect 3 the stream migrates towards the left bank.

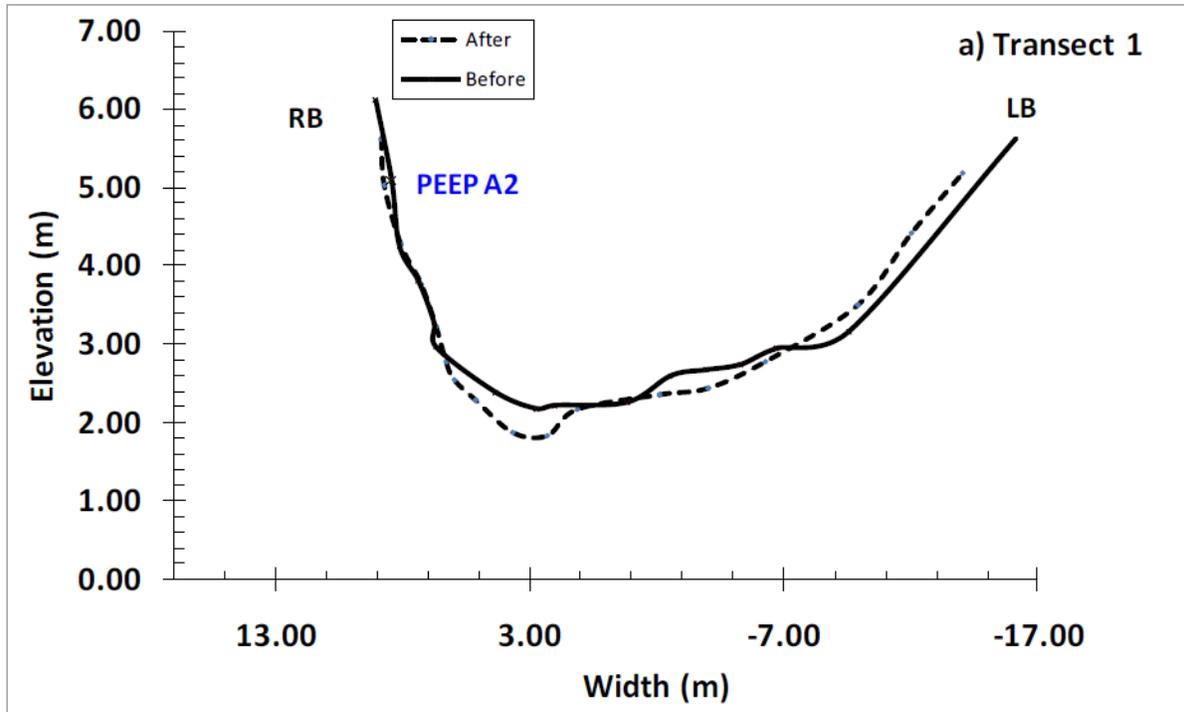
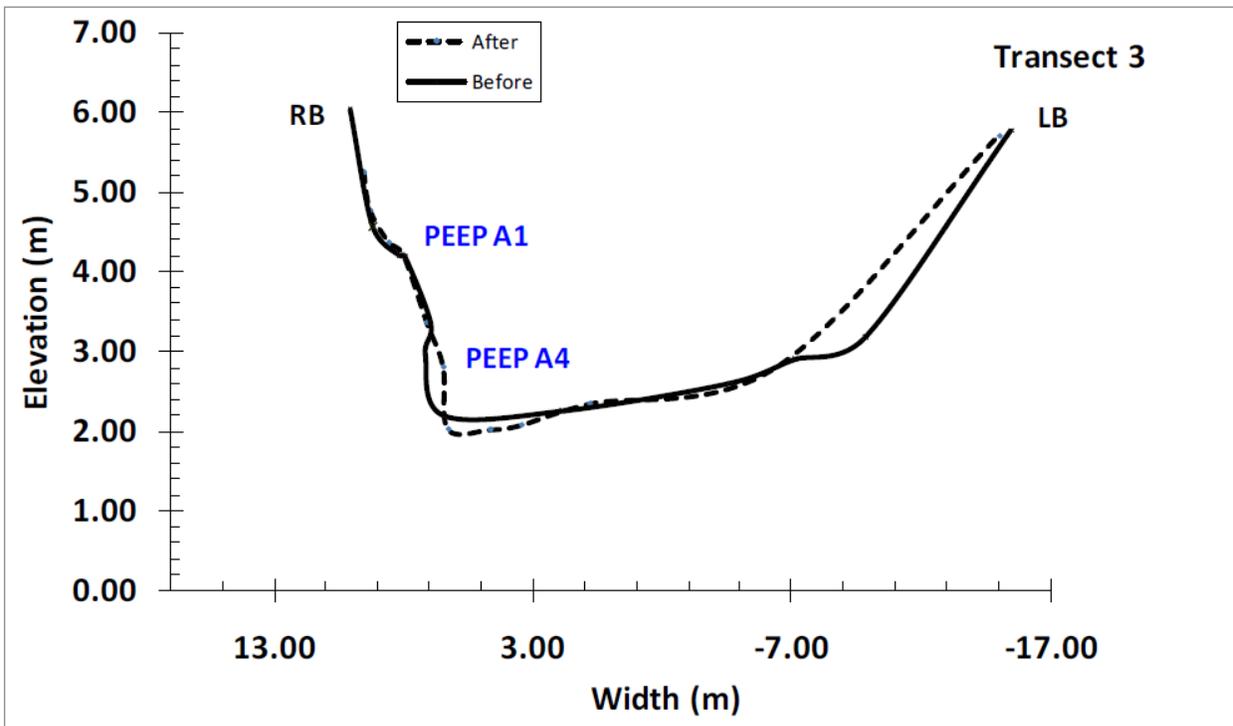
Figure 4.5 Bank Profile Delimitation before and after the August 27th Event Using the PEEP Data: (a) Transect 1 and (b) Transect 3. The bank profile is delimited using the survey data of July 30th and September 30th 2009. If positioned facing downstream, “RB” stands for Right bank and “LB” for left bank.
