Report # MATC-KSU: 110

Final Report

Assessing the Damage Potential in Pretensioned Bridges, Caused by Increased Truck Loads Due to Freight Movements (Phase I)

May 2010

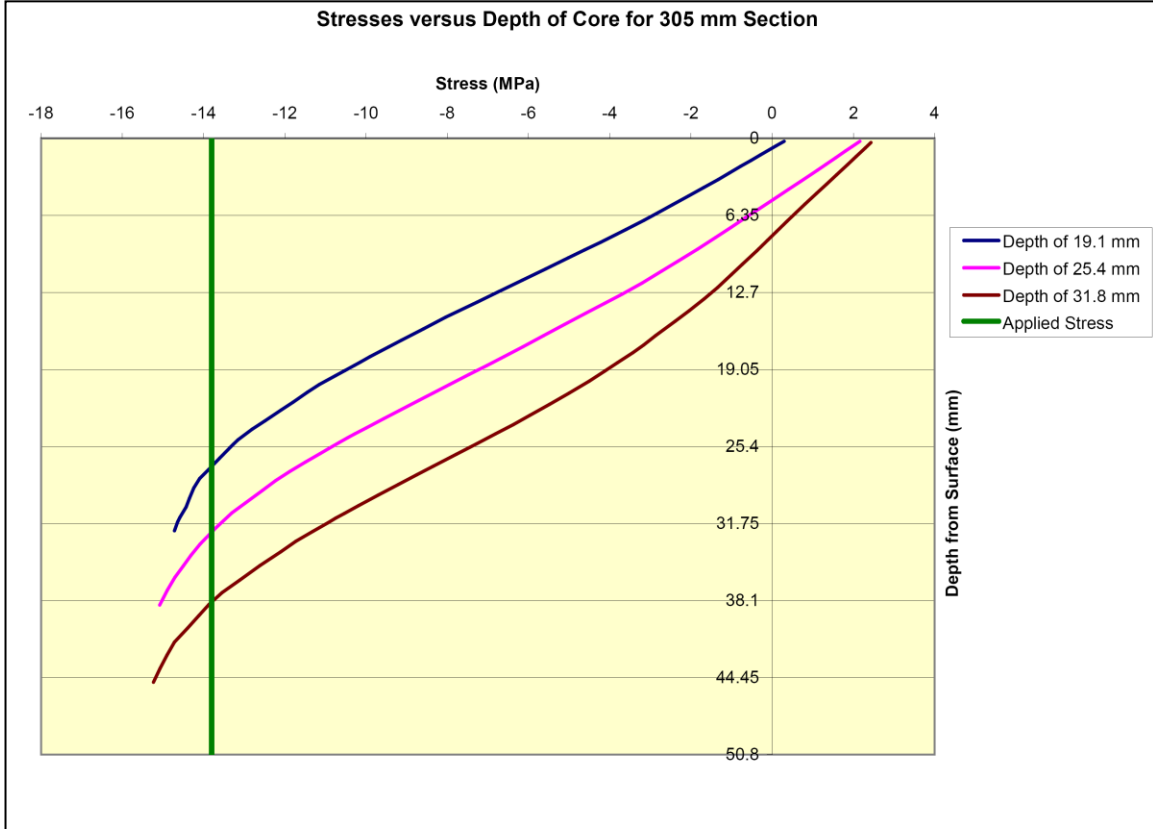
Figure 2.4 Stresses versus depth of core for 305 mm x 305 mm square cross section

A second model was created to verify that the positive stress at the surface was due to the shear at the base of the core, and not due to bending in the relatively slender member caused by the coring operation. This member had a larger square cross section with sides of 305 mm (approximately 3 times the size of the first model) and had a total length of one meter. The same restraints and mesh were applied along with a larger force to maintain the same constant stress. This second model yielded similar results. Thus, it was evident that the deeper depth equal to the core diameter, as recommended by Kesavan, would not be necessary.

In order to eliminate the transfer of strains between the member and the cored section the authors developed a method to extract the core out of the hole, thus relieving the internal shear stress. The depth of 25.4 mm was chosen to make sure that a core hole was drilled deep enough to relieve the stress in the core and to ensure that when the core was extracted, it would be deeper than the minimum depth of 19 mm. Note that when the core is fractured, the fractured plane is always less than the actual depth to which the core is drilled (refer to figure 5.5). Figures 2.3 and 2.4 each show a near-linear trend through the core depth. For each core depth, a positive (tension) stress is created at the surface due to the interaction between the core and the member, as the shearing stress along the

bottom results in a stress at the surface. An increase in depth from 19.1 mm to 25.4 mm shows a jump of 1.6 MPa at the surface. At a depth of 25.4 mm to 31.8 mm the jump is very small. These models indicate that some calibration method or a method to remove the additional stress may be needed to improve the accuracy of the test results.

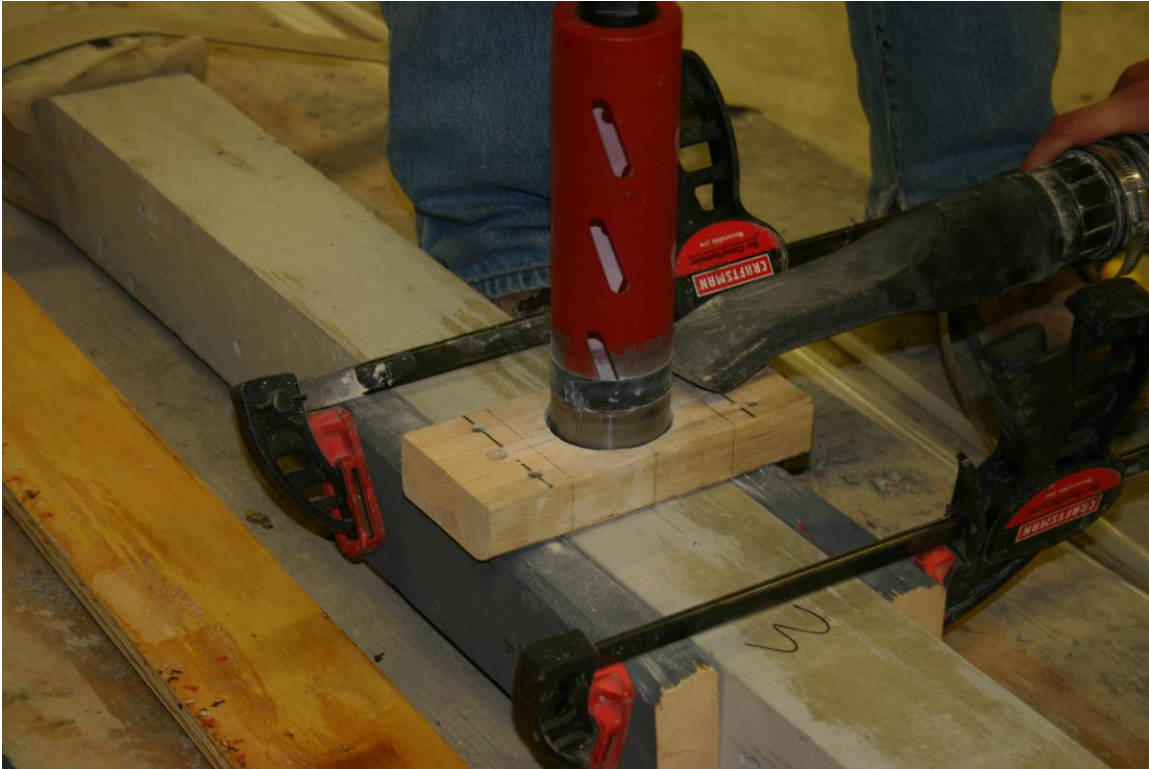
Figure 5.3 Coring the member

A coring guide was used to steady the core bit when first rotating to prevent the bit from shifting on the specimen and damaging the strain gage or wires. The guide consisted of a hole drilled in a block of wood slightly larger than the outside diameter of the core bit. Attached to each side of the guide block was another perpendicular block of wood which served to center the core bit on the concrete specimen. Two clamps then secured the coring guide to the concrete specimen shown in figure 5.3. Before coring, a check was conducted to make sure the guide was centered on the strain gage, and the wires were secured out of the way to prevent any damage to them while coring. A hammer drill was used with the hammering feature turned off. A vacuum was used to reduce and remove the concrete dust from around the core bit. Once the core bit reached half the depth, the coring was stopped, the guide removed, and the dust removed from the hole. This was done to prevent the core bit from binding up and damaging, or possibly fracturing, the core. With the guide removed and the area cleared, the coring resumed to the desired depth of 25.4 mm. Using tape, the desired depth was marked on the core bit. Once the core bit reached the depth, the bit was removed from the hole, the dust

vacuumed up, and the strain gage was then reconnected to the P-3500. Using a micrometer, the depth of the core hole was checked in multiple locations. The strain reading was then recorded along with the amount of time that had passed after the coring.

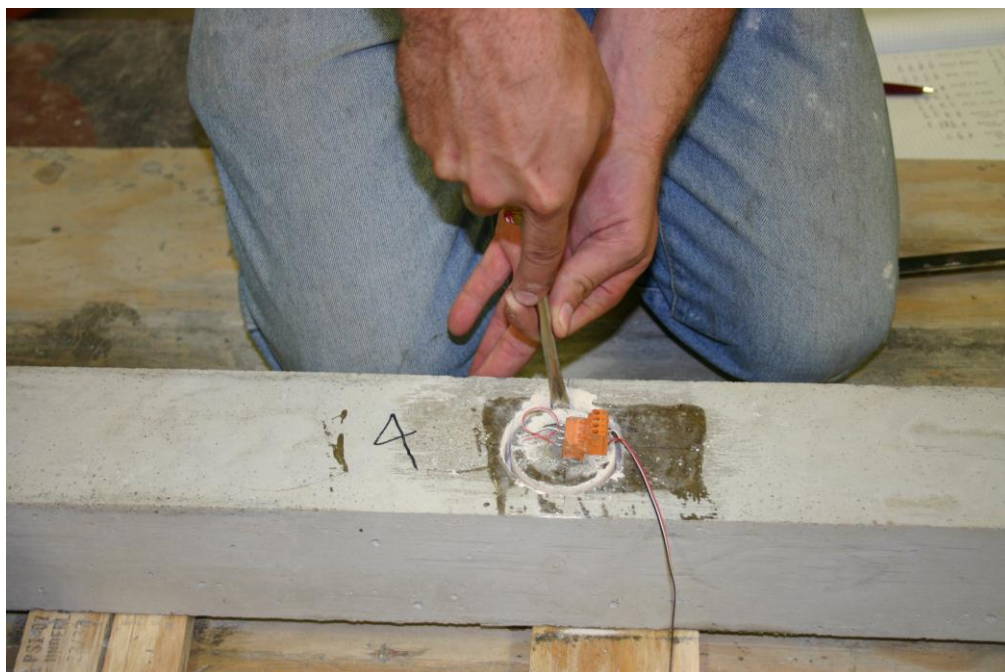
Figure 5.4 Fracturing the core center from the surrounding beam

Through repeated trials a positive strain or a strain caused by a tension force was noticed at the surface of the core. To help reduce the amount of this strain, a method was devised to extract the core to relieve all internal strains. Using a large flat bar, that was inserted into the side of the core, and using steady pressure, the core was fractured along the plane of the bottom of the core as shown in figure 5.4. This caused a change in the strain value. The core was then removed, as shown in figure 5.5, and the value of strain was recorded along with the time, and the strain value was monitored over a period of four hours.

The third member was the first member fabricated where the core was fractured along the base, removing the possibility of any other stresses affecting the full release of the strain. The mix for this member had a modulus of elasticity of 2.17 GPa and an average compressive strength of 30.9 MPa. Table 5.3 shows the applied stress, the stress immediately after coring, and the stress once the core was fractured. The percent error was calculated between the applied stress and the re-bounding stress with the core
