Use of Steel Fiber-Reinforced Rubberized Concrete in Cold Regions

FHWA-AK-RD-76319, HFHWY00001

December 2017

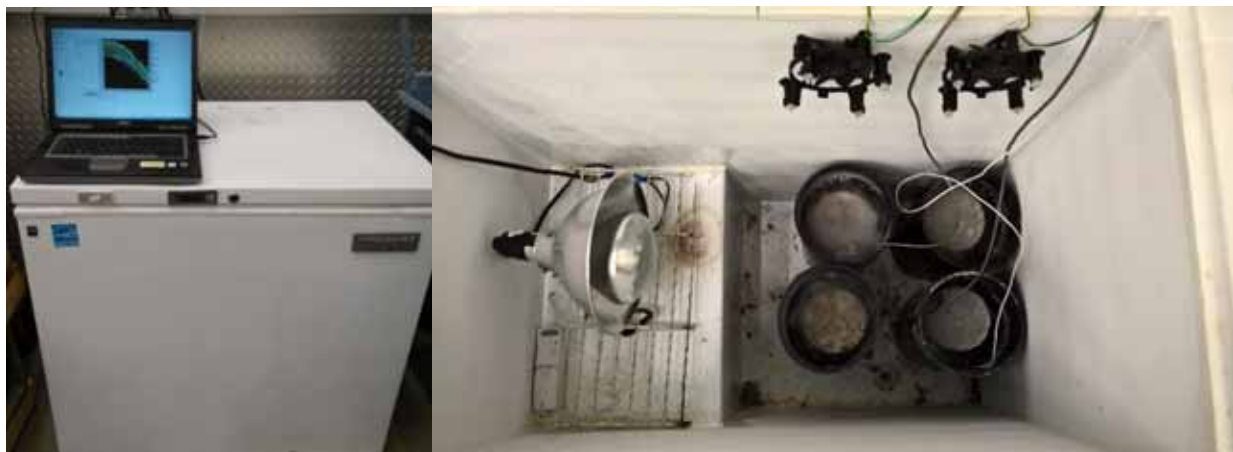
Figure 1: UAA freeze-thaw testing system.

Once the mix was verified, further investigation was conducted to determine the freeze-thaw characteristics of the material. At the UAA materials laboratory, a system was established that simulates accelerated freeze-thaw cycles in conformance with ASTM C666 (Abaza and Bergeron, 2014). The system utilized a commercial freezing unit along with a heating element and thermal probes, as shown in Figure 1. The system is controlled by a software program that completes a freeze-thaw cycle by activating the freezer until core temperatures drop to 0°F; then the heating element brings the core temperature above freezing so that the process can be repeated. To effectively test the freeze-thaw resistance of the material, it is recommended that 300 cycles be performed.

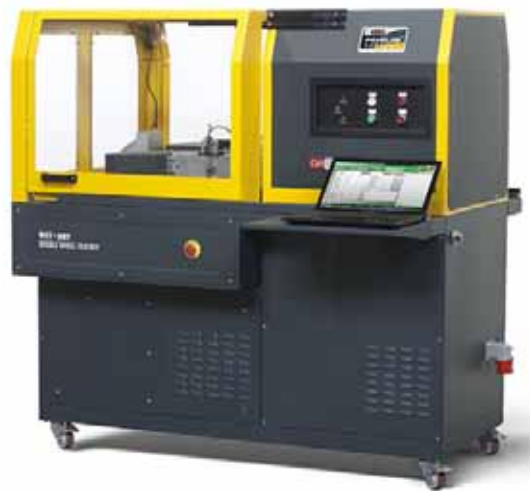
Figure 2: The Controls Group double wheel tracker system.

The wheel tracker apparatus located at the UAA materials laboratory was used for determining the abrasion resistance of the SFRRC material. The apparatus was a Controls Double Wheel Tracker (DWT), Pavetrack 77-PV33E05, state-of-the-art loaded wheel system (Figure 2).

The AASHTO T324 procedure uses stainless steel wheels for testing, while the EN 12697-22 uses rubber tire wheels, but no procedure has been standardized for use of studs on a rubber tire with the wheel tracker apparatus. In order to conduct experimental studded tire testing, theoretical values must be obtained and translated to accurately represent real-world situations. Using the studded rubber tire was a deviation from the AASHTO T324 specification.

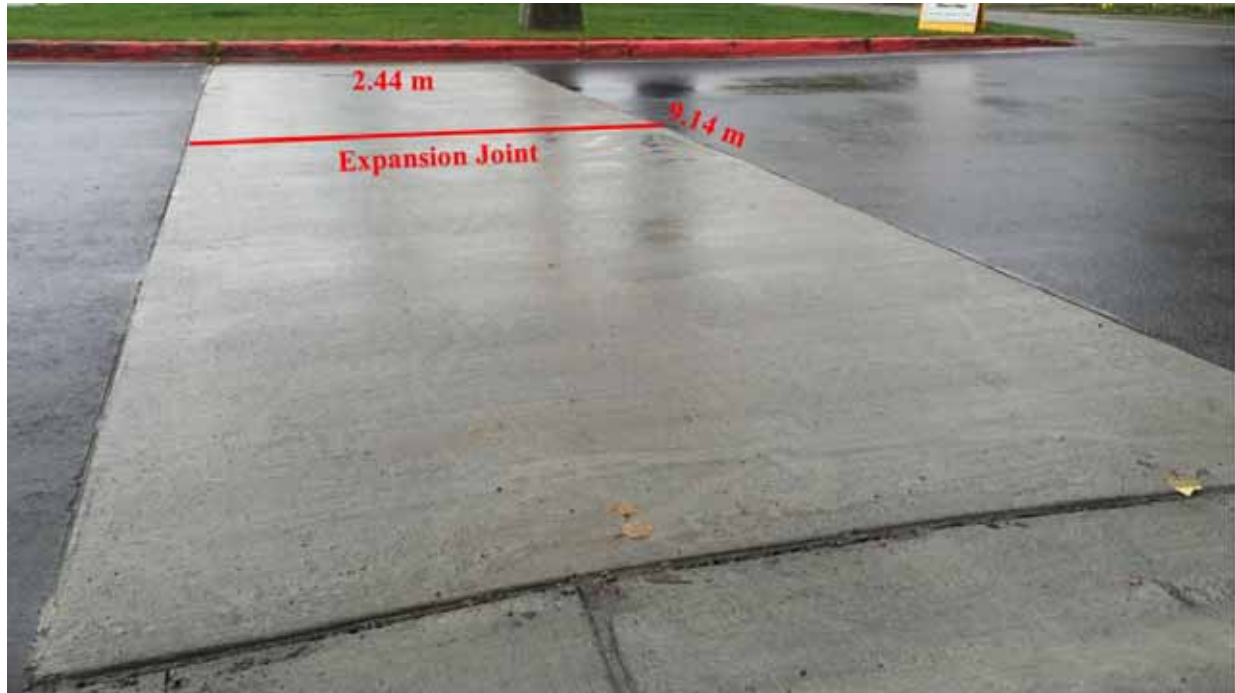
Figure 4: SFRRC trial slab location with planned dimensions and orientation.

With a thickness of 17.78 cm determined, it was necessary to create a typical slab section. For the experimental slab at UAA, the dimensions were 2.44 m long by 9.14 m wide. Calculations were completed using material properties, traffic data, and a maximum slab length of approximately 4.57 m based on AASHTO recommendations (Huang, 2004). The slab was divided into two halves by placing an expansion joint at mid span. The approximate length and orientation of the slab are shown in Figure 4.

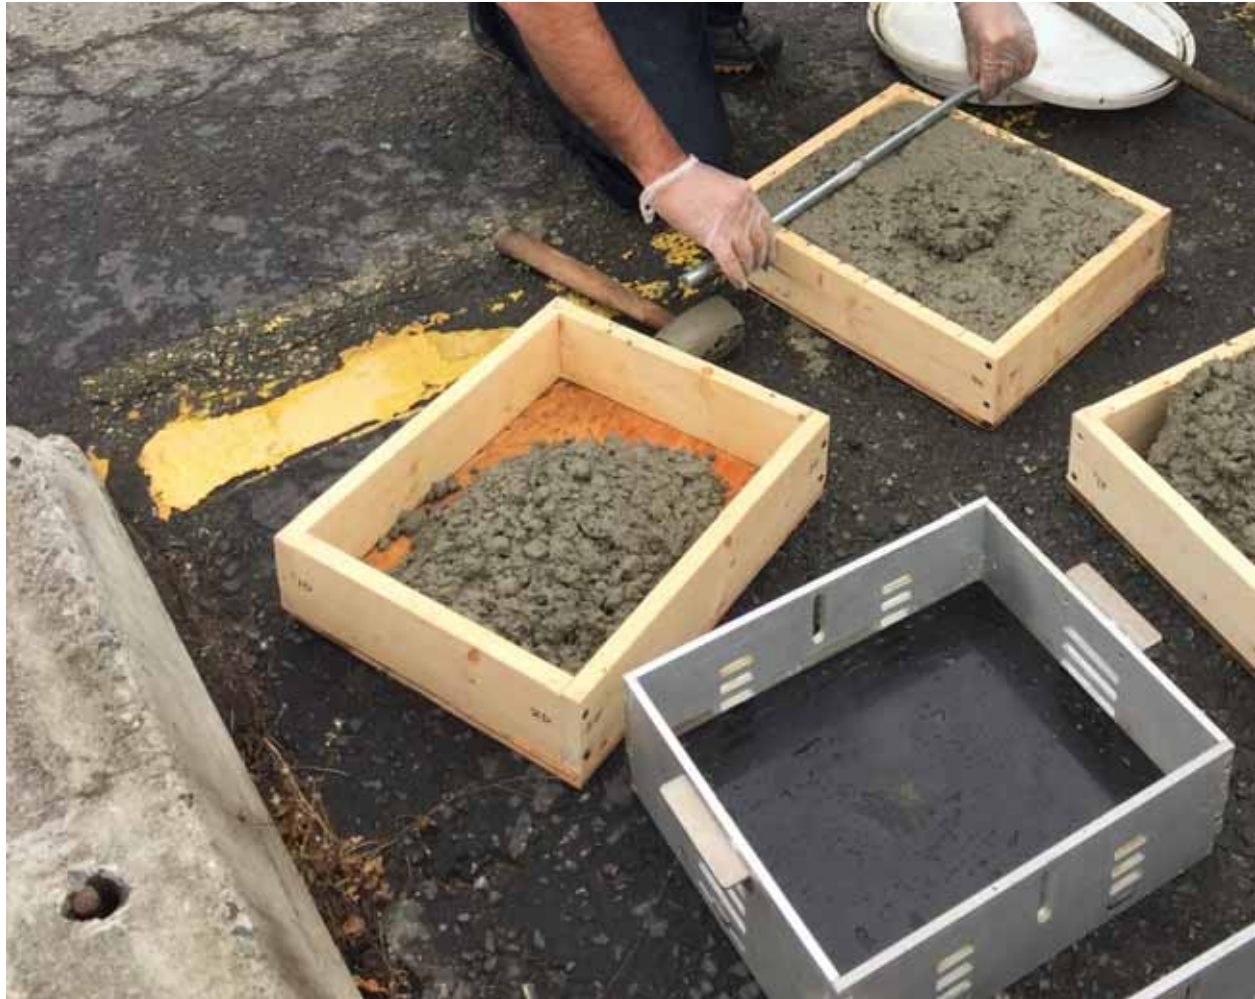
Figure 7: Molding of the wheel tracker SFRRC samples.

The SFRRC material was batched, and molds were made for the DWT Pavetrack 77-PV32E05. As shown in Figure 7, the samples were molded into 36.20 cm long by 29.85 cm wide by 8.89 cm deep slabs, as required for the apparatus. The material was hand-tamped into the molds and vibrated to ensure consolidation throughout.

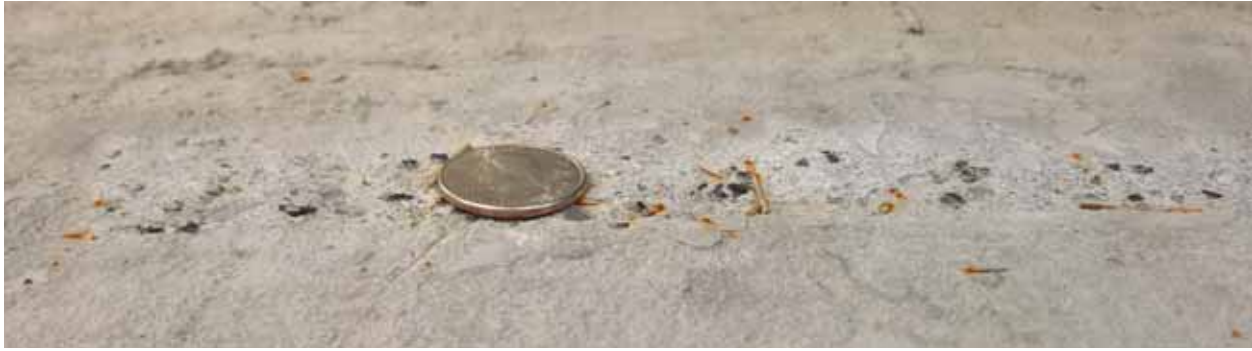
Figure 8: SFRRC sample after 20,000 repetitions with the steel wheel.

The DWT was calibrated and equipped with steel wheels to perform the AASHTO T324 procedures. Two samples of SFRRC were placed into the testing apparatus under each wheel, and the 20,000-cycle process was administered. The samples were run under wet conditions, as prescribed by the testing procedures. Inspection of the samples showed minor surface wear of less than 0.076 cm (see Figure 8).

The test results from the AASHTO T324 procedure show that SFRRC resulted in less deformation than HMA, both Type II and Type VH. There were no signs of deformation on the SFRRC sample and only minor surface wear from the procedure. Inspection of both HMA mixes showed that plastic deformation occurred as the material was consolidated under the wheel path or shoved to the edge of the sample.

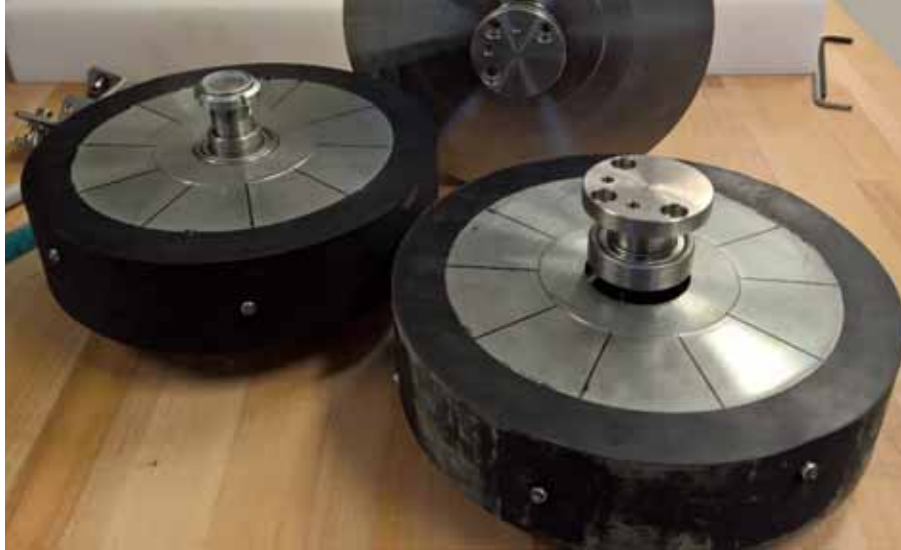
Figure 9: The DWT Pavetrack rubber tires with the studs installed.

To determine SFRRC stud resistance in these conditions, we performed a modified AASHTO T324 test. A rubber wheel was embedded with standard studs, as shown in Figure 9. The studded rubber wheel was placed on the wheel tracker apparatus, and the AASHTO T324 test procedure was performed. After 20,000 cycles were completed, we inspected the sample for stud wear.

Based on analysis of the sample, we determined that the AASHTO T324 procedure would not provide realistic results of studded tire wear because of the wheel path the apparatus traverses. In actual conditions, studs on tires make contact with the roadway in random locations. With the wheel tracker apparatus, the wheel follows the same path for all 20,000 cycles. This lack of variation results in each stud contacting one location throughout the test cycles.

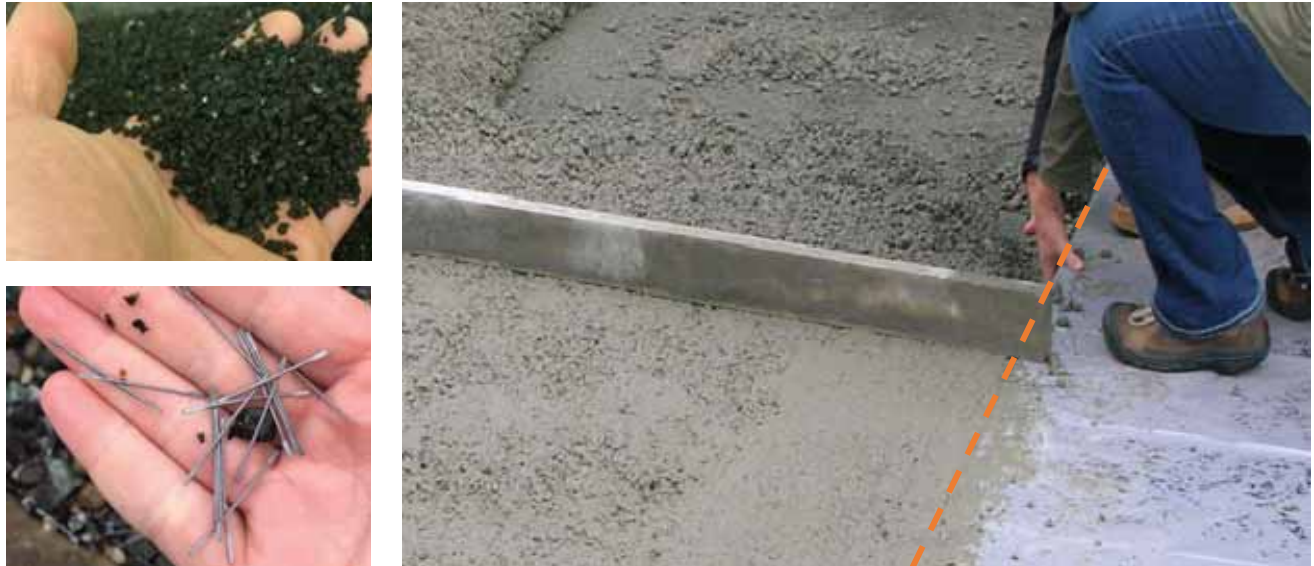
Figure 11: Pavement adjacent to the slab undermined to allow keying of SFRRC with samples of crumb rubber and steel fiber used.

Once the pour date was established, the designated location of the slab was excavated and prepared for SFRRC placement. The east and west sides were poured against an existing concrete curb and gutter, and the north and south edges were tied in with the existing asphalt. Material was removed from below the asphalt at the north and south tie-in locations to allow SFRRC to flow below the asphalt when poured, as shown in Figure 11. This created a keyed joint and allowed for more efficient load transfer from the asphalt to the SFRRC slab. In addition, the keyed joint would minimize frost heave or settlement by prohibiting water intrusion compared with a vertical joint.

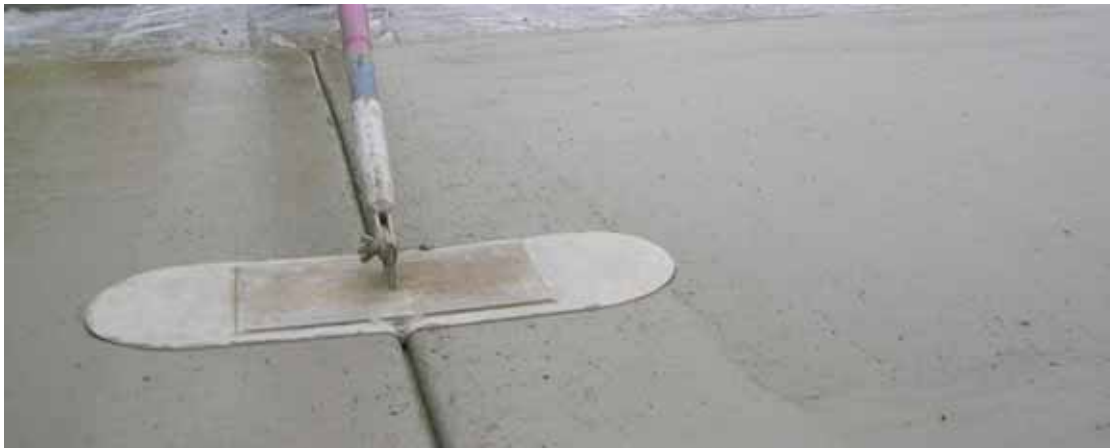
Figure 12: Initial finish of the UAA slab and mid-slab contraction joint.

The slab was finished to proper elevations using a manual screed to match the existing asphalt pavement (see Figure 12). After the initial finish was complete, the slab was allowed to cure before a broom finish was applied. The Finishing Edge crew had more difficulty completing this task. Because of the interconnected microstructure of the steel fibers, as the broom finish was being applied the surface of the slab would shift and tear. The surface was wetted to allow the material to be more malleable and the broom finish was completed. In future use of the material, broom finishing should occur prior to allowing the long cure duration. The intertwined structure of the steel fibers is a benefit to the SFRRC slab, however, as it mitigates migration of micro cracks when the slab shifts due to freeze-thaw actions. A detailed report and images of the slab construction can be found in Appendix G.

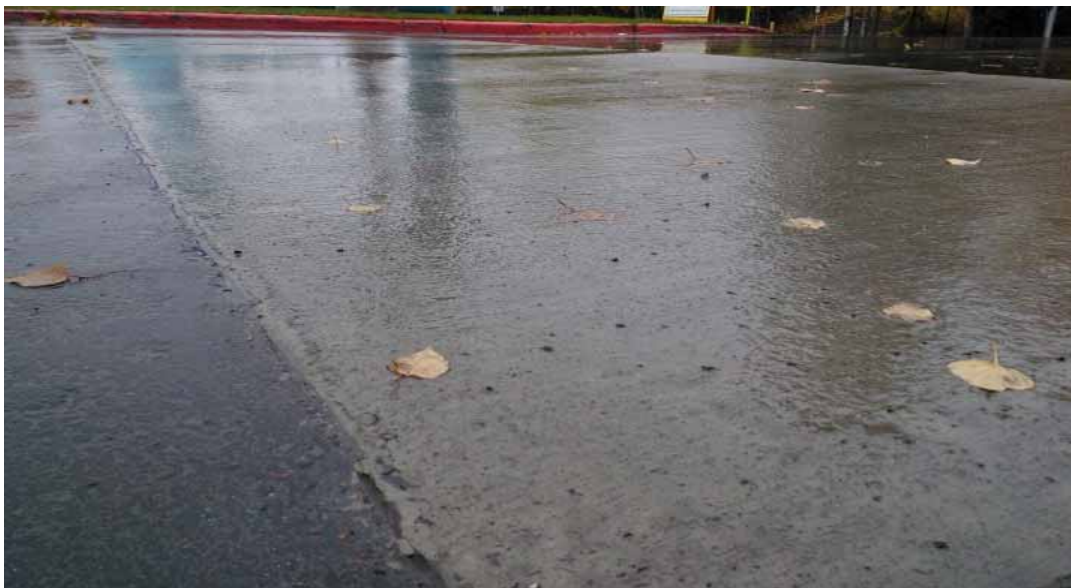
Figure 13: The UAA SFRRC trial slab shortly after construction.

The initial observations showed smooth transitions from the existing asphalt pavement onto and off the slab. As shown in Figure 13, the surface of the concrete was fairly smooth with a broom-textured finish; no major deformations caused ponding.

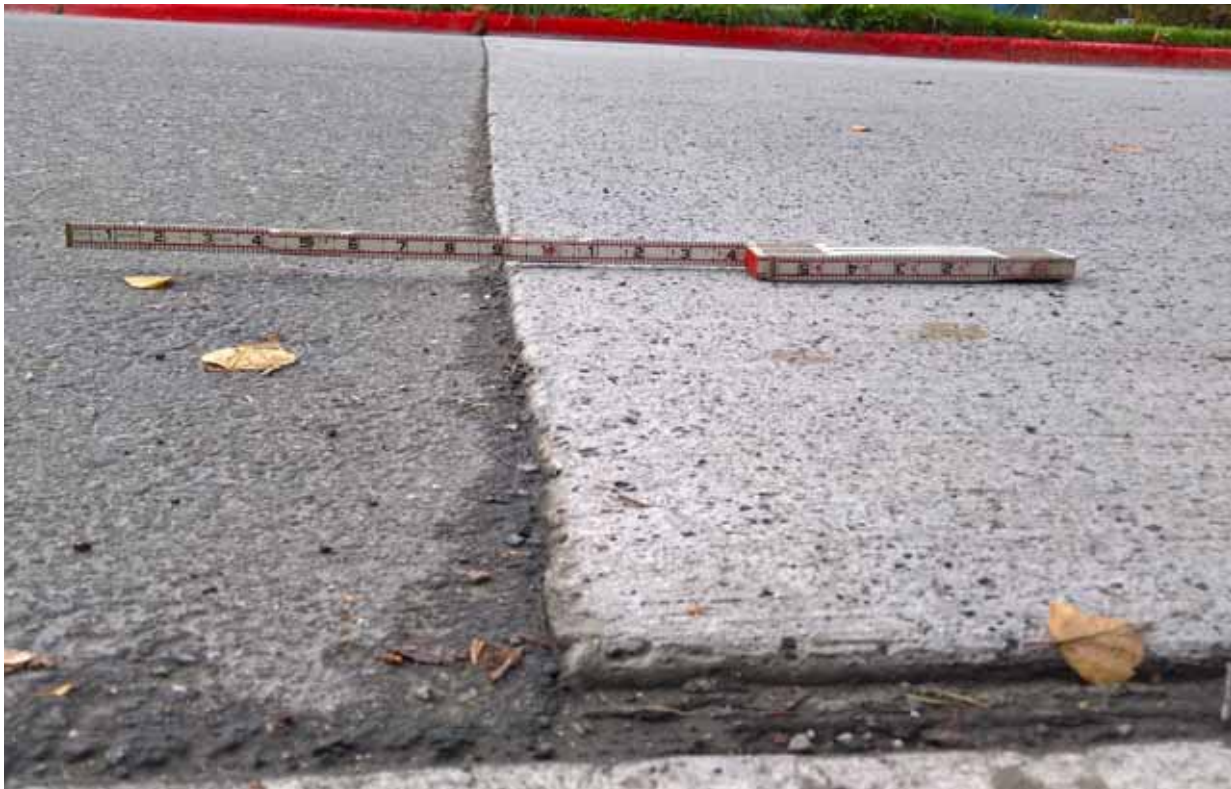
Figure 14: The north joint of the UAA trial slab showing an elevation difference of 1.27 cm.

The edge of the slab was designed to include SFRRC material extending under the adjacent material to resist any uneven heaving that would cause a lip at the joint. Inspection of the slab revealed a minor height difference at the joint between the concrete and the adjacent asphalt pavement of approximately 1.27 cm. Inspection of the concrete gutter running on both sides showed that the slab was still level with the gutter elevation. We determined that the adjacent pavement may have compacted or settled slightly as the SFRRC slab remained in place. Further investigation next winter will determine if any changes in the slab have occurred.

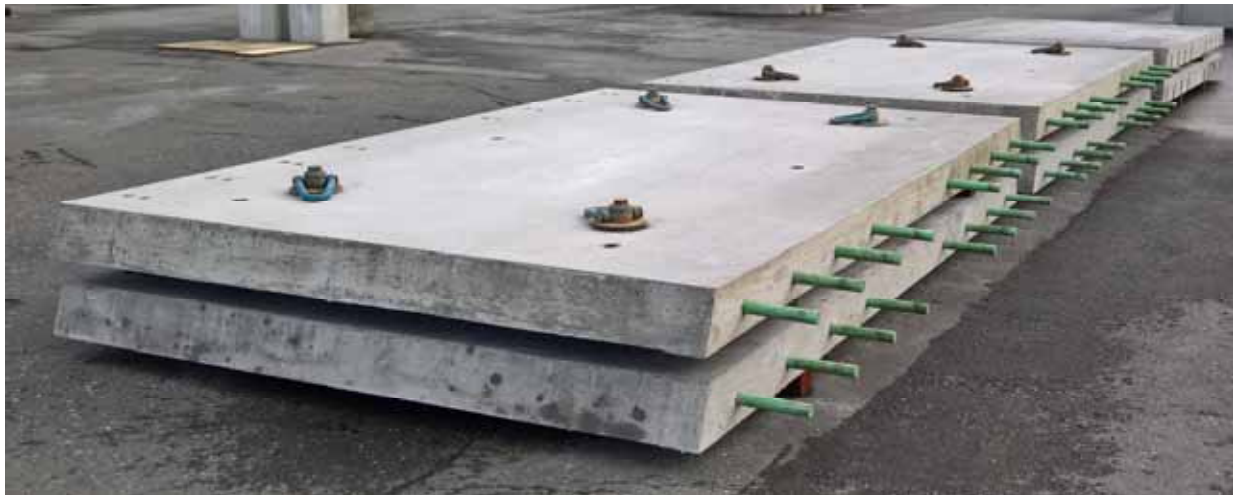
Figure 15: Pre-cast SFRRC panels for Abbott Road test section.

Once the design process was complete, the Abbott Road capital project was advertised and awarded to Quality Asphalt Paving (QAP) for construction. QAP subcontracted a local concrete company, D&S Concrete Inc., to construct the pre-cast panels at their facility. D&S created forms to meet the required 12-foot-wide by 8-foot-long by 7-inch-thick design, including grout ports and channels, dowel slots and inserts, locations for the strain gauge sensors, lifting eyes, rebar enforcement, and tapered edge designs, as shown in Figure 15. D&S created two forms to work with, so the casting process required approximately 20 days to complete the required 15 panels. After pouring 2 panels, a minimum cure period of 3 days was allowed prior to removing cured panels and pouring the next set. Pouring began on August 25, 2016 and complete September 14, 2016. Testing for compressive and flexural strength was completed on each panel. Details about the layout of the slabs as well as the site location are shown in Figure 17 Appendix C. In addition, Detailed reports on the daily pouring process and strength testing can be found in Appendix H.

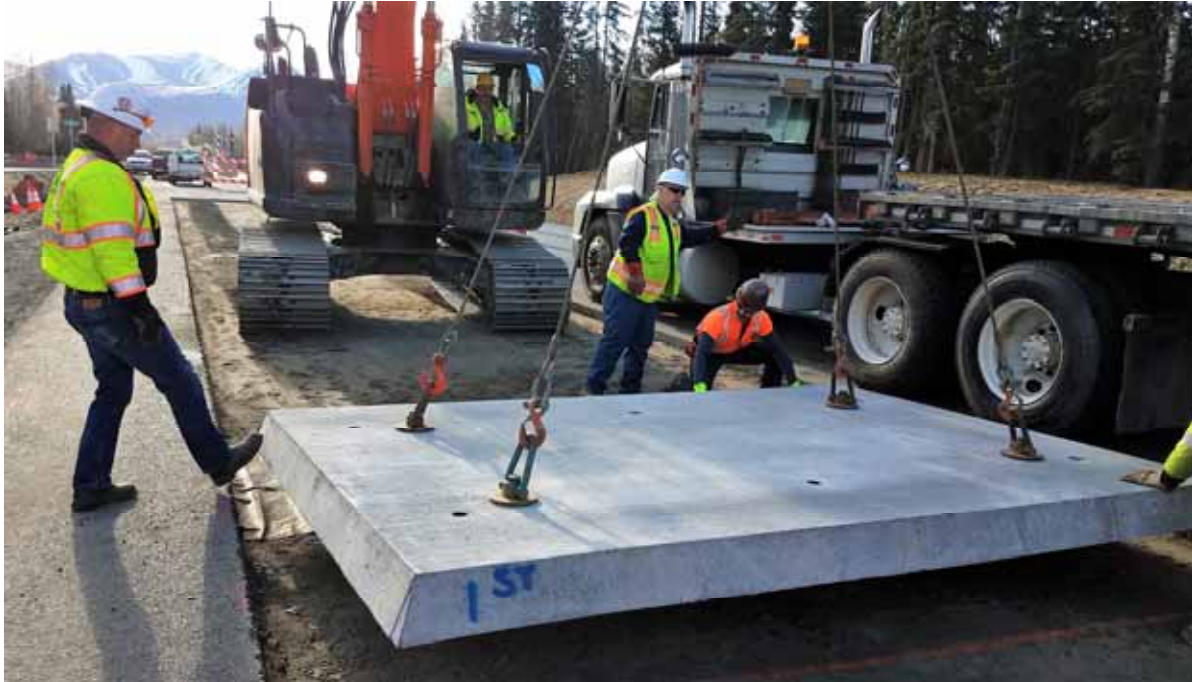
Figure 16: Placement of the first SFRRC panel using an excavator and harness.

The panels were stored at the D&S facility until May 2017, when construction on the project began. The panel location was prepared by removing the temporary hot mix asphalt (HMA) and placing a fine-grade sand layer. The panels were transported to the site on a flatbed semi-truck and trailer in May 2017. The first load brought out four panels. An excavator with a lifting harness was used to place the panels (see Figure 16). There was slight difficulty lifting the third and fourth panels high enough due to the limited reach of the excavator arm. Two loads of four panels were transported on-site, and subsequent loads only contained three panels or less per trip.

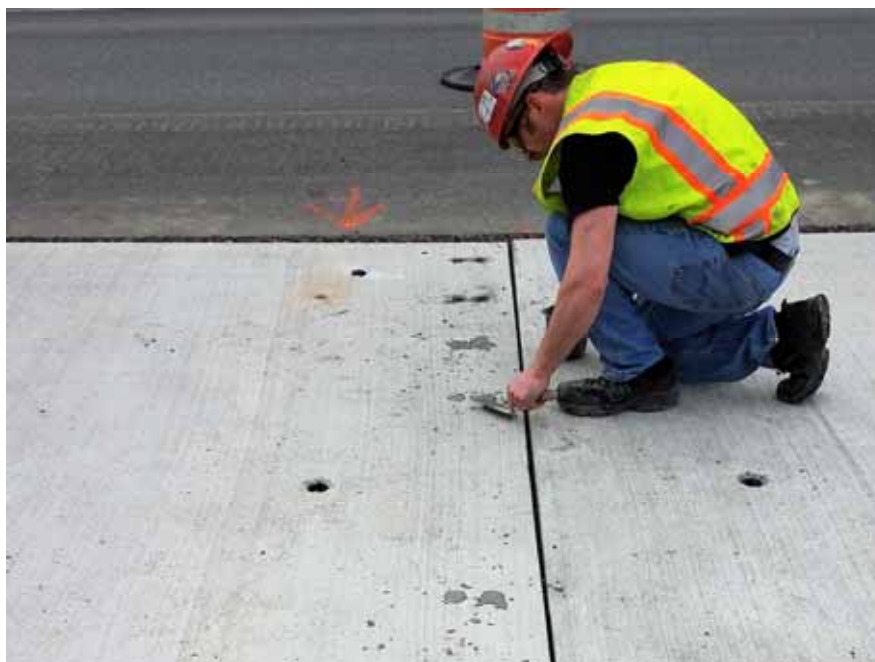
Figure 17: Pouring of the dowel and bedding grout for the SFRRC test section.

Once the panels were placed and leveled properly, the grouting process was conducted. This process included installation of the dowel and bedding grout. The specifications required differing strength grouts, but to simplify the process, the grout supplier used one grout meeting the higher strength requirement. The dowel ports were filled first using a gravity flow method from higher to lower locations, followed by the grout ports. Some panels required more grout than others based on the number of voids present. The process was completed in a day's shift.

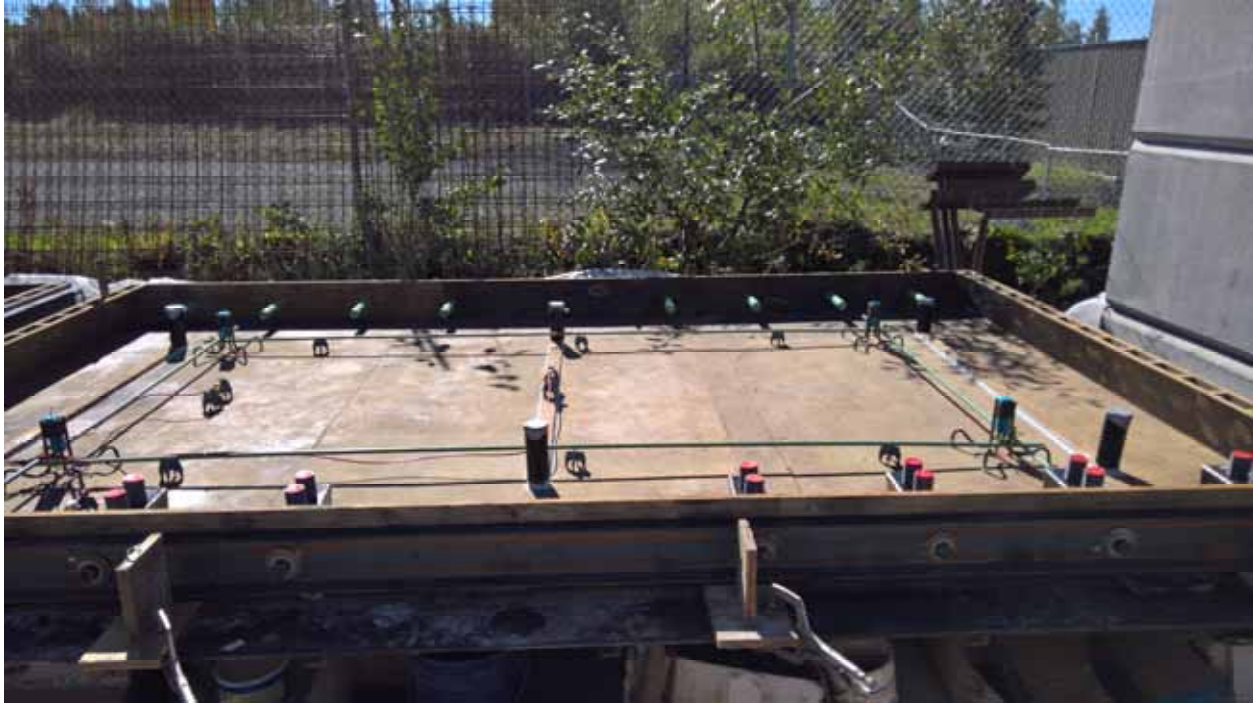
Figure 48: Formwork for pre-cast SFRRC panel with strain gauges installed.

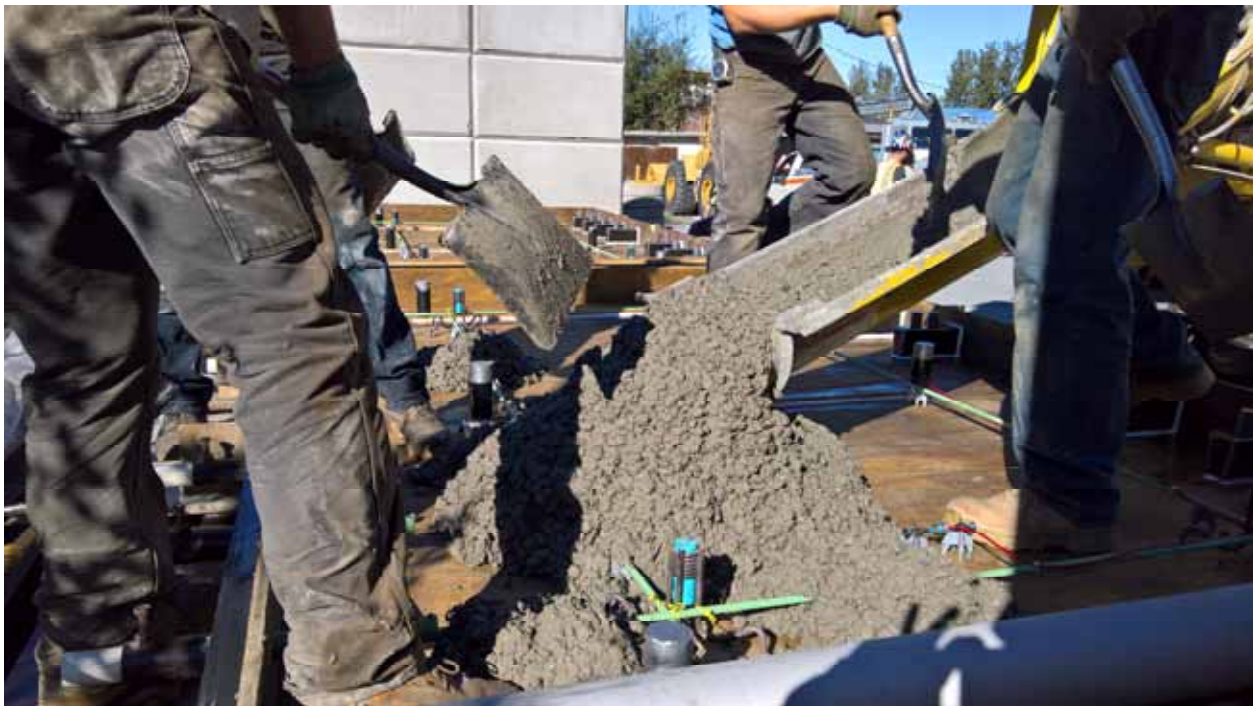
Figure 49: Placing SFRRC material in forms, with strain gauges installed.

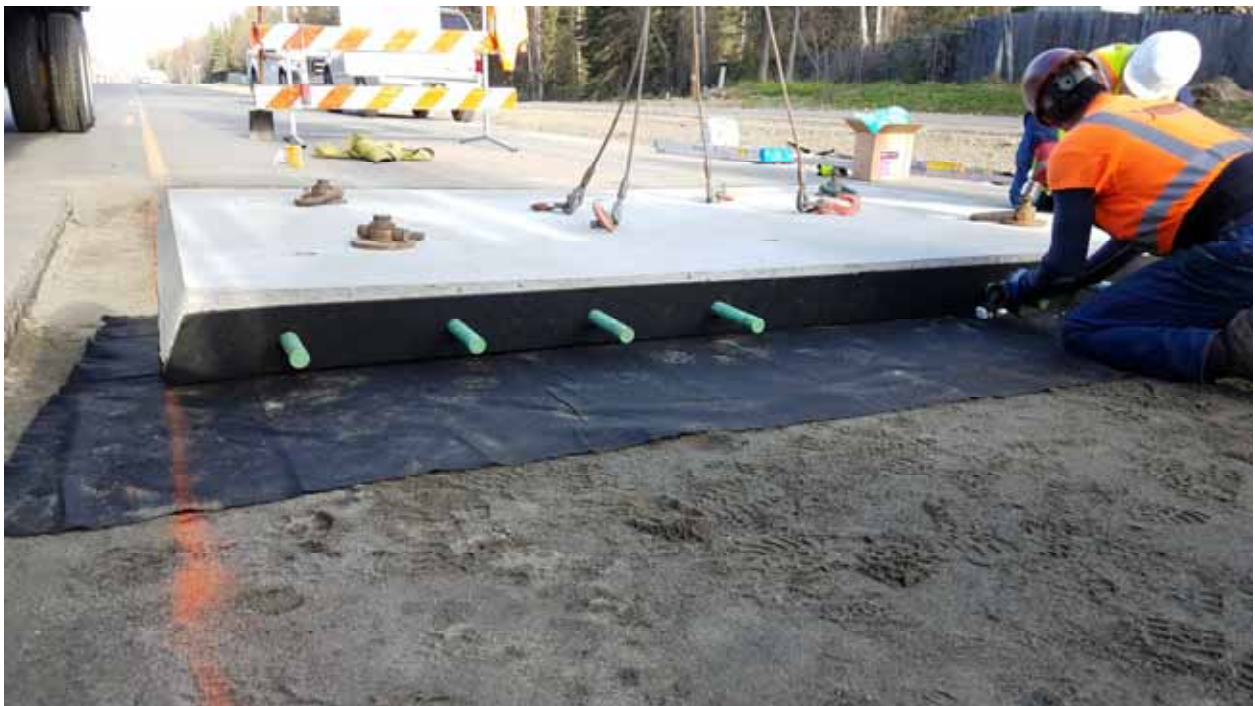
Figure 51: Placing de-bonding agent on dowels and the installed joint expansion board.

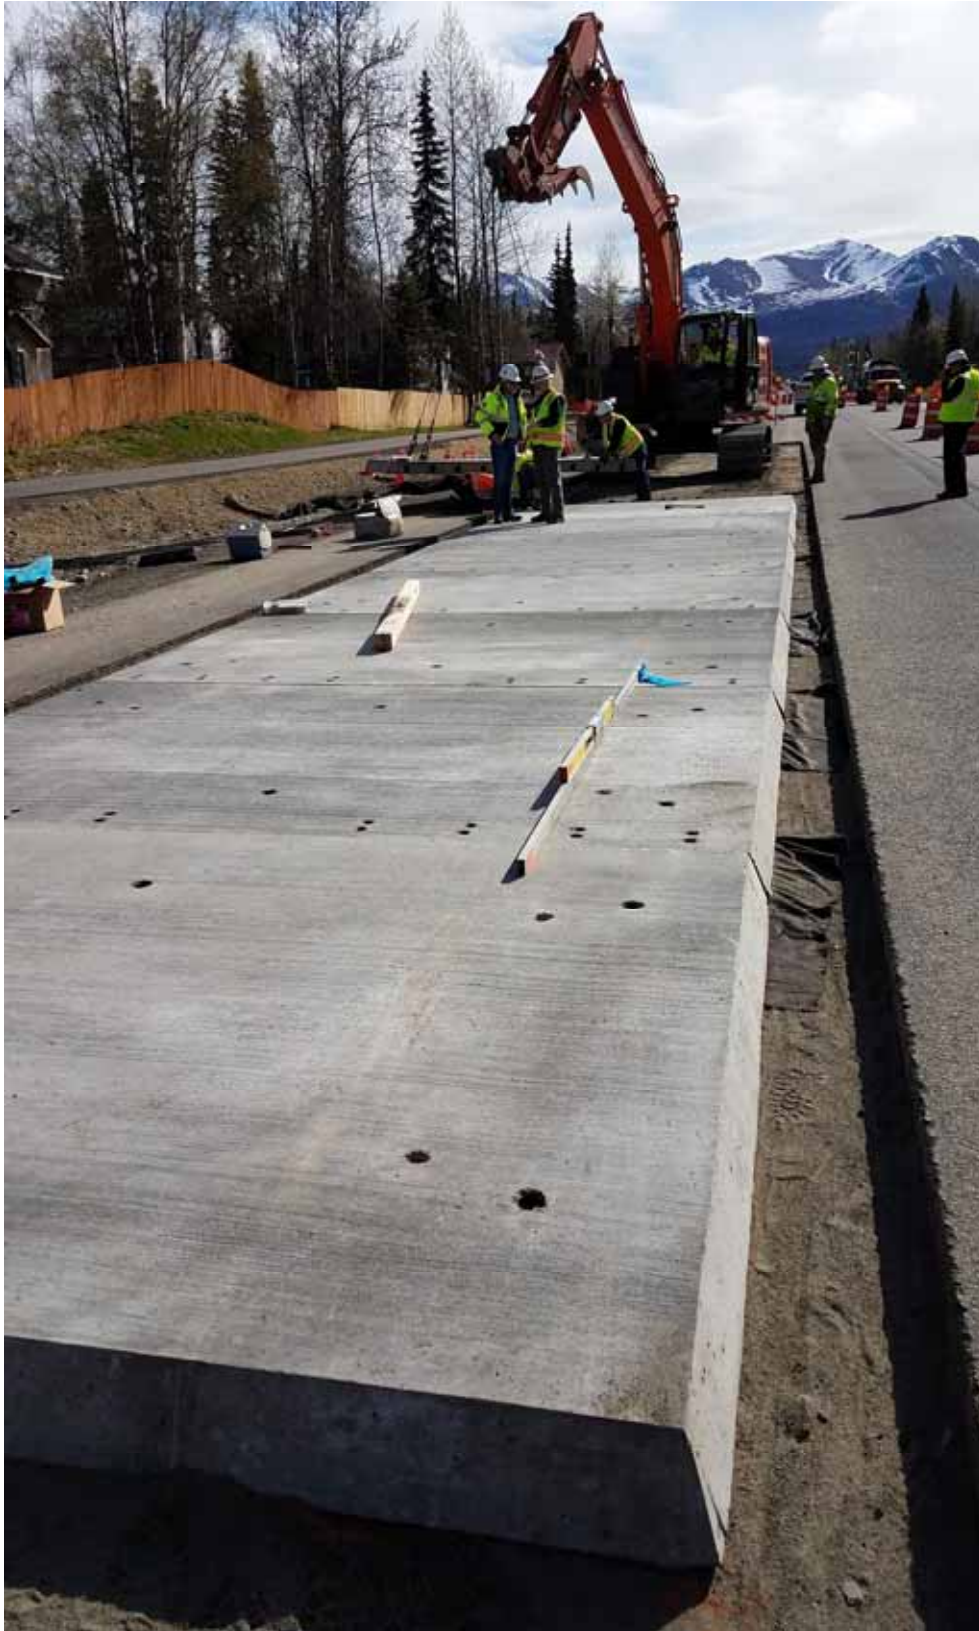
Figure 52: Placing of the test section panels with proper alignment and leveling.
