# **Repair & Strengthening of Distressed/Damaged Ends of Prestressed Beams with FRP Composites**

Research Report No. FHWA-ICT-18-001

**ICT PROJECT R27-156**

**February 2018**

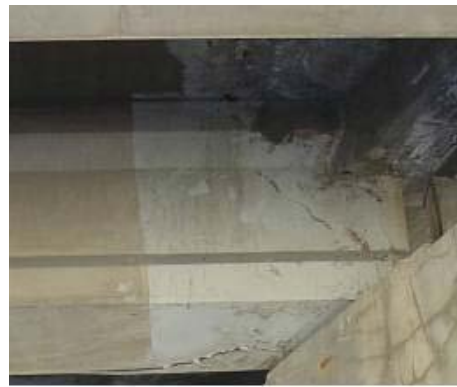
**Figure 1.1. End region damage and mortar repair of concrete bridge girder.**

(a) End damage of girder (Ramseyer and Kang 2012)

(b) Typical mortar repair of girder end

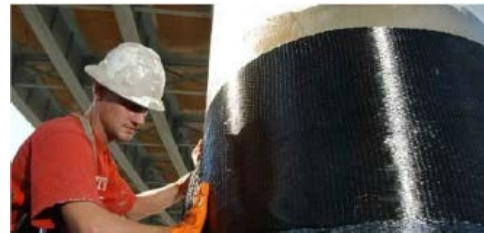
(b) Wet layup of CFRP on column

**Figure 2.1. Externally bonded FRP laminates (Mojarrad 2015).**

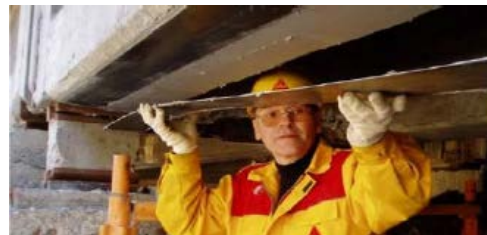
(d) CFRP plate flexural reinforcement of slab

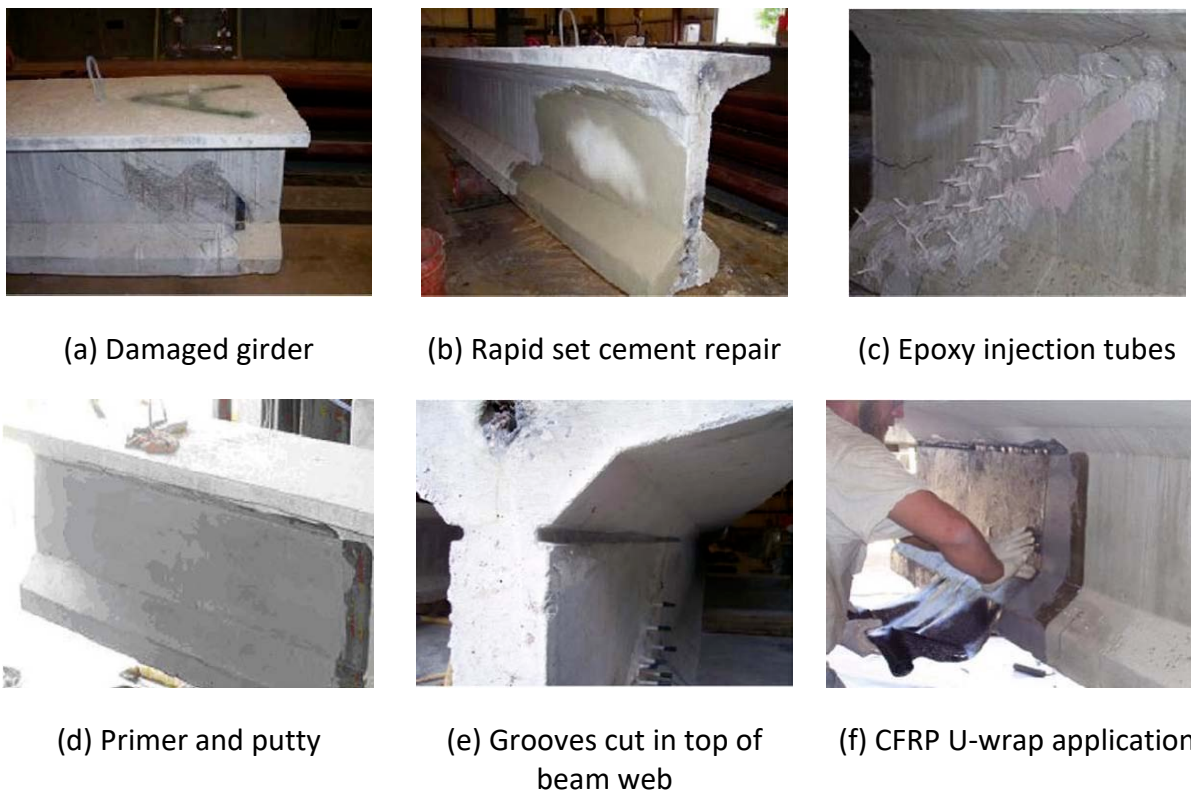
**Figure 2.3. Post-Damage repair of PC girders (Ramseyer and Kang 2012).**

Research for this specific application has been very limited thus far. Ramseyer and Kang (2012) performed shear tests on AASHTO Type II girders that had been damaged and repaired with CFRP and GFRP laminates. In these tests, the girders were tested in shear using a shear span-to-depth ratio of

1. Damage was imposed by first loading the girder to its maximum load in shear, which simulated a corrosively failed end region. Post-damage repair consisted of application of rapid set cement, epoxy-injecting cracks (for some tests), and application of externally bonded wet layup CFRP and GFRP 90° U-wraps. Grooves were cut at the top of the web and metal bars were inserted to anchor the fiber sheets. Figure 2.3 illustrates this repair process. This study concluded that CFRP has the greatest amount of stiffness recovery while GFRP has the highest percentage of strength recovery. Only one test, however, was able to recover the original shear strength of the girder (GFRP with epoxy injected cracks).

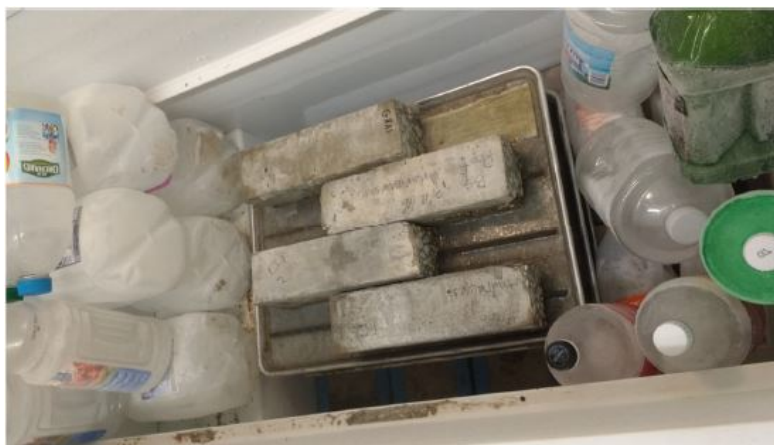
**Figure 3.3. Specimens in freezer during freeze cycle.**

specifies the use of  $\text{CaCl}_2$  with a concentration of 4 g/100 ml (0.33 lb/gal) of solution, but states that other chemical deicers may be used. Since rock salt is commonly used as a deicing chemical, NaCl was used as a substitute, with an equivalent concentration of  $\text{Cl}^-$  (4.21 g/100 ml (0.35 lb/gal) of NaCl). One freeze/thaw cycle was performed per day ranging from -18 to 4 °C (0 to 40 °F). The cycle consisted of 16 hours to lower the temperature from 4 to -18 °C (40 to 0 °F), 6 hours at -18 °C (0 °F), and 2 hours to raise the temperature from -18 to 4 °C (0 to 40 °F) (Figure 3.2). Freeze/thaw cycling was performed in a conventional chest freezer (Figure 3.3), with the use of an electric resistance heater to thaw the specimens. The trays were rotated throughout the cycling process in order to account for any uneven distribution of heat within the freezer. After 40 cycles, the concrete specimens showed moderate scaling, and half of the aged specimens were tested along with the unaged specimens. The rest of the specimens were continued on to 100 cycles, at which point they were tested.

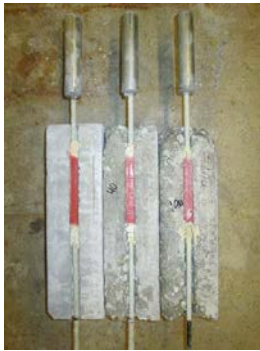
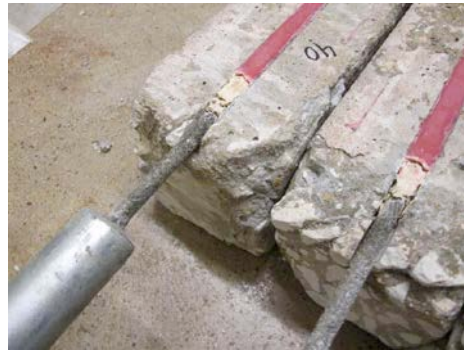
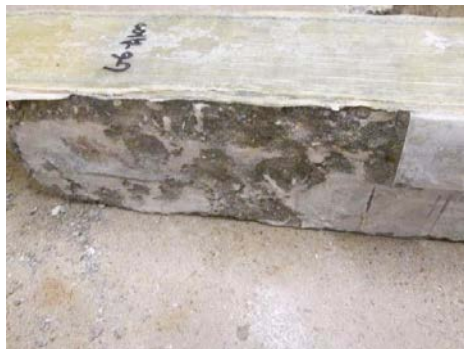
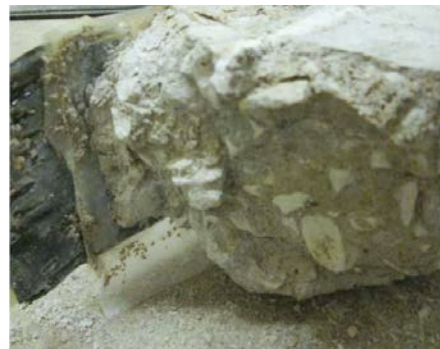
Compared to the 40 cycle specimens, the 100 cycle specimens showed increased scaling of the concrete (moderate to severe), and in many cases coarse aggregate had been exposed and/or completely spalled off. Figure 3.4(a) compares a set of concrete specimens with no aging, 40 freeze/thaw cycles, and 100 freeze/thaw cycles. The most severe of concrete damages occurred mainly at the ends of the specimens (Figure 3.4(b)), which generally left the bonded portions of FRP intact. One laminate specimen (G-6-A100) had scaling on one side that resulted in loss of a minor portion of bonded area, as shown in Figure 3.4(c). There were also two 100 cycle CFRP laminate specimens that had severely damaged ends that rendered the specimens untestable due to lack of bearing area against the plates in the test fixture, one of which is shown in Figure 3.4(d). For this reason, the results for these 100 cycle CFRP laminates are omitted. Other than some salt depositions on the laminates, the FRP laminates, bars, and epoxy filler had no visible signs of deterioration.

(a) G-b-4 specimens: A0, A40, A100

(b) Scaling/spalling at specimen ends

(c) Scaling induced loss of bonded area

(d) Severe end damage on C-6-A100

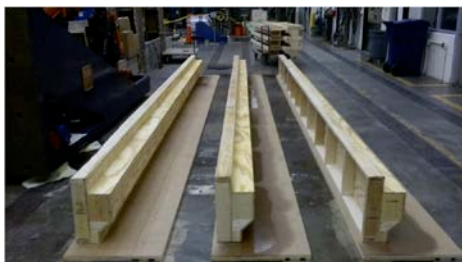
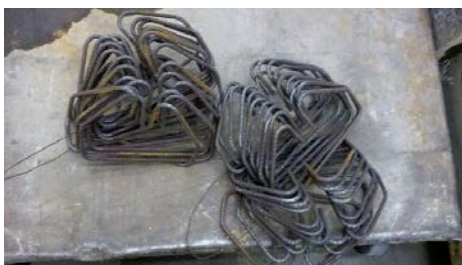
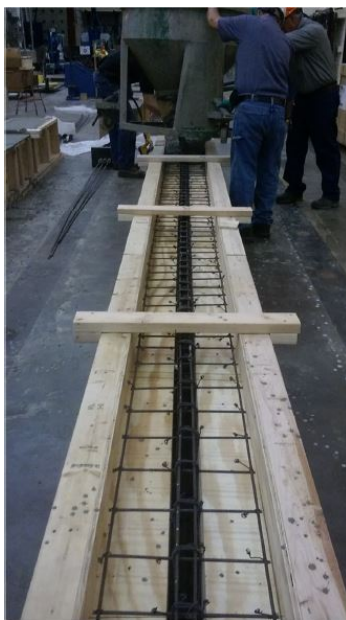
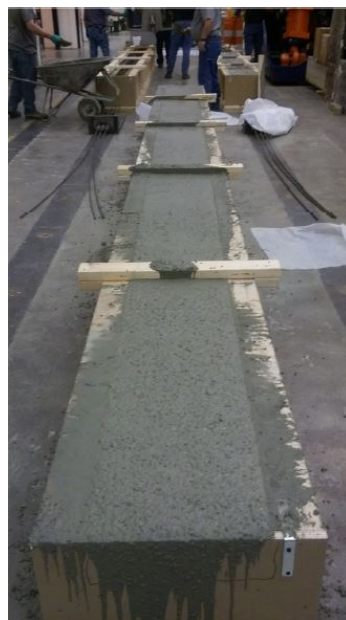
(a) Formwork construction

(b) Bent rebar

(c) Concrete pouring

(d) Completed pouring

Figure 4.2. Beam specimen casting.

treated threaded rod. After determining the ideal temperature, the heat treatment was applied to all of the threaded rod used for stirrups in the beam ends. Figure 4.2 shows the casting process of the beam specimens.

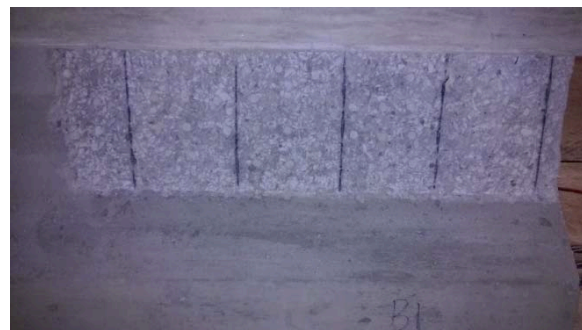
(b) Beam after cover removal

**Figure 4.5. Concrete cover removal.**

In order to observe the effect on shear capacity of the types of deterioration seen in the field, damages were imposed on the beam ends for all tests but the control. Since shear capacity is the critical component being investigated, damages were only applied to the web of the beams prior to testing. This also allowed the damages to be easily reproduced for consistency between the different spans tested. Over the entire shear span for all tests with cover damage, the concrete cover was removed to a depth of 12.7 mm (0.5 in.), or to approximately the centerline of the threaded rod stirrups, from the entire web. The concrete cover removal process is illustrated in Figure 4.5. First, a grid of holes was drilled 12.7 mm (0.5 in.) deep using a hammer drill with a 9.5 mm (0.375 in.) diameter drill bit. Then, the cover was removed using a hammer drill with a chisel attachment, being careful not to damage the stirrups. The damaged region was vacuumed and air blasted to remove any concrete particles and dust from the surface. The removal of the concrete cover resulted in a 33% reduction in the width and cross-sectional area of the beam web.

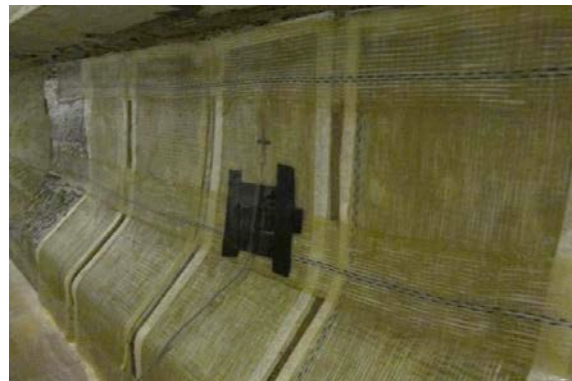
Figure 4.6 shows the design of the FRP laminate repairs used in this study. Longitudinal anchors of the same FRP material used for shear reinforcement were placed at the top of the web, the bottom of the web, and along the bottom edge of the bottom flange. In order to increase development of the anchors at the beam end, the anchors were wrapped around the end of the beam and continued along the other side. It is possible that the space constraints could prevent the proper adherence of the FRP anchor to the end of the beam. As a result, the anchors were left unsaturated with epoxy and unbonded to the web where they loop around the beam end. Horizontal fiber orientation (0°) was used for the anchors. The widths of the two web anchors were 50.8 mm (2 in.), while the width of the bottom flange anchor was 38.1 mm (1.5 in.) to allow it to pass underneath the prestressing strands, which protruded from the end of the beam. In addition to the instrumentation shown in Figure 4.4, a strain gage was placed vertically on the FRP shear laminate closest to the center of the shear span (see Figure 4.6) to measure the strain obtained in the FRP laminate.

(a) FRP repair dimensions (in.)

(b) FRP strain gage

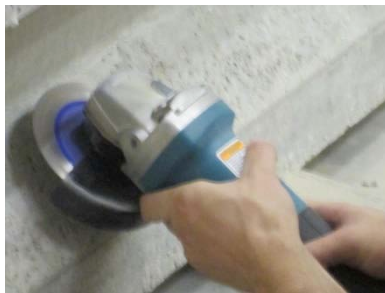
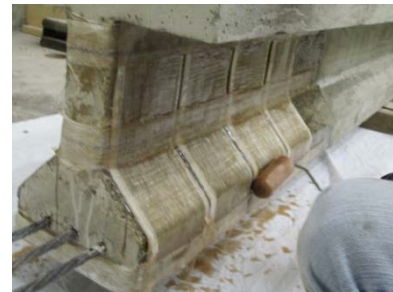
The FRP laminate repair process is illustrated in Figure 4.7. After the mortar had set for 24 hours, the surface was prepared using an angle grinder with a diamond tipped concrete blade. Surface preparation was performed on both the mortar repaired surface web and the original concrete along the bottom flange. The surface was vacuumed and air blasted to remove dust and laitance. Next, the concrete surface was saturated with the two-part epoxy resin. Once the resin became tacky, FRP sheets were applied. The FRP sheets were then saturated with epoxy resin, and in the case of GFRP more plies were added. When applying multiple layers of GFRP, we observed that the increased thickness caused a tendency for the laminate to detach from the concrete at both of the angles in the bottom flange. We were extra careful to make sure the first layer was sufficiently bonded to the concrete before adding subsequent plies. After the FRP shear wraps were saturated, the longitudinal anchors were applied and fully saturated. The epoxy was allowed to set for 48 hours prior to testing.

(a) Surface grinding

(f) Saturating GFRP anchors

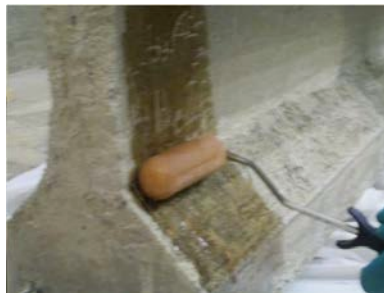
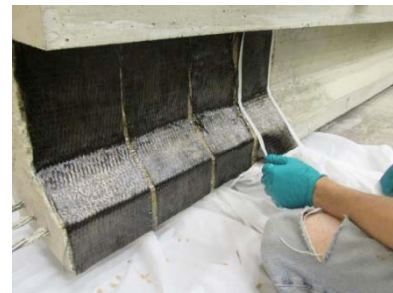
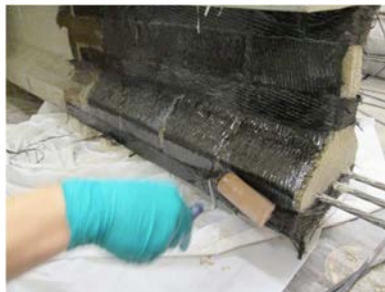
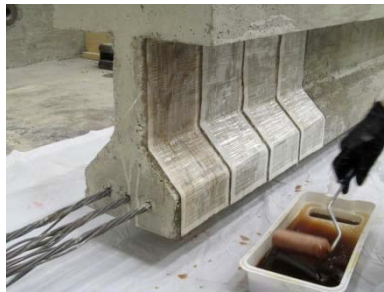
(b) Epoxy saturation of concrete

(c) Applying shear CFRP

(d) Saturating CFRP anchors

(e) Applying shear GFRP

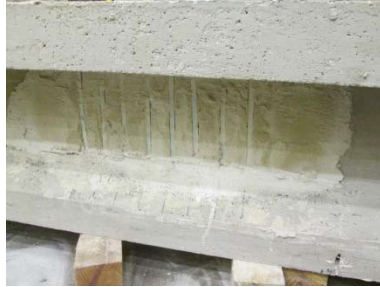
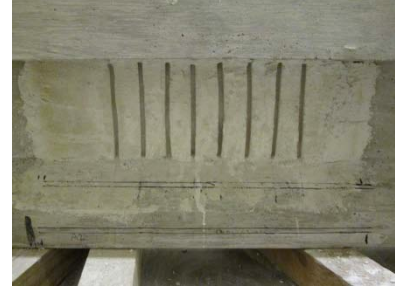
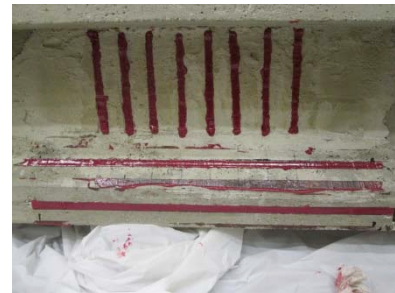
The CFRP bar repair process is illustrated in Figure 4.9. One difficulty presented by the small-scale of the beam was cutting the notches for in the web for the vertical CFRP NSM bars. Due to the geometry of the top flange, it was not possible to cut a notch all the way to the bottom of the top flange using a circular saw with an 86 mm (3.38 in.) diamond grit blade. Therefore, we needed to maximize the development length and thus the strain capacity of the NSM bar repair. In order to accomplish this, an alternative technique was used to create these notches. During the mortar repair process for this span, 11.1 x 11.1 x 190 mm (0.44 x 0.44 x 7.5 in.) stiff foam pieces were placed within the repaired web region in order to preform notches in the mortar repair. The width and depth of these foam pieces were slightly greater than the minimum groove dimension 1.5db (9.5 mm, or 0.38 in.) required by ACI 440.2R-08(ACI 2008) for NSM FRP bar reinforcement. This was to ensure that the CFRP bars would fit in the resulting groove, even if any slight misalignment or deformation in the foam was caused by the mortar application. After the mortar repair had set, the foam was removed from the groove using a flathead screwdriver. Since the bottom flange was both easily accessible and not affected by the damage/mortar repair process, the two longitudinal grooves were cut using the circular saw with a diamond grit blade. Two longitudinal cuts were made at the furthest extents of the groove, and the remaining portion of concrete along the middle of the groove was chiseled away. From here, the same repair process explained in Chapter 2 was performed. The interior surfaces of the grooves were vacuumed and air blasted to remove dust and laitance. Then, masking tape was applied along the edges of the grooves. The grooves were filled halfway with epoxy, the CFRP bars were inserted, and then the groove was completely filled. The excess epoxy was then troweled away and the tape removed. The repair was allowed to set for 48 hours prior to testing.

(a) Foam notch fillers cut

(b) Mortar repair with foam notch placed

(c) Foam removed and longitudinal notches marked

(f) Final repair after troweling and removing tape

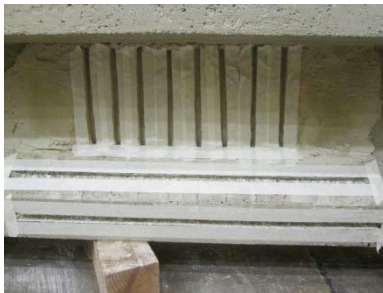
(d) Notches taped after cutting longitudinal notches

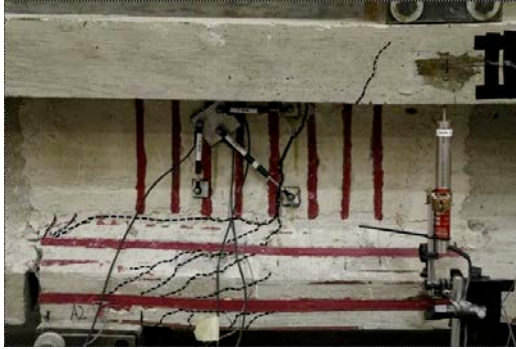
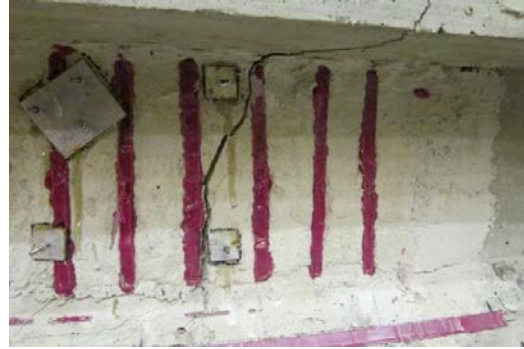
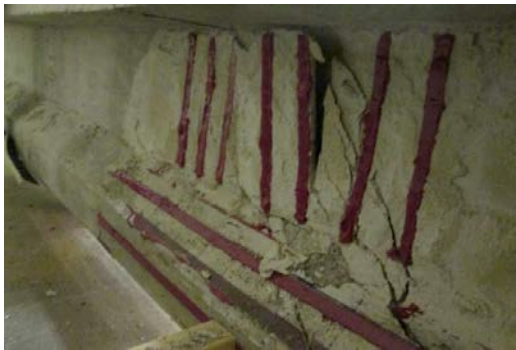
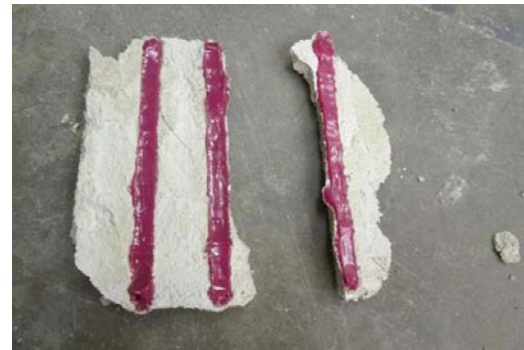
beam, the development length of the vertical bars may have been insufficient. Additionally, the weak interface between the mortar repair and the existing concrete coincided with the bottom of the notches for the vertical bars. This weak interface promoted cracking at the mortar/concrete interface, which undermined any potential effectiveness of these bars since stresses were not transferred evenly through the concrete and mortar. On one side of the beam large pieces of the mortar repair spalled away from the beam web. This was due to the combination of the weak mortar/concrete interface and the tendency for the cracking in the web to propagate between the vertical bars (see Figures 4.16(c)-(d)).

(a) Cracking pattern

(b) Cracking around CFRP bars in web

(c) Debonding at epoxy/concrete interface

(d) Debonded section of mortar

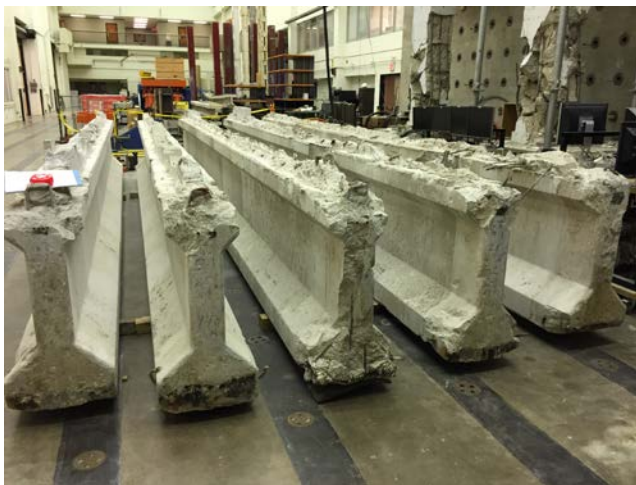
**Figure 5.1. AASHTO Type II prestressed girders.**

Five AASHTO Type II prestressed girders that were in service in the State of Illinois for over 40 years were extracted from a bridge and shipped to lab at the University of Illinois at Urbana-Champaign as shown in Figure 5.1. Two of the girders has length equal to 7.9 m (26 ft.) and the rest of the girders were 8.5 m (28 ft.) long. All the girders shared the same cross-section as depicted in Figure C.1 in Appendix C.

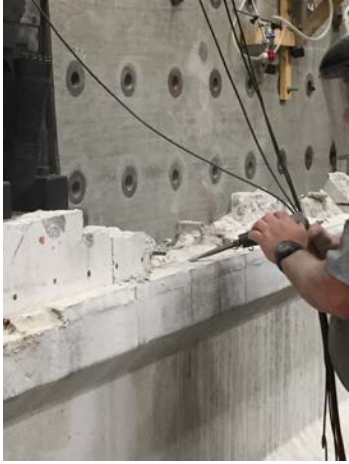
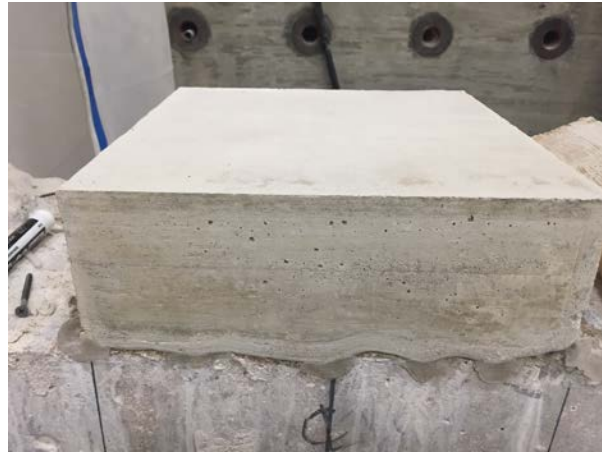
(a) Removal of uneven concrete

(b) Casting of grout block

**Figure 5.2. Casting of the load bearing grout block.**

Since the top of the girders were uneven, it was not feasible to apply the load directly on the girders top using an actuator. Therefore, to provide an even bearing area for the actuator, uneven concrete was removed from the top and a 304.8 x 304.8 x 101.6 mm (12 x 12 x 4 in.) block was cast using high strength mortar (Rapid Set Mortar Mix from CTS Cement, Inc.) as shown in Figure 5.2. As per the design plans, the girders were prestressed with six 12.7 mm (0.5 in.) diameter 7-wire stress relieved prestressing strands with an elastic modulus of 186.2 GPa (27,000 ksi) and ultimate strength of 1862 MPa (270 ksi). The strands were pretensioned to 1303 MPa (189 ksi), approximately 70% of their ultimate strength. The mild steel used was Grade 40 with yield strength equal to 276 MPa (40 ksi). With a service life of over 40 years, the compressive strength of the concrete was unknown.

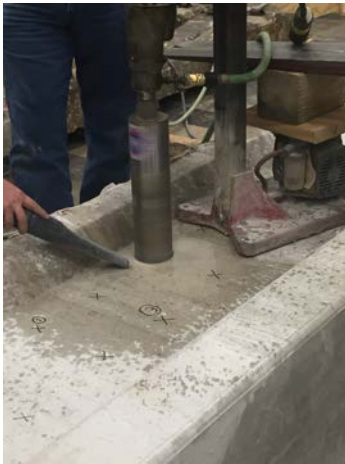
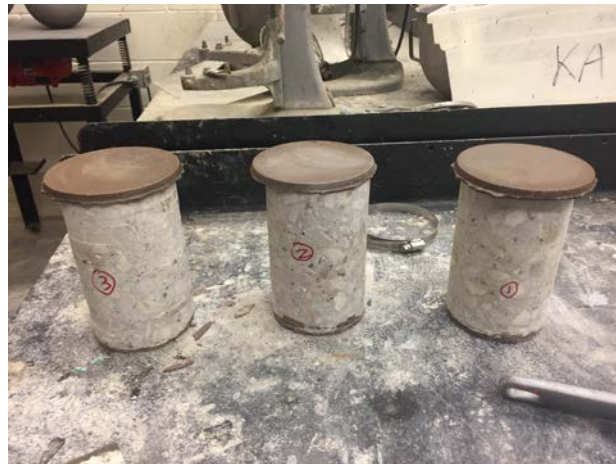
(a) Drilling cylinder from web

(b) Cylinders obtained from web

**Figure 5.3. Testing of concrete compressive strength.**

Therefore, after one of the girders was tested, cylinders were drilled from the web of the girder and tested to obtain the compressive strength of the concrete as shown in Figure 5.3. The average compressive strength of concrete was found to be 60.3 MPa (8.75 ksi).

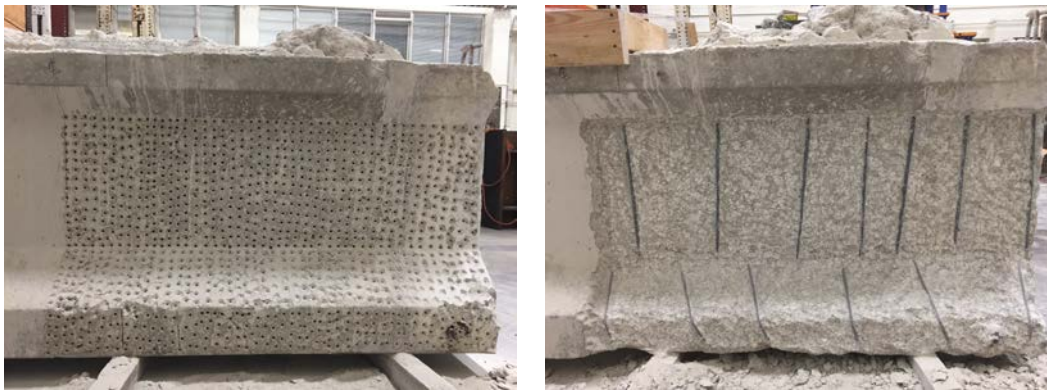
To mimic the damage/deterioration that girders are subjected to at their end regions during service life, the concrete cover was removed. Unlike the small-scale beams, for full-scale girders, the concrete cover was removed from the web through bottom flange. This is needed in order to introduce a more severe and practical damage pattern. For all the cases except the Control case, concrete cover was removed to approximately the centerline of the stirrups. To remove the cover, first, a grid of holes with a depth to the centerline of stirrups was drilled. The grid served two purposes: one was to control the depth of the concrete cover removed; the other was to ease the removal process after drilling. Then, a hammer drill with a chisel was utilized to remove the cover. The removal procedure is shown in Figure 5.6.

(a) Grid of drilled holes

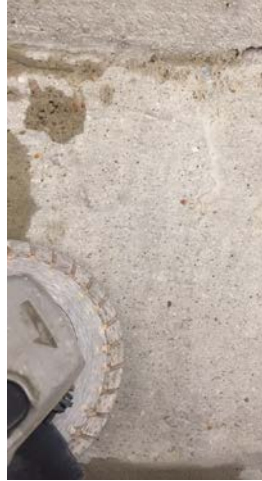
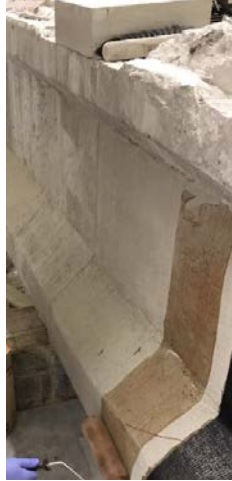
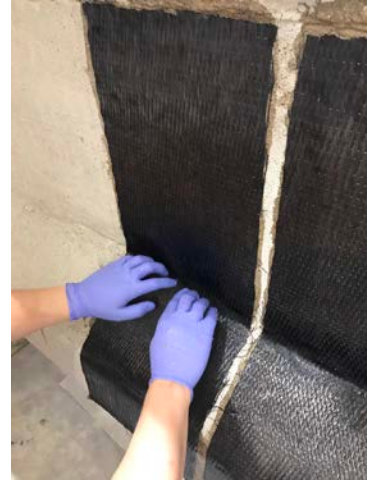
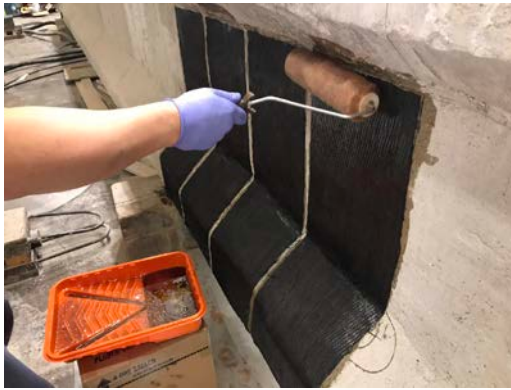
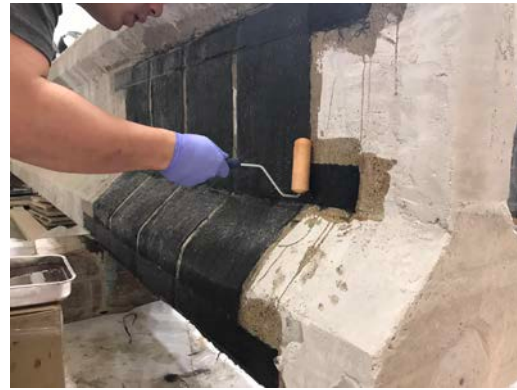
(a) Surface grinding

(b) Resin application

(c) FRP laminates application

(d) Saturating laminates with resin

(e) Applying longitudinal strips

**Figure 5.8. Process of applying CFRP laminates.**

To apply CFRP laminates using the wet layup method, first, the mortar surface was grinded using a diamond tipped blade to provide a rough surface and increase the bond between epoxy and mortar. Then, a thin layer of two-part epoxy was applied to saturate the surface. Afterwards, a CFRP panel was placed to the surface and pressured by hand to remove any air bubbles under the panel. After four panels were attached, epoxy was applied to saturate the laminates.

The same process was repeated to apply longitudinal strip. The epoxy was allowed to set for 48 hours. The procedure is shown in Figure 5.8.

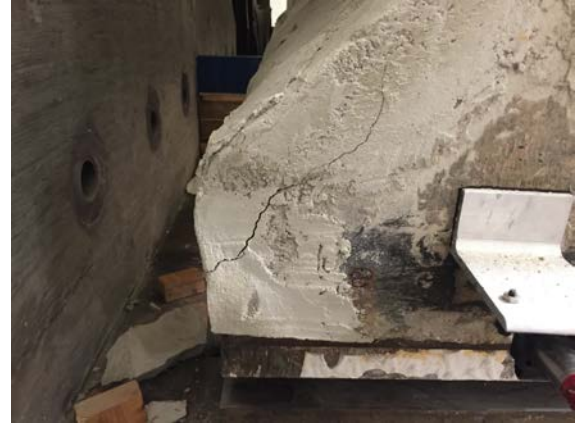
**Figure 5.12. Failure mode of Mortar specimen.**

From the load vs. deflection curves, it can be seen the Mortar repair case nearly coincided with the Damage case. Compared to Control case, the Mortar case showed a reduction of 8.6%, 15.3% and 20.0% in peak load, initial stiffness and secant stiffness at yielding point. The ductility of Mortar case was even worse than the Damage case with 53.5% reduction compared to the Control case. Based on the test results, it seemed that the mortar repair alone failed to restore the shear capacity and ductility of the girder. There are several reasons that might have caused such unexpected behavior. First, the bond between mortar mix and base concrete was not strong enough to allow stress transferred to mortar. Therefore, unlike the Control and Damage cases where more inclined shear cracks developed during loading, the Mortar repair case only showed one main shear crack as shown in Figure 5.12(a). Second, cracks developed in the mortar above the bearing plate were observed on both sides of the girder as shown in Figure 5.12(b). This is because the mortar surface was not on the same plane with the base concrete. As a result, the vertical reaction was originally resisted by the mortar cover until an even surface was achieved at bearing plate, which caused the cracking above the bearing plate, as shown in Figure 5.13. Such cracks jeopardized the integrity of the mortar cover and limited its participation in resisting shear stress. To prevent such cracks from developing, it is recommended that mortar repair should be terminated slightly above the bearing plate to prevent any contact with bearing plate. Unlike small-scale beams where mortar repair would recover partial shear capacity, mortar repair in full-scale girders showed negative effect and proved to be too insufficient to recover the shear capacity and ductility of the girder.

(a) Mortar after failure

(b) Cracks above bearing plate

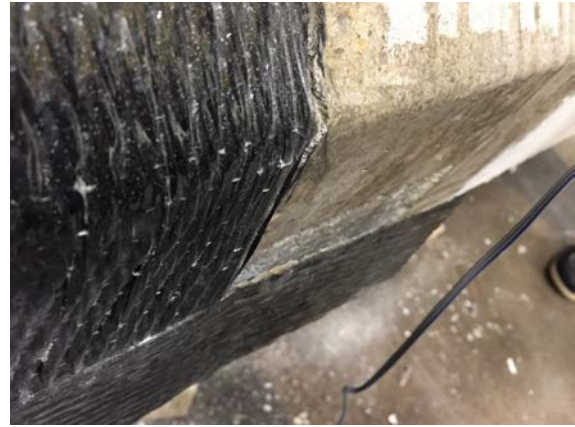
(b) Total debonding of longitudinal strip at ends

**Figure 5.14. Debonding of CFRP laminates.**

From Figure 5.9, it is observed that the overall behavior of the damaged girder was improved with CFRP laminate repair. Both peak load and ductility exceeded the Control case with an increase of 2.6% and 9.6%, respectively. Even though a small difference (2.3%) existed, the CFRP laminate repair was able to recover most of initial stiffness. This is mainly because the FRP laminate facilitated the mortar to get engaged in the shear behavior during early loading stage, which was not possible with the absence of FRP laminate in Mortar repair case. Overall debonding of FRP panel was not observed during the test with only partial debonding concentrated around the second and third panel (see Figure 5.14(a)). Longitudinal strip serving as anchorage system provided sufficient anchoring between vertical FRP panel and mortar cover and only showed debonding at its ends when the girder failed, as shown in Figure 5.14(b).

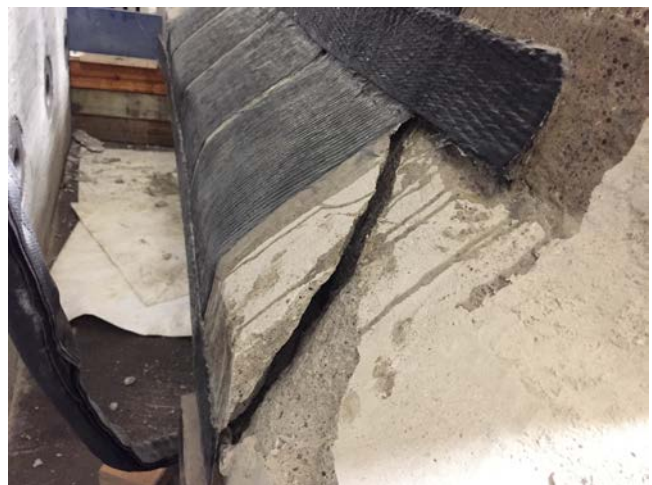
The failure mode of the CFRP case differed from the other cases by showing major flexural cracks under the loading point as shown in Figure 5.15(a). Significant shear crack was not observed on either side of the girder. This indicates that the CFRP laminate repair had strengthened the damaged end and enhanced its shear capacity of the girder because the failure mode was shifted from shear failure to flexural failure.

(a) Flexural cracks under loading point

(b) Large cracking above bearing plate

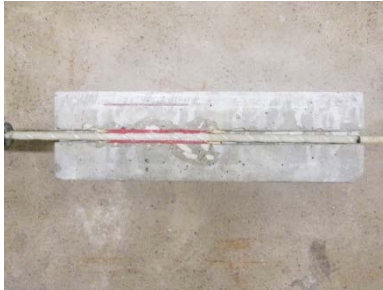
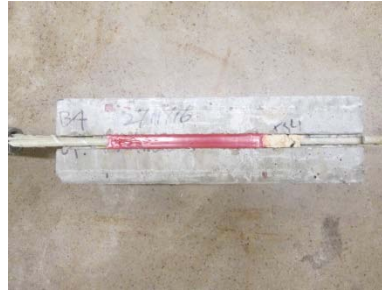
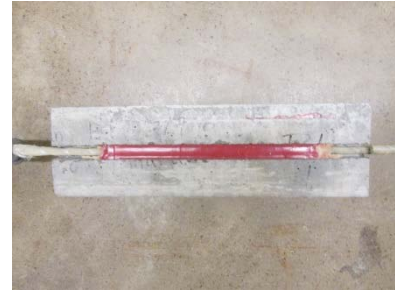
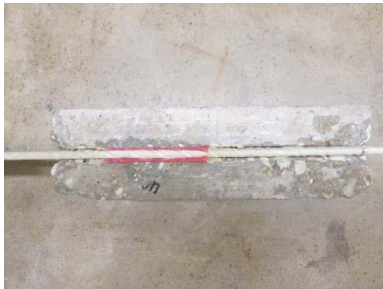
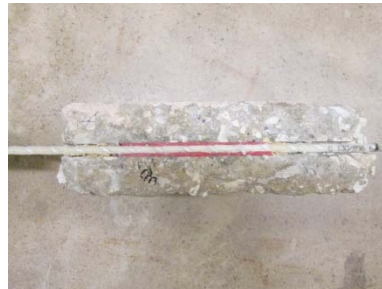
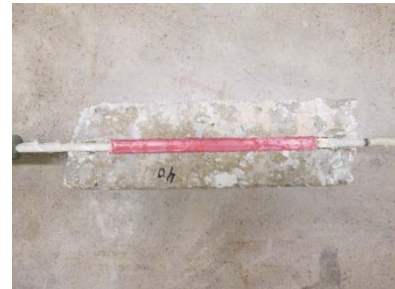
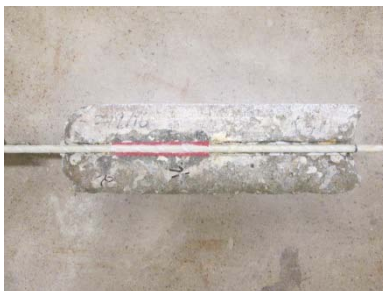
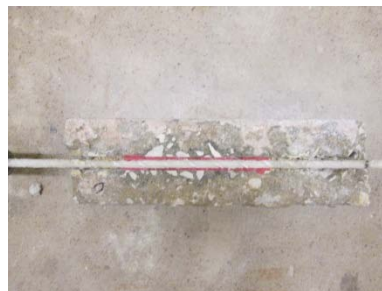
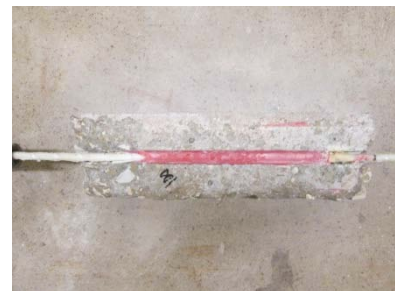
**Figure A.1. GFRP NSM bar failure surfaces.**

This appendix contains figures of the post-failure surfaces of all GFRP and CFRP NSM bar specimens.

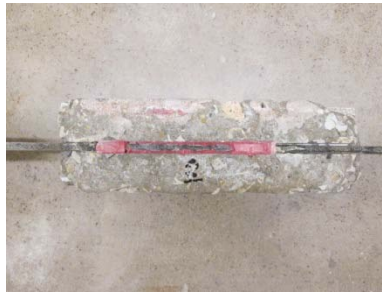
(h) C-b-6-A100

**Figure A.2. CFRP NSM bar failure surfaces.**
