Pavement Edge Treatment — Final Report

WA-RD 798.2

Experimental Feature WA 11-01

Pavement Edge Treatment

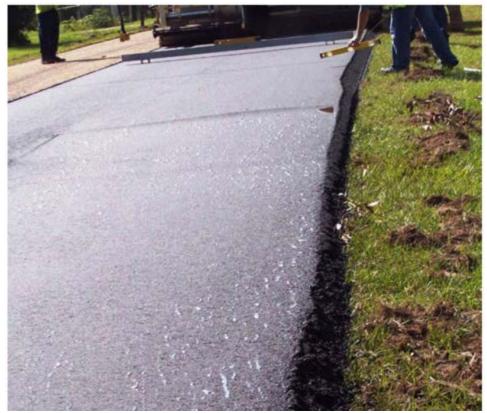
Figure 7. Pavement edge without the Safety Edge_{SM} in foreground and with the Safety Edge_{SM} in the background. (FHWA Safety Edge PowerPoint)

The Safety Edge_{SM} pavement edge treatment provides a non-vertical wedge at the edge of the pavement which reduces the steering forces needed for re-entering the roadway. With this treatment, the pavement edge is sloped at a 30° angle (see Figure 2). The presence of a slope instead of a vertical face makes it easier for a vehicle to re-enter the roadway. Figures 3 and 4 are diagrams of a pavement edge with and without the pavement edge treatment. Figures 5 and 6 are photos of a pavement with a vertical edge and one with the pavement edge treatment. Figure 7 shows a pavement under construction.

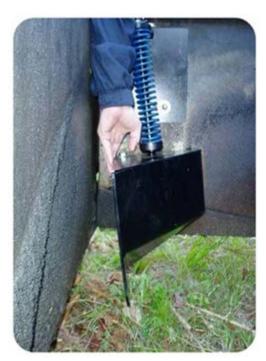
Figure 9. Troxler SafeT $Slope^{TM}$ Edge Smoother.

The Troxler SafeT*Slope*TM Edge Smoother is mounted on the paver screed extension against the end gate (see Figure 9). A guide rail with a two-inch radius allows the device to ride along the surface of the road shoulder following its contour. The two-inch radius helps the transition when the device encounters an obstacle such as a driveway cut or road intersection. A self-adjusting internal spring provides downward force to keep the guide rail in contact with the shoulder surface. A 30° forming edge produces the smooth wedge fillet. A 45° compound angle surface forces more asphalt mix under the device. An extended smoothing surface acts as a

trowel to smooth the surface of the wedge fillet. Both left and right-hand devices are available for paving with or against traffic.

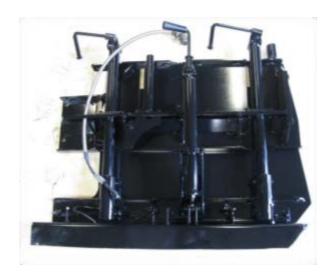
Figure 10. Carlson Safety Edge End Gate hardware. (FHWA, Madison Co., WI)

The Carlson Safety Edge End Gate features a spring loaded and heated end gate for the paving screed (see Figures 10 and 11). It utilizes the length of the end gate to apply compaction to the slope face of the pavement edge treatment. The screed operator's normal end adjustments automatically control the edge. The end gate ski is flat in the front and transitions to 30° at the back of the ski. The relatively long length of the end gate ski results in a smooth/sealed slope face.

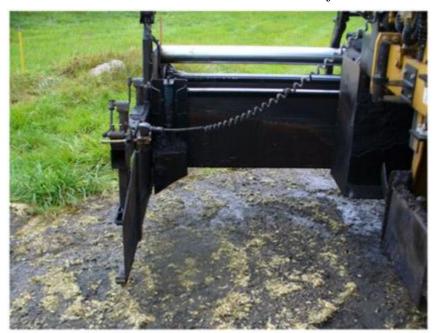
Figure 14. Advant-EdgerTM mounted on a paver. Unit is designed to automatically adjust to shoulder elevation changes (driveways and intersections).

The Advant-EdgerTM attaches to the screed extension and shapes the edge to a 30° tapered angle (Figures 12 and 14). It automatically adjusts to changes in shoulder elevations (i.e. driveways) via its internal spring. The Advant-EdgerTM is reversible so that it may be attached to either side of the paving machine. A new model called the Ramp ChampTM is designed to create either a safety edge or a tapered longitudinal center lane joint (Figure 13). It is also spring loaded to automatically adjust for changes in shoulder elevation. The slope of the safety edge is adjustable from 5° to 30° and its forming surfaces (shoes) are detachable permitting the same unit to create a variety of edge profiles.

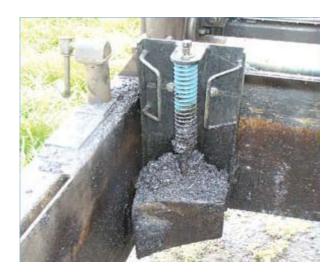
Figure 1. Pavement edge "shoe" bolted to paving machine screed (FHWA).

The pavement edge treatment is a wedge of pavement placed by a device bolted to the screed of the paving machine (Figure 1). FHWA recommends an angle of 30° to 35° between the roadway slope and the slope of the wedge (Figure 2). After completion of paving the gravel is graded back flush with the new pavement just as when a conventional vertical pavement edge is constructed.
