**A REMOTE SENSING AND GIS-ENABLED HIGHWAY
ASSET MANAGEMENT SYSTEM PHASE 2**

1. Report No.: FHWA-GA-17-1210	2. Government Accession No.:	3. Recipient's Catalog No.:	
4. Title and Subtitle: A Remote Sensing and GIS-enabled Asset Management System (RS-GAMS) Phase 2		5. Report Date: February 2018

6. Performing Organization Code:	
7. Author(s): Yichang (James) Tsai; Zhaohua Wang		8. Performing Organ. Report No.:	
9. Performing Organization Name and Address: Georgia Institute of Technology 790 Atlantic Drive Atlanta, GA 30332-0355		10. Work Unit No.:

11. Contract or Grant No.: PI# 0010896	
12. Sponsoring Agency Name and Address: Georgia Department of Transportation Office of Research 15 Kennedy Drive Forest Park, GA 30297-2534		13. Type of Report and Period Covered: Final; May 2012 – May 2017

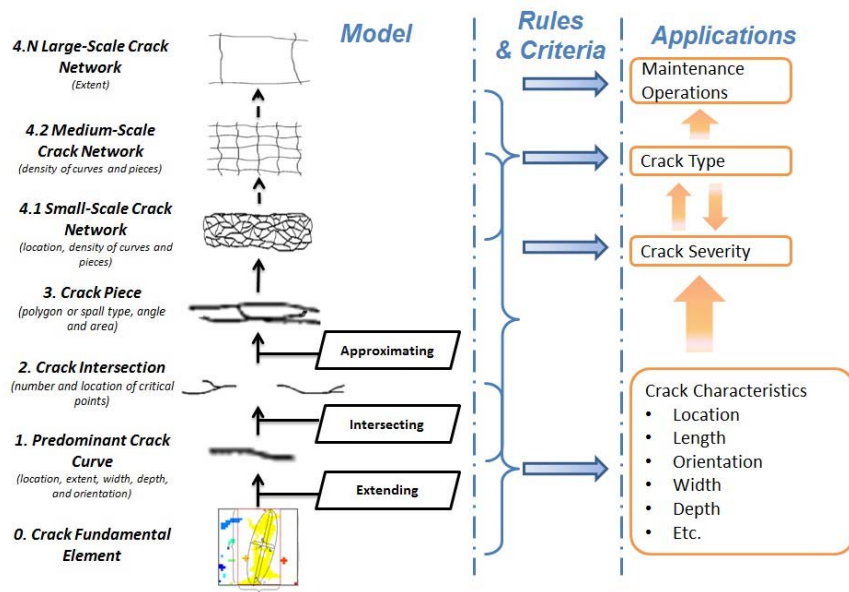
FIGURE 2.2: Crack classification using extracted crack properties

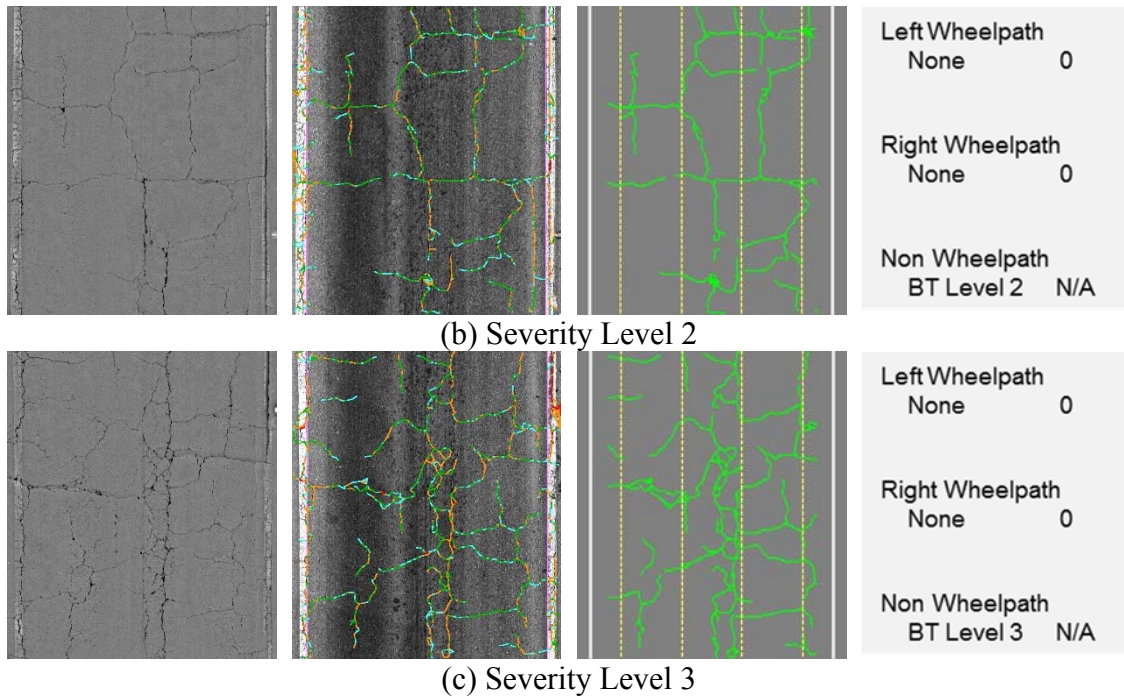
FIGURE 2.4: Representative B/T cracking evaluation outcomes, from left to right: range image, crack map on intensity image, load cracking (red) and B/T cracking (green), and evaluation outcomes (unit: foot)

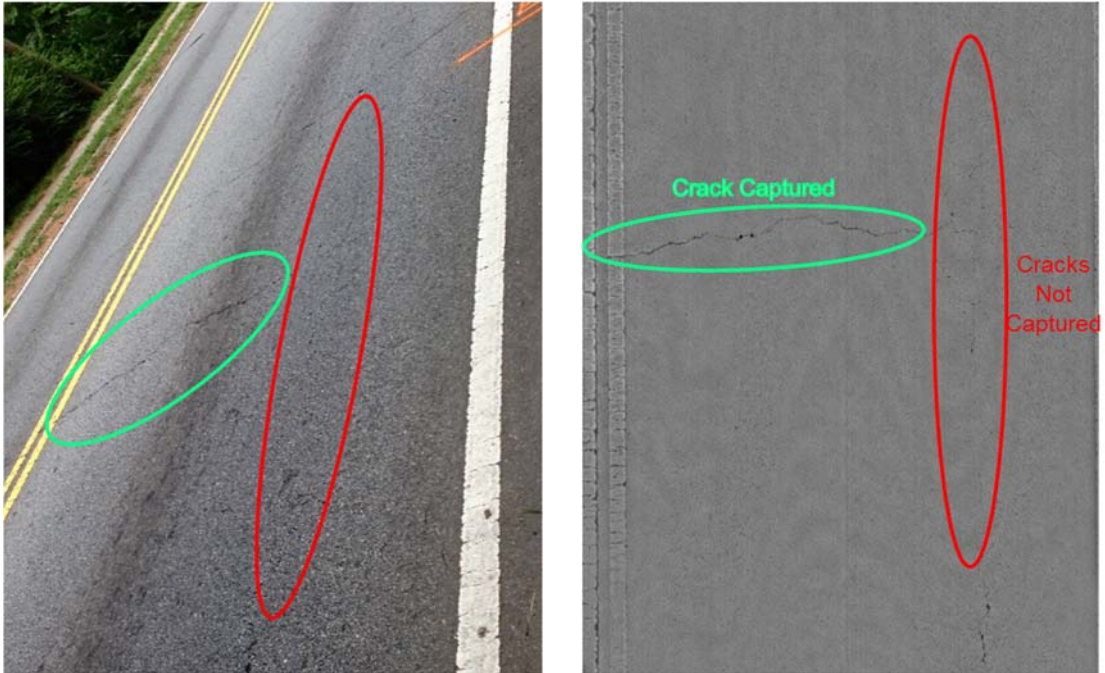
FIGURE 2.5: Limitation of current technology on hairline cracking (images from SR236 Site #3)

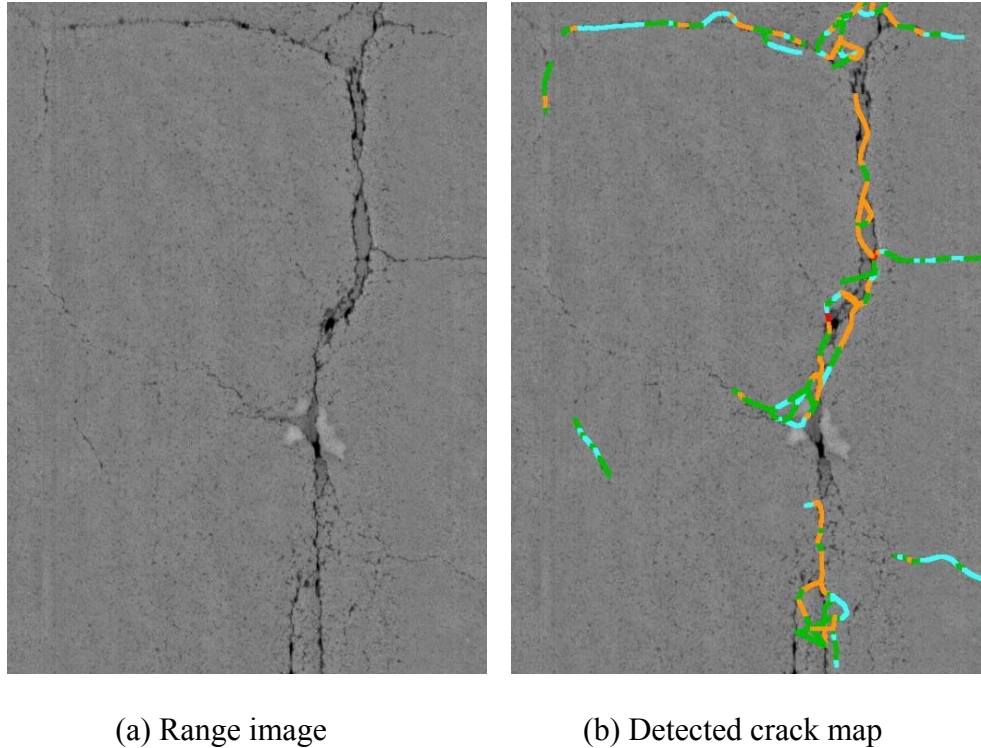
FIGURE 2.6: Limitation of crack detection algorithms (images from SR 236 Site #2)

Furthermore, the automatic crack detection algorithm cannot be guaranteed to provide a precise crack map on every image. As shown in FIGURE 2.6, some cracks were only partially detected, and the pavement areas with clearly double-crack lines were detected as only a single crack line. The limitation of automatic crack detection also impacts the performance of the subsequent crack classification and measurement.

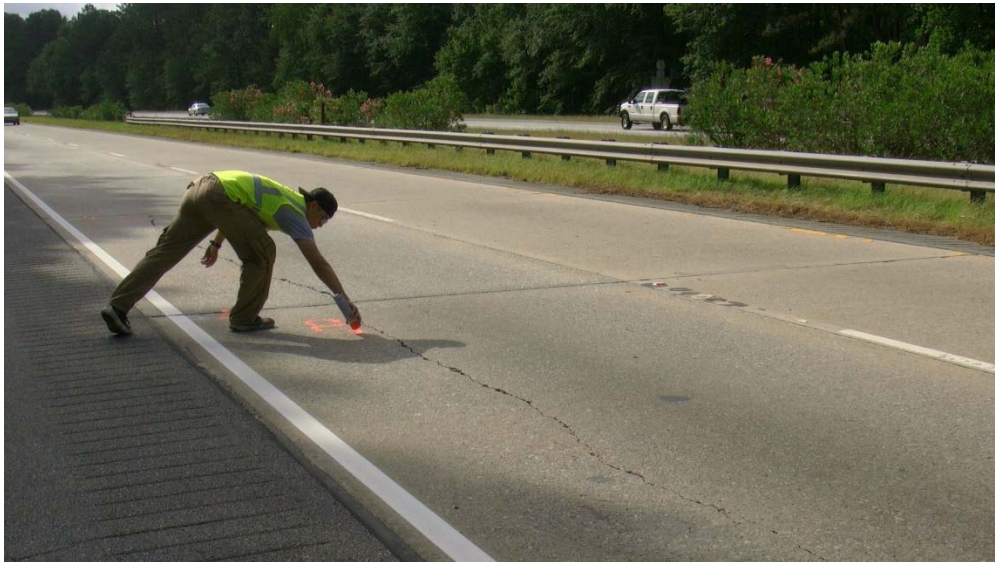
FIGURE 3.2: Manually labeling the selected concrete slab for crack detection validation

On the I-16 test site, we selected a total of 27 slabs westbound from MP159 to MP157; this roadway has representative cracking patterns, most of which are transverse cracking / broken slabs. Each of these slabs is marked with a unique ID for future reference (as shown in FIGURE 3.2), and the distresses on these slabs are drawn roughly for comparison purposes. On the I-516 test site, we selected 15 slabs northbound from MP3 to MP4. Similarly, each of these slabs was marked with a unique ID. Digital photos of the selected testing sites were taken from the road shoulder to track the detailed distress condition and provided certain reference through the validation.

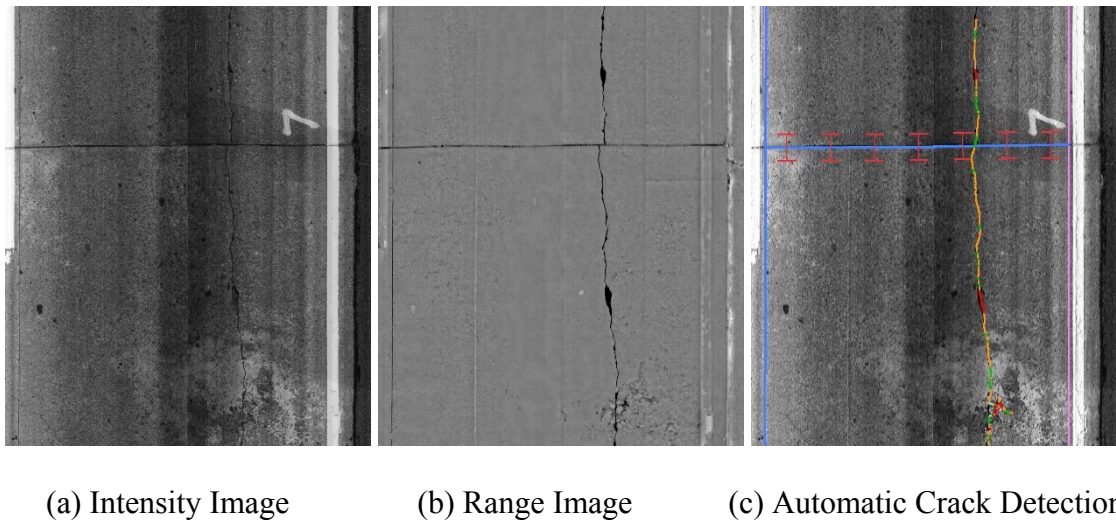
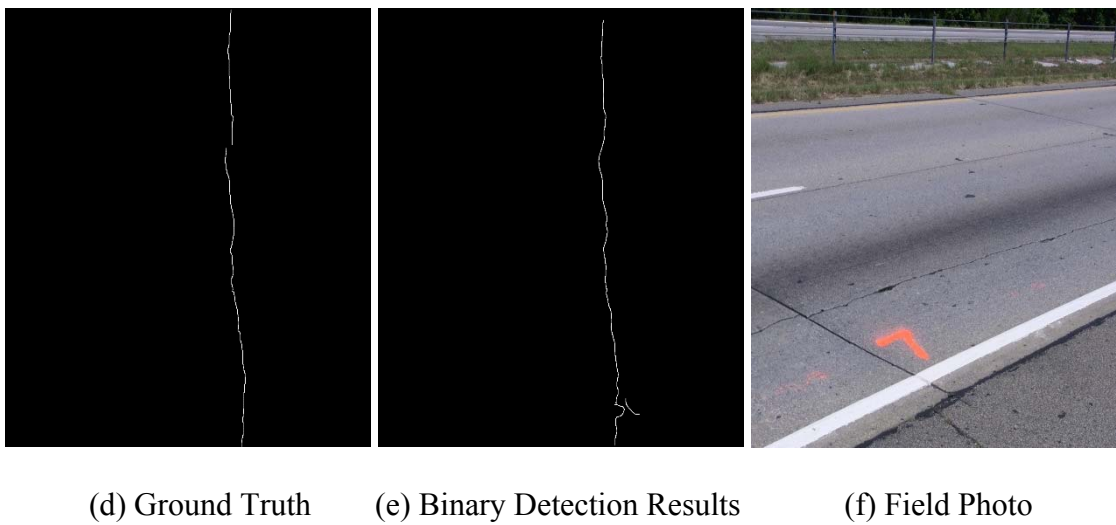
FIGURE 3.7: Crack detection on Slab #7 on I-516 test site (Score: 93.4601)

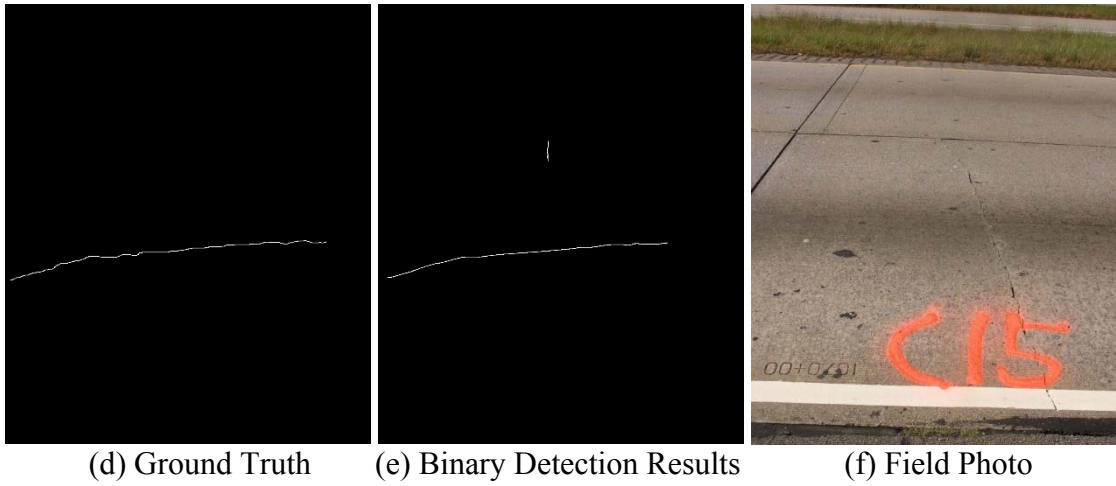
FIGURE 3.8: Crack detection on Slab #C15 on I-16 test site (Score: 90.4512)

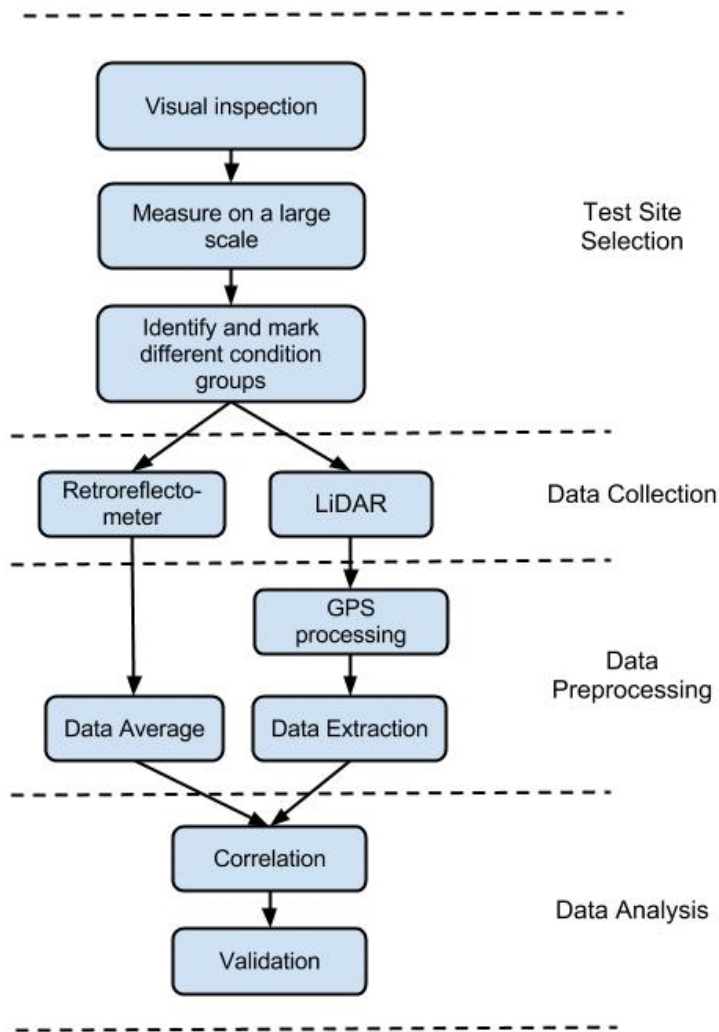
FIGURE 4.4 Flowchart of establishing correlation retroreflectivity and retro-intensity
