Connected Commercial Vehicles—Retrofit Safety Device Kit Project

Applications Performance and Functional Test Report

Publication No. FHWA-JPO-14-108

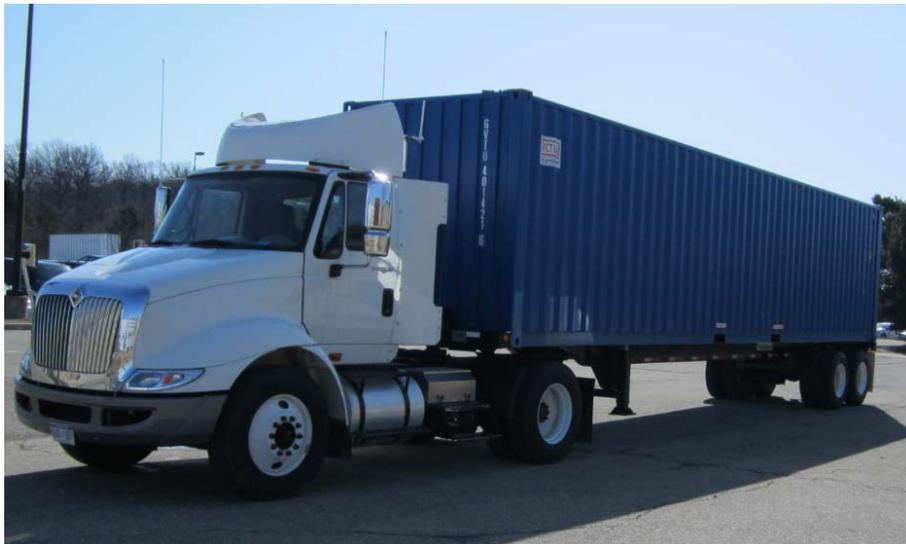
Figure 1. Photo. Host vehicle: International ProStar 8600 Day Cab with the 40-ft modular container that was attached for some tests.

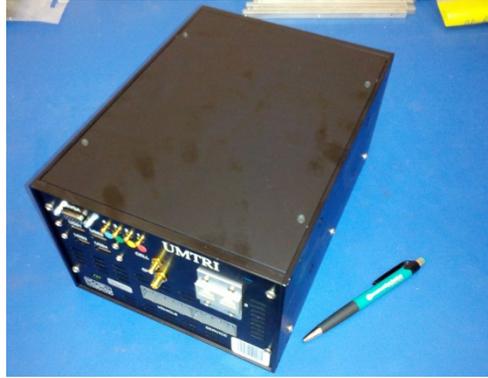
Figure 2. Photo. UMTRI Gen5 DAS.

The RSD HVT was equipped with the safety applications being tested, as well as an UMTRI data acquisition system (DAS) shown in figure 2. The DAS in the HVT was outfitted with a live display of DAS data for use by the test engineer driving the tractor (figure 3). This display was useful for establishing proper test conditions, such as headway distance.

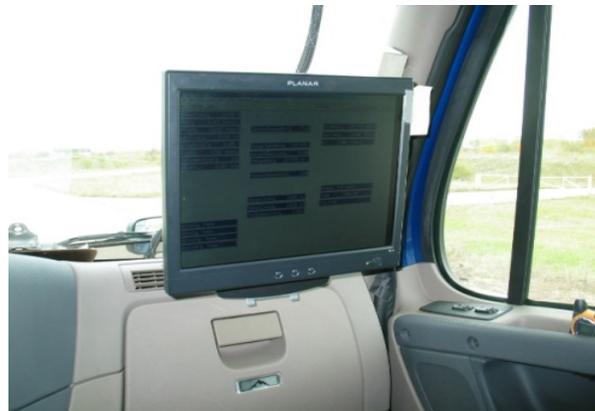
Figure 3. Photo. Interface for HVT driver.

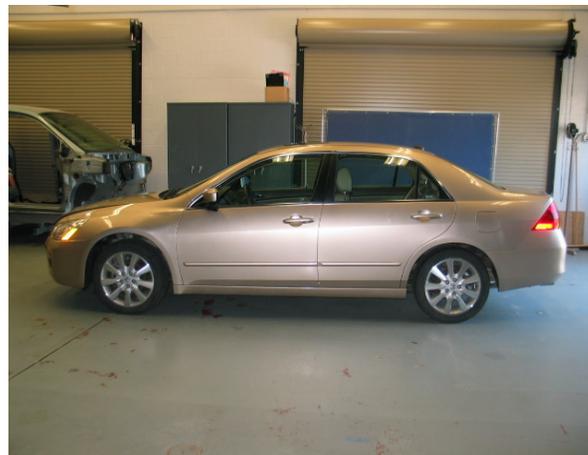
Figure 4. Photo. Remote vehicle outfitted with a newer GEN5 DAS and a DENSO miniWsu.

The primary remote vehicle (RVL) was a 2006 Honda Accord SE equipped with a DENSO miniWSU, as shown in figure 4. In tests that required a second remote vehicle, the 2005 Subaru Outback shown in figure 5 was used. The DENSO MiniWsu onboard equipment broadcasted basic safety messages (BSMs) outlined in the SAE J2735 standard throughout testing [3]. The test procedures called for several remote vehicles (RVs), however, with the revisions of tests, as discussed in chapter 3, only a second remote vehicle passenger (RVL) was used. That system was also equipped with a portable DENSO WSU device to allow testing with three interacting vehicles for specific scenarios.

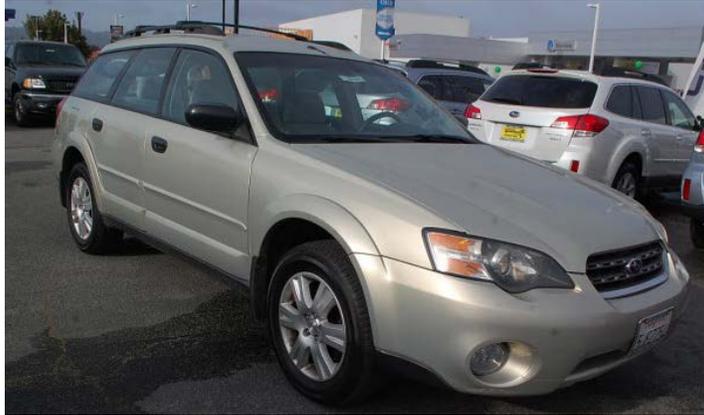
Figure 5. Photo. Second remote vehicle outfitted with a DENSO MiniWsu.

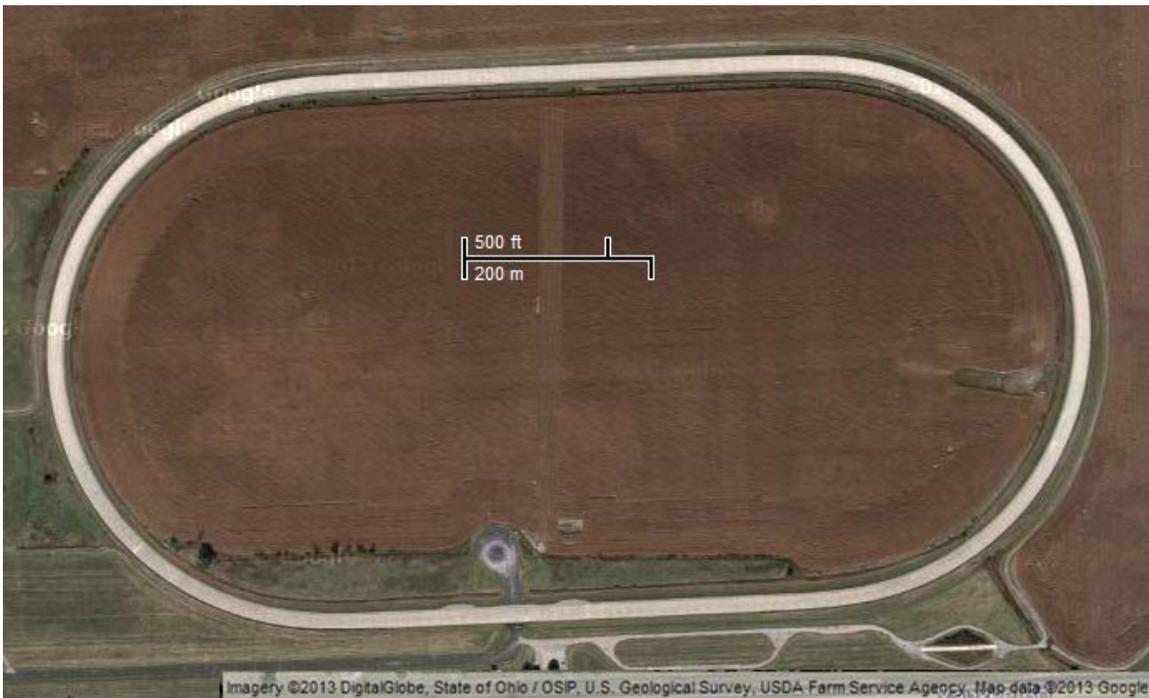
Figure 6. Photo. MITRP oval test track.

Testing was conducted at the Michigan Technical Research Park (MITRP) in Ottawa Lake, Michigan. MITRP includes an oval test track and associated proving grounds encompassing 330 acres and a wide range of test surfaces (see figure 6). Only the oval test track and its staging area were used for RSD testing.

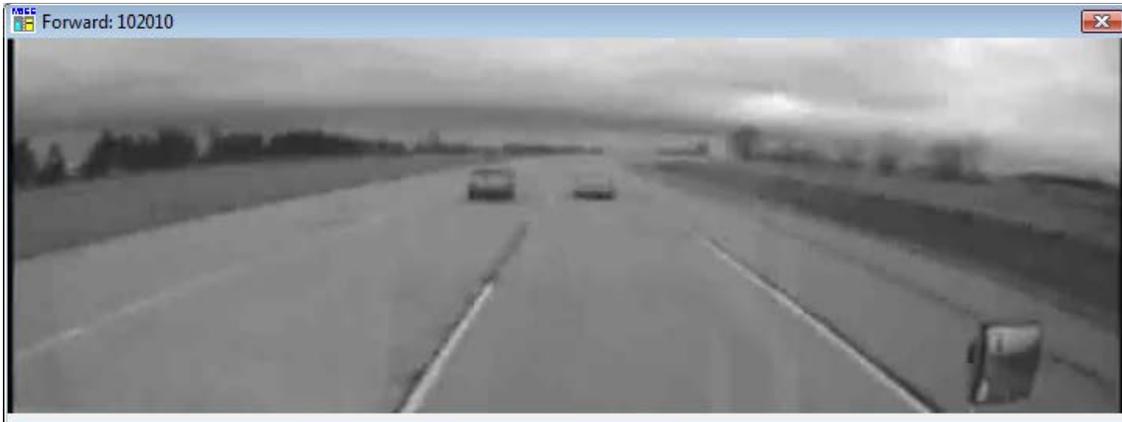
Figure 11. Photo. Picture of RVT1 (blocking vehicle on left) and RVL2 shortly after RVT1 changes lanes.

When the initial conditions for the test were satisfied, the test conductor in the HVT instructed the driver of the RVL2 by radio to perform a hard braking event. A few moments after RVL2 applied the brakes, the driver of the blocking vehicle RVT1 would change lanes to avoid striking the RVL2. (See figure 11, which shows the two vehicles from a camera mounted in the HVT.)

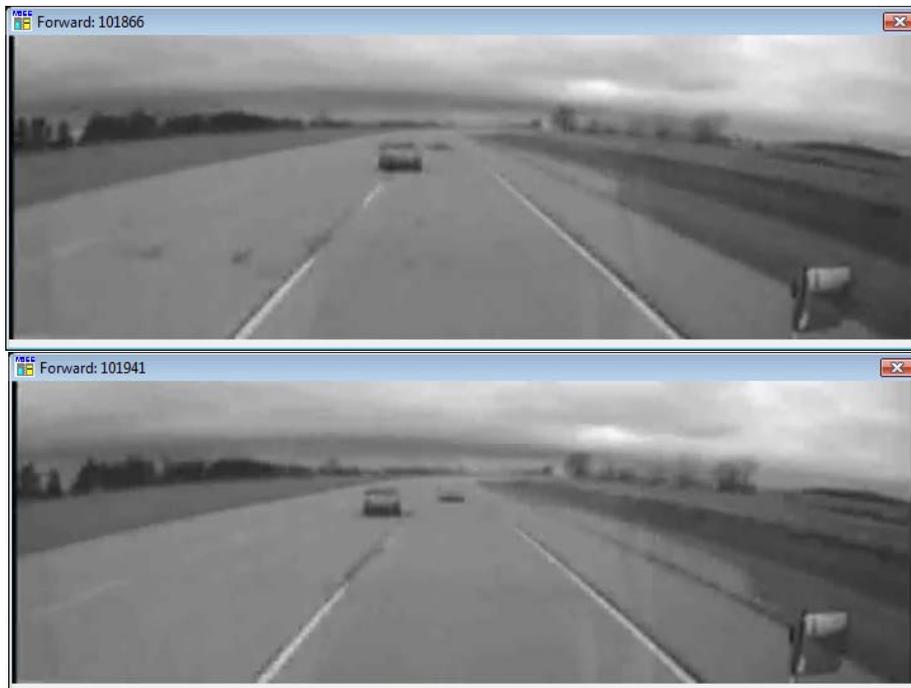
Figure 17. Photos. FCW-2: picture of RV1 moving left to reveal stopped RV2.

As illustrated in figure 16, RVT1, changed lanes as it approached RVL2 on a straight section of track. Figure 17 shows two sequential pictures of the scenario. The first picture shows RV1 making a lane change to reveal RV2, while the bottom picture, taken 3 s later, shows RV2 stopped in the path of the HVT.

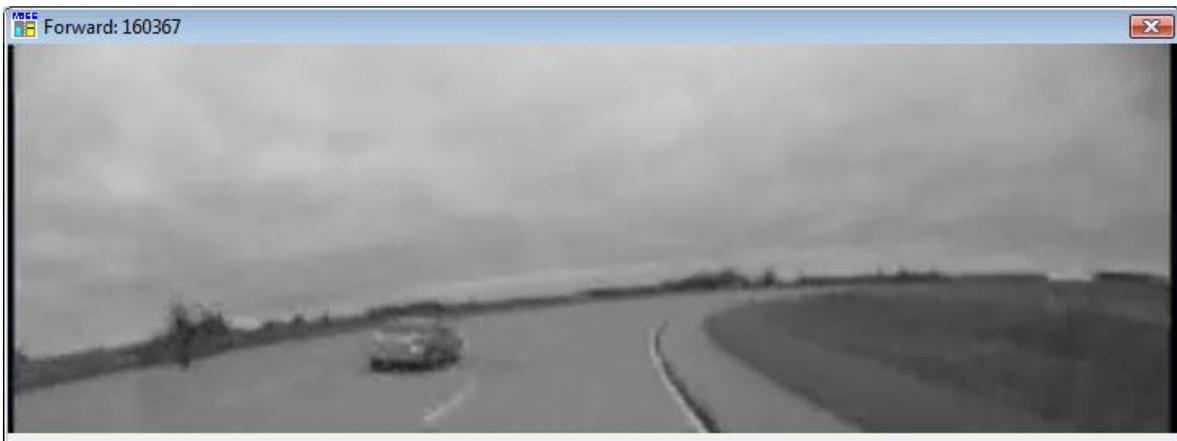
Figure 25. Photo. Picture of RVL during FCW-6: passing a stopped RVL in a curve (false-positive scenario).

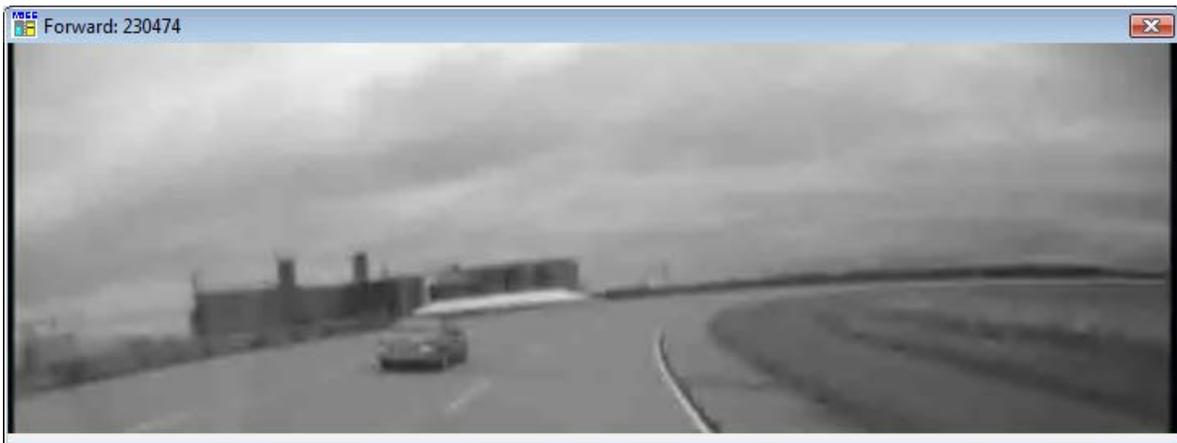
Figure 28. Photo. Picture showing the RVL in FCW-8 curve (false-positive scenario).

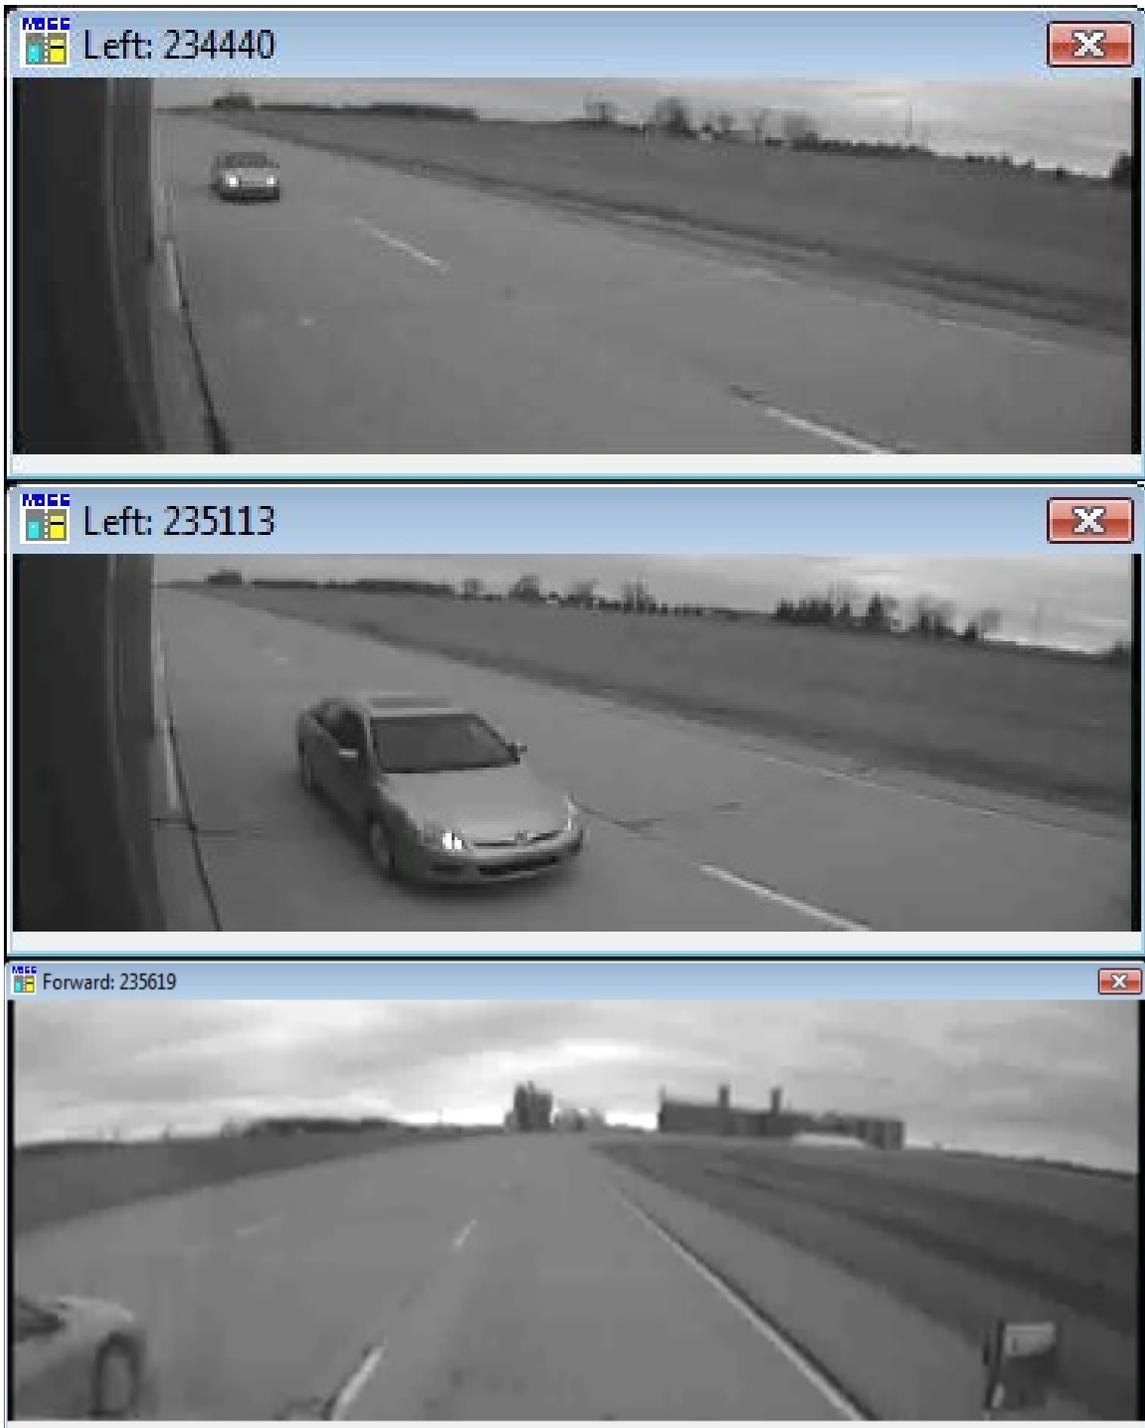
Figure 31. Photos. Picture of RVL at the start and end of the HVT BSW inform zone on the HVT left.

Figure 31 contains pictures from the HVT side and forward cameras of the RVL as it enters (top) and exits (bottom) the inform zone of the HVT.

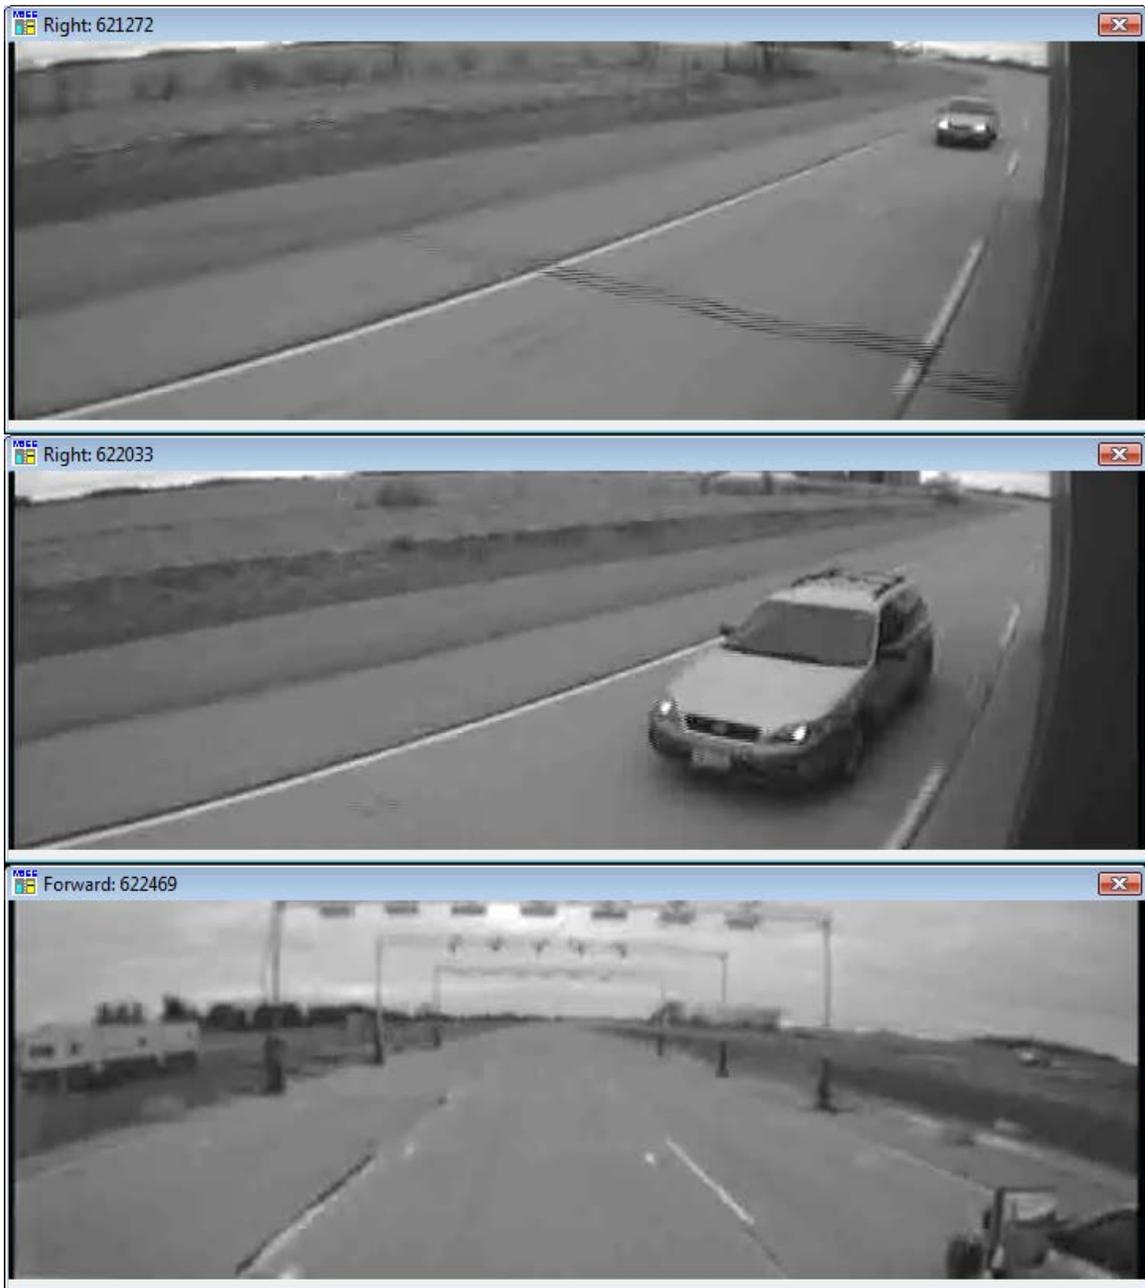
Figure 33. Photos. Sequence of pictures of the RVL as it passes the HVT on the right.

This scenario (illustrated in figure 32) is identical to BSW-1 with the exception that the RVL is on the right side of the HVT. Figure 33 shows pictures from the HVT side and forward cameras of the RVL as it enters (top) and exits (bottom) the inform zone of the HVT.

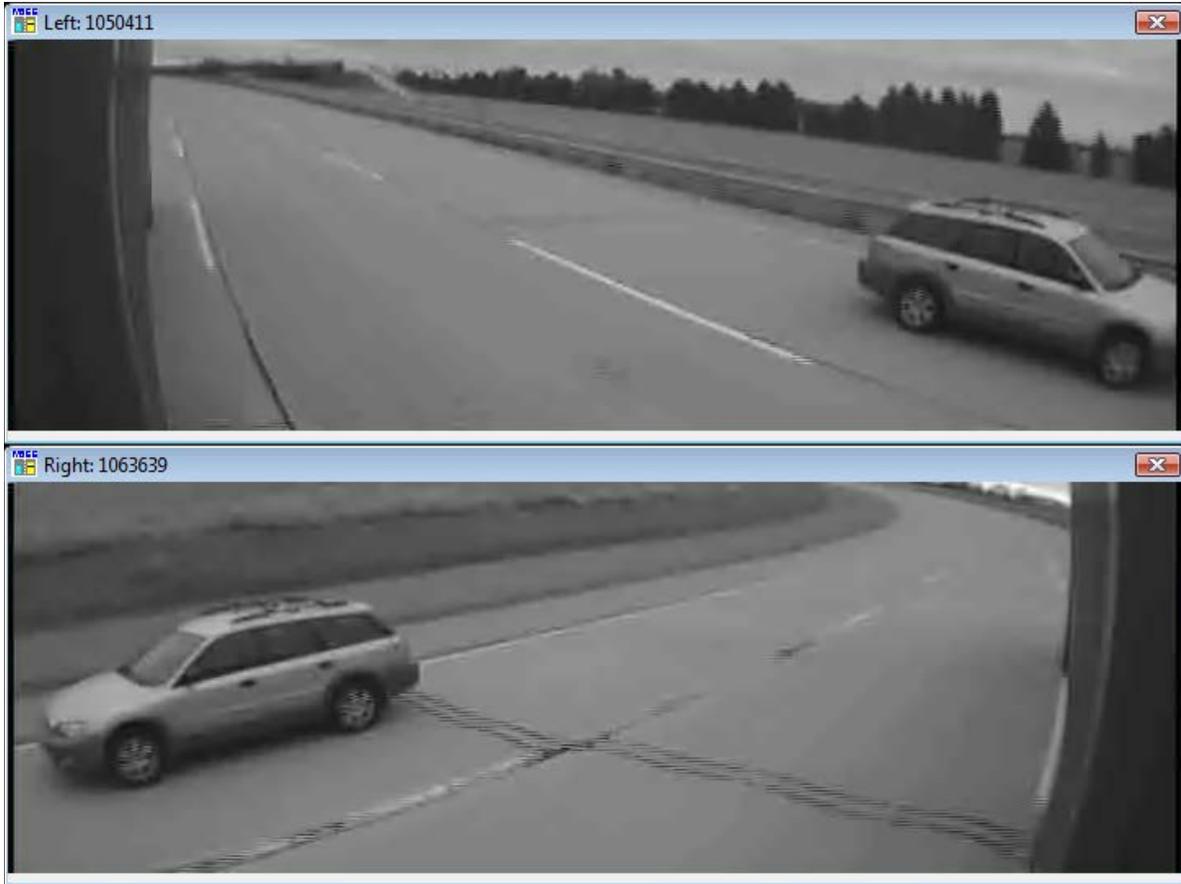
The HVT speed was 35 mph and was held constant using the HVT cruise control. The RVL driver was instructed to move longitudinally, relative to the HVT, in the third lane (with an empty lane between vehicles) to verify that the BSW did not indicate that the RVL was in the space adjacent to the HVT. This maneuver by the RVL was done numerous times with the RVL on both the left and the right of the HVT, and no alerts were issued by the HVT DVI. Thus the system passed this test.

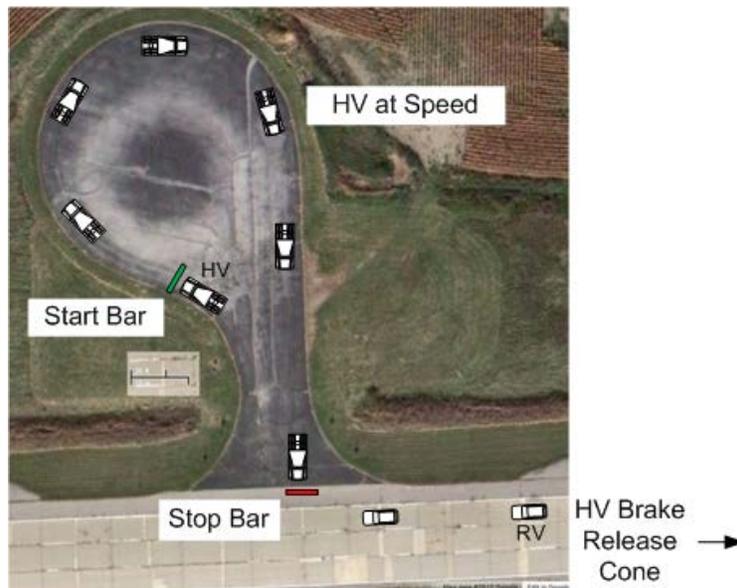
Figure 44. Illustration. IMA test set-up for a moving RVL and a stopped HVT.

This and the following test scenarios involve a stopped HVT and a moving RVL. The general set-up and procedure for this scenario is shown in figure 44. A general description of how to run the procedure for the HVT driver is as follows:

1. HVT stopped at the Start Bar. When ready, the HVT driver accelerates to a speed above 15 mph (the threshold speed for IMA) while negotiating around the perimeter of the staging area as shown in figure 44.
2. The HVT driver then does a moderate braking maneuver to a stop at the Stop Bar, keeping the brake pedal depressed after the vehicle comes to a stop

Figure 44 illustrates how the scenario is conducted. The starting position of the RVL was a function of the RVL test speed and the position was selected to allow the HVT to be stopped for 3 to 5 seconds at the stop bar before the RVL reached the HVT Brake Release cone. For the 40 mph tests of IMA-2B, the HVT driver was instructed to ignore the HVT Brake Release cone and simply release the brake when the approaching RVL was in a position that would require very aggressive braking to avoid a crash with the HVT.
