RP 247

The Reliability and Effectiveness of a Radar-Based Animal Detection System

Western Transportation Institute -
Montana State University (WTI-MSU)

IDAHO TRANSPORTATION DEPARTMENT
RESEARCH REPORT

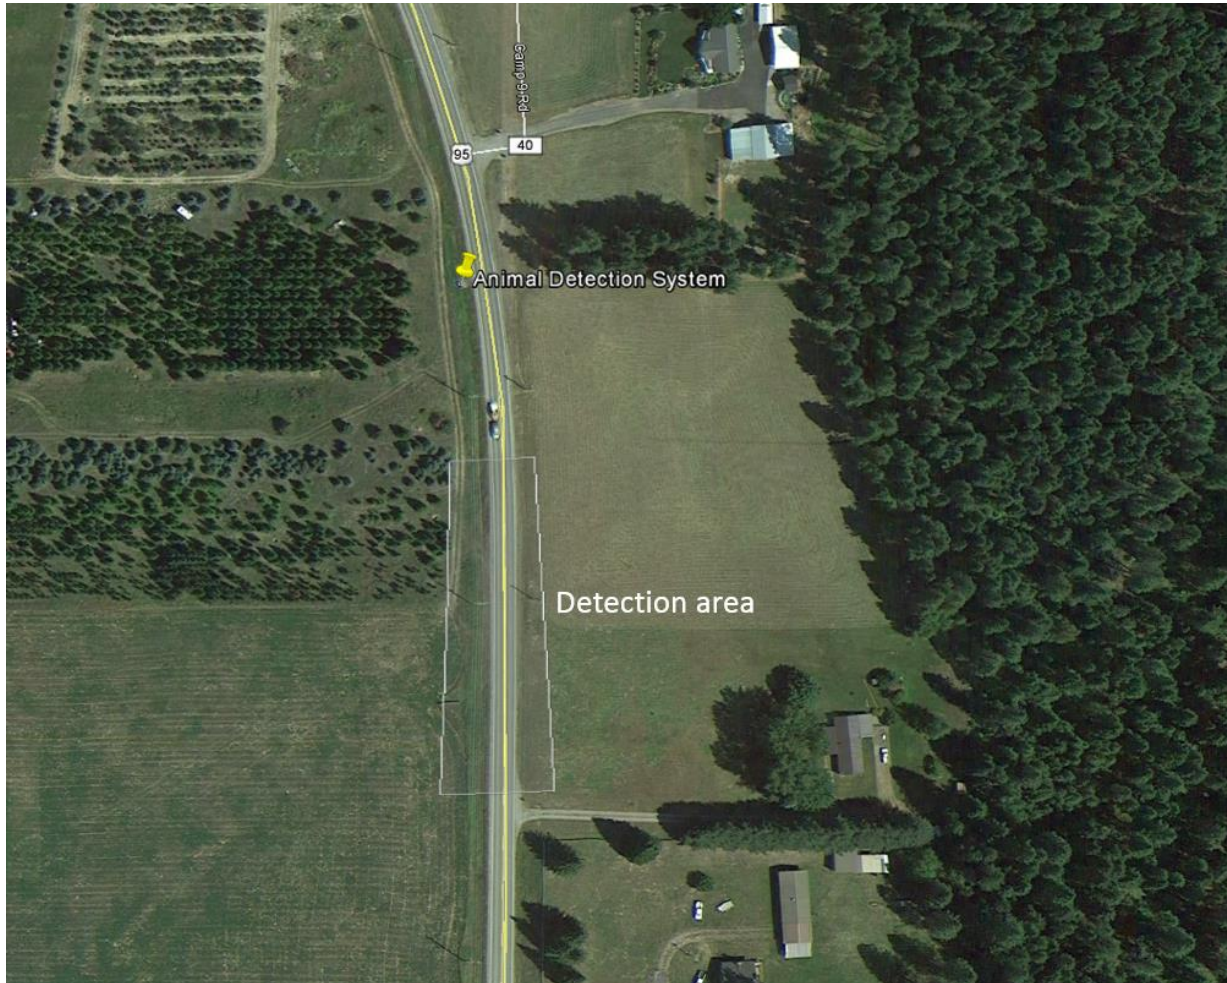
The system used a Doppler radar to detect large mammals along a 371 ft (113 m) long road section (Figure 3). The detection area was between 22 and 37 m wide and included the paved road and a zone adjacent to the paved road. However, the Doppler radar can be programmed to detect large mammals over much longer distances (about 1312 ft (400 m); Pers. Com. Brice Sloan, Sloan Security Technologies).

Figure 3. The Location of the Doppler Radar System and the Detection Area.

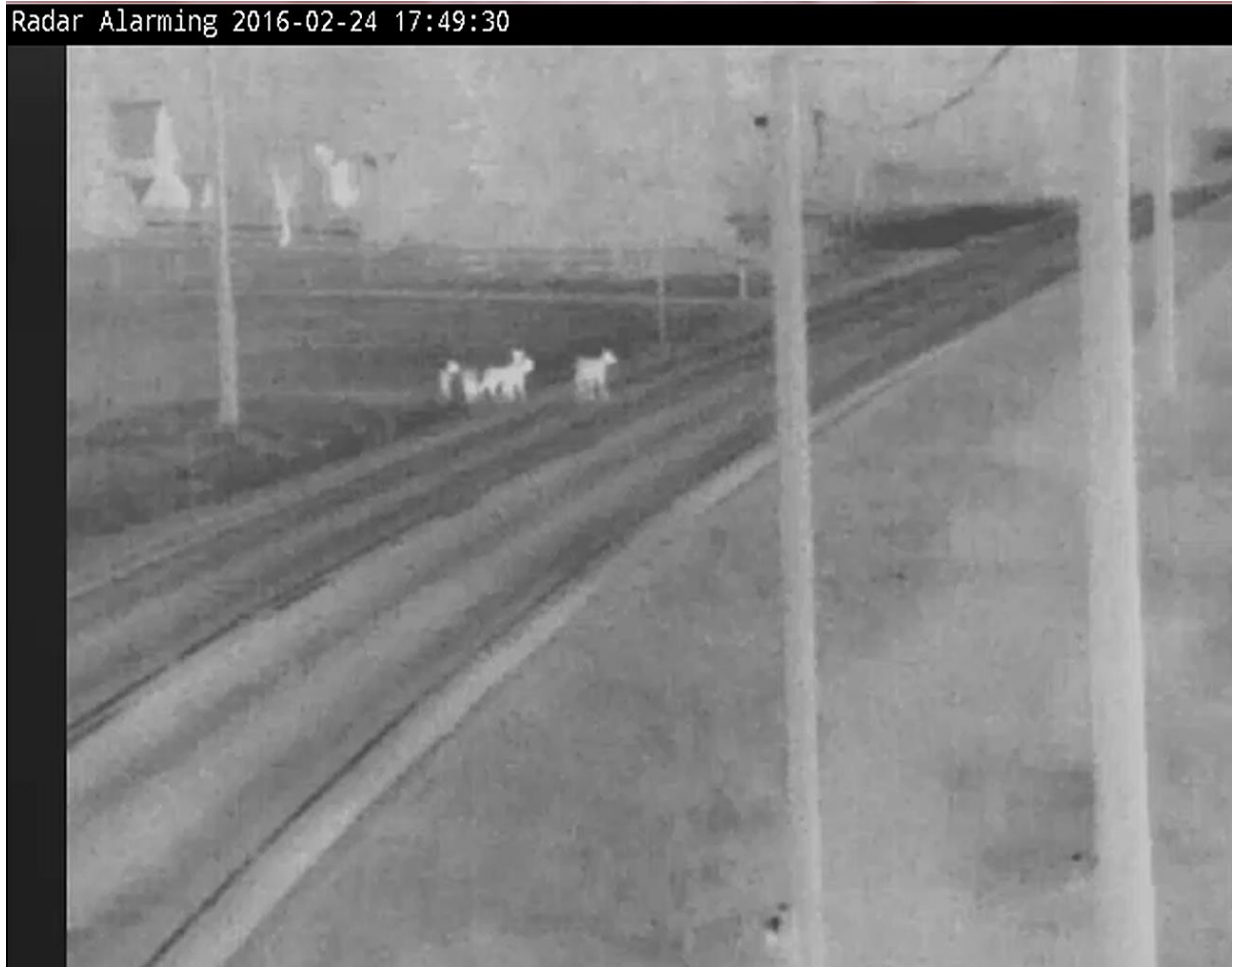
Note: The image shows deer on and near the road. The date, time, and whether the radar is detecting a “large mammal” is imprinted on the video images.

Figure 6. Screen Shot of Deer from a Video Recorded by the Thermal Camera.

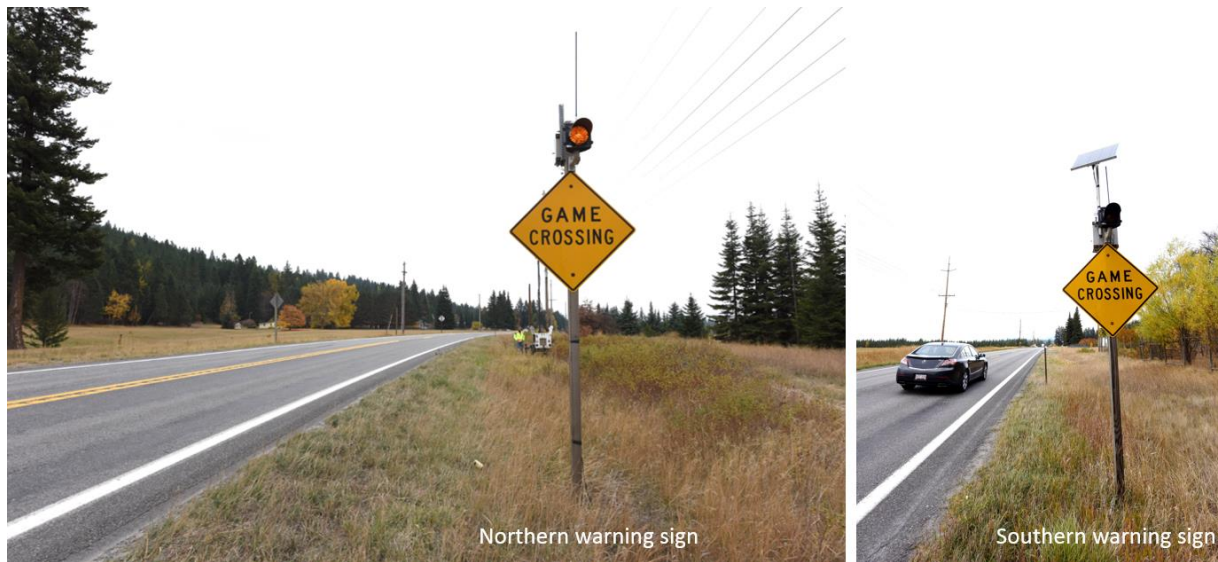
The warning signs displayed the text “GAME CROSSING” (always visible), and an amber flashing light was present above each warning sign. The amber flashing lights were activated only when detection of a “large mammal” was ongoing, and it remained on for about 40 seconds after the detection stopped. Should another detection occur before the 40 seconds were up, the clock resets and the amber lights remained active until 40 seconds after the last detection. The amber flashing light was “off” when there was no ongoing detection of a “large mammal” or if at least 40 seconds had passed since the last detection. The warning lights were activated through radio signals (2.4 GHz). The northern light was hooked up to the electric grid, but the southern light was powered by a solar panel and a battery.

Figure 8. The Warning Signs.

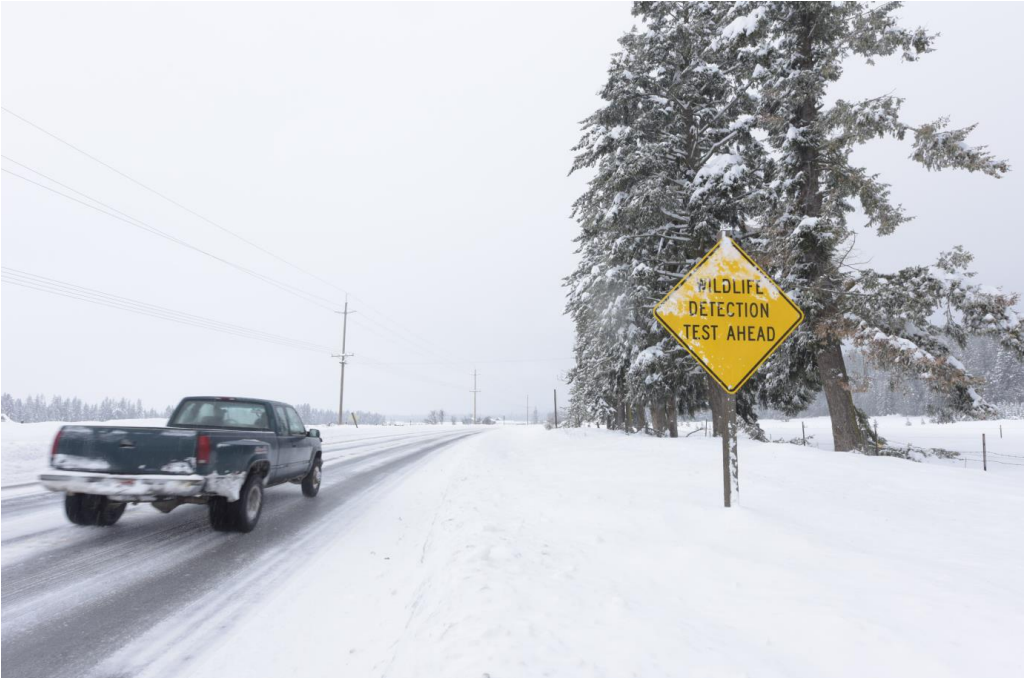
Figure 10. The Southern Sign Stating, “WILDLIFE DETECTION TEST AHEAD”.

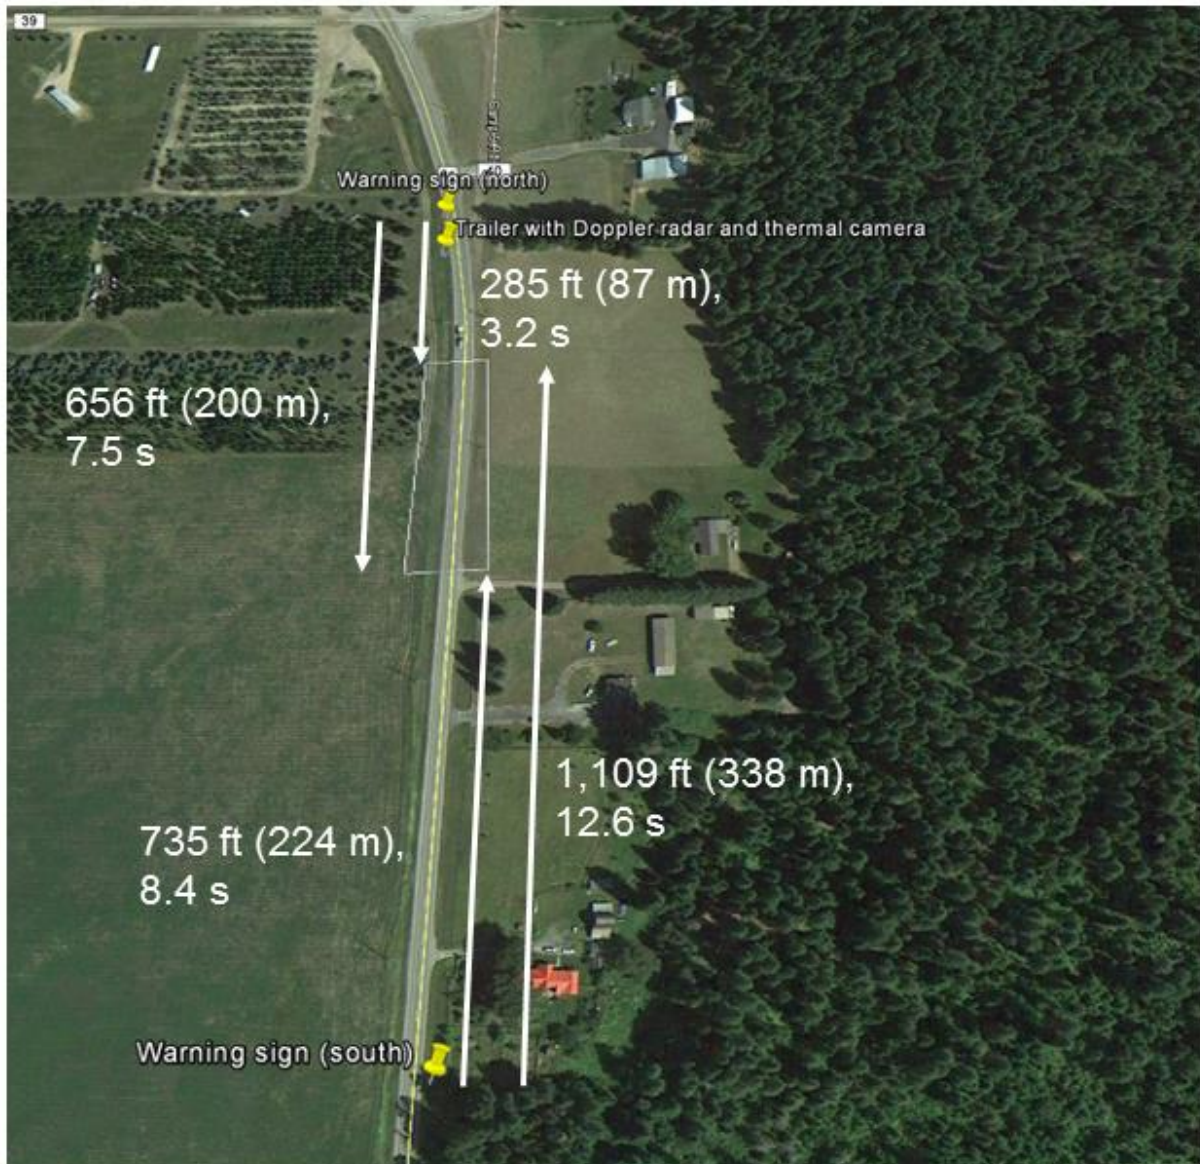
Note: Also shown are the detection area covered by the Doppler radar (delineated by the white line) and the location of the two warning signs.

Figure 18. Distances and Travel Times Between Warning Signs and the Outer Edges Detection Area.

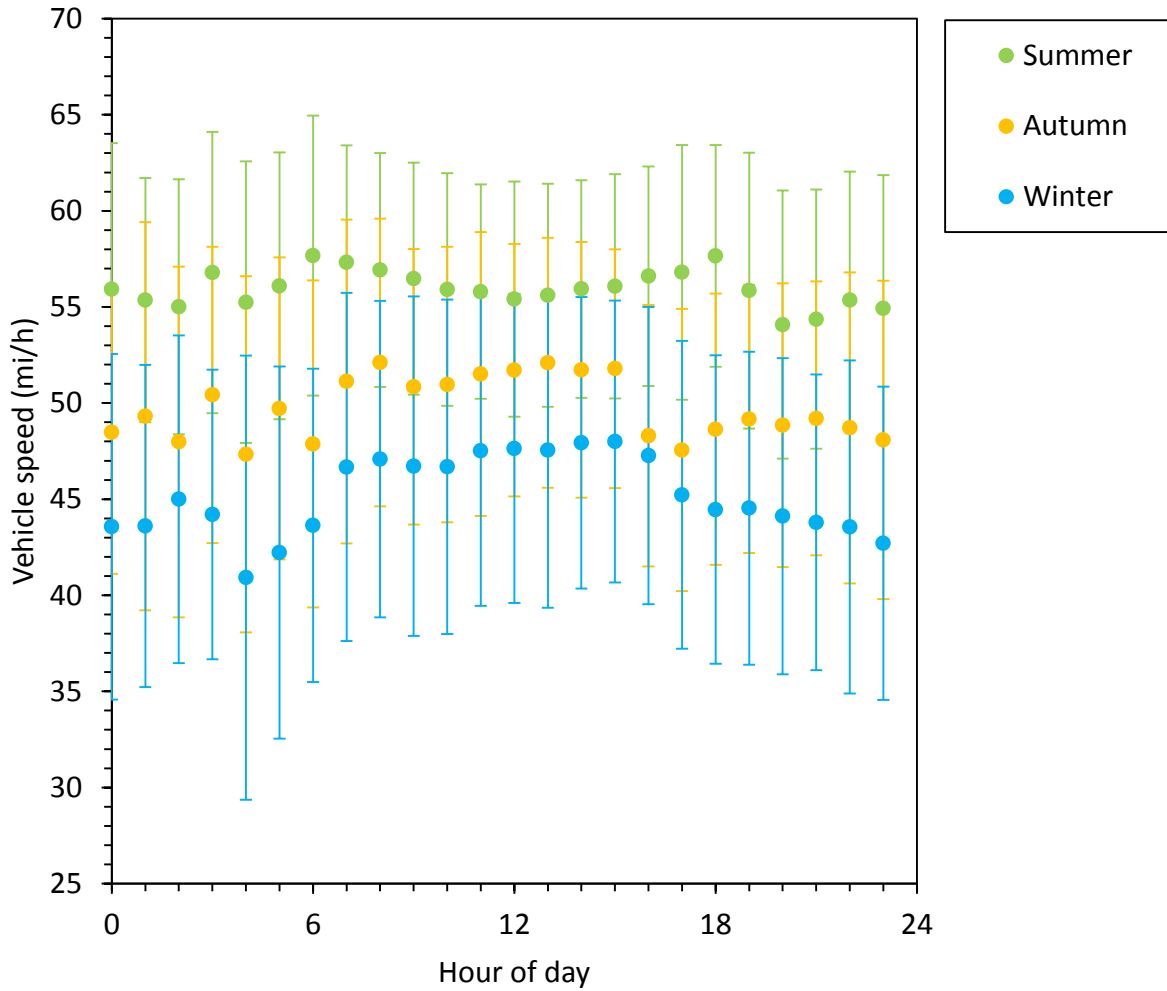
Vehicle speed was highest in summer and lowest in winter (Figure 21). In general, vehicle speed was highest during the day and lowest during the night.

Note: The data relate to the ten consecutive speed trial days in the three seasons. 6 = Between 6 and 7 A.M., etc.).

Figure 21. Average Vehicle Speed per Hour and Associated Standard Deviation for the Three Seasons.
