U.S. Department of
Transportation

**Federal Railroad
Administration**

Sled Tests Using the Hybrid III Rail Safety ATD and Workstation Tables for Passenger Trains

9. SPONSORING/MONITORING AGENCY NAME(S) AND ADDRESS(ES) U.S. Department of Transportation Federal Railroad Administration Office of Railroad Policy and Development Office of Research, Development and Technology Washington, DC 20590			10. SPONSORING/MONITORING AGENCY REPORT NUMBER DOT/FRA/ORD-17/10

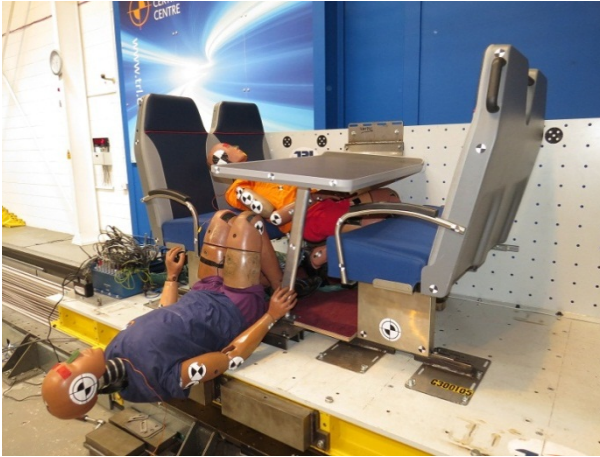
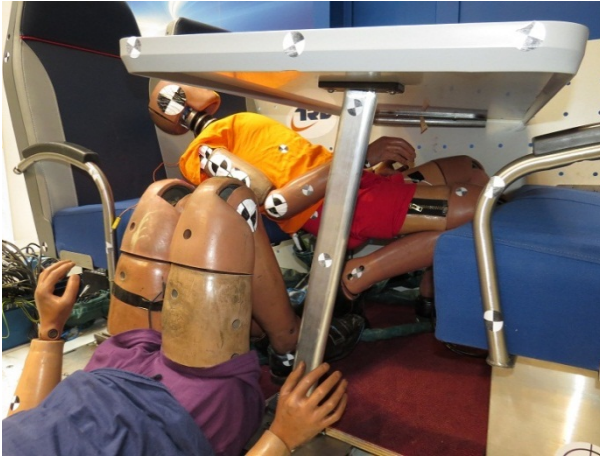
The deformation of the table caused the ATD in the aisle seat to fall into the aisle after impact with the table, but compartmentalization was achieved as defined by the APTA standard.

Leg contact with the opposing seats occurred during the impact and the Hybrid III-RS came to rest with its legs still in contact with the opposing seat.

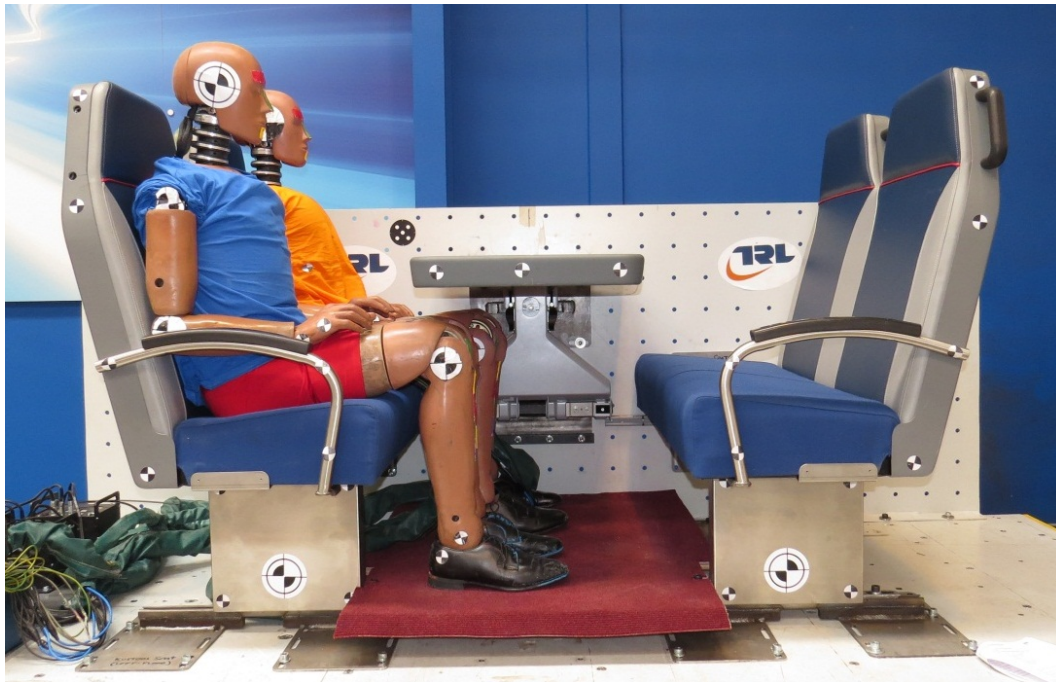
Figure 19. Pre-test view of Test 6 – seat 1, table design 5

The pre- and post-test ATD and table positions are depicted in Figure 19 and Figure 20. The test pulse is plotted in Figure 21; the calibration run pulse obtained prior to testing is plotted in Figure 1, demonstrating that the test conforms as far as possible to the requirements of the standard.

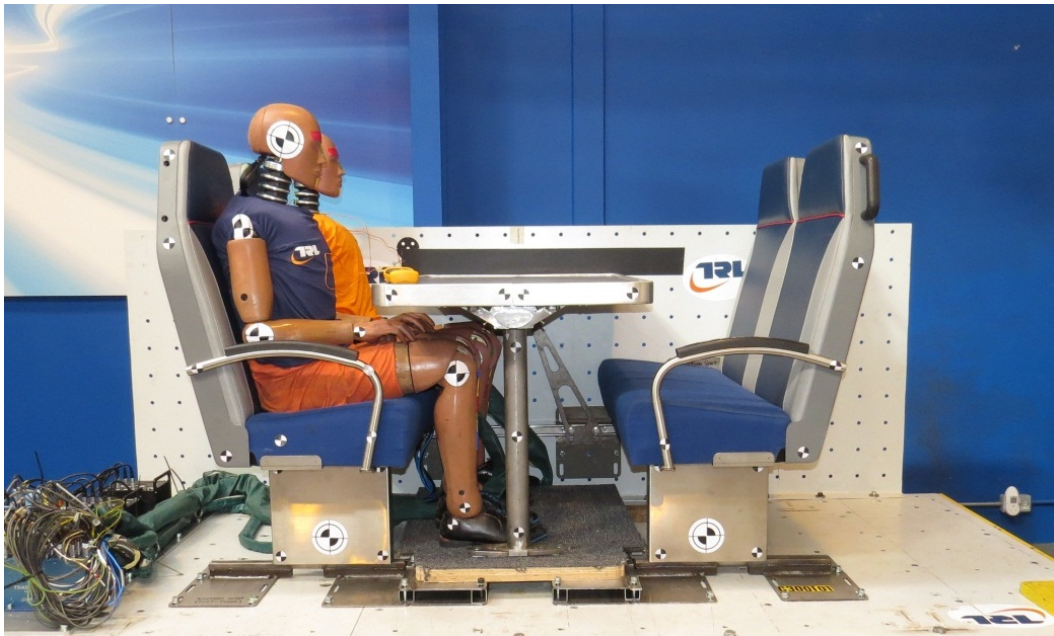
Figure A.1.1: Pre-Test

This injury test was for the seat configuration depicted above. The seat design was ‘Seat 1’ and the table design was ‘Table 1.’ The installation of seats and table was carried out by TRL test staff; all mountings and interface plates were designed and fabricated by TRL.

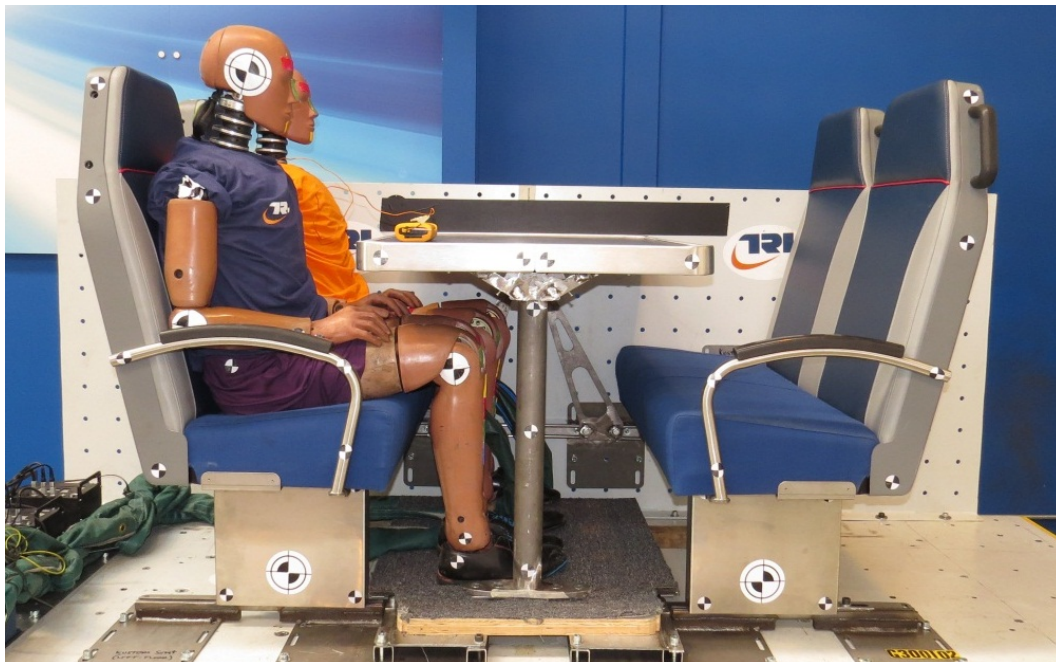
Figure A.2.1: Pre-Test

Test Number	G300I02
Configuration	Forward Facing
Test Type	APTA-PR-CS-S-018-13 Prototype Table Test (28 mm taller than in Test 1)
Dummies	Hybrid III RS and Hybrid III both 50 th Percentile
Result	Failure of upper and lower left chest deflection criteria, H3-RS (wall-side ATD)

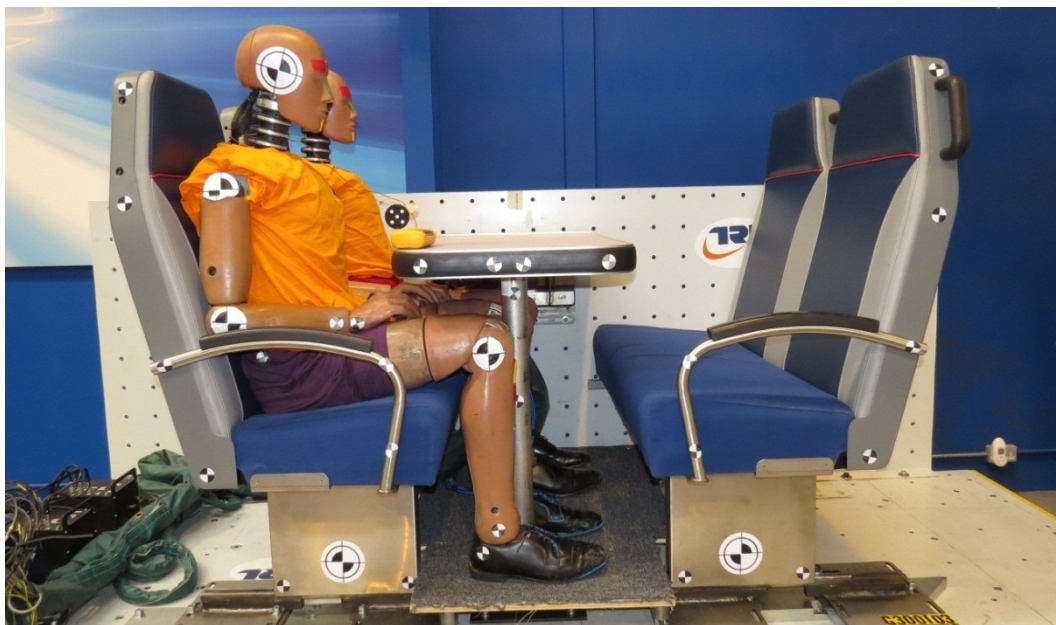
Figure A.3.1: Pre-Test

This injury test was for the seat configuration depicted above. The seat design was ‘Seat 1’ and the table design was ‘Table 3.’ Since the table was not designed to be used with these seats, it was placed asymmetrically (per the installation drawing) to give a representative distance from the ATD chest to the table edge and from the ATD knees to the opposing seats. The installation of seats and table was carried out by TRL test staff, and all mountings and interface plates were designed and fabricated by TRL.

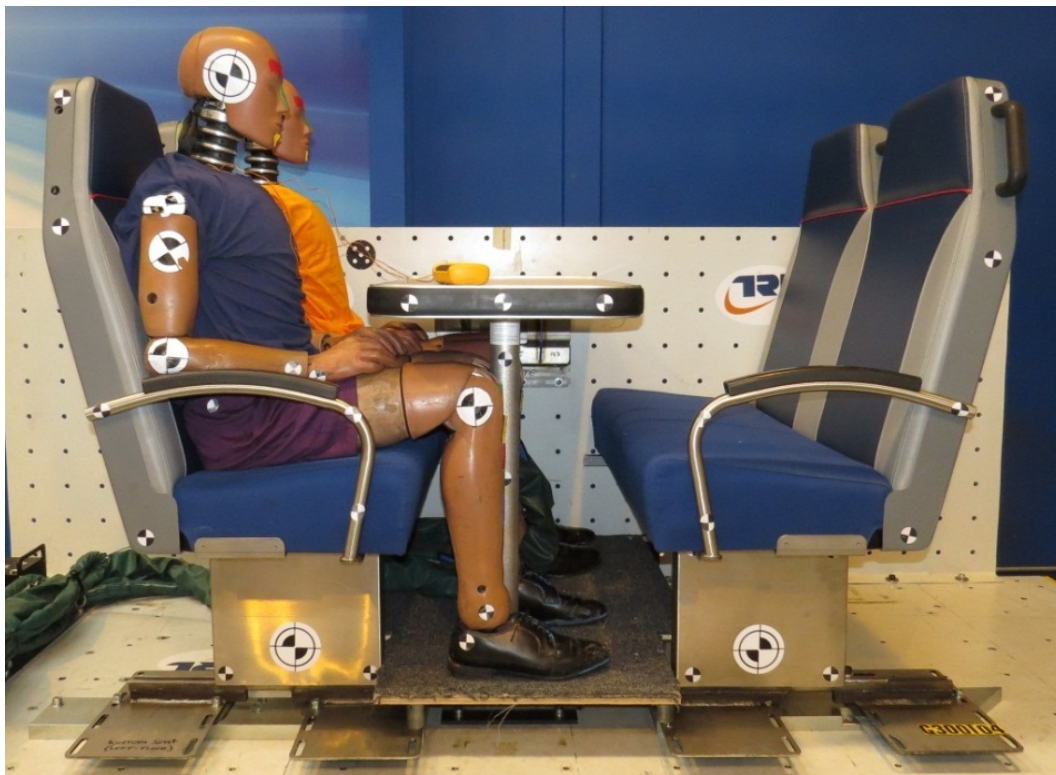
Figure A.4.1: Pre-Test

This injury test was for the seat configuration depicted above. The seat design was ‘Seat 1’ and the table design was ‘Table 3.’ As the seats and table were not intended to be installed together, the table was installed asymmetrically (per the installation drawing) in order to give a representative distance between the seat back and table edge, and between the ATD knees and opposing seats. The installation of seats and table was carried out by TRL test staff, and all mountings and interface plates were designed and fabricated by TRL.
