Magnetic Tomography – Assessing Tie Bar and Dowel Bar Placement Accuracy

1 Report No. KS-17-05	2 Government Accession No.	3 Recipient Catalog No.	
4 Title and Subtitle Magnetic Tomography – Assessing Tie Bar and Dowel Bar Placement Accuracy		5 Report Date December 2017	6 Performing Organization Code
		7 Performing Organization Report No.	
7 Author(s) Cliff Hobson, P.E.		10 Work Unit No. (TRAIS)	
9 Performing Organization Name and Address Kansas Department of Transportation Bureau of Research 2300 SW Van Buren Topeka, Kansas 66611-1195		11 Contract or Grant No.	
		13 Type of Report and Period Covered Final Report	
12 Sponsoring Agency Name and Address Kansas Department of Transportation Bureau of Research 2300 SW Van Buren Topeka, Kansas 66611-1195		14 Sponsoring Agency Code	
		15 Supplementary Notes For more information write to address in block 9.	
<p>The Kansas Department of Transportation (KDOT) constructs portland cement concrete pavements (PCCP) for new highway expansions and/or for replacement of existing highway pavement using slip-form paving operations. Typical concrete pavement construction in Kansas requires reinforcing steel across the joints.</p> <p>Correct placement

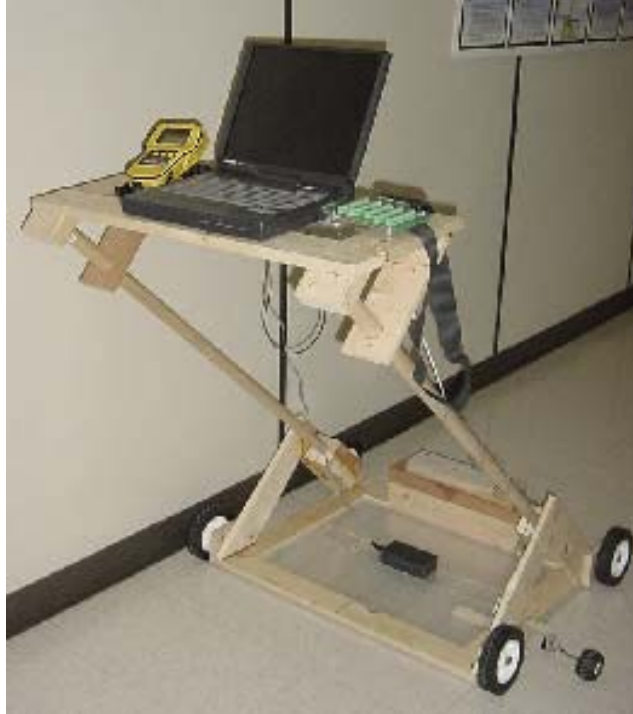
Figure 1.1: Prototype Instrument Developed by DeVault and Miller in 2003

A preliminary study funded by KDOT and completed by Kansas State University (KSU) from August 2002 to November 2003 assembled a working instrument capable of collecting the magnetic-pulse-induction sensor readings from steel tie and dowel bars in a manpower and time efficient manner and converted the scanned sensor readings into easily discernable graphics, as well as to estimate the position of the steel from the sensor readings (DeVault & Miller, 2005). The steel finder cart design from 2003 is shown in Figure 1.1.

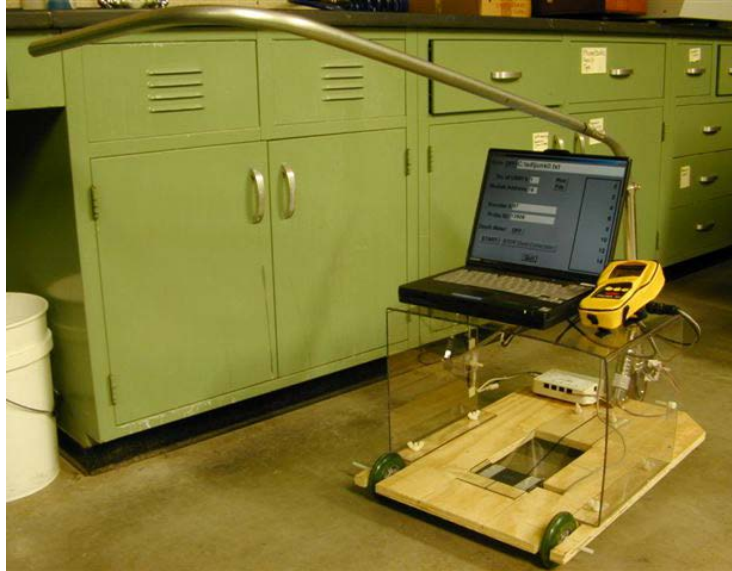
Figure 1.2: Prototype Built and Tested by MRC Personnel in 2004

The prototype device developed by DeVault and Miller in 2003 went through several more development iterations during 2003 and 2004 by personnel at the KDOT Materials & Research Center (MRC) laboratory before a functional prototype was produced and successfully demonstrated in field tests during the 2004 summer construction season (Young & Holle, 2005). The steel finder cart design from 2004 is shown in Figure 1.2.

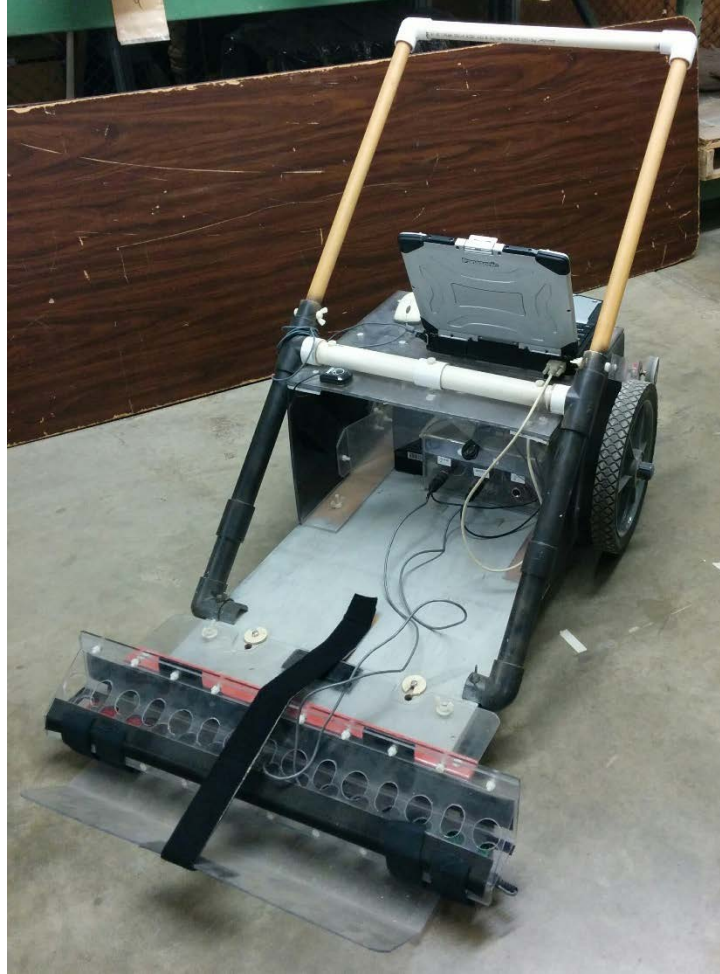
Figure 1.3: Prototype Built and Tested by KSU in 2006

A second study completed by KSU and funded by KDOT, Koss Construction, and others improved on the 2004 prototype and added a second sensor for a 3-D magnetic mapping system. The 2006 prototype mapping device extended the work previously done with versions that incorporated single sensors. Multi-sensor capability was added to enable determination of spatial orientation of the steel bars with a single data pass over a pavement joint. Additional features such as GPS location and in-field calibration techniques were used to streamline the data collection and report generation process (Holle, 2017). The steel finder cart design from 2006 is shown in Figure 1.3.

The 2006 prototype PCCP steel bar scanning device had resolved many design problems encountered with previous prototypes and proved the functional real-time concept. The selected electronics integrated custom cover meters with a laptop computer using several off-the-shelf components to convert magnetic signals to show the steel location, log the position, and record the GPS location.
