## Storm Water Control Management & Monitoring

FINAL REPORT

By Laura Toran  
Temple University

## **Task 9: Final Report**

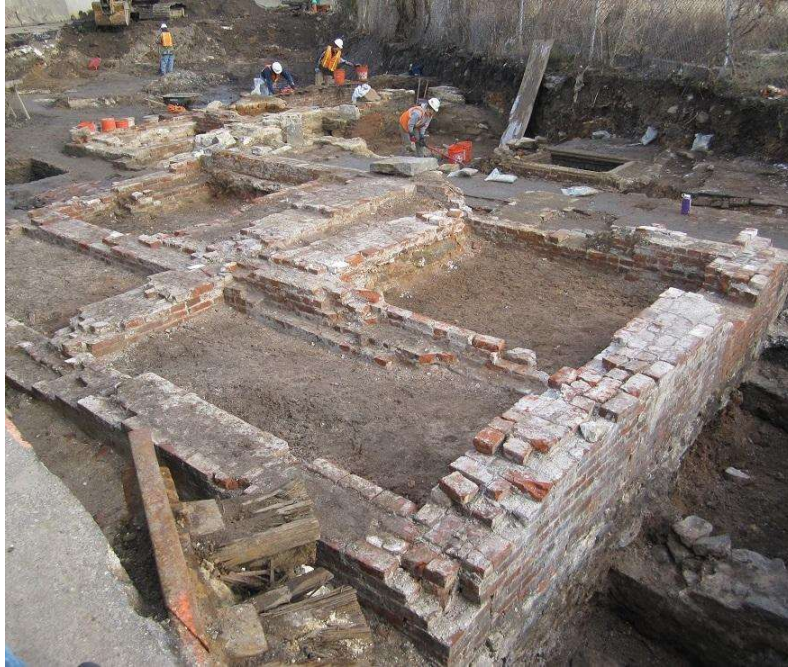
*Fig. 2-6. Excavation around MW6 showing the 19<sup>th</sup> century glassworks foundations.*

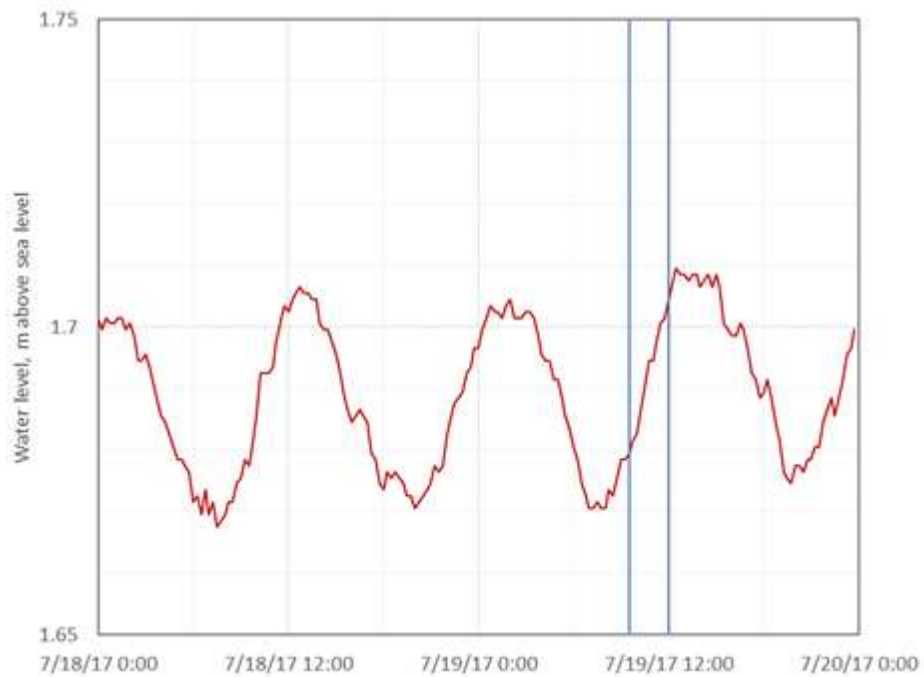
*Fig. 2-7: Water level response in MW2, adjacent to the Basin C before, during, and after the Simulated Runoff Test (SRT) on July 19, 2017. Water was injected into the basin during the period marked by vertical blue lines.*

from the SMP, resulting in the relatively higher increases groundwater levels. Further evidence that infiltrating water from the basin does not influence water level response is that when water was injected into Basin C for a Simulated Runoff Event (SRT), no water level increase was observed in MW2 adjacent to the basin (Fig. 2-7). The storm responses in MW6 likely are influenced more by the perched water table rather than the relatively small nearby SMP.

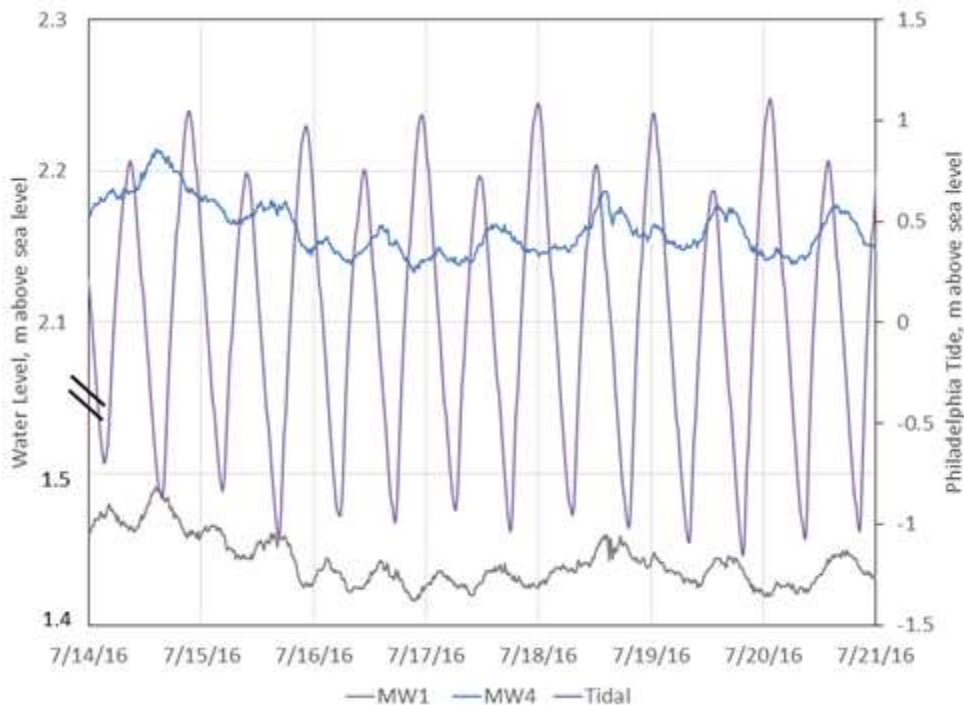
Figure 2-8. Comparison of tidal fluctuations in MW1 and MW4 plotted at the same scale (note axis discontinuity)

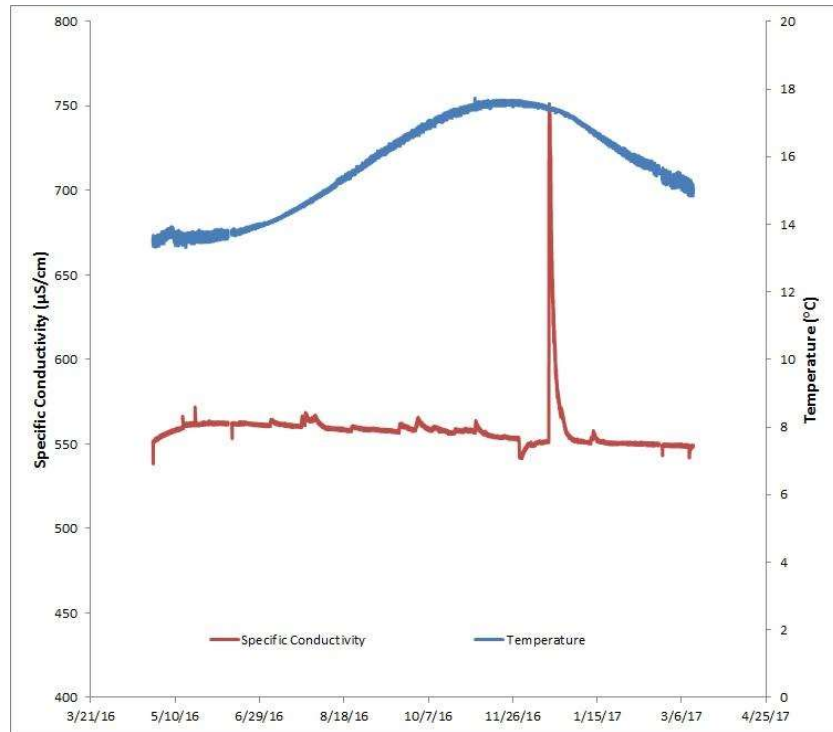
*Fig. 2-12. Groundwater specific conductivity ( $\mu\text{S}/\text{cm}$ ) and temperature ( $^{\circ}\text{C}$ ) measurements in MW3 over the period of observation.*

Specific conductivity in MW3 ranged between 538  $\mu\text{S}/\text{cm}$  and 751  $\mu\text{S}/\text{cm}$ , and water temperature in MW3 ranged between 13.34  $^{\circ}\text{C}$  and 17.73  $^{\circ}\text{C}$  (Fig. 2-12). During the period of record, the water temperature in MW3 gradually increases until it reaches a maximum of 17.73  $^{\circ}\text{C}$ , and then seemingly exhibits an equally gradual decrease. This pattern is likely driven by seasonality.

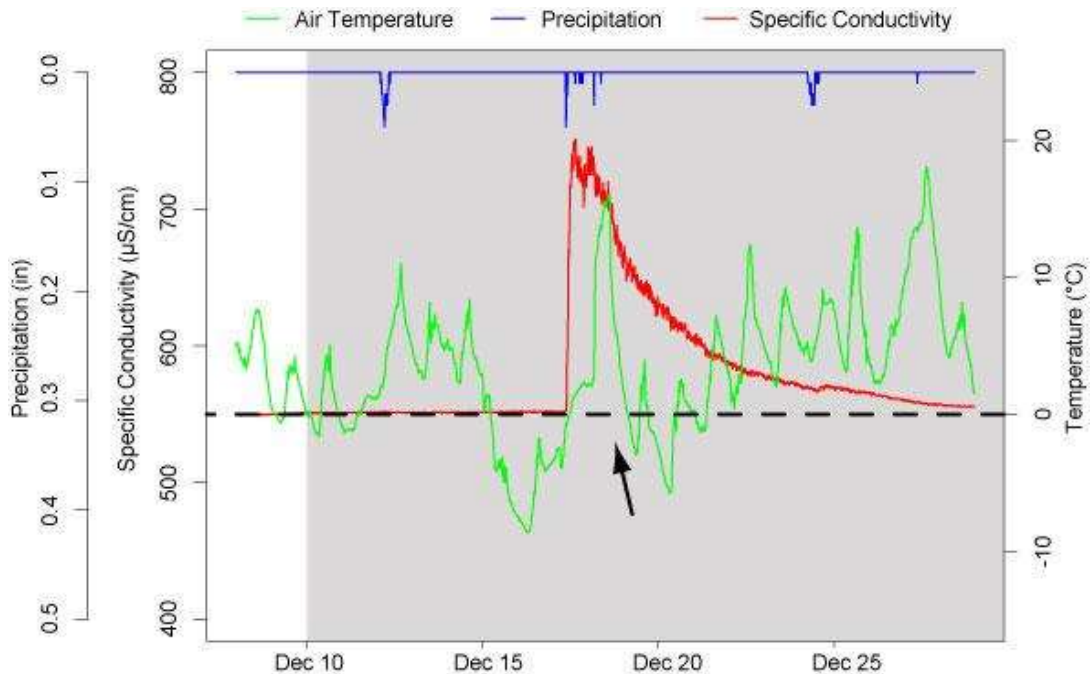
*Fig. 2-13. Specific conductivity (red) in MW3 waters, air temperature (green), and precipitation (blue) for the period of December 8 – December 28, 2016. The grey shaded box indicates the period where road deicers were likely applied to roadways. The arrow indicates the period when a melt event likely occurred.*

Specifically, the dissolution of road salt ( $\text{NaCl}$ ) in roadside meltwaters generally increases loadings of  $\text{Na}^{+}$  and  $\text{Cl}^{-}$  to shallow ground waters (Labadia and Buttle, 1996), thereby increasing the electrical conductivity in these waters (Bauske and Goetz, 1993). Thus, the sharp rise in specific conductivity on December 17 could indicate the infiltration of a pulse of salt-rich meltwater.

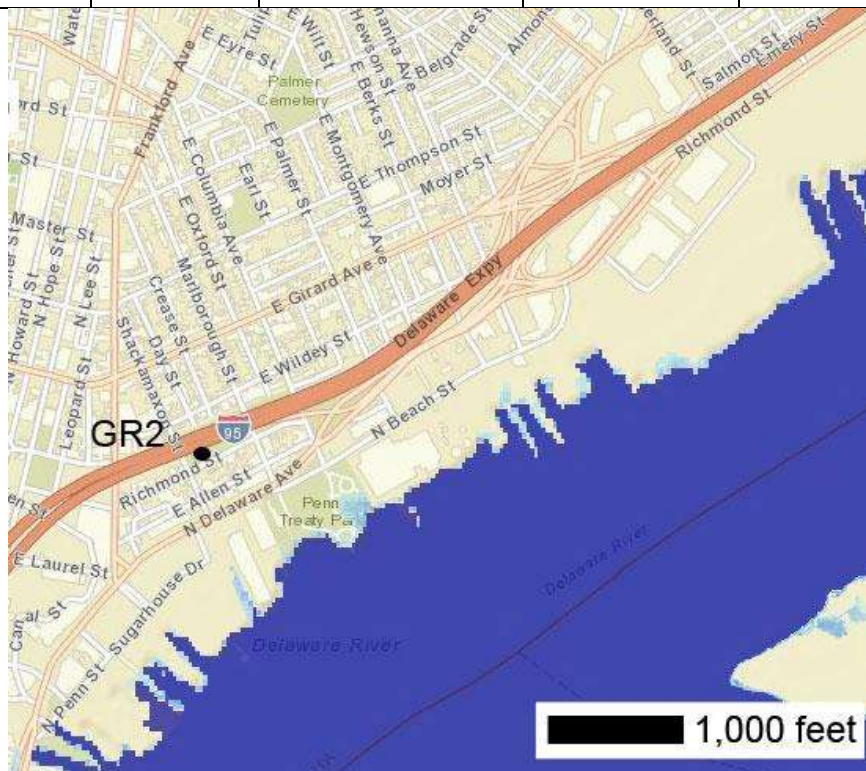
Fig. 2-14. Predicted inundation (light blue) in the area surrounding GR2 caused by a 3ft rise in sea level (NOAA Coastal Services Center, 2017).

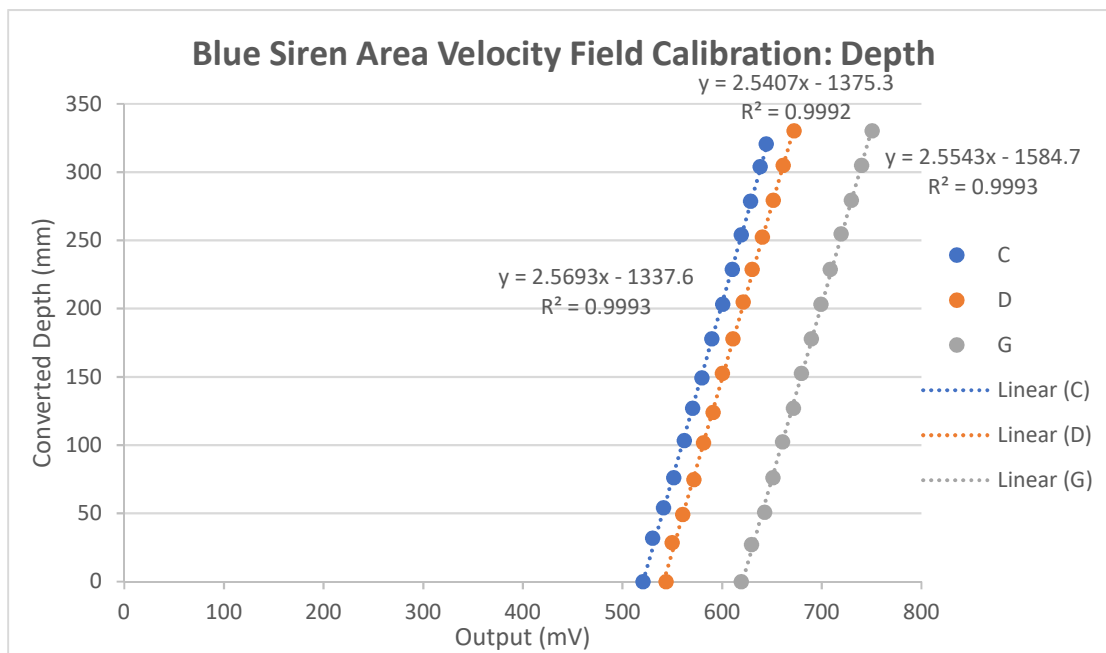
*Figure 3-13: Depth Calibration Curves for Blue Siren Area Velocity sensors installed in the field. Date of calibration: 3/29/17*

curves were entered the datalogger code so that the raw data would reflect the accurate depth levels converted to the correct units (from mV to mm).

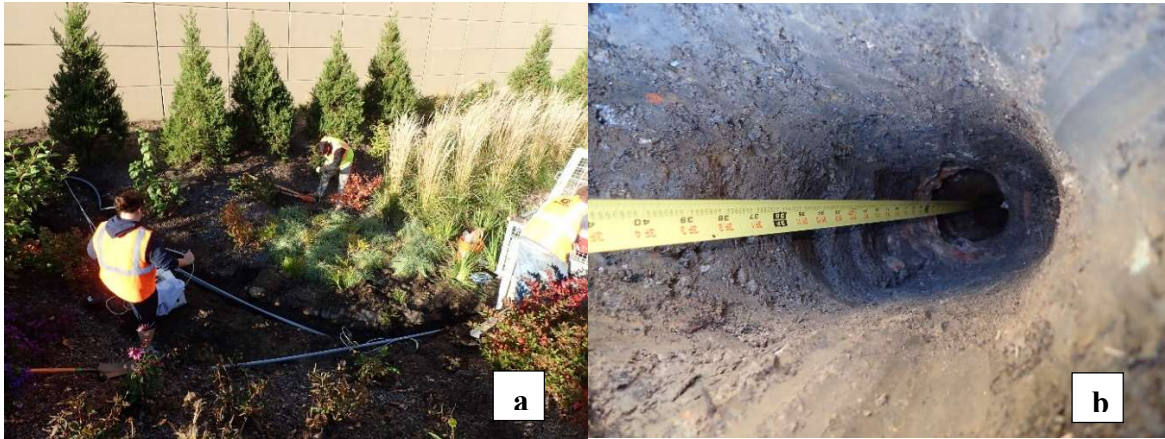
*Figure 3-15: Digging and Laying Conduit in SMP D (a). Hole prior to soil moisture probe installation (b)*

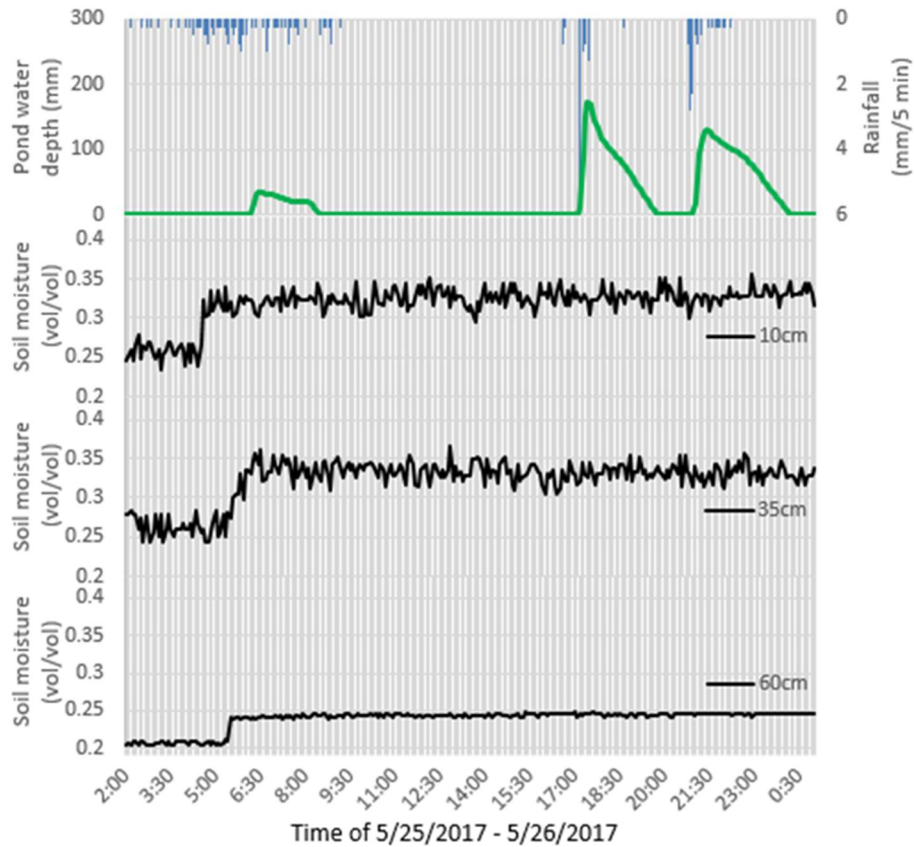
*Figure 3-23. Summary of data collected for SMP A during the back-to-back storms on 5/25/2017.*

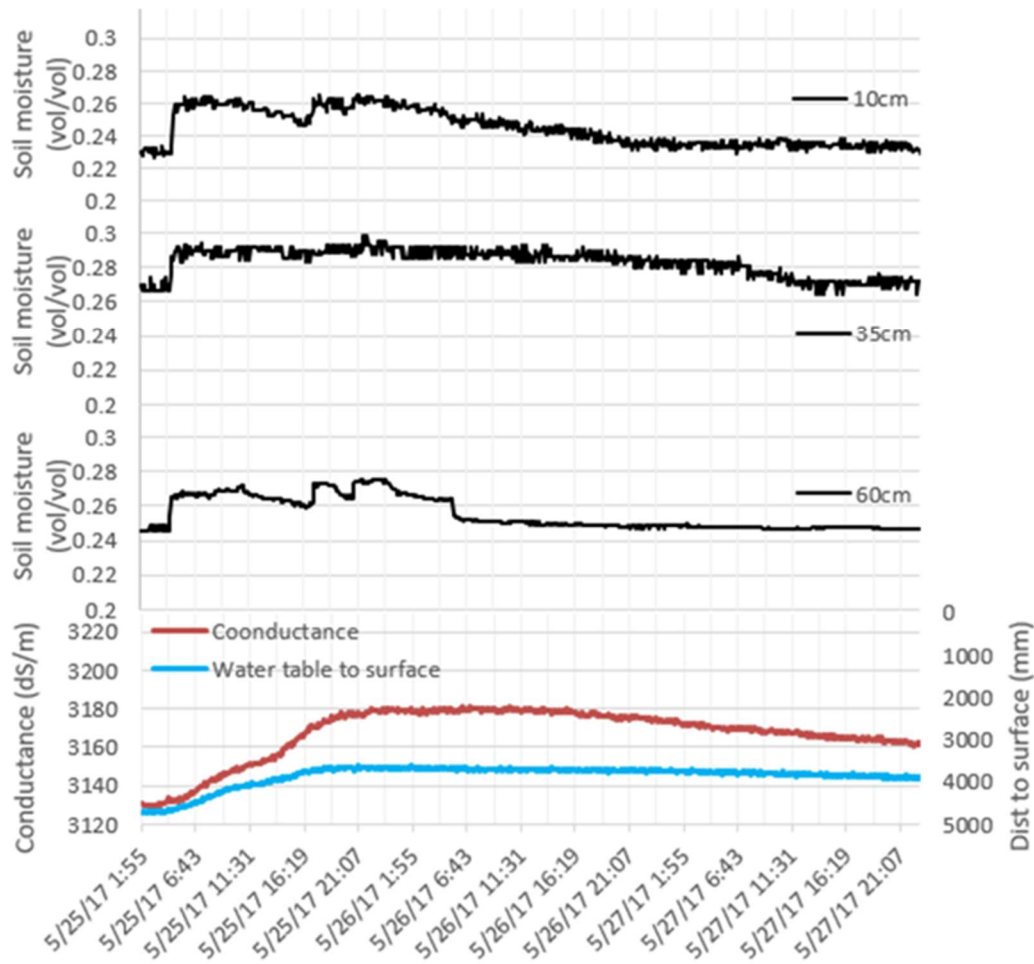
Figure 3-25: Soil moisture and groundwater data from SMP C for the longer time frame (5/25/17-5/27/17)

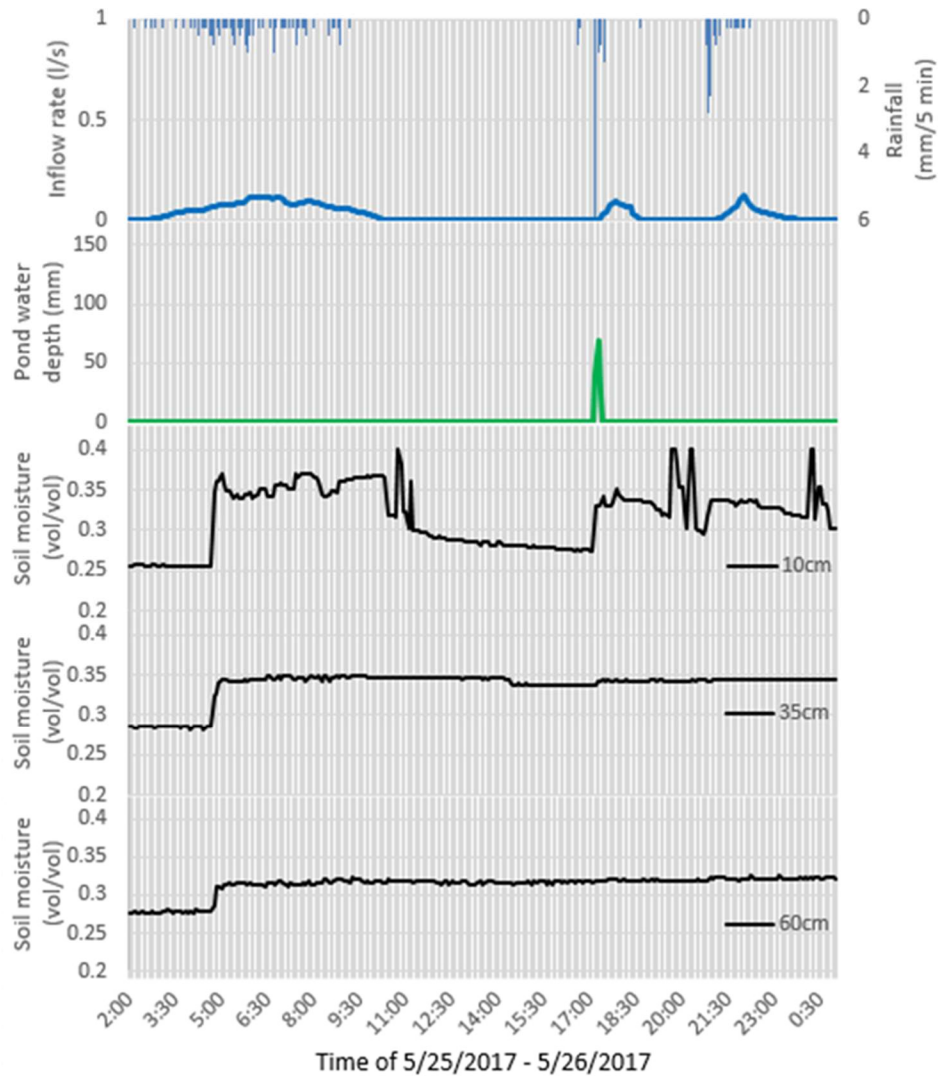
Figure 3-26: Summary of data collected for SMP D during the back-to-back storms on 5/25/2017

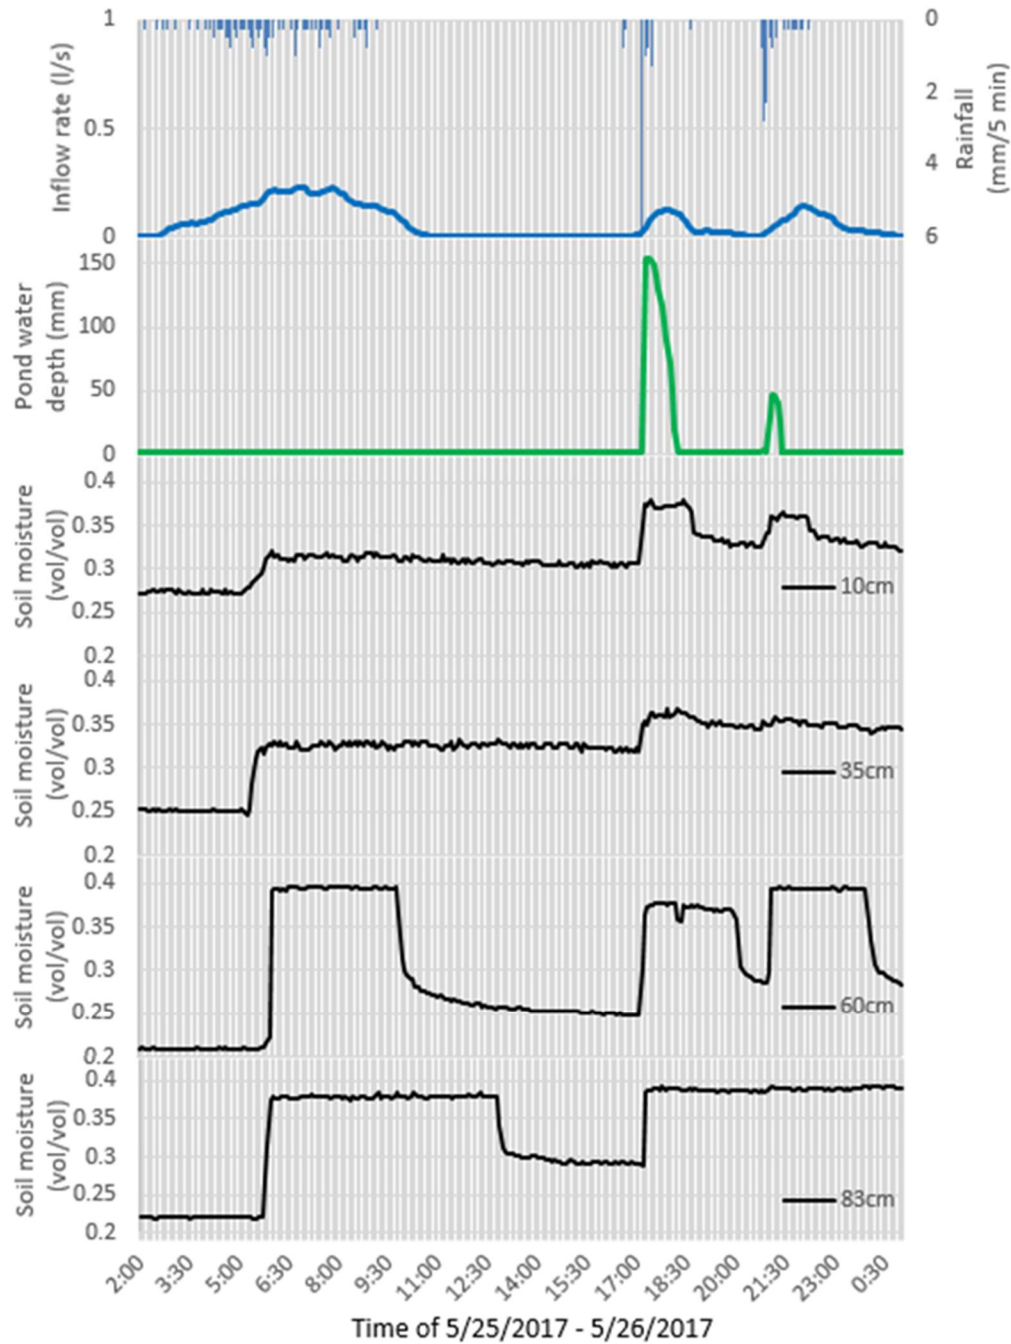
Figure 3-27. Summary of data collected in SMP G during back-to-back storms on 5/25/2017

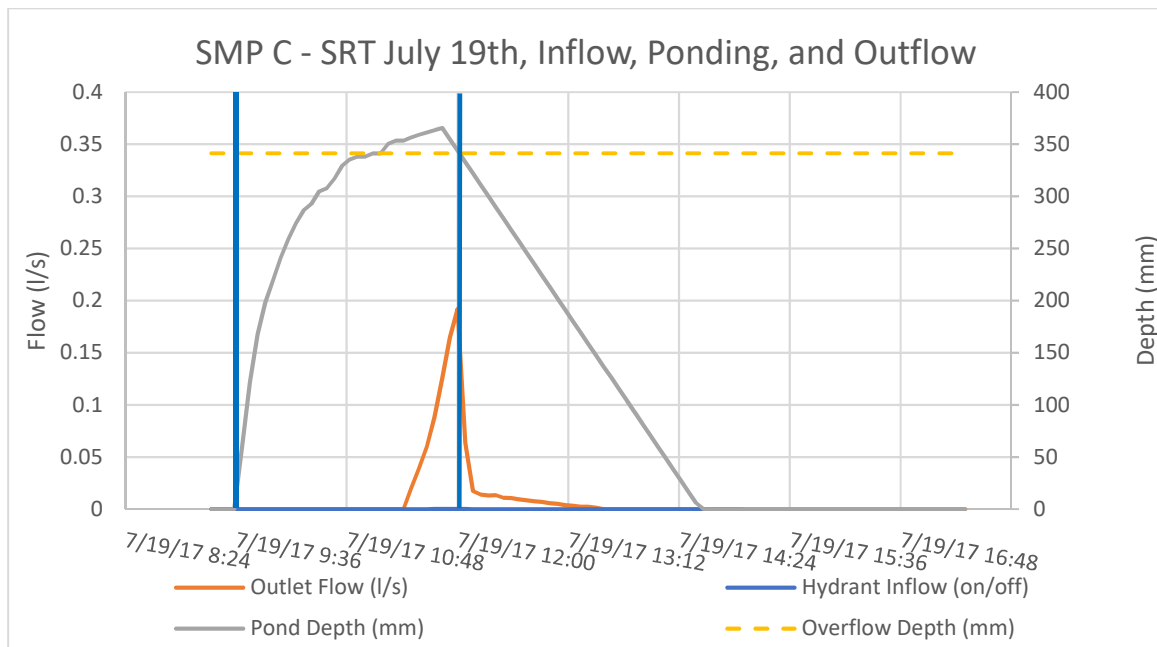
*Figure 3-32. SRT ponding depth versus inflow and outflow from SMP C. Since flow was significantly larger at the inflow than at the outflow, the inflow is depicted with two blue lines that signify when the hydrant inflow was turned on and off.*

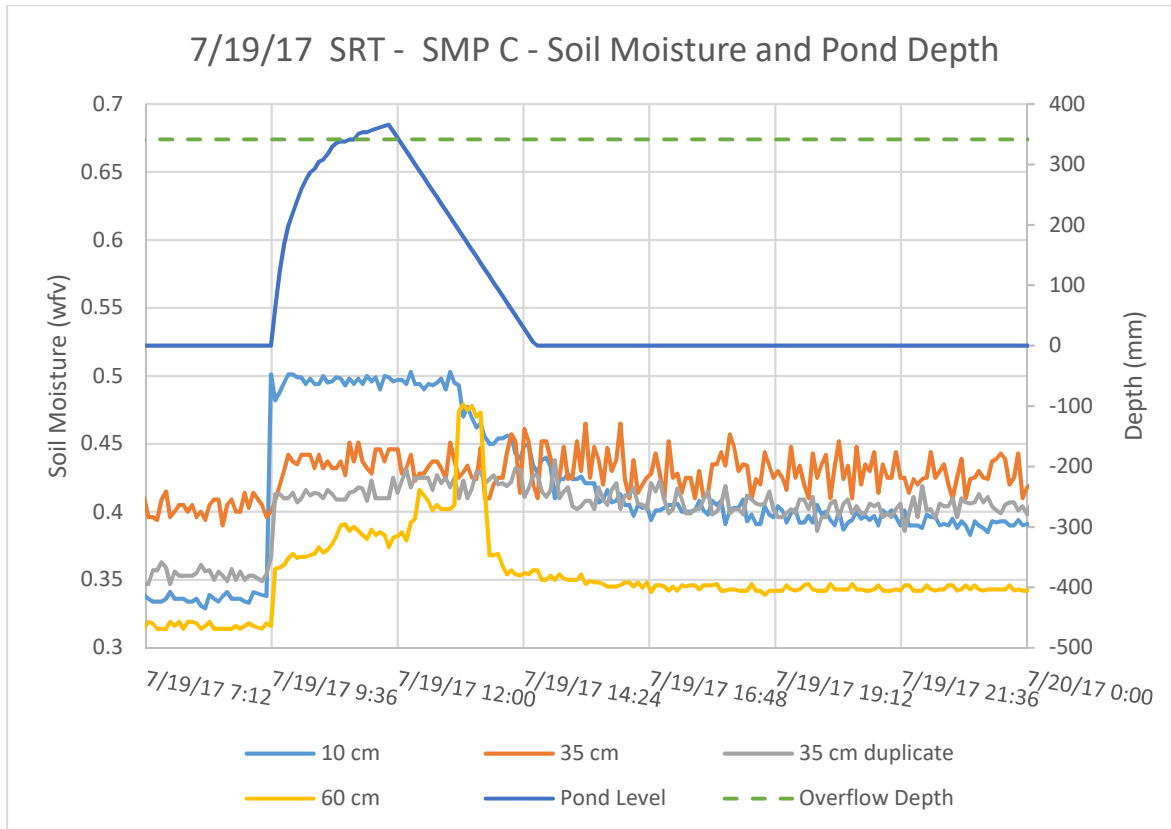
*Figure 3-33: Soil moisture readings in SMP Pond C during SRT on 7/19/17*

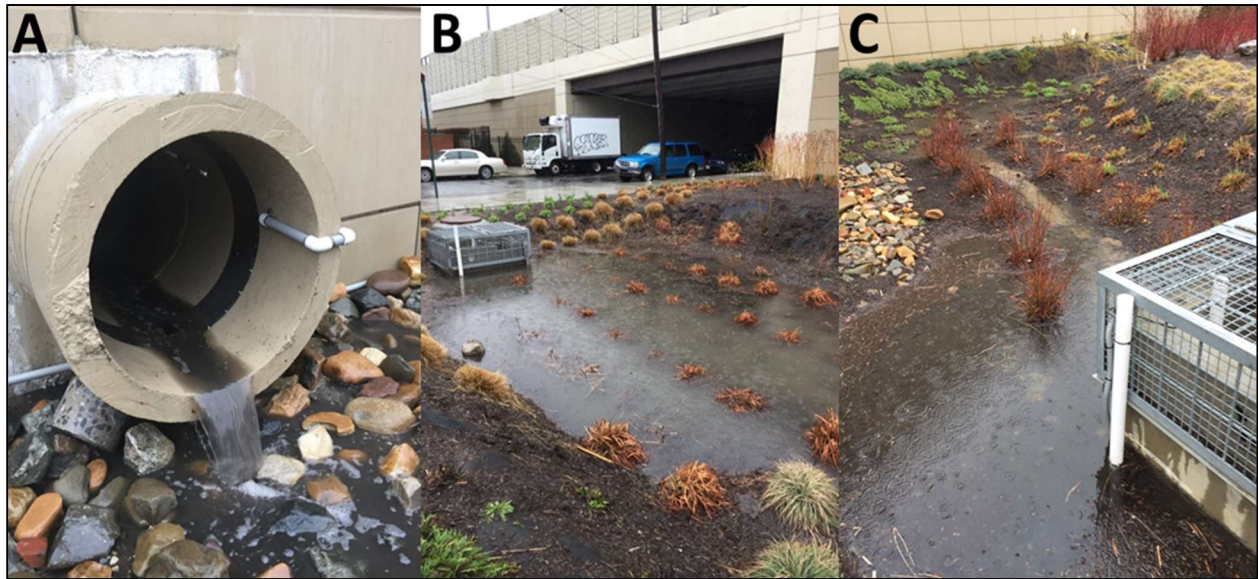
*Figure 4-1. Pictures taken on GR-2 site during an intense storm on March 31. A: First flush from the inlet of SMP C. B: Ponding water in SMP C. C: Ponding water in SMP D.*

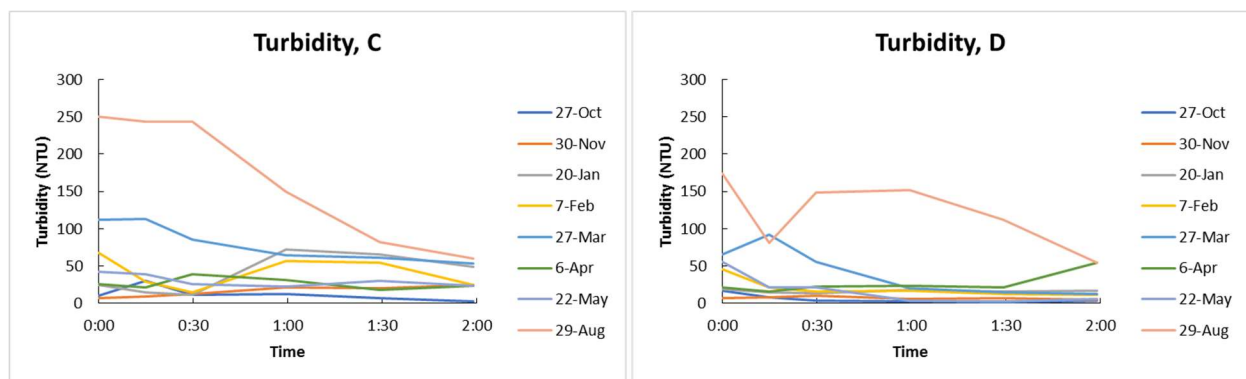
Figure 4-11. Turbidity measured in runoff water for the two SMPs C and D for the eight storms.

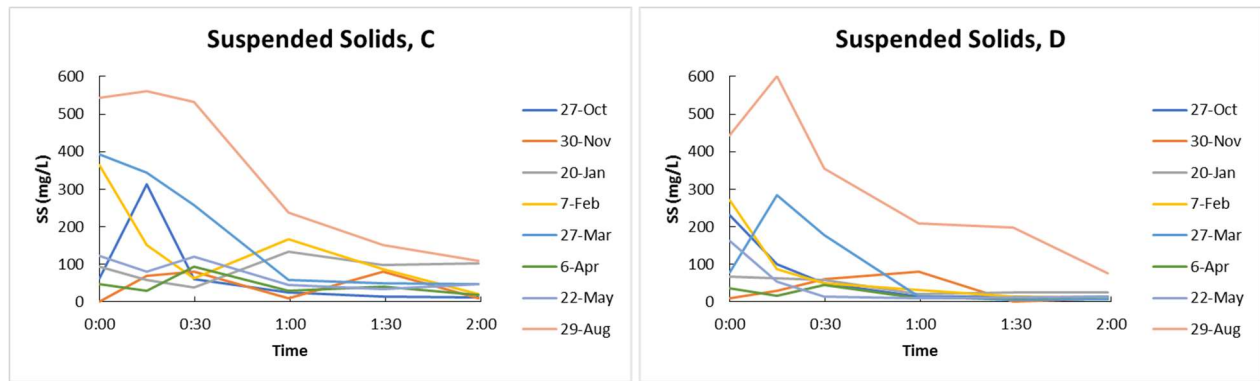
Figure 4-12. Suspended solids measured in runoff water for the two SMPs C and D for the eight storms.

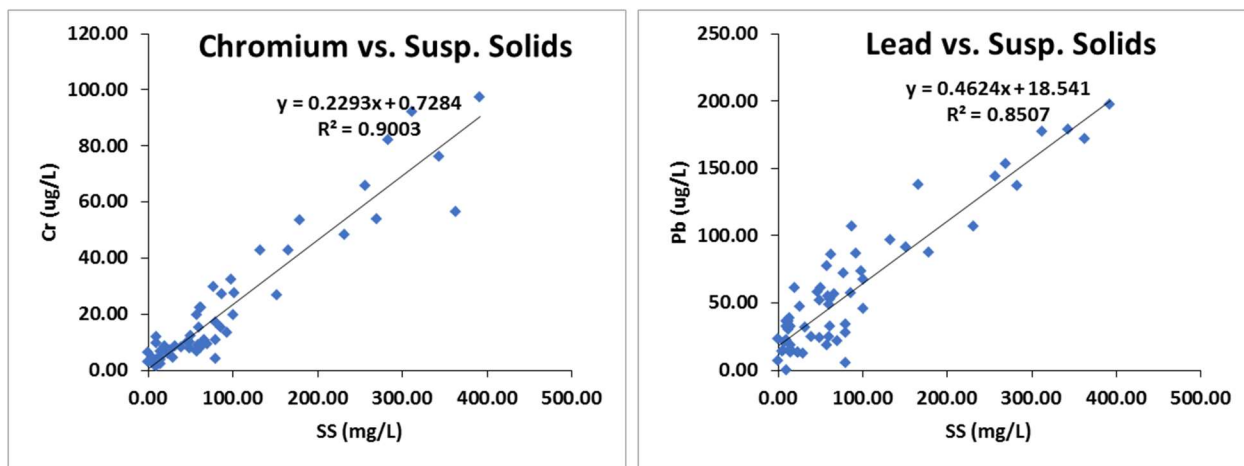
Figure 4-25. Correlation between metal concentration (Cr and Pb) and SS in runoff water for the five storms.

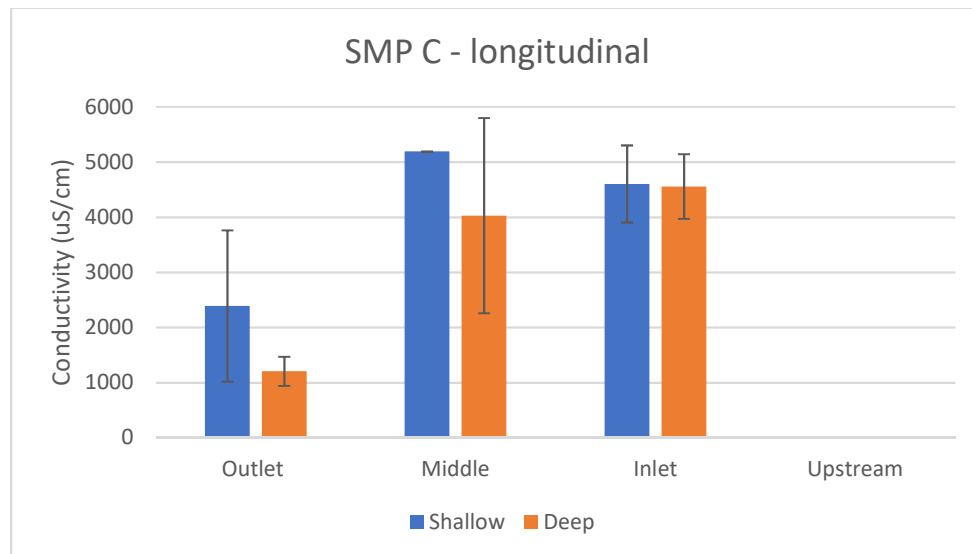
Figure 4-26. Conductivity descriptive statistics for shallow and deep lysimeters in SMP C.

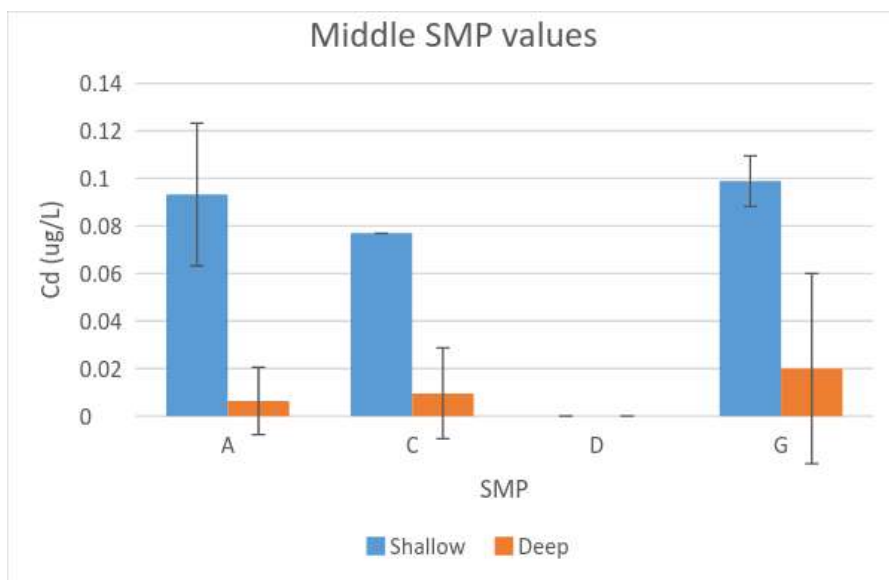
Figure 4-32. Cadmium concentrations in shallow and deep lysimeters located in the middle of each SMP.

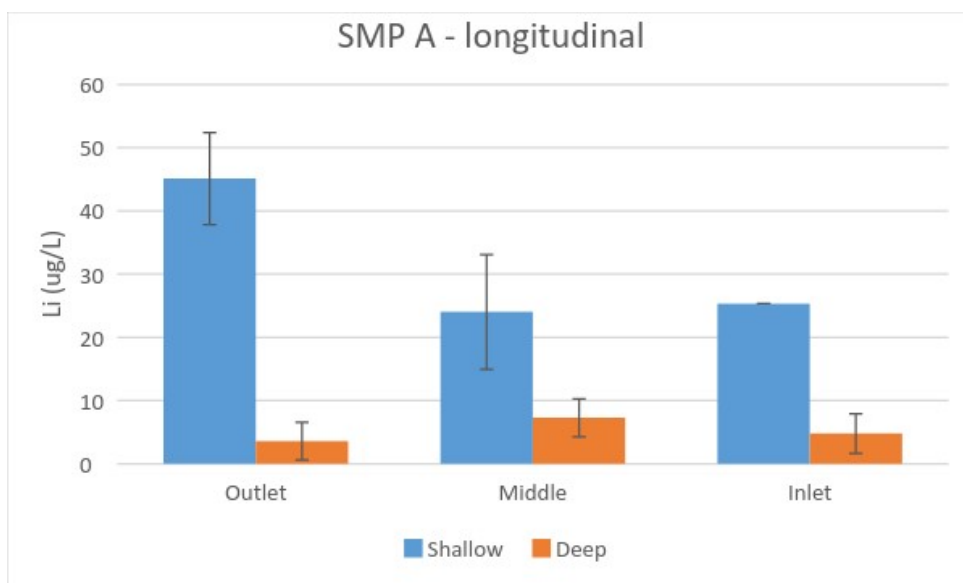
Figure 4-35. Lithium concentrations, included as a cationic tracer in the simulated runoff test, in shallow and deep lysimeters in SMP A.

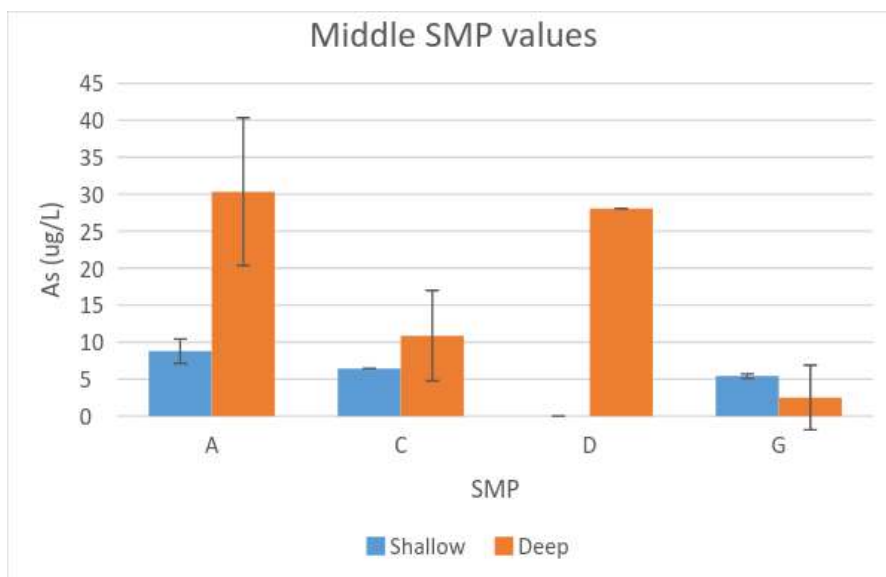
Figure 4-36. Arsenic concentrations in shallow and deep lysimeters in for the middle of each SMP.

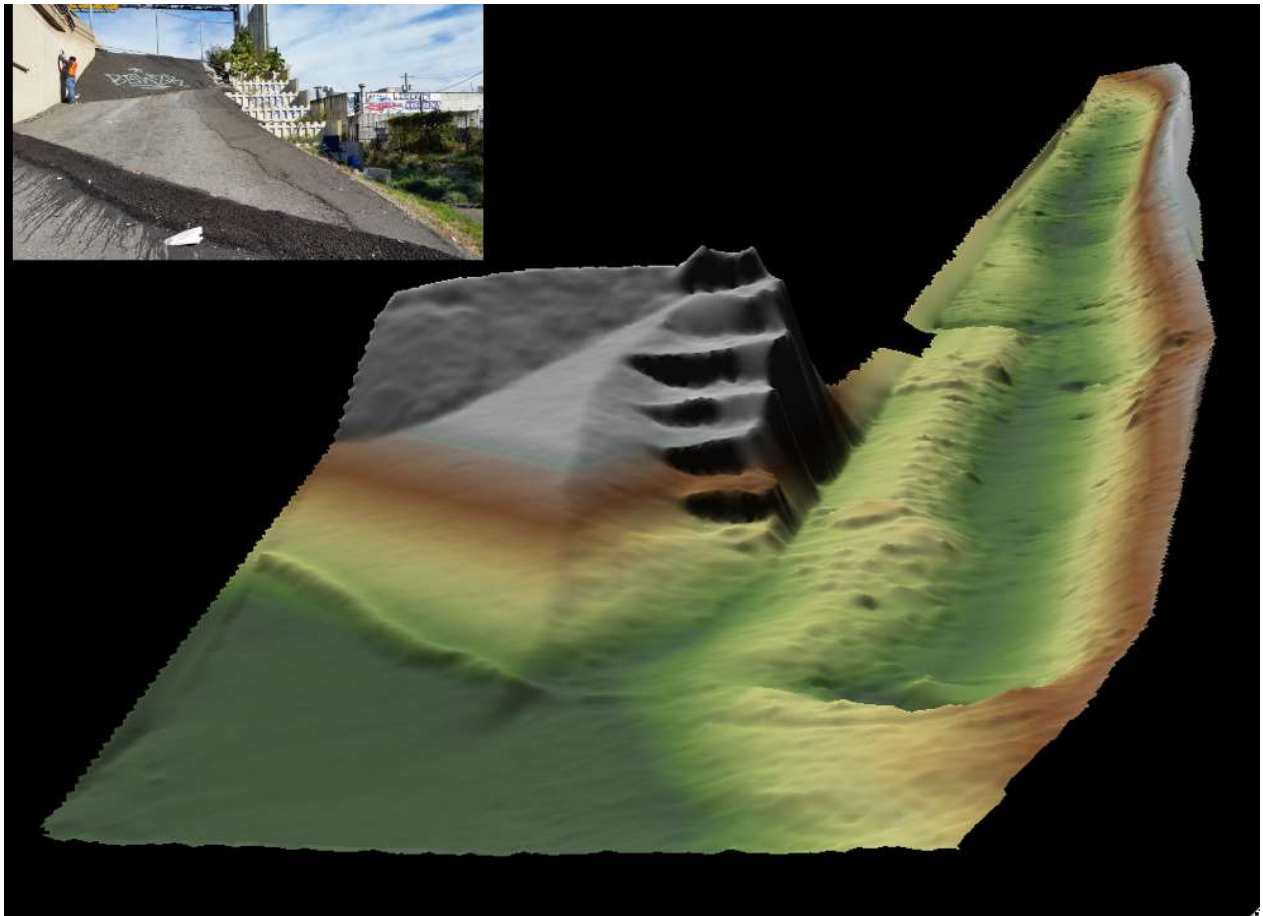
*Fig. 5.4. The 3D DEM produced from the filtered point cloud data. Inset shows a photograph of the asphalt ridge visible in the lower left corner of the DEM. The ridge was constructed to direct runoff flowing down the I-95 ramp into the stormwater basin.*

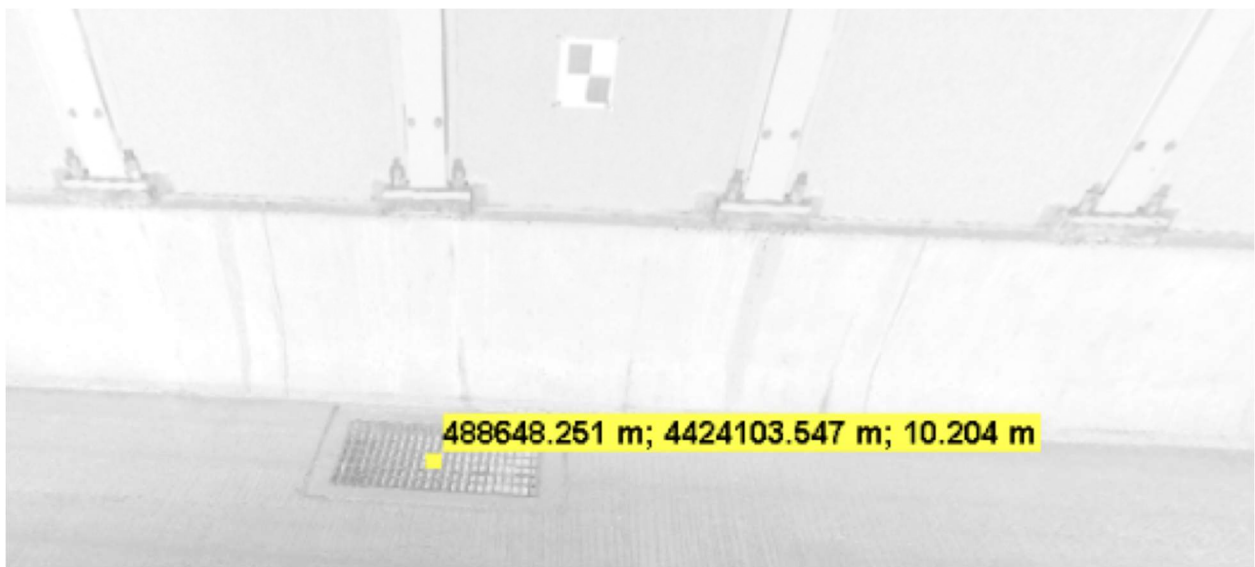
*Fig. 5.7 Example of a storm drain coordinate (UTM WGS94) picked from the LiDAR point cloud.*

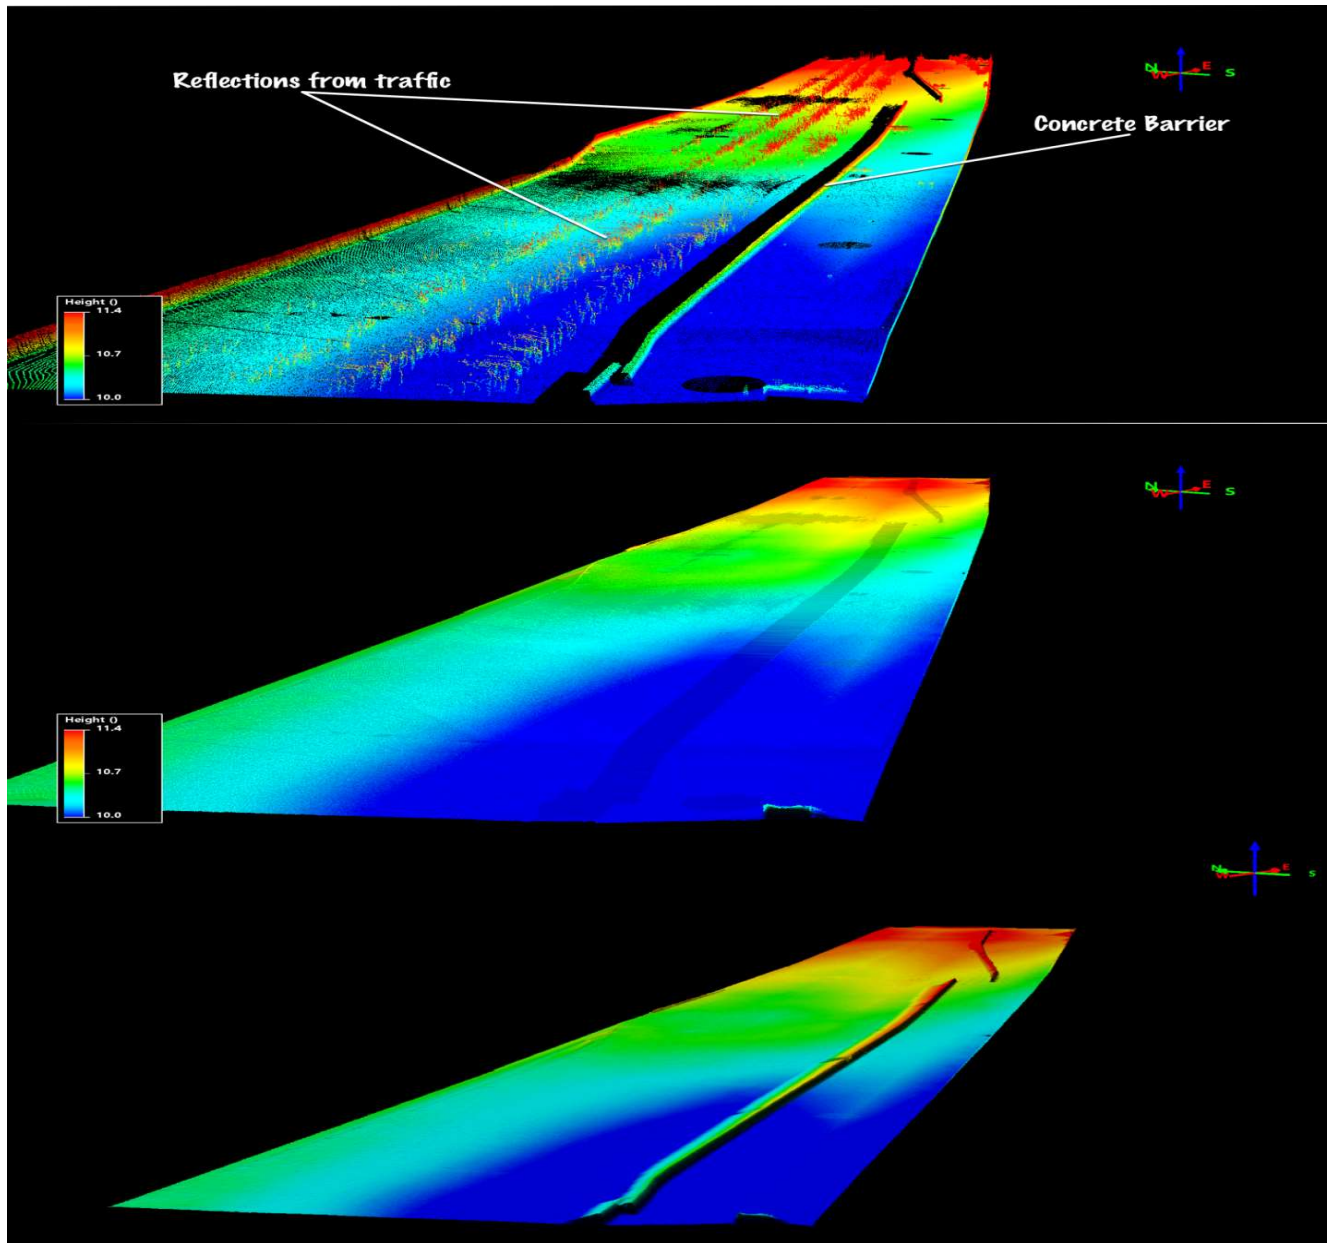
*Fig. 5.8 (Top) Point cloud for region of interest, color-coded by elevation. Note the spurious reflections from traffic. (Middle) DEM constructed only from ground surface reflections, which removed the barrier. (Bottom) DEM constructed from ground reflections with the barrier added back in. Due to the lack of LiDAR returns in the shadow of the barrier, interpolation caused the barrier to appear ramped on one side; this had a minimal effect on subsequent drainage calculations as flow is still blocked.*

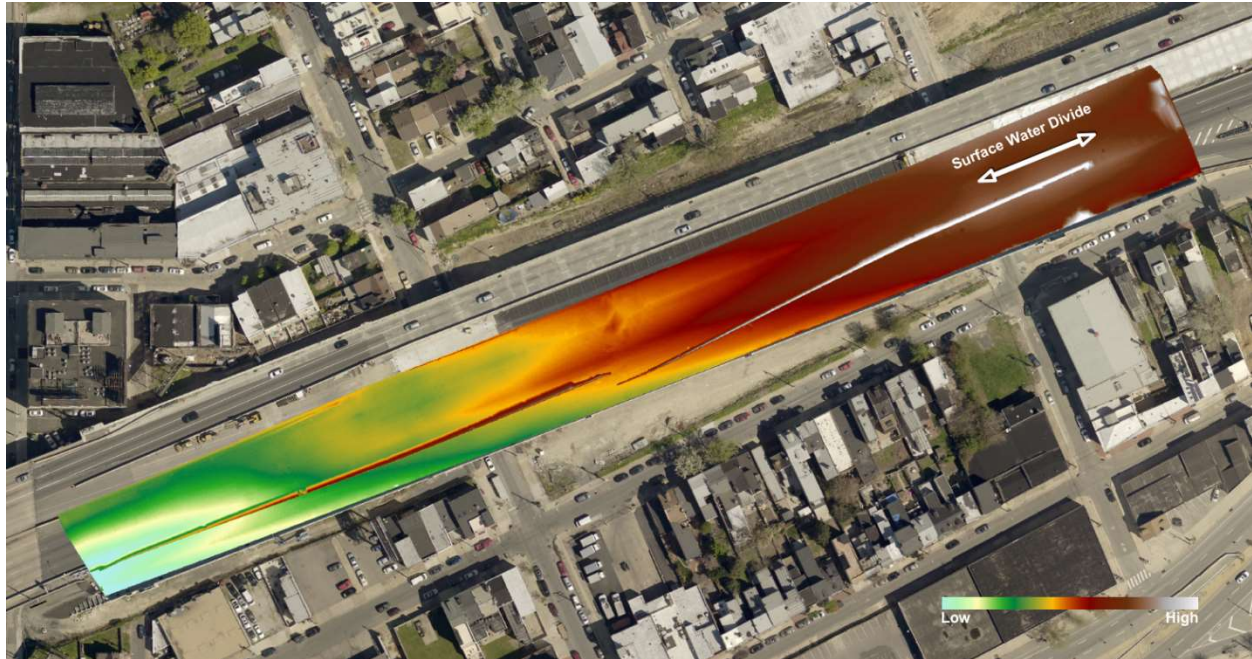
*Fig. 5.9 Color-coded DEM of the I-95 roadway surface (barrier included). A version without the barrier was also calculated. Note the surface water divide.*

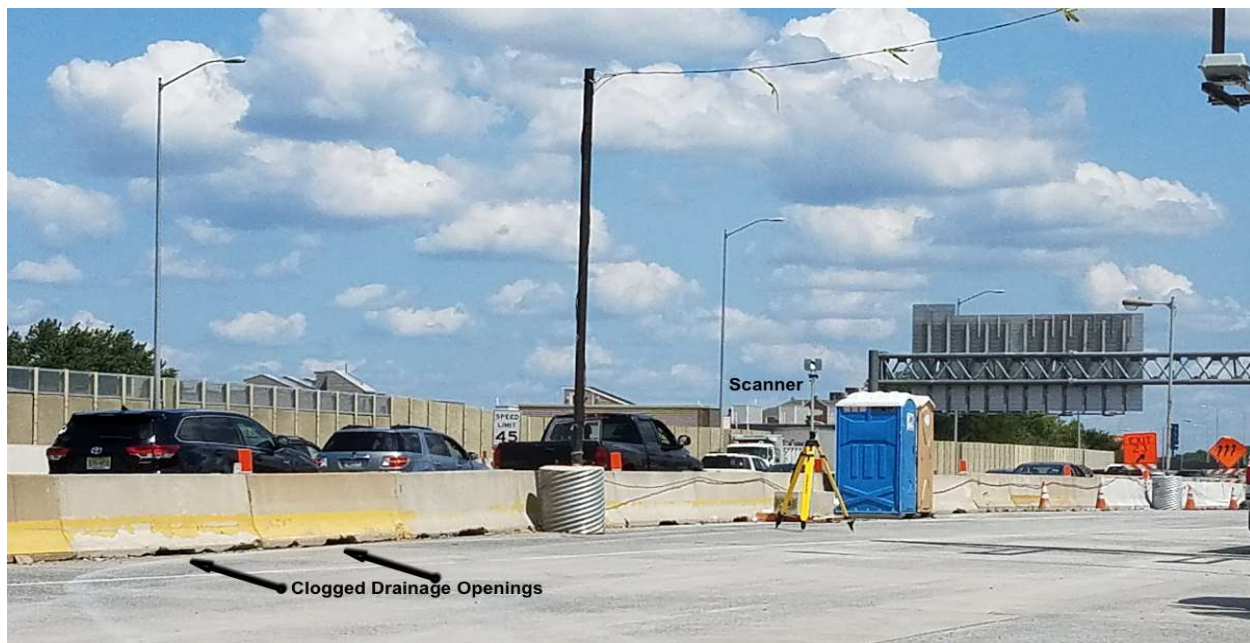
Fig. 5.10 Photograph showing the LiDAR scanner, concrete barriers, and their drainage openings.

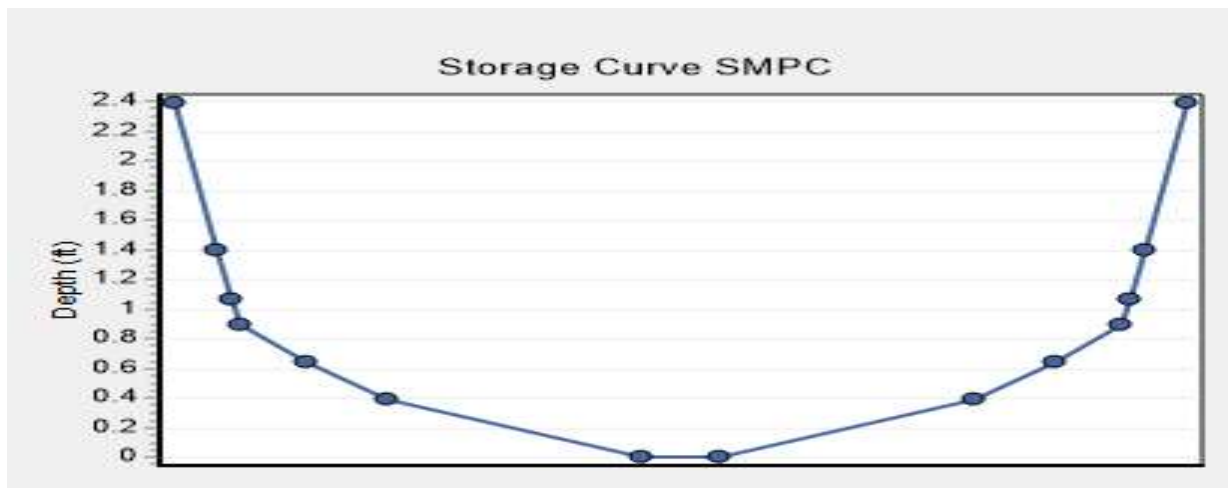
Figure 6-4: Storage curves for bioswales as represented in SWMM.
