## Storm Water Control Management & Monitoring

FINAL REPORT

By Laura Toran  
Temple University

## **Task 9: Final Report**

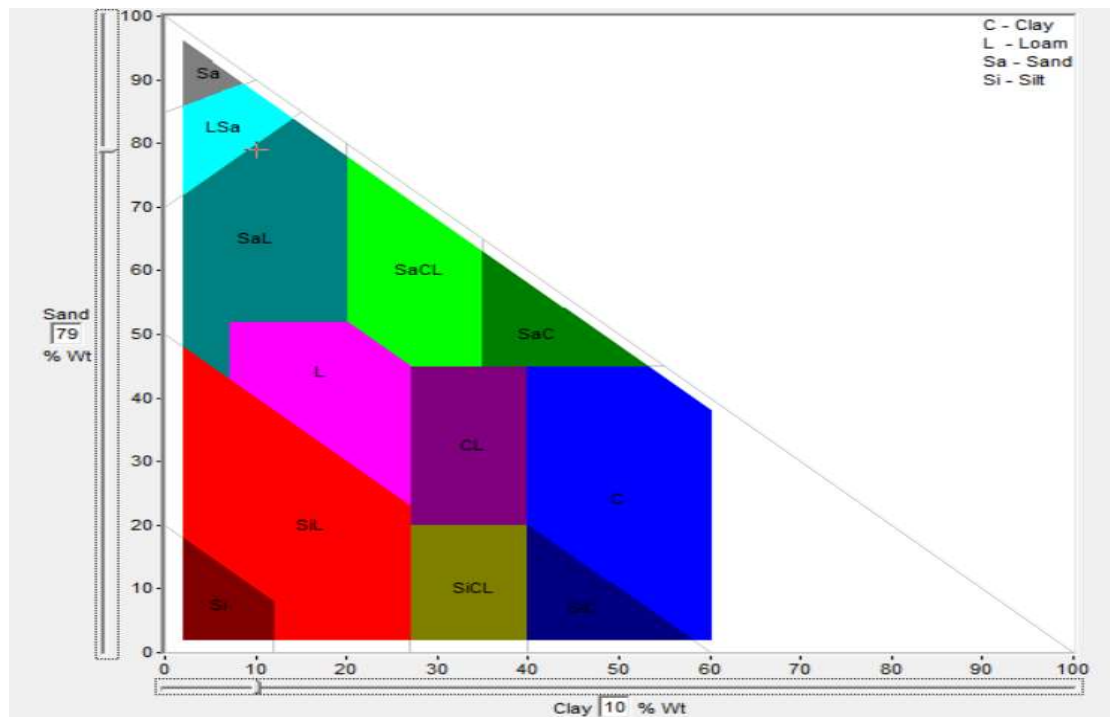
Figure 6-5: Loamy sand with 79% sand and 10% clay (75-82% sand and less than 10% clay as defined by AECOM) entered into the SPAW model

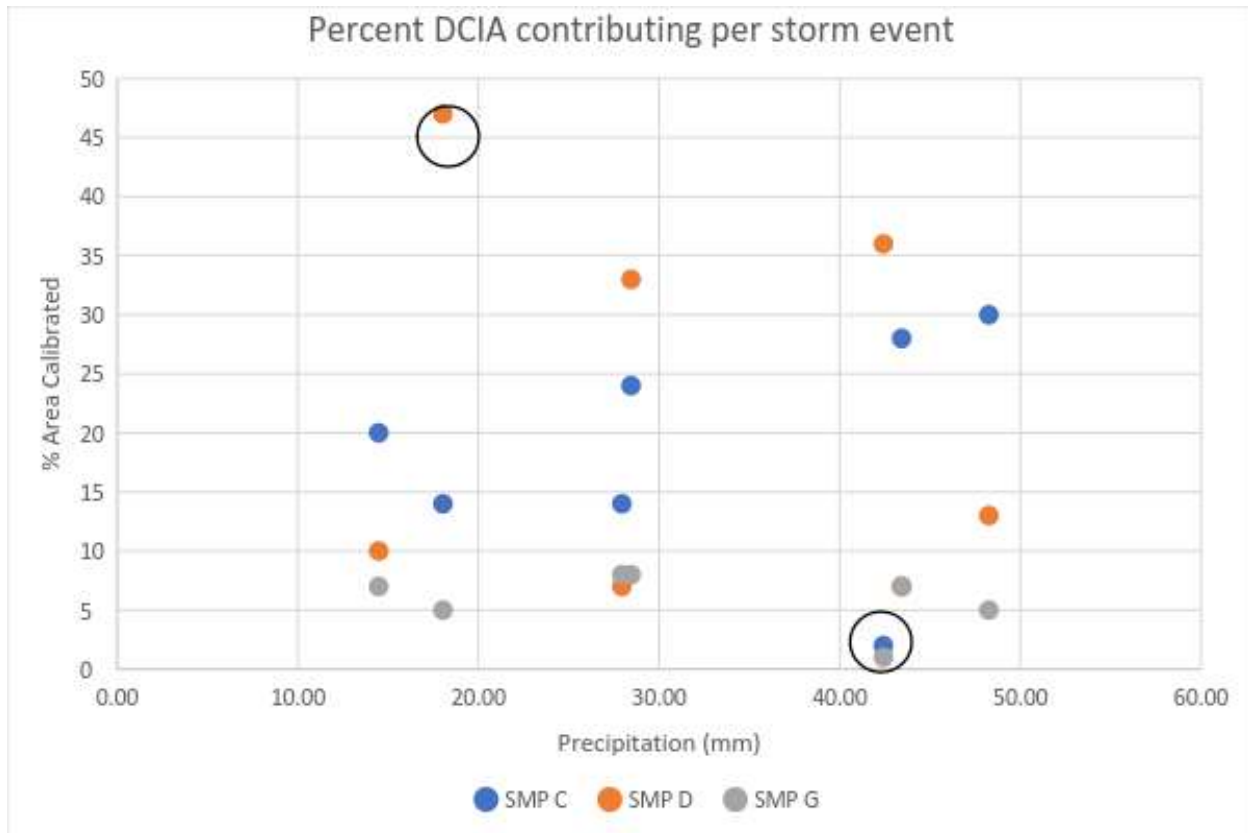
Figure 6-9: Percent of contributing area of SMP C, D, and G for each storm. The March 30th storm is circled and considered to be an outlier.

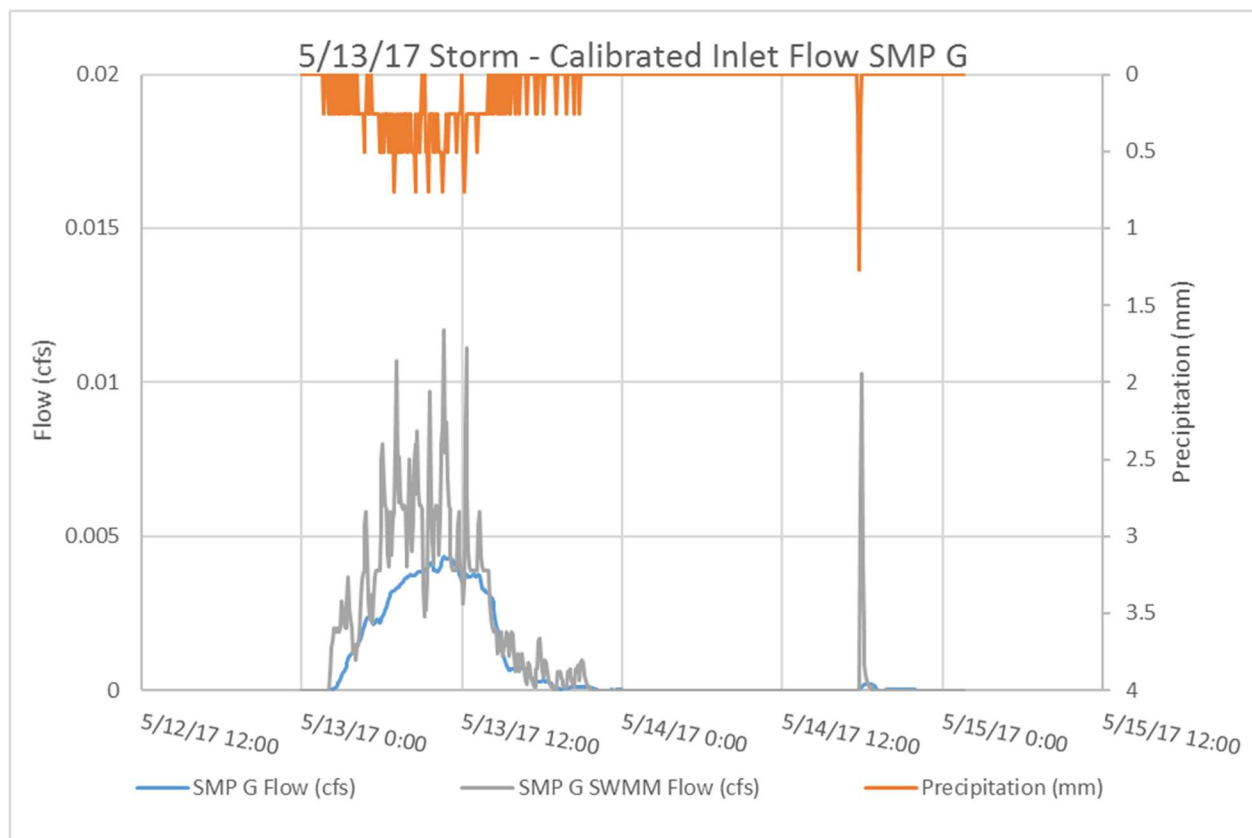
*Figure 6-10: SMP G measured versus calibrated inflow during 5/13 storm (48.26 mm precipitation)*

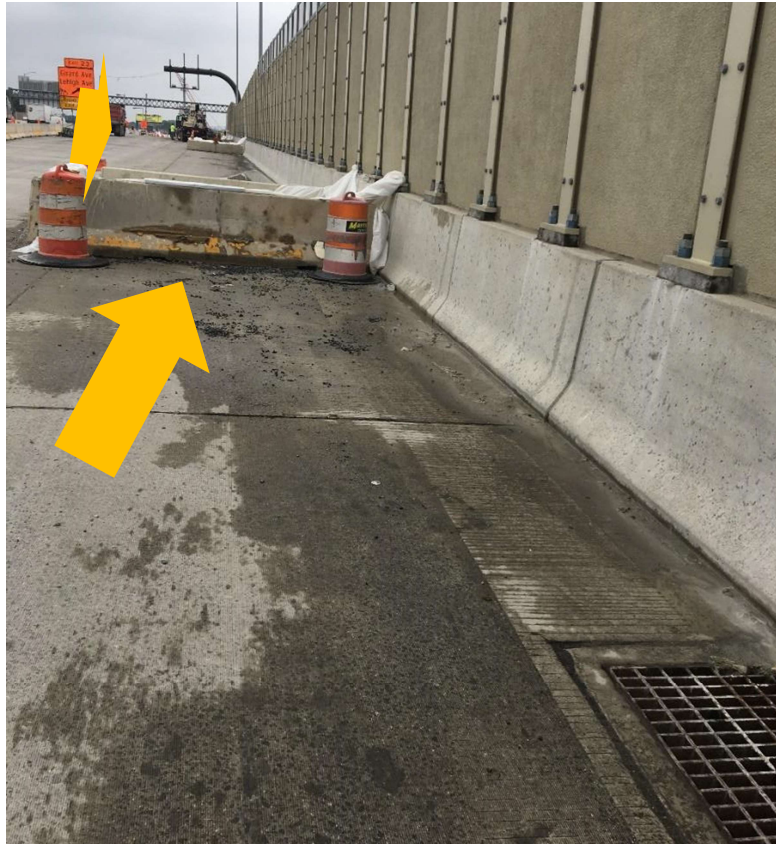
*Figure 6-13: Inlet draining to SMP D, with construction blockade immediately upstream shown by the big yellow arrow. The smaller arrow is pointing to the construction blockade recently installed next to the inlet to SMP G.*

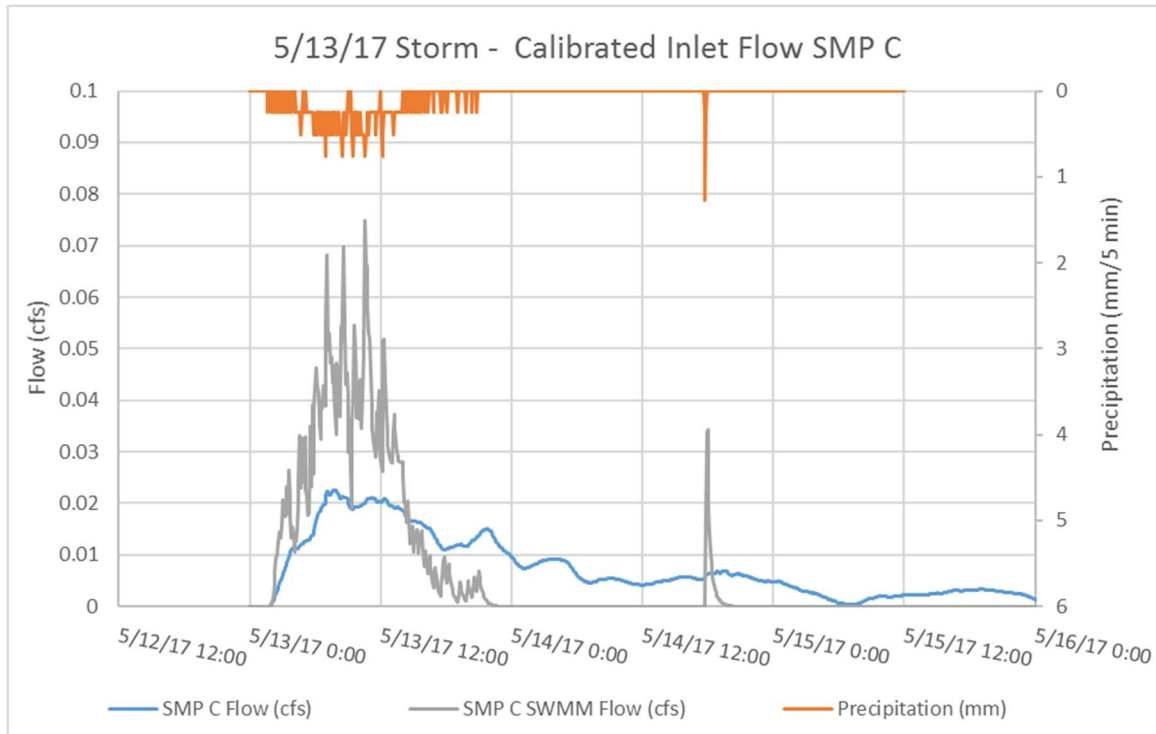
Figure 6-14: SMP C calibrated for timing and area – 5/13/17 Storm (48.26 mm precipitation)

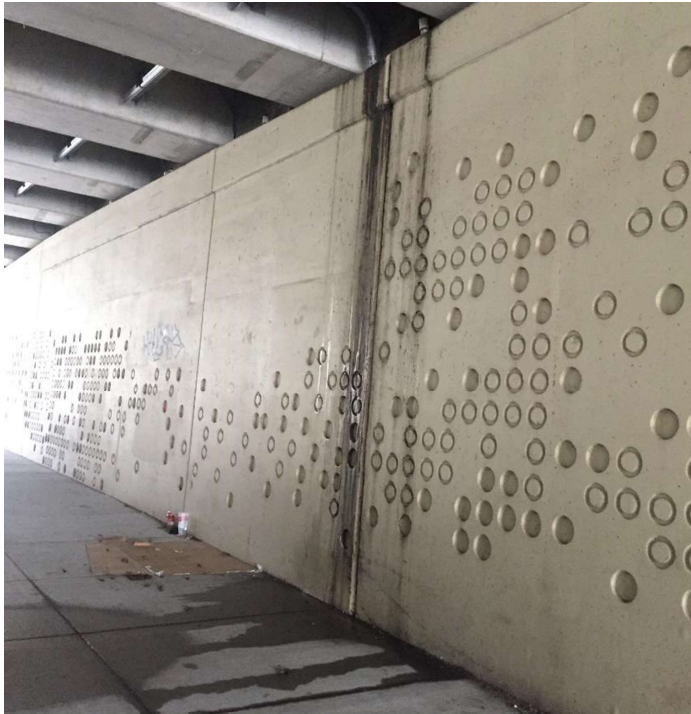
Figure 6-15: Shackamaxon Street overpass leak under drainage area for SMP A during July 6th storm (1.65 mm of precipitation had occurred in 1.5 hours at the time of this photo).

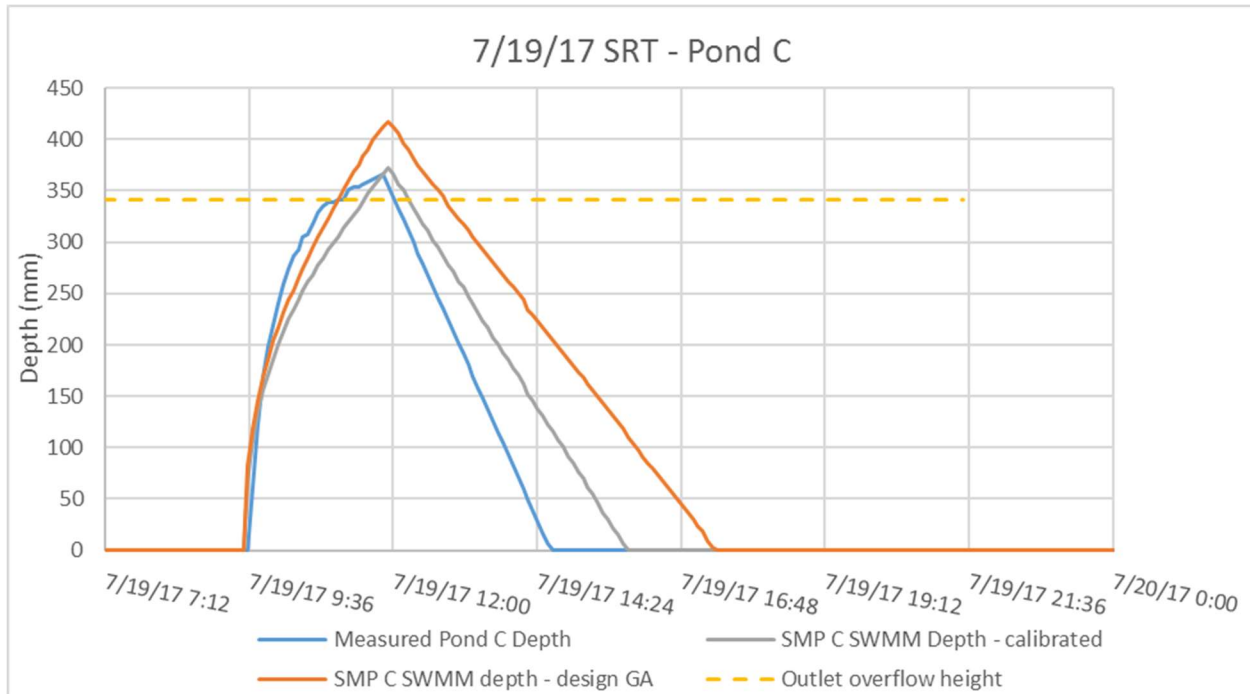
Figure 6-16: Pond C calibration for depth during SRT on 7/19/17 compared to the non-calibrated and measured pond depths. The dotted line is the depth when overflow first occurs.

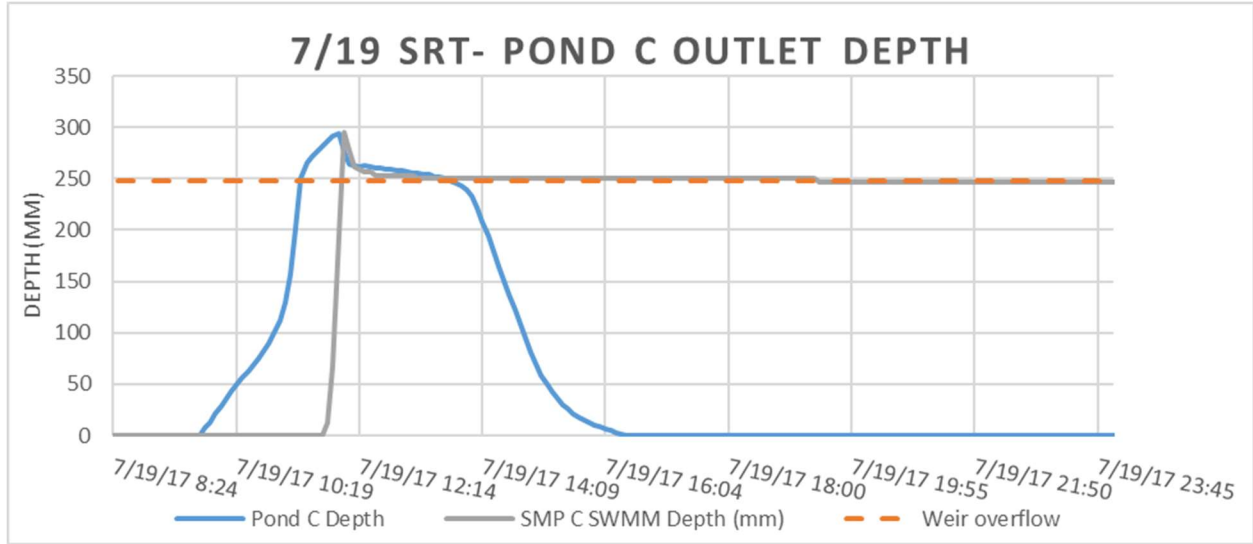
Figure 6-17: Outlet depth for SMP C during the 7/19/17 SRT

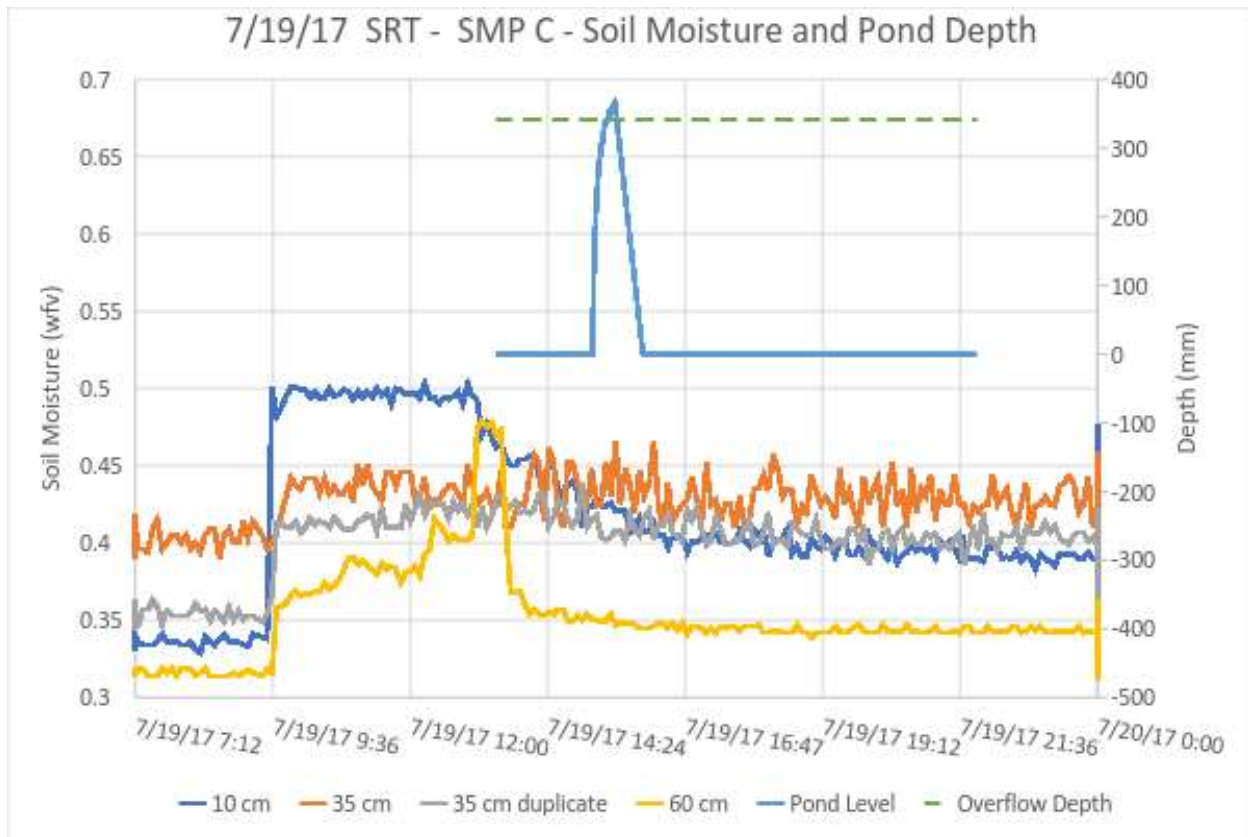
Figure 6-18: Soil moisture readings in SMP Pond C during SRT on 7/19/17

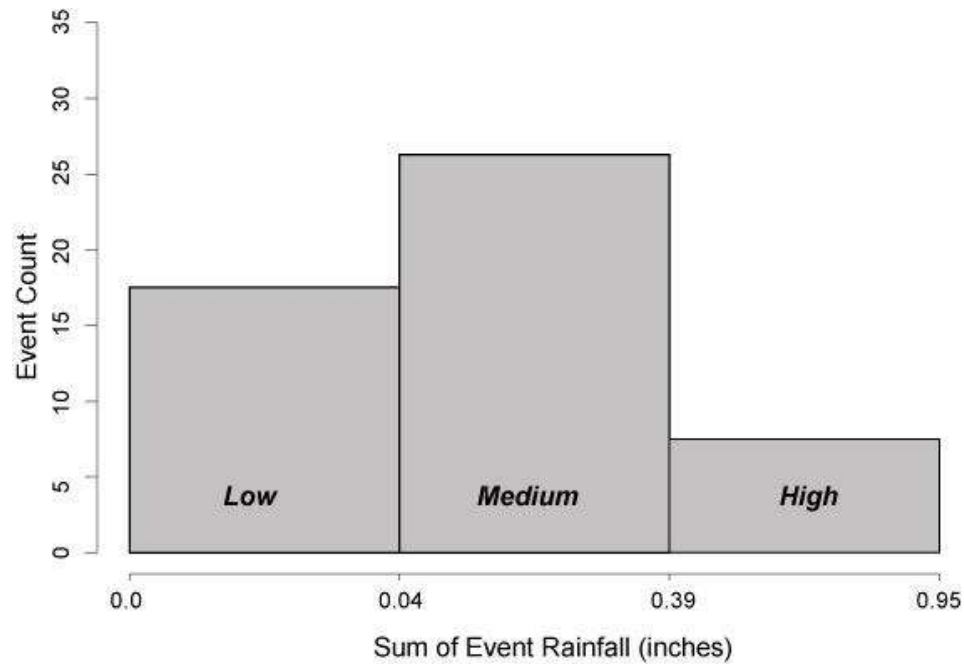
Fig. 6-21. Frequency histogram of precipitation events occurring between October 2016 and March 2017.

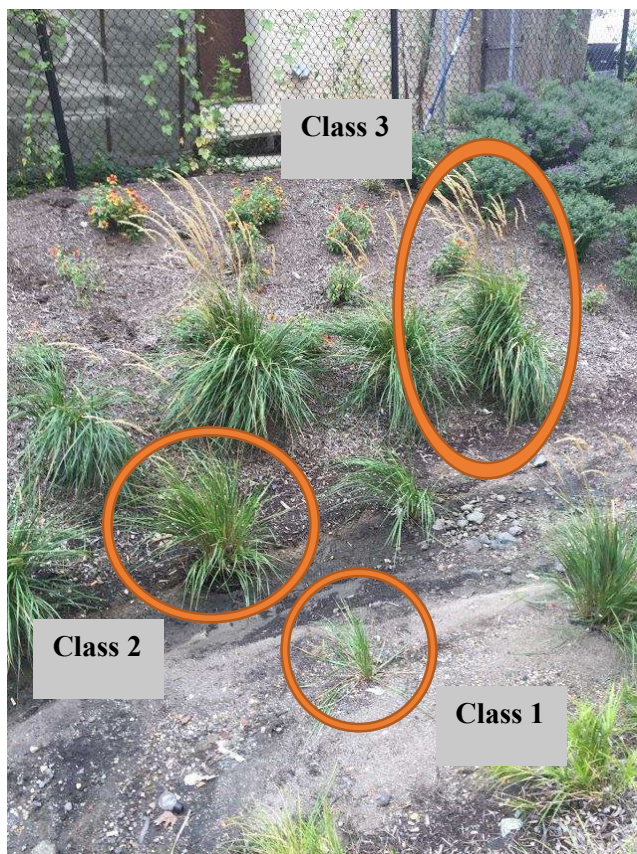
Figure 7-1. Examples of health rating classes 1-3. The remaining class (designated 0) is assigned to dead plants. The species shown is *Calamagrostis* × *acutiflora* ‘Karl Foerster’, which is one of the most abundant species in the study area.

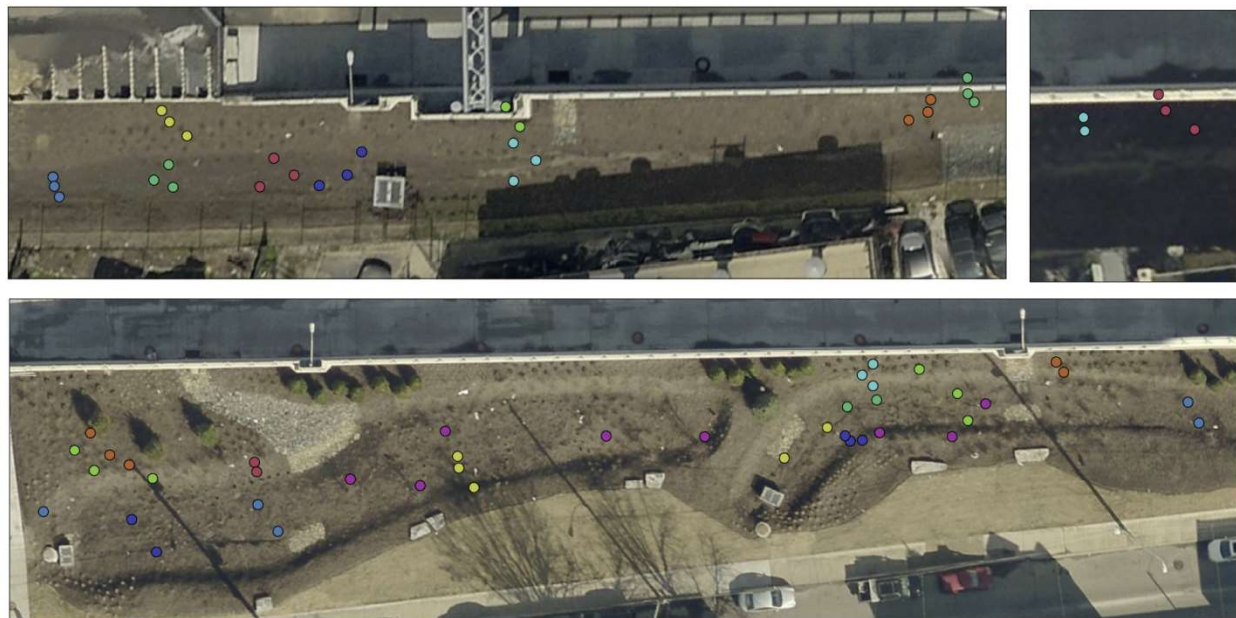
**Plant locations overlaid on 3-inch aerial photography from 2015**

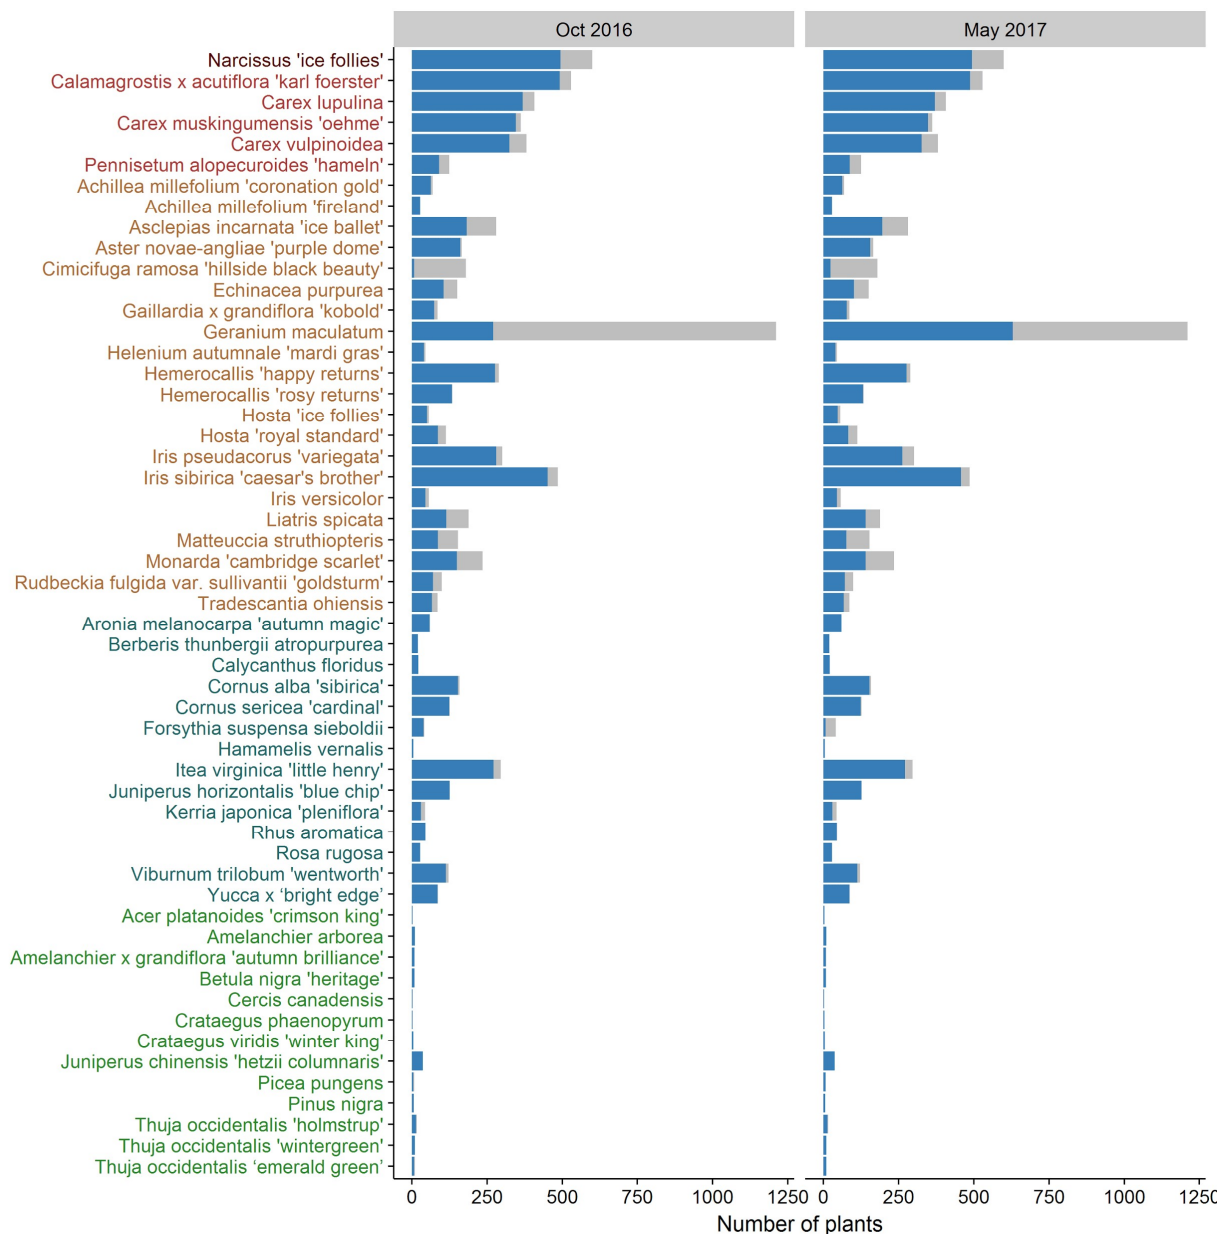
Figure 7-4. The number of plants of each species found living during surveys (blue bars), and the total number planted (gray bars). Coloration of species names corresponds to functional groups: bulbs (dark red), graminoids (light red), perennials (brown), shrubs (blue), trees (green).

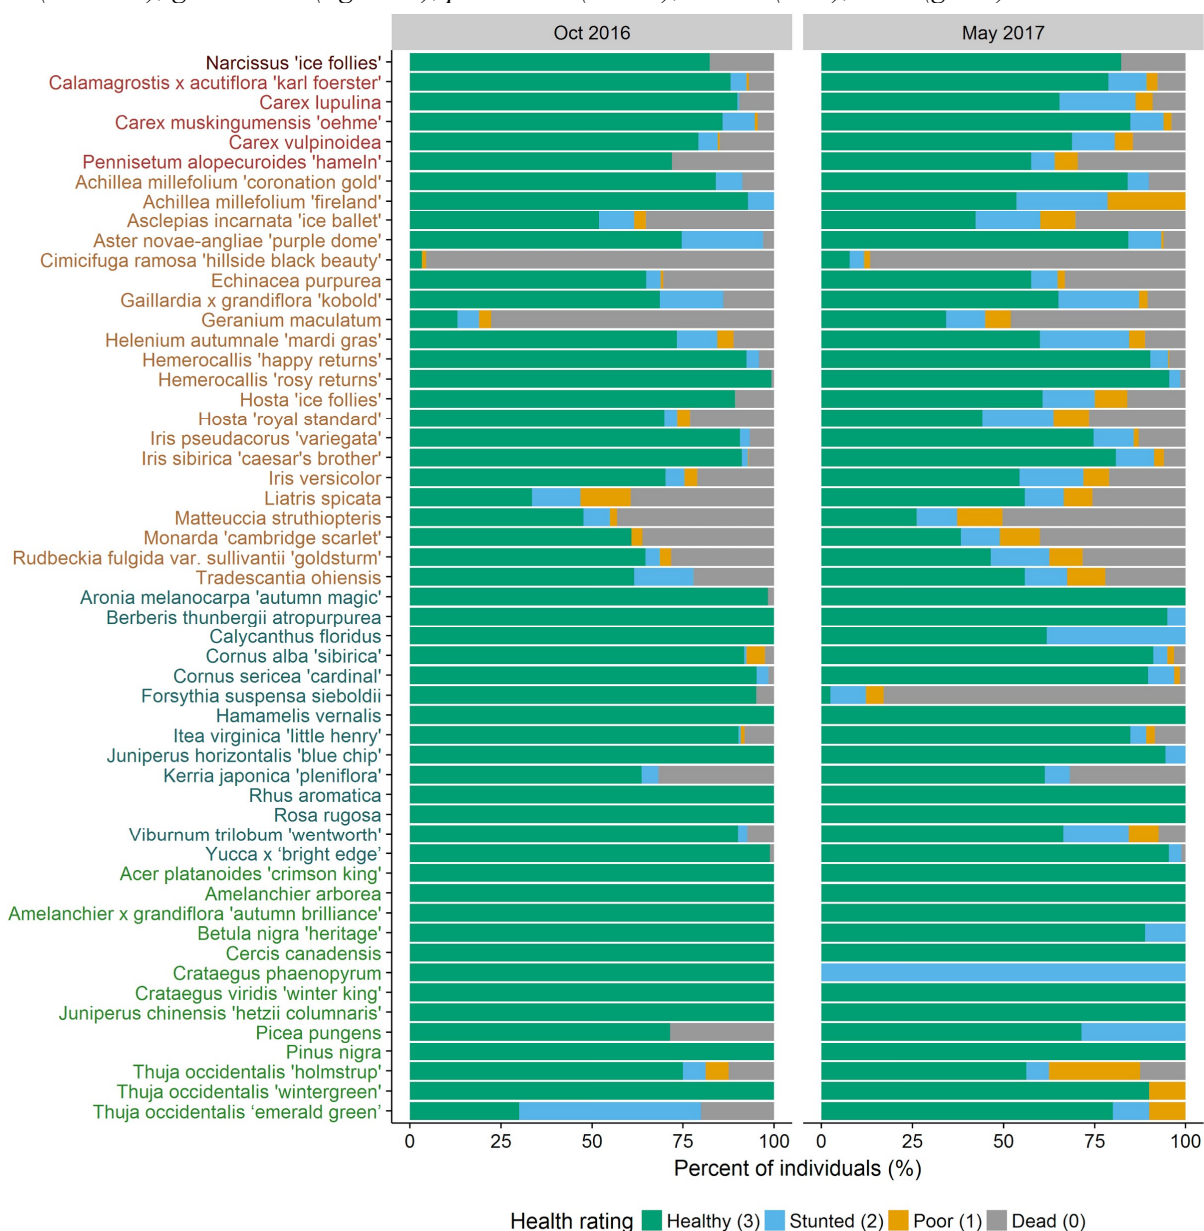
Figure 7-5. The percentage of plants of each species falling into each of four health rating classes. See text for a more detailed explanation of the criteria used to rate plant health. Coloration of species names corresponds to functional groups: bulbs (dark red), graminoids (light red), perennials (brown), shrubs (blue), trees (green).

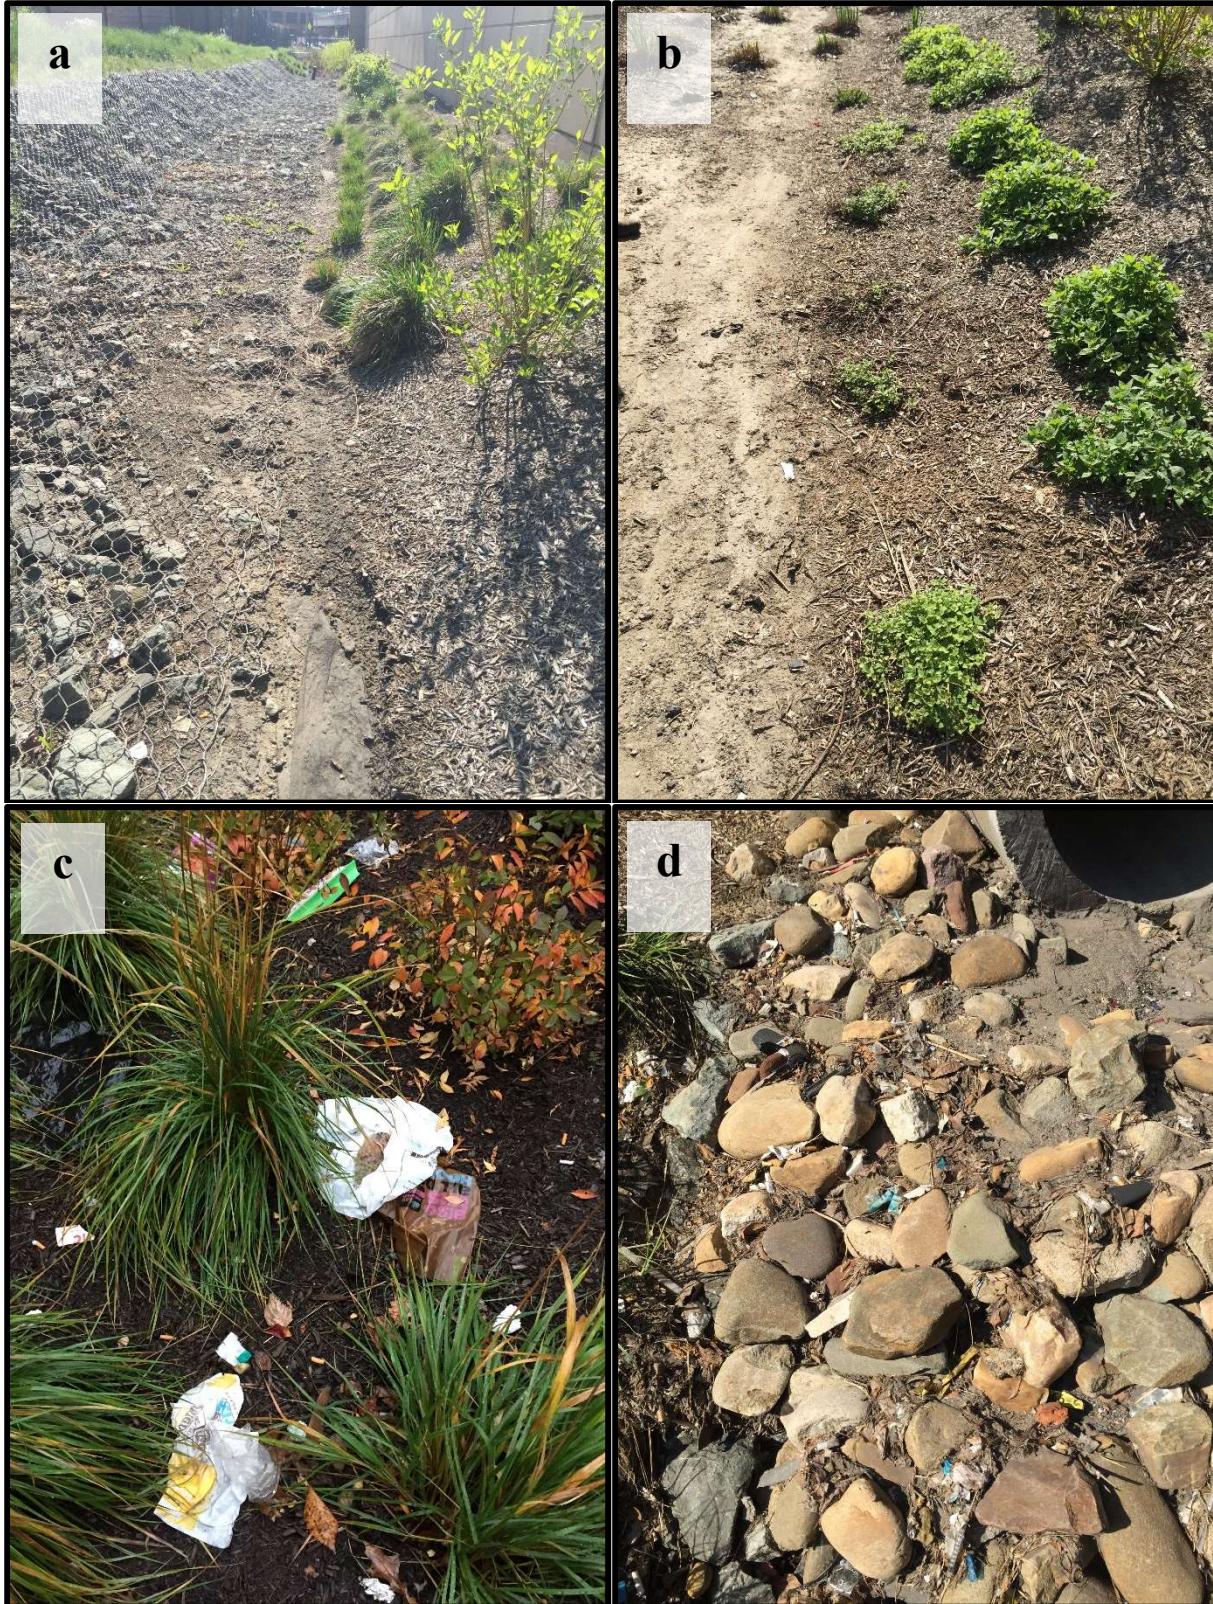
*Figure 8-1. SMP A is showing signs of erosion along the lower edge of the gabion (a), along the lowest elevation of the basin (b). There is also an accumulation of large (c) and small (d) trash items.*

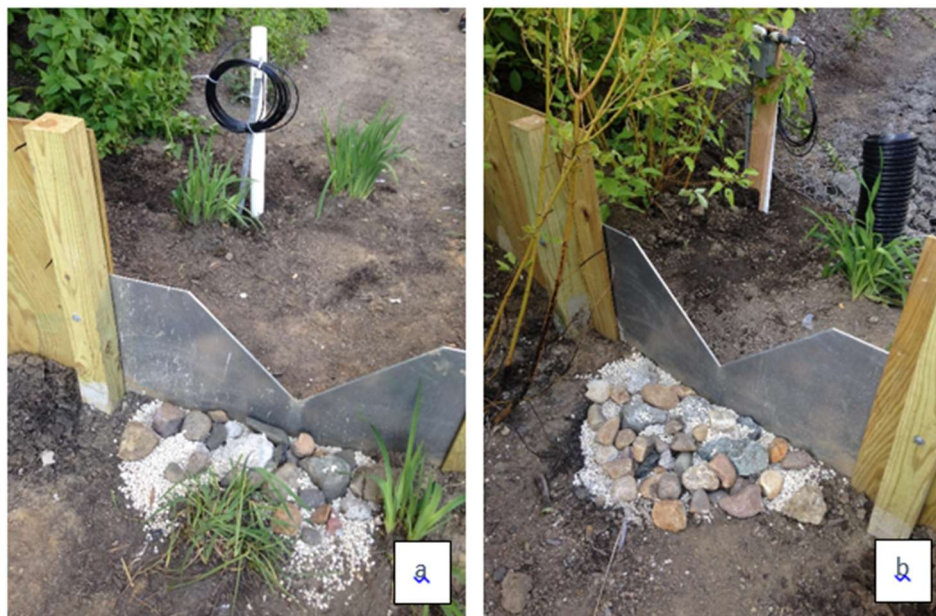
Figure A2-3: (a) Upstream and (b) Downstream V-Notch Weirs

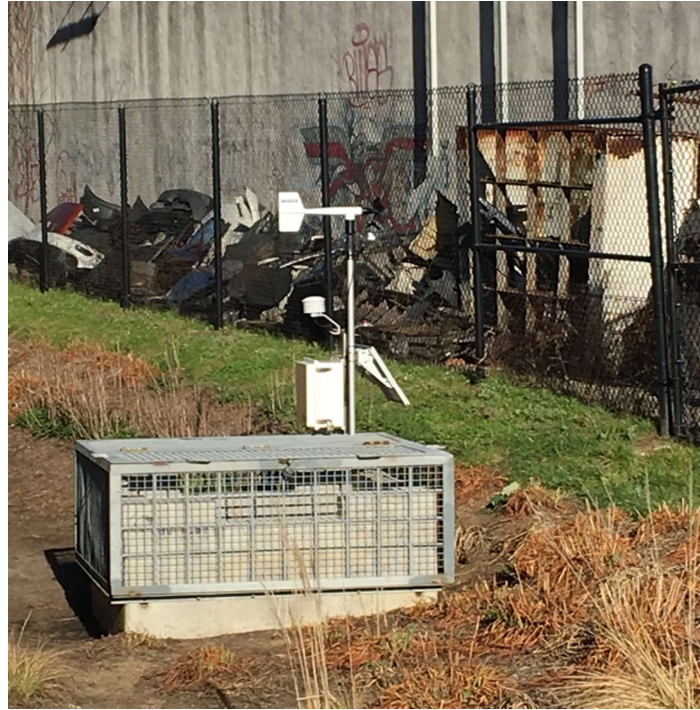
*Figure A2-4: Small Weather Station at Outlet B2*

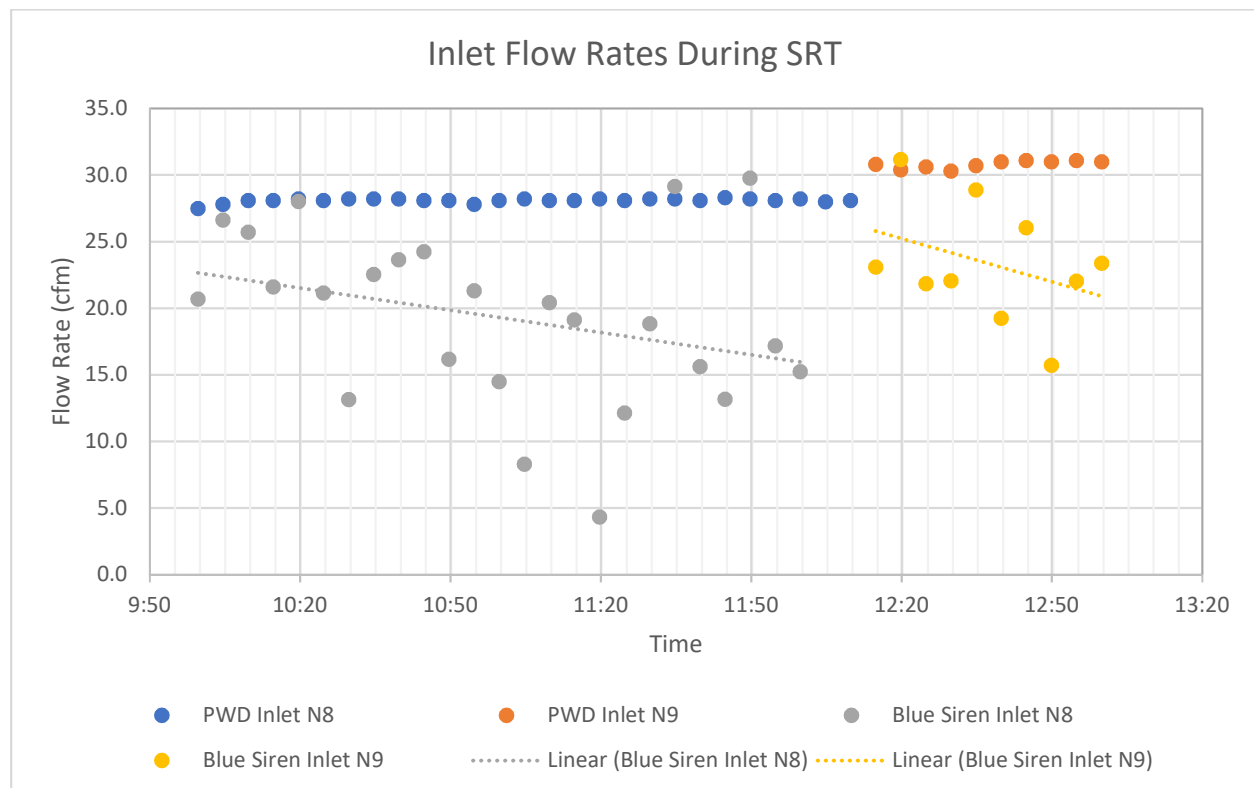
Figure A2-7: SRT Inlet Flow Rates (N8 and N9)

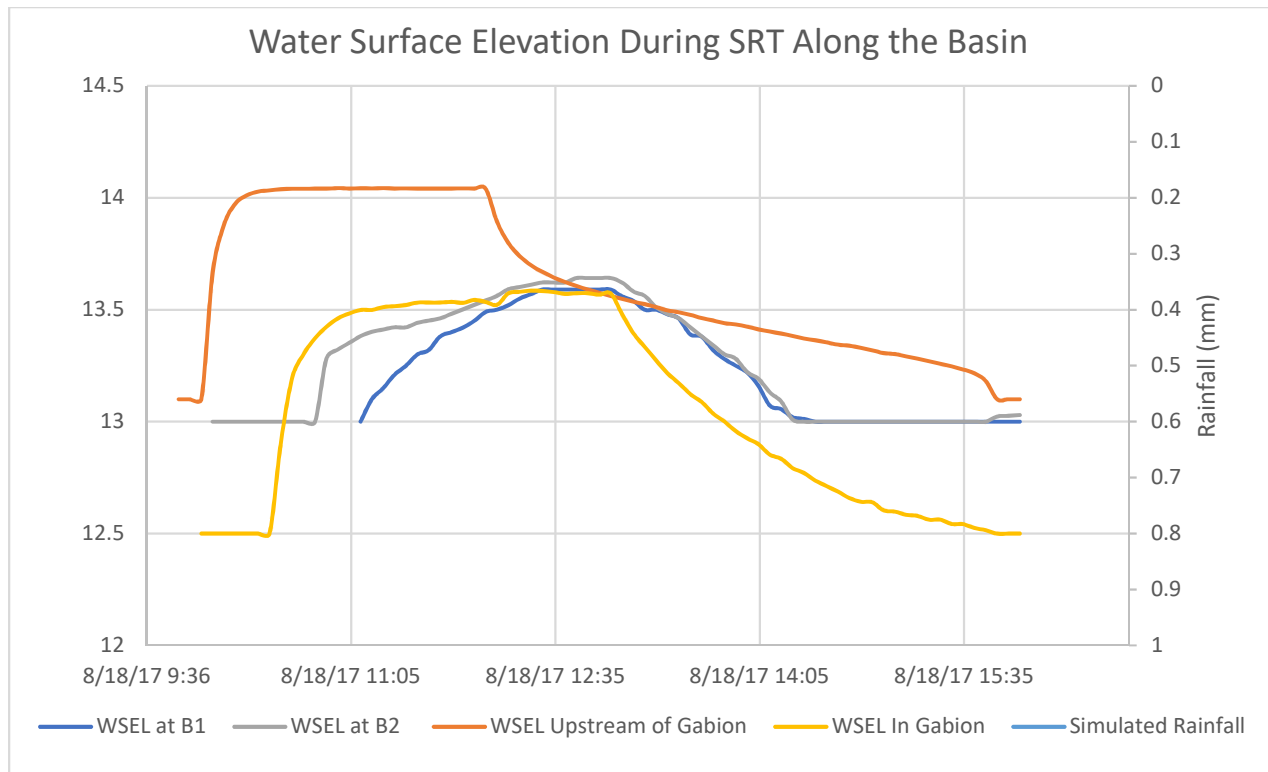
*Figure A2-8: Water Surface Elevations (ft) Along SMP A During the SRT*

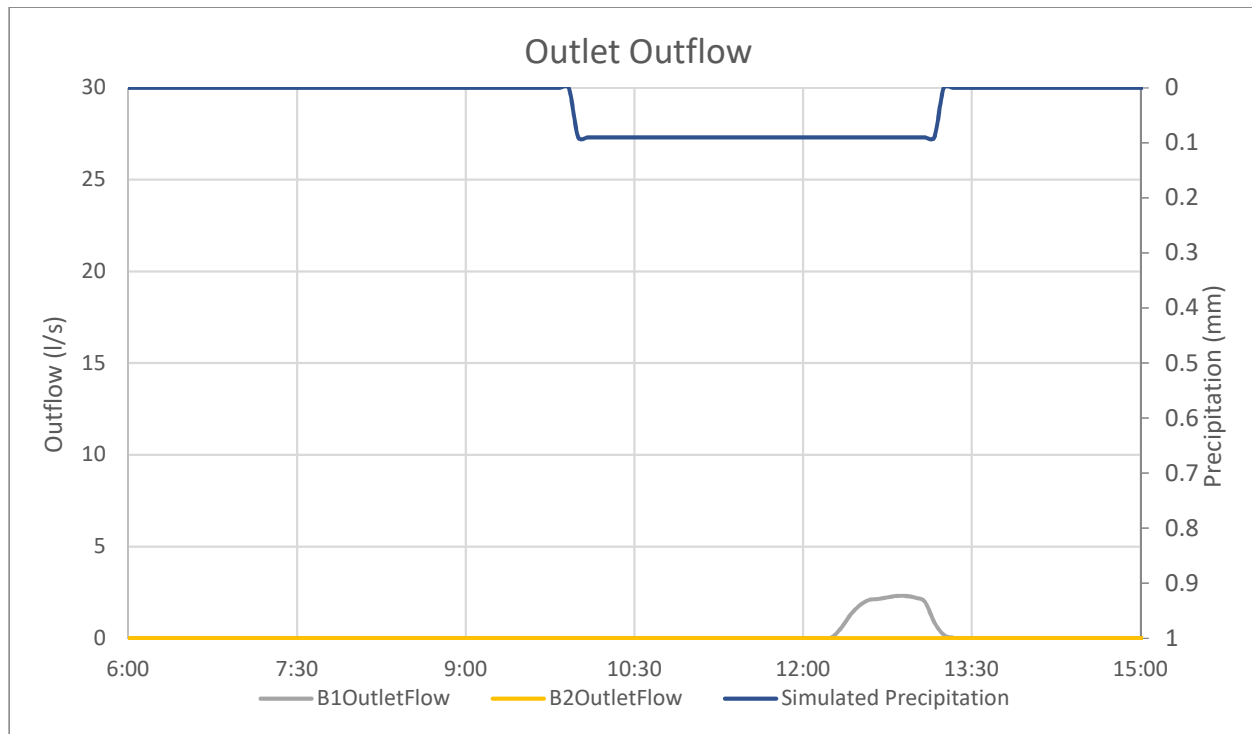
*Figure A2-9: Outlet Outflow During SRT*

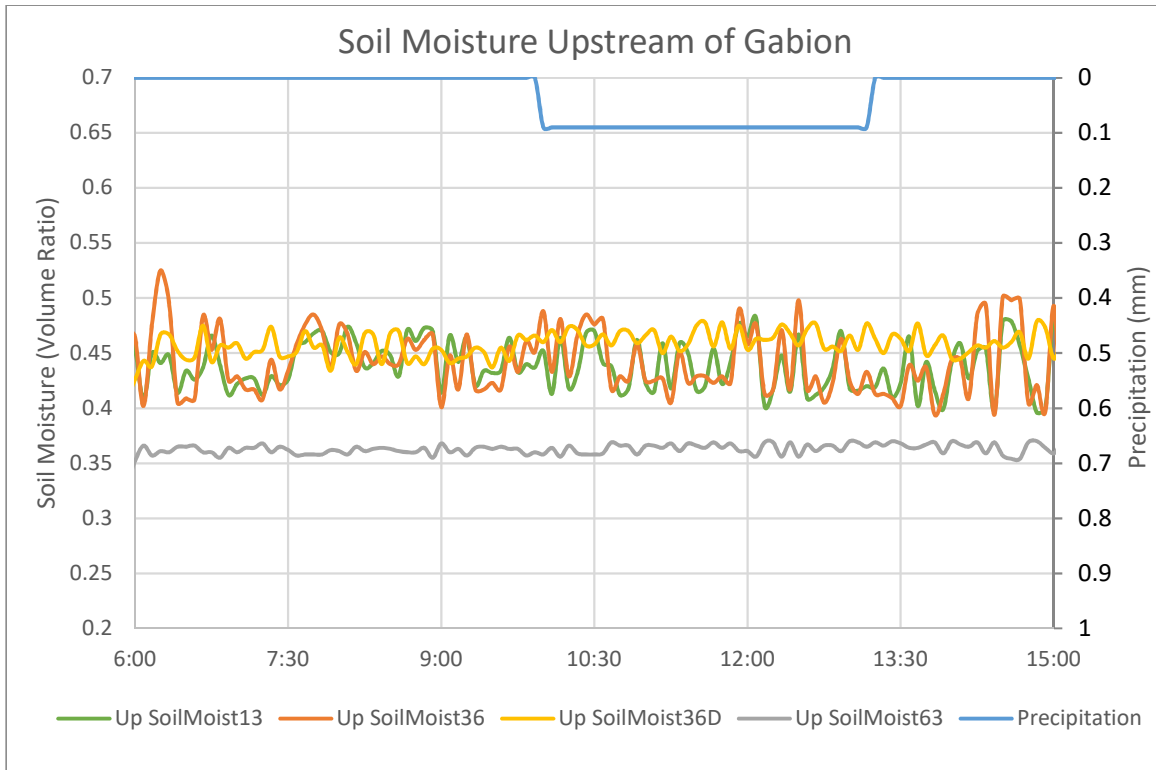
Figure A2-10: Soil Moisture Upstream of Gabion during SRT

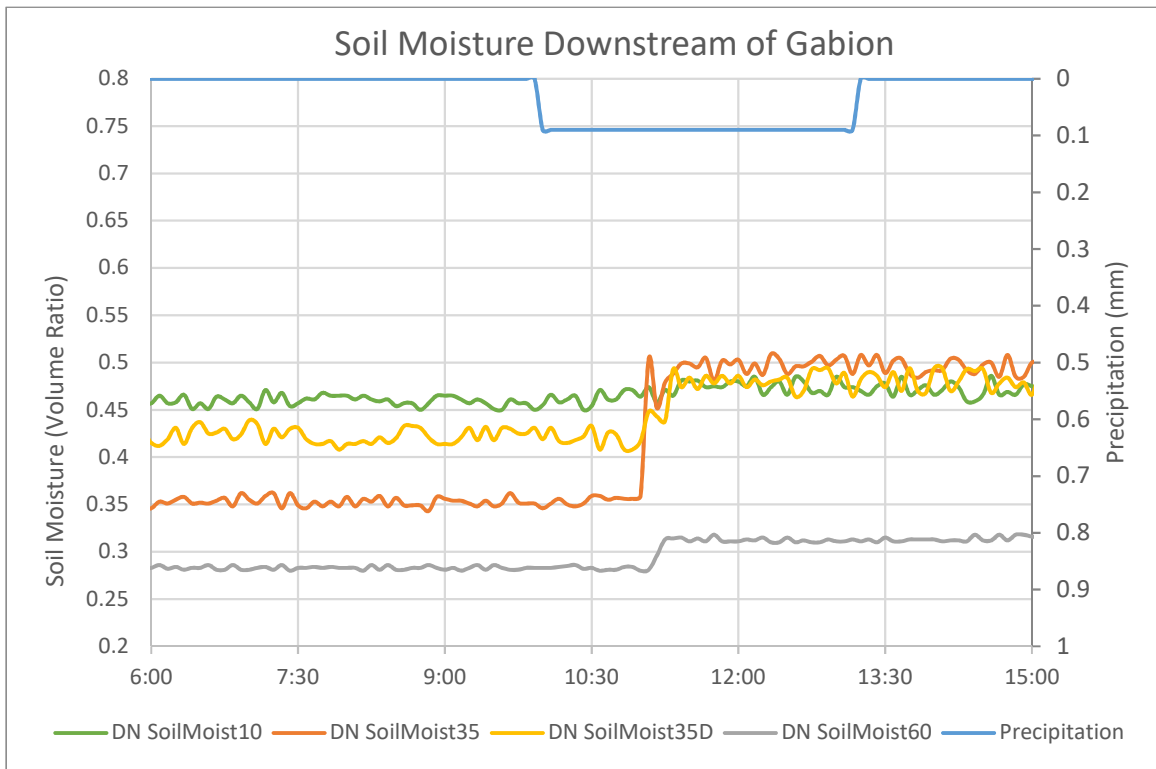
Figure A2-11: Soil Moisture Downstream of Gabion during SRT

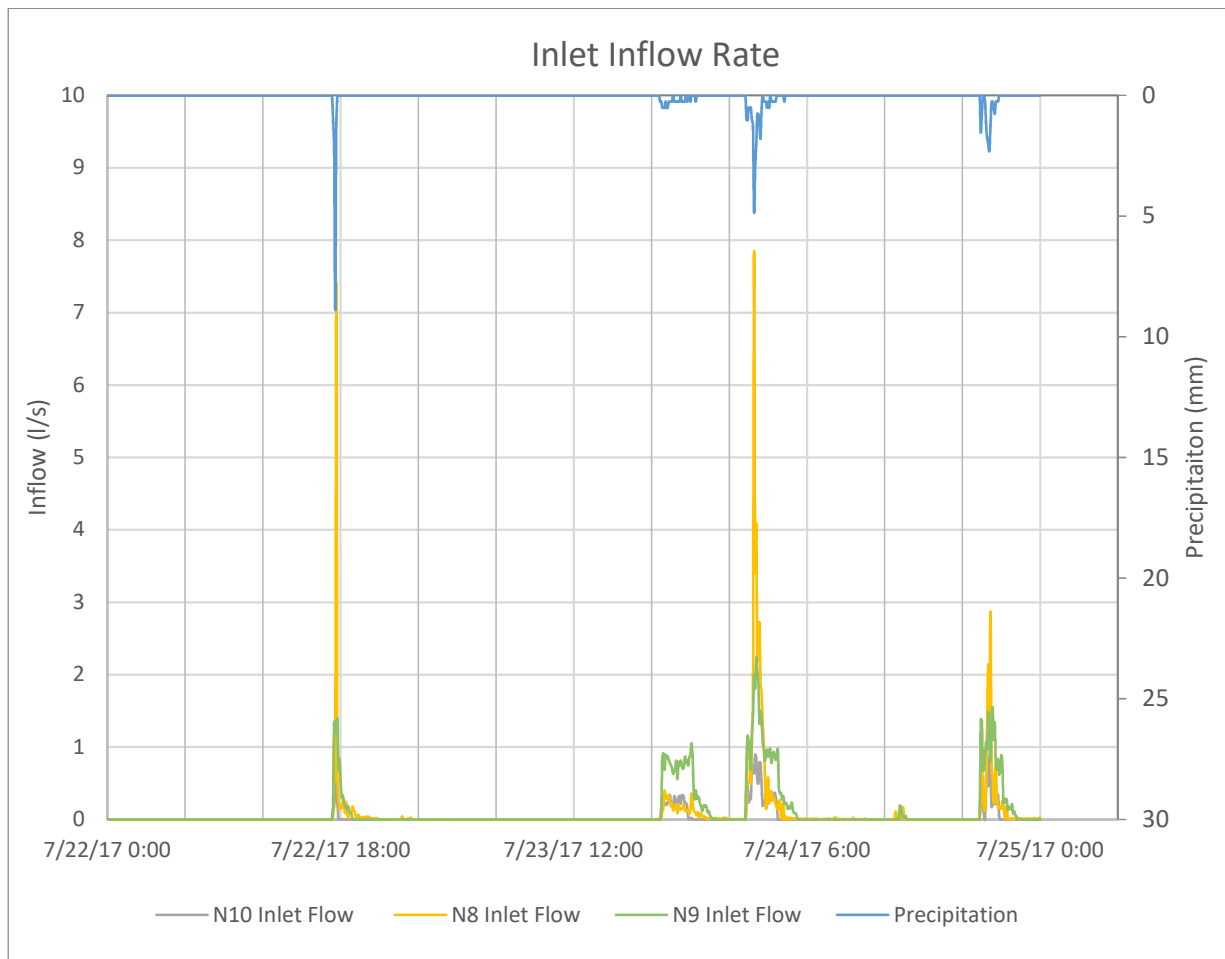
*Figure A2-12: 7/22-25/17 Inflow*

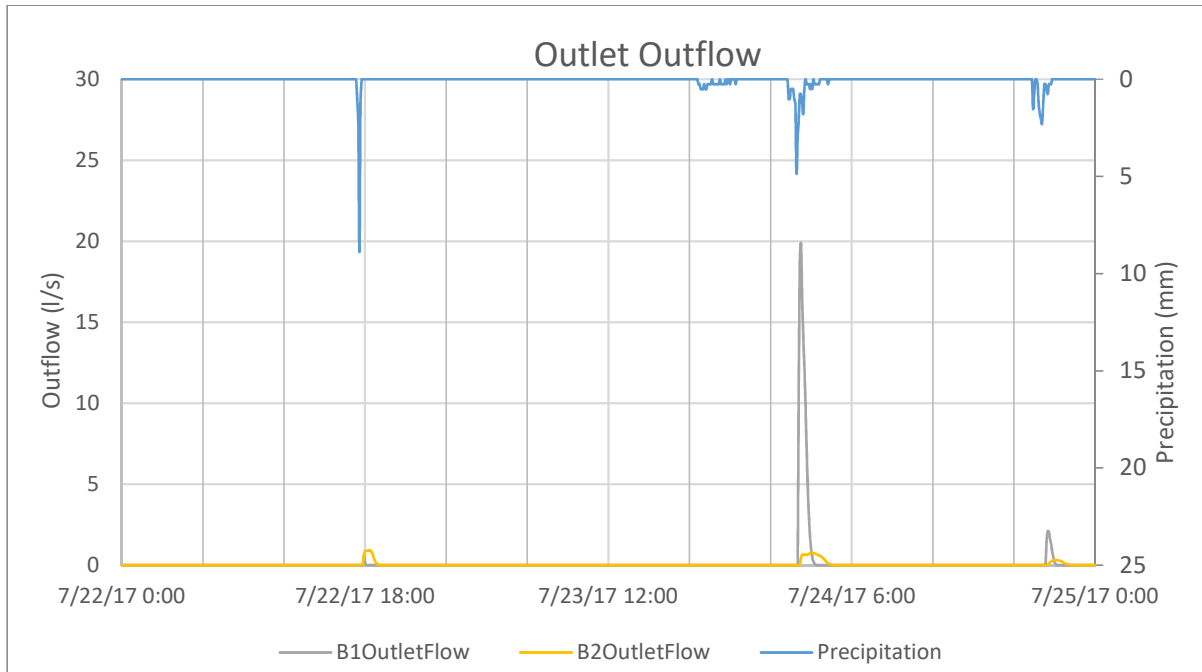
*Figure A2-5: 7/22-25/17 Outflow*
