## Storm Water Control Management & Monitoring

FINAL REPORT

By Laura Toran  
Temple University

## **Task 9: Final Report**

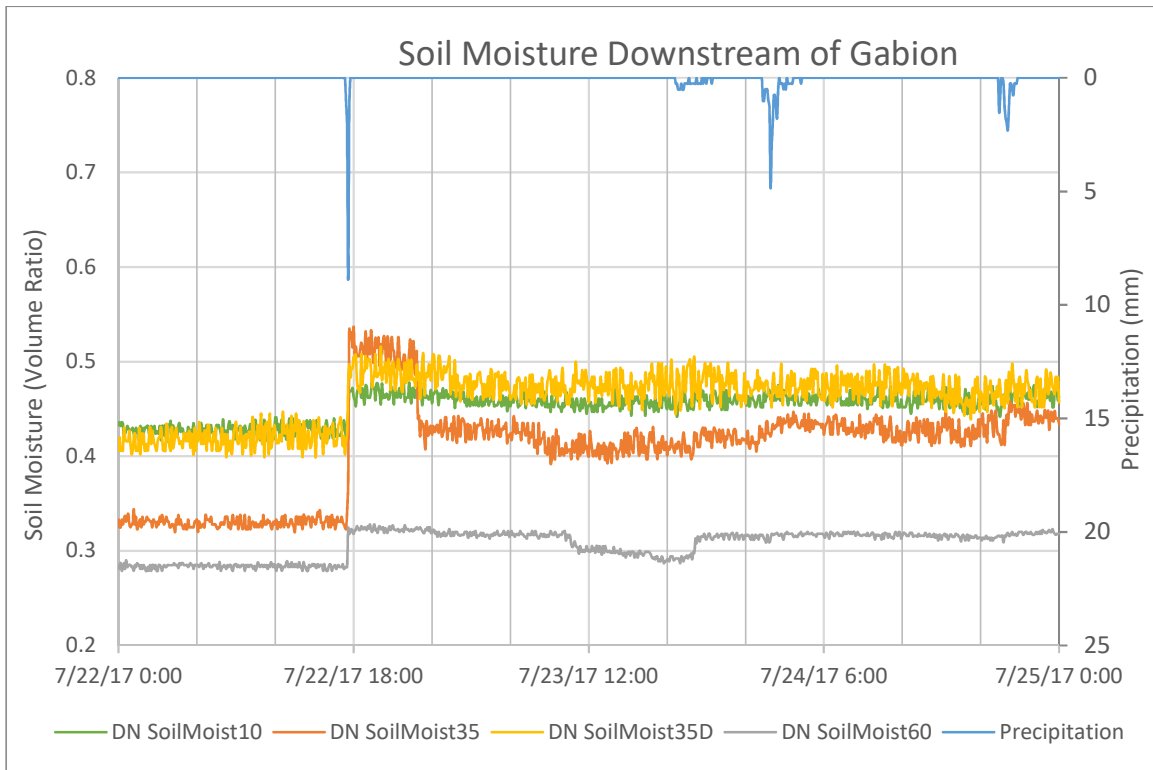
*Figure A2-6: 7/22-25 /17 Soil Moisture Downstream of Gabion*

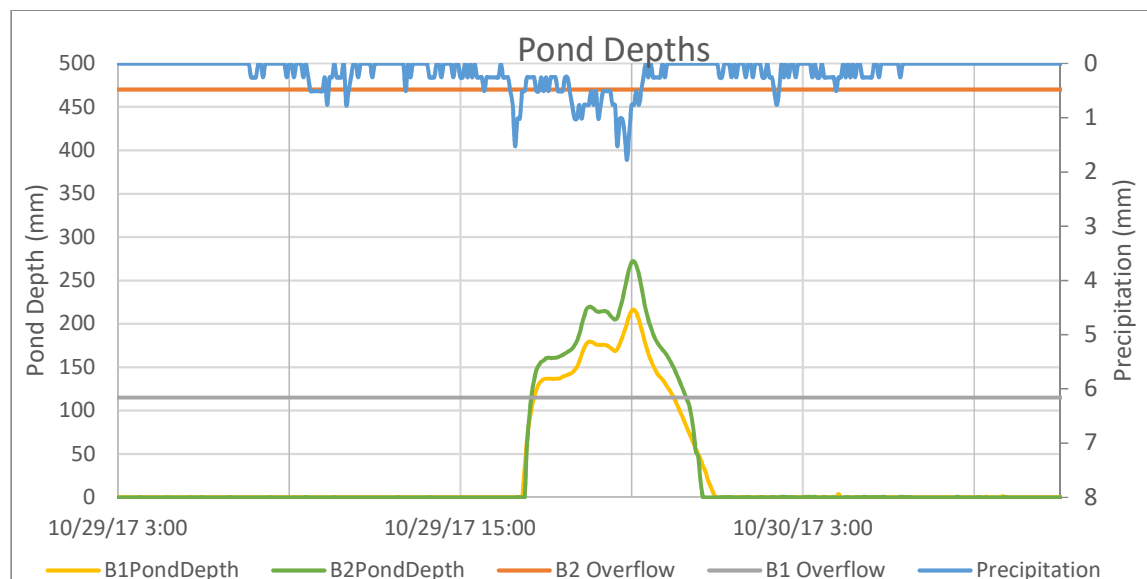
*Figure A2-16: 10/29/17 Pond Depths*

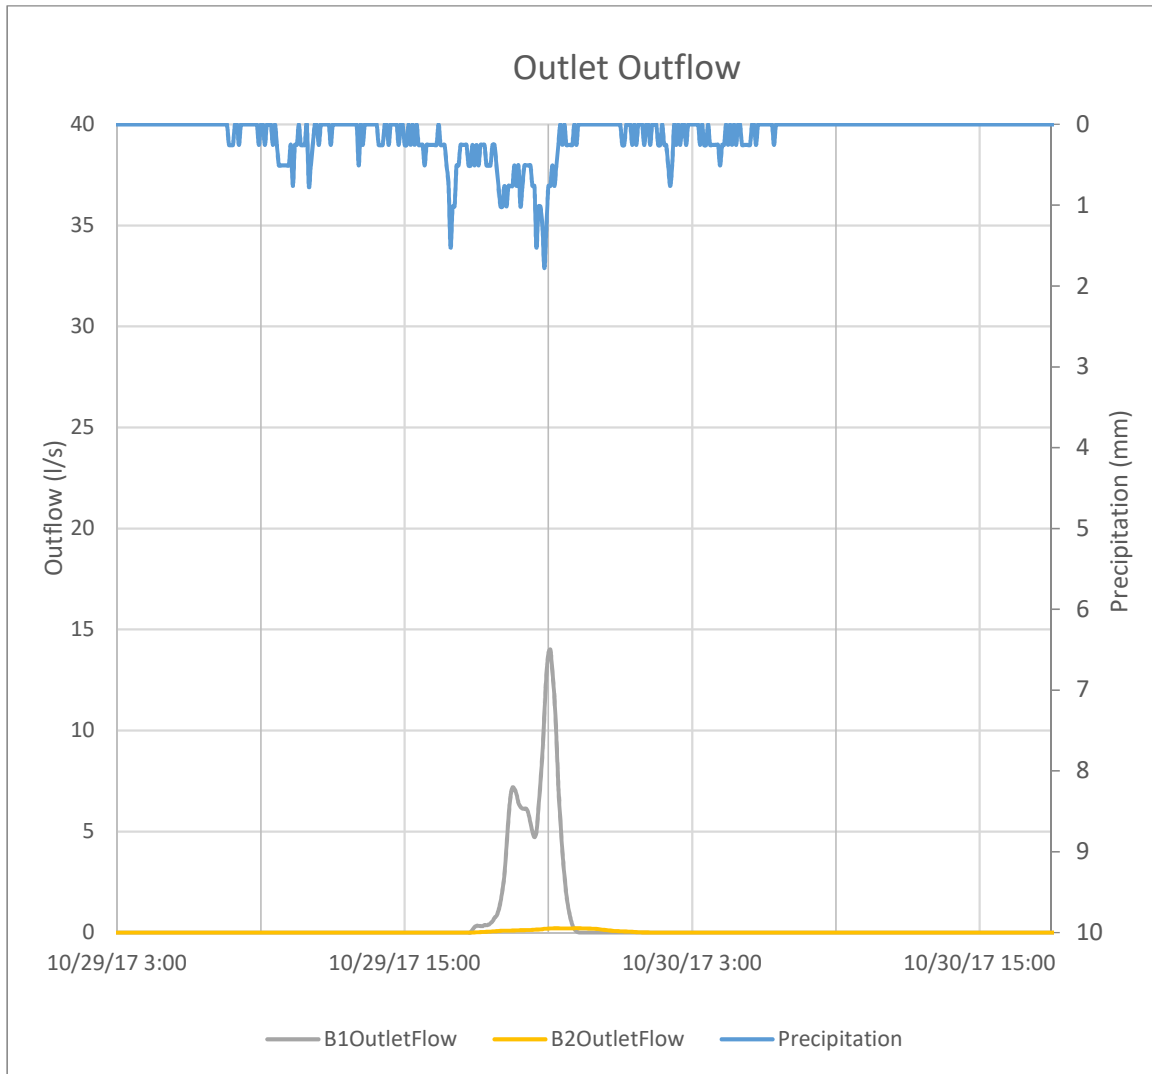
*Figure A2-7: 10/29/17 Outlet Outflows*

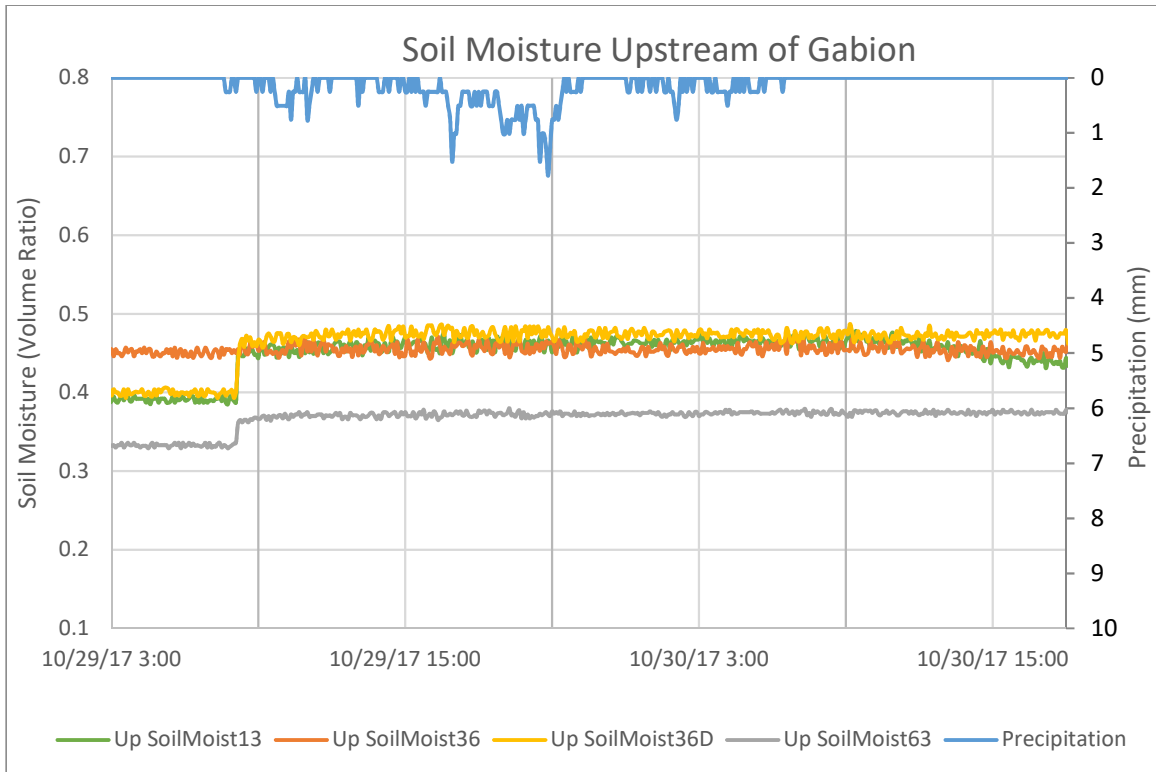
Figure A2-18: 10/29/17 Soil Moisture Upstream of Gabion

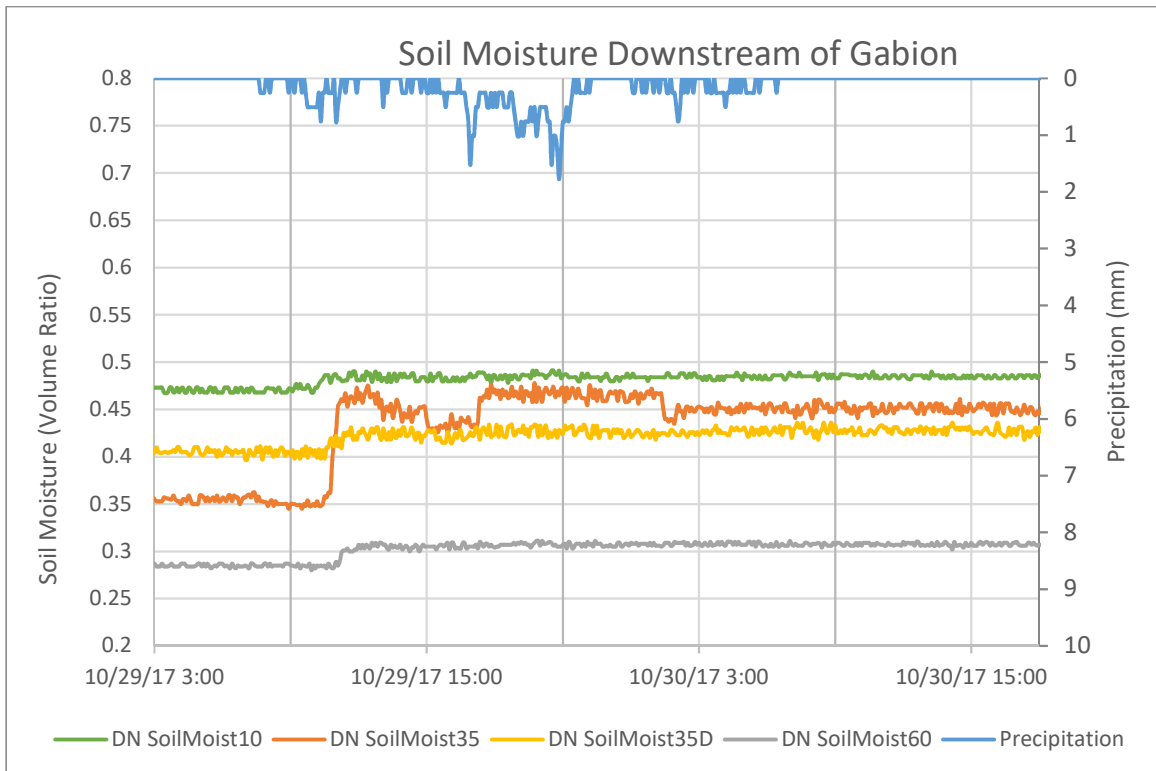
Figure A2-19: 10/29/17 Soil Moisture Downstream of Gabion
