GEORGIA DOT RESEARCH PROJECT 14-13

FINAL REPORT

**Evaluation of NCHRP 747 Pavement Forensic Guide
for GDOT's Adoption**

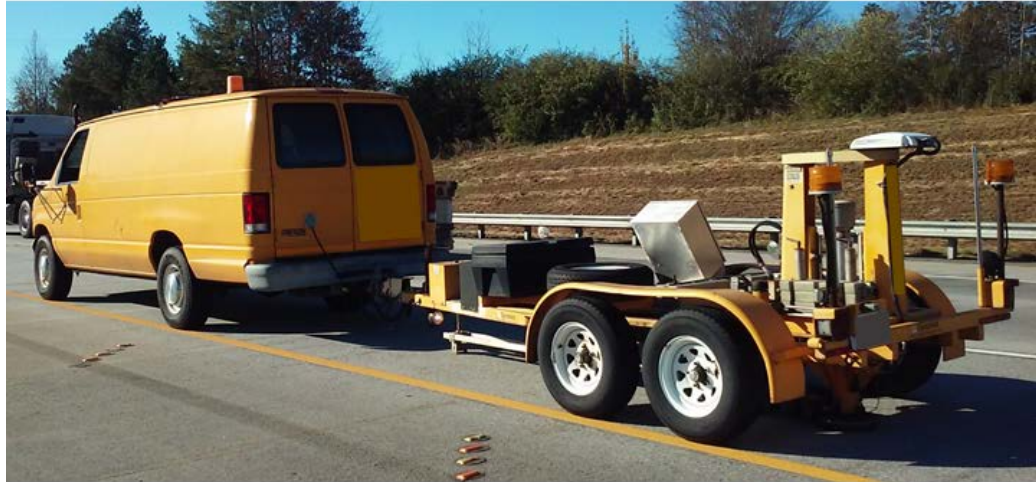
Figure 2 - Falling Weight Deflectometer

The need for non-destructive testing will usually be decided based on a visual assessment. A Falling Weight Deflectometer (FWD) is a device that applies a load to a pavement section and measures the resulting deflections (FHWA 2006). Figure 2 shows an image of the FWD harnessed to the back of a van. FWD equipment can quantify structural issues by means of measuring deflections. These deflections are measured in at least 7 locations along the test section using sensory instrumentation according to the American Society for Testing and Materials (ASTM), “Standard Test Method for Deflections with a Falling-Weight-Type Impulse Load Device” (ASTM-D4694, 2003). The standard gives instructions on conducting FWD tests to assess AC pavements and their respective parameters such as deflection, structural number, and elastic modulus, etc. (Bilodeau 2012). For site investigations, the FWD test is typically performed in one lane, unless there are thickness variations between lanes. The sections are then interpreted through software to give material properties and the pavement bearing capacity. Unfortunately, test location and temperature can influence FWD measurements and must be accounted for when calibrating the equipment. The Impulse Stiffness modulus (ISM) of the pavement sections is defined as the applied load (in kN) divided by the maximum deflection of the loading plate (in millimeter) (USDOT FAA 2011). Impulse Stiffness Modulus (ISM) plots display the stiffness over the length of the pavement, providing a simplified way to check for the overall strength of the pavement section.

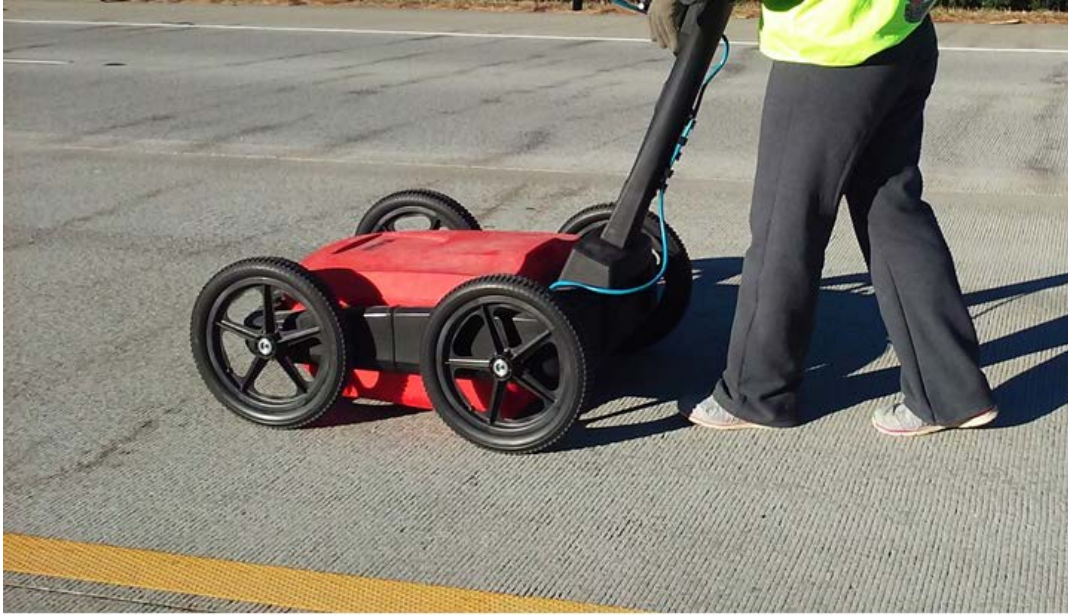
Figure 3 - Ground Penetration Radar

A Ground Penetration Radar (GPR) uses an antenna to send energy waves through pavement and monitors the surface reflection, or dielectric (ASTM-D6432 2011). A picture of a GPR is shown in Figure 3. The GPR rapidly and effectively analyzes layer thickness and detects problems such as “debonding, presence of moisture, voids under concrete slabs, and other issues that are normally assessed through coring” (Rada 2013; Zhao et al. 2016). This technology has been used by many DOTs to discover problematic areas in pavement. Using a GPR is very effective in detecting moderate to severe stripping in hot-mix asphalt (HMA) (Chen 2003). The GPR energy waves can penetrate approximately three feet (one meter) and can be operated at highway speeds, when attached to a vehicle, making it a useful addition to non-destructive testing technologies (Chen 2008). Unfortunately, the data results decrease in quality as the highway speeds increase, which may require road closures to receive accurate results. In addition, interpreting GPR data requires a technician with special training (Rada 2013). The GPR is wheeled over the pavement sections and the results are collected in the form of images that use colors to distinguish the variations of dielectric signals that differentiate material properties (Morey 1998). These images are then compared with core samples to verify pavement thickness.

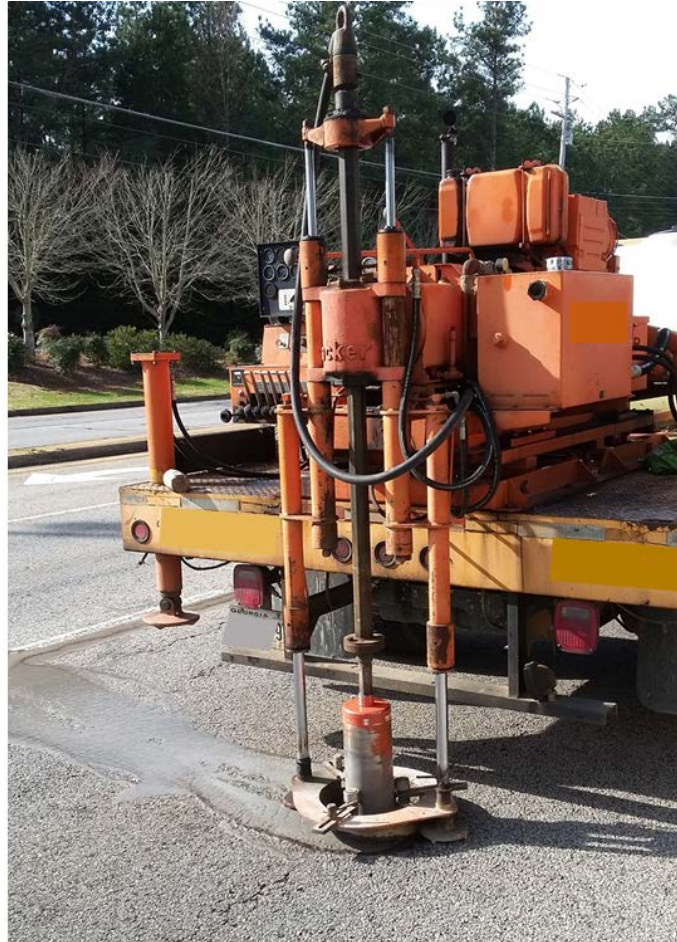
Figure 4 - Coring machine

Carbonation, and alternating current loop impedance” (Mallela 2006; Salgado and Yoon 2003). Air-void content, dynamic modulus test, Hamburg wheel track test, binder content, aggregate grading and properties, and resilient modulus are common for cores from flexible pavement. To address specific problems associated with pavement, state DOTs conduct many laboratory tests on freshly cored pavement samples.

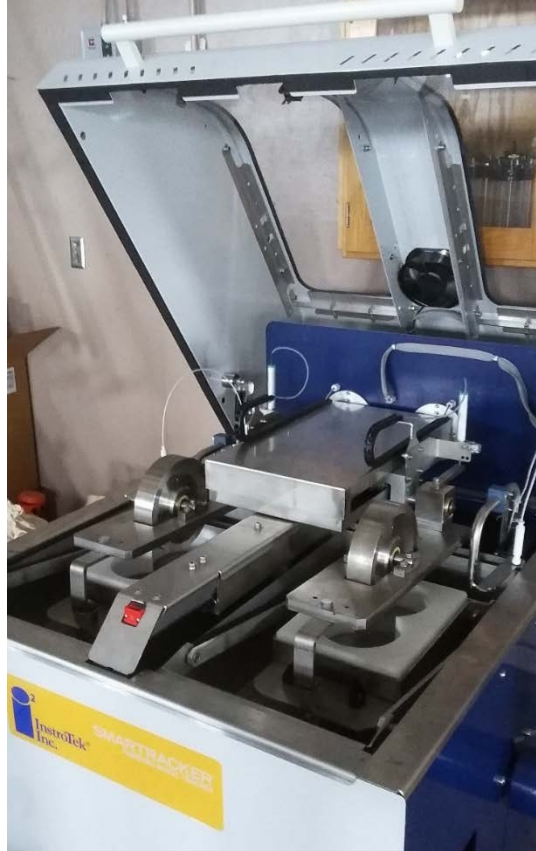
Figure 5 - Hamburg Wheel Tracking Machine at UGA

A Hamburg Wheel Tracking Test measures rutting and stripping in asphalt pavements by continuously rolling a steel wheel over the pavement surface (CDOT, 2014). During testing, the sample is submerged in 50°C water to evaluate moisture susceptibility. After testing, the rut depth of the sample is compared with the amount of wheel passes before failure (20,000 max). The result is used to determine the rate of pavement deformation, by approximating the stripping inflection point (SIP). The SIP is known as the point where “moisture damage starts to dominate performance” (FHWA, 2007). This value is formed by the intersection of the creep slope and the stripping slope. The creep slope refers to the slope of the graph before SIP, whereas the stripping slope is the slope after SIP has occurred (Izzo, 1999). A Hamburg Wheel Tracking Test machine can be viewed in Figure 5.

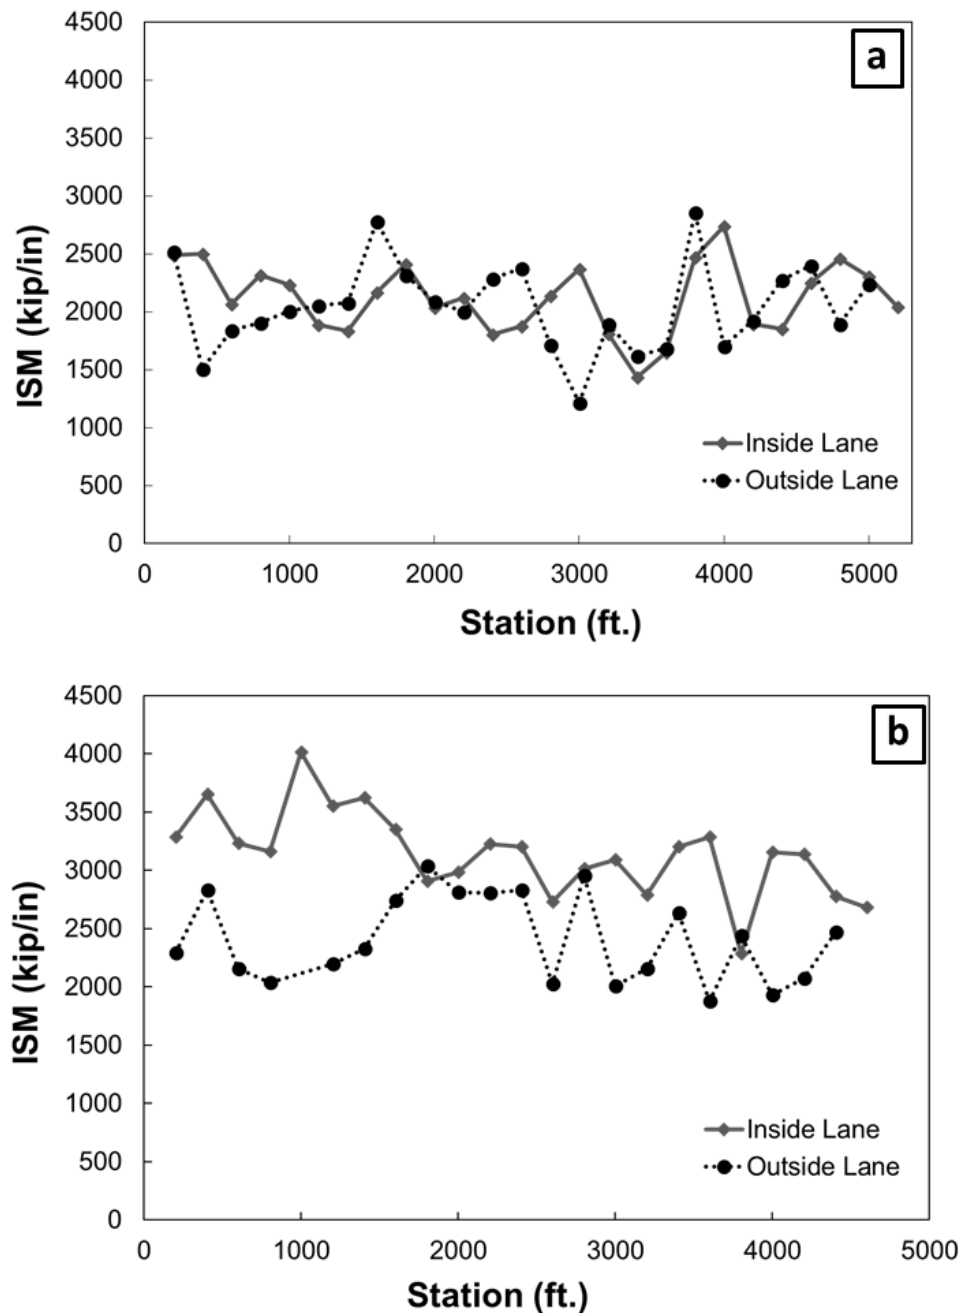
The ISM plots created from the FWD testing are shown in Figure 10. Compared to the ISM plot in SR-22, the ISM plot from I-75 shows a certain degree of variation along with distance, that might be interpreted as a construction variability. Using the FWD data, a modulus of subgrade reaction, k was back-calculated based on the 1993 AASHTO design guide (AASHTO, 1993) and is summarized in Table 7.

Figure 10 - Selected ISM Plots determined from FWD tests
(a) SR-22 (good condition); (b) I-75 (poor condition)

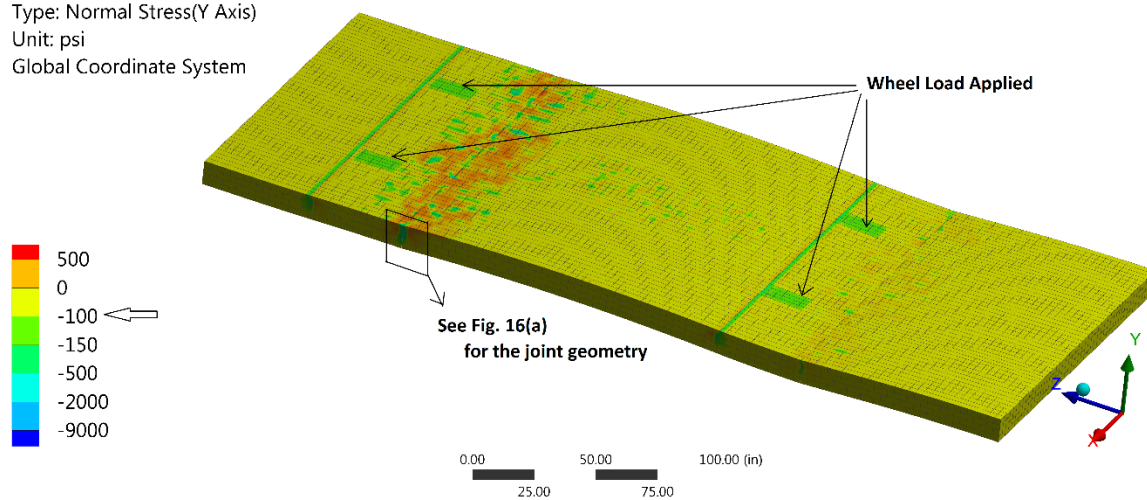
Based on the FEA analysis, it is ascertained that thermal deformation combined with structural deformation from the wheel loads causes longitudinal cracks at joints parallel to the centerline of the concrete slabs. The analysis did not account for the microcracks developed during the concrete placement, minor ASR damage in the concrete material, or an increased cover depth during construction found in the I-75 site investigations. The extent of cracking may have been exacerbated if these effects were taken into consideration in the material model. Many of these problems are not common in Georgia pavements, therefore these conclusions apply only to I-75. A full report of conclusions and recommendations can be viewed in Section 8 – Conclusions.

(a) Typical Joint Model

(b) Isometric view of the FEA analysis model under traffic loading

Figure 16 – Applied pressure and FEA strain results.
 (note: The deformation is magnified by a factor of 500).

(c) Principal strain plot of the middle slab under combined traffic and thermal loading

(d) Enlarged joint view

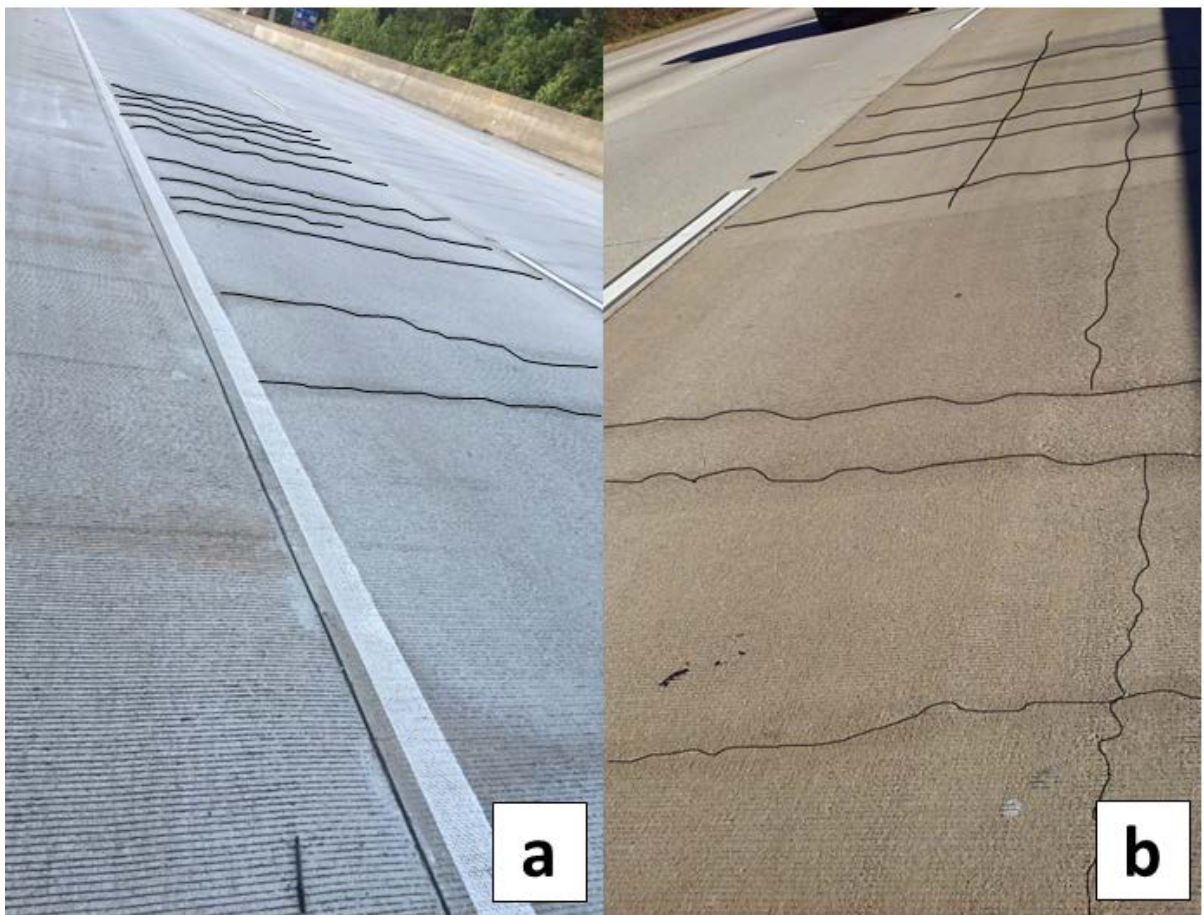
Figure 19 - Site Photos of CRC Pavement

The two sections used for this study are part of Interstate (I) 85 which runs through Coweta County, Georgia. The site that exhibits fair pavement performance is located between mileposts 45-44. The site showing poor performance is located between mileposts 55-54. A visual comparison of both sites is shown in Figure 18. Table 9 includes a comparison of site conditions and pavement profile/construction parameters in the two CRC sections. Currently, the PACES rating for CRCP is calculated based on the JPCP distress types (i.e., faulting), which is invalid for CRCP condition evaluations. Therefore, the CRCP PACES rating was not taken into the consideration for the site investigations. For the remainder of the CRCP section, I-85 milepost 45-44 will be referred to as MP 45 and I-85 milepost 55-54 will be referred to as MP 55.

. (a) I-85 MP 45-44 (Fair Condition) (b) I-85 MP 55-54 (Poor Condition).

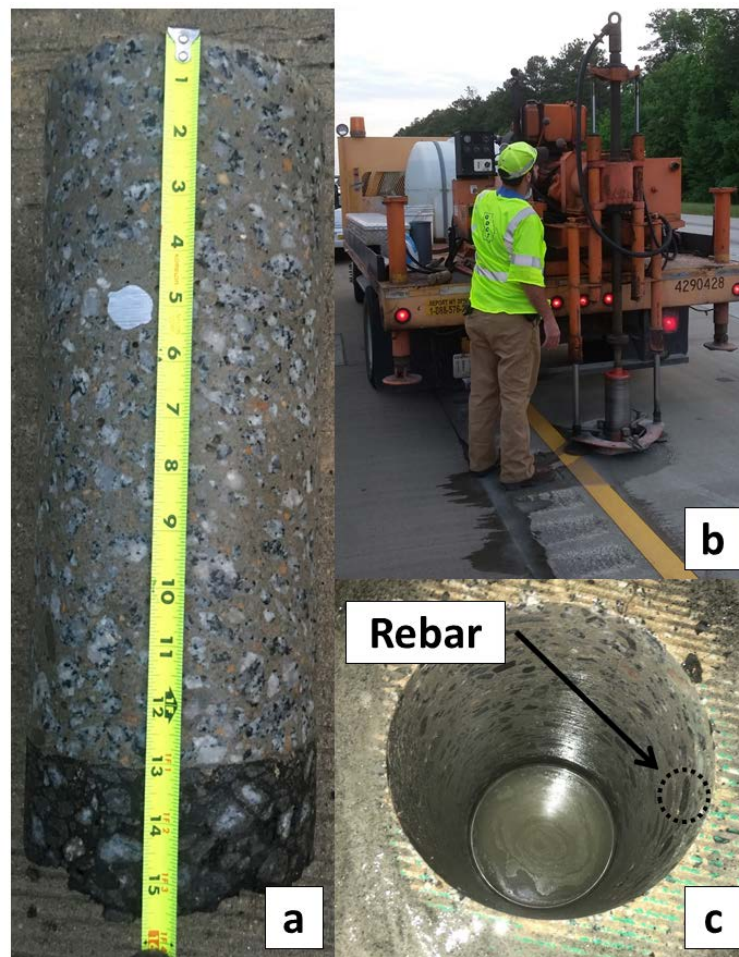
utilized to observe existing pavement thickness and reinforcement size & location. Based on the recommendations in Section 7.3 of the NCHRP 747 report, the cores were taken on the centerline of the slab, wheel paths in slow and fast lanes, and cracks to document the crack depth (Rada, 2013). Additionally, the coring locations for both sites were reviewed from the non-destructive test data and visual inspection information. The locations of cored specimens are shown in Figures 23 and 24 which provide a 3D schematic of the pavement section.

Figure 23 - Typical Cores at Rebar Locations, (a) Core sample; (b) Coring machine; (c) Inside view of a cored pavement.

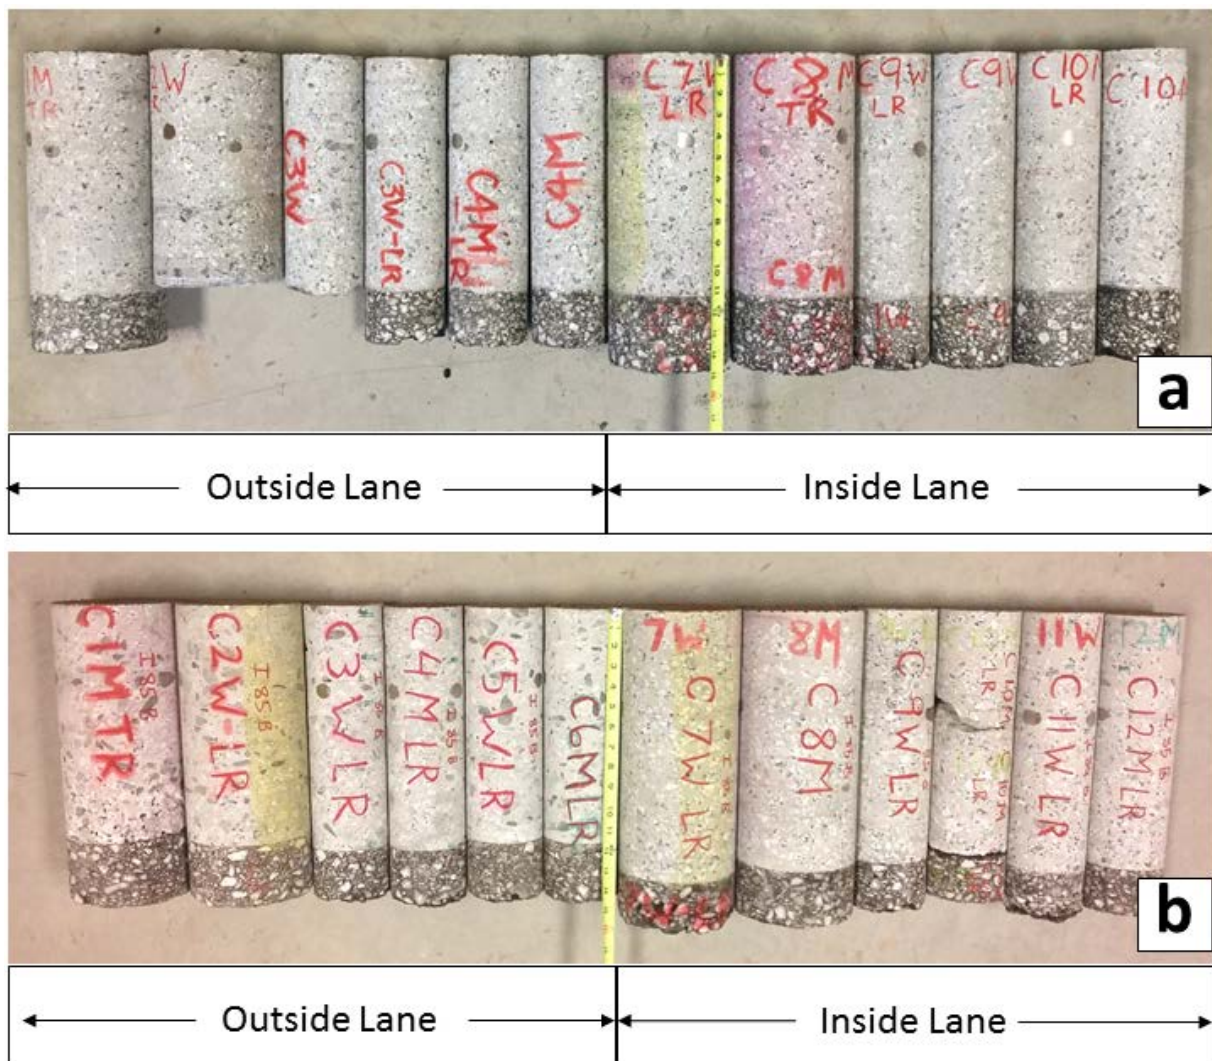
Figure 26 - All cores extracted

Photos of all cores extracted are shown in Figure 25. As seen in the Figure, the reinforcement depth varies by ± 0.5 inches. MP 45 shows relatively consistent consolidation with few voids. MP 55 has consolidation problems in the slow lane, more specifically, sample C1MTR. A visible difference can be seen when comparing the concrete from the outside and inside lanes from MP 55. More details on these two material differences are explained in section 5.6 -Petrographic Examination.

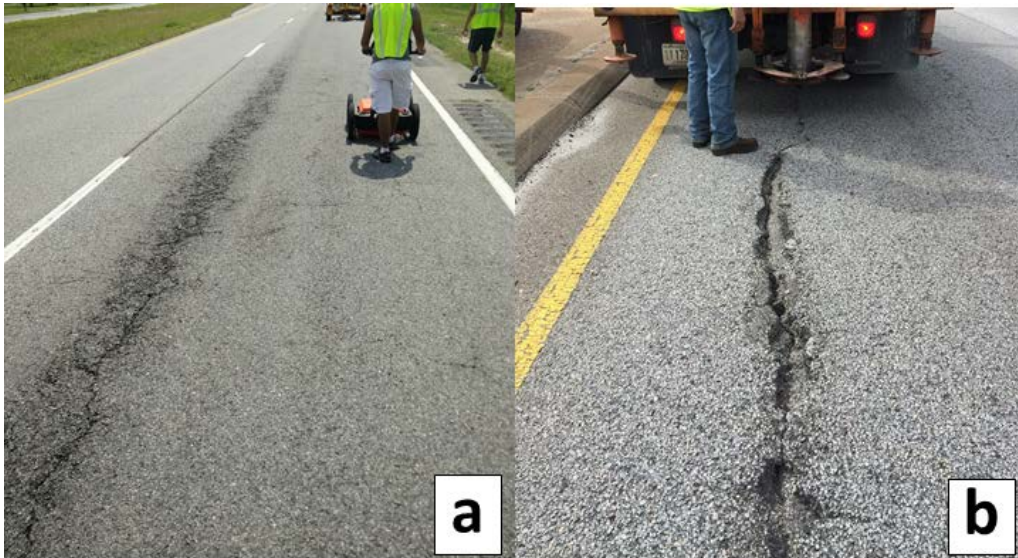
Figure 30 - Typical Distress
(a) SR-38 (b) SR-54

As previously mentioned, SR-38 exhibits moderate raveling and fatigue cracking on the left side of the outside lane (Figure 29(a)). Due to the unique location of longitudinal cracking, it is suspected that the distress may be initiated by reflective cracking and deteriorated further due to traffic. Observation of cored specimens from SR-38 confirms that cracking is reflected from soil cement. Reflective cracking is a common distress among pavements when a soil cement is used as the soil cement typically experiences shrinkage cracks, which is reflected upward to the pavement surface (Adaska, 2004).

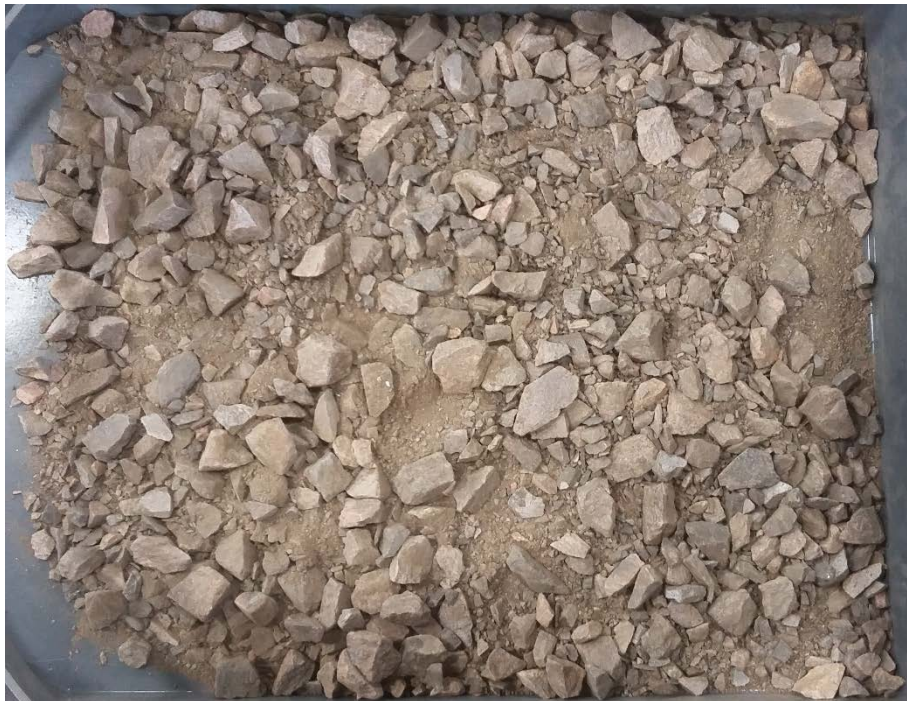
Figure 36 - Asphalt Sample after Ignition Burning

The surface course from SR-38 (sample C-2) contained a binder content of 5.1%, which is 17% higher than the binder content of SR 54 Sample C-2. The binder course has an average binder content of 5.96%, which is 28% higher than the binder content of SR 54 Sample C-2. SR 54 Sample C-2 and SR 38 Sample C-4 also have a differing binder content for their base course, with a 16% relative difference.
