Concrete Repair Best Practices: A Series of Case Studies

Prepared by:
Michael Darter, Ph.D., P.Eng.
Applied Research Associates, Inc.

1. Report No. cmr 17-013	2. Government Accession No.		3. Recipient's Catalog No.	
4. Title and Subtitle Concrete Repair Best Practices: A Series of Case Studies		5. Report Date Originally prepared June 2017 to September 2017 Published: November 2017

This report is a compilation of six individual case studies on different repair methods. In addition, a technical brief has also been prepared for each case study. They have been separately published (see list below).

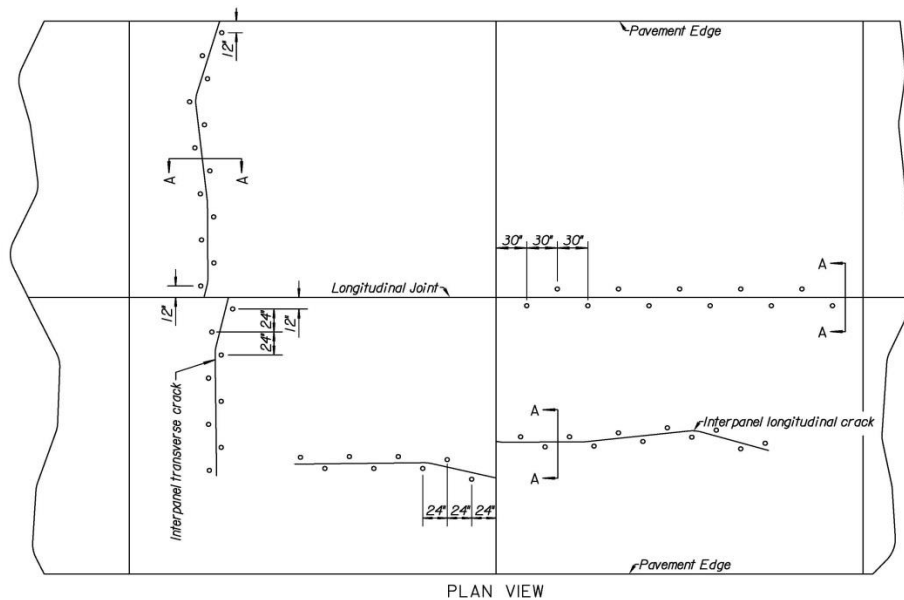
Figure 1. Kansas DOT, concrete pavement details, cross-stitching of joints and cracks.

The Kansas cross-stitching design is specified in Kansas DOT “Concrete Pavement Details, Tiebar Insertion RD723” (see Figure 1 and Figure 2). Holes are drilled on alternating sides of joint or crack at the following spacing:

Figure 1 shows a diagram of the Kansas cross-stitch specification standard for different joints and cracks, as summarized above. Figure 2 shows a diagram of the actual cross-stitching bar with various dimensions. Note that the goal is to place the tie bars at mid-depth of the slab.

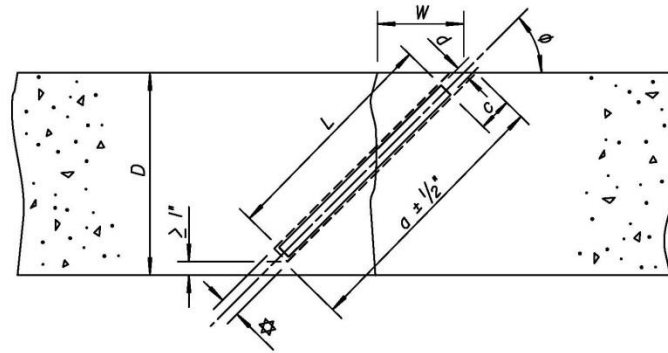
SECTION A-A
TIE BAR INSERTION DETAILS

☆ Drill diameter will be not less than $\frac{1}{4}$ " larger than the tie bar diameter and no more than $\frac{3}{8}$ " larger than the tie bar diameter.

Note that all of the dimensions depend on slab thickness. Thus, it is important to determine the slab thickness, as this will directly affect the length of the rebar required in the hole, the angle with the horizontal and other dimensions. This is an interesting rebar design specification in that it provides increased reinforcement to help ensure that the most critical crack/joint is held tightly together, providing strong reinforcement to maintain a very tight joint or crack and even good load transfer under heavy truck wheels.

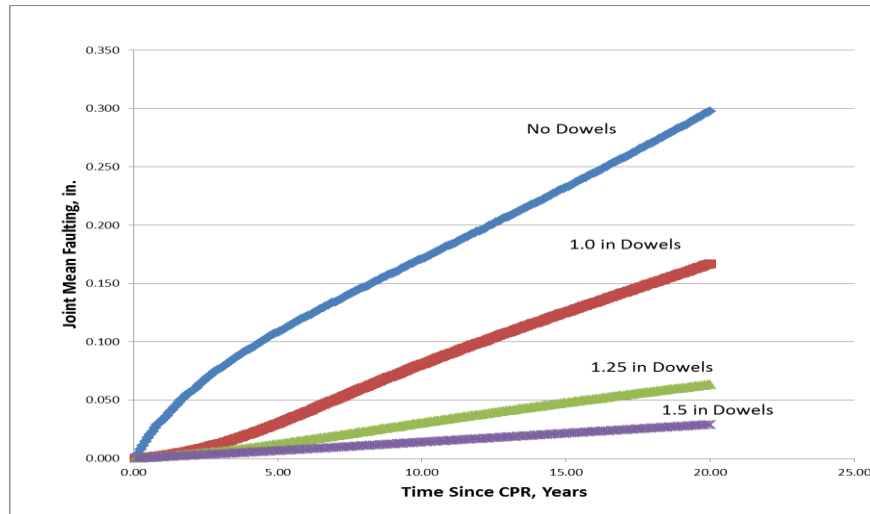
Figure 3. AASHTOWare Pavement ME Design example output for a JPCP CPR grinding project, with and without DBR.

One tool that is now available to predict future joint faulting after an existing JPCP has been diamond ground is the AASHTOWare Pavement ME Design software. The “Restoration” pavement type must be chosen and the required data entered to run the program to estimate mean joint faulting over the next 10 to 20 years. Figure 3 shows the projected joint faulting for a JPCP over a future 20 years, both with and without DBR of varying diameters. This is a valuable tool to provide another estimate of what will happen if no dowels are installed versus a full DBR installation with varying diameters. Figure 3 shows the potential for extra life until critical faulting is reached. Note the impact of dowel diameter on mean joint faulting, which is due to lower dowel/concrete bearing stress under load. The Pavement ME Design software also calculates slab fatigue transverse cracking and IRI, given the after-grind slab thickness.

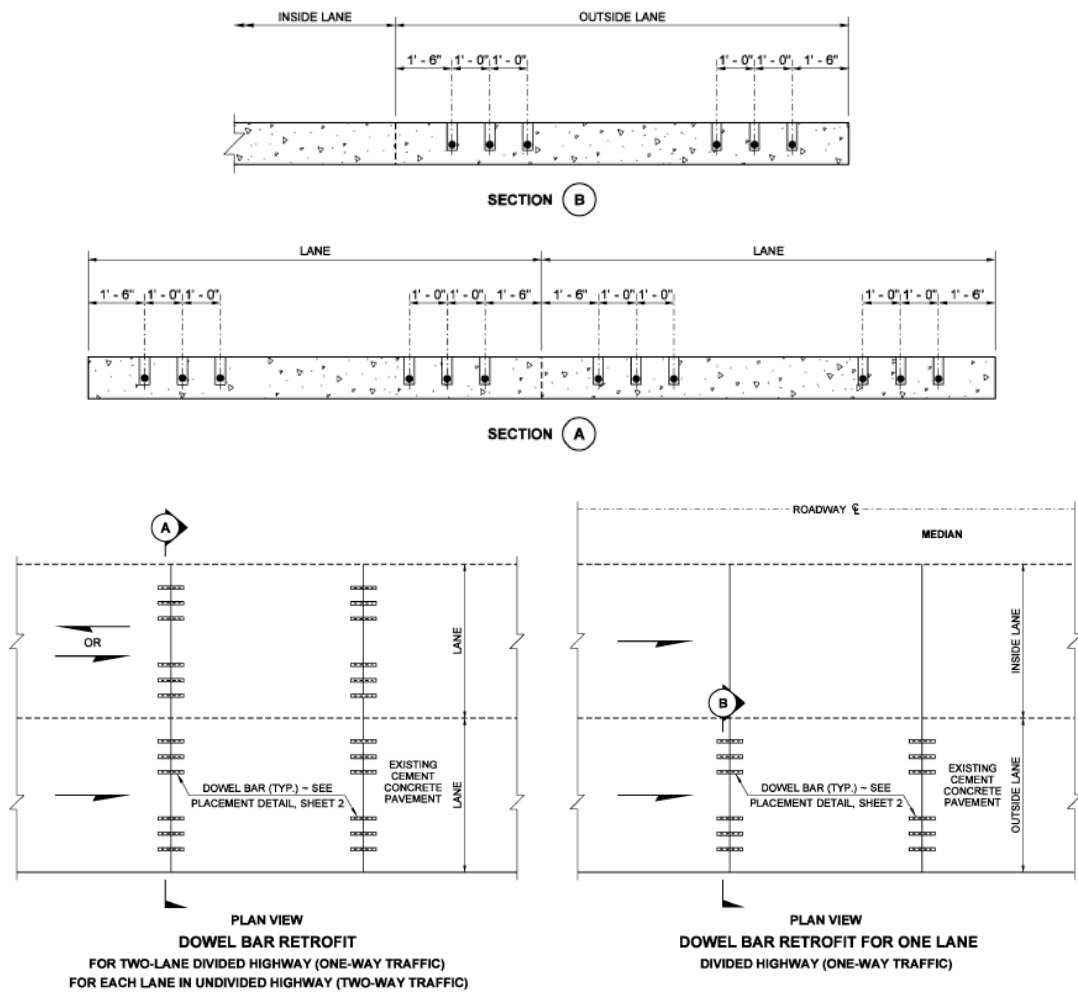
Figure 4. Washington State DOT DBR design and plan layout diagram for perpendicular joints. (Washington State DOT Standard Plan for DBR, A-60.20-03)

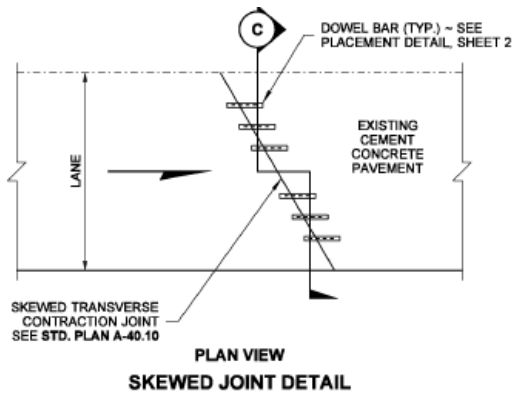
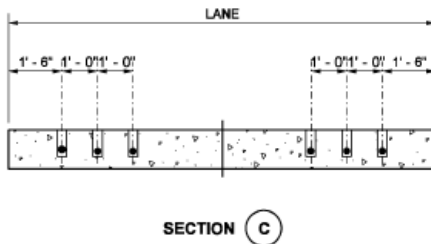
Figure 5. Washington State DOT DBR design and layout diagram for skewed joints.
(Washington State DOT Standard Plan for DBR, A-60.20-03)

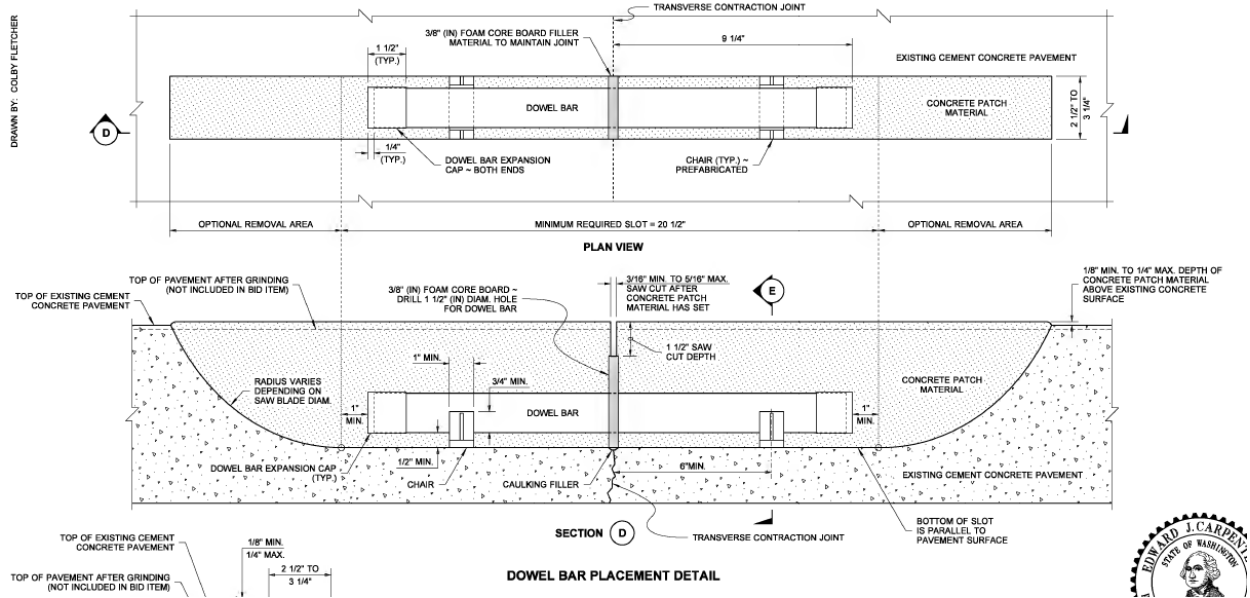
Figure 6. Washington State DOT DBR placement detail.
(Washington State DOT Standard Plan for DBR, A-60.20-03)

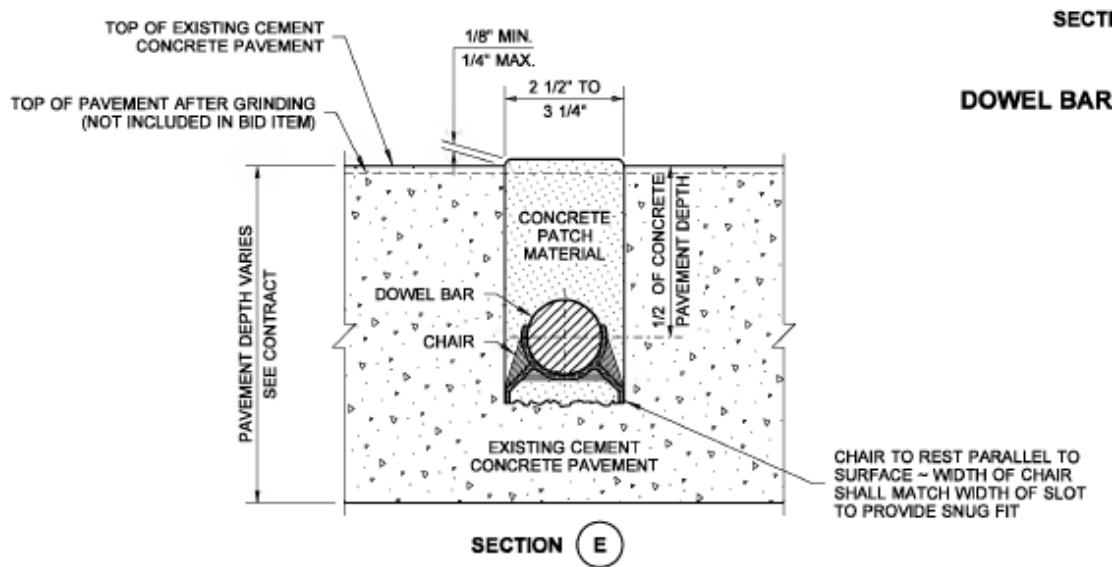
Figure 7. Washington State DOT DBR cross-section layout diagram.
 (Washington State DOT Standard Plan for DBR, A-60.20-03)

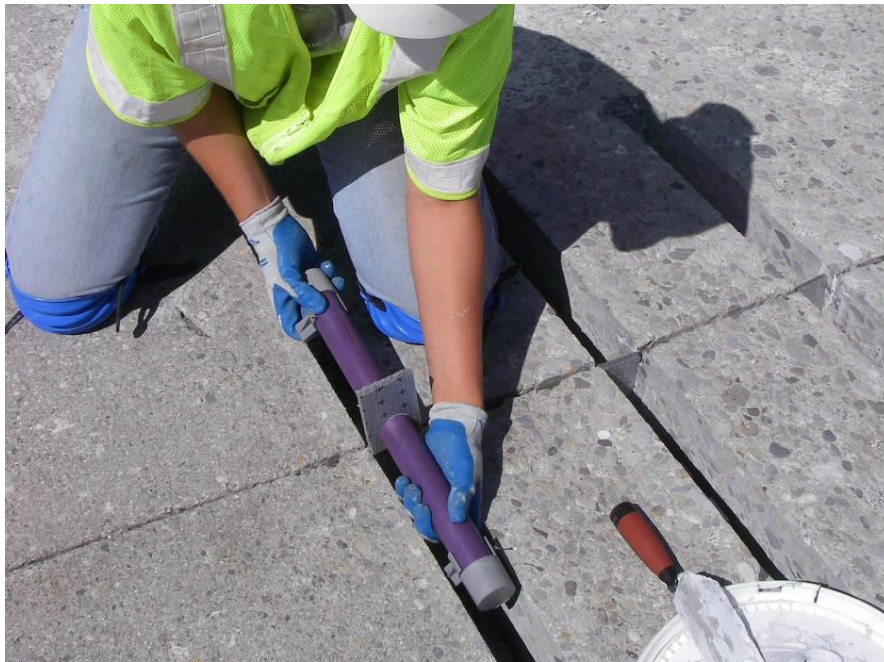
Figure 8. Inserting dowel bar assembly into slot. (Photo Courtesy of Jeff Uhlmeier, WSDOT)

The lubricated dowel bar assembly is placed into the slot as shown in Figure 8. The assembly is placed in the center of the slot. Other States utilize a very similar approach to that of Washington.

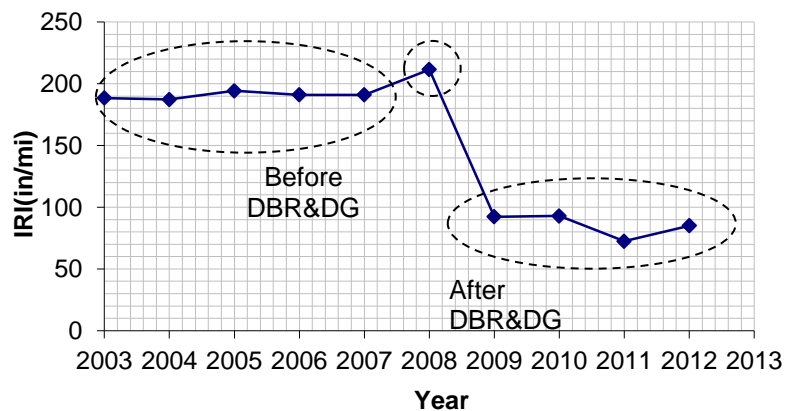
Figure 9. Texas US 69 JPCP diamond grinding (52% reduction).

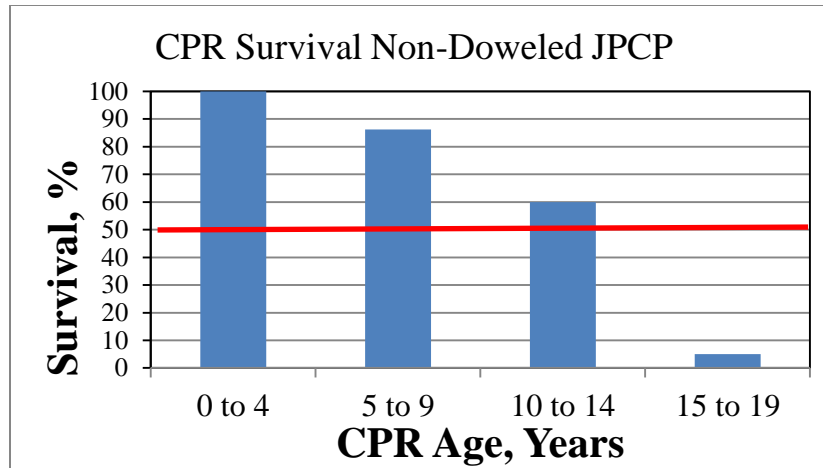
Figure 10. Survival analysis of diamond grinding of Utah non-doweled JPCP.

Figure 10 shows the results of a survival analysis of 60 diamond ground largely non-doweled JPCP (about 10 had received DBR). At 10 to 14 years, 60 percent of these diamond ground JPCP had received no CPR, overlays, or reconstruction, but from 15 to 19 years nearly all had received CPR, overlays, or reconstruction. Thus, the 50th percentile CPR survival age is approximately 15 years for these non-doweled JPCP. The faulting of these DBR projects is significantly lower, and they are expected to have a much longer life than those without dowel bars because faulting has not returned.

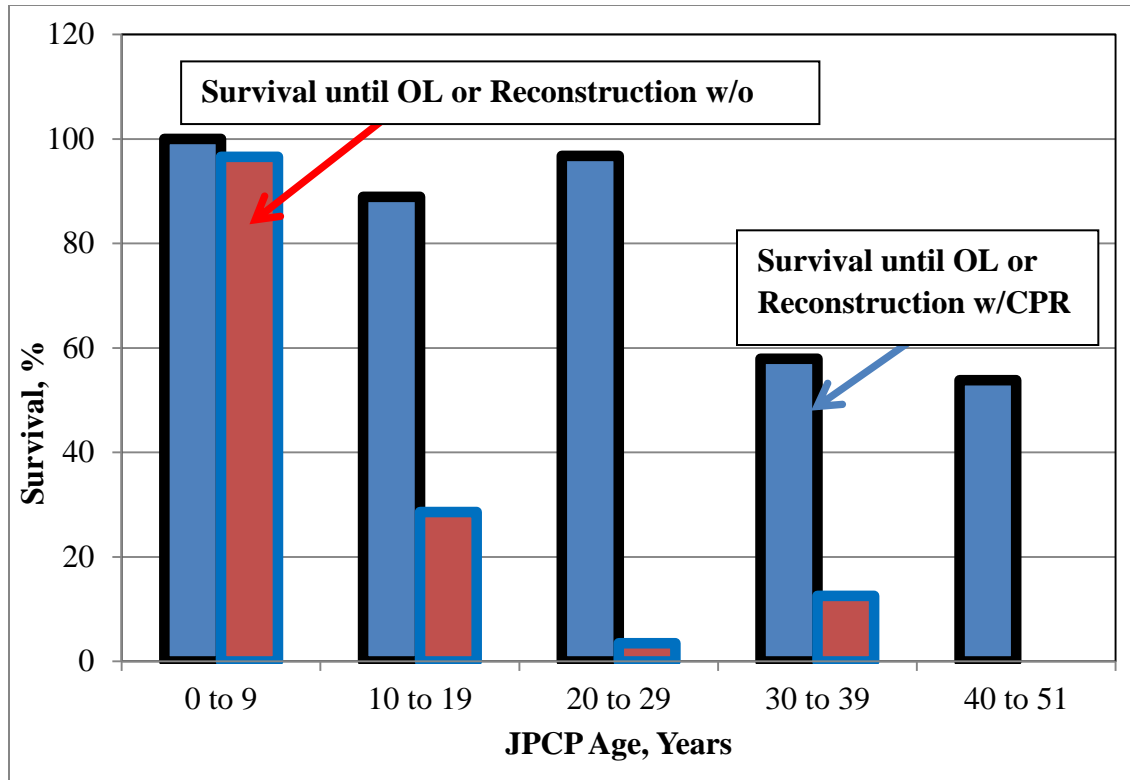
Figure 11. Comparison of service life of non-doweled JPCP with and without CPR in Utah.

What about life extension of these non-doweled JPCP beyond their 20-year design life? Analysis results of all 108 JPCP projects in Utah are shown in Figure 11. Two sets survival results are illustrated:

These results show that the service life of non-doweled JPCP (until an overlay or reconstruction) can be more than doubled by applying CPR including diamond grinding as needed. Diamond grinding has thus been an effective preservation treatment in Utah. Note also that, in terms of meeting the 20-year design life of these JPCP, the timely application of CPR with diamond grinding made it possible for over 95 percent of these projects to achieve the 20-year design life.

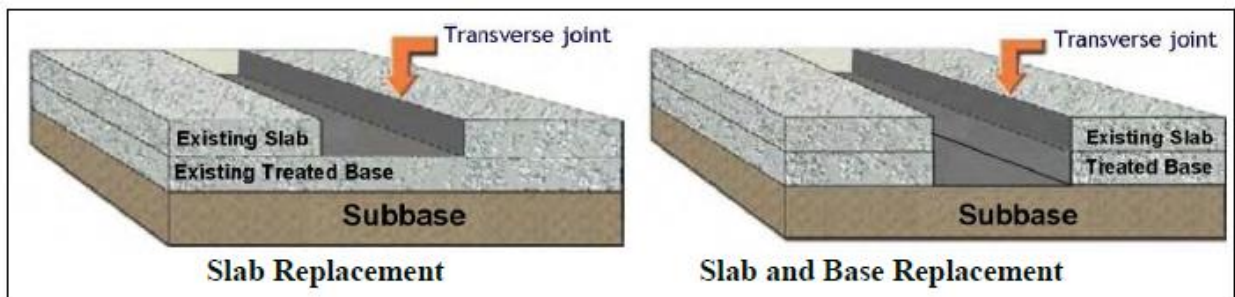
Figure 12. Slab and base replacement. (Caltrans Concrete Pavement Guide, 2015)

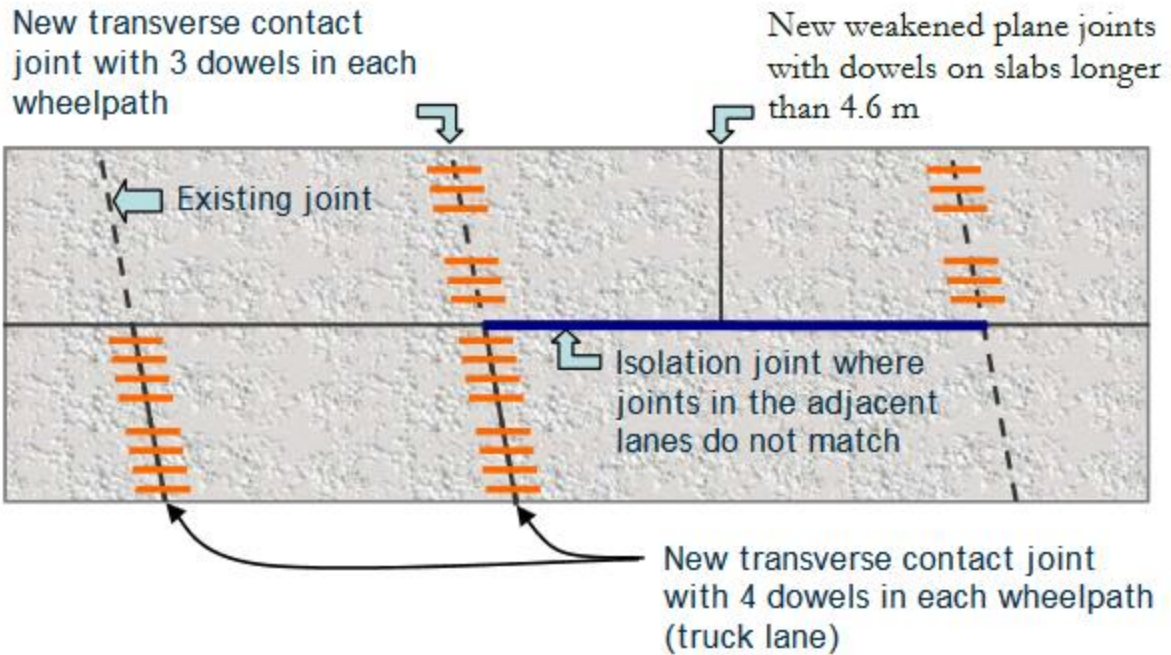
Figure 13. Plan showing number of dowel bars per joint in California. (Caltrans Slab Replacement Guidelines, 2004). Note that perpendicular joints are used with dowels.

California. Standard Specifications 2015 Section 41-9.01C (3), Revised Standard Plan: RSP P10 and P8. For non-truck lane, three dowels per wheel path are used, and for truck lane, four dowels per wheel path are used. Dowels are spaced at 12 inches. For slab thickness ≤ 9 inch, 1.25-inch dowel diameter is used, and for slab thickness ≥ 9 inch, 1.5-inch dowel diameter is used. The minimum FDR length is 6 feet, and the lane width is 12 feet. Figure 13, Figure 14, and Figure 15 provide plan and layout of FDR with dowel bar retrofit. Note the isolation longitudinal joint where transverse joints in the adjacent lane do not match to avoid reflection cracking. Half lane widths are not allowed due to instability of the FDR under loading. Maximum length is 15 ft.

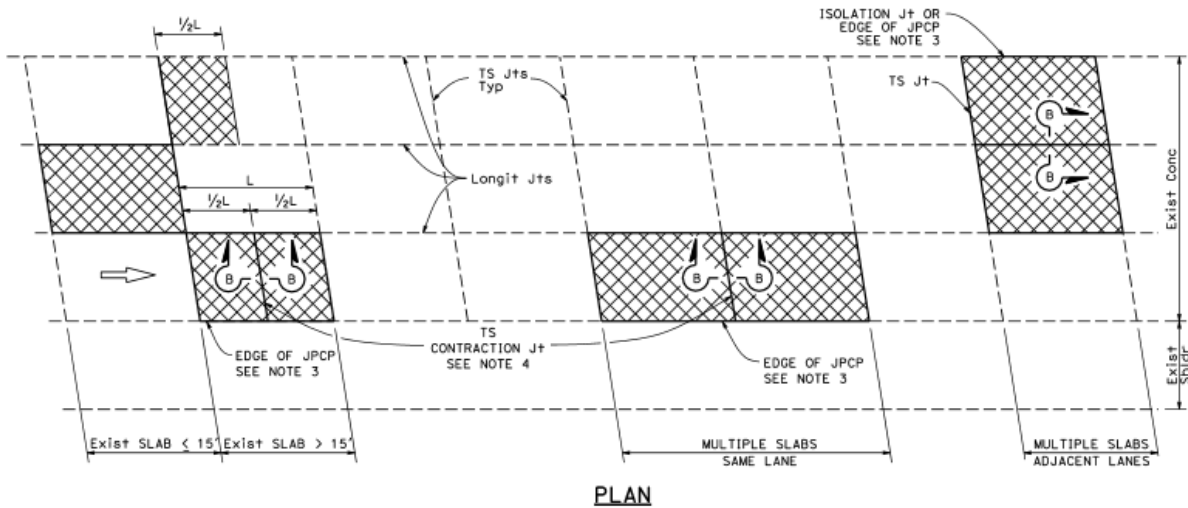
Figure 14. Plan showing individual slab replacement in California. (Caltrans Standard Plans, P8, 2015). Note that perpendicular joints are used with dowels.

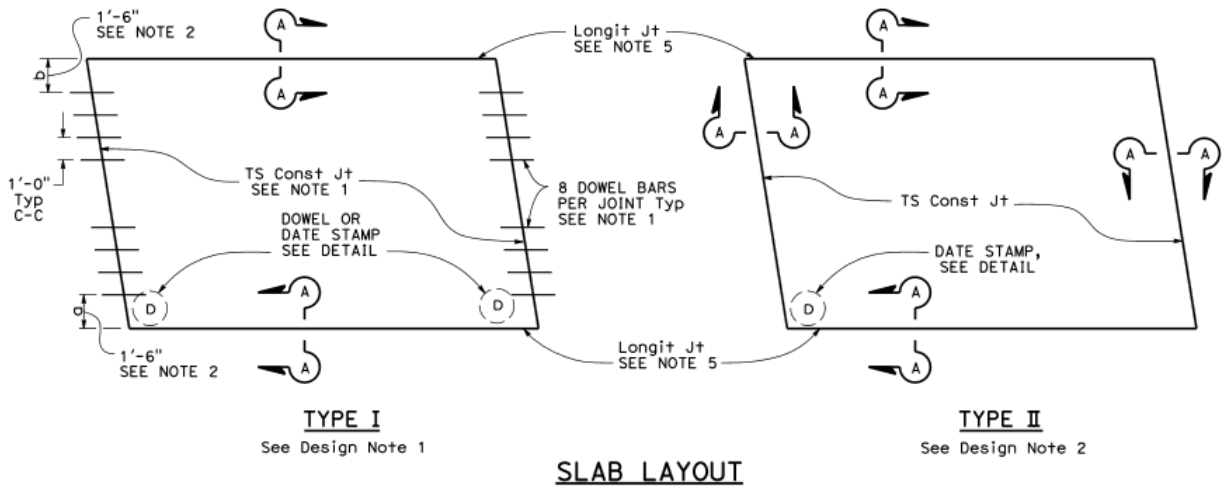
1. For concrete slab repair with > 5 years design life.
2. For short term repairs with 5 yrs or less design life or for slab replacements with cracking and seating.

Figure 15. Slab layout showing individual slab replacement with number of dowels per joint in California. (Caltrans Standard Plans, P8, 2015). Note that perpendicular joints are used with dowels.

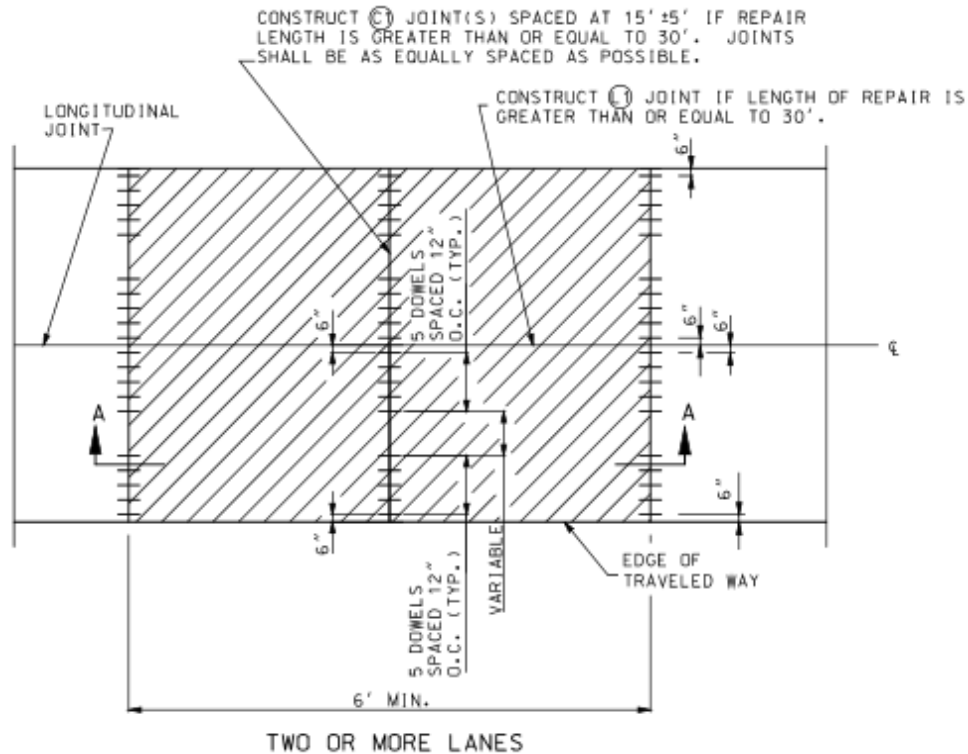
Figure 16. Plan showing number of dowel bars per joint in Missouri. (MoDOT Standard Plans, 2017)

Missouri. Five dowels per wheel path, 12-inch spacing, and a 1.0-inch dowel diameter are specified. The minimum FDR length is 6 feet and the width is 12 feet. FDR of JRCP is typically done at transverse joints and at transverse deteriorated cracks that are the weak points in JRCP design. Both of these areas can be fully repaired with an FDR. Figure 16 shows plan and profile layout for JRCP in Missouri. Repair lengths ≤ 30 feet are not tied to the adjacent lane. Note the transverse joints spacing requirements (15 ft \pm 5 ft) if repair length is ≥ 30 ft.

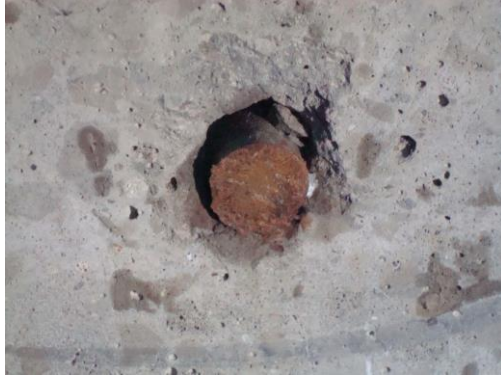
Figure 17. Poor anchoring of dowel into hole that resulted in faulting of the transverse FDR joint. (Photo Courtesy of Mark Snyder)

Anchoring of the dowel bars into the existing slab is the critical construction step for FDR. If this is not done adequately, the dowels will eventually become loose, the FDR joint will lose joint LTE, and pumping and faulting will develop along with cracking and settlements. Figure 17 and Figure 18 show one of many poor anchoring examples, where the grout or epoxy material was not properly surrounding the dowel bar and the continual pounding of loads has completely eroded it away.

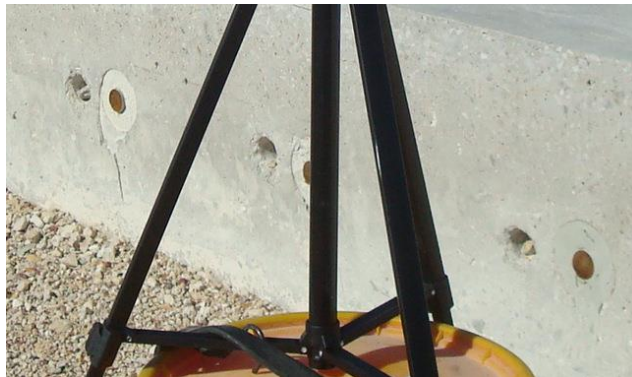
Figure 18. Use of grout retention disks provides good coverage. (Photo Courtesy of Mark Snyder)

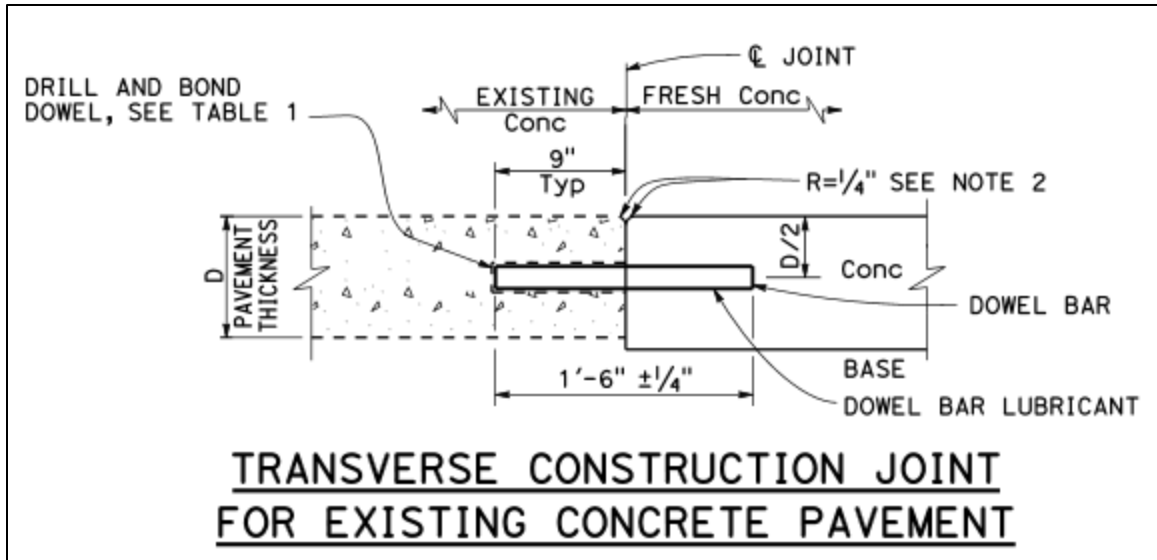
Figure 19. Dowel bar anchoring in California. (Caltrans Standard Plans, P10, 2015)

California. Drilled hole is $\frac{1}{4}$ inch larger than dowel. Bars are anchored with epoxy and no grout retention disks are used. Figure 7 shows the dowel bar anchoring requirements in California.

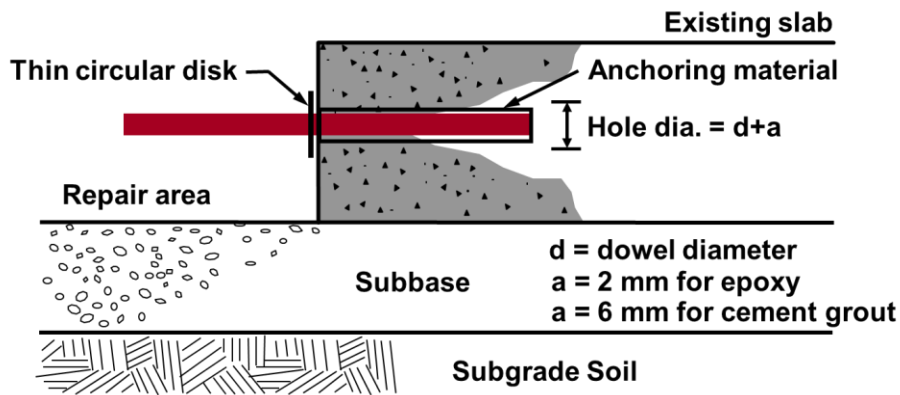
Figure 20. Dowel bar anchoring in slab face with grout retention disk. (FHWA, 1998)

Missouri. Drill holes, clean, inject epoxy resin into hole, rotate bar during insertion, use grout retention rings, end caps on protruding dowels, coat bars with lubricant. The grout retention rings are an important part of a system of anchoring dowels, and that system includes the proper consistency and strength of anchor materials (cementitious grout or epoxy-based material), the right annular gap for the material being used, the proper injection of the material into the drilled hole, proper technique for inserting and rotating the dowel for good filling of the gap and the grout retention ring to force full grout coverage at the joint face and hold it all in place until it sets. Figures 8 and 9 show a typical dowel bar anchoring with a grout retention disk.

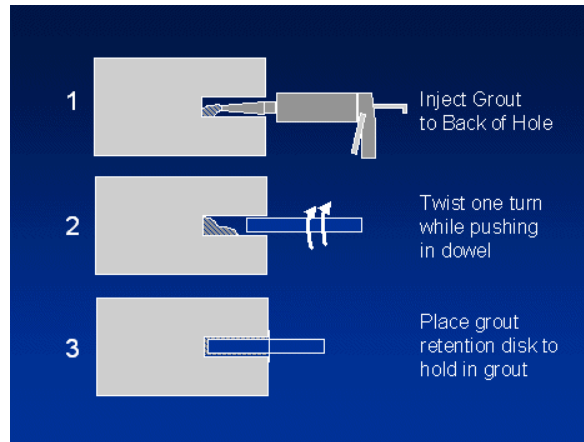
Figure 21. Illustration of recommended procedure to anchor dowels securely into face of slab.
(Courtesy of Mark B. Snyder)

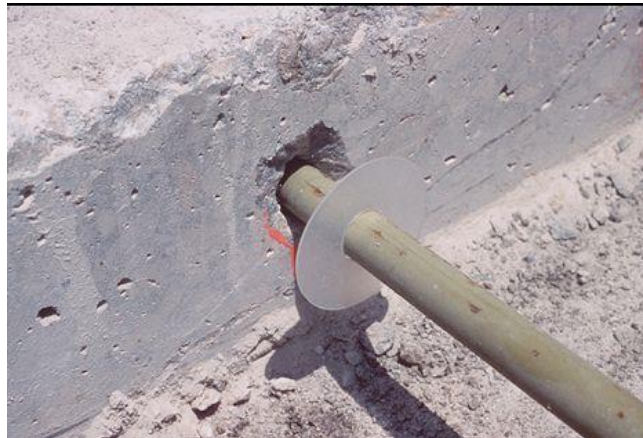
Figure 22. Grout retaining disk. (Photo Courtesy of Mark B. Snyder)

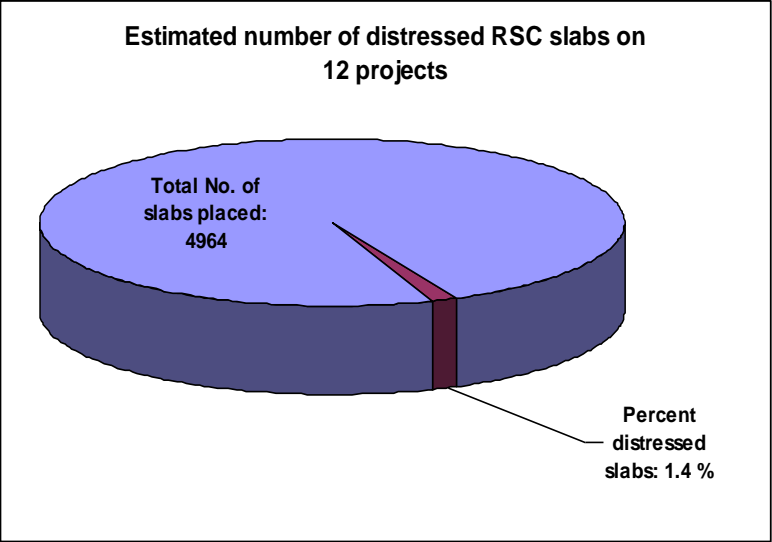
Figure 23. Percent distressed slabs on 12 surveyed RSC projects in California.

Of the few RSC FDR that were distressed, the majority exhibited midpanel and surface cracking as shown in Figure 24. Distresses in the FDR included spalls and corner cracking, midpanel and surface cracking, shrinkage cracking, aggregate pockets, and moving slabs. Figure 25 shows the percent distressed slabs on surveyed RSC projects.

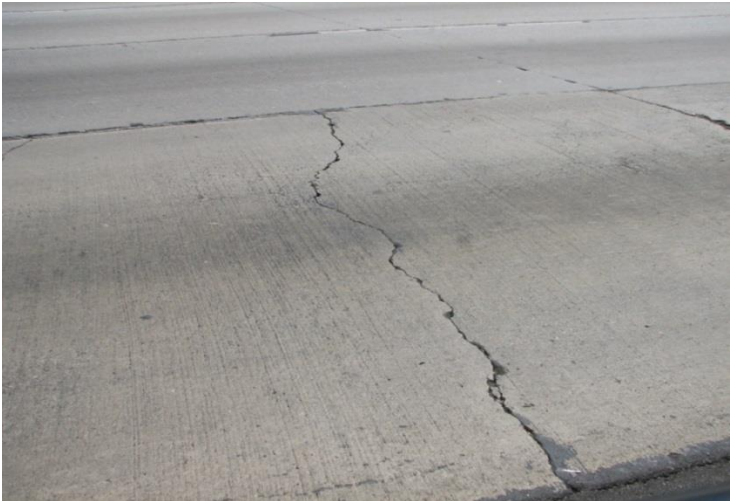
Figure 24. Midpanel cracking on an RSC slab on I-5 in Los Angeles County.

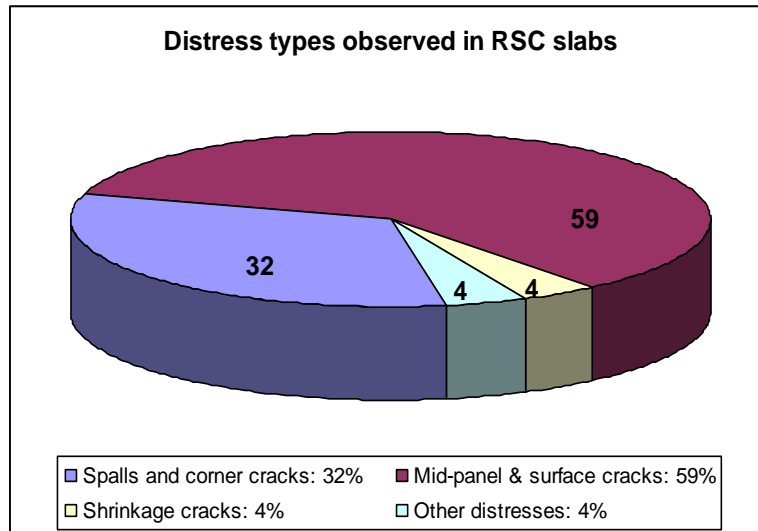
Figure 25. Distribution of distress types observed in the distressed slabs on RSC projects.

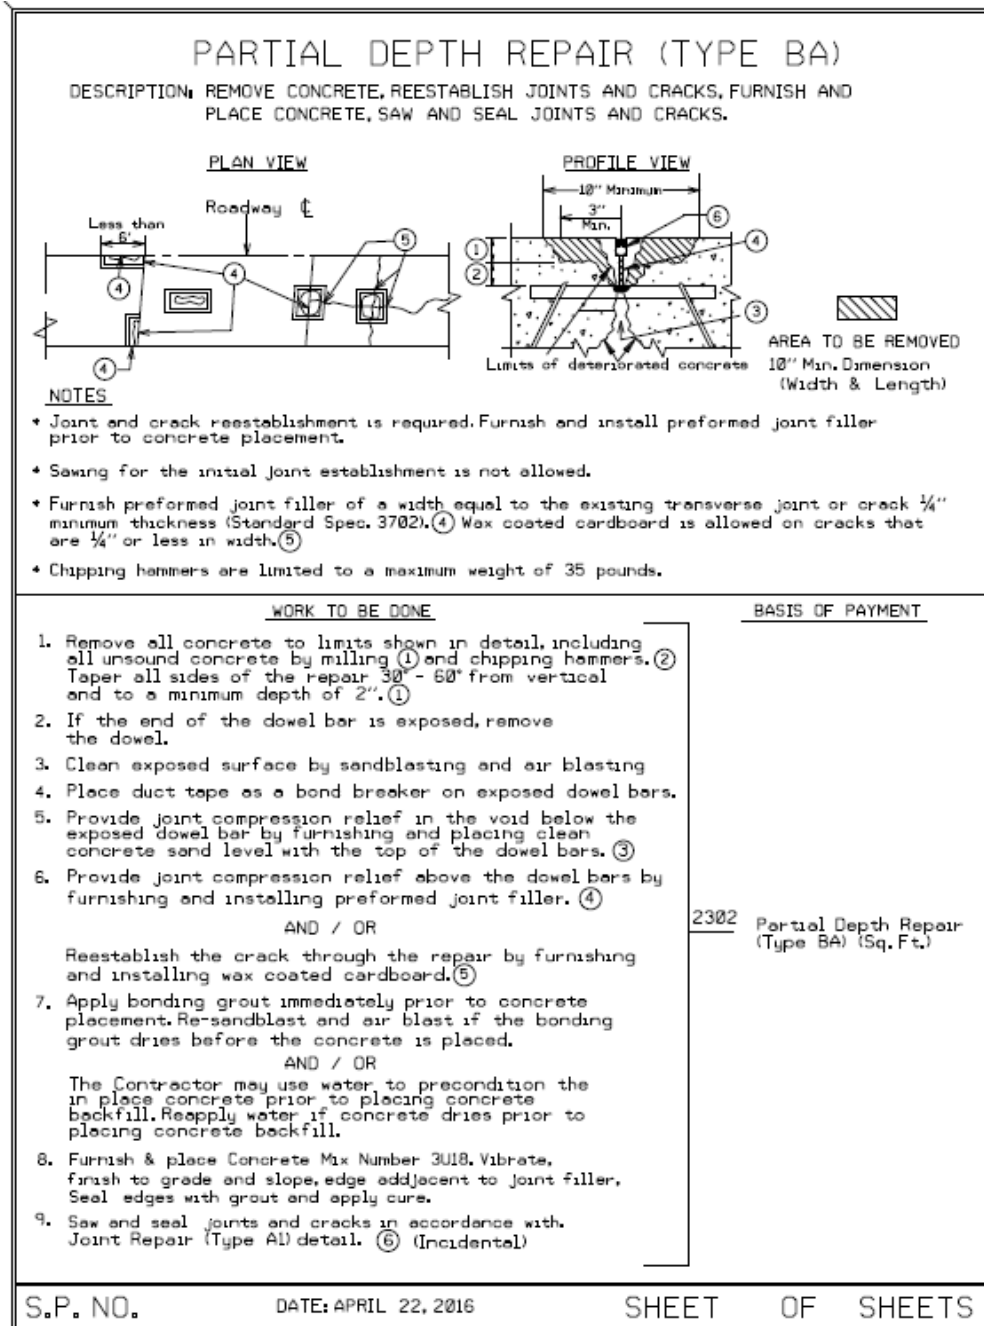
Figure 26. Minnesota PDR BA diagram for milling. (MnDOT, 2017)

MnDOT does the coring to determine if a pavement is a good candidate for a CPR project. If it is a CPR candidate, then the cores are used to estimate PDR/FDR quantities. If MnDOT finds the lower portion of the PCCP is unsound they will then skew the repairs more towards FDRs. A sample graphic and instruction sheet for PDR is shown in Figure 26.

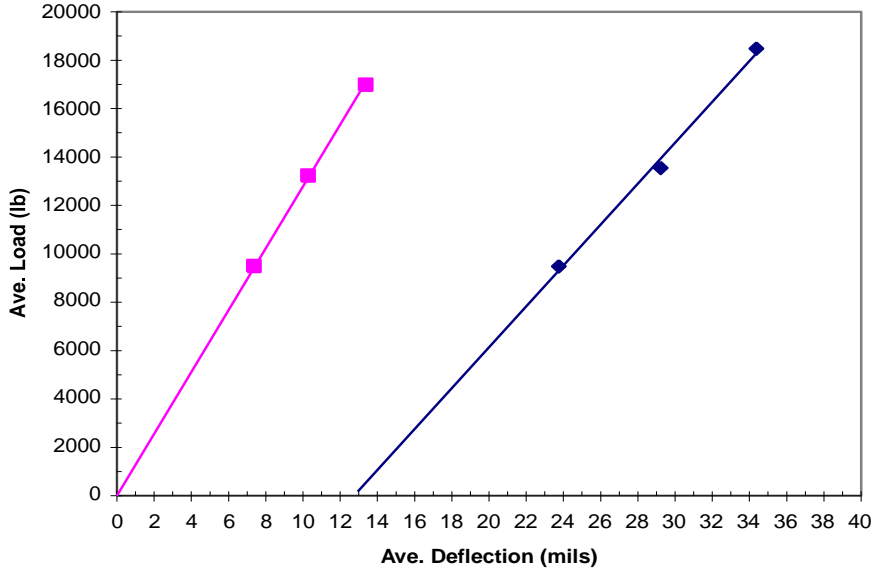
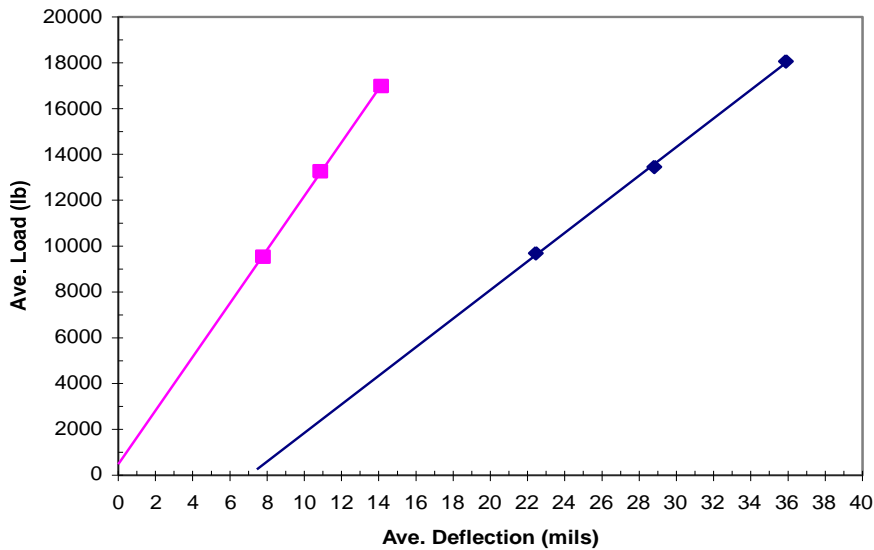
US 71 NB at
Bridge A-2022
in Jasper Co.
3rd Approach Slab

US 71 NB at
Bridge A-2022
in Jasper Co.
2nd Approach Slab

Figure 27. One Missouri slab corner tested by FWD at 9,000, 13,000, and 16,000 lb before and after slab stabilization showing impact of stabilization to restore support.

Although it is the primary intent of another study to evaluate the effectiveness of the polyurethane undersealing process, it can be concluded from the FWD tests that a positive improvement in support did occur under most of the slabs. It may be a more reliable process than grout undersealing, which, although cheaper, has in the past on occasions caused uneven filling of voids, because of its high viscosity, and created greater support problems than existed before.
