SUMMARY REPORT

Analysis of Cracking in Jointed Plain Concrete Pavements

FHWA Publication No.: FHWA-HRT-16-073
FHWA Contact: Deborah Walker, HRDI-30, 202-493-3068,
deborah.walker@dot.gov

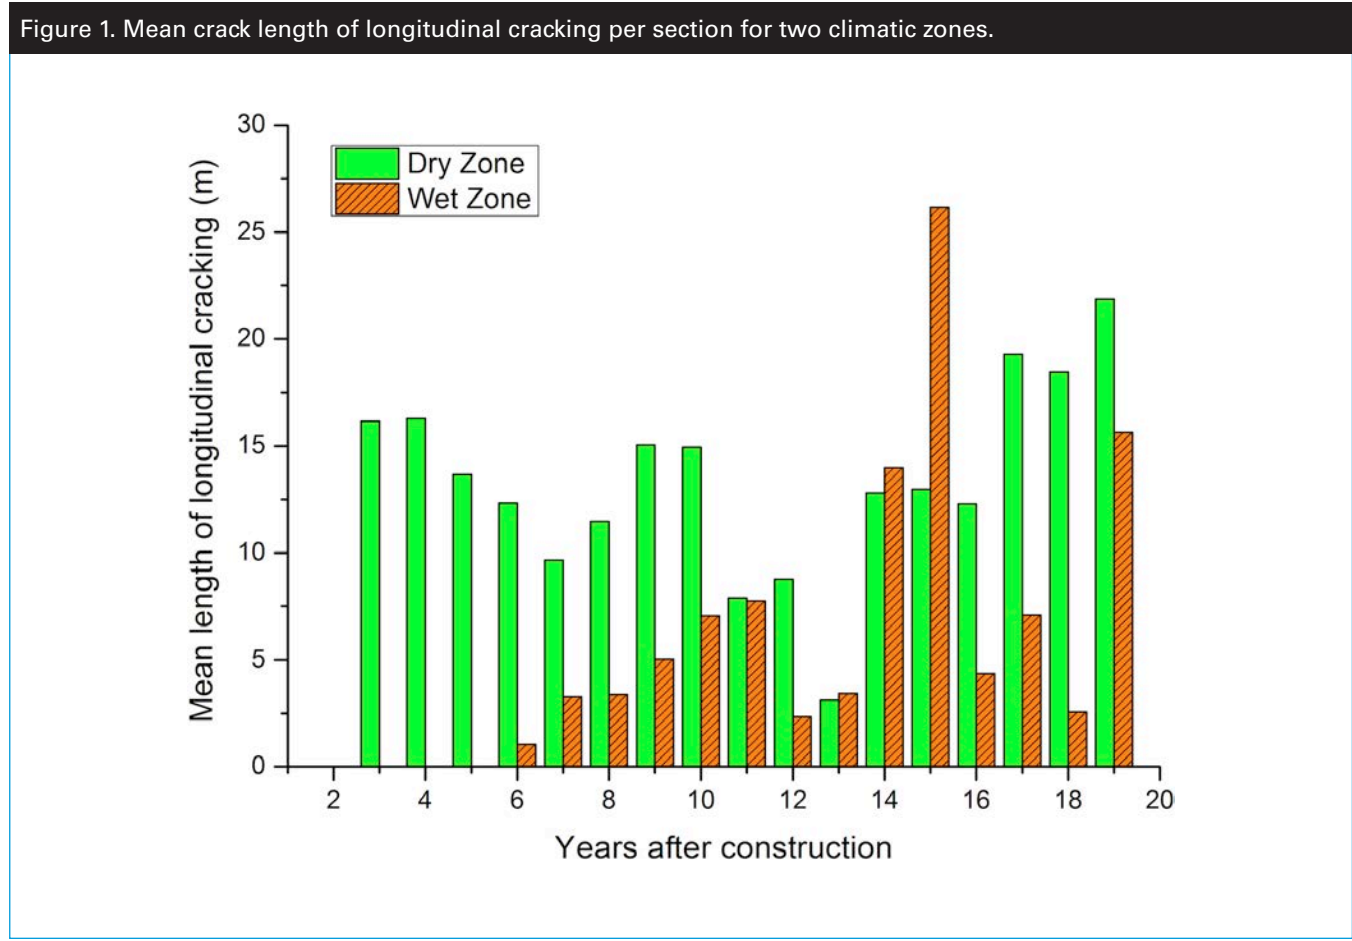
Figure 1 and figure 2 show the mean length of longitudinal and transverse cracking in all SPS-2 sections as a function of the year post construction for two climatic zones, respectively. Sections in the dry zone cracked sooner and more extensively than those in the wet zone for both longitudinal and transverse cracks. Significant cracks appeared in the dry zones in year 3. Pavements in the wet zones cracked more gradually, with minor transverse cracking from year 4. However, major longitudinal and transverse cracks were only present from about year 8 onward. Maintenance work was performed at various times but particularly in years 10 and 12, when a significant reduction in crack lengths was apparent.

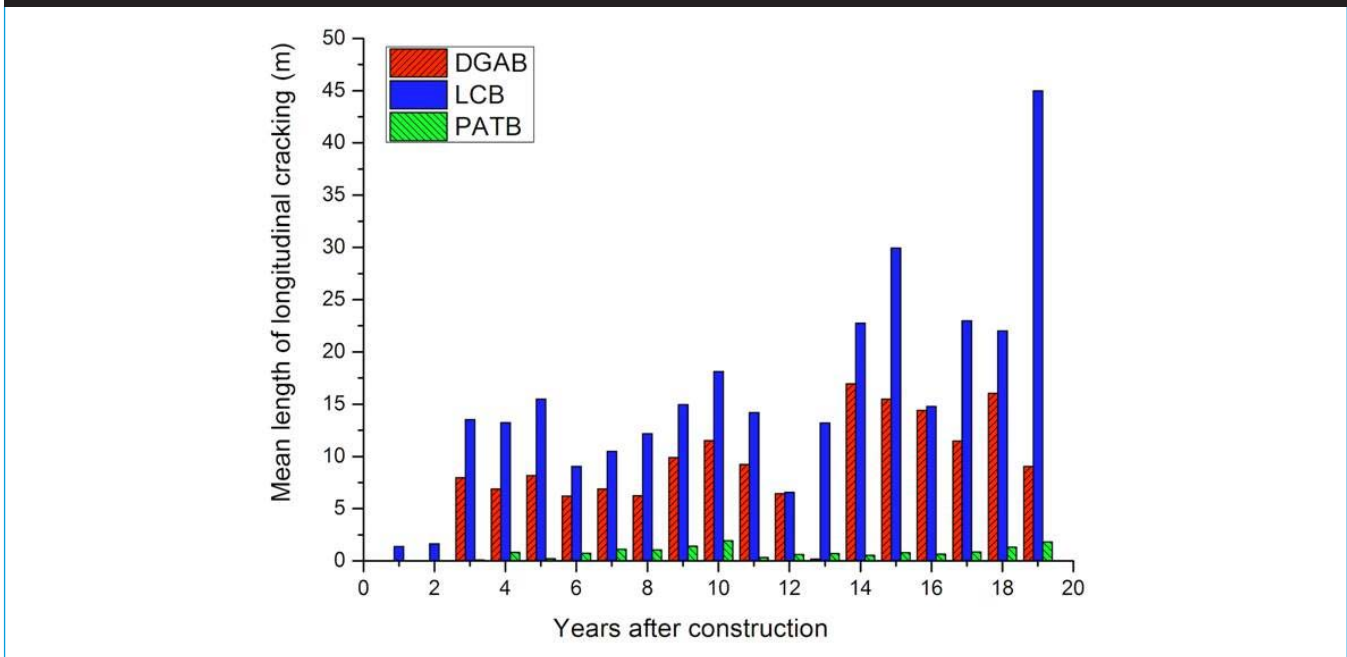
Figure 3. Mean longitudinal crack length per section over time for three different pavement base types.

Figure 3 and figure 4 show the effects of pavement base type on longitudinal and transverse cracking performance throughout the life of the SPS-2 sections. The SPS-2 sections were constructed with three types of base: dense-graded aggregate base (DGAB), lean concrete base (LCB), and permeable asphalt-treated base (PATB).^(4,5) As shown in figure 3

and figure 4, the PATB bases provided pavements with the best cracking resistance. DGAB provides pavements with moderate cracking resistance, while LCB provided pavements with the worst cracking resistance. This conclusion concerning the influence of base type for transverse cracking was also drawn in some earlier studies.^(6,5)

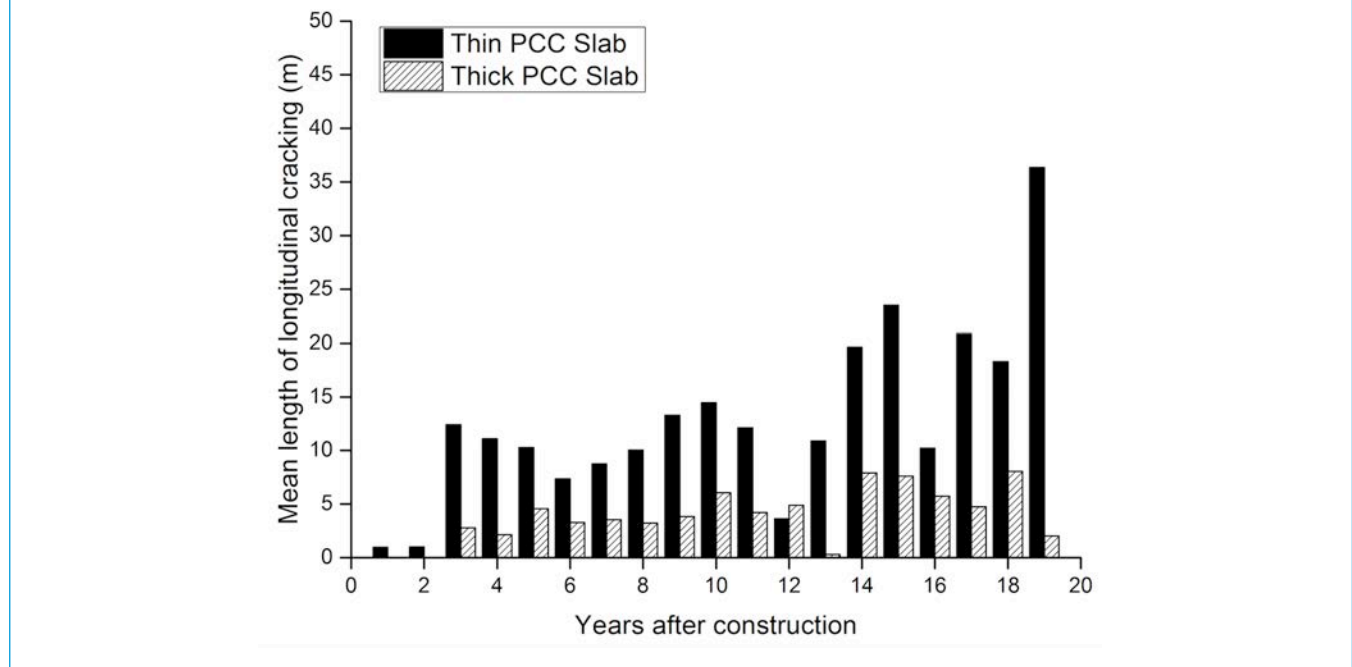
Figure 5. Mean longitudinal crack length per section over time for thin PCC slabs and thick PCC slabs.

design and construction values.⁽⁵⁾ Figure 5 and figure 6 demonstrate that thicker PCC slabs have better cracking resistance—they develop fewer cracks later in life than the thinner ones.

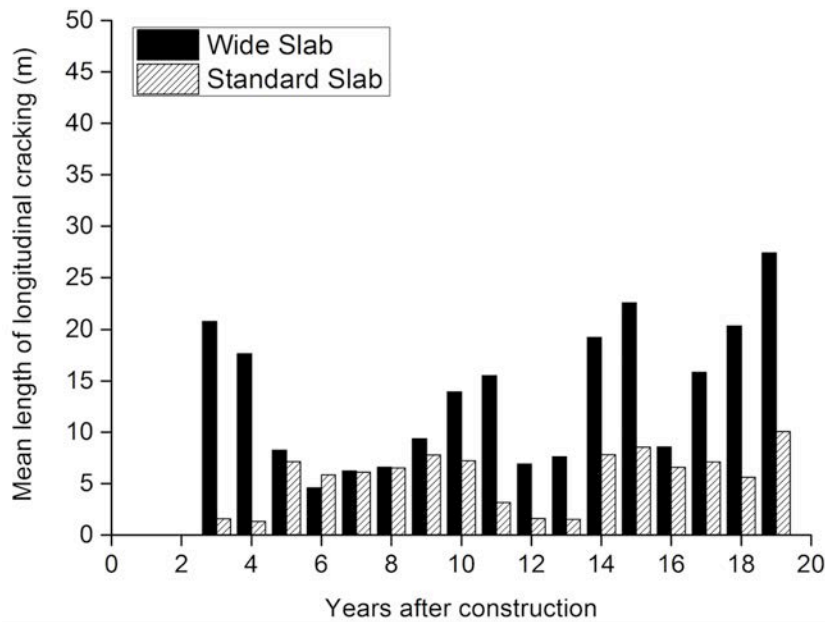
Figure 7. Mean longitudinal crack length per section over time for wide PCC slabs and standard PCC slabs.

The SPS-2 pavement sections were constructed with two different slab widths: "standard" slabs of 3.66 m and "wide" slabs of 4.27 m.⁽⁵⁾ Figure 7 and figure 8 show that, on average, the sections with widened PCC slabs developed more extensive

longitudinal cracking. Conversely, standard slabs appeared to start cracking transversely earlier in life. Overall, the long-term levels of transverse cracking were approximately the same for both slab widths.

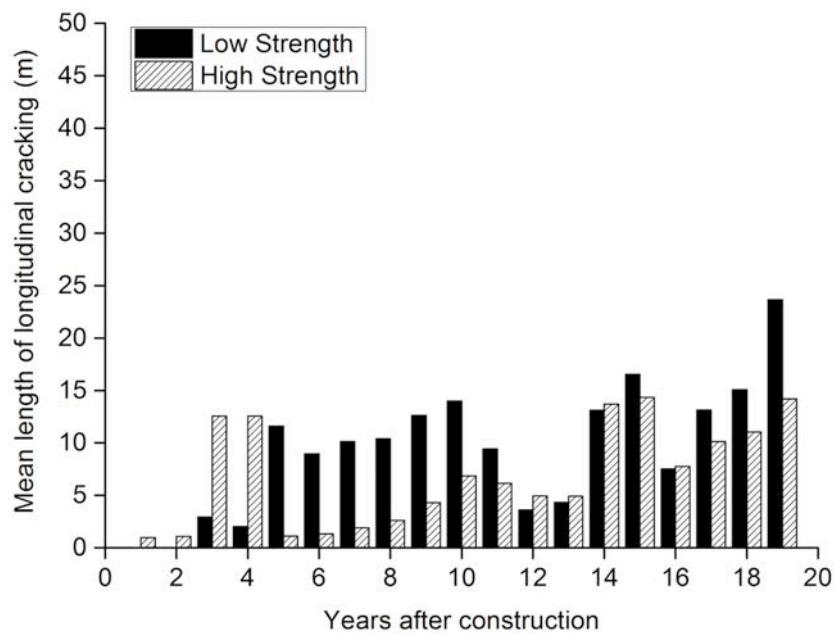
Figure 9. Mean longitudinal crack length per section over time for low-strength slabs and high-strength slabs.

The SPS-2 experiment specification included two levels of concrete strength (at 14 d): 3.8 and 6.2 MPa. Figure 9 and figure 10 show that some sections with high slab strength display earlier longitudinal and

transverse cracking. Between 6 and 12 years after construction, the weaker concrete showed more cracking, but, in the long term, there was little to distinguish between them.

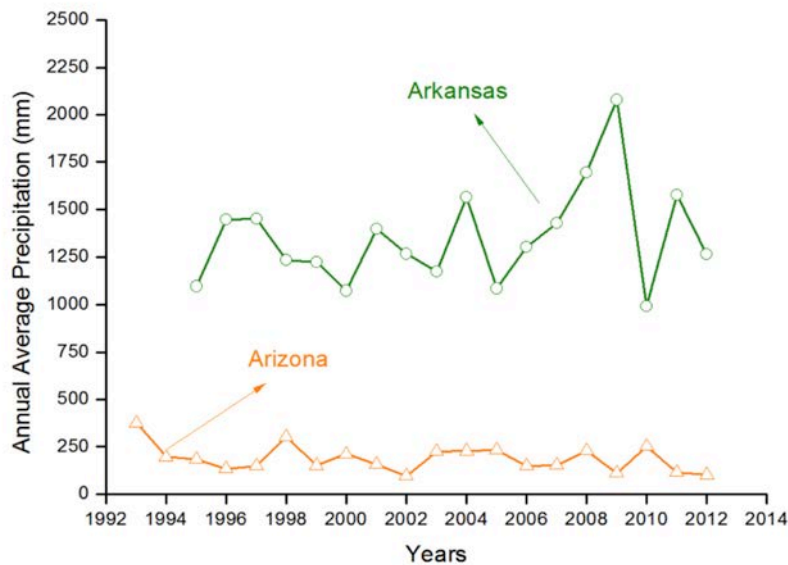
Figure 12. Annual average precipitation at the SPS sites in Arizona and Arkansas.

level, Arkansas is defined as a wet site, and Arizona is defined as a dry site. The rainfall level was implicated in some failures of concrete pavements such as pumping.

Figure 12 shows the annual average precipitation in the two sites. According to the average precipitation

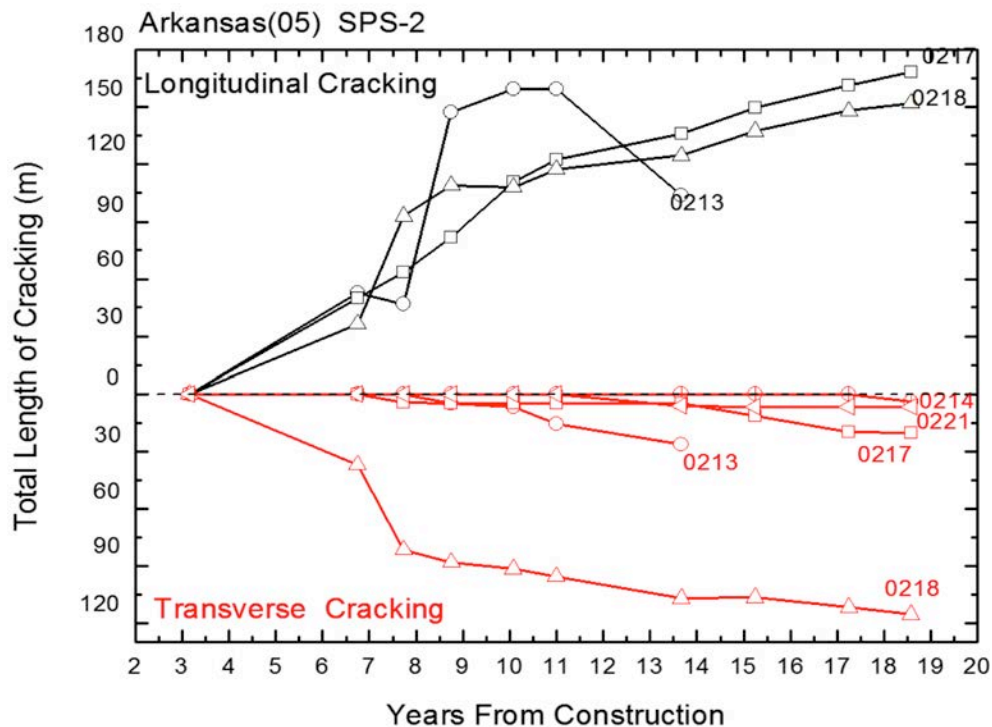
Figure 13. The total length of cracking over time in the Arkansas SPS-2 sites. (Transverse cracking is plotted below the axis for convenience.)

Figure 13 shows the total length of longitudinal cracking and transverse cracking over time on the Arkansas SPS-2 site. The following can be seen:

- Sections 0213, 0217, and 0218 had both longitudinal and transverse cracks.

- Sections 0214 and 0221 had only transverse cracks with low severities.
- Sections 0215, 0216, 0219, 0220, 0222, 0223, and 0224 had no cracks.

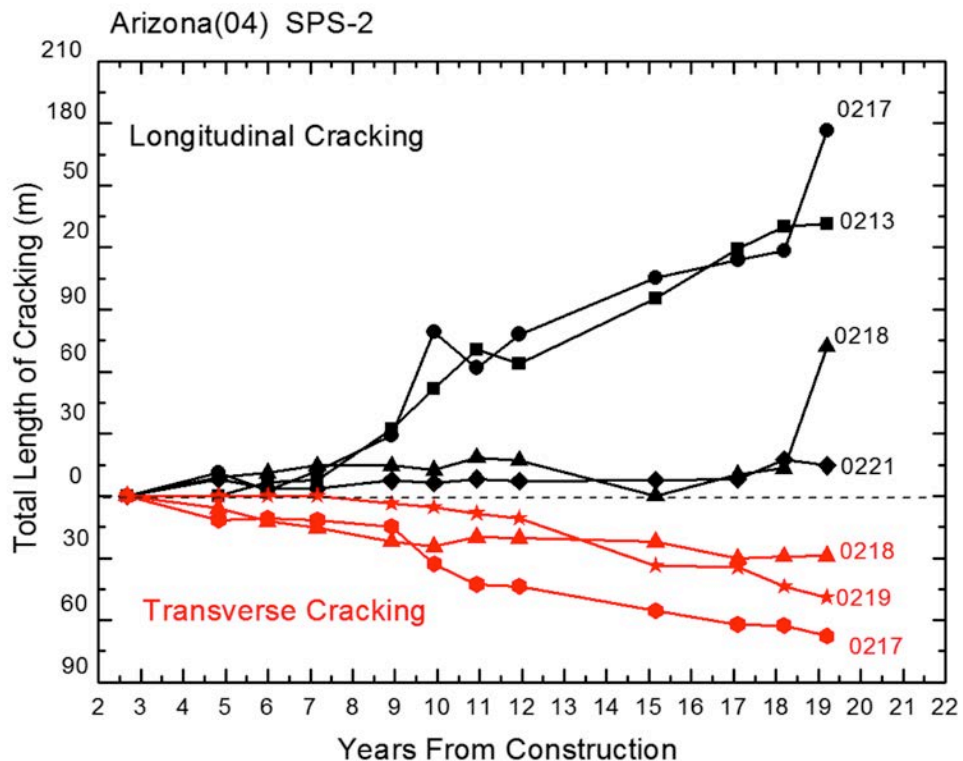
Figure 14. The total length of cracking over time in the Arizona SPS-2 sites. (Transverse cracking is plotted below the axis for convenience.)

Figure 14 shows the total length of longitudinal cracking and transverse cracking over time in Arizona. The following can be seen:

- Sections 0217 and 0218 had longitudinal and transverse cracks.
- Sections 0213 and 0221 had only longitudinal cracks.
- Sections 0214, 0215, 0219, 0220, and 0222 had very small magnitude of cracking.
- Sections 0216 and 0223 had no cracks.

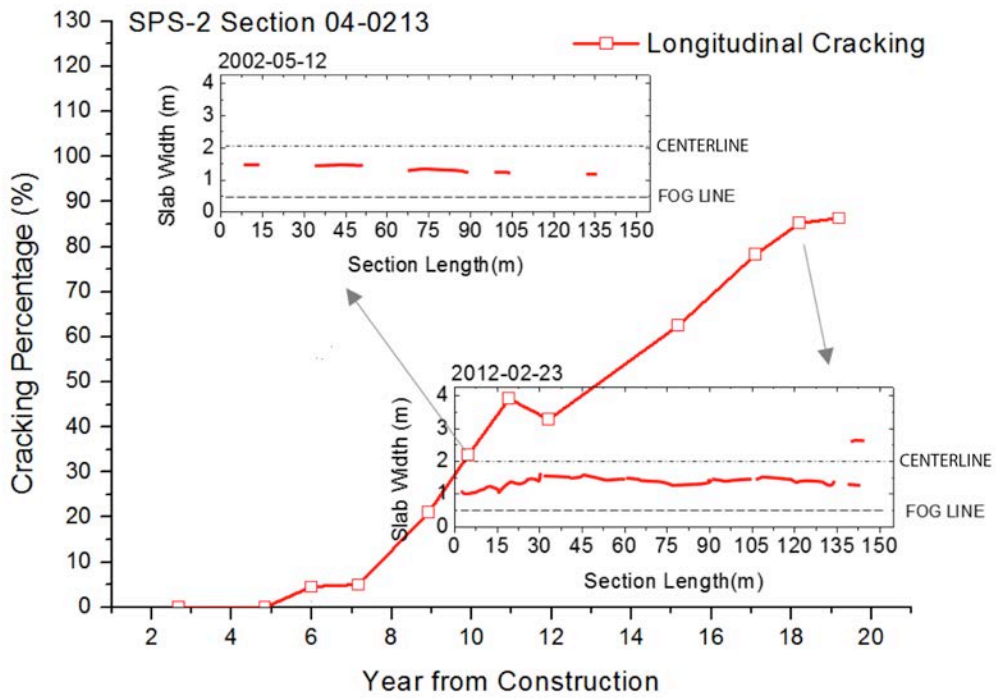
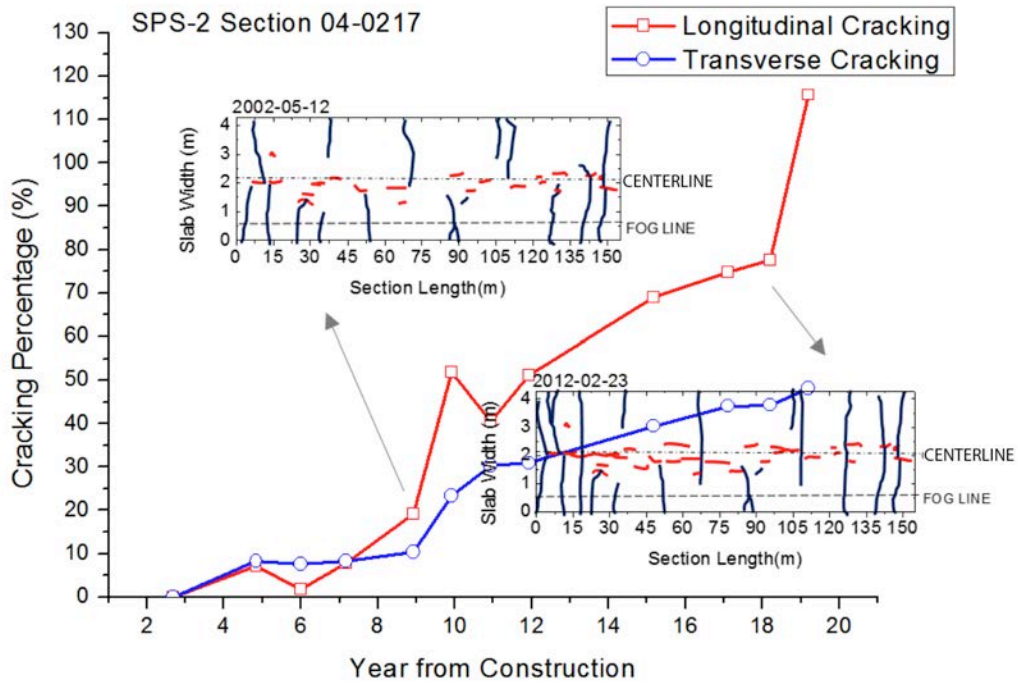
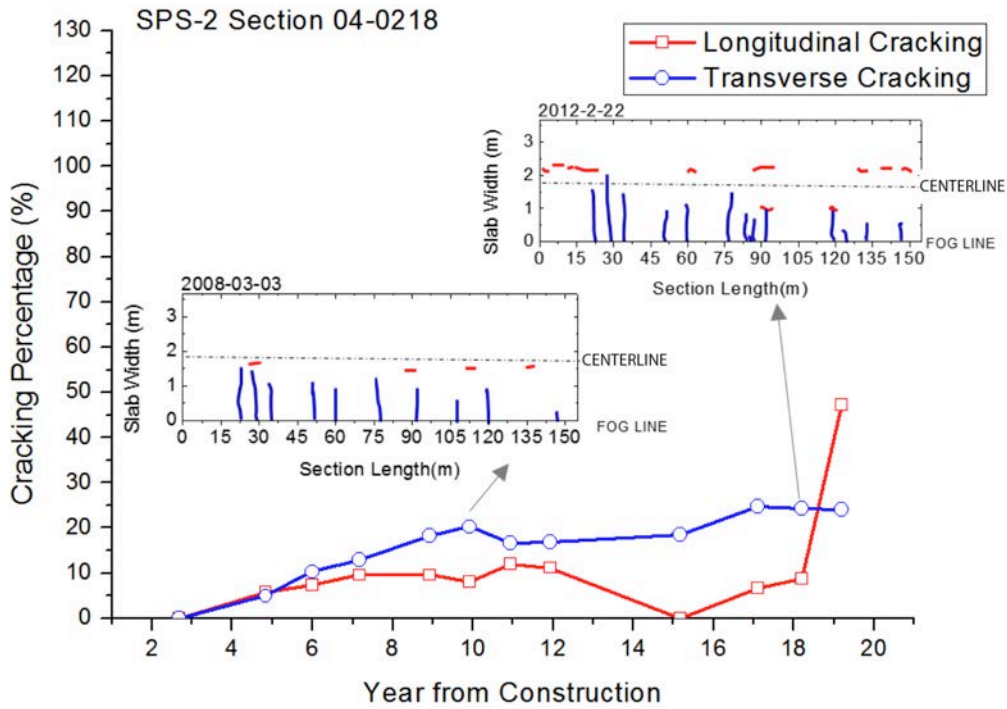
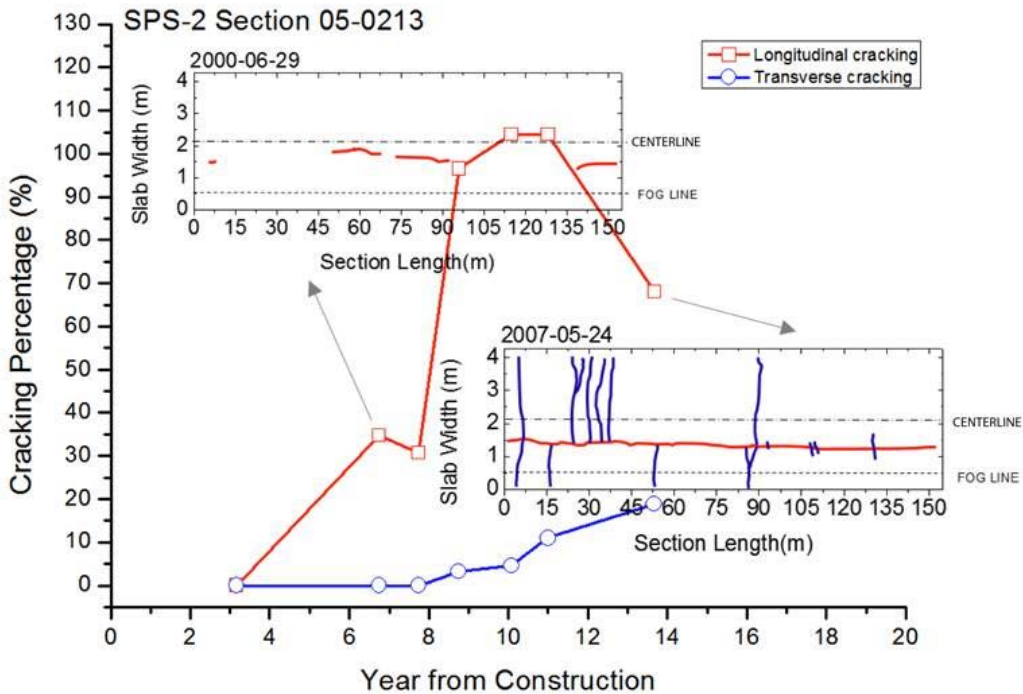
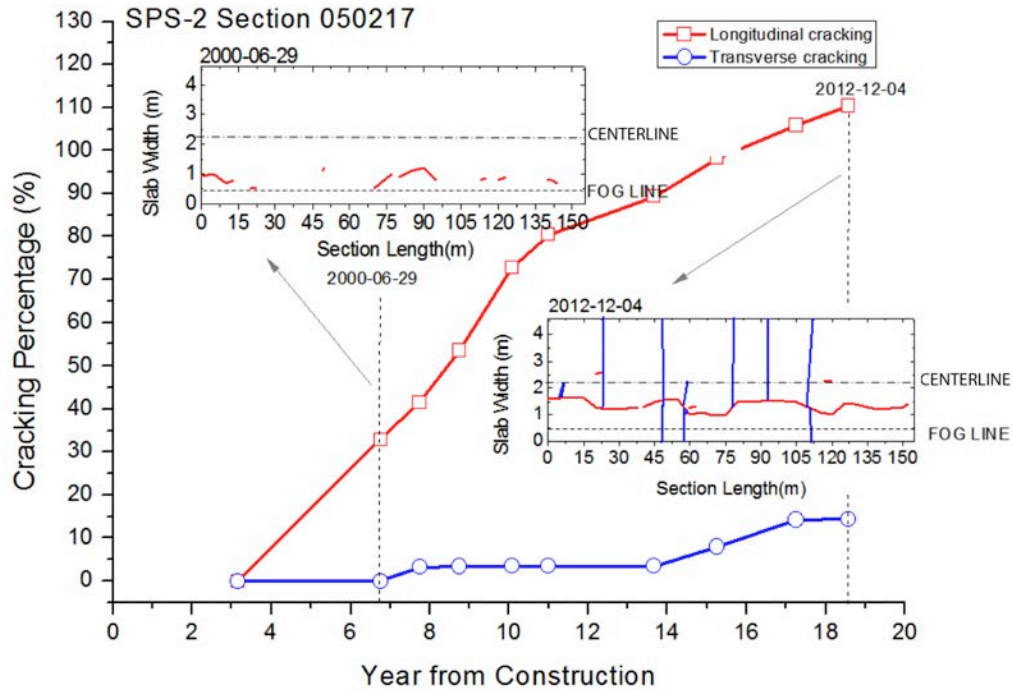
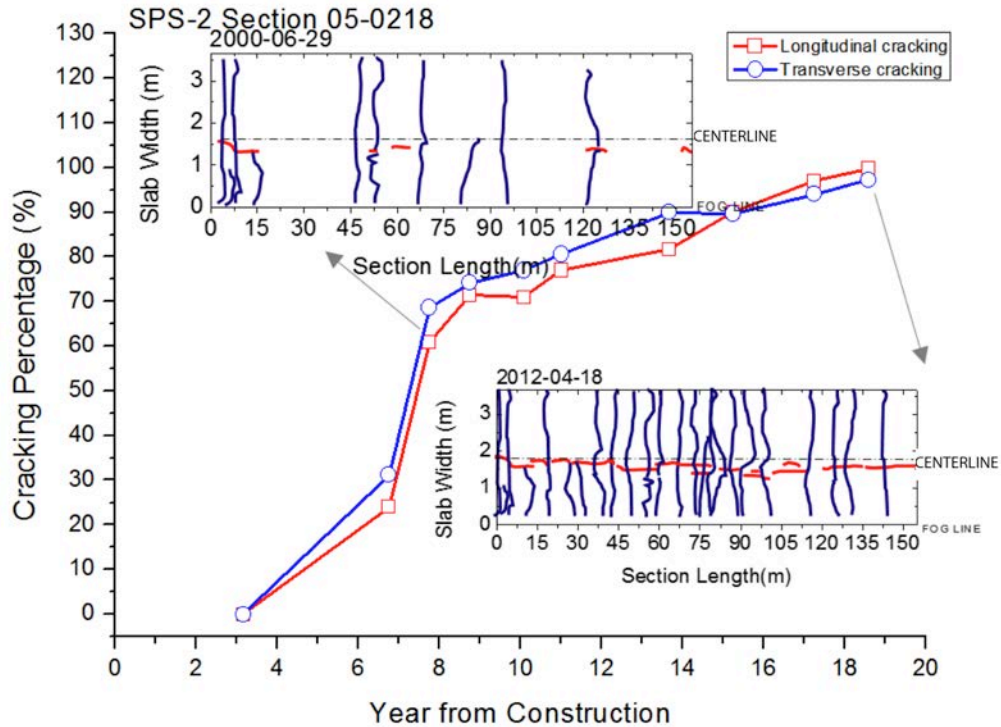
Figure 15 through figure 20 display details of the cracking process in three sections (0213, 0217, and 0218) for Arizona and Arkansas, respectively. Each figure shows the percentage cracking along with recorded snapshots of the patterns of longitudinal and transverse cracks.

The crack patterns revealed that most longitudinal cracks initiated at slab transverse edges, and the rest initiated from transverse cracks. Most transverse cracks initiated at the concrete slab edge close to the shoulder, and the rest initiated either at the slab edge in the middle of the lane (i.e., with the longitudinal joints) or from longitudinal cracks.

The following two patterns of longitudinal cracks were apparent at 20 years of service:

- Almost continuous single crack relatively near the shoulder (as seen for sections 04-0213, 05-0213, and 05-0217).

- A set of discrete cracks closer to the longitudinal centerline of slabs (as seen for sections 04-0217, 04-0218, and 05-0218).

Figure 15. The development of cracking in Arizona-0213 section.

Figure 16. The development of cracking in Arizona-0217 section.

Figure 17. The development of cracking in Arizona-0218 section.

Figure 18. The development of cracking in Arkansas-0213 section.

Figure 19. The development of cracking in Arkansas-0217 section.

Figure 20. The development of cracking in Arkansas-0218 section.

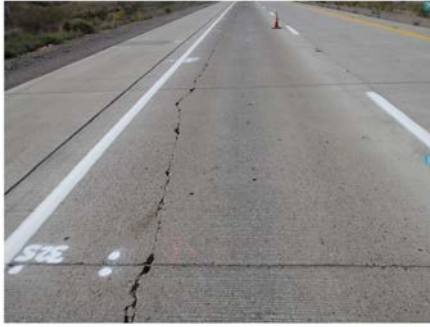
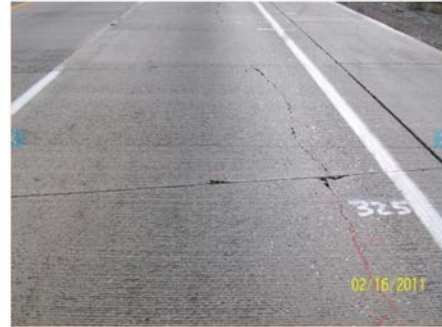
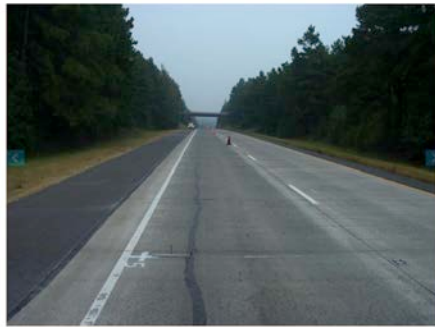
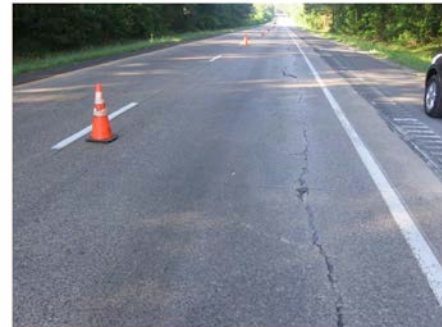
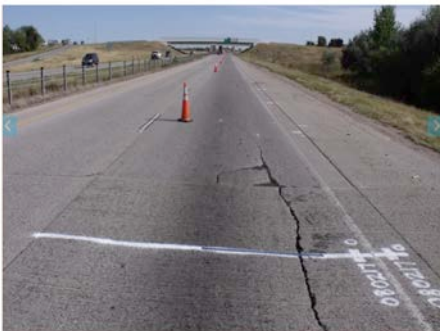
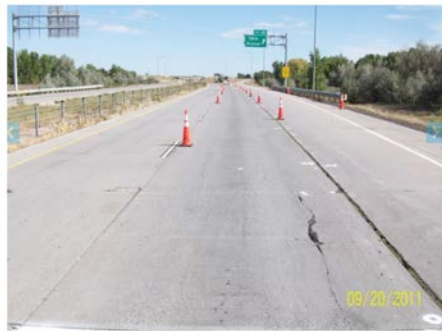
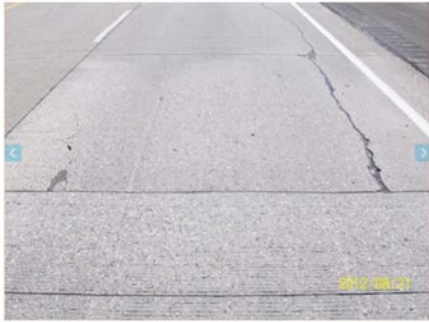
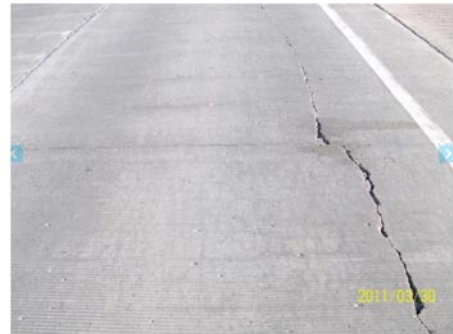
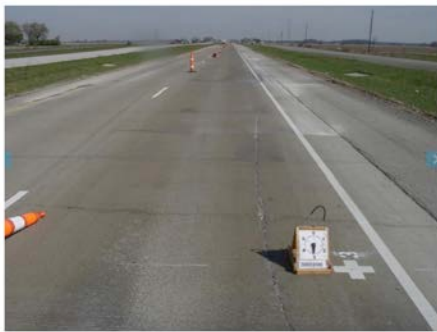
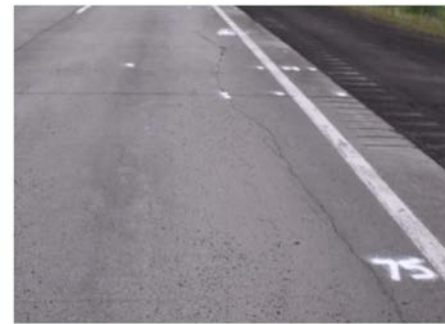
The snapshots featured in figure 21 through figure 30 were selected from 10 different sections in 7 sites (States). They share almost continuous single cracks relatively near the shoulder. These cracks occurred only

in the sections with DGAB (section 0213) and LCB (sections 0217, 0218, and 0206). This pattern of cracking was only found in the 10 sections in LTPP SPS-2 (according to monitoring results updated in 2013).

Figure 21. Longitudinal cracking near the shoulder in Arizona-0213 section (February 16, 2011).

Figure 22. Longitudinal cracking near the shoulder in Arizona-0262 section (February 16, 2011).

Figure 23. Longitudinal cracking near the shoulder in Arkansas-0213 section (May 24, 2007).

Figure 24. Longitudinal cracking near the shoulder in Arkansas-0217 section (December 4, 2012).

Figure 25. Longitudinal cracking near the shoulder in Colorado-0217 section (September 20, 2011).

Figure 26. Longitudinal cracking near the shoulder in Colorado-0218 section (September 20, 2011).

Figure 27. Longitudinal cracking near the shoulder in North Dakota-0217 section (August 21, 2012).

Figure 28. Longitudinal cracking near the shoulder in Iowa-0217 section (March 30, 2011).

Figure 29. Longitudinal cracking near the shoulder in Ohio-0206 section (September 12, 2006).

Figure 30. Longitudinal cracking near the shoulder in Washington-0206 section (May 23, 2013).

Details of the structural factors and climatic conditions of these sections are presented in table 3. The table shows that the pattern of longitudinal cracking was only exhibited in thinner pavements (design depth: 203 mm). By contrast, other sections with thick slabs (design depth: 279 mm) did not exhibit such longitudinal cracking. The table also shows

that this pattern of longitudinal cracking occurred mainly in sections constructed with wide slabs (with the exception of section 08-0218). This longitudinal cracking pattern (single cracking near the shoulder) occurred for soil types, shoulder types, and climatic conditions.
