**GEORGIA DOT RESEARCH PROJECT 12-12**

**CENTERLINE RUMBLE STRIPS SAFETY AND  
MAINTENANCE IMPACTS**

1. Report No.: FHWA-GA-14-1212	2. Government Accession No.:	3. Recipient's Catalog No.:	
4. Title and Subtitle: Centerline Rumble Strips Safety And Maintenance Impacts		5. Report Date: September 2014	6. Performing Organization Code:

**Centerline Rumble Strips Safety Impact Evaluation**

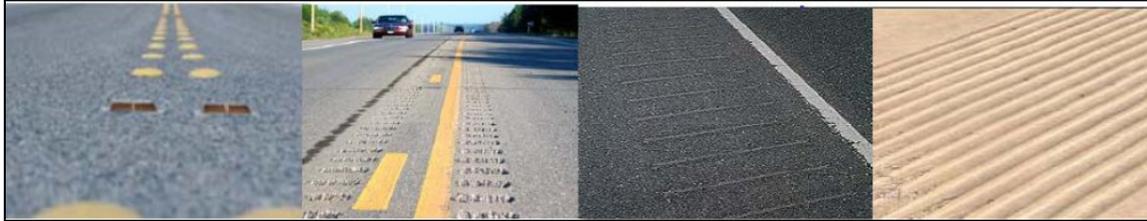
**Figure 1: Forms of Centerline Rumble Strips; from left to right: Raised, Milled-In, Rolled, Formed (23)**

The actual rumble strips themselves predominantly come in four types: raised, milled-in, rolled, and formed; these are illustrated respectively in Figure 1 (23, 25). By far the most common form of centerline rumble strips is the milled-in rumble strips (26).

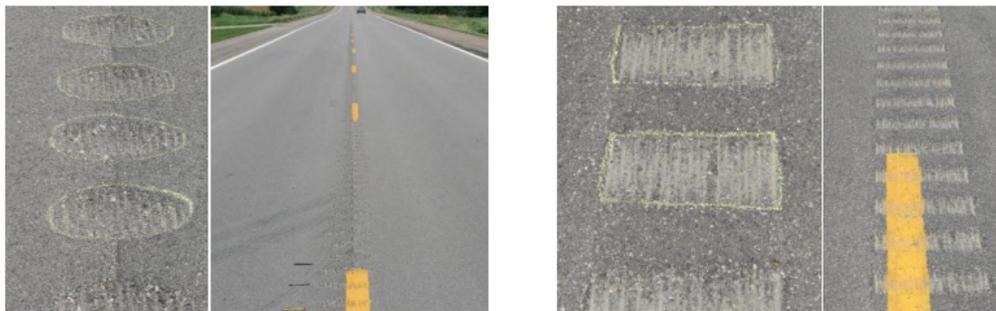
**Figure 2: Patterns of Milled-in Centerline Rumble Strips, from left to right: Football-shaped, Rectangular-shaped (29)**

Milled-in rumble strips, also known as ground-in rumble strips, are cut into the road surface by a machine with a cutting head (5). These grinding machines can grind up to 1.25-mph, and carves out regular indentations on roadway independent of the roadway age (20). The repetitive milling of the roadway creates smooth, uniform, and consistent grooves in the pavement surface in one of two shapes: football shaped or rectangular shaped (Figure 2). In terms of safety benefits, no statistical differences between the two shapes have been found (29).

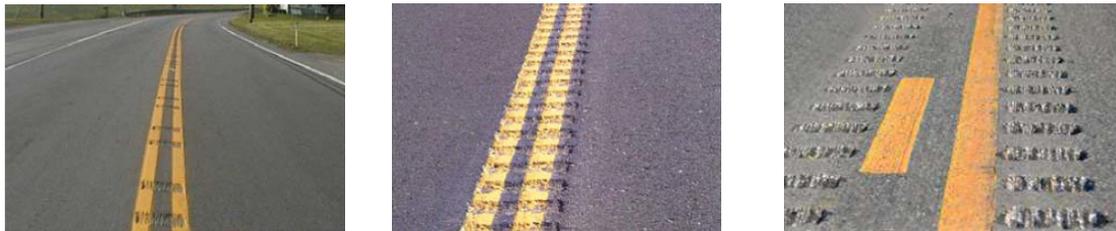
**Figure 3: Examples of Different Lateral Placements of Centerline Rumble Strips; from left to right: Within Pavement Markings, Extended into Travel Lane, on Either Side of Pavement Markings (40)**

Though centerline rumble strips are always installed at the centerline, the actual installation locations may vary. While predominantly installed within the pavement markings that constitute the centerline, centerline rumble strips can be placed in a variety of places around the centerline (11, 40). Some example placements are illustrated in Figure 3.

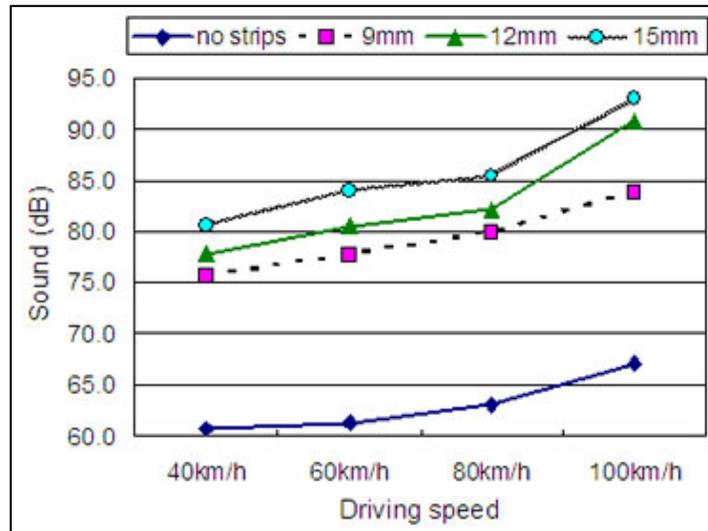
**Figure 4: Average Sound Heard by Motorists Driving on Rumble Strips at Various Speeds (8)**

positive correlation between rumble strip depth and sound levels, and between speed and sound levels, as seen in Figure 4 (8).

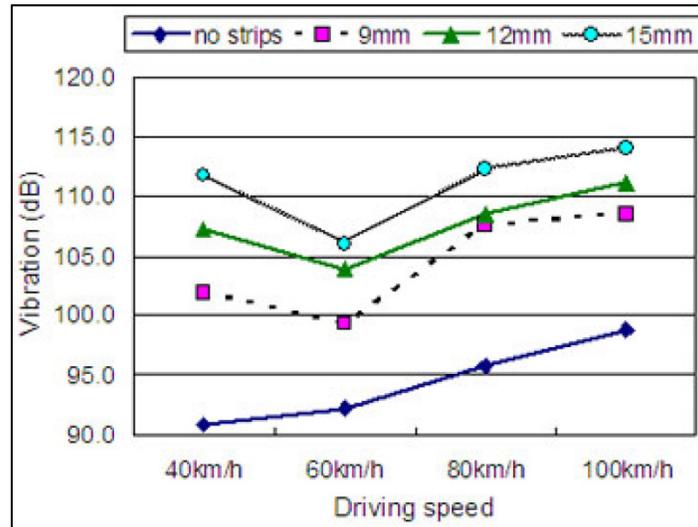
**Figure 5: Average Vibration Experienced by Motorists Driving on Rumble Strips at Various Speeds (8)**

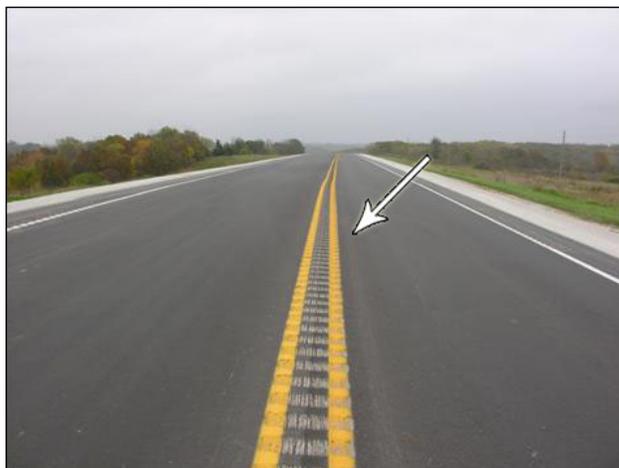
**Figure A - 1: Centerline Rumble Strip Example**

For confirmation, this is an installation of centerline rumble strips (source: <http://safety.fhwa.dot.gov/>):
