# Interlaboratory Variability of Slip Coefficient Testing for Bridge Coatings

PUBLICATION NO. FHWA-HRT-14-093

DECEMBER 2014

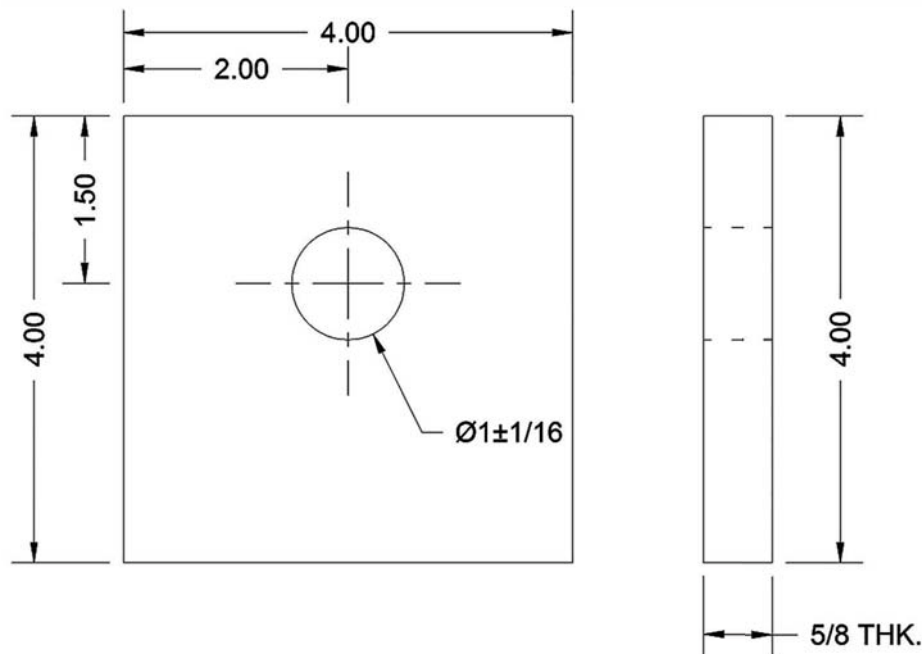
Note: Units are shown in inches.

**Figure 1. Illustration. Test plate.**

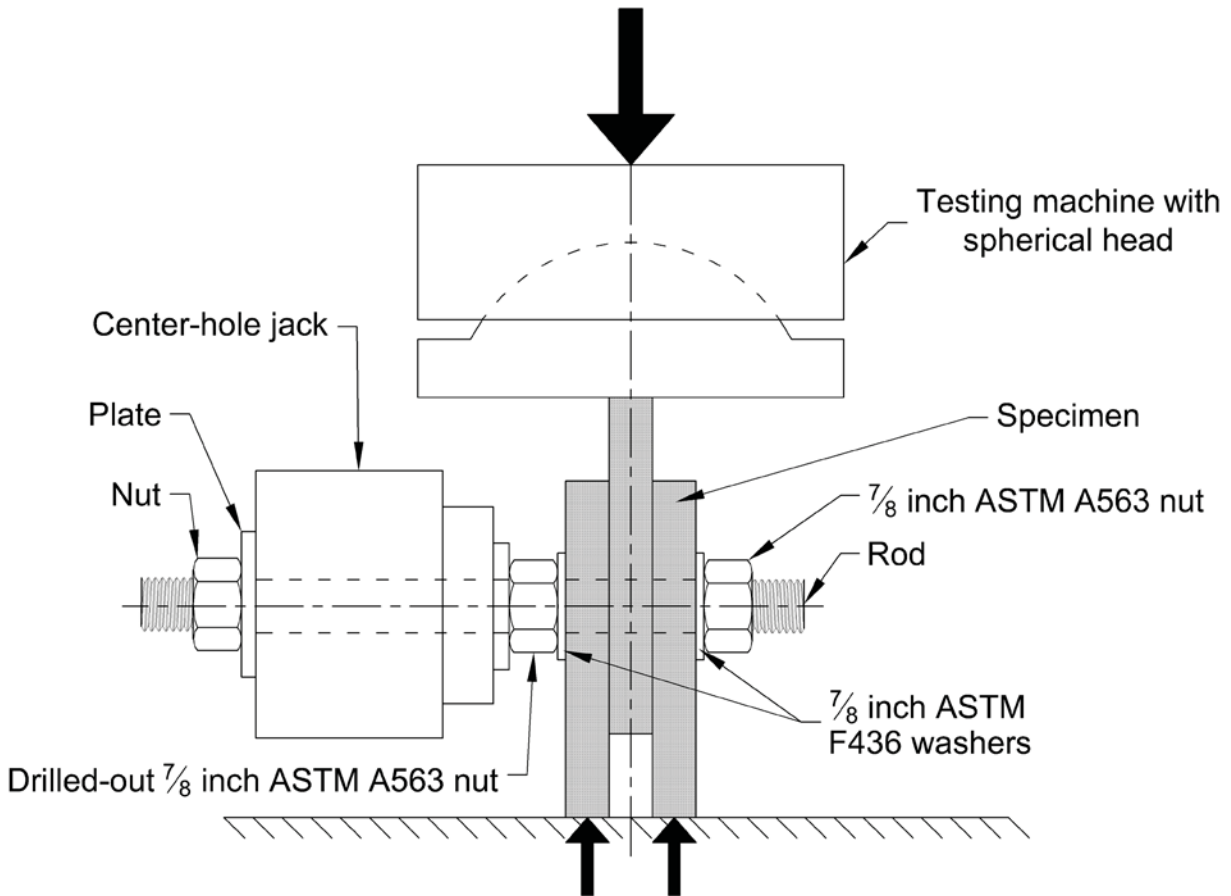
**Figure 2. Illustration. RCSC compression slip test setup.**

The three plates are stacked together, and the middle plate is rotated 180 degrees from the outer two. This is shown in figure 2 along with a generic representation of the loading system. A rod passes through the three test plates and is tensioned via an external hydraulic jack that clamps the three plates together. The clamping load is imparted on the plates through ASTM A563 nuts and ASTM F436 washers so the test accurately represents the loading conditions of a tensioned high-strength bolt.<sup>(4,5)</sup> The stack of three plates is then placed between a compression testing apparatus with fixed and spherical loading platens.

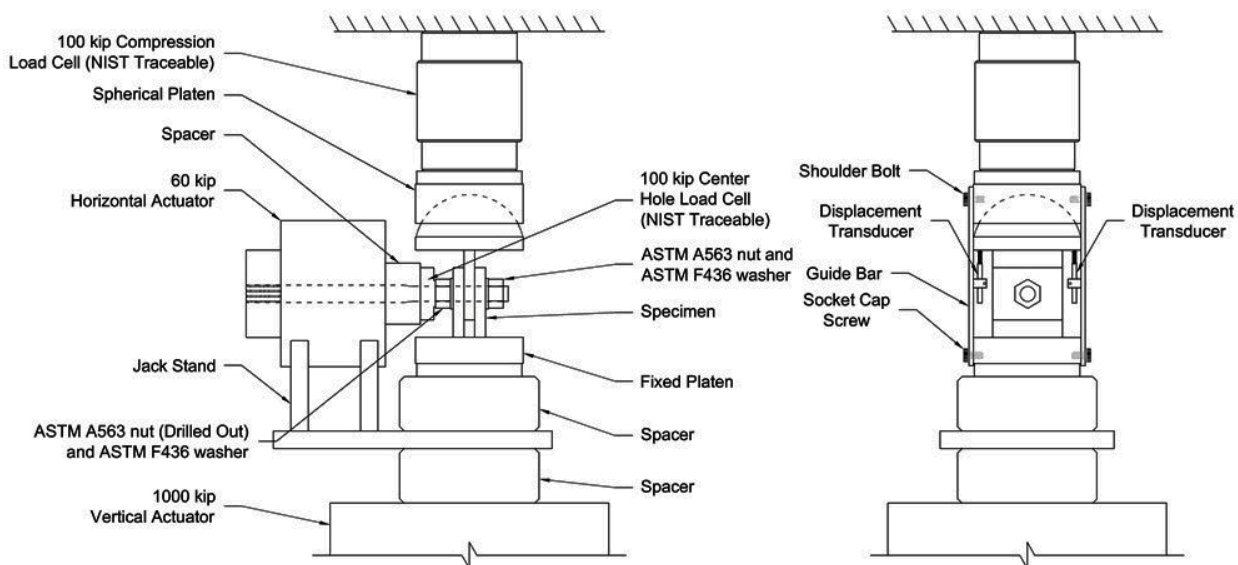
The testing concept used in lab 1 is shown in figure 3. An existing 1,000-kip compression machine was used to apply the vertical load, while a separate 60-kip hollow core jack was used to apply the horizontal clamping load.

Figure 3. Illustration. Lab 1 testing system.

The loading rod that clamped the plates together was custom fabricated for this test setup. It was fabricated from an SAE 4340 alloy that was heat treated to a Rockwell C hardness between 38 and 42, which should yield strength properties equal to or higher than an ASTM A490 bolt.<sup>(6)</sup> The rod had a  $\frac{7}{8}$ -inch diameter where it passed through the test plates with a threaded end to accept a  $\frac{7}{8}$ -inch-diameter ASTM A563 nut but had a 1-inch diameter where it passed through the horizontal jack.<sup>(4)</sup> The horizontal jack had a custom end plate with a threaded hole in the center in which the load rod screwed into directly. A jack stand was also fabricated to support the horizontal jack such that the loading rod was in alignment with the holes in the test plates.

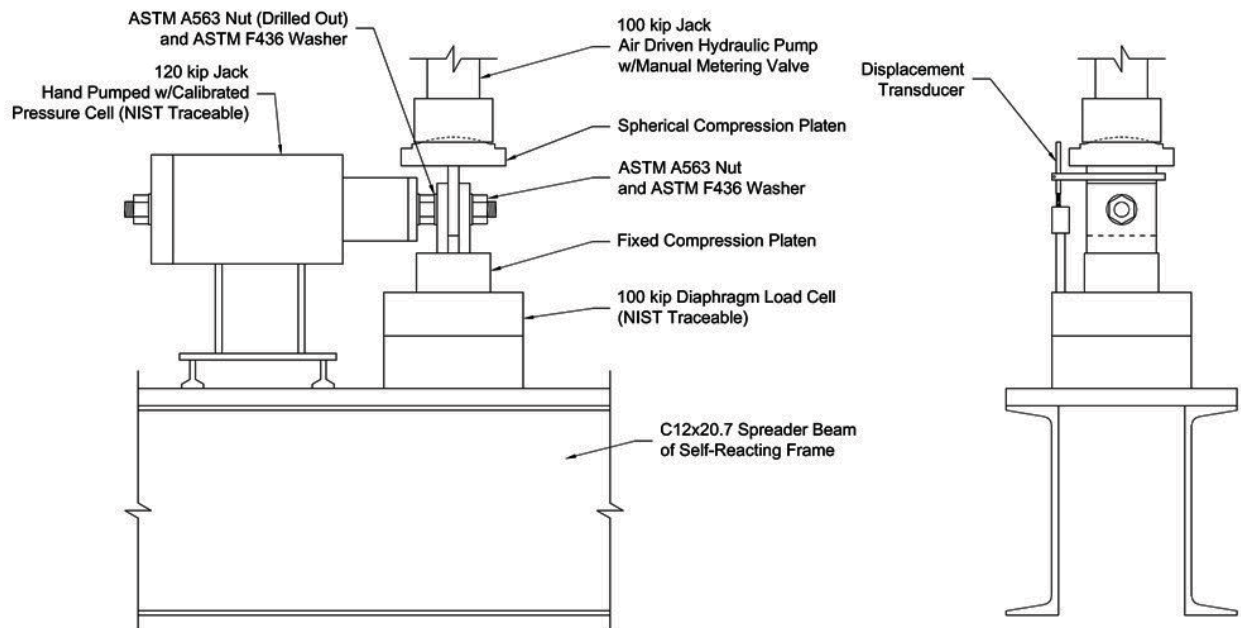
The testing concept used in lab 2 is shown in figure 4. The test arrangement employs a dedicated load frame equipped with an air-driven hydraulic jack for vertically loading the specimens. The vertical load is measured with a 100-kip diaphragm load cell that is installed in line with the load train. The clamping force is supplied by a hand-pumped hydraulic jack with a calibrated pressure cell linked to a digital readout visually monitored throughout each test run to ensure consistent compressive load is applied to the sample throughout.

**Figure 4. Illustration. Lab 2 testing system.**

The three specimen plates were loaded onto the rod. The lab had its own custom spacer plate to place under the center plate to elevate it to produce the maximum possible amount of slip. The nut was hand-tightened to clamp the plates together enough such that the center plate would not

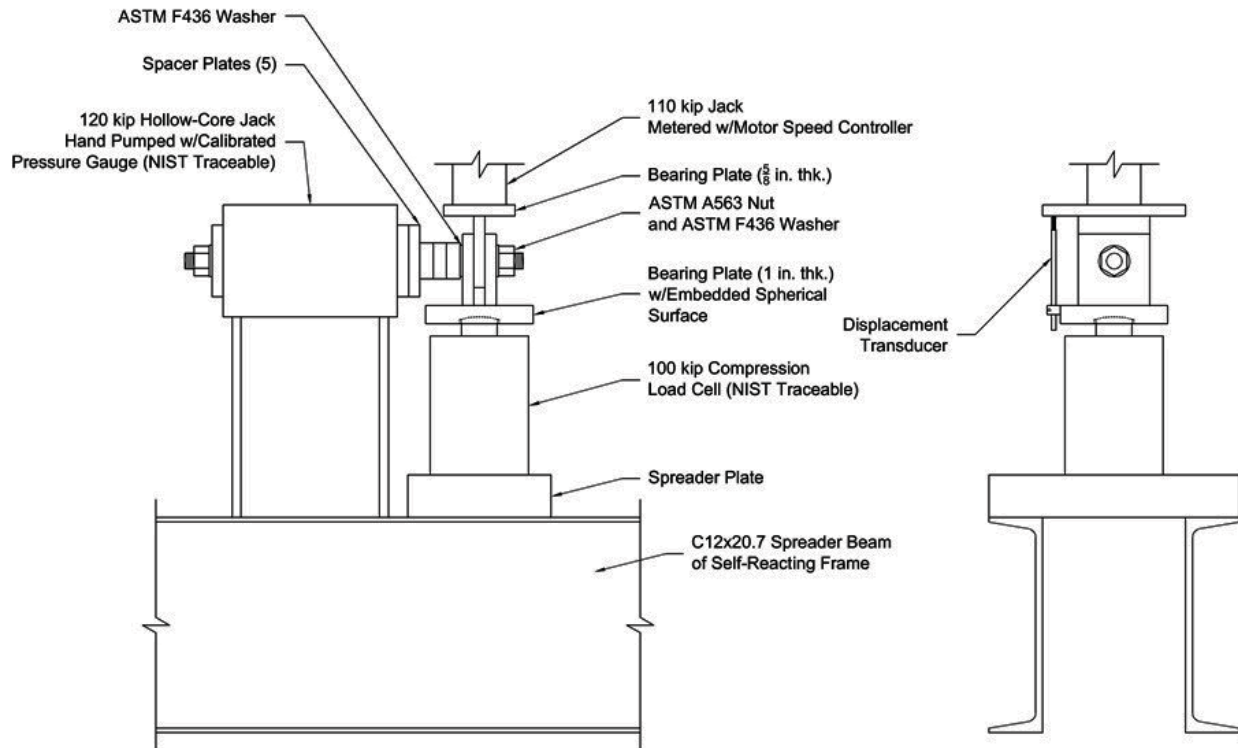
The testing arrangement and equipment used in lab 3 is depicted in figure 5. A 60-kip jack was used to provide the horizontal compressive load to the test plates. The jack was loaded with

**Figure 5. Illustration. Lab 3 testing system.**

The vertical compressive load was applied using a self-reacting frame with a 110-kip jack linked to a pump powered by a motor controller with a dial setting (i.e., a rheostat). The motor controller only regulated the rotation rate of the pump. As a result, the rate of oil flow into the jack was constant, but this did not translate into a constant load or displacement rate on the jack because of the frame compliance. The rheostat on the motor controller was set on the same rate for every test (the rate was chosen based on experience of running so many tests by the lab). The operator verbally indicated that it was within the RCSC limits. The load during the test was read from a digital readout linked to the vertical load cell. A single LVDT was used to measure displacement. The vertical slip load and LVDT displacement signals were sent to an analog X-Y plotter, which traced the load-displacement profile during each test.

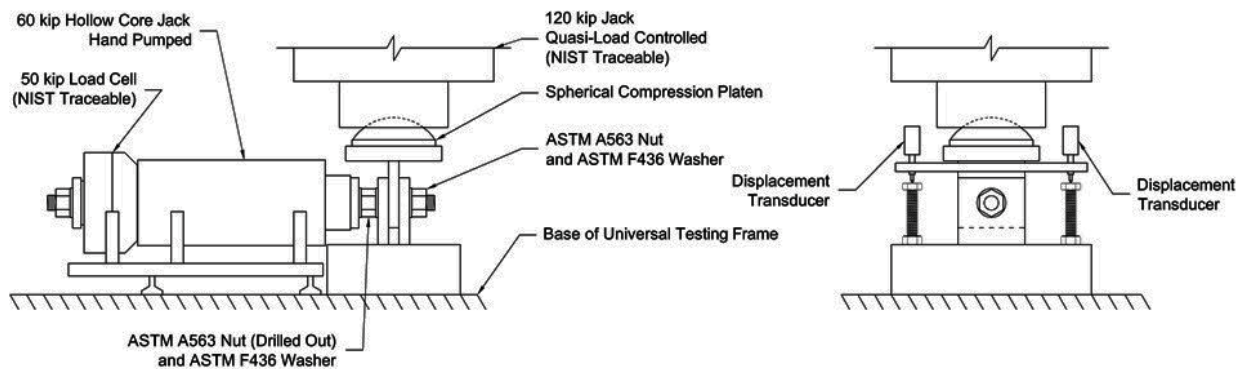
The slip tests conducted in lab 4 were performed in an existing 100-kip universal testing machine with a 30-ton center hole hydraulic jack applying the clamping force to the test plates. The overall test setup is shown in figure 6. The horizontal jack was arranged in series with a 100-kip load cell to allow monitoring of the clamping force. This jack and load cell were placed in a wood cradle constructed to hold them in horizontal alignment; this wood cradle also had four leveling feet supporting it to allow leveling of the clamping system and alignment with the test specimens. A  $\frac{7}{8}$ -inch threaded rod (heat treated for additional strength) was inserted through the jack and load cell and held in place against the load cell with a plate washer and  $\frac{7}{8}$ -inch nut. Due to the large diameter of the actuator's center hole, the threaded rod was able to shift significantly when not engaged. To minimize displacement at this interface, a plastic spacer was fabricated and placed over the  $\frac{7}{8}$ -inch threaded rod to ensure a tight fit between the elements. A plate washer and  $\frac{7}{8}$ -inch nut (which has its threads drilled out to enable free movement along the threaded rod) were then placed on the threaded rod against the jack.

Figure 6. Illustration. Lab 4 testing system.

At the beginning of each test, a  $\frac{7}{8}$ -inch washer was placed over the drilled-out nut, and the test plates were placed on the rod in the configuration provided. The test plates sat on a 3-inch-thick steel plate to allow alignment with the clamping system. This plate also held the bolts that the LVDTs bore against. A  $\frac{7}{8}$ -inch washer and nut were then attached to the threaded rod and tightened until the middle test plate was aligned with the spherical head installed on the 100-kip testing machine. The middle plate was then raised until the bottom of its hole was in contact with the threaded rod (to ensure maximum possible slip) and then held in place with two wooden wedges. The horizontal jack was then extended (by use of a hand pump) until 49 kip of clamping force was applied. Due to creep in the coatings and bleeding in the actuator, this load often slowly dropped over time, so additional pumping was needed over the course of the test to maintain the clamping load within the 0.5-kip tolerance of the RCSC specifications. During clamping, the test plates often underwent a small shift in position upon initial contact with the actuator. Due to this shift, the plates could move out of alignment such that one test plate did not bear against the reaction surface. Thus, after clamping, a visual inspection of the plates was conducted to confirm contact between both plates and the bearing surface.

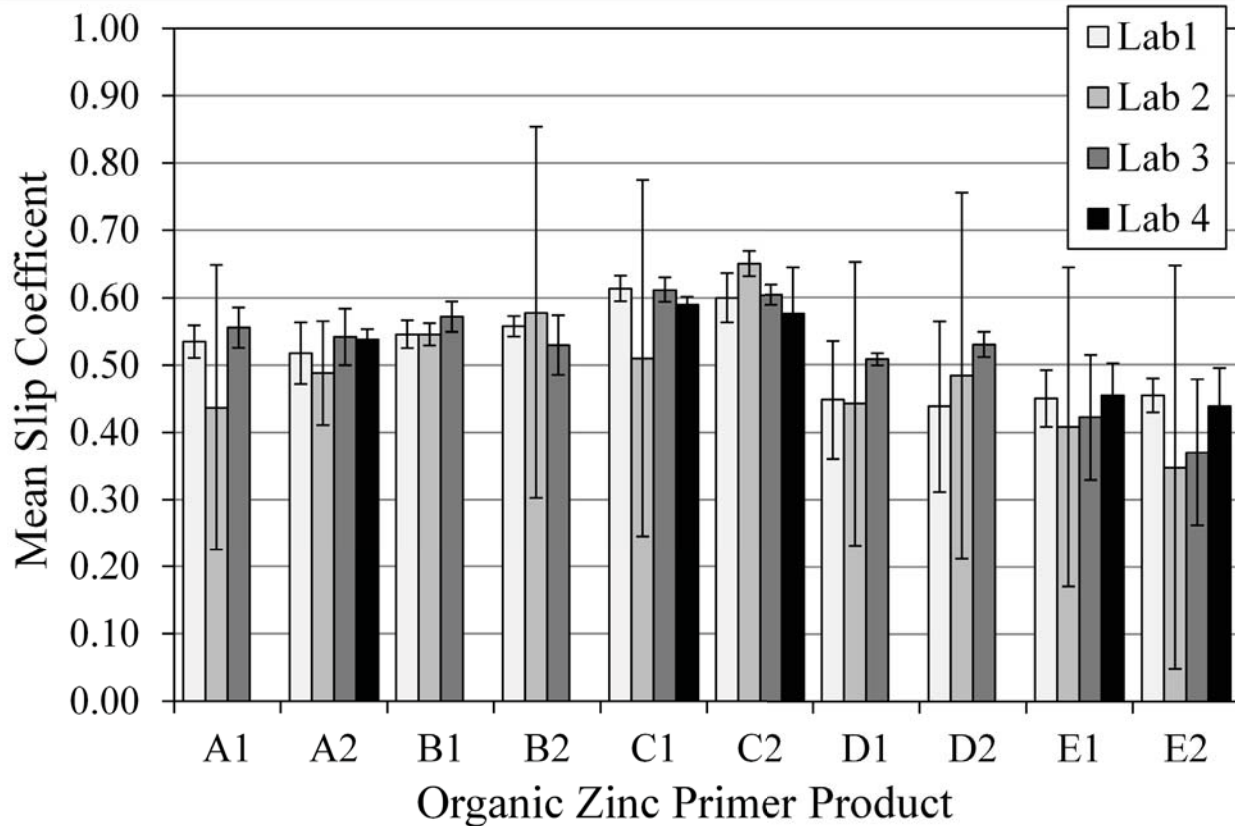
Table 2 also reports the average and coefficient of variation (COV) for sets of five samples that were tested by each lab and for each coating. Figure 7 displays all the slip data for each coating and lab. Each bar in the graph has error bars that are symmetrically plotted based on the COV value. The load versus slip plots for every specimen, from each lab, and each coating can be found in the appendix A. Two of the labs recorded data on analog X-Y plotters, and scans of the plotter paper had to be manually encoded into a spreadsheet so uniformity of the plots could be shown. It was universally interpreted by the labs that the intent of the RCSC specification was to assume that zero slip had occurred when 1.0 kip of vertical load was applied to the specimen. Therefore, some of the datasets strictly began from a point of 1.0 kip of load and zero slip displacement, and other labs continuously recorded the data and manually subtracted off the displacement at 1.0 kip when determining failure load using the 0.02-inch displacement criteria. For uniformity of the data presentation in the appendix, for the two labs that recorded all the data, their curves were shifted in the X-direction such that the curves intersected the y-axis at 1.0 kip.

**Figure 7. Graph. Mean slip coefficient for each coating system tested at each test lab using existing RCSC failure criterion.**

In comparing the mean slip values as shown in figure 7, there is no discernable trend of one lab consistently producing higher or lower numbers than the other labs. However, the error bars for lab 2 were consistently much larger than the other labs. When the COVs were averaged across all the coatings tested by each lab, it was found that labs 1–4 had an average COV of 0.044, 0.188, 0.040, and 0.040, respectively. Clearly, the data indicate that variability is quite consistent between labs 1, 3, and 4 and different in lab 2.

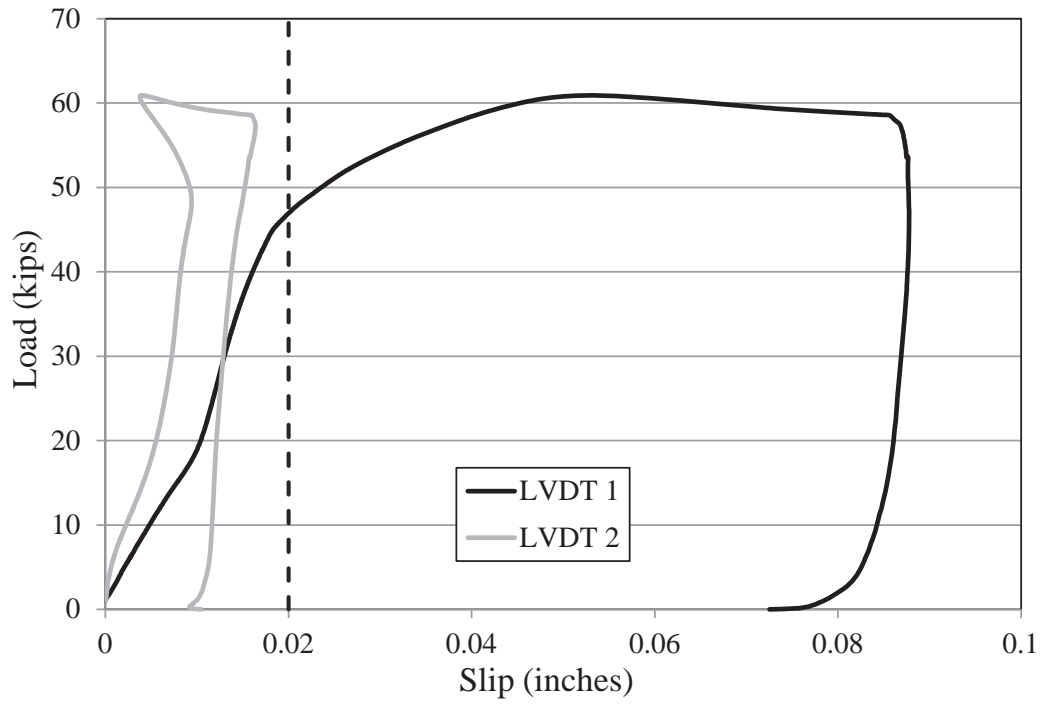
**Figure 8. Graph. Load versus slip displacement response of two LVDTs from lab 4 for specimen C2-1.**

To further show the effect of variability using one displacement measuring device, all data were reanalyzed ignoring the 0.02-inch slip failure criterion, and the slip coefficients were calculated using just the peak loads. The slip coefficient data based on just the peak load response are shown in table 3 and figure 9. When looking at just the peak load data, for many of the coatings where lab 2 deviated considering the 0.02-inch criteria, the average was closer to the other three labs as well a reduction in scatter. This further indicates that the measurement technique of slip displacement was the major factor in variability between labs.

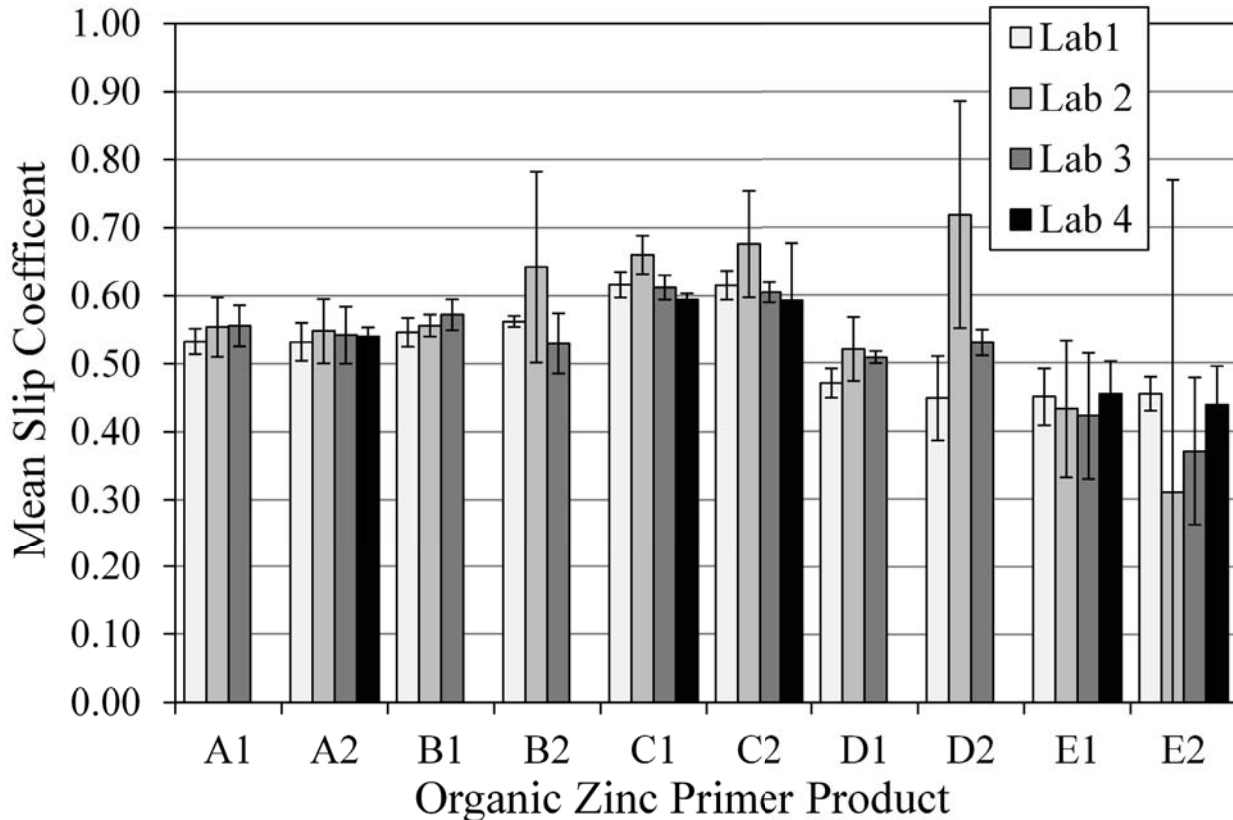
**Figure 9. Graph. Mean slip coefficient for each coating system tested at each test lab only using peak load response.**
