# Interlaboratory Variability of Slip Coefficient Testing for Bridge Coatings

PUBLICATION NO. FHWA-HRT-14-093

DECEMBER 2014

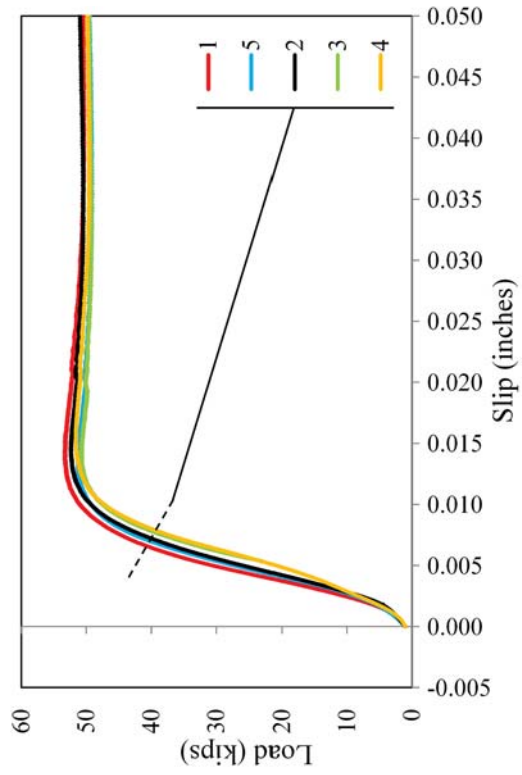
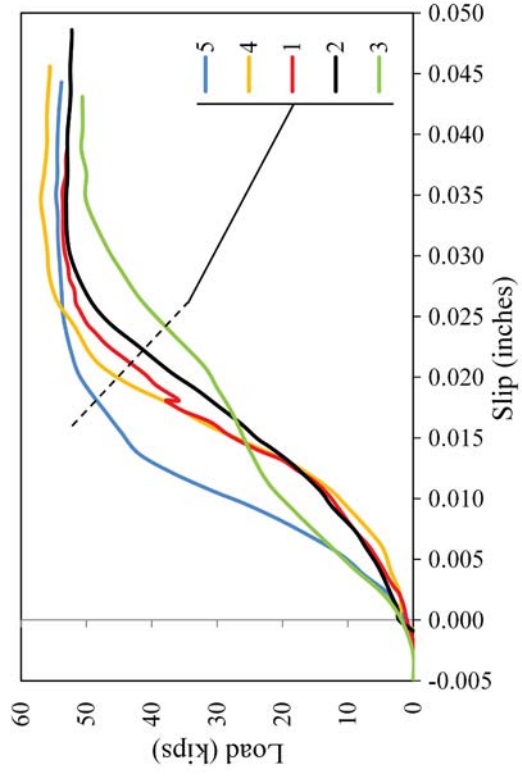
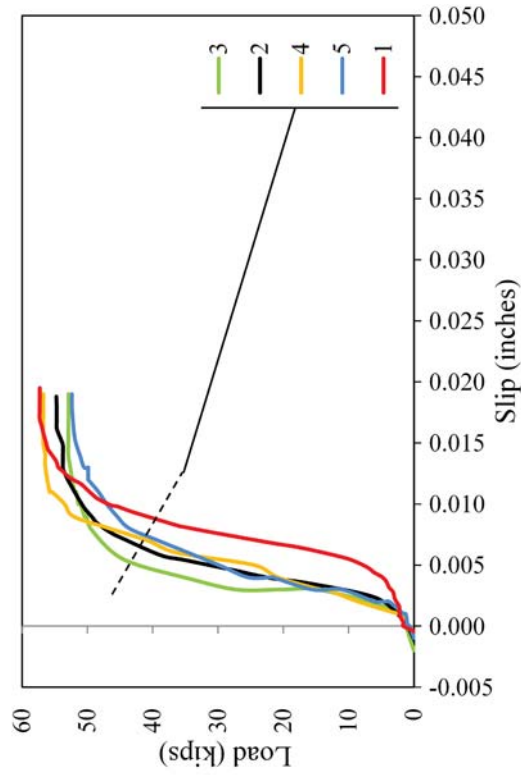
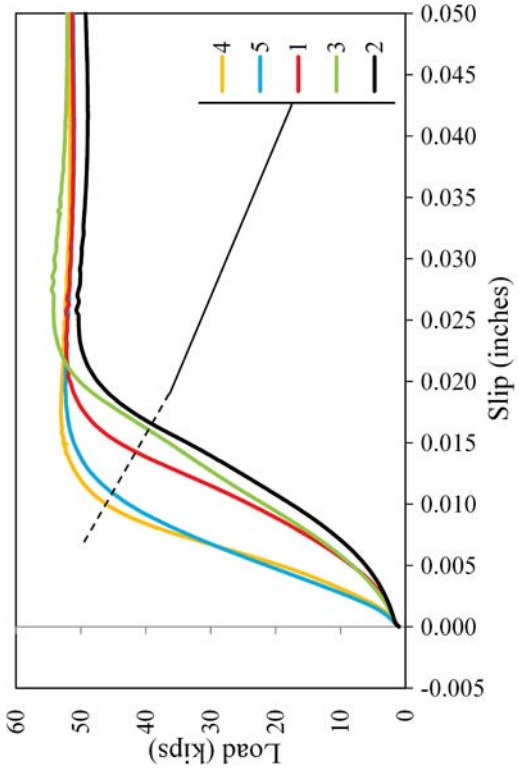
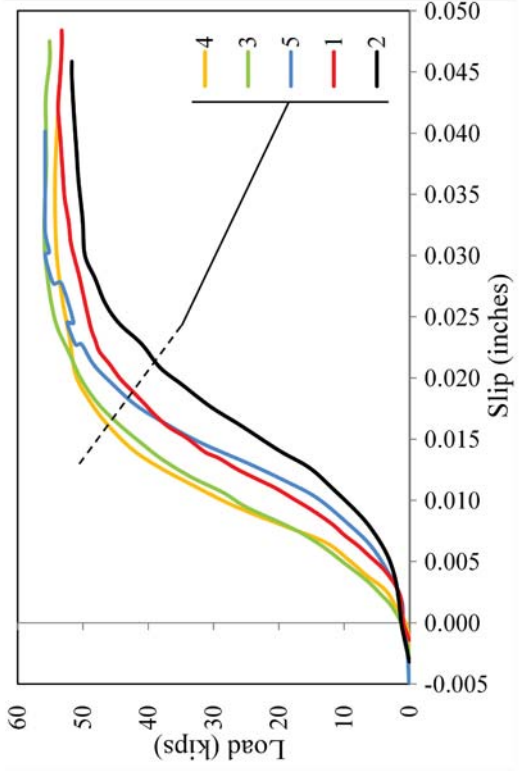
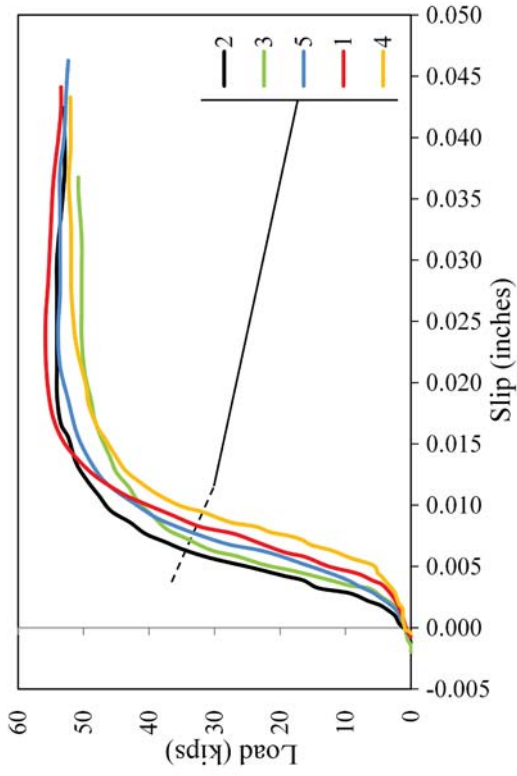
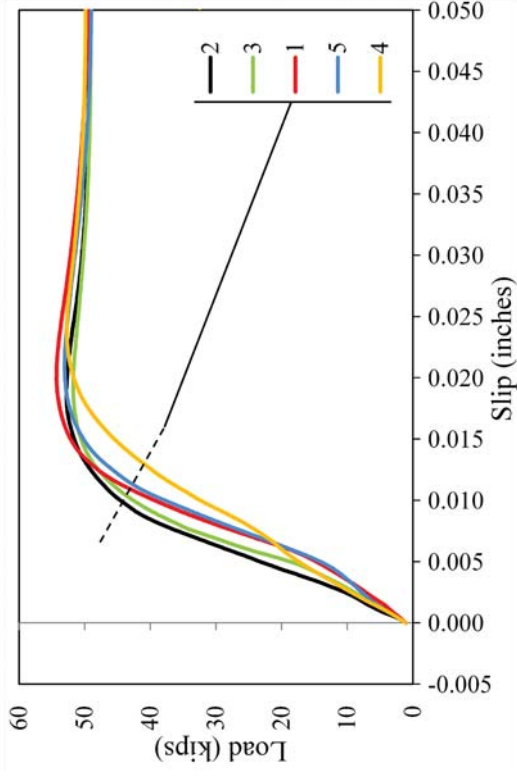
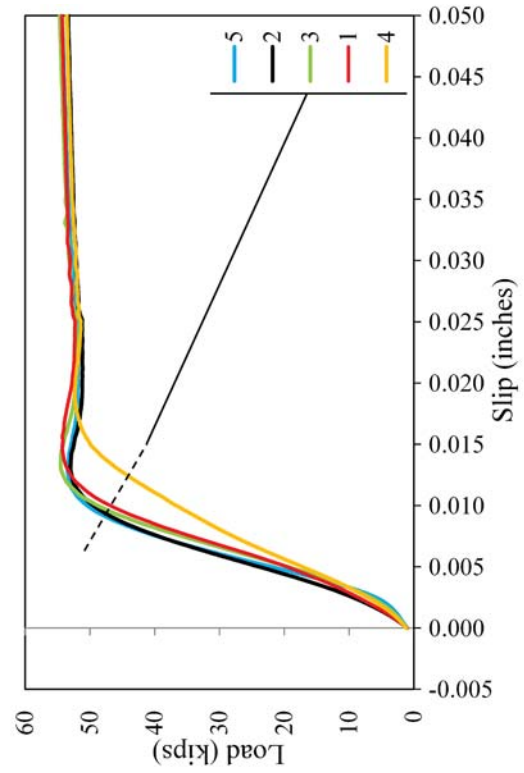
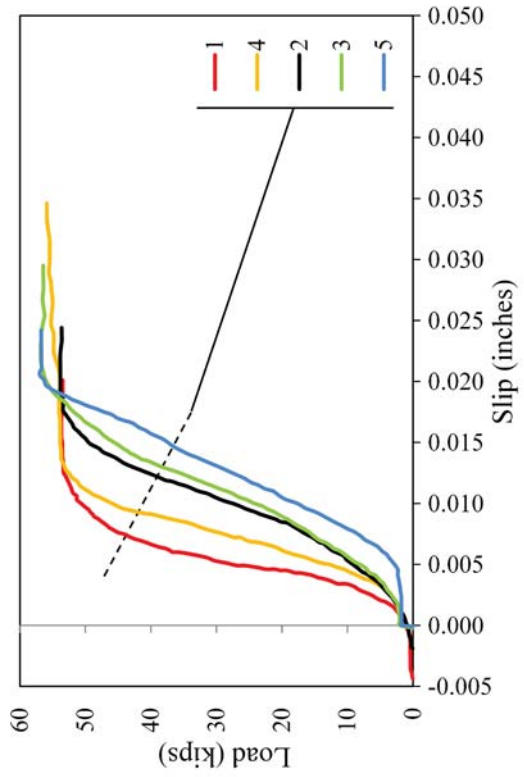
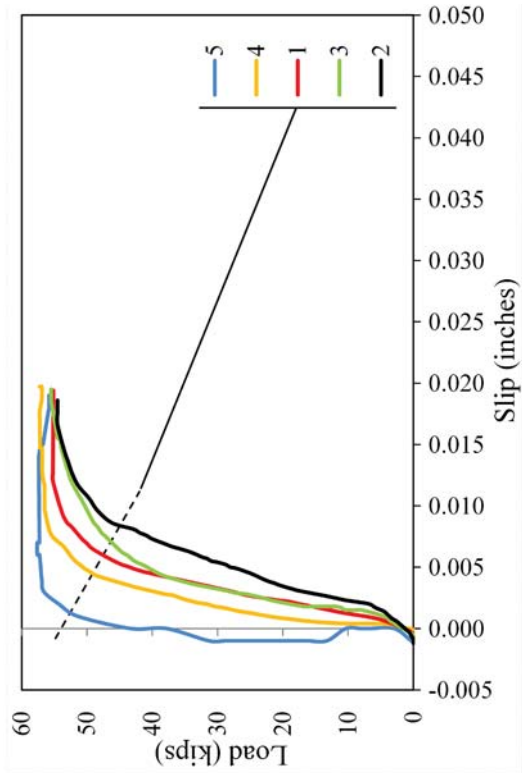
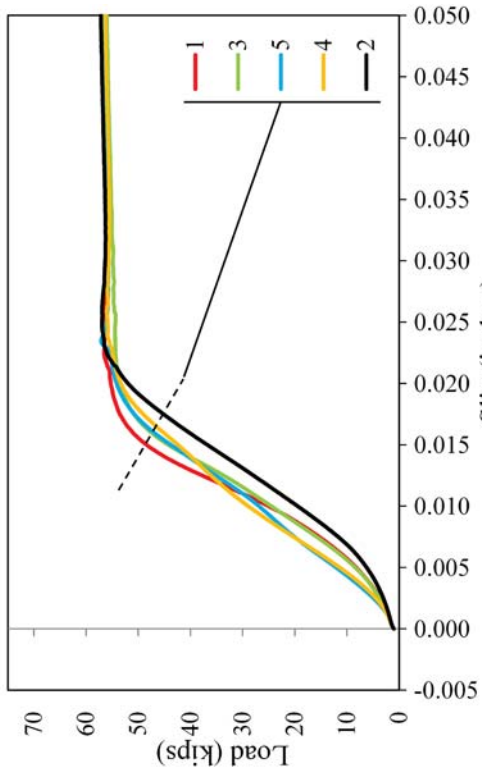
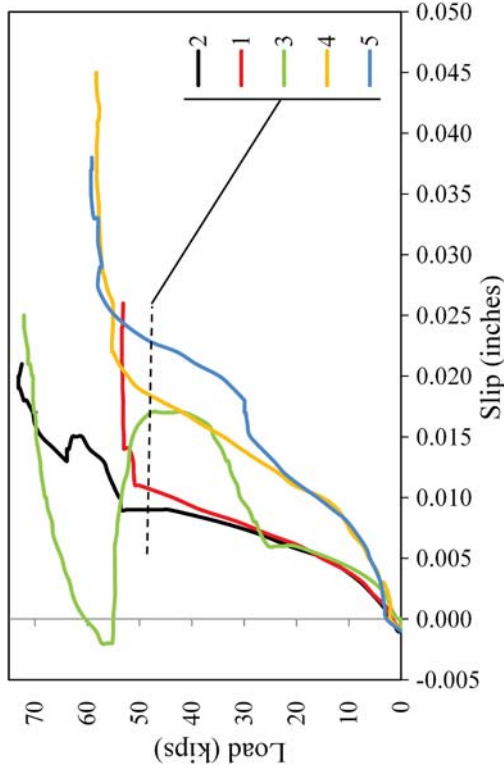
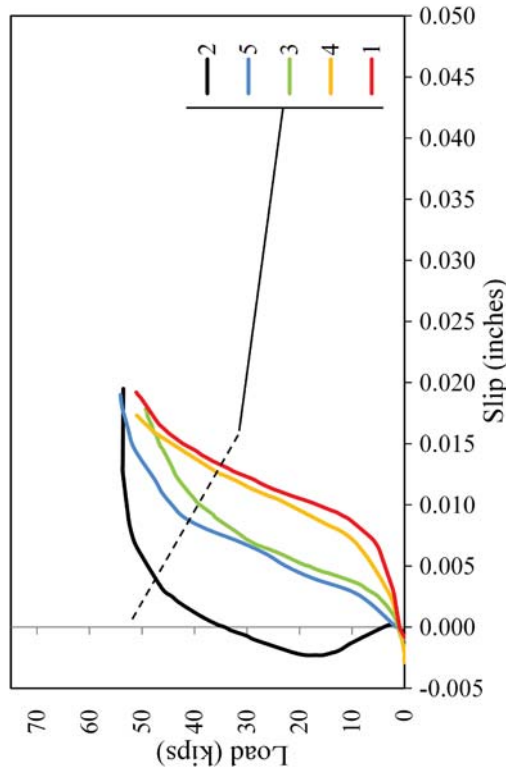
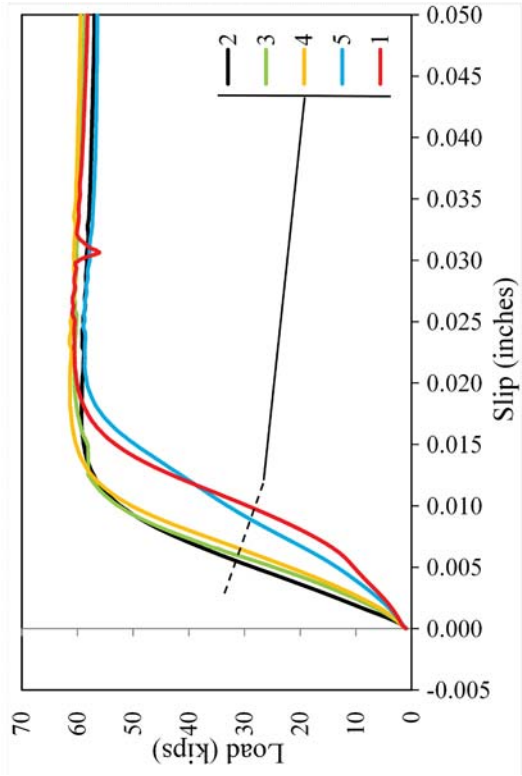
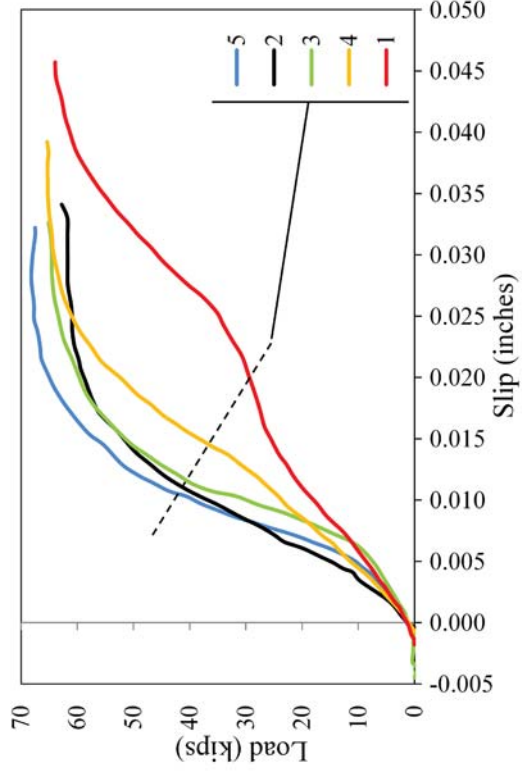
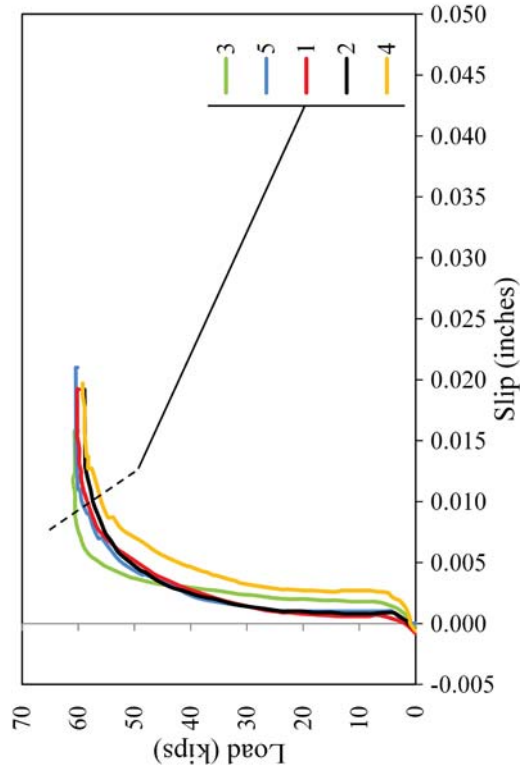
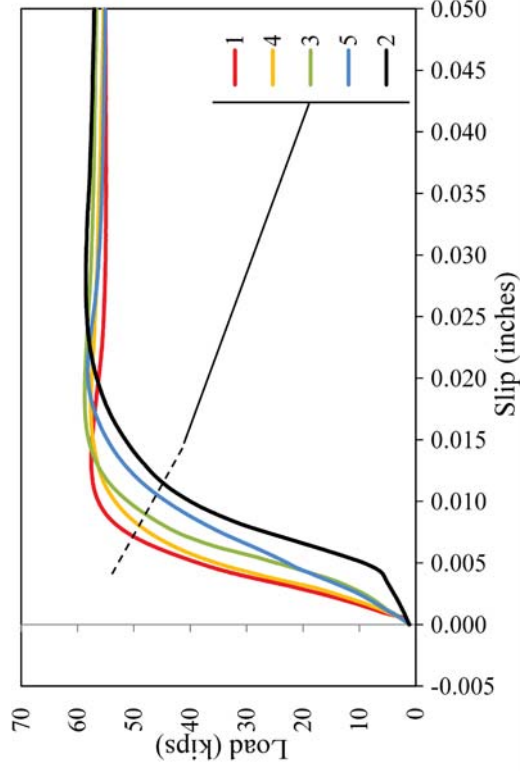
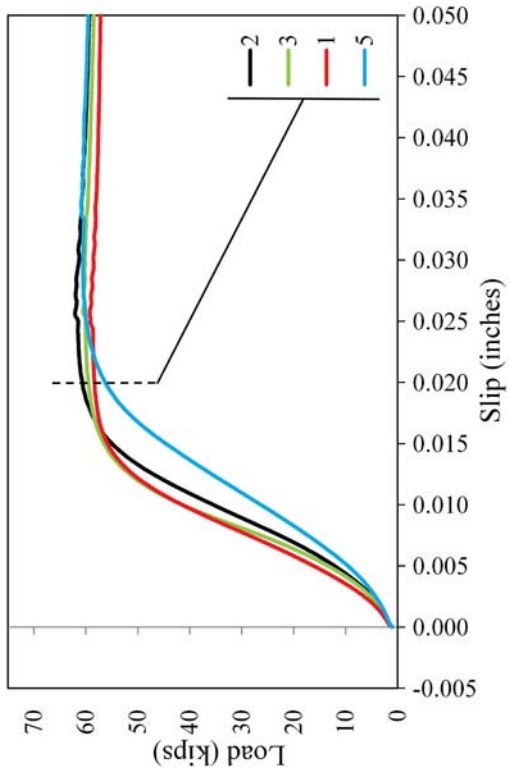
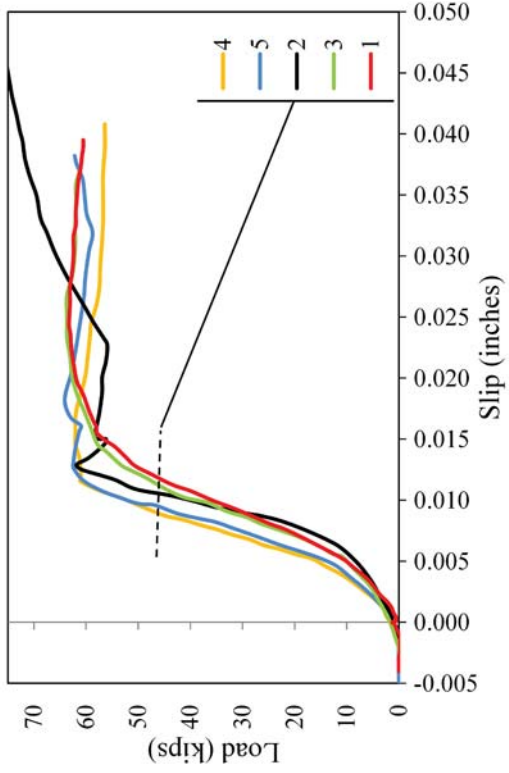
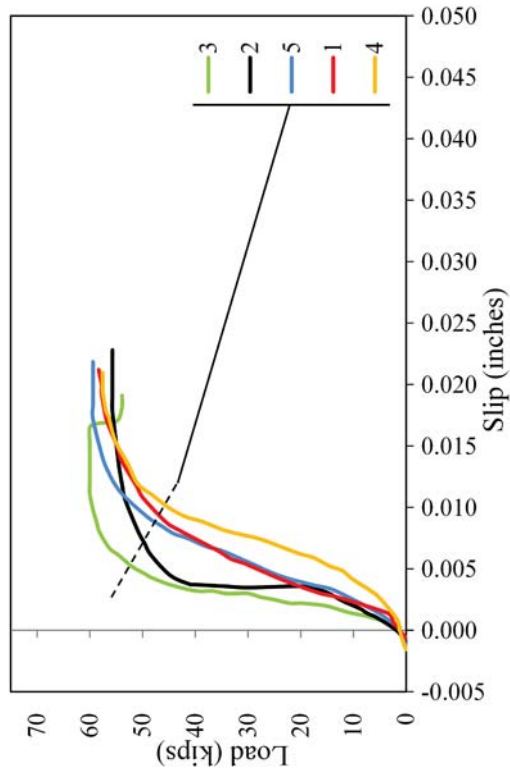
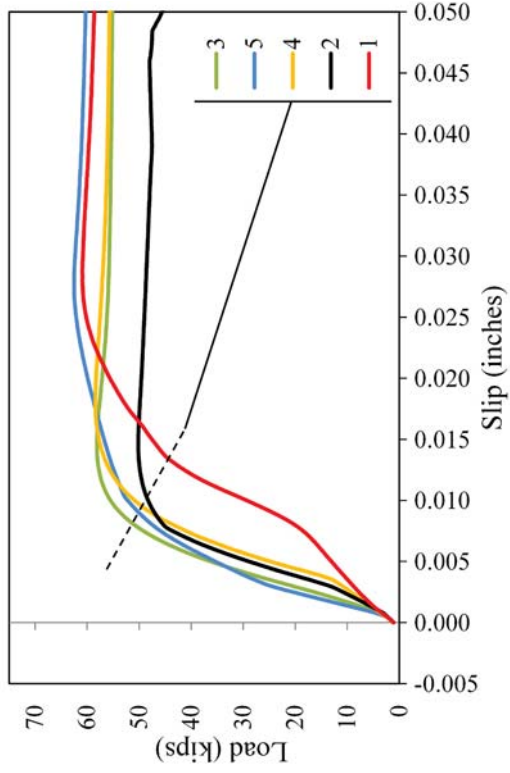
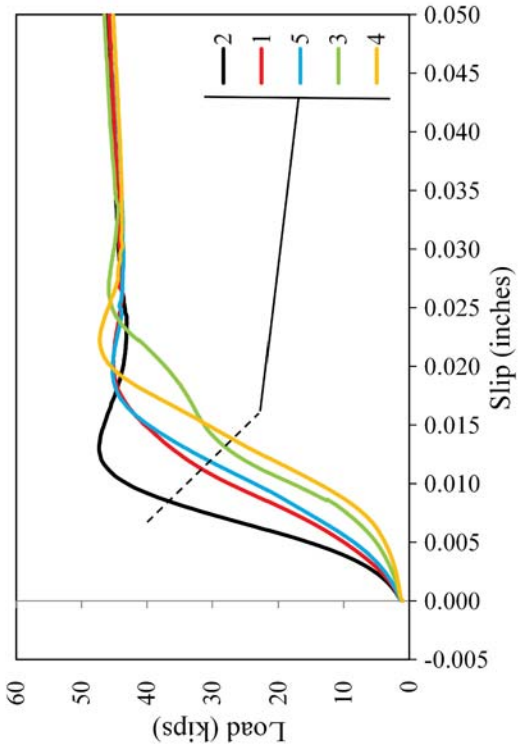
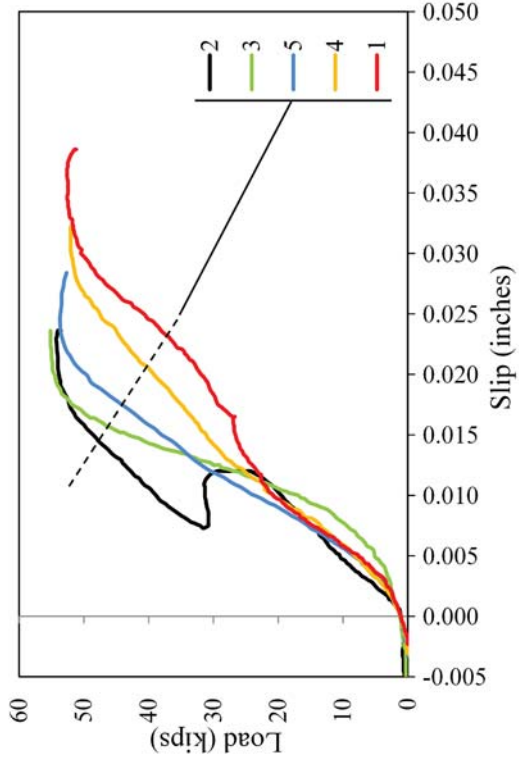
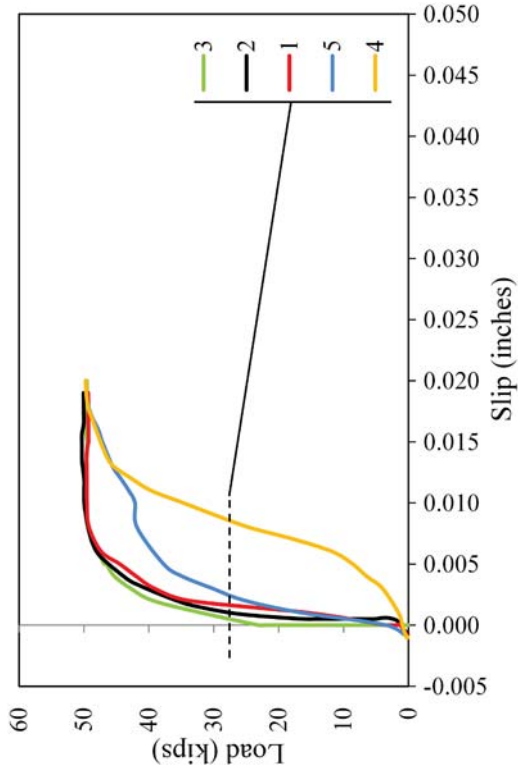
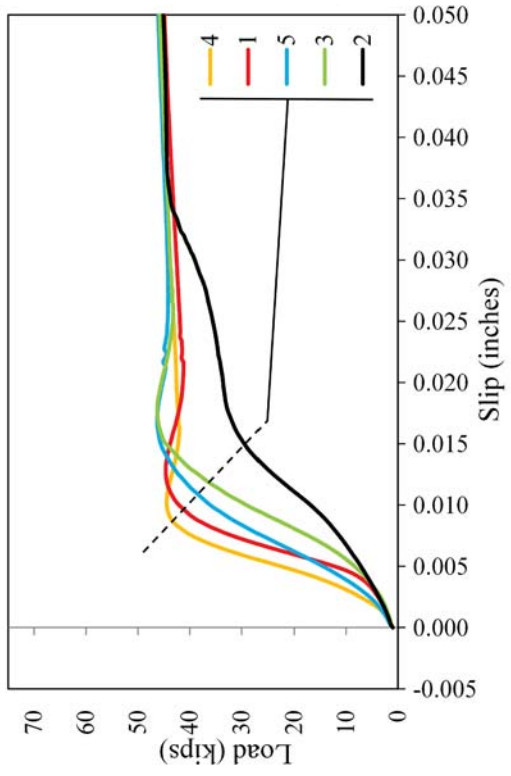
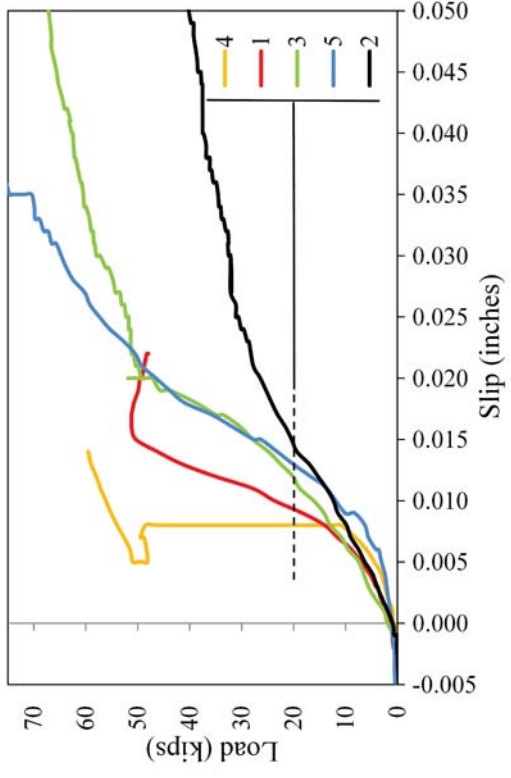
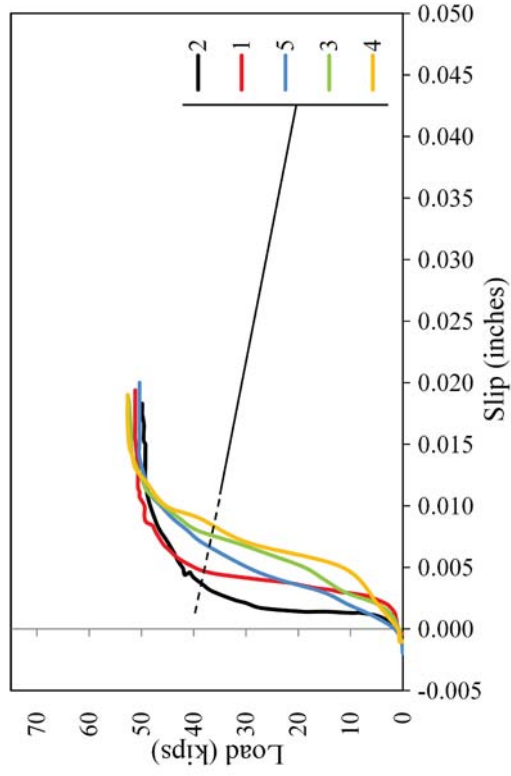
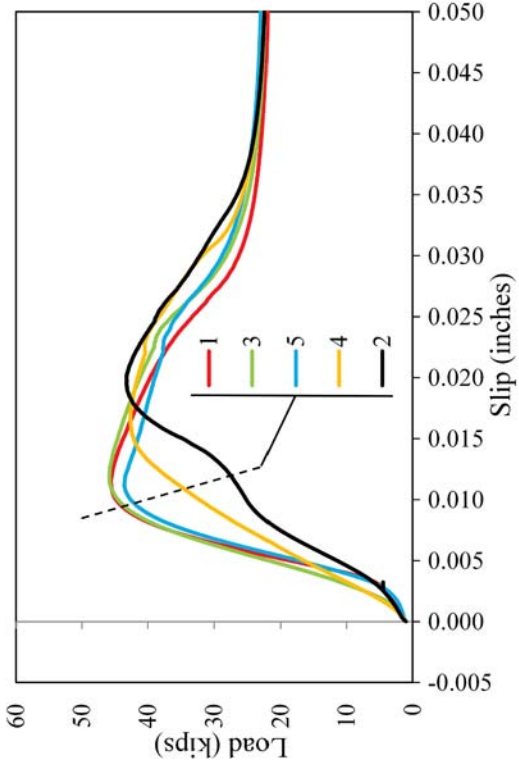
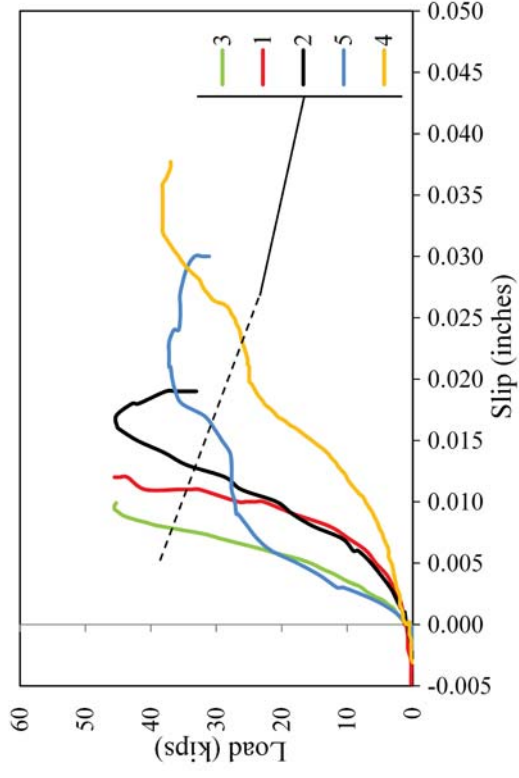
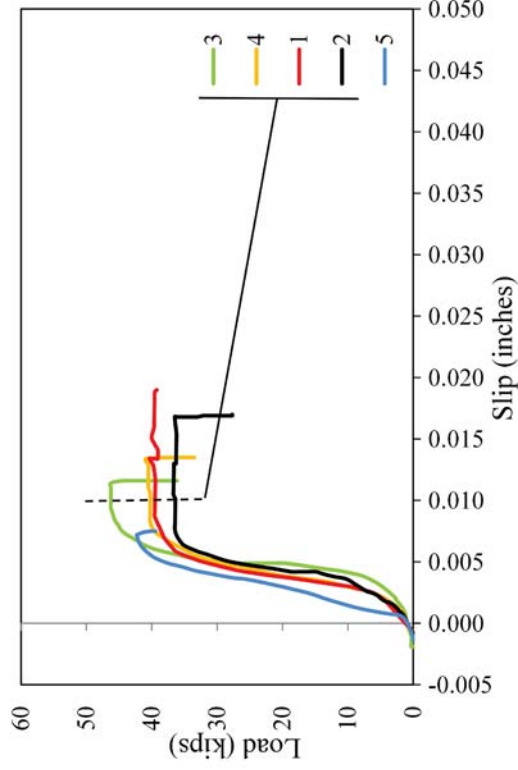
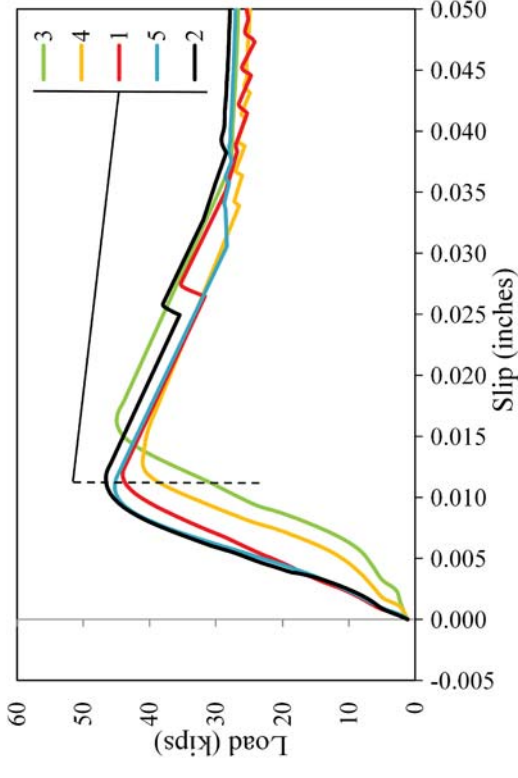
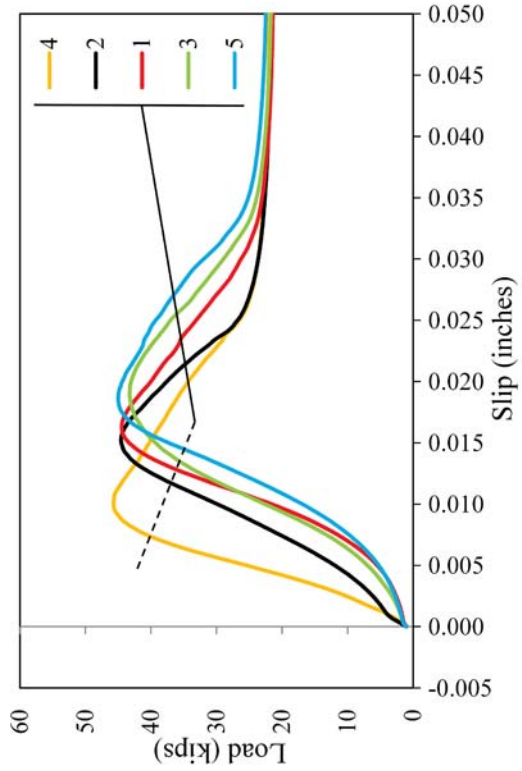
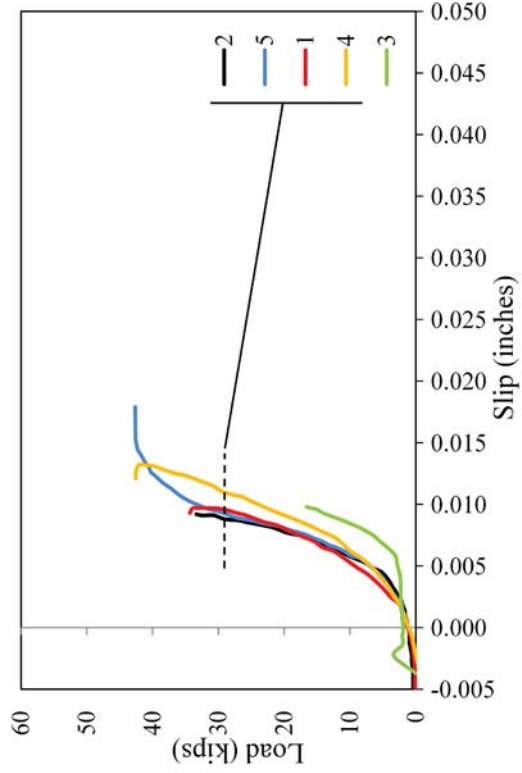
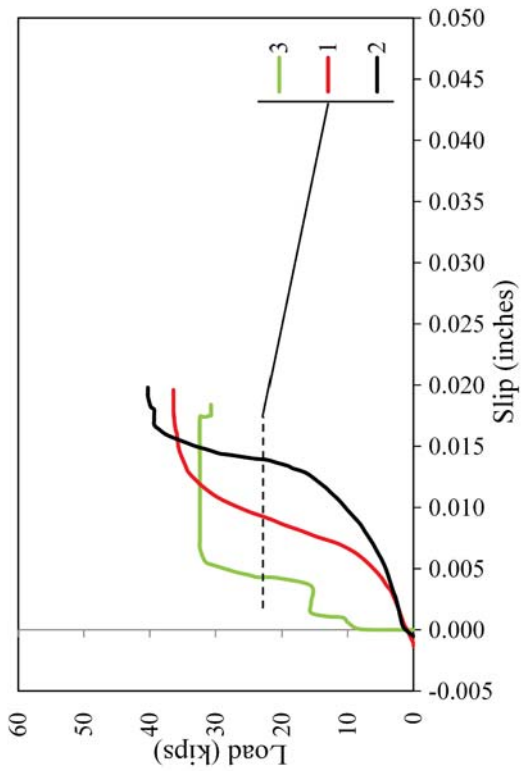
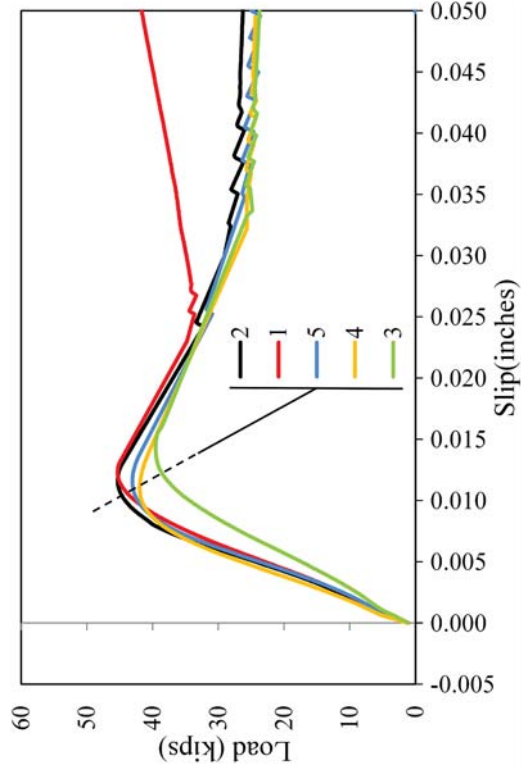
This appendix contains the load versus slip plots for all specimens tested as part of the interlaboratory variability study. For each coating series, the plots are scaled uniformly for the three or four labs participating to highlight the differences between individual laboratory practice in conducting the RCSC test. Lab 4 only participated in half of the coating series.

For some graphs, the individual data plots within them may be so close to each other that it is difficult to discern one line from the other. To assist readers, a black dashed line has been drawn intersecting all plots at one section. The dashed line is connected to a leader line that connects to the legend. The order of the legend from top to bottom correlates to the order in which the dashed line intersects the individual plots. The intersected plot furthest from the leader is the top entry in the legend, and the intersection closest to the leader is at the bottom of the legend.

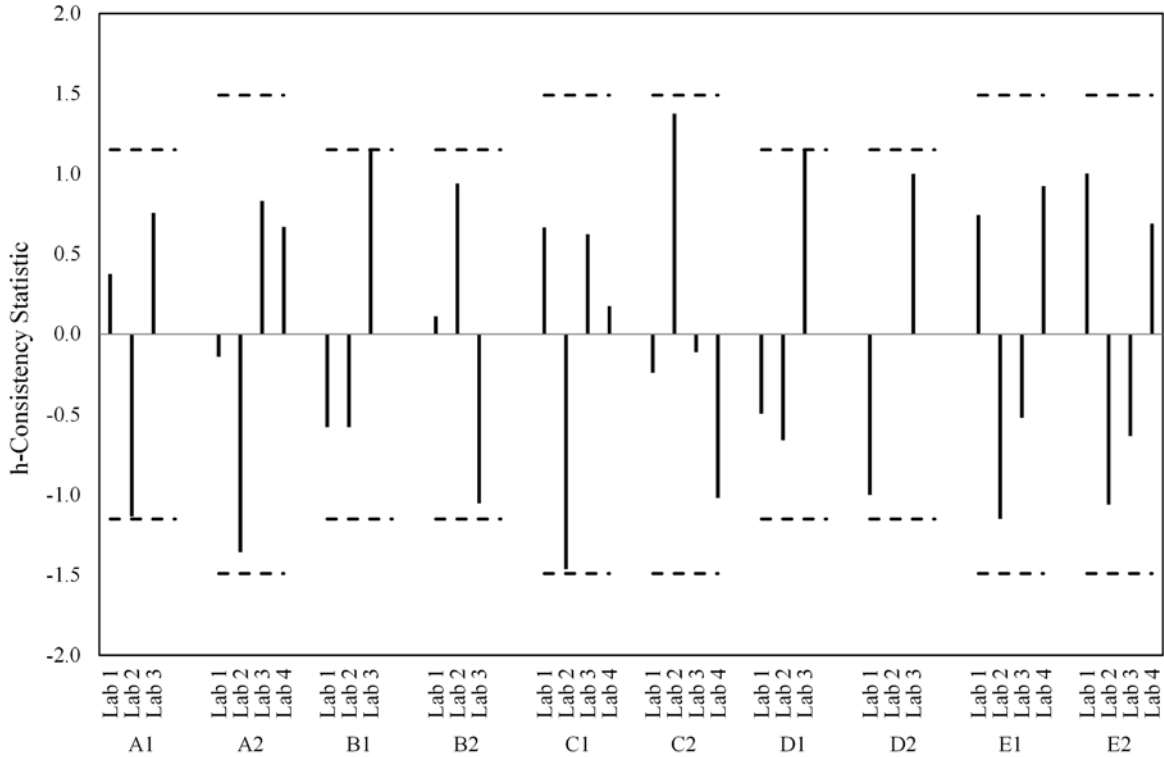
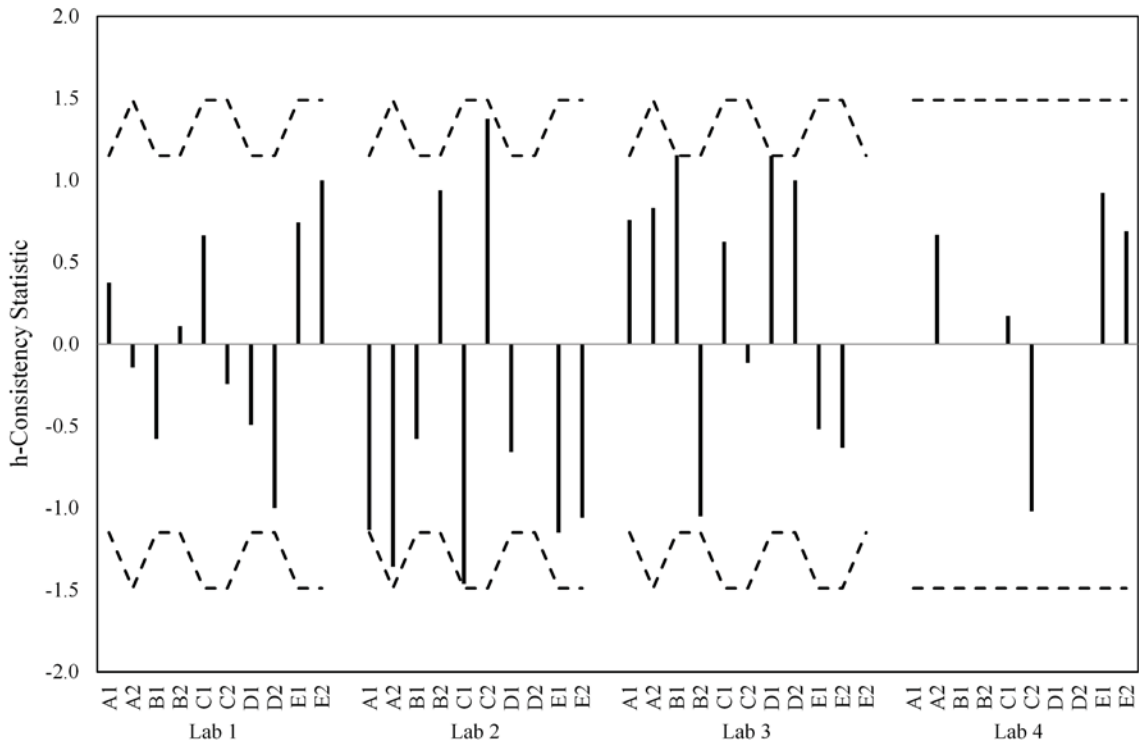
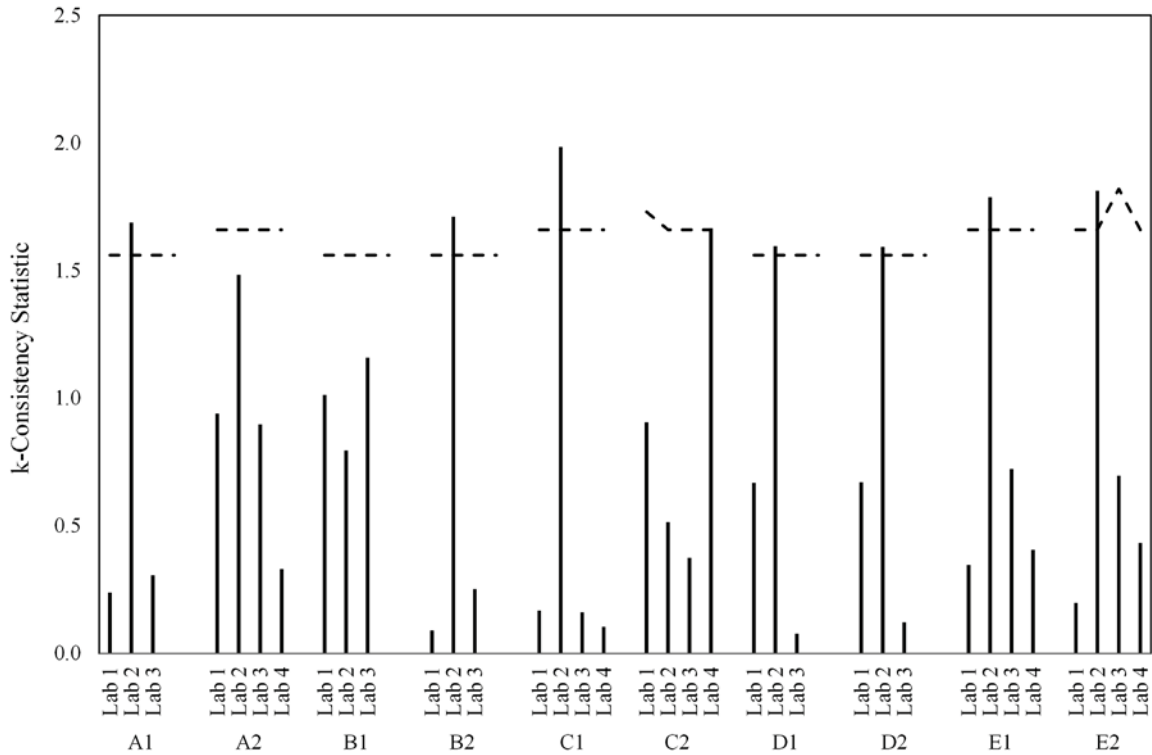
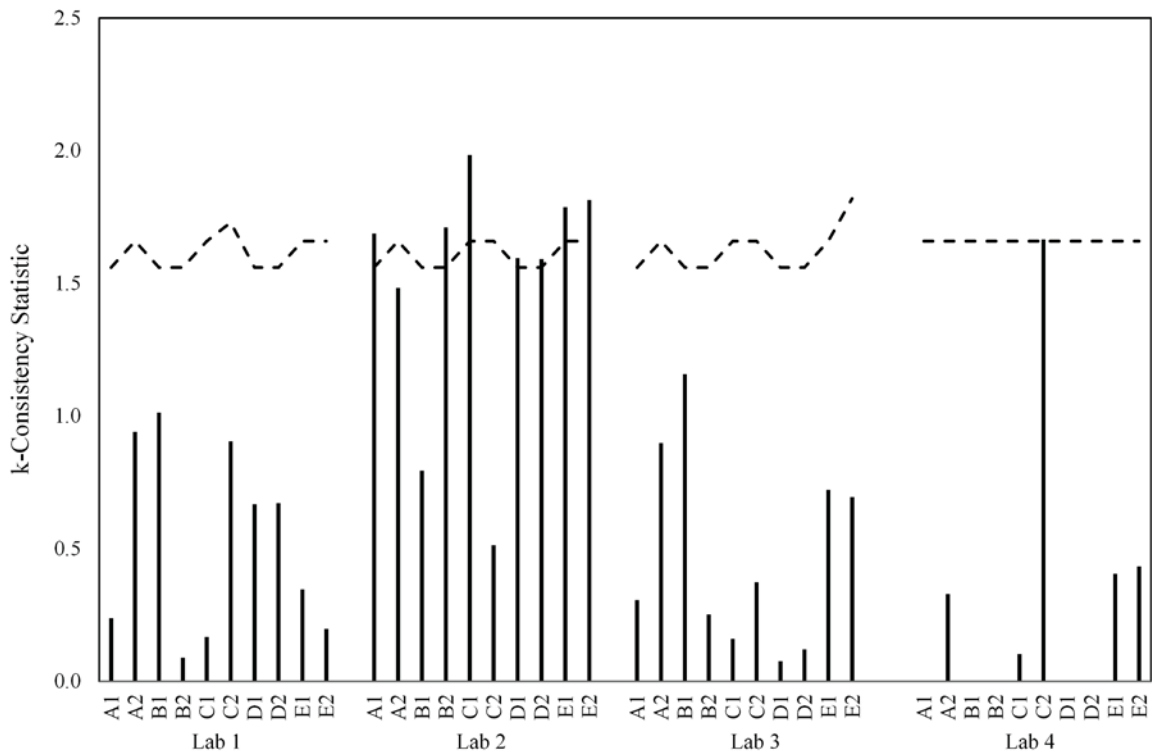
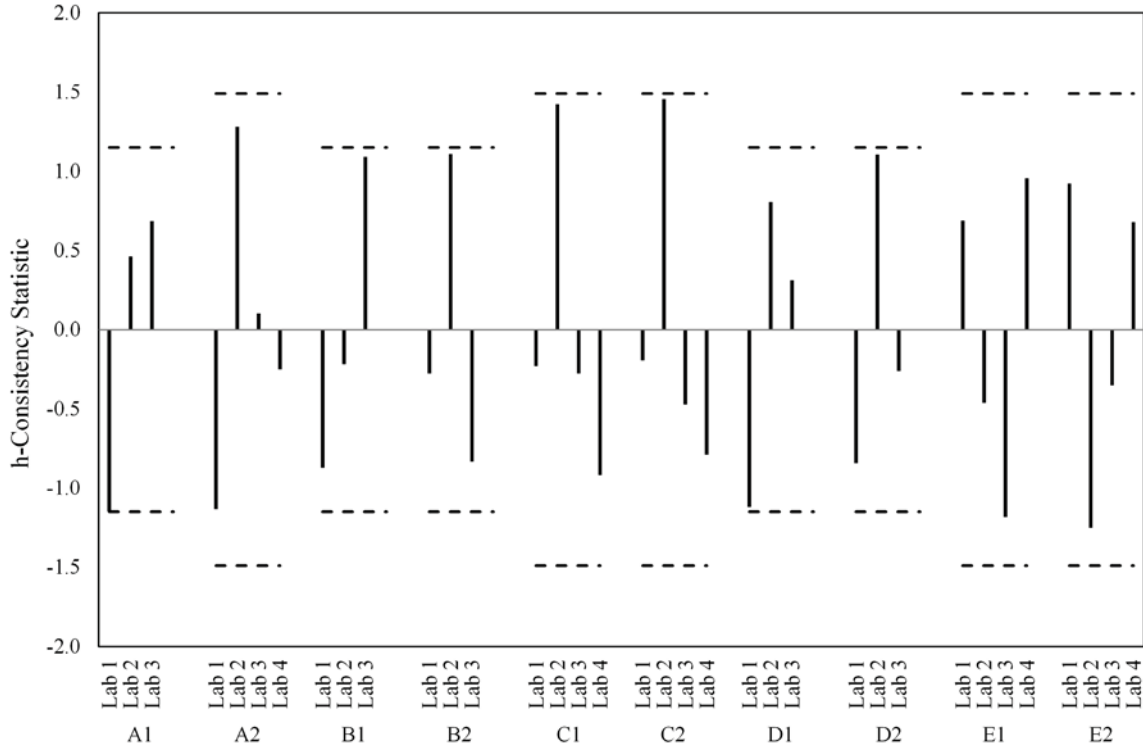
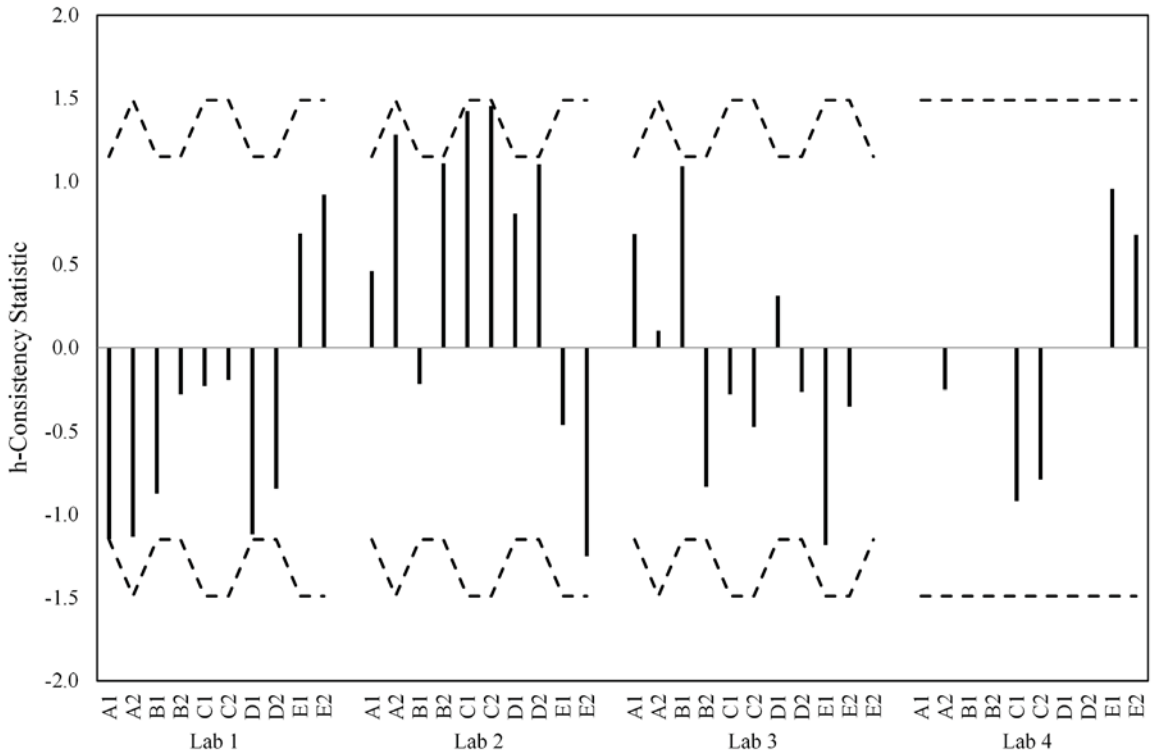
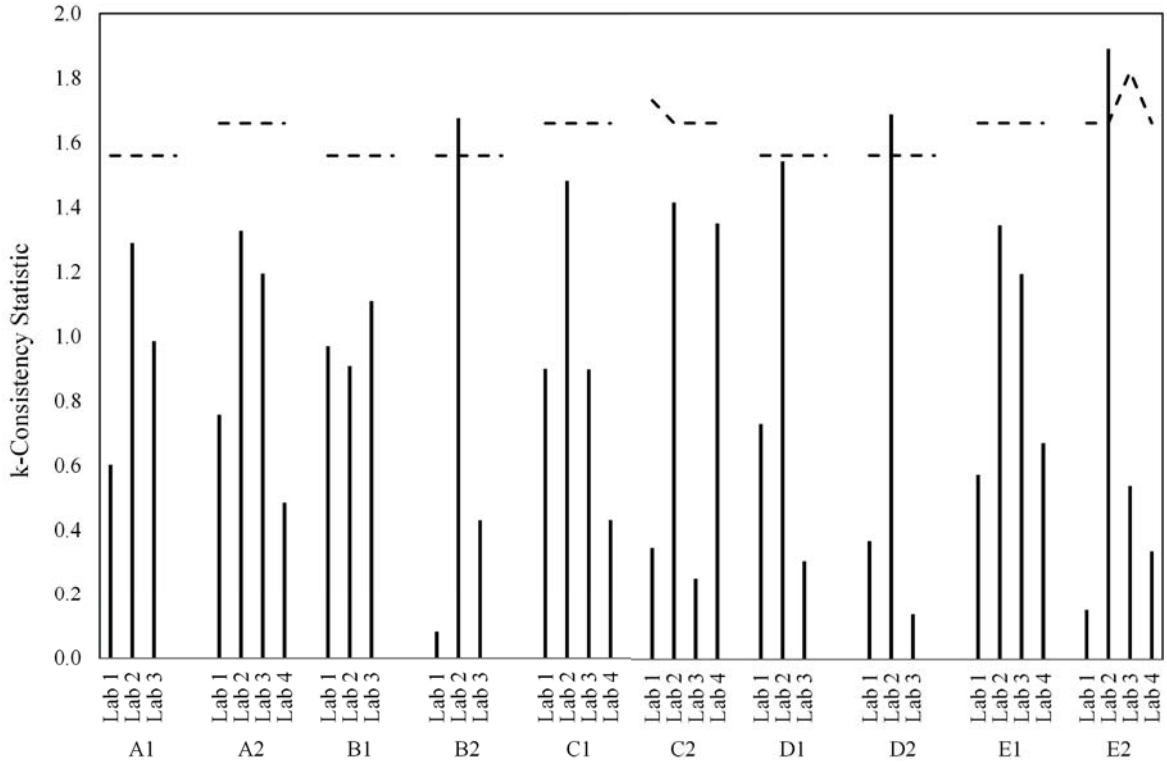
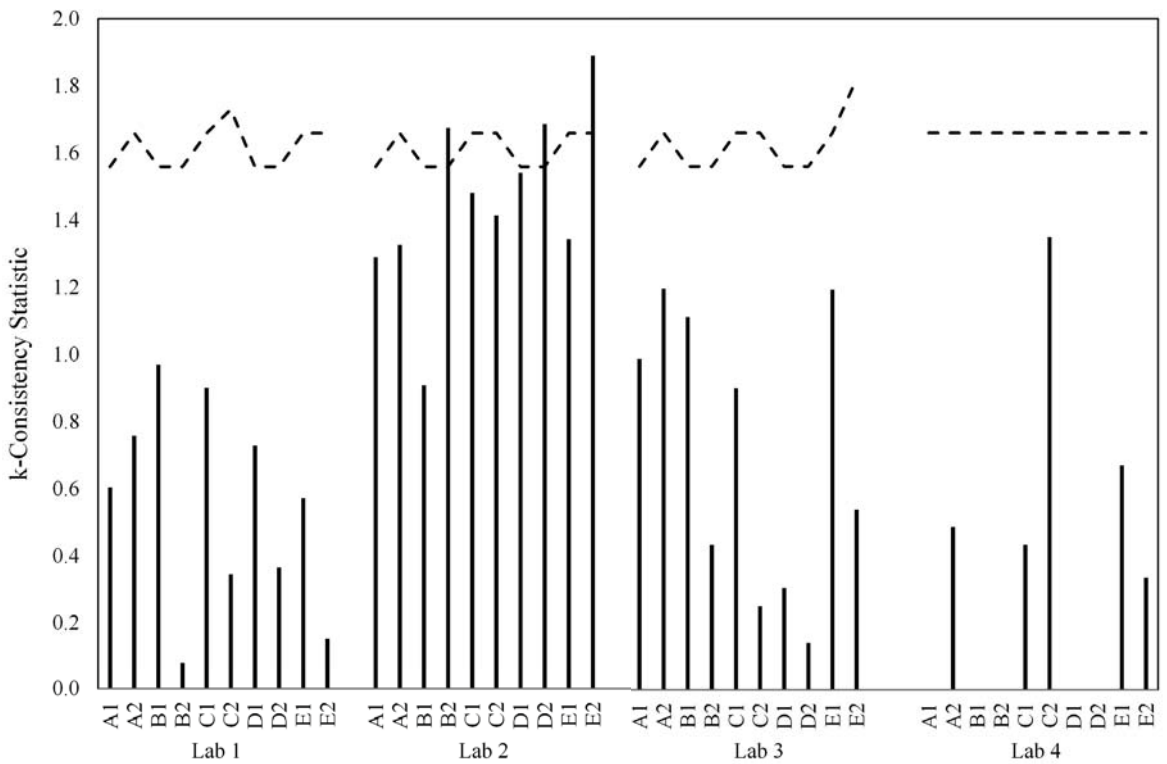
Provided all the labs produced similar data, it would not be expected that any *h*-statistic data would exceed the critical values, and inspection of the plots finds this to be the case. The ASTM E691-13 specification also alludes to the notion that there should be no expected pattern in these plots.<sup>(3)</sup> That is, data per lab could have both positive and negative *h* values, or a lab could be entirely positive provided there are an equal number of labs that are all negative. The *h*-statistic data for both criteria do not have any discernable pattern and all fall with the 95 percent confidence limits.

The critical values for the *k*-statistic are a function of the number of participating labs and number of replicates tested in each series. Since lab 4 did not participate in all series and because the number of replicates varied from three to five, there are multiple critical *k*-statistic values. As in the graphs for the *h*-statistic, black dashed lines are plotted for the critical *k*-statistic values. Since the *k*-statistic can only be a positive value, the parameter to look for is if a lab or material exceeds the critical *k*-statistic value. Inspecting the *k*-statistic graphs for lab 2 highlights the lab's differences. When considering the 0.02-inch failure criteria, 7 of the 10 materials for lab 2 had a *k*-statistic in excess of their critical values, while all other labs were much lower than their critical values (see figure 47 and figure 48). When using just the peak load criteria, lab 2 only exceeded the critical *k*-statistic value for 3 of the 10 materials, and variability was overall closer to the other 3 labs (see figure 51 and figure 52).

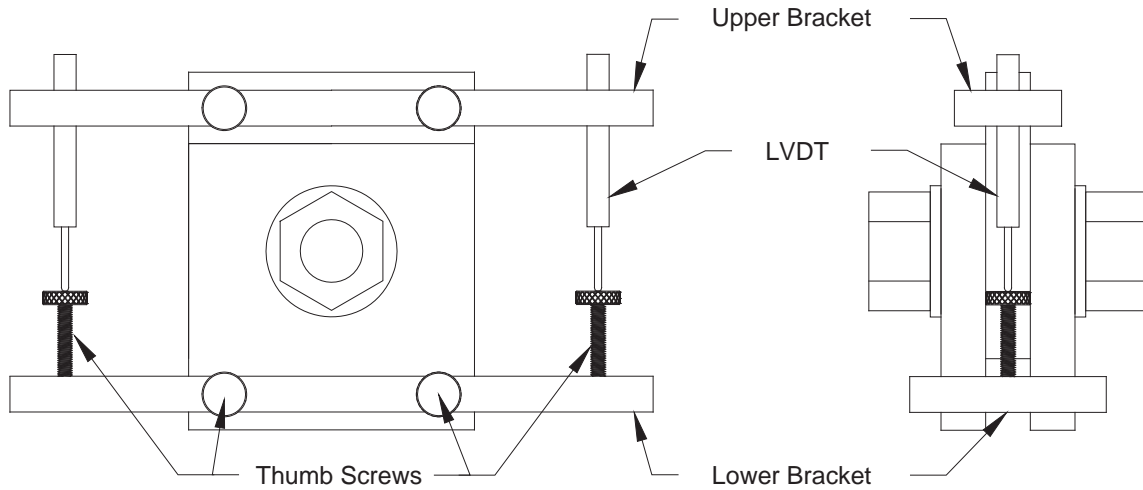
**Figure 53. Illustration. Overall view of modified slip measuring device mounted to a specimen.**

The aging study began after RCSC had begun to digest the preliminary results from the interlaboratory variability study. As such, RCSC had formed a task group to make recommendations to modify their testing specification, and the aging study was used to test some of the preliminary ideas. Mostly, the aging specimens were tested according to the existing RCSC specification except for two modifications. First, after clamping, the specimens were preloaded with 5 kip of vertical load and then unloaded to 0 kip of vertical load to set the specimen against the platens. Second, the test began from a state of 0 kip of vertical load, whereas in the variability study, it was implied that testing should begin from 1 kip of vertical load. The preload step was ignored when testing the five specimens of coating A2 to test if that step was necessary with the modified displacement measuring device.

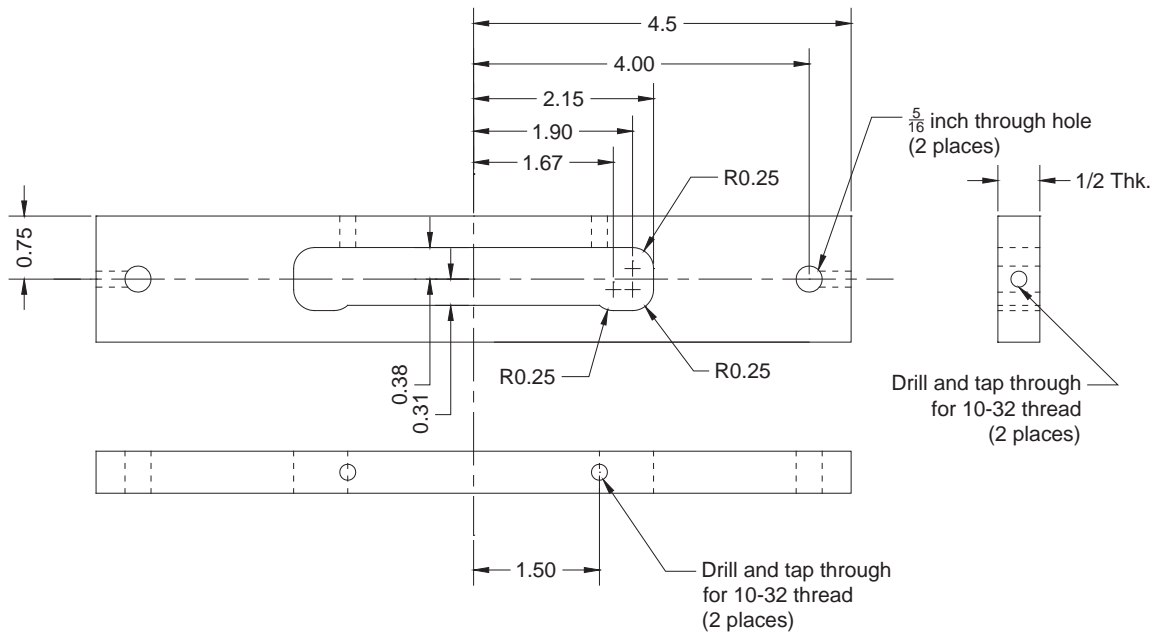
**Figure 54. Illustration. Upper bracket detailing of modified slip measuring device.**
