# Interlaboratory Variability of Slip Coefficient Testing for Bridge Coatings

PUBLICATION NO. FHWA-HRT-14-093

DECEMBER 2014

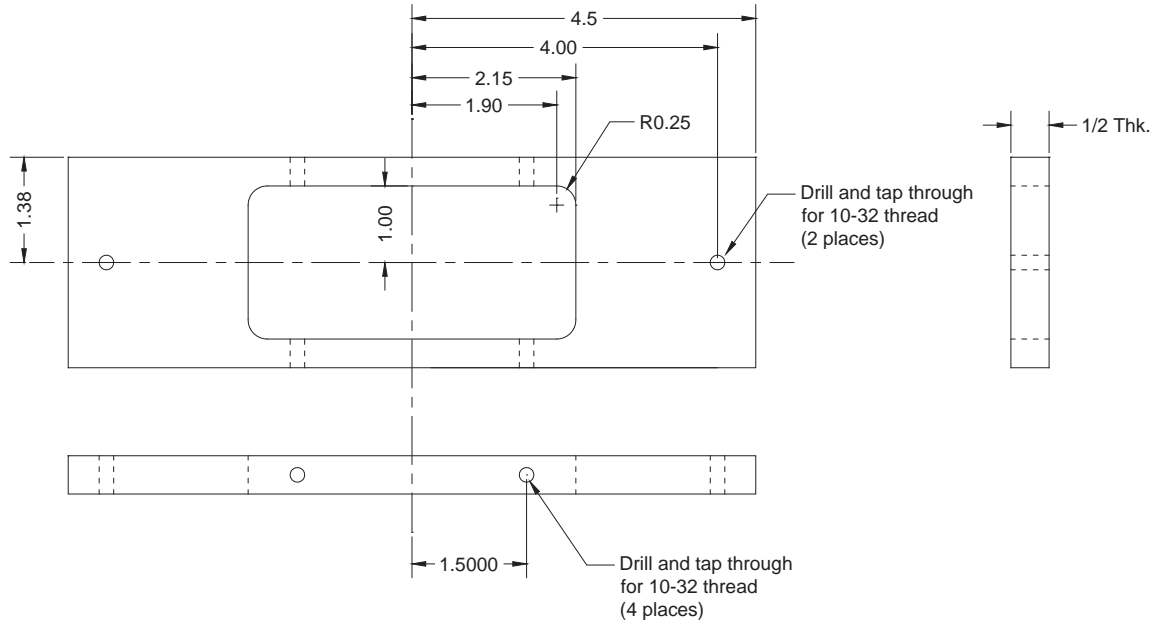
**Figure 55. Illustration. Lower bracket detailing of modified slip measuring device.**

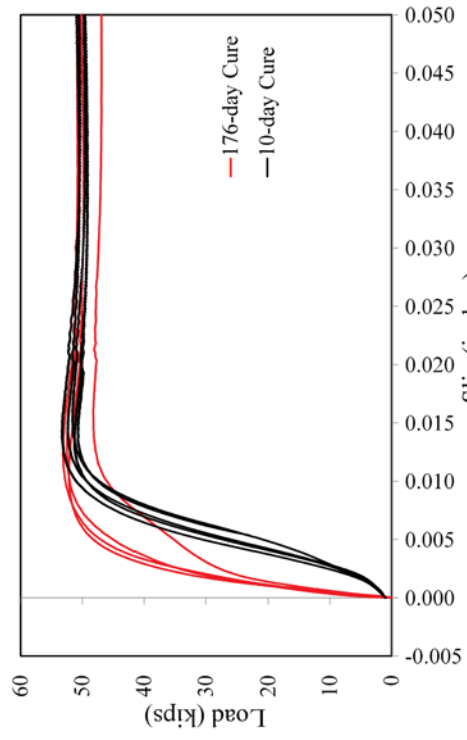
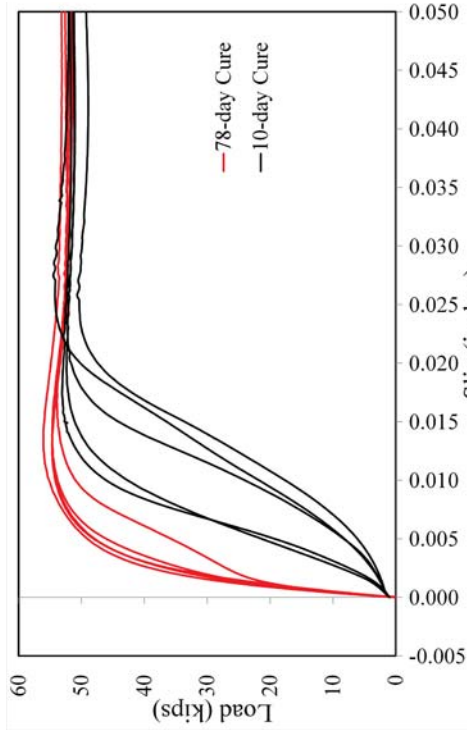
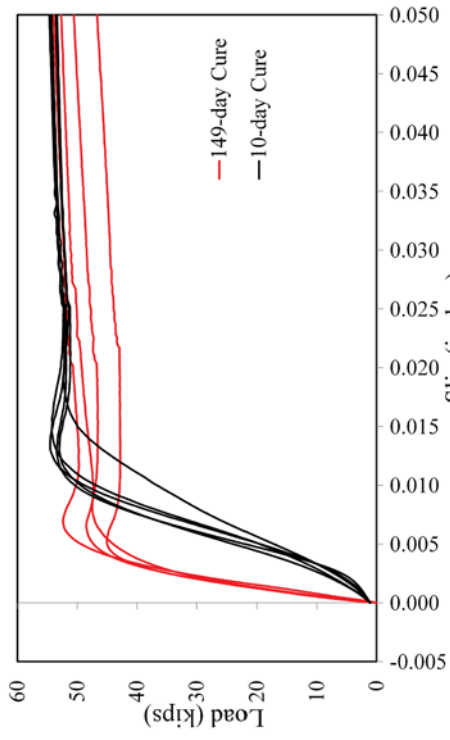
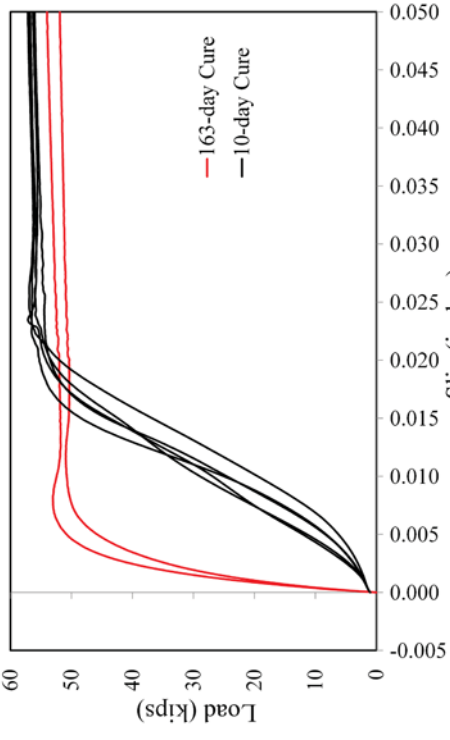
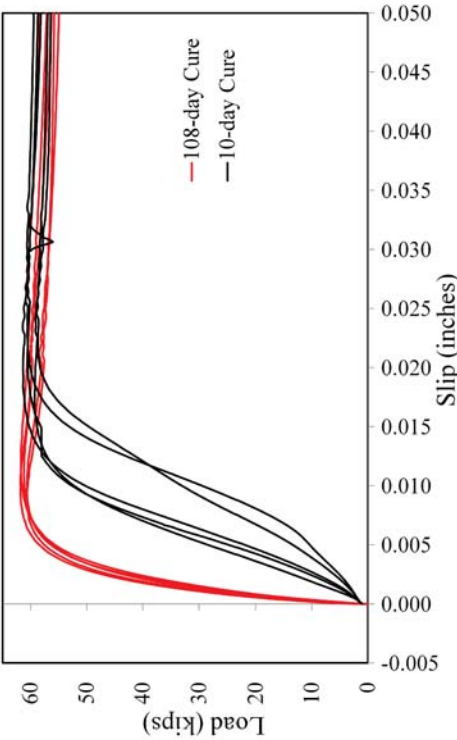
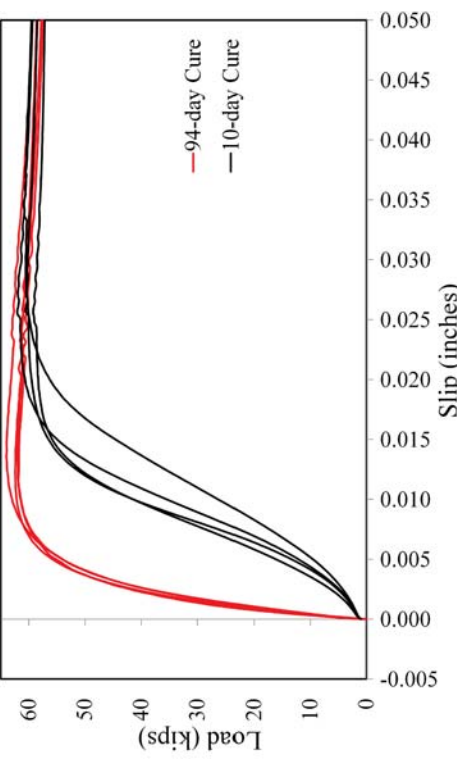
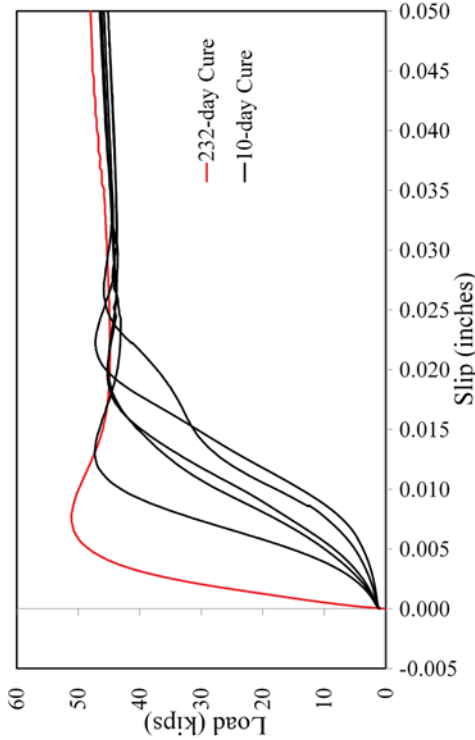
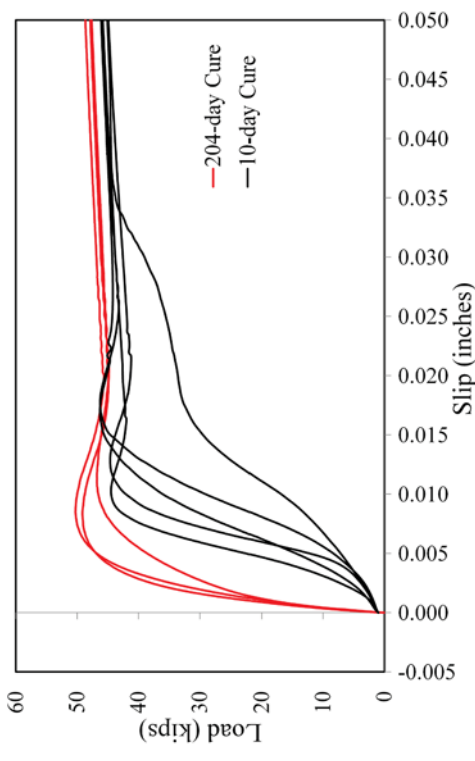
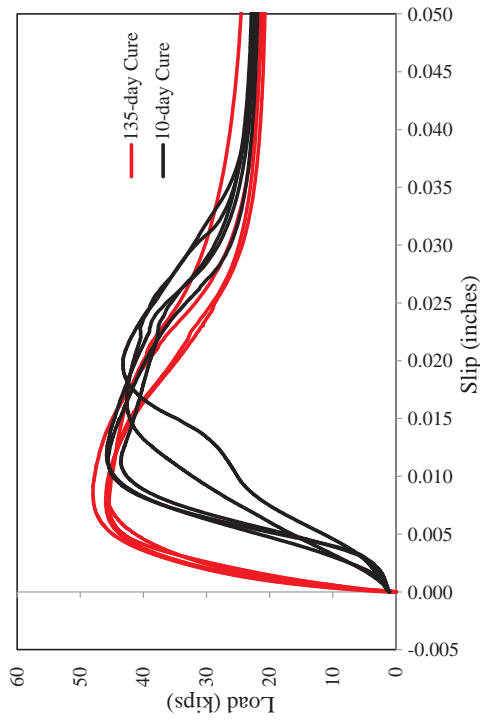
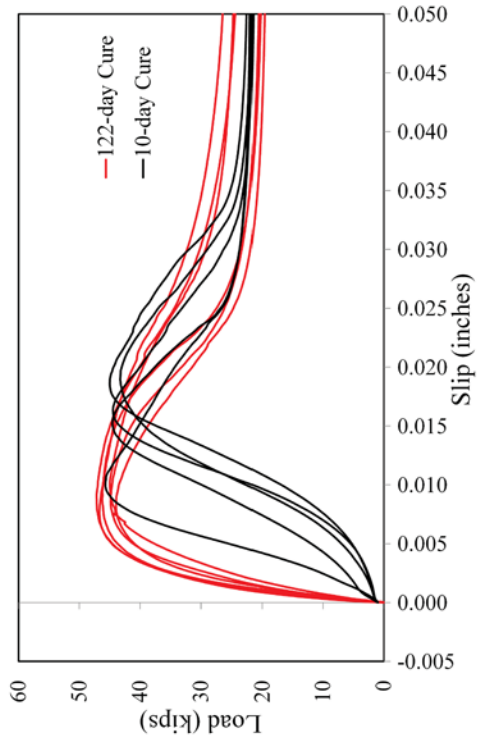
**Figure 56. Graph. Comparison of slip behavior with cure time for coating A1.**

Table 12 compares the average slip coefficients attained from the aging study to those from the interlaboratory variability study using the peak load ignoring the 0.02-inch criteria. When using the modified measuring device, none of the specimens ever came close to being controlled by the 0.02-inch displacement criteria. COV is not presented in table 12 since each coating series had different numbers of specimens, many not even having enough specimens to make a viable COV calculation. The final row in the table presents the difference in slip coefficients between the aging and variability portions of the overall study. Mostly, the average slip coefficient increased with the extended cure time. The one noted exception is coating B, which exhibited more variability and overall reduced average slip coefficient with an extended cure at both the +1- and +2-mil thicknesses.
