BICYCLE AND PEDESTRIAN CONSIDERATIONS AT ROUNDABOUTS

Final Report

Florida Department of Transportation

Lehman Center for Transportation Research

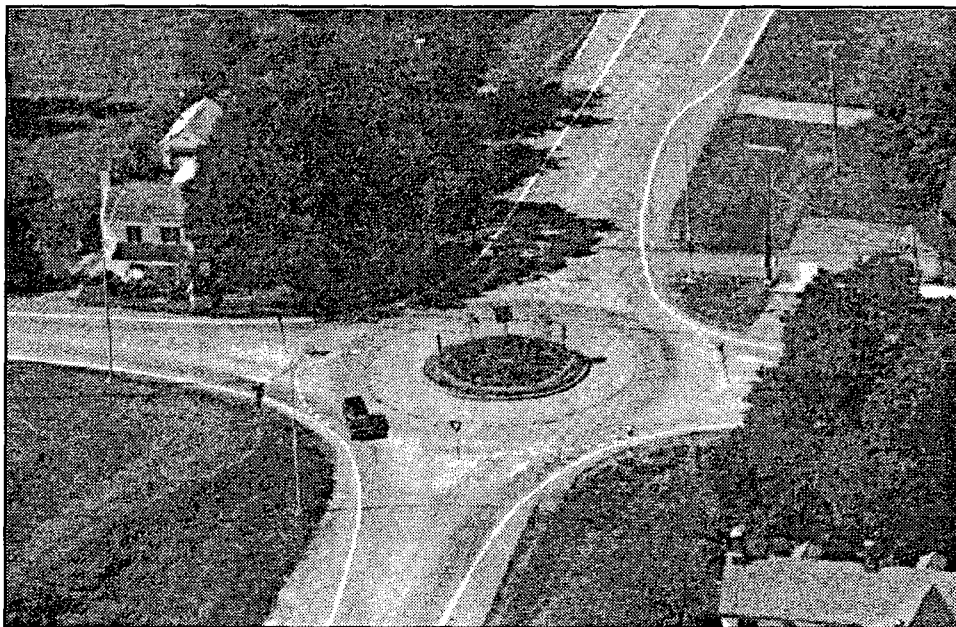
Figure 2.13 - The First Roundabout in Lisbon, Maryland

Maryland's first modern roundabout was built in 1993 in Lisbon (see **Figure 2.13**). The roundabout replaced a lightly traveled four-leg intersection regulated by a flashing beacon. The former intersection had averaged eight accidents with eight personal injuries per year. Two accidents occurred in the first three months after construction of the roundabout, resulting in two personal injuries. For the following 21 months, there were no reported accidents. By April 1993, roundabouts at approximately 25 intersections had been considered, and three were in the final design process. There have been no reported accidents at those intersections since the roundabouts were installed, and the community has been satisfied with the improvement (Myers, 1994).

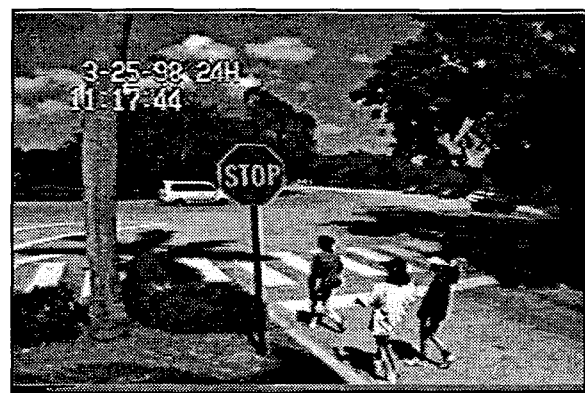
Figure 4.3 - Pedestrians Getting out of Cocoplum Community Use the Roadway

Figures 4.2 to 4.6 were clipped from the video tapes for the Cartagena Plaza Circle. These figures show how pedestrians and bicyclists cross the approaches of the Circle, as well as the location of the main conflict points.

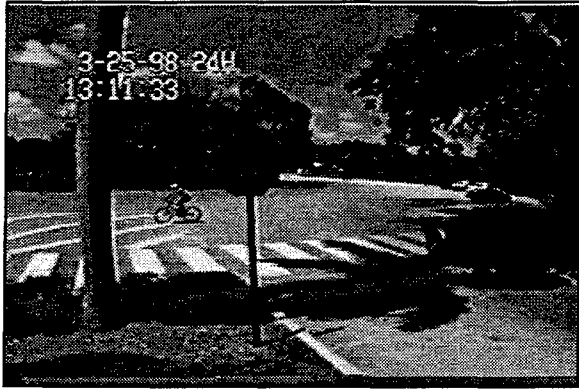
Figure 4.4 - A Cyclist Going Opposite to Traffic on the Circulating Roadway

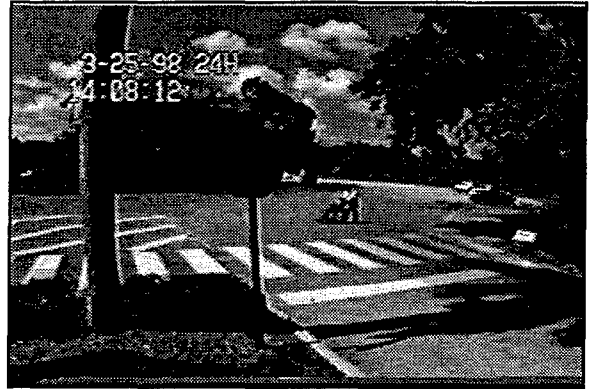
Figure 4.5 - Pedestrian on Roller Skates Pushing a Wheelchair in the Circulating Roadway Going Opposite to the Traffic Flow

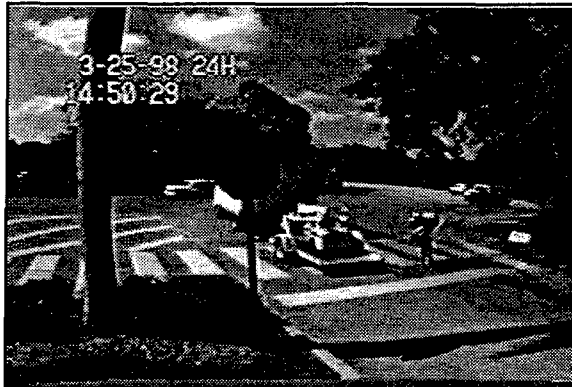
Figure 4.6 - Cyclists are not Willing to Stop for Vehicles Already on the Crosswalk

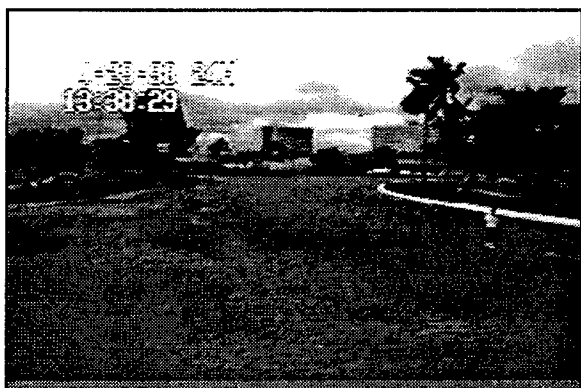
Figure 4.12 - A Pedestrian Walking in the Middle of the Circulating Roadway

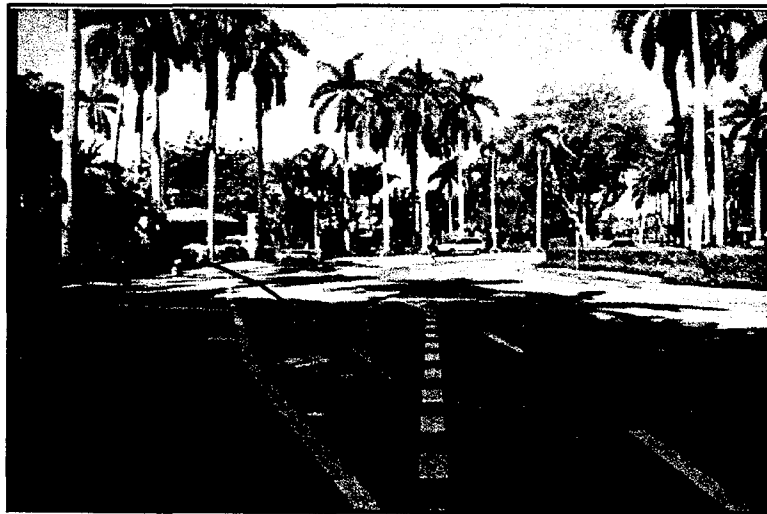
Figure 4.29 - Yield Line for Vehicles Exiting Royal Palm Residential Community

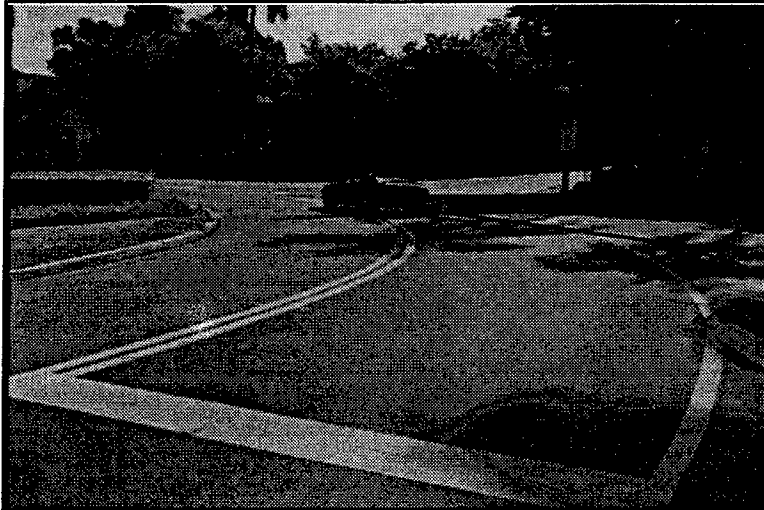
Figure 4.30 - Motorists Behavior Exiting Royal Palm Community

- 3- Allow vehicles to merge with circulating traffic as close as possible to the exit of the residential community, as shown in **Figure 4.30**.
- 4- The “Traffic Circle Ahead” and speed limit signs should be installed on all of the approaches to the roundabout. It was observed that some motorists drive at high speeds, exceeding 55 mph (88 km/hr), when approaching the roundabout from both the east and west directions.

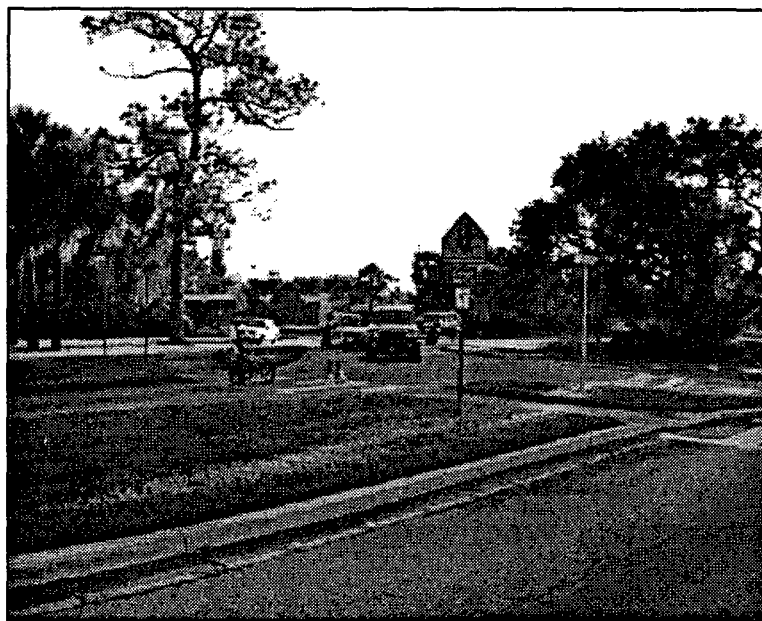
Figure 4.32 - A Student Crossing the West Exit of the Roundabout

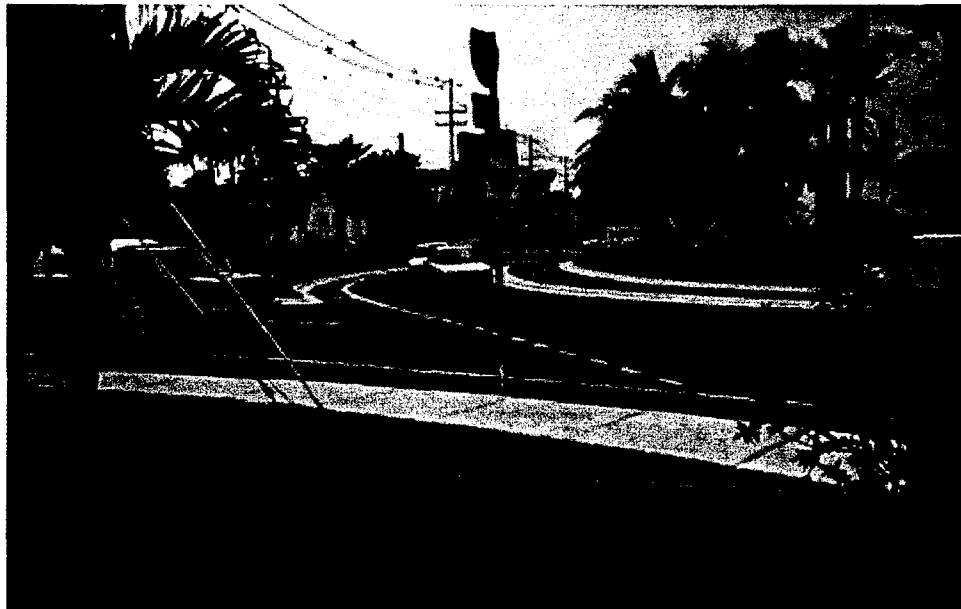
Figure 4.35 - Yield Line Location at Lucerne Avenue

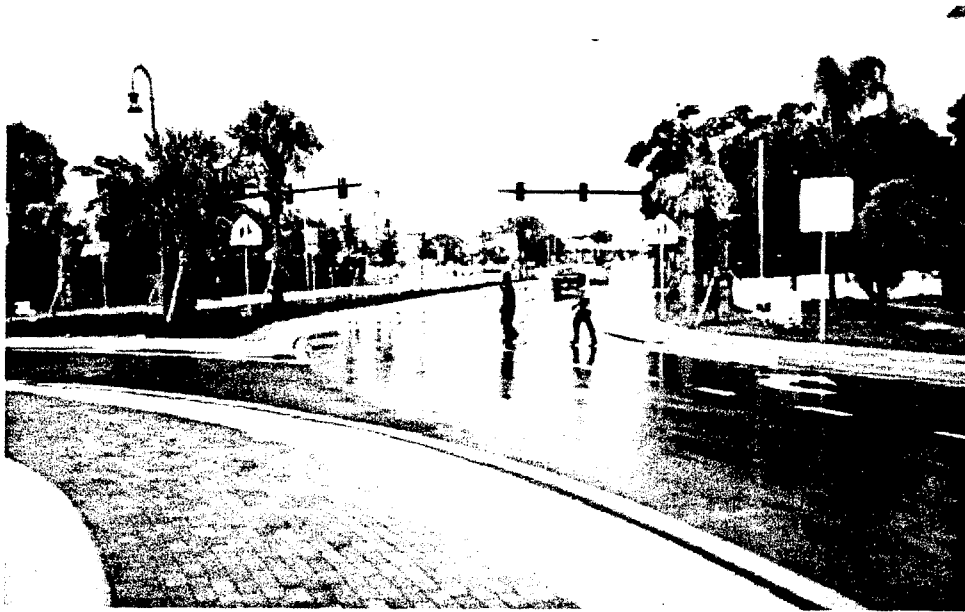
Figure 4.37 - Pedestrians are not using the Crosswalk at the Roundabout

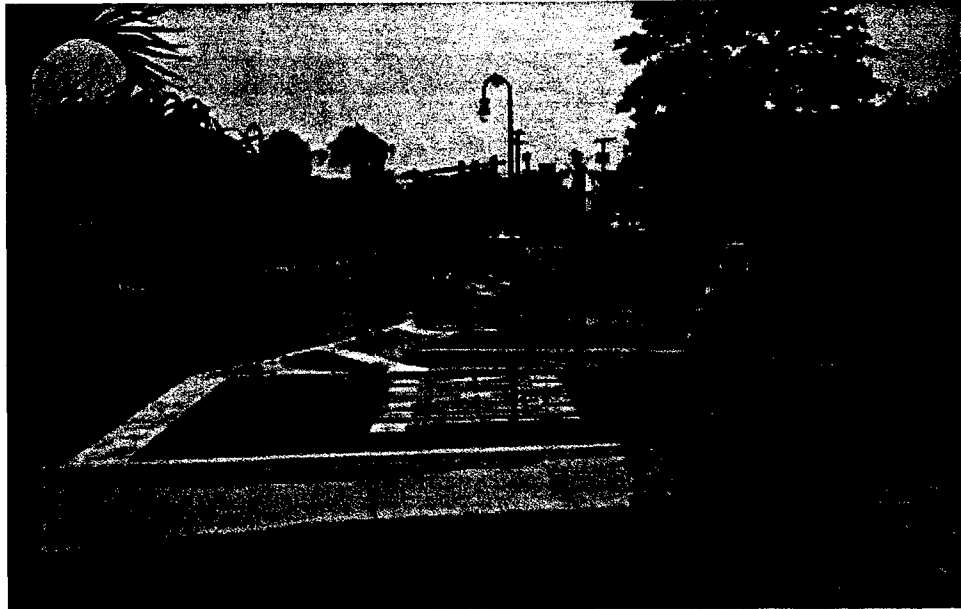
Figure 4.38 - "SCHOOL" Pavement Markings at the Exit of the Roundabout

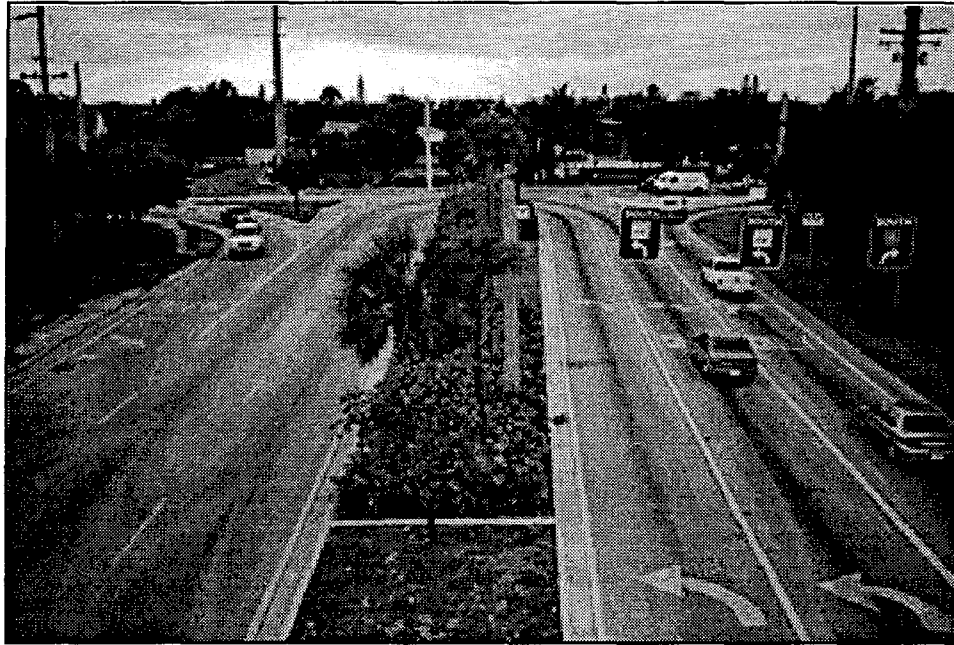
Figure 4.41 - Current Configuration for the Key West Entrance

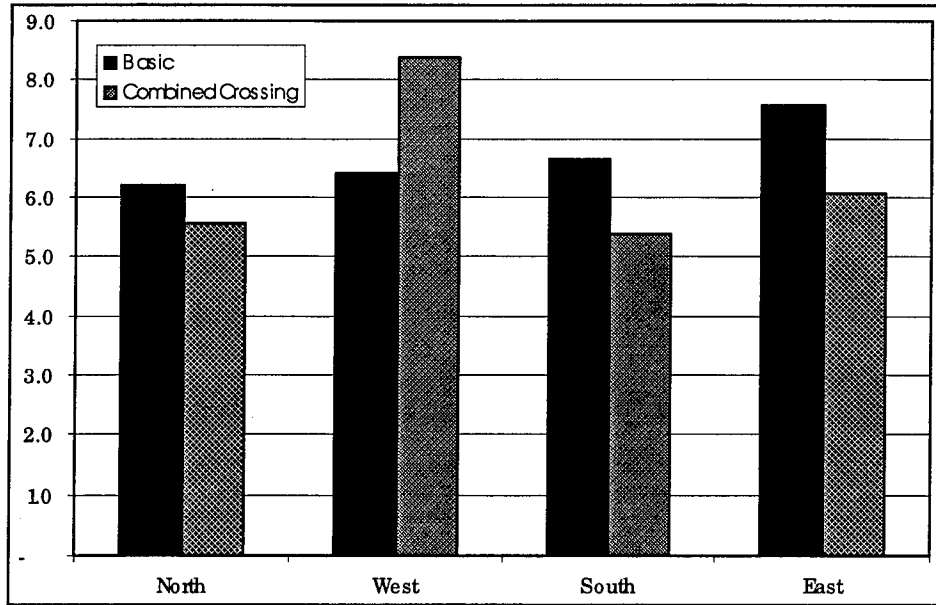
Figure 5.8 - Comparison of Average Delays after Installing a Crossing Facility

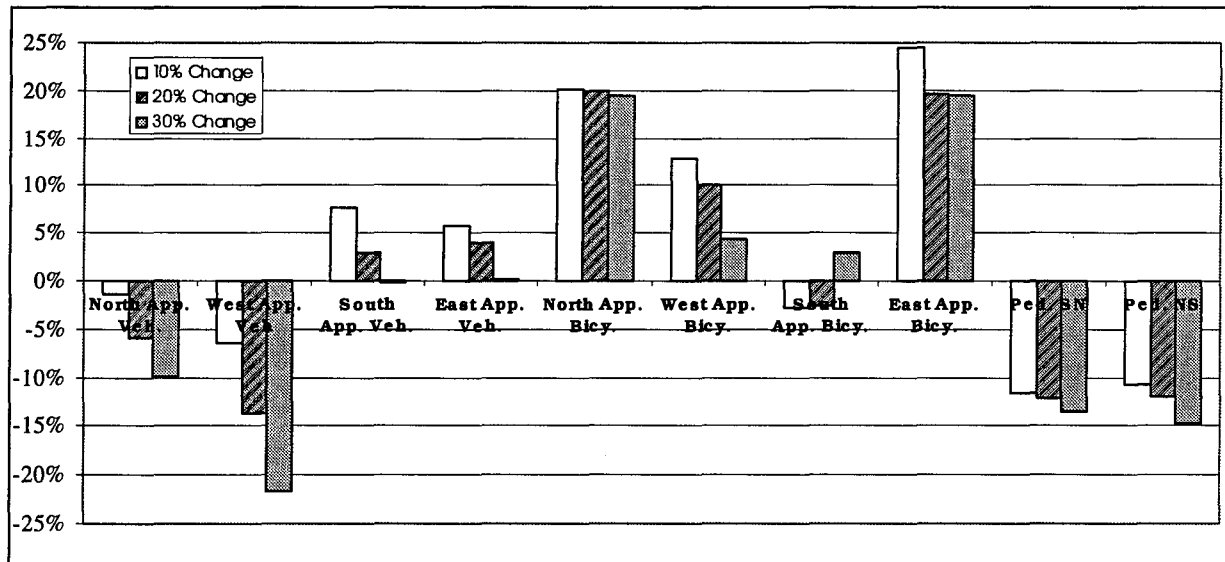
Figure 5.9 - The Effect of the Bicycle Lane on the Time Needed to Negotiate the Roundabout
