**Report No. CDOT-DTD-R-2001-8  
Interim Report**

# **CENTERLINE RUMBLE STRIPS**

**COLORADO DEPARTMENT OF TRANSPORTATION  
RESEARCH BRANCH**

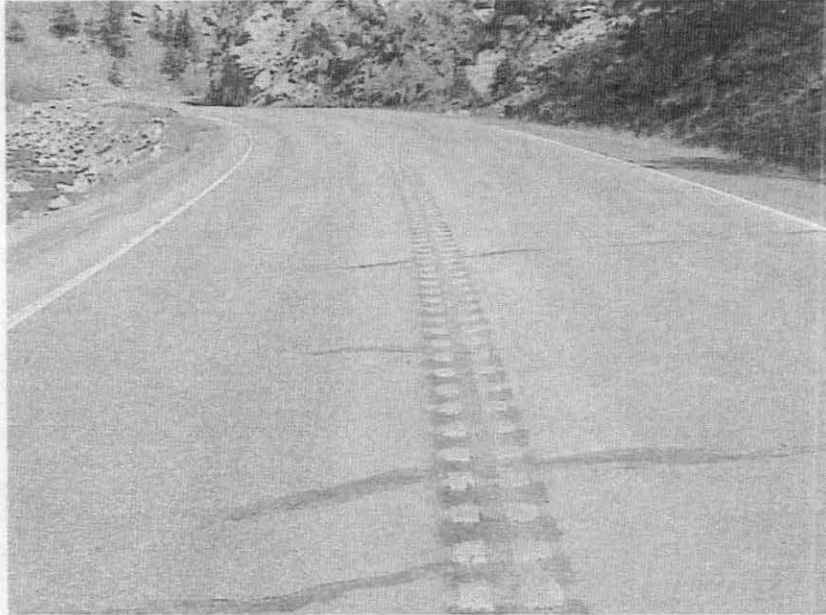
**Figure 1. State Highway 119 in Boulder Canyon winds through Forest Service land.**

The centerline rumble strip site is located in Boulder Canyon on SH 119 from Milepost (MP) 23, just east of Nederland, to MP 40, about two miles west of Boulder. This is a winding stretch of two-lane highway that has limited site distance and a double yellow "no passing" center stripe for most of its length (Figure 1). In the 17-mile stretch through the canyon, centerline rumble strips were placed at all no passing locations except through intersections. In areas where sufficient sight distance allowed safe passing, no rumble strip was installed.
