# Research to support design and siting of deposition areas for dredged material from the Rodanthe Emergency Channel

**NCDOT Project 14-0790**

**June 2017**

Final Report : NCDOT Project 14-0790

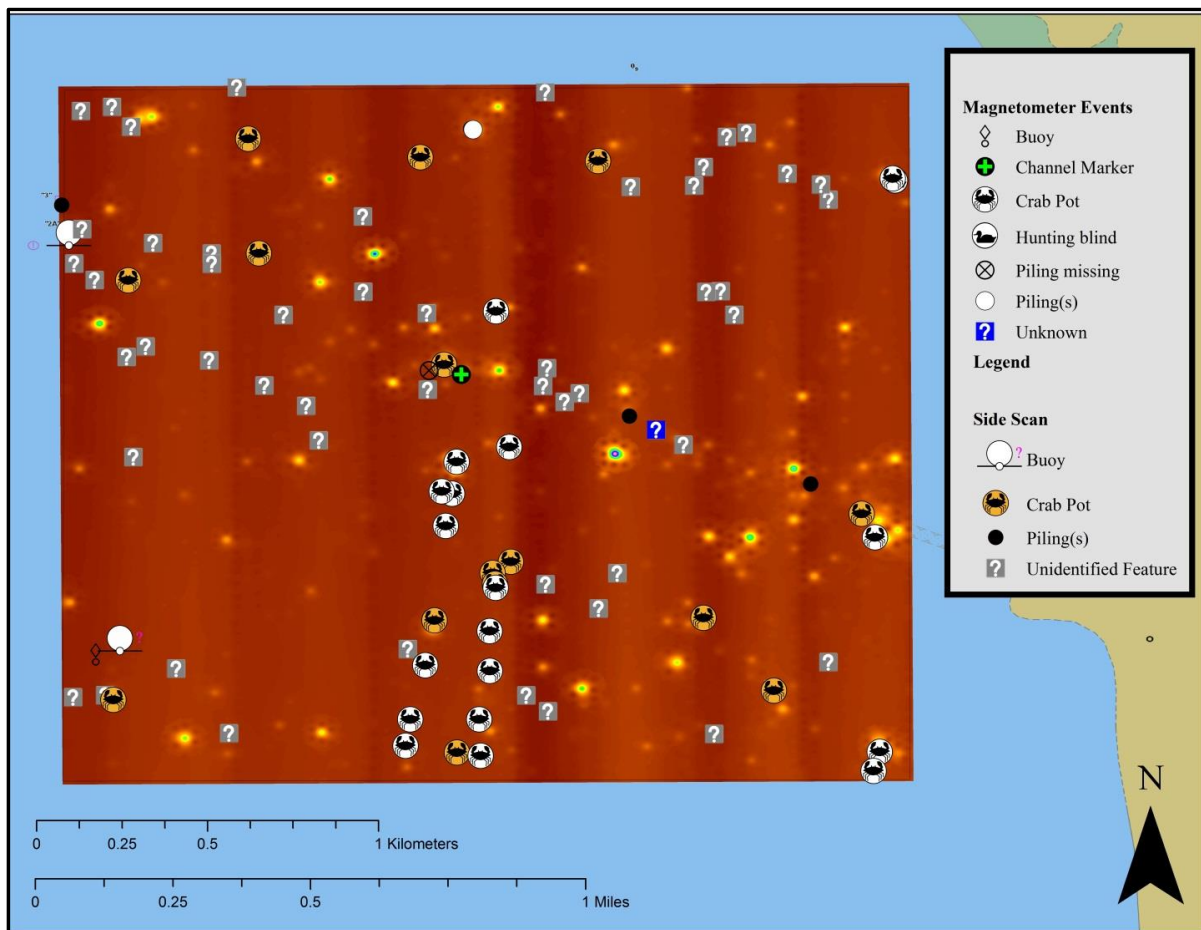
**Figure 2. Depiction of interpolated magnetism and sonar targets, with the addition of "surface events" noted during remote sensing survey).**

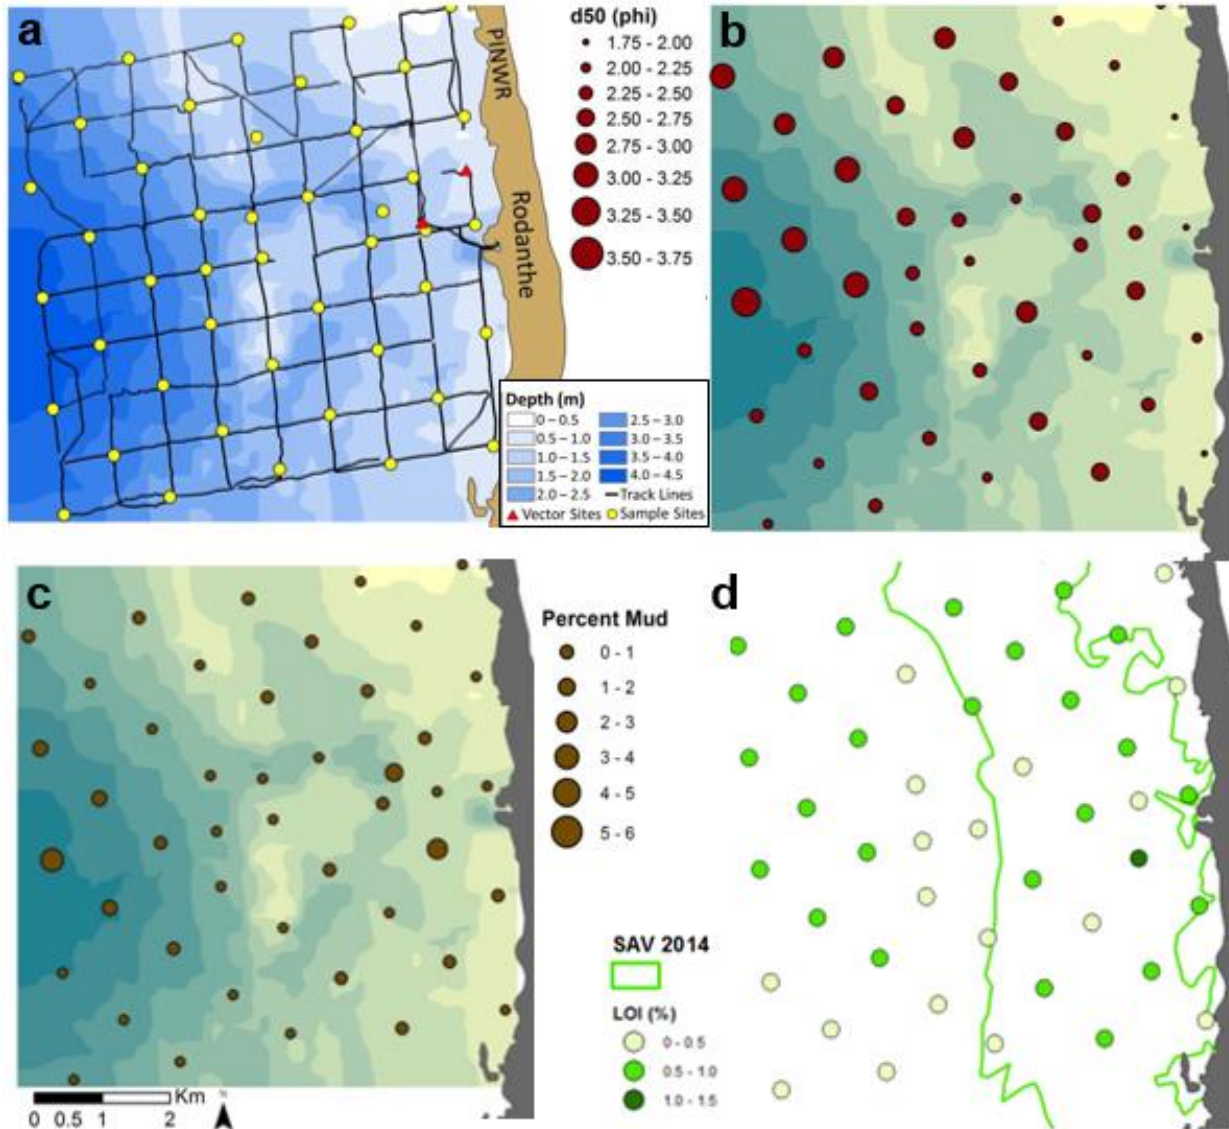
Figure 5. a) Bathymetric map showing sites of sediment samples (yellow) and transport measurements (red). (b) Median grain size ( $d_{50}$ ) of sediment samples in phi units, (c) Percent mud in samples, and (d) Loss on ignition as a proxy for organic content.

Construction of such an island would likely occur west of the shallow back-barrier area (Fig. 17). Measurements of waves and currents at the tripod sites (see Fig. 5 for location) showed that conditions are episodically conducive to sediment transport in the shallow back-barrier area (i.e., between the shoals and the back-barrier shoreline; Fig. 7 and Appendix 2). Because wave heights would be elevated in the deeper portions of Pamlico Sound (e.g., Mulligan et al., 2016), a similar reworking concern exists for an open-sound disposal site. Thus, armoring would likely be required to minimize dispersal, and this could dramatically increase costs. If planning for the longer term (3-5 decades), the cost may be more easily justified.

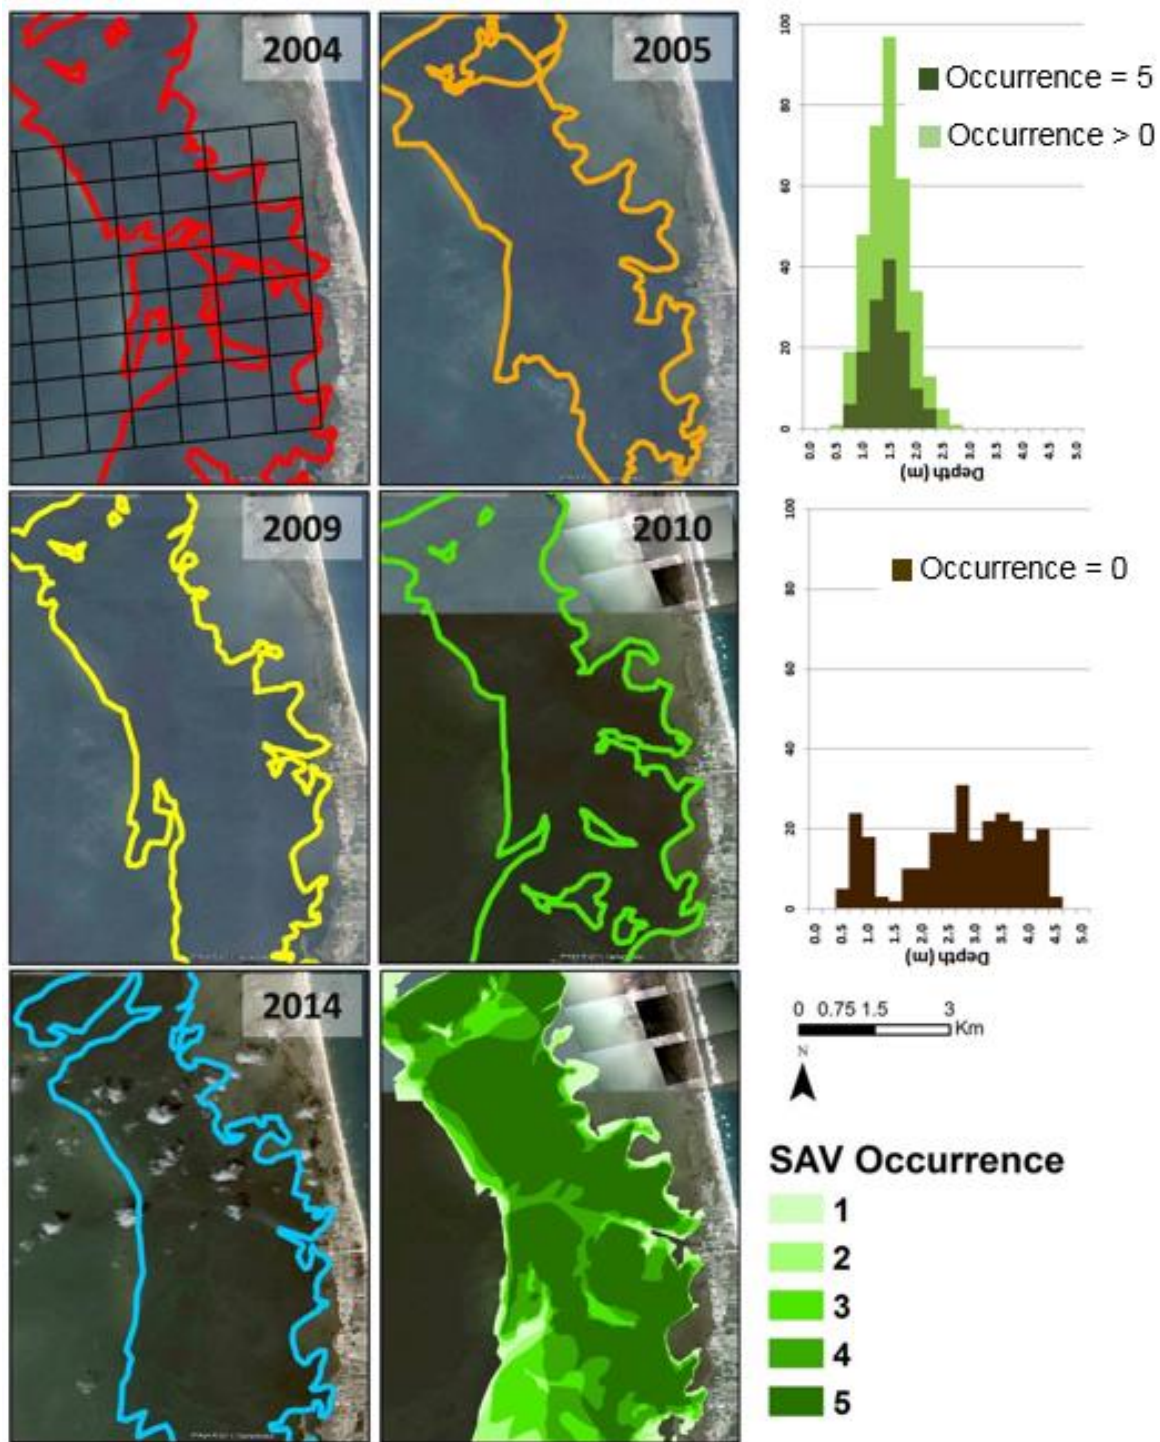
Figure 6. Heads-up mapped SAV boundaries for all time steps. Study area grid is shown in the 2004 data. The occurrence of SAV between all-time steps is summarized in the bottom right map. Occurrence = 1 means SAV was only present during 1 year mapped. Occurrence = 5 means SAV was present at all years mapped. Data show persistent coverage of SAV with moderate variability between years. SAV frequency with depth (top right) and depth without SAV present (bottom) provide data on region SAV growth is expected. Occurrence of 5 shows SAV persistent across all maps. Occurrence >0 shows SAV presence during at least one map. The depth range of persistent SAV was 0.5-2.2 m, and all SAV was 0.4-2.7 m.

The persistent depth zone of SAV in this study (0.5-2.2 m) is somewhat different than reported elsewhere (Angradi et al., 2013; Orth et al., 2010). Depth ranges for SAV vary greatly across the eastern U.S. as a result of varying water quality conditions. Previous studies suggest SAV habitats are largely controlled by depth due to light dependence (Findlay et al., 2014; Angradi et al., 2013; Koch et al., 2001; Hall et al., 1999). Other studies found that SAV habitats were generally shallower than 1 m below mean low water level (Findlay et al., 2014; Angradi et al., 2013). An SAV habitat depth range of 0.3 – 1.3 m would be expected in the study area if water level was controlled by tide alone. Water level data from the instrument deployment in Rodanthe shows a region affected by astronomical as well as wind tides. Wind-influenced water level changes may prevent shallower habitat growth ( $> -0.5$ ) in study area shoals by increased subaerial exposure during strong NE wind events (Angradi et al., 2013; Palinkas and Koch, 2012), and the deeper depth ( $>1.3$  m) is likely due to relatively clear water in the area.

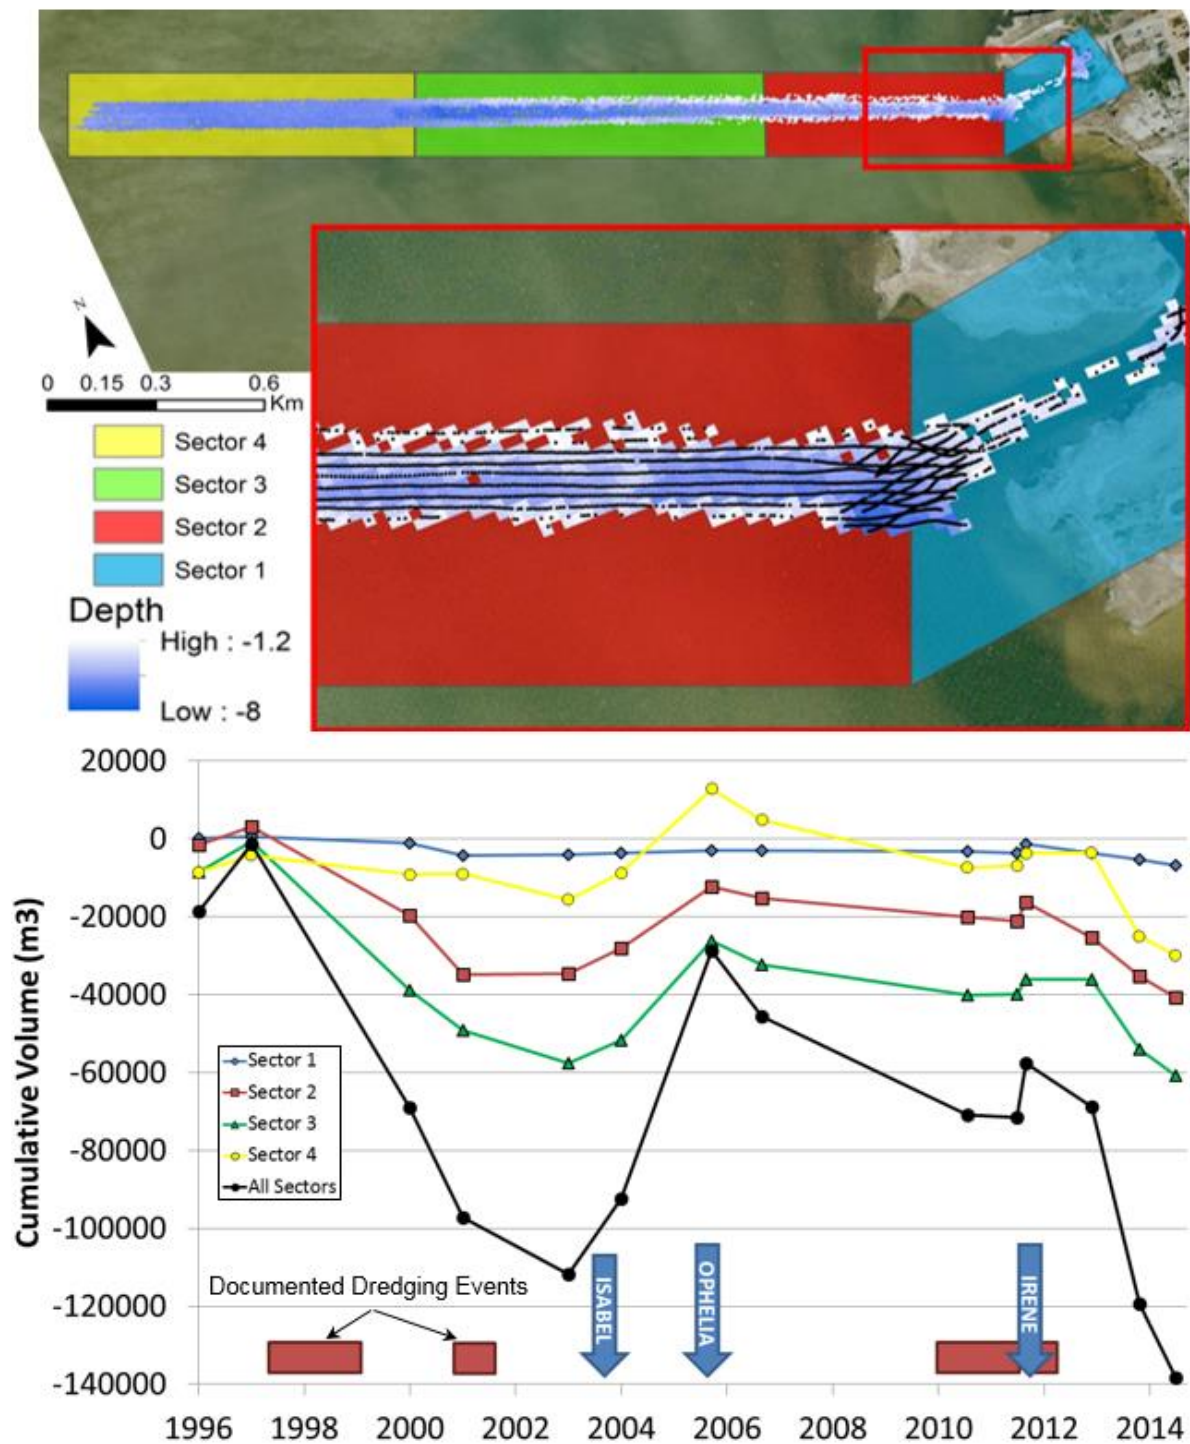
Figure 8. The emergency ferry channel was divided into 4 sectors to evaluate sediment volume changes with time (e.g., differencing bathymetric datasets). Cumulative volume change (bottom) for the channel by sector and for all sectors combined show significant changes with time. Note the large volumetric increases in 2003-2005 and 2011 associated with named tropical systems and the known dredging events that reduced sediment volume.

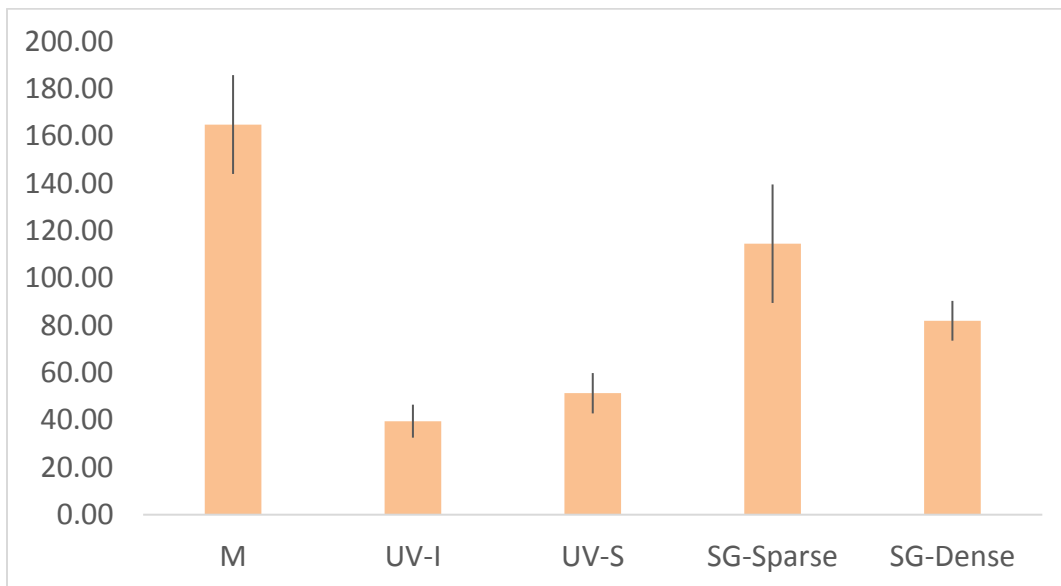
**Figure 11. Biomass of benthic microalgae (g m<sup>-2</sup>) in the major habitat areas in the REFC.**

Assessments of current conditions in the area proximate to the REFC revealed that structured habitats had generally higher rates of denitrification and higher biomass of benthic microalgae. These findings corroborate related findings in the literature and are in line with studies assessing the importance of habitats for fish habitat (ref). These data can be extrapolated to the entire study area using the seagrass and shoreline maps presented in the Sediment Dynamics chapter. Using results from this work we are able to populate the decision matrices to provide guidance for the best and simplest sites for sediment deposition. In addition to using the matrices to select sites for sediment deposition, these results can be used to quantify immediate and future

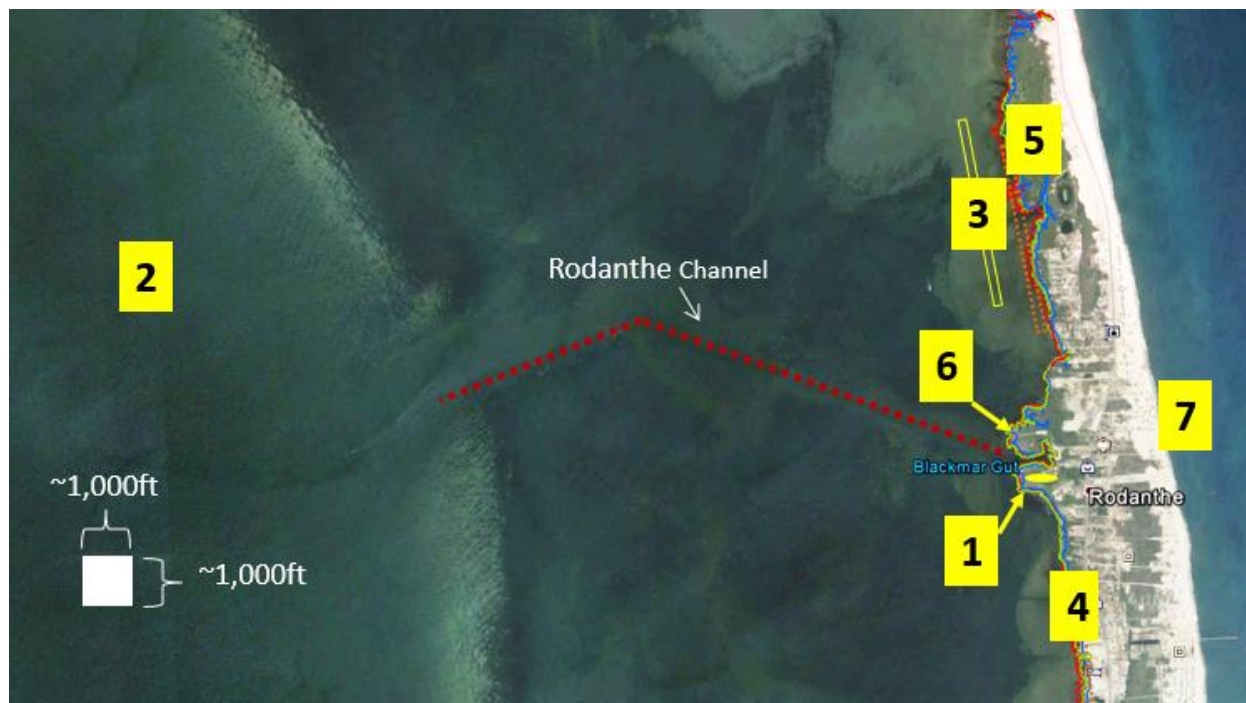
**Figure 13. Disposal options considered in this study: 1) Existing Disposal Area, 2) Pamlico Sound Island, 3) Back-barrier Shoal, 4) Shoreline Nourishment and Reconstruction, 5) Marsh Accretion 6) New Local Area and 7) Distal Area.**

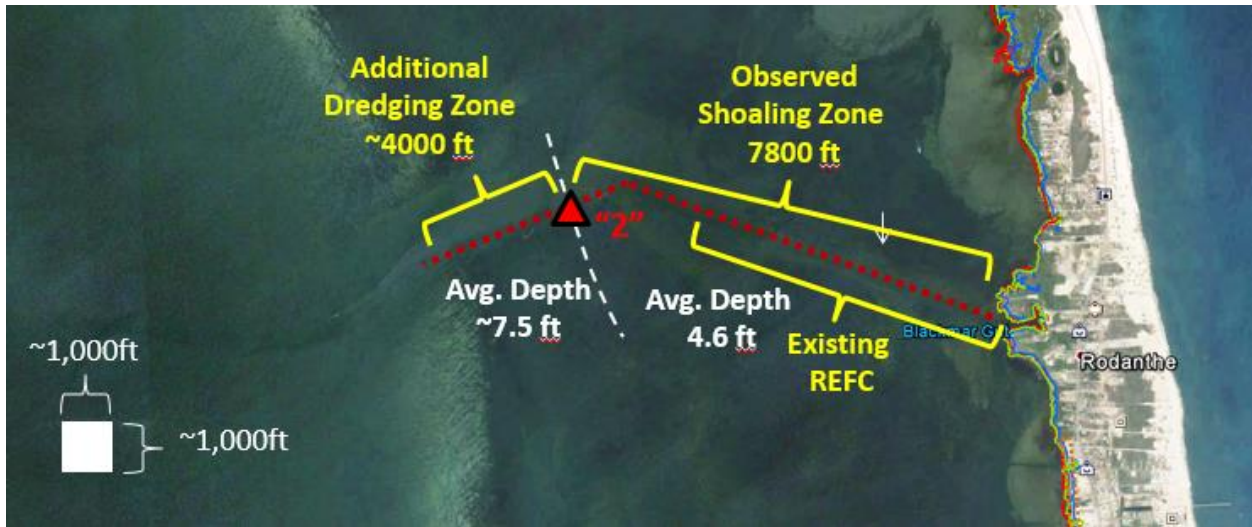
Figure 14. Channel lengths and average seabed depths used for calculations in Table 1.

\*Denotes the measured distance from the Rodanthe boat basin to Marker “2”, where depths generally exceed 7 ft (Fig. X). %denotes amount dredge volume estimated from past maintenance efforts. #For channel improvements, dredging west of Marker “2” would also be required, therefore this length indicates the estimated value for the channel portion west of Marker “2” that would also require dredging to reach designated depth. §Indicates total estimated dredge volume considering portions east and west of Marker “2”.

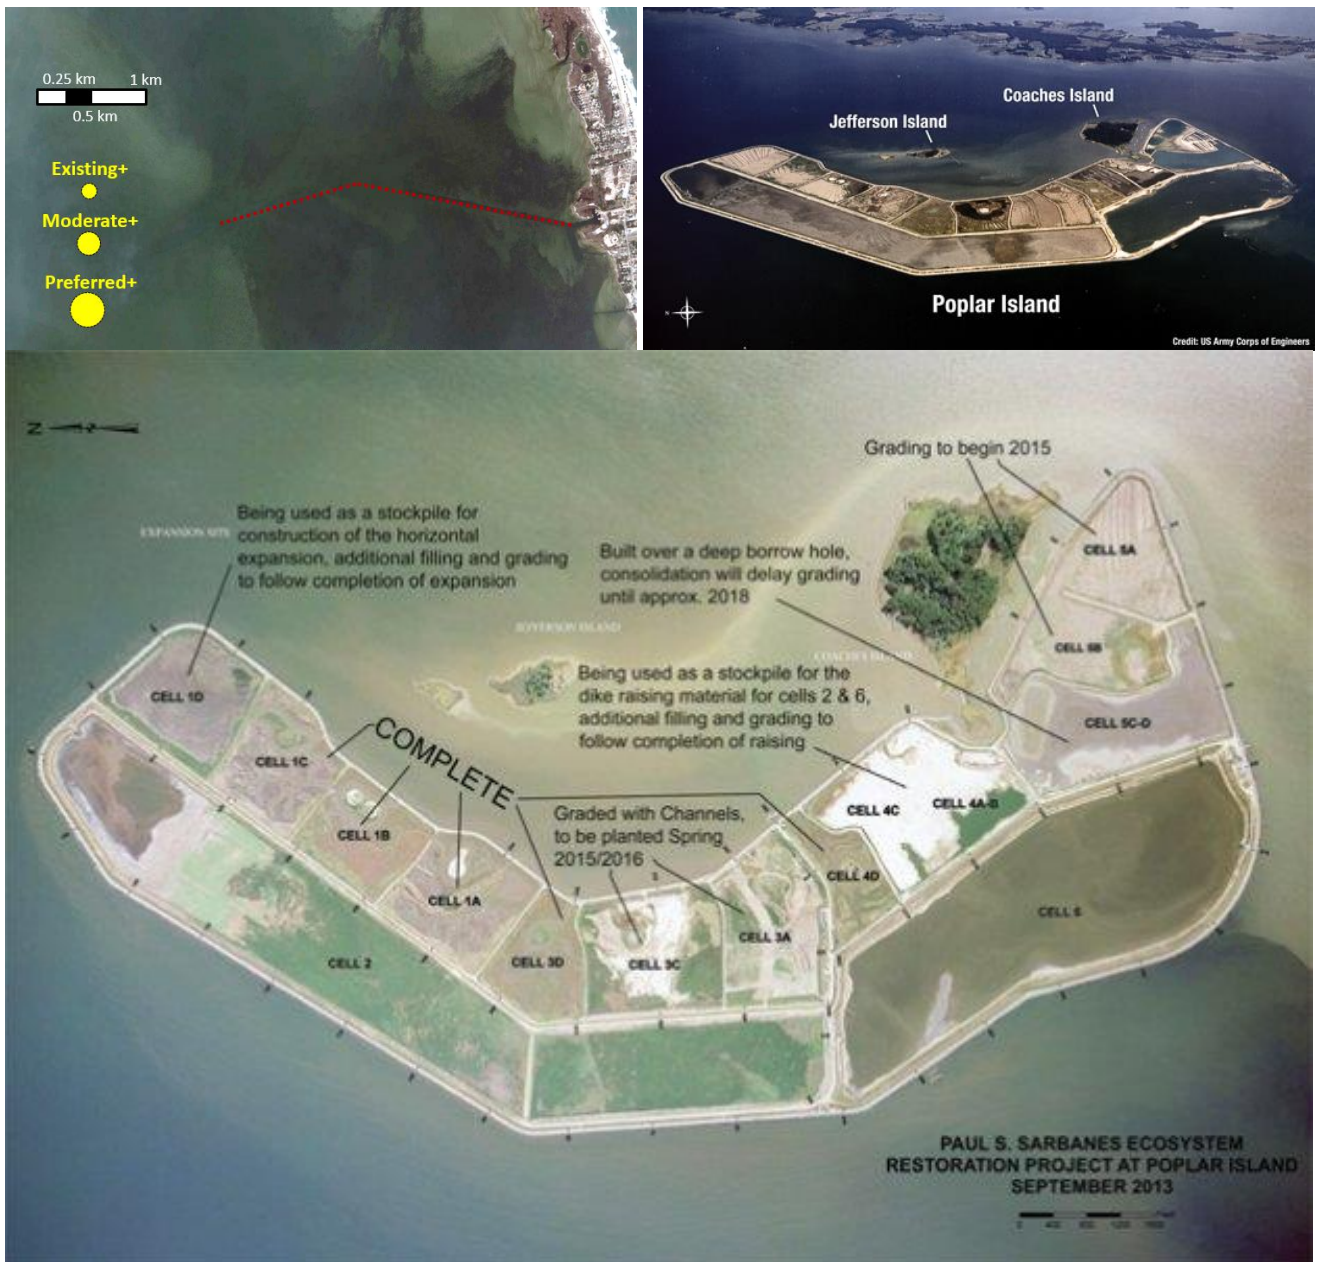
Figure 17. Potential size and approximate location of island (top left), oblique (top right) and annotated (lower) aerial example of a dredge spoil island (Poplar Island, MD). Image in top right from USEPA/USACE (2007b). Annotated image from Stinchcomb and Sharrett (2015). Of course, the location should not obstruct ferry traffic.

Disposal of sediment in Pamlico Sound could take the form of a submerged mound or an island. Existing examples of such disposal are found around the world, including some not far from the study site. For example, Big Foot Island near Ocracoke proved to be an important area for nesting birds during Hurricane Arthur (Vankevich, 2015). The shapes and sizes of spoil islands vary widely. An oft-used example is Poplar Island in Blackwater, VA (USEPA/USACE, 2007a; 2007b). This collaborative project involving the U.S. Army Corps of Engineers, the U.S. Fish and Wildlife Service and the Maryland Port Administration seeks to rebuild an island which was much larger in the mid-19<sup>th</sup> century. Here, 1,140 acres of wildlife habitat (half wetland and half upland) will be created by the deposition of 40 million cubic yards of dredged material. The dyked disposal area is a 3-mile-long by 0.7-mile-wide crescent-shaped island (Fig. 17).

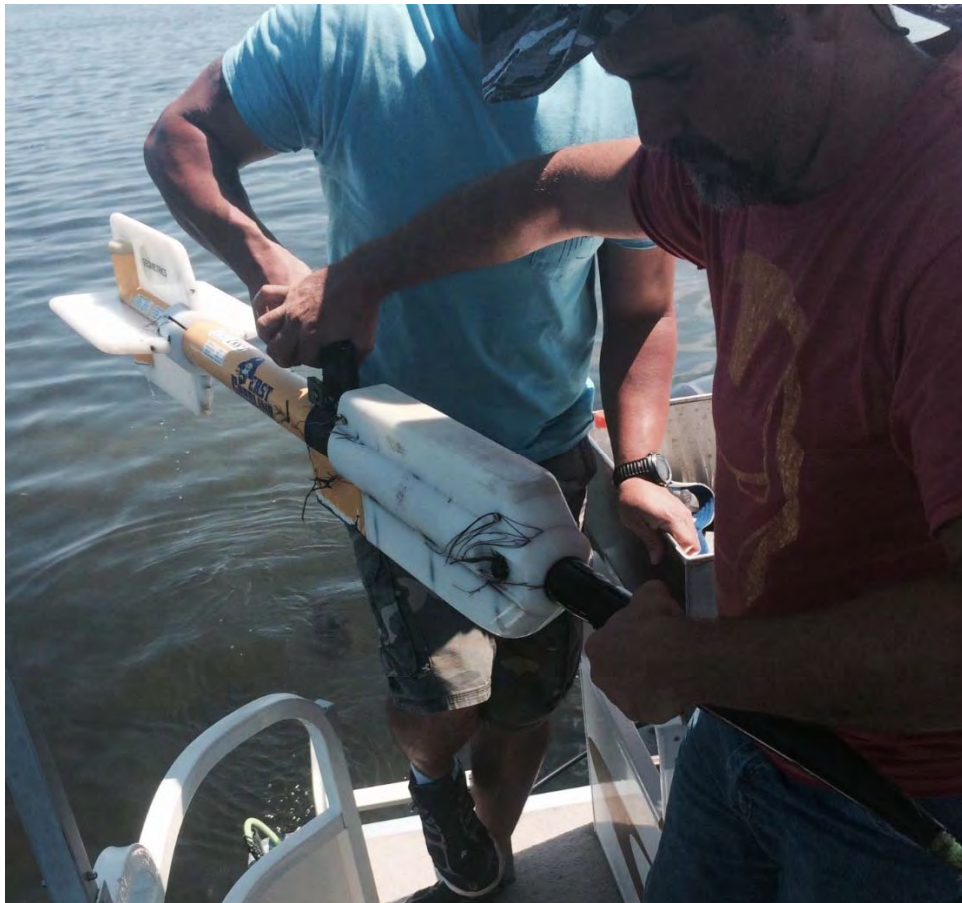
**Figure 6. Jim Kinsella and Scott Rose retrieve Geometrics G882 magnetometer (Nathan Richards/CSI).**

Field work to collect data within the survey area (Figure 1) was conducted from 20 July to 19 August 2015. The proposed methodology for the remote sensing portion of the survey included using a Klein 3000H dual frequency (445/900 kHz) model side scan sonar, a Geometrics G882 Cesium magnetometer (Figure 6), and a Trimble AgGPS542 differential global positioning system (GPS). The sonar and GPS belonged to University of North Carolina’s Coastal Studies Institute (CSI) while the magnetometer was on loan from East Carolina University’s Program in Maritime Studies. Additionally, the vessel chosen was R/V *Viper*, rented from East Carolina University’s Diving and Water Safety Office.

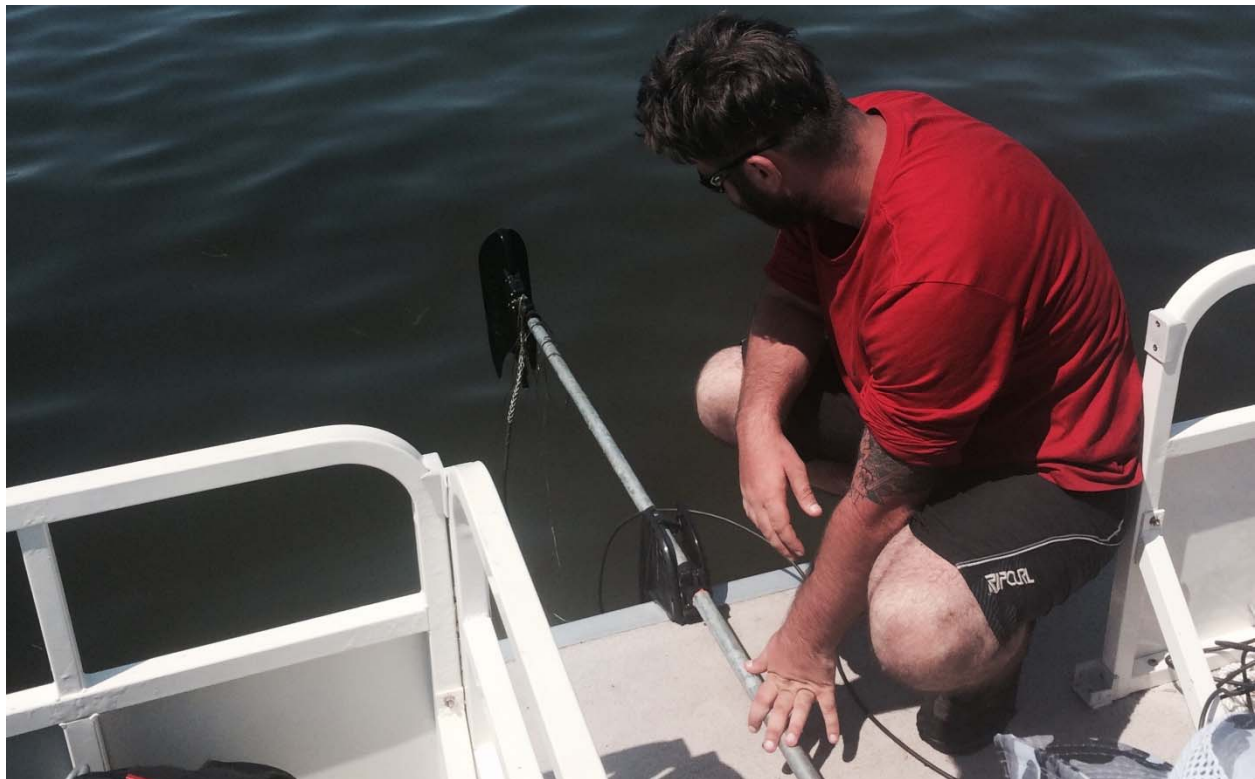
Figure 7. Adam Parker retrieves pole-mounted Tritech Starfish 650F sonar (Nathan Richards/CSI).

After considering the other fleet options available to the team at East Carolina University and the Coastal Studies Institute, a viable solution was found. Researchers employed a pontoon boat with an alternative sonar system -- a Tritech Starfish 450F which was mounted by a stainless-steel pole off the bow. Due to the configuration of the boat hull, researchers could deploy at a shallower depth than the Klein sonar. While the Tritech sonar offered a lower resolution than the Klein (50% reduction) it still produced the standard resolution for sonar projects – and would be sufficient for the discovery of cultural anomalies. If significant sonar targets equating to a substantial inundated archaeological site were discovered, researchers planned to return with the Klein 3000H for a confined area survey adjacent to the target was possible (given the lack of shipwreck candidates discovered during historical research, this was highly unlikely). Thus, the final remote sensing configuration was to mount the Tritech sonar on

the bow of the pontoon boat (Figure 7) while the magnetometer was towed behind it. This change of boat and sonar device configuration did not precipitate any change to the lane spacing for the survey (25 meters).

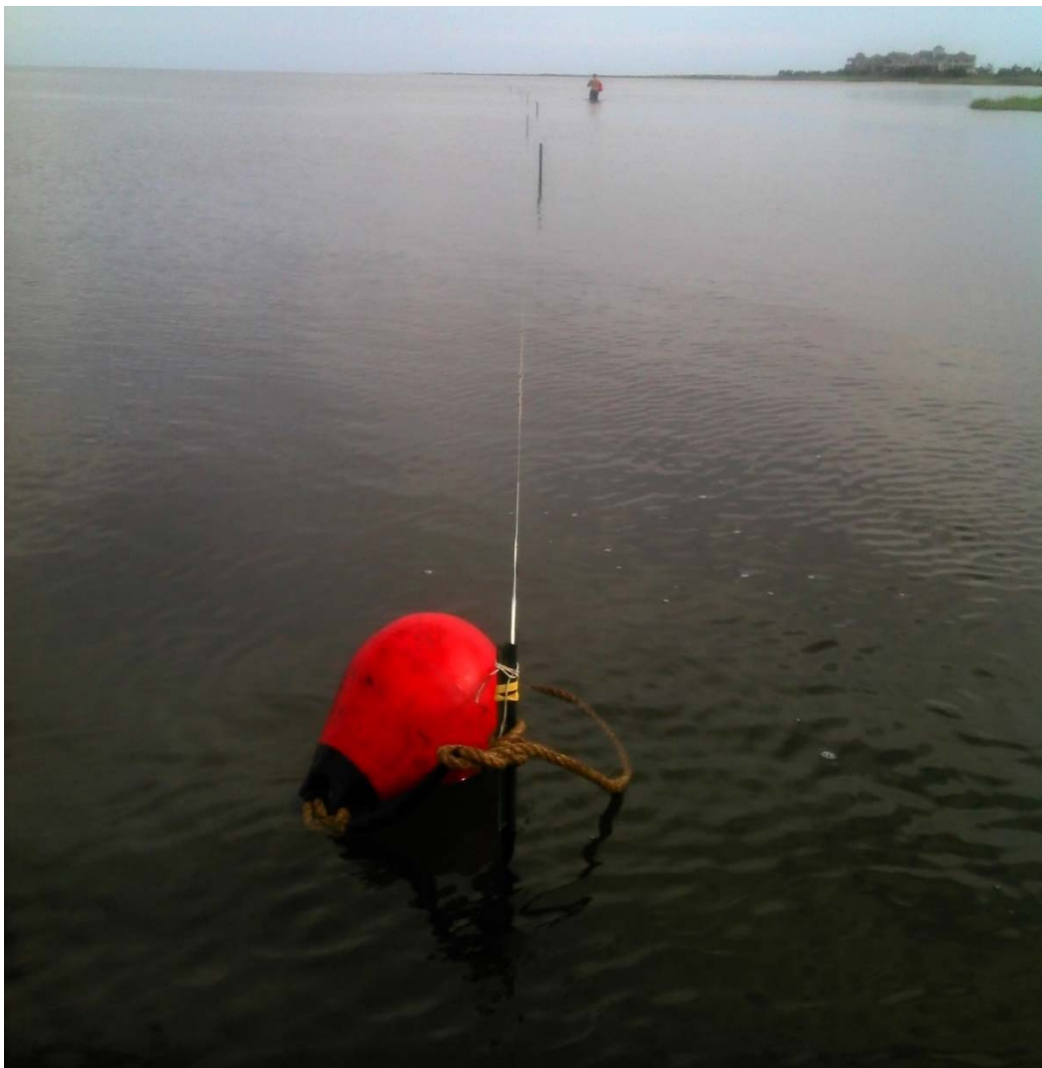
**Figure 8.** Image of baseline and datums for seabed inspection and close-plot metal detection survey (Nathan Richards/CSI).

The baseline for the survey area was set off the immediate shore in roughly ankle-deep water. The baseline was laid with a 300-foot-long measuring tape and staked off at both ends and every 40 feet. These stakes were then buoyed to serve as visual identifiers after the team moved further out in the search grid and to warn recreational kite surfers and kayakers in the area of the danger. From the 0 end, the baseline was the run directly north at 0 degrees (magnetic) until the end of the first 300-foot section. From here, stakes were taken out due W at 270 degrees from the baseline, set in, and buoyed at 300 feet and 600 feet. GPS positions were then taken of every stake (Figure 9).

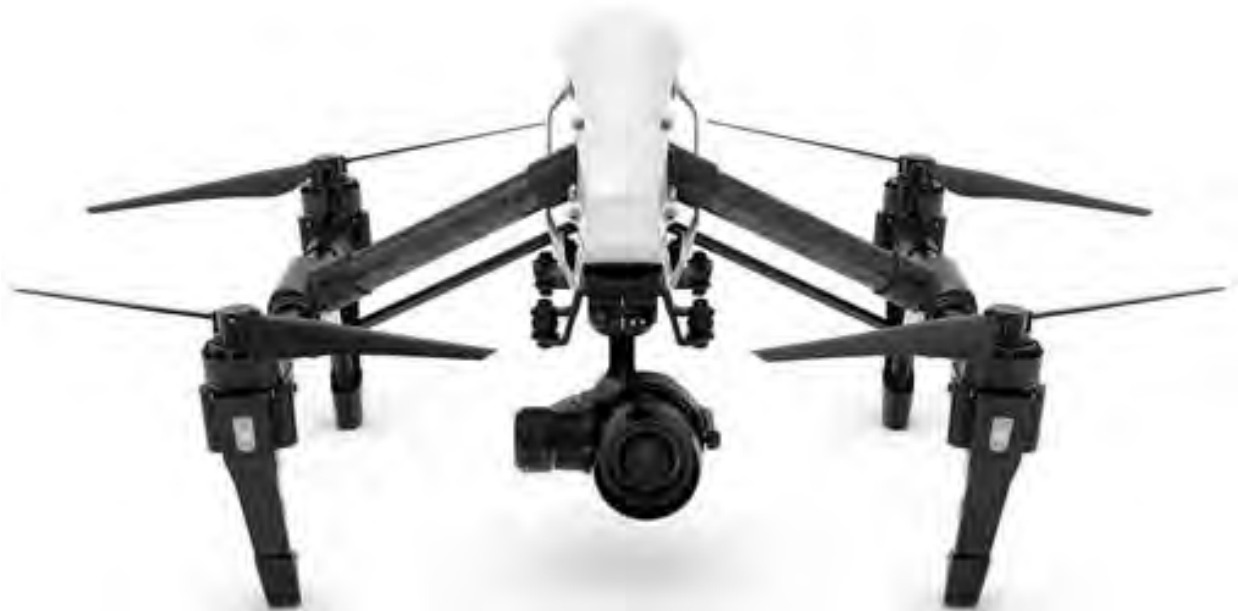
Figure 10. DJI Inspire Pro 1 drone (Source: DGI).

A drone (a DJI Inspire 1 Pro, Figure 10) with an X5 Camera was piloted by John McCord (Figure 11). The DJI Inspire 1 Pro used micro 4:3 sensor camera with a 15-mm lens from a height of 101 meters. The camera stills obtained were 16 MP (JPG and DNG raw formats).

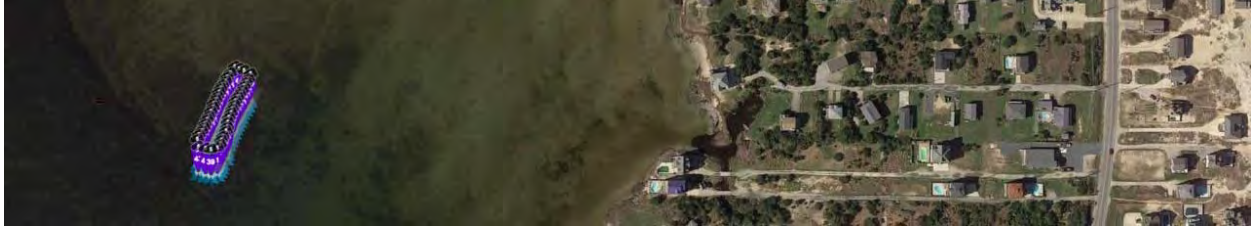
Figure 13. Flight plan for aerial capture of PAS0001, 10 February 2017 (Image by John McCord, 10 February 2017).

On 10 February 2017, an additional photogrammetric assessment was undertaken with the same equipment. With a successful single-image orthophoto of PAS0001, and a multi-image photogrammetric model and orthophoto of the area adjacent to the study area, researchers decided to take advantage of lower water levels and low wind to attempt a high-resolution multi-image photogrammetric model and orthophoto of PAS0001 to assess condition, determine if much debris surrounded the wreckage, and hopefully identify the hull at a future date. A tight series of transects were designed to be flown at a height of 10-20 meters (33-66 feet) across each dimension of the vessel (see flight plan in Figures 13-14). During this recording, it was also noted that since November 2016, two new hunting blinds had been erected in the area near PAS0001, perhaps suggesting that the loss and re-erection of such blinds happens periodically (and the hunting blinds are unlikely to have any historical significance).

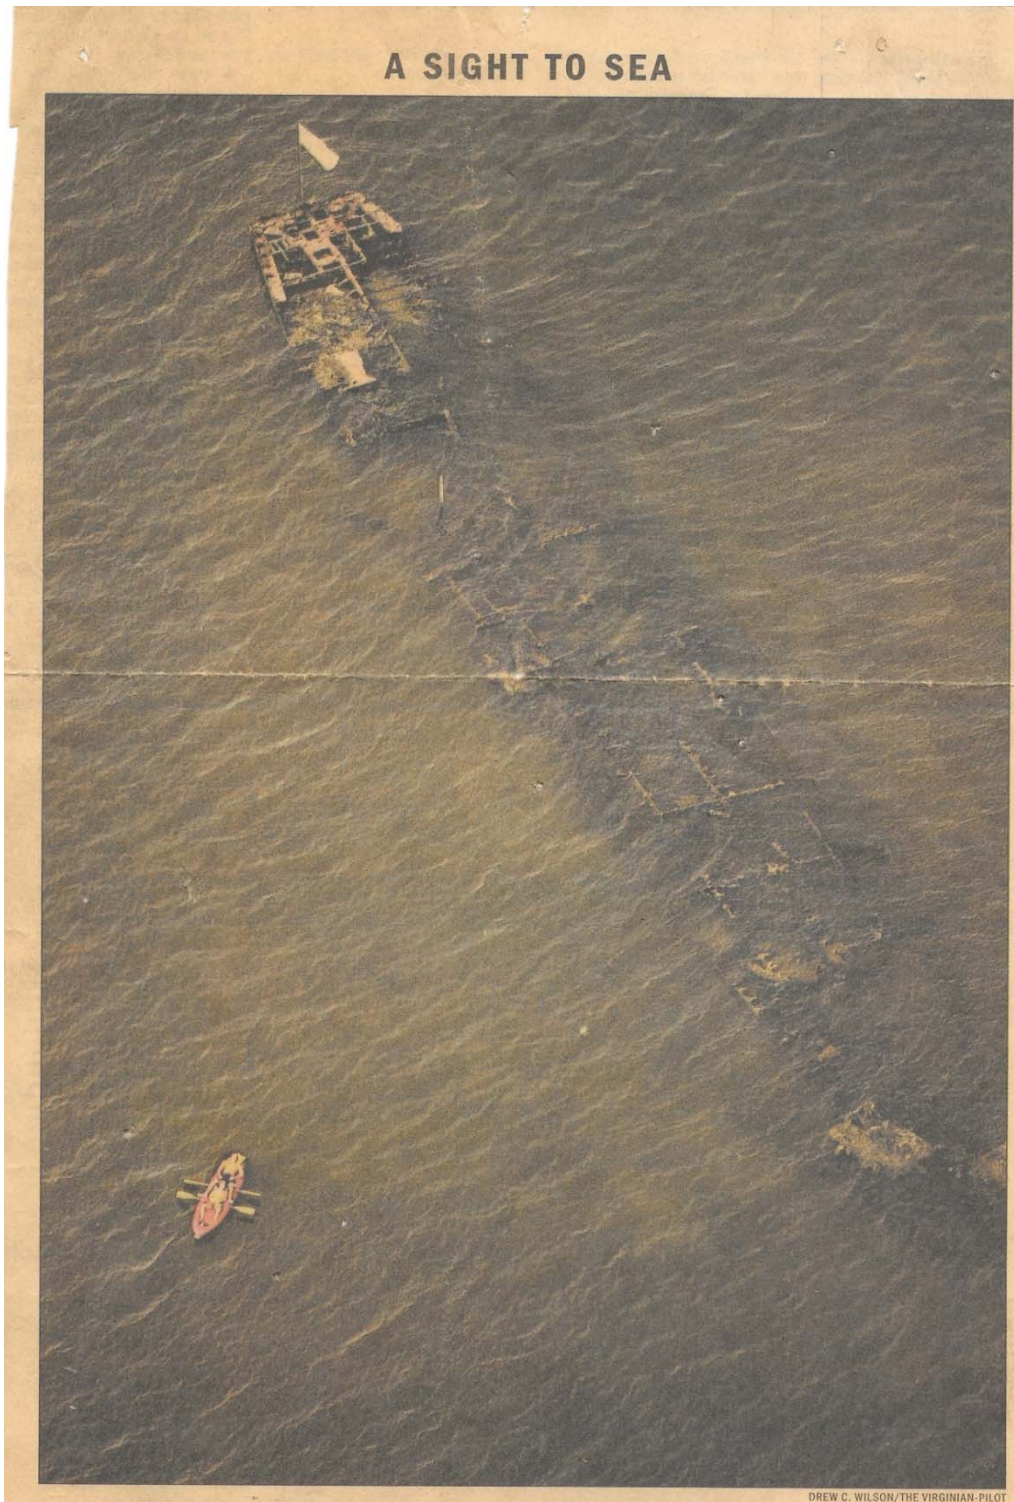
Figure 40. "A Sight to Sea" Color photo Drew C. Wilson/The Virginian-Pilot. A pair of kayakers float Monday near the dilapidated hulk of an old wooden vessel sunk in Pamlico Sound west of Rodanthe. The vessel, about 150 feet long, is only one-quarter of a mile from shore and has become a popular destination for paddlers (*The Virginian-Pilot* (Norfolk, VA) - July 23, 2004, page Y1)

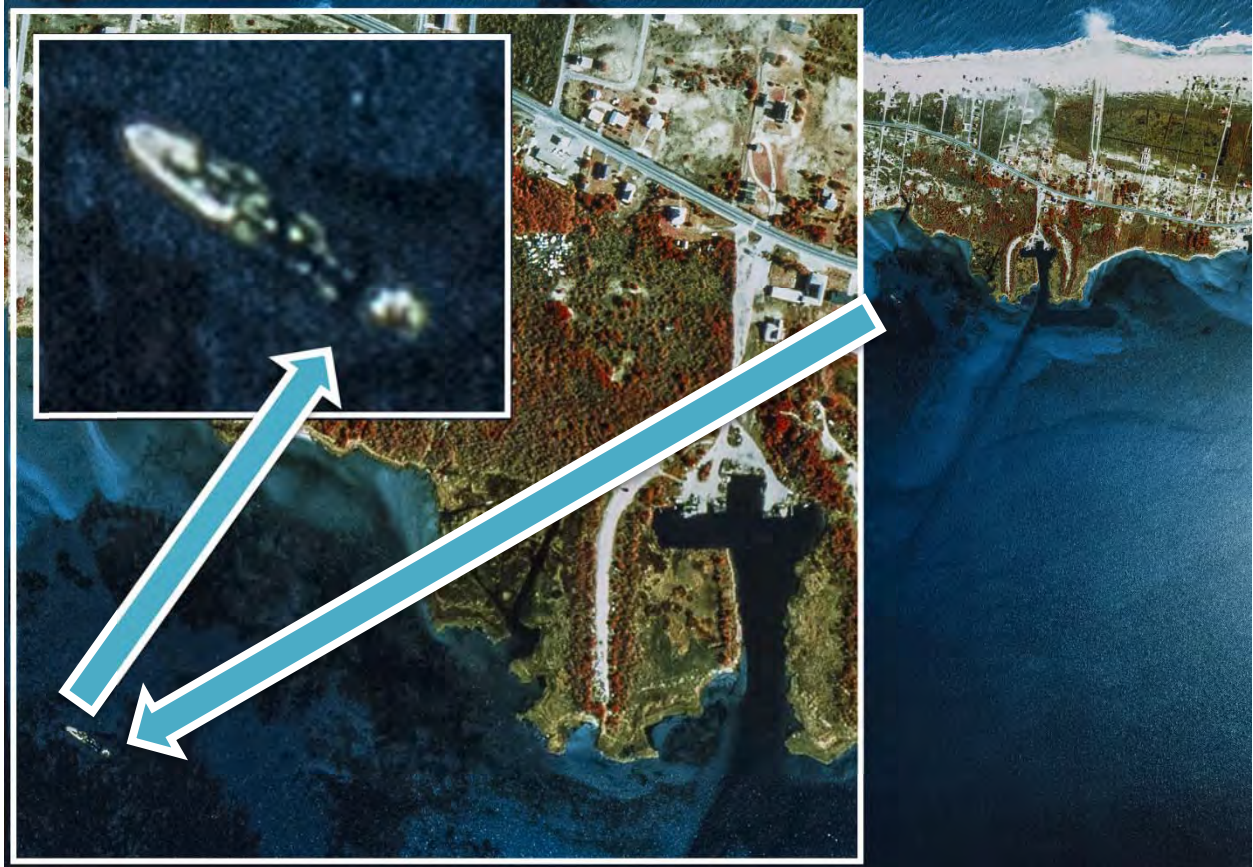
**Figure 52. Three views of USGS aerial photo 22 December 1982 showing location and state of preservation of PAS0001 (USGS single frame aerial photo ARL820510505046).**

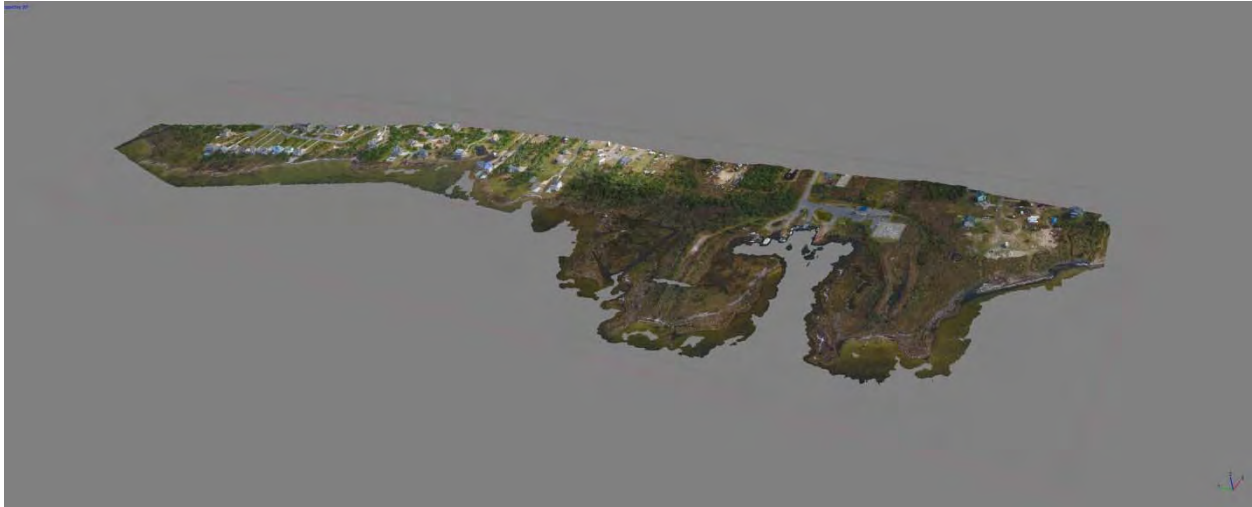
**Figure 67. High resolution three-dimensional photograph of survey area (Image by John McCord/CSI).**

As mentioned in the methodology section, drone-based photogrammetry data collection was successful on two occasions. On 15 November 2016, researchers successfully captured a high resolution orthographic photo and three-dimensional model of the shorelines adjacent to the study area, including the entirety of Black Mar Gut (Figure 67). Examination of the three-dimensional mesh produced by the modeling process in addition to inspection of details in the photographic representation suggest no additional extant structures protruding from the water or occupying the coastal fringes the surround the study area.

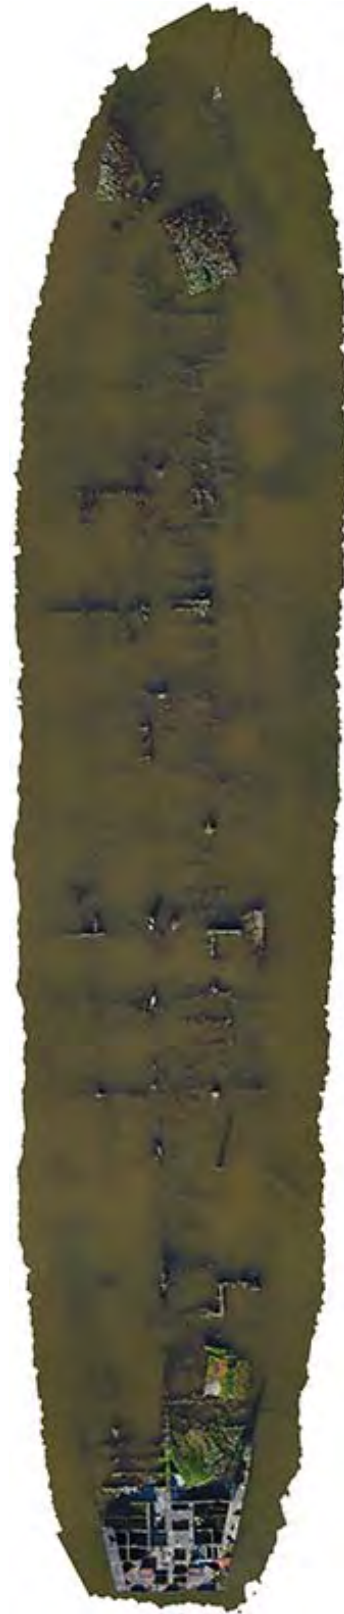
**Figure 69. High resolution multi-image orthophoto of PAS0001 (Image by Nathan Richards).**

Personnel returned in 10 February 2017 when water levels were low and wind was weak and successfully created both a three-dimensional model and a very high-resolution multi-image ortho-photograph of PAS0001 (see Figure 69). The results indicate a degree of penetration of some of the water across the surface of the wreck, and indicate that areas around the wreckage – particularly areas on the starboard side (right hand side of image) may have buried hull plates and other vessel components. Using these results, it is now possible to investigate further leads to potentially identify the hull by focusing on diagnostic elements of the vessel. For example, the 2010 site plan implies that the location of the extreme end of the bow is known – but the multi-image orthophoto suggests this may not be discerned properly and that the hull could be shorter or longer than once thought (i.e. disarticulated debris must be differentiated from articulated hull in more detail).

By capturing some elevation data in the three-dimensional model, it may also be possible to compare the present-day wreckage with the photographs from the 1970s, 1980s and early 2000s already presented and infer the loss of material from the hull in such a way as to predict potential future hull material deterioration.

The orthophoto and 3D model will also allow for future archaeological work to occur on the site. This may range from correlation between hull features and builder's plans that may be discovered in the future. It also shows that there is likely a zone around the wreckage which does not represent articulated hull structure, but may be hull plating which has fallen away from the hull and is now buried an unknown distance from the present-day intact structure. Due to poor water clarity, only re-survey of PAS0001 will be able to determine the actual outline and dimensions of the wreckage and the extent (and burial depth) of associated debris. Some of these questions may only be answered through additional remote sensing of the site, and some invasive archaeological activities (i.e. excavation of silt within and adjacent to the site).
