Crash Tests of Work Zone Traffic Control Devices

RESEARCH REPORT 147

Final Report on Research Project 102-13

Research Report 147
February 1990

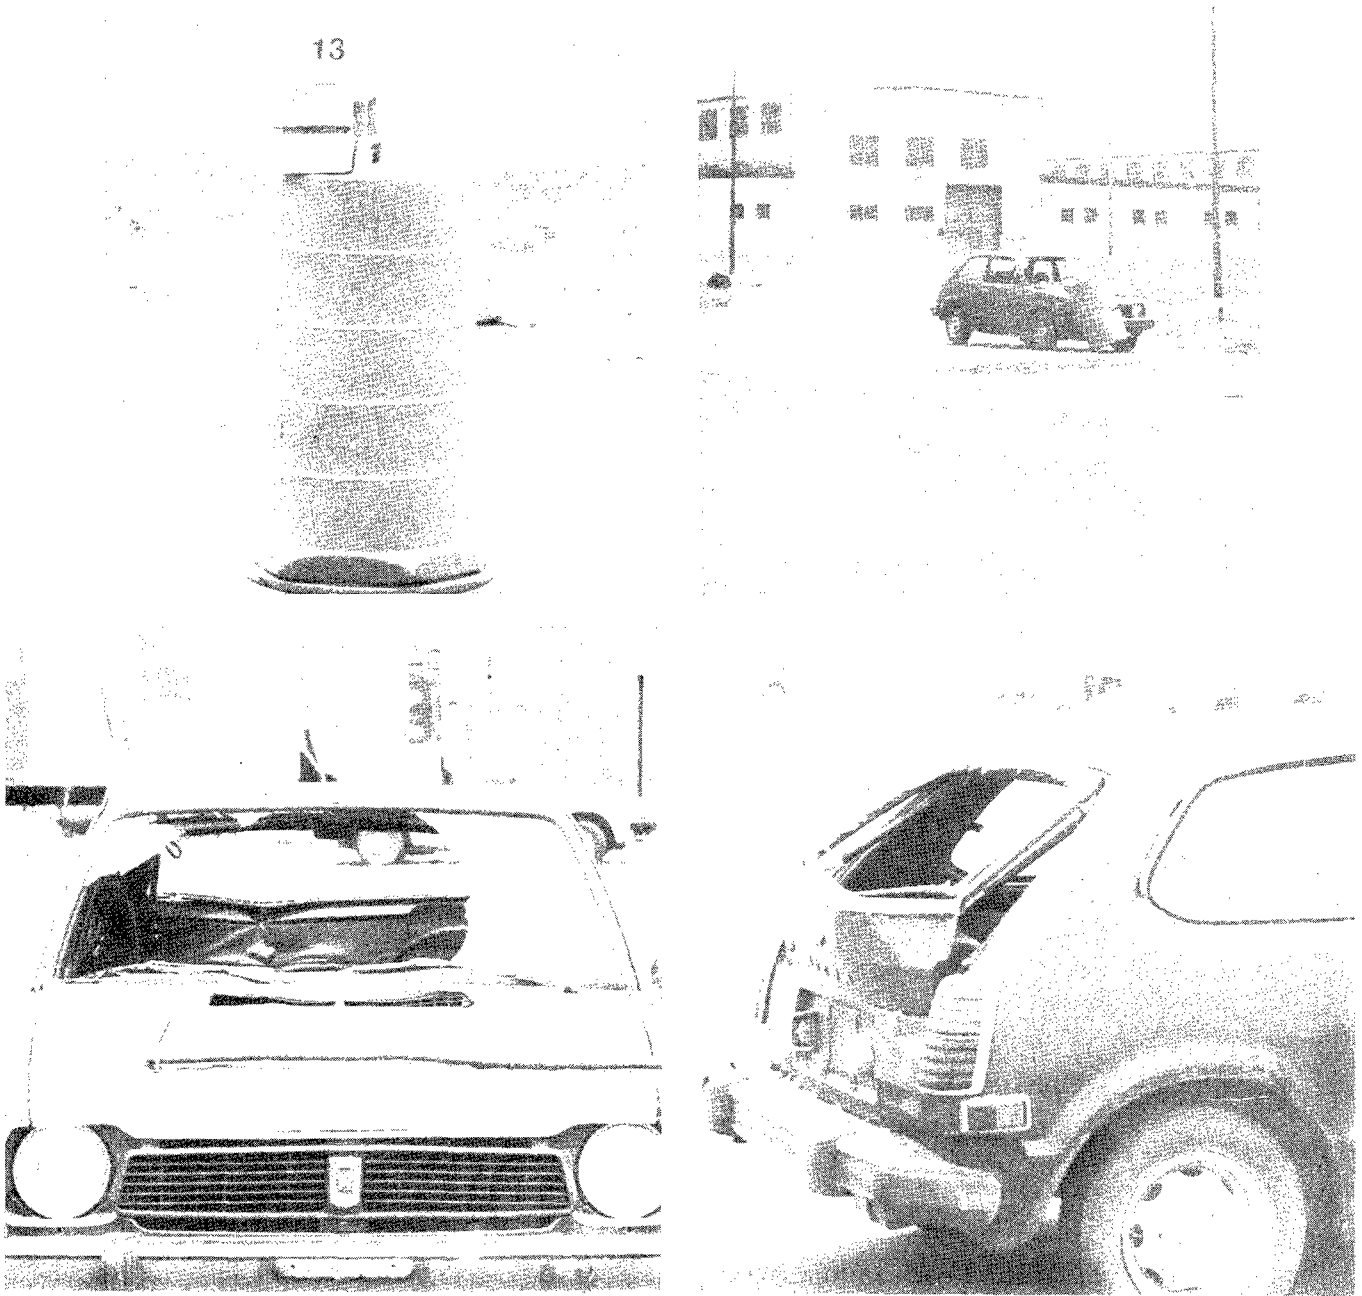
Figure 3. A 42-lb concrete-block ballast placed on a drum resulted in unacceptable intrusion into the passenger compartment.

A concrete block weighing 42 lb was placed on top of plastic drums in two tests. This ballast is similar in size and weight to heavy-duty batteries sometimes placed on top of drums to power warning lights. Pieces of rock or broken concrete pavement provide similar ballast.

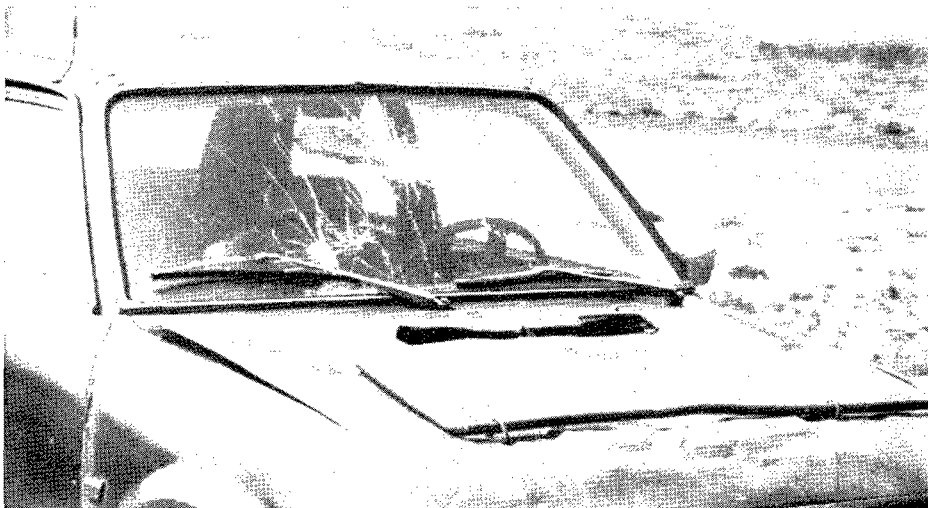
Figure 4. Attaching warning lights to channelizing drums resulted in lights being thrown on impact and drums flying over the vehicle (top), with varying degrees of windshield damage (center and bottom).

Of 19 tests of plastic drums with Type A warning lights attached (Fig. 4), only five met the primary evaluation criteria. Lights were attached to the drums by various methods. The primary problem was that the lights -- weighing about 6 lb including lantern batteries -- separated on impact and flew through the work zone, creating hazards to workers or other vehicle windshields. In two 60-mph tests, batteries traveled about 250 ft from impact, and in several others over 150 ft from impact.

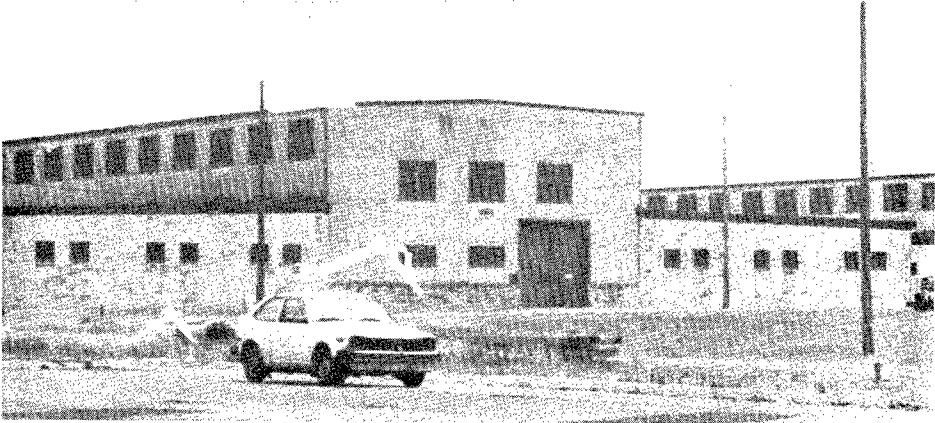
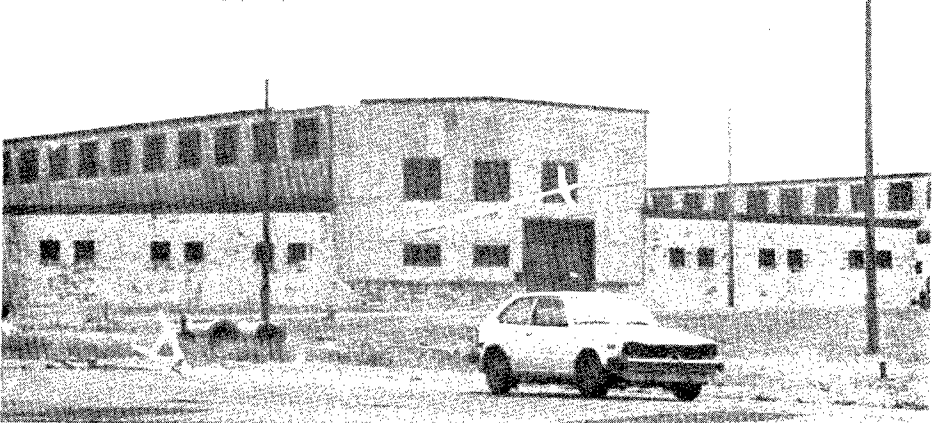
Figure 6. Collision with a Type I barricade resulted in unacceptable debris.

Four tests on Type I barricades resulted in debris thrown into the work zone, threatening workers and other traffic (Fig. 6). In three 60-mph tests, debris was thrown from 102 to 172 ft, and in the single 30-mph test debris was thrown 70 ft. Considering that these barricades weighed from 18 to 32 lb and included various steel and wood members, this debris appeared to present a significant hazard if it were to strike a worker or the windshield of another vehicle. In each case, debris was thrown high in the air, presenting a substantial risk that such contact would occur.
