Evaluation of the ADAPTIR System for
Work Zone Traffic Control

Research Report
KTC-99-61

**EVALUATION OF THE ADAPTIR SYSTEM
FOR WORK ZONE TRAFFIC CONTROL**

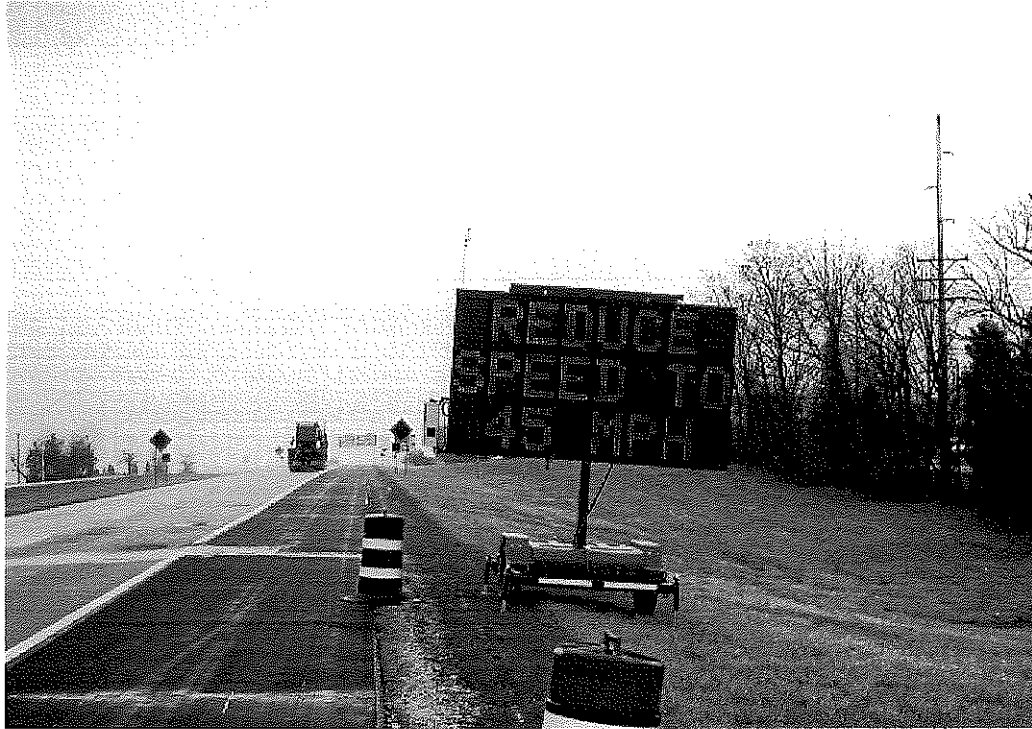
Figure 3. Speed Advisory Message.

Average speeds were calculated at each VMS and the arrow display at set intervals (every two minutes westbound and every three minutes eastbound). When the average speed between two adjacent radar locations was reduced by 10 mph or more, a message was displayed on the VMS upstream from the location at which the radar found the reduced speed. The speed warning consisted of a sequence of the following two messages.

ROADWAY		REDUCE
ADVISORY		SPEED TO
XX AM OR PM	followed by	XX MPH

Photographs showing these messages are shown in Figures 2 and 3. The message was updated every two minutes for the ADAPTIR system used in the westbound direction and every three minutes for the contractor’s system in the eastbound direction. The “time stamp” gave a new time so motorists would realize the information was current. The speed was given in five mph increments with the speed rounded to the next lowest five mph interval from the average. If traffic was stopped at one location giving a zero speed, the upstream VMS gave a speed of five mph.

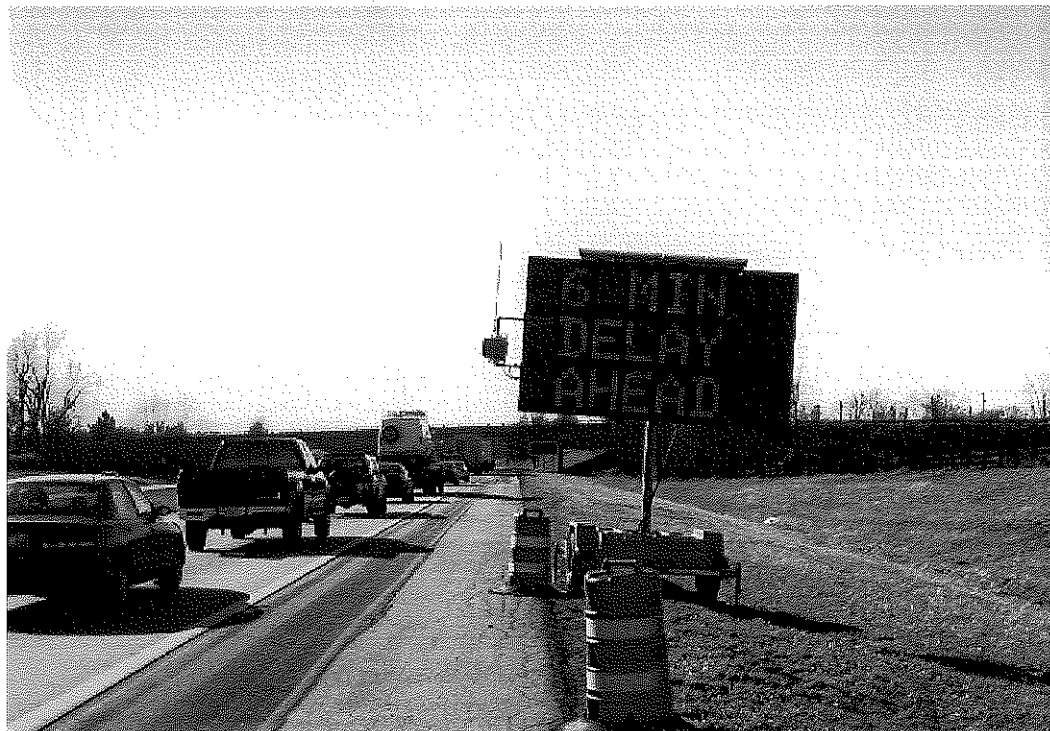
Figure 4. Delay Message.

The delay from a specific VMS to the end of the work zone was calculated by comparing the time necessary to travel from that VMS at the posted speed limits compared to the time required to travel through the work zone at the speeds measured by the radar units. The speed limits used were 65 mph in advance of the lane closure and 55 mph through the lane closure and extending approximately to the first VMS. Slightly different methods were used by the two systems to determine speeds between signs. Either the speed determined at a specific sign was used as the speed to the next downstream sign or the average speeds between two adjacent signs were used as the speed between those signs. The speed at the arrow display was used as the speed through the lane closure portion of the work zone. A minimum speed was used through the work area (after the start of the lane closure) since no radar units were placed in this area. A minimum speed of 10 mph was used by ADAPTIR. The length of the work area (lane closure) varied slightly depending on where the work was being conducted. In any case, the work zone was a few miles in length and the speed at the arrow display (with the specified minimum) was used over this length. A delay message was displayed when the delay through the work zone reached a threshold of five minutes. The delay message consisted of a sequence of the following two messages. A photograph showing a delay message is shown in Figure 4.

ROADWAY		X MIN
ADVISORY		DELAY
XX AM OR PM	followed by	AHEAD

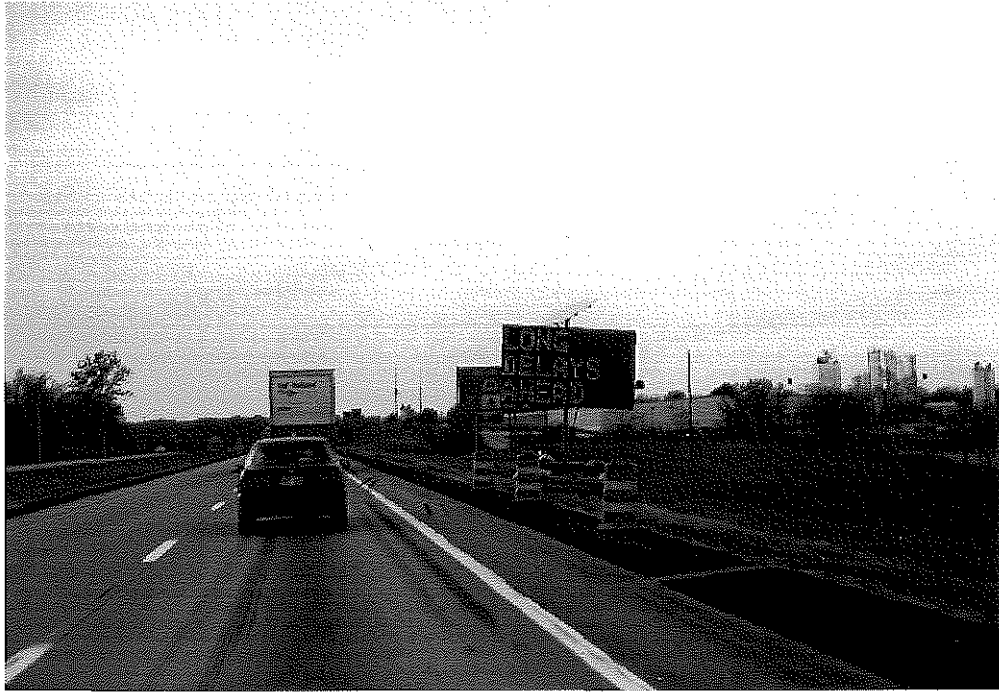
Figure 5. Long Delay Message.

The final message related to an alternate route. It was displayed when the delay reached 15 minutes and this delay was maintained for a minimum time of 10 minutes for the ADAPTIR system and 9 minutes for the contractor’s system. The diversion message consisted of a sequence of the following two messages (Figures 5 and 6).

LONG		ALT RTE
DELAYS		FOLLOW
AHEAD	followed by	EXIT XX

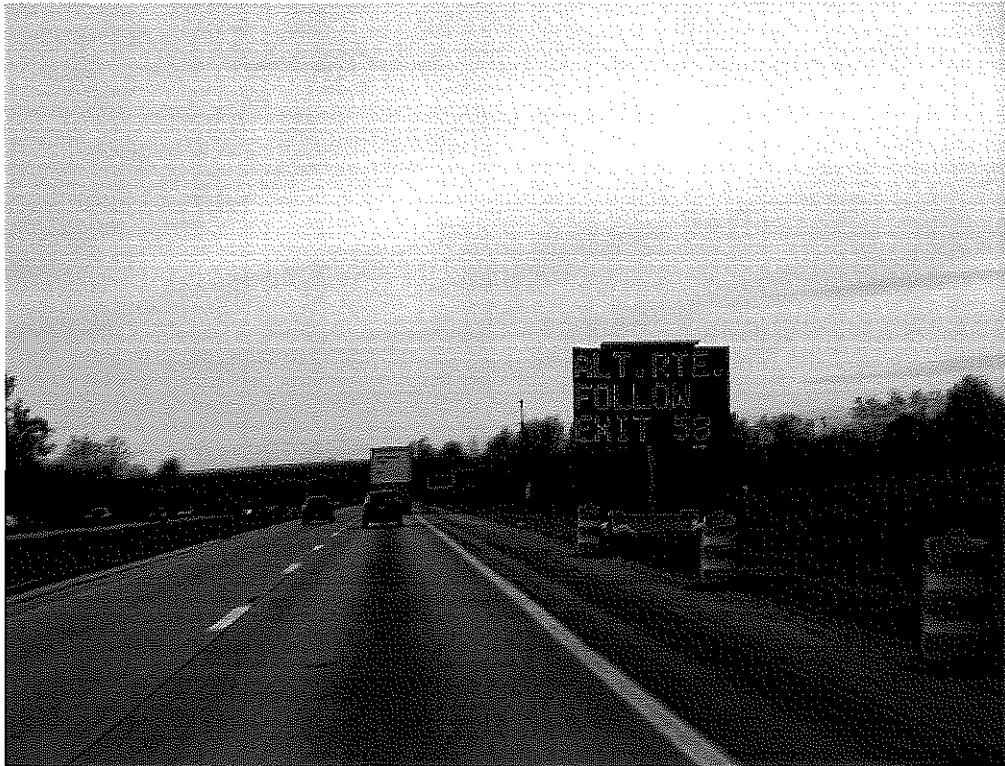
Figure 6. Alternate Route Message.

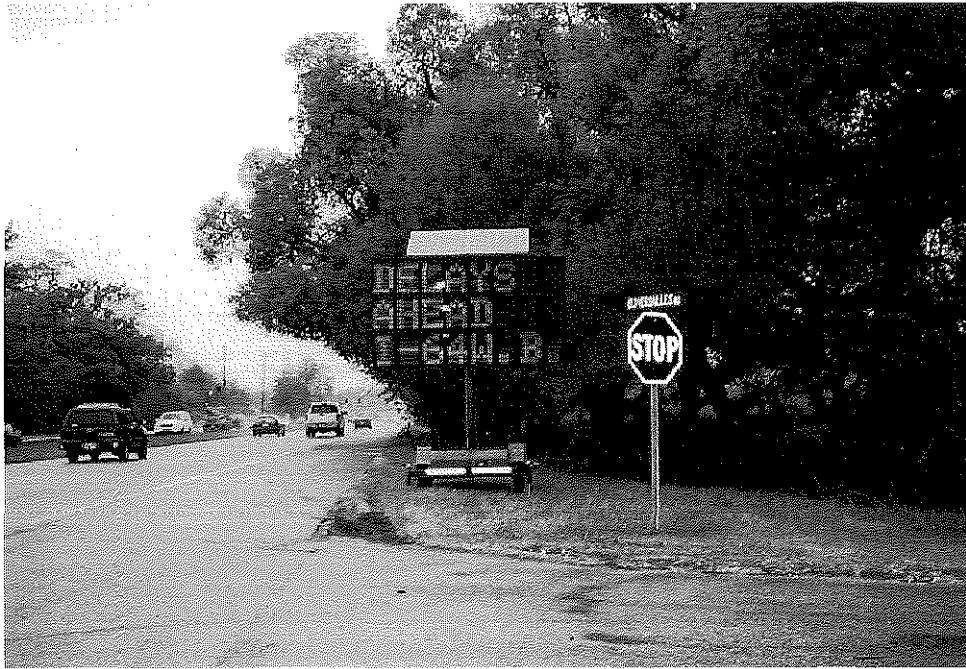
Figure 7. Message on Intersecting Route Advising of Delay on I 64.

This system provided information to motorists on the interstate. Additional VMS were placed on the diversion route to provide information when excessive delays occurred (Figures 7 and 8). The messages on these signs were input manually.

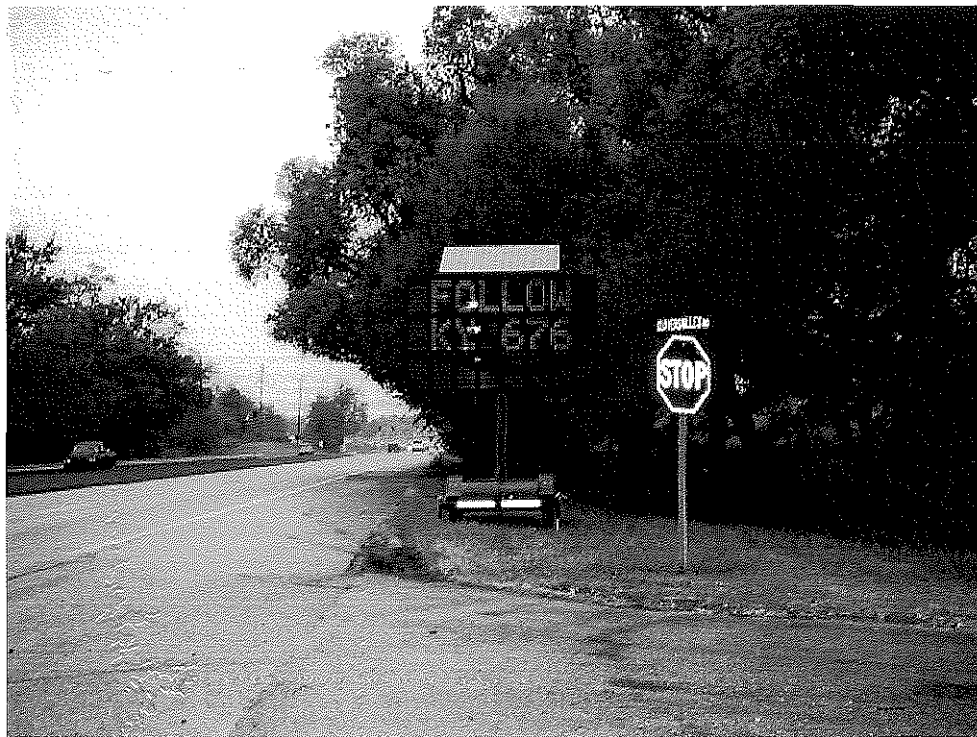
Figure 8. Message on Intersecting Route Advising Use of Alternate Route.
