PERFORMANCE OF COARSE- GRADED MIXES AT WESTRACK— PREMATURE RUTTING

Final Report

June 1998

ANALYSIS CONDUCTED BY
AN INDEPENDENT TEAM

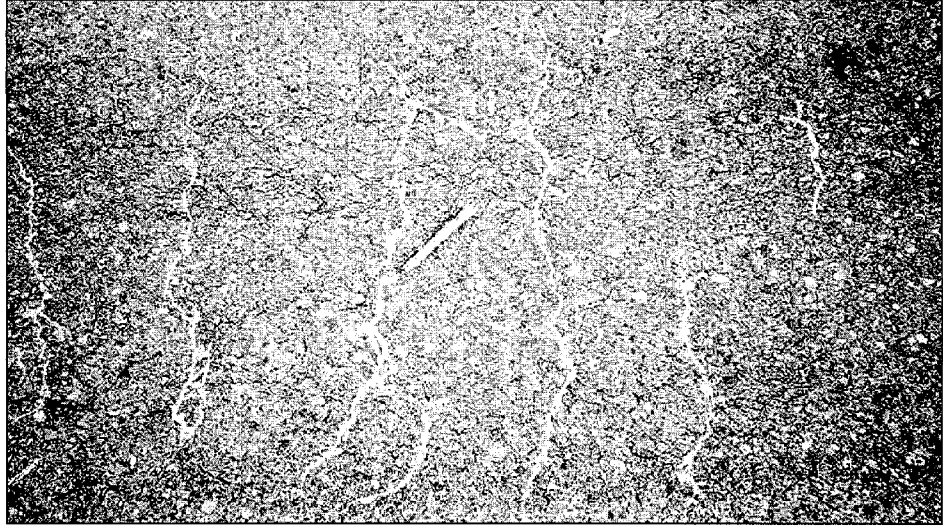
It started as short transverse cracks across the wheelpath. Then, the cracks started to connect and a typical fatigue-cracking pattern occurred, as shown in figure A-1. The short cracks are a different manifestation of fatigue cracking than the experience of most team members. Usually, fatigue cracks start as longitudinal cracks along the edge of the wheelpath, followed by transverse cracks between them. Team members familiar with thin pavements carrying heavy traffic have seen the WesTrack pattern before on thin pavements.

Figure A-1. Typical fatigue cracking pattern at WestTrack.

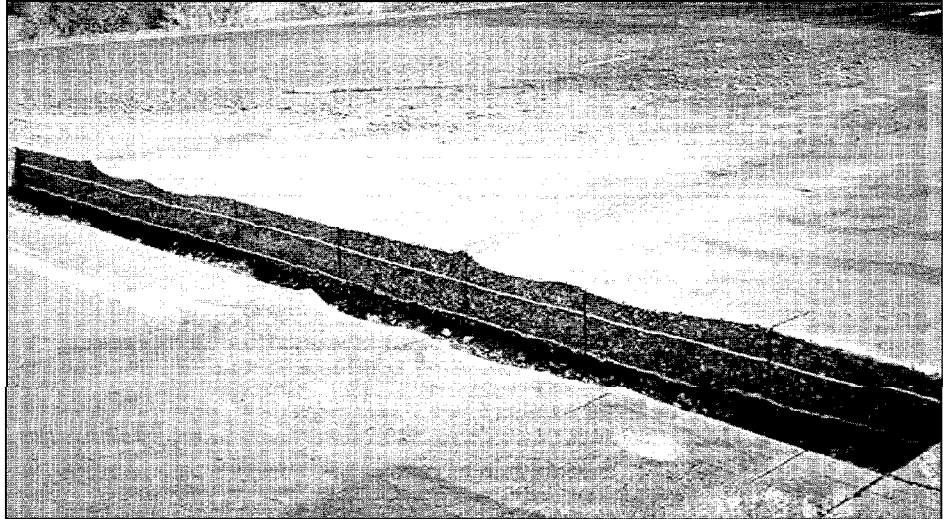
In the original WesTrack sections, the coarse gradation mixtures showed more rutting than the fine mixtures. Trenching in fall 1996, after 1.1 million ESALs, showed that the rutting was occurring within the asphalt mixture and not in the aggregate base as shown in figure A-2.

Figure A-2. Forensic trench showing rutting confined to upper asphalt layer.

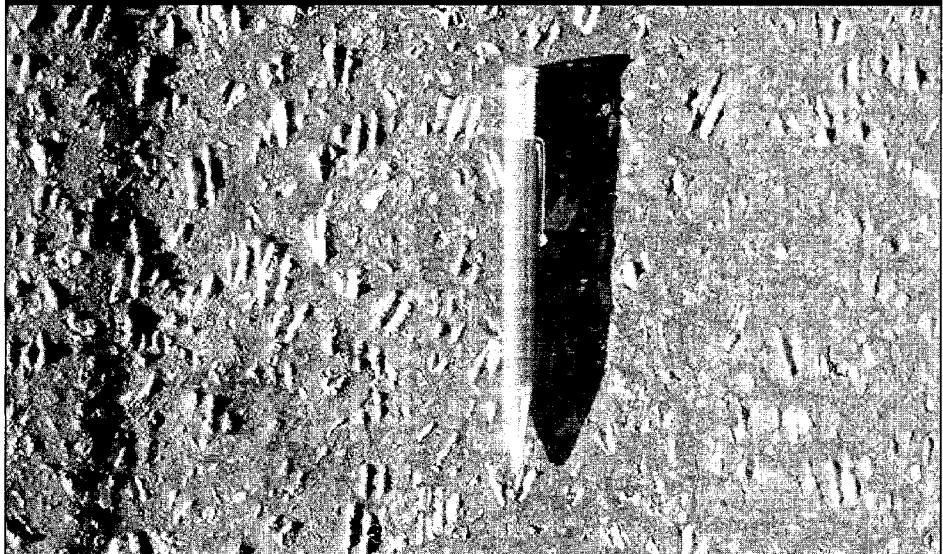
If strain within the asphalt mastic is large enough, aggregate particles will have the ability to reorient. If aggregate particles reorient, the skeleton collapses. Air voids decrease and rutting occurs. The amount of reorientation will depend on the amount of strain in the mastic and the mastic stiffness. If the mastic is very stiff, the

Figure A-3. Aggregate reorientation in surface of rutted mixtures.
