SmartPark Technology Demonstration Project, Phase II: Final Report

U.S. Department of Transportation
Federal Motor Carrier Safety Administration

May 2018

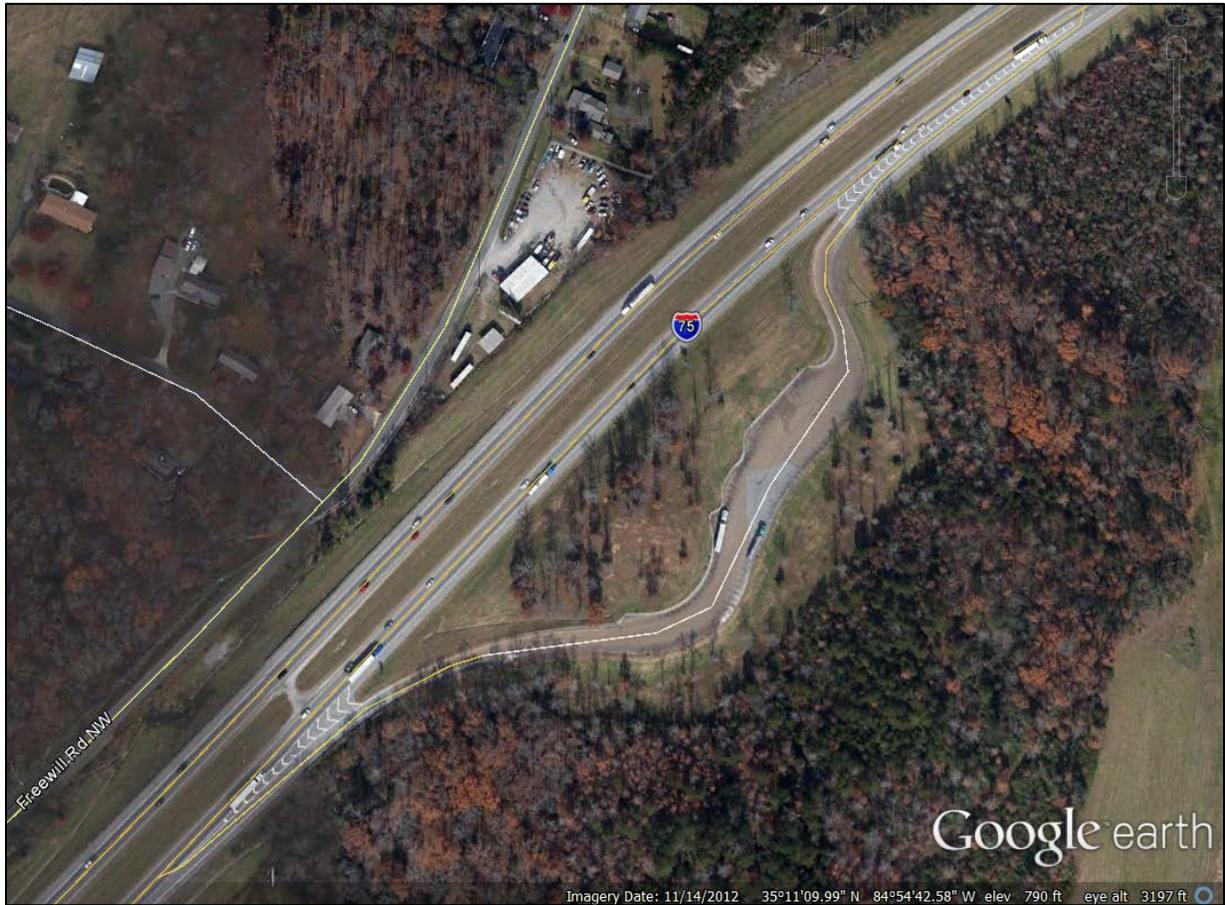
Figure 3. Photograph. MM23 test site satellite image before renovation (courtesy of Google Maps).

The site as it looked before its renovation can be seen in the satellite view provided in Figure 3.

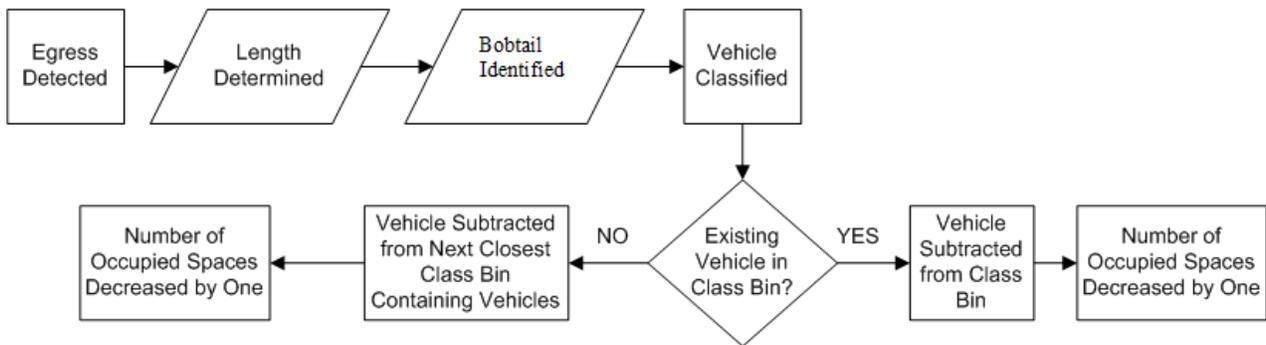
Figure 7. Egress algorithm.

The egress algorithm used in the analysis mimics the ingress process. An extra step was added to the egress process to avoid losing vehicles not already represented in the system. Due to variations in the installation of the detector technology between ingress and egress of a site, a vehicle leaving the lot may have been classified differently than it was classified when entering the lot. When departing a site, if there were no vehicles of the classification assigned by the egress detector, then the exiting vehicle would be subtracted from the next-closest class bin with one or more vehicles in it. This process preserved the overall count of the system in the event that there was no vehicle in the proper bin from which to subtract. When classifications differed between a vehicle’s ingress and egress, subtracting from the classification bin designated by the egress detector could have resulted in a negative number (if the classification bin already had a value of zero), or the egress would not be counted at all, thereby throwing off the overall count of the system. The extra step in the egress process ensured that while a vehicle may have been classified differently at the ingress and egress, the integrity of the overall lot count was not affected. If the lot count was already zero, the system would effectively erase an egress event’s effect on the count.

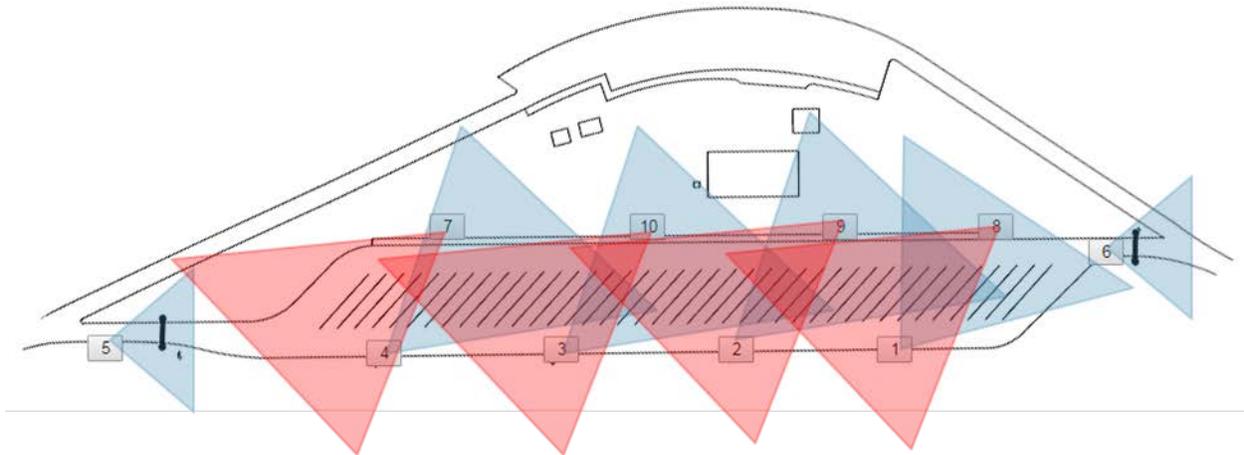
Cameras pointed at the parking lot were mounted on existing or new light poles. Cameras pointed at the gantries at the ingress and egress were mounted on poles that supported the Doppler radar equipment. Camera locations and their approximate fields of vision for each site are displayed in Figure 8 and Figure 9 (the different colors within the figures are to help separate camera fields of vision).

Figure 8. CCTV camera locations and fields of vision for MM45.

CCTV cameras were placed strategically throughout the rest area and truck parking area to provide a means of monitoring the site from remote locations. Cameras were carefully located such that the cameras provided visibility of all spaces within the lot as well as the ingress and egress gantries.

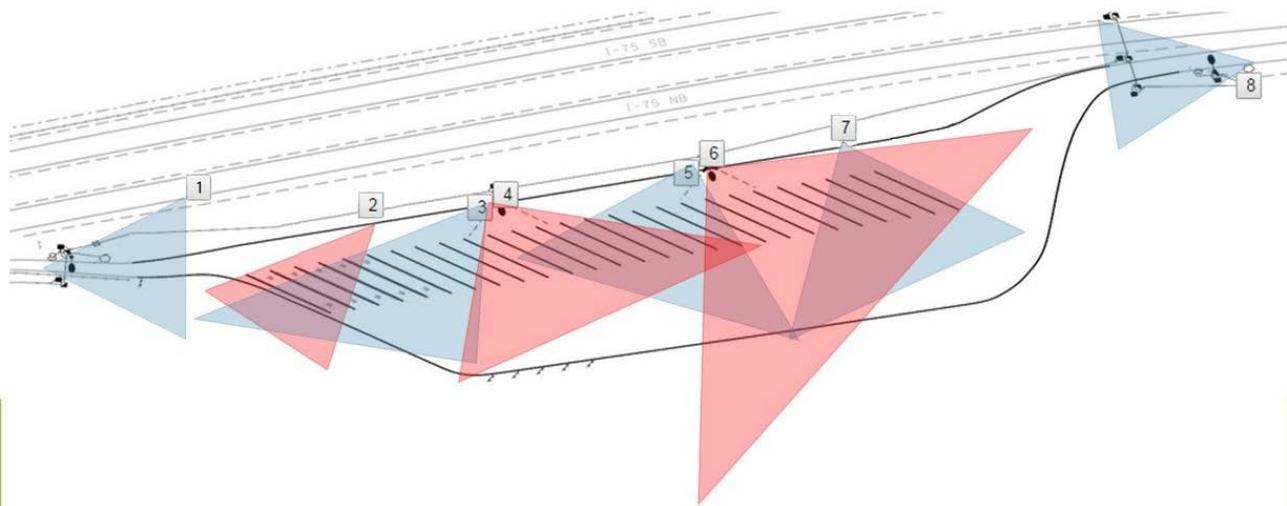
Figure 9. CCTV camera locations and fields of vision for MM23.

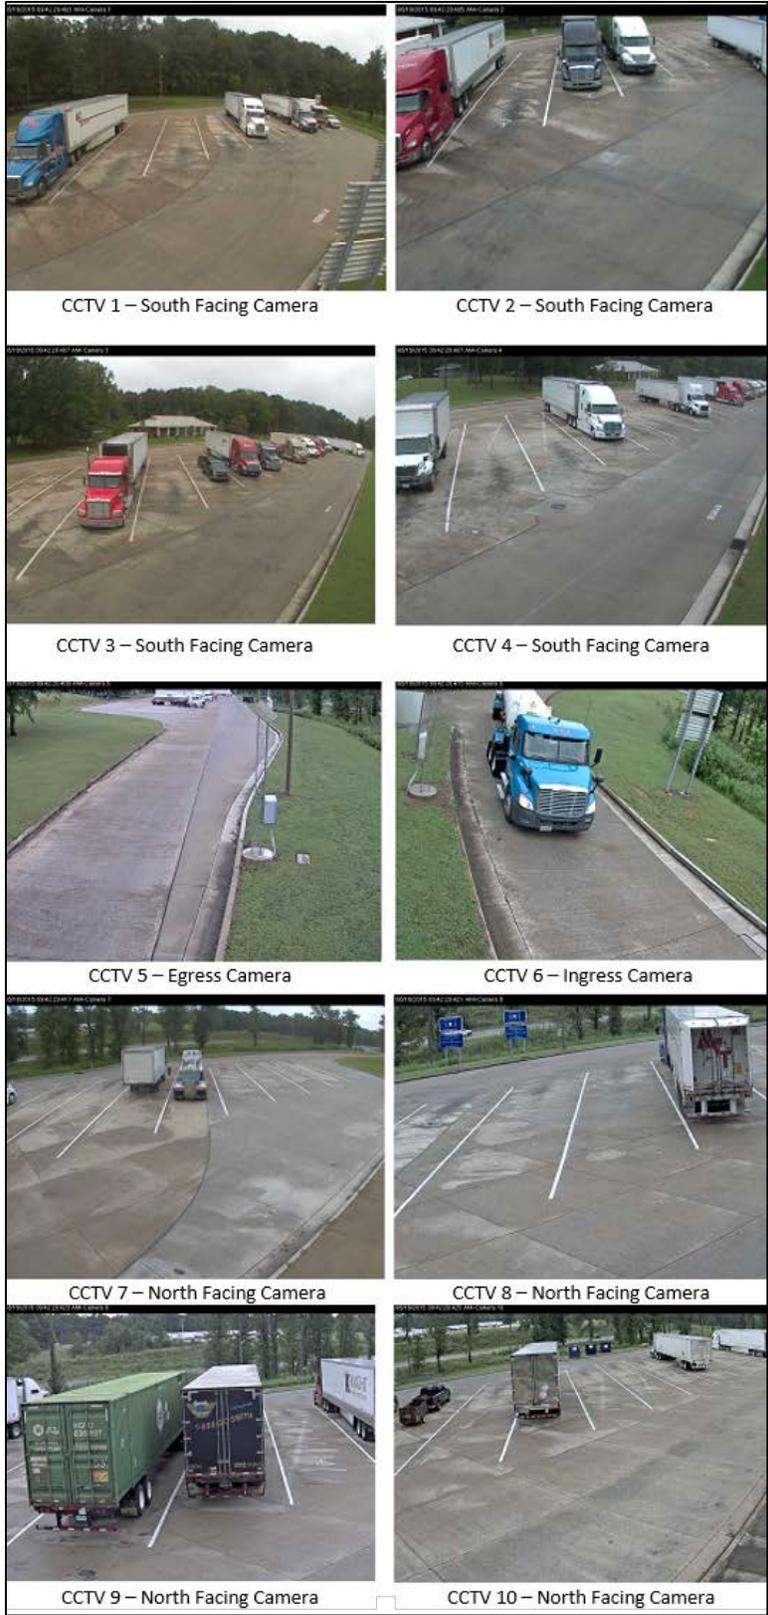
Figure 10. Grouped image. CCTV camera images for MM45 SmartPark site.

Each of the CCTV cameras was linked to the on-site data server for their parking site. Each of the cameras were viewable, one at a time, using the internet and the project Web site. Viewing from the project Web site was limited to a single camera at a time due to bandwidth limitations of the connection to the rest area site. The fields of view of the MM45 rest area cameras are displayed through snapshots in Figure 10 and the fields of view of the MM23 site cameras are displayed in Figure 11.

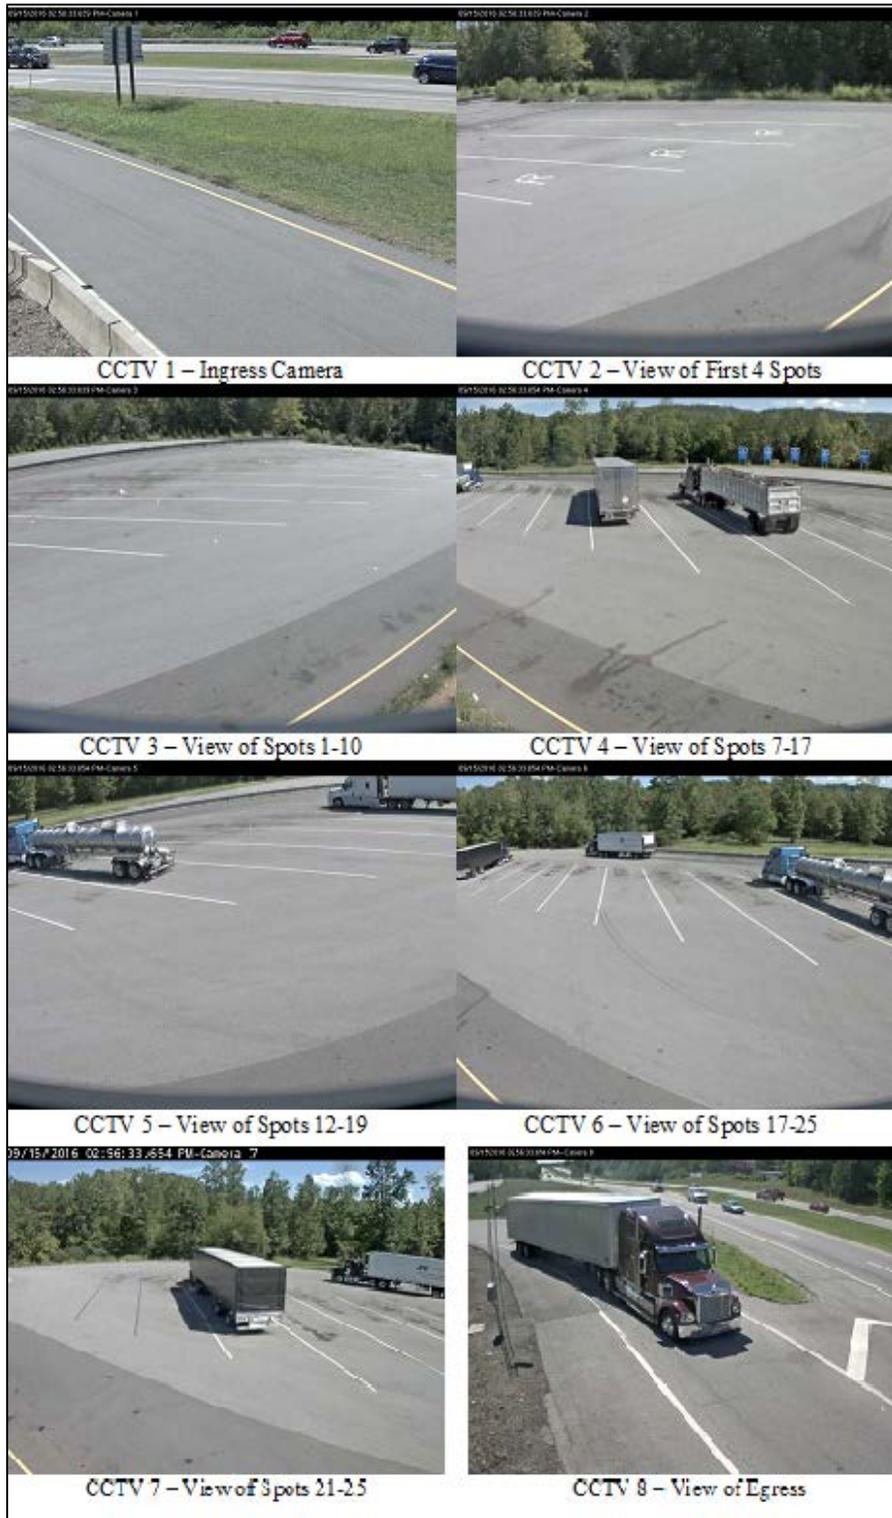
Figure 11. Grouped image. CCTV camera images for MM23 SmartPark site.

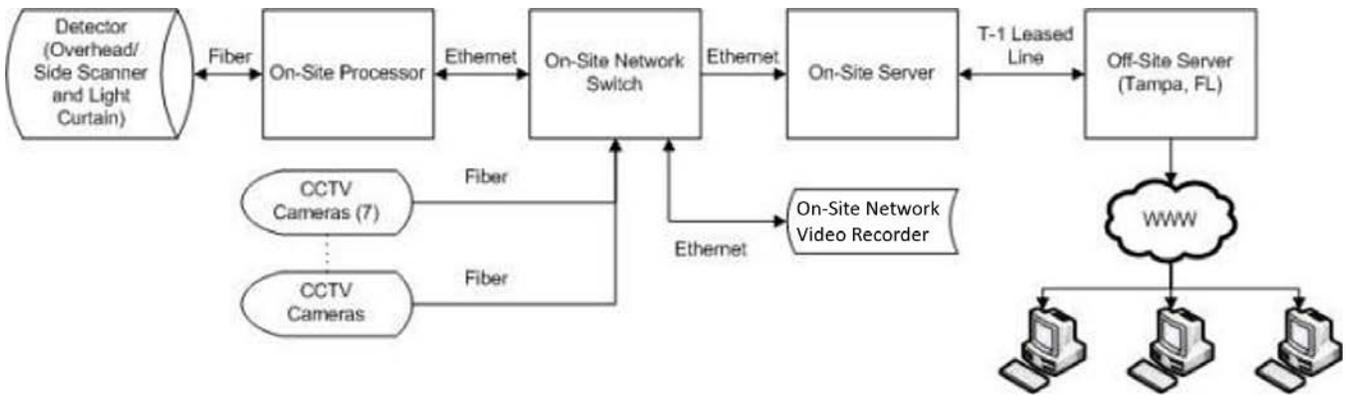
All equipment at both sites were connected using a series of multimode fiber optics and Ethernet and communicated via a local area network (LAN) established for the project. The sites were interconnected via a wide area network (WAN) created by leasing lines from internet service providers: T-1 connection at MM45 and cable internet at MM23. The network architecture is summarized in the diagram in Figure 15.

Figure 15. Diagram. SmartPark local area network architecture summary.

A leased T-1 line connection was established at the MM45 site for all communications to and from the project site. The T-1 had a standard bandwidth of approximately 1.544 megabytes per second (mbps). At the MM23 site, cable internet from a local service provider was established. The bandwidth of this connection was approximately 500 mbps.

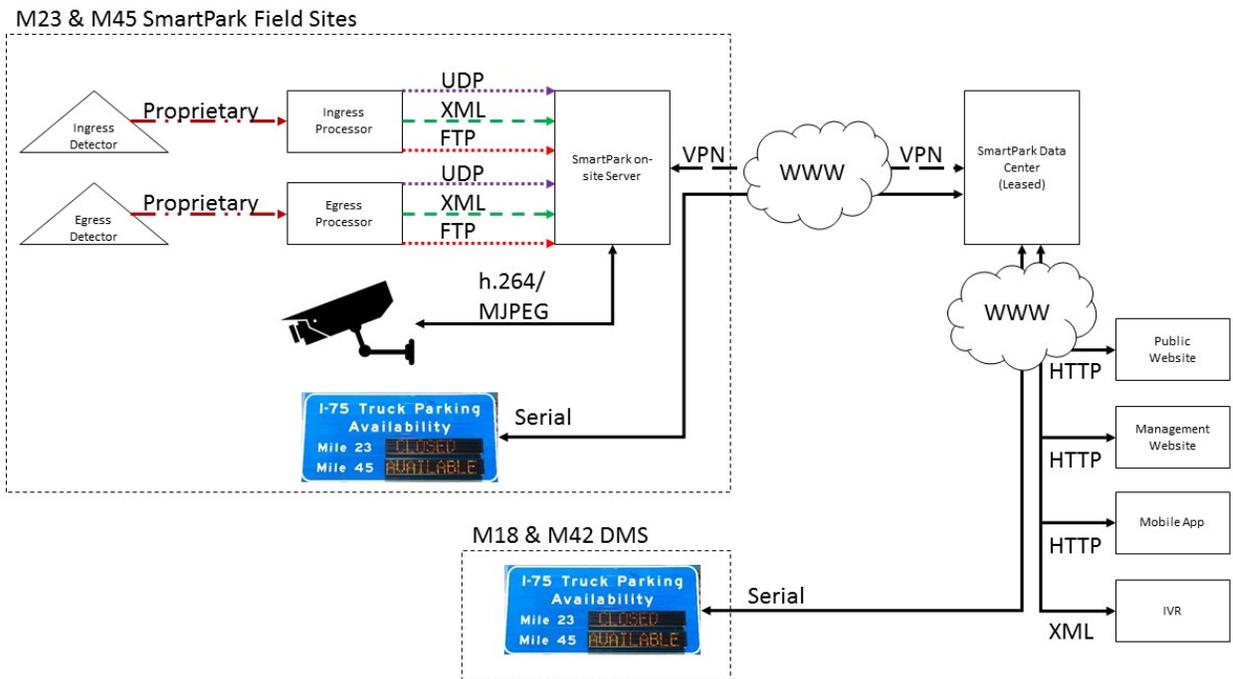
SmartPark utilized several services to exchange data internally and to send data externally. The protocols are summarized in Figure 16. These various protocols were used to complete functions within the SmartPark system to capture, record, and process data.

Figure 16. Diagram. SmartPark protocols.

The processes are described in detail below, including each one's location, source information, author, and purpose within the SmartPark system.

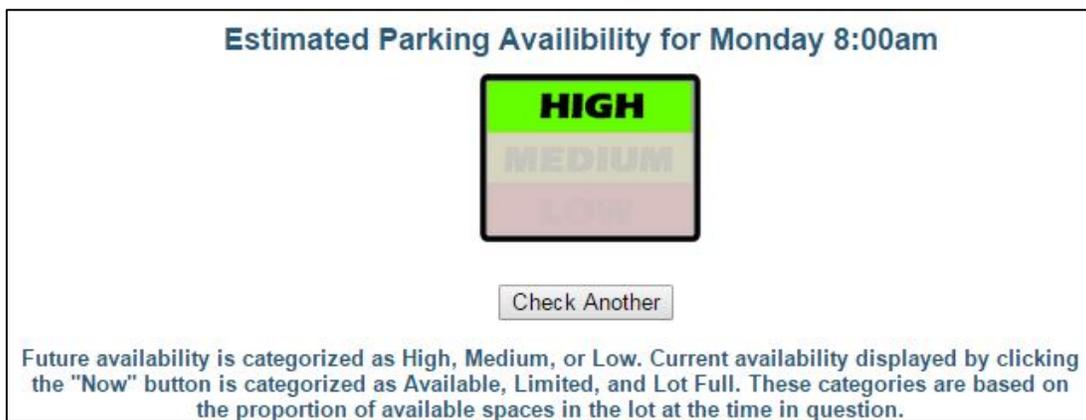
Figure 17. Screenshot. Parking availability on public Web site.

The public Web site, found at www.smartparkingusa.com, allowed users to view availability of truck parking at the two sites and make reservations. This Web site enabled users to register for the reservation service and provided them with a 5-digit personal identification number (PIN) which they could use to log in when using the IVR. Their login credentials could be retrieved through a “Forget password or PIN?” link in the system which automatically sent the user an e-mail with the requested credentials. On the Web site, users could create and manage reservations as well as view availability information without logging in or registering. The parking availability could be viewed for both sites at any given time, and the estimated availability could be viewed for a future time. Current availability was displayed by clicking the “Now” button and was described as “Available,” “Limited,” or “Lot Full” (quantitative thresholds are given later under “Dynamic Message Signs”). These categories were based on the proportion of available spaces in the lot at the time in question. Future availability was categorized as “High,” “Medium,” or “Low.” This future availability was estimated by using historical availability data for the day and time entered by the user. An example of this capability is presented in Figure 17, below.

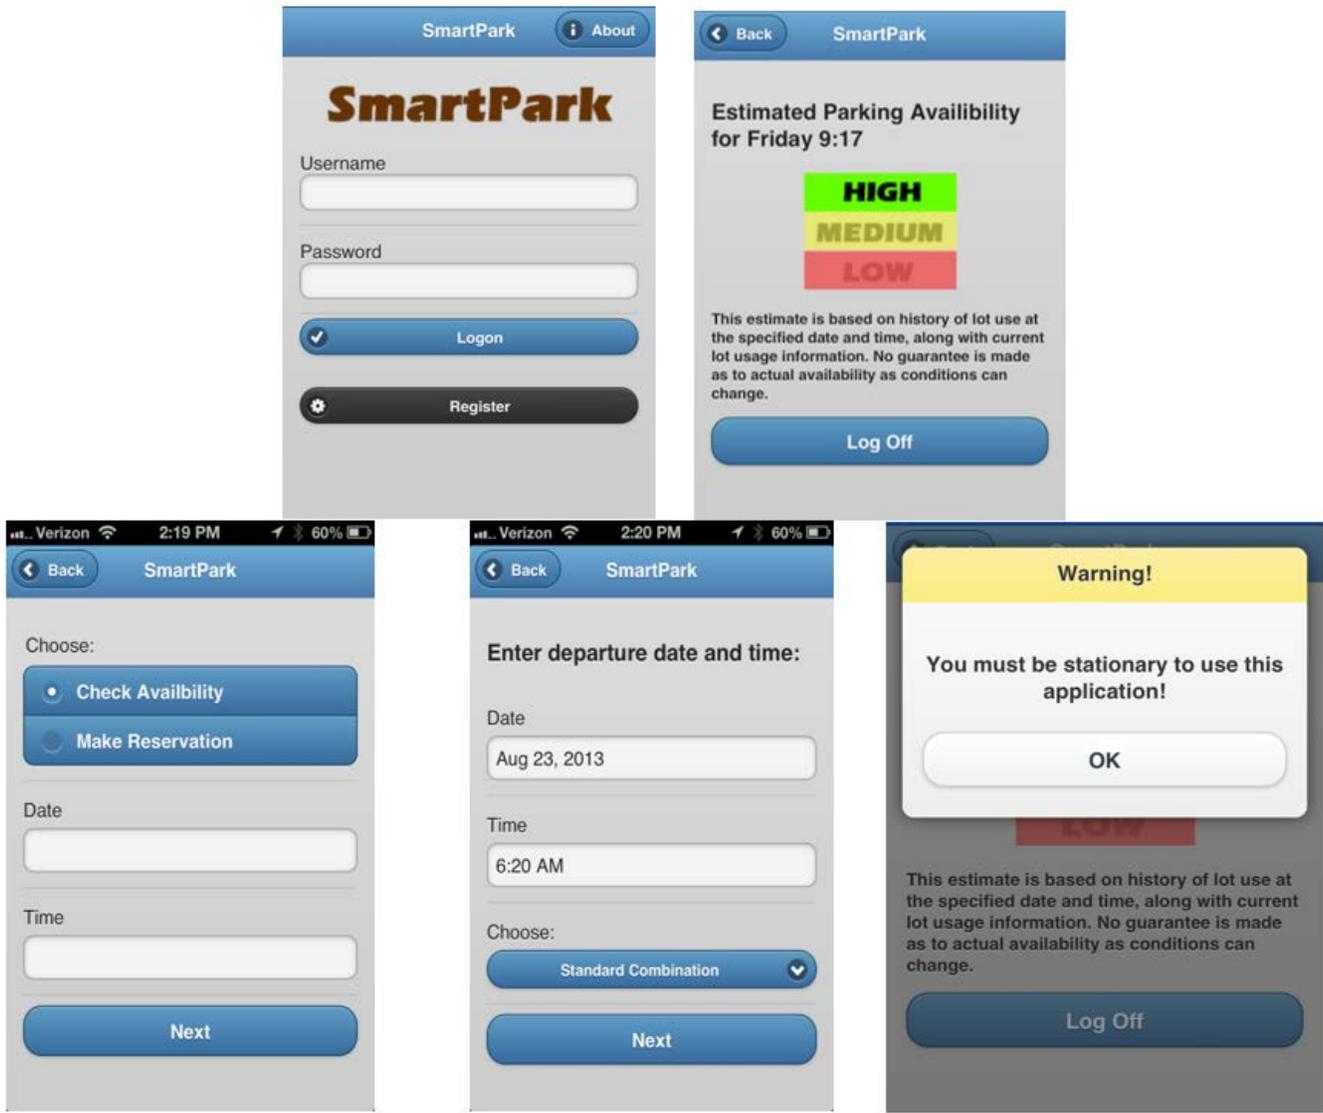
Figure 18. Grouped image. Mobile application example screens.

The mobile SmartPark application could be downloaded on the Google Play market and the Apple App store for free. The mobile application had the same capabilities as the public Web site but was more easily accessible “on-the-go” because it was optimized for use on smartphones. The application addressed safety concerns by utilizing the phone’s GPS coordinates and/or accelerometer to disable the application over a predetermined speed to prevent users from using the application while driving. An example of the look and feel of the application can be seen in Figure 18.

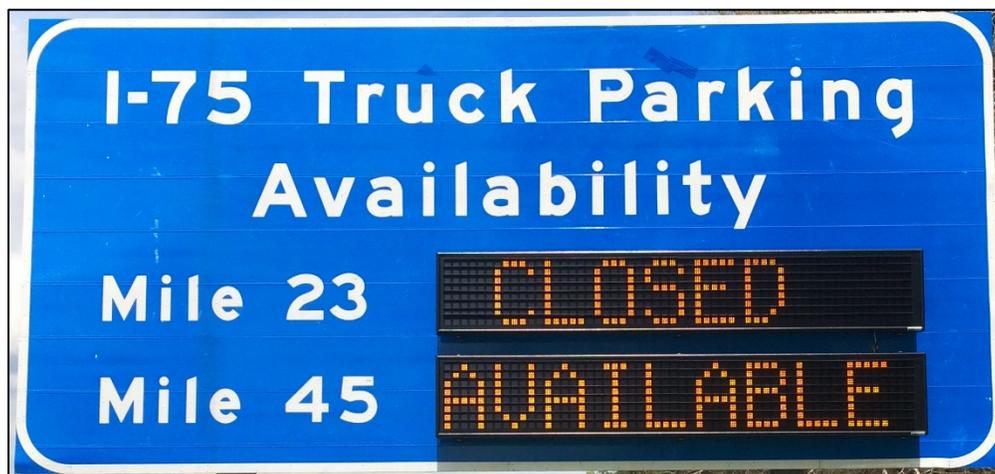
The “Type-A” DMS insert displayed parking availability according to the thresholds, as follows:

- “Available” – more than 4 spaces available.
- “Limited” – 2 to 4 spaces available.
- “Full” – 1 space available.

Figure 19. Photograph. Sign type upstream of MM23.

The purpose of these signs was to provide information on parking lot availability to the motorists so that they could make informed decisions prior to reaching either rest stop.

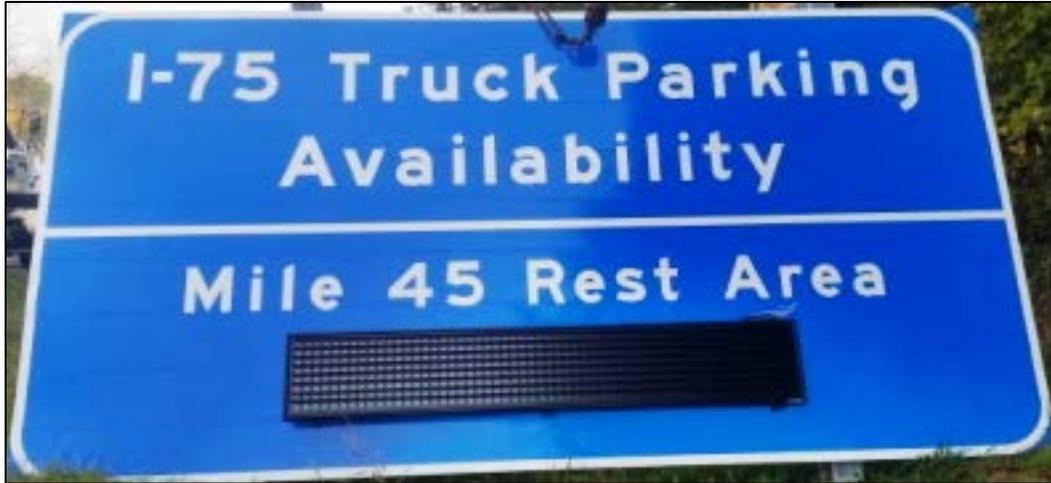
Figure 20. Photograph. Sign type upstream of MM45 and downstream of MM23.

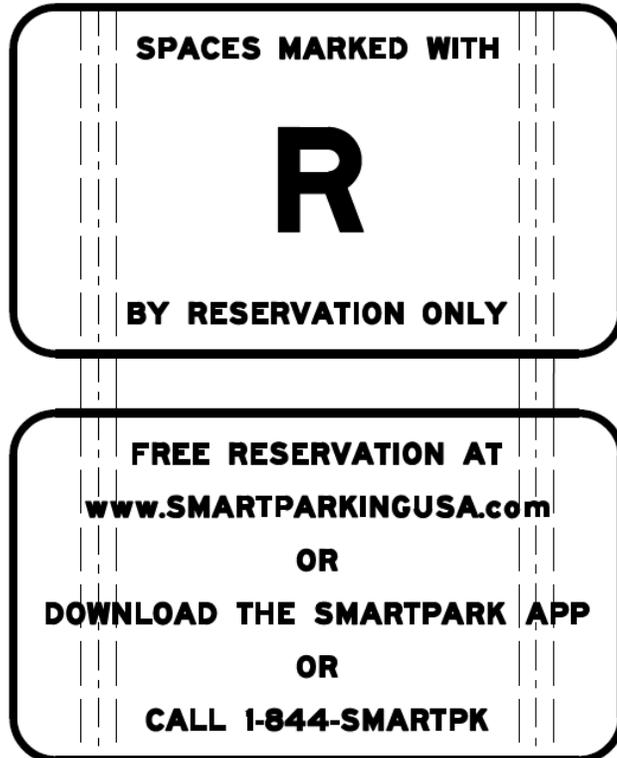
Figure 21. Image. Reserved space information static sign examples.

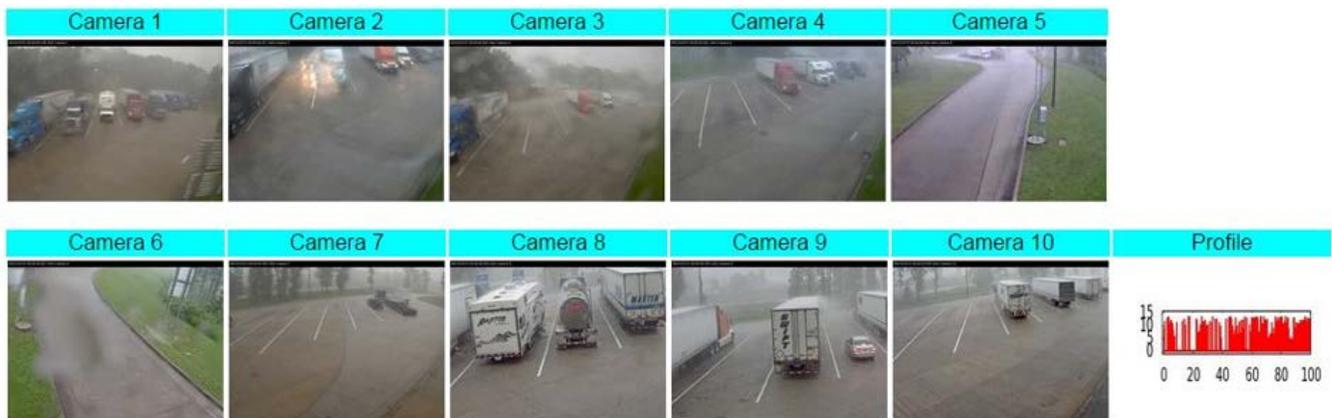
Prior to the start of the official testing period, both SmartPark sites were monitored for anomalies and potential issues. During this period, it was found that during heavy rain events, the ingress and egress detectors perceive rain droplets as though they were vehicles entering or exiting the lot. This occurred most often in the ingress detector in the MM45 lot than in the egress detector. The false detections drove up the number of vehicles that the system believed were in the lot, giving false availability information (by incorrectly reducing the number of available spaces). An example of a false ingress detection occurred on August 23, 2015, at 8:07 a.m. (see Figure 22). As can be seen in the image, the system believed a vehicle entered the lot even though there is no vehicle near the ingress in the camera still for Camera 6. The profile included in the event log shows that the detectors were sensing “sheets” of rain as they fell from above, resulting in the false detection of a Class OV (oversized) vehicle. This issue was resolved whenever a manual correction was done for the lots through the SmartPark Management System.

Figure 22. Image. False detection caused by rain in MM45.

This issue was subsequently addressed with the manufacturer by adjusting the algorithm that interpreted the scanner data and produced vehicle profiles. Following the adjustment, no further rain-caused false detections were identified (after a cursory review).

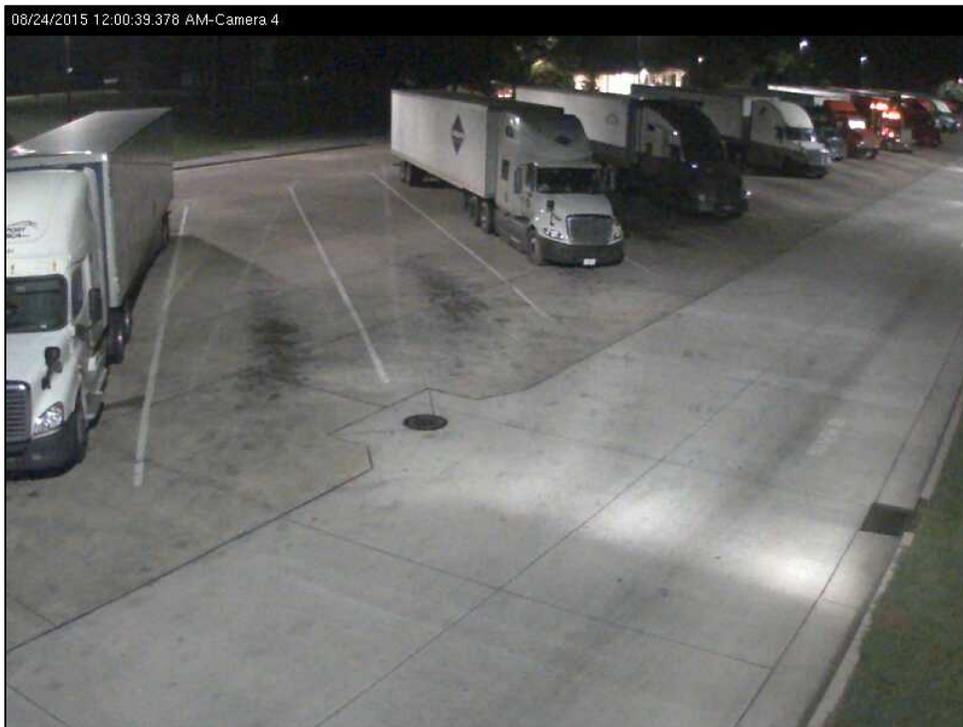
Figure 23. Photograph. Nighttime view of the parking lot from Camera 4 in MM45.

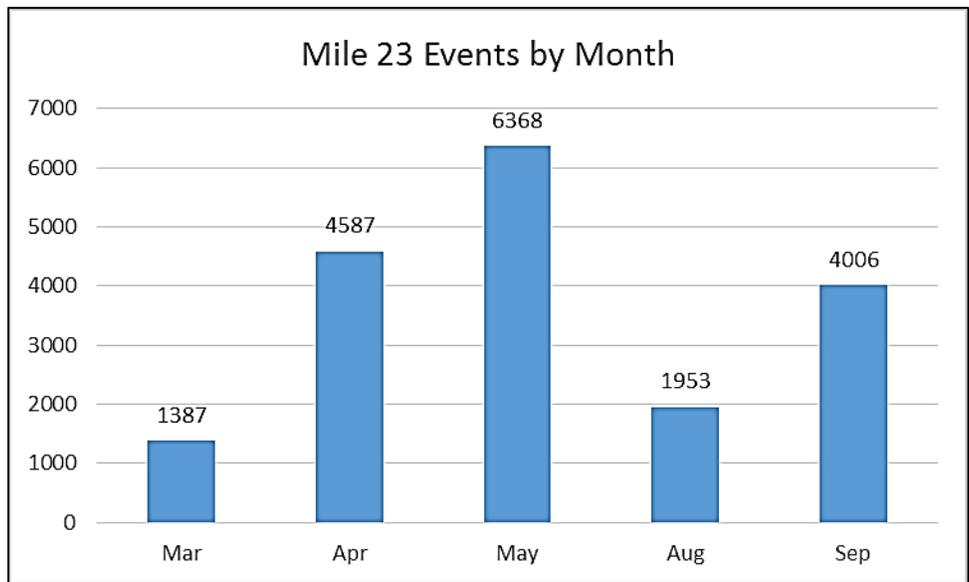
Figure 24. Bar chart. MM23 number of vehicles by month.

Figure 24 and Figure 25 display the number of daily ingresses at MM23 and MM45, respectively. Ingresses are an approximation of the total number of vehicles that used the facility. April and May represent the best months to compare usage across the two facilities since there was relatively little outage during this period. During April, MM23 experienced approximately a third (or 37.7 percent) of the activity as MM45. During May 2016, this increased to approximately half (or 47 percent) of the activity. However, upon closer inspection, the increase in usage is an anomaly. Figure 26 shows the daily usage at the MM23 location for each day during the testing period, less any outages. The spikes that occurred on May 2, 3, and 4 of 2016 are attributed to the Highway Safety Patrol using the site as a temporary weigh/inspection station. As a result, every truck on the interstate was required to pass through the site, inflating the daily usage numbers.

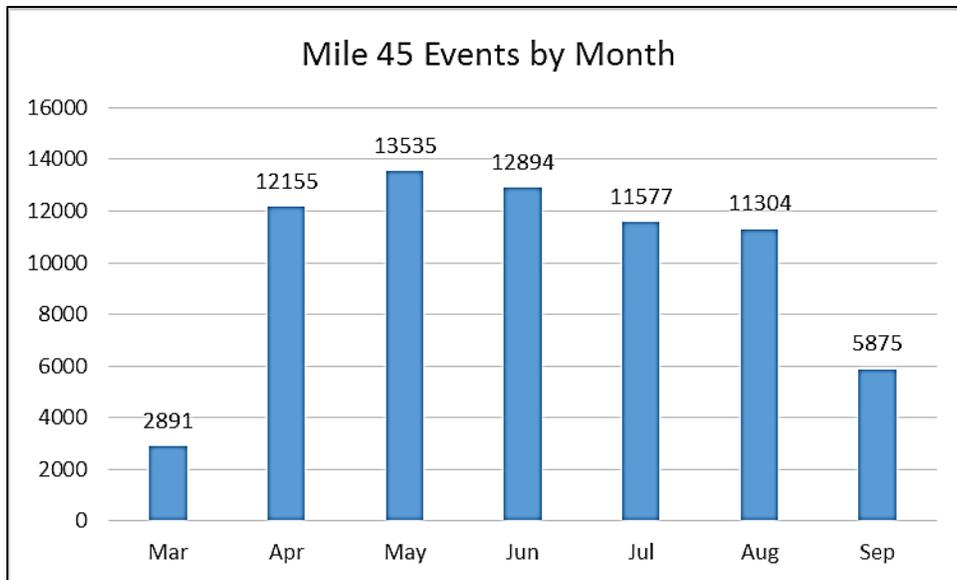
Figure 25. Bar chart. MM45 number of vehicles by month.

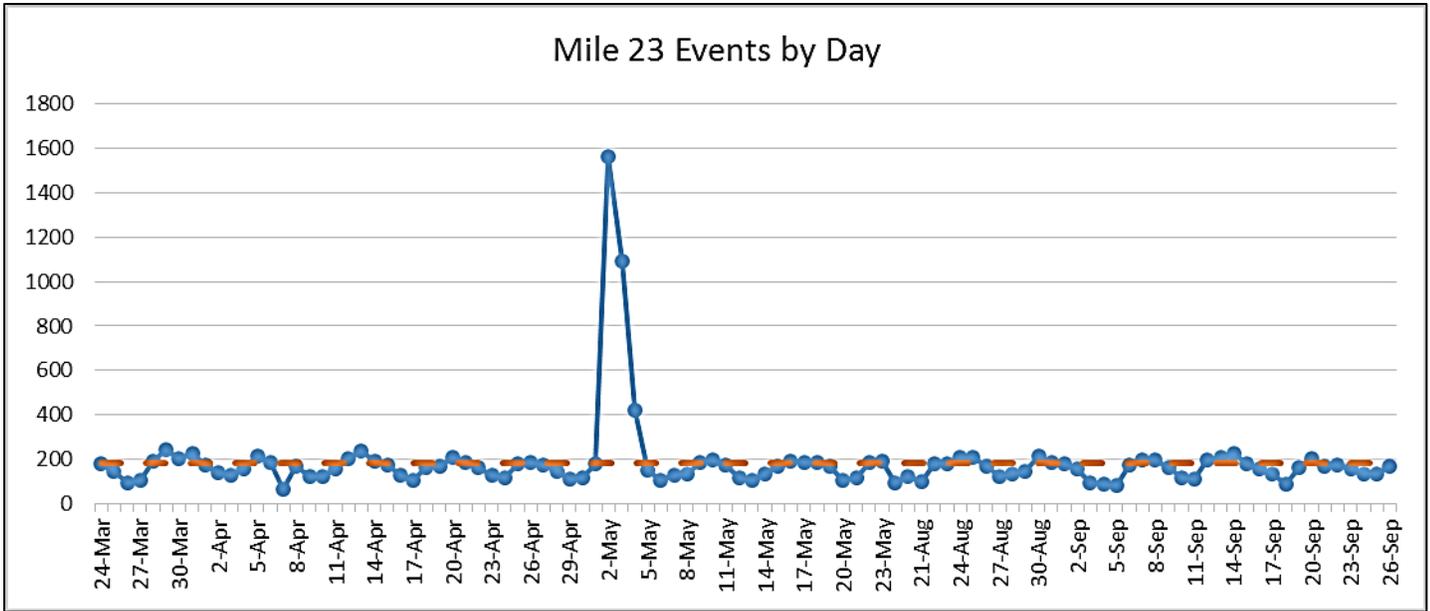
Figure 26. Line graph. MM23 daily usage statistics.

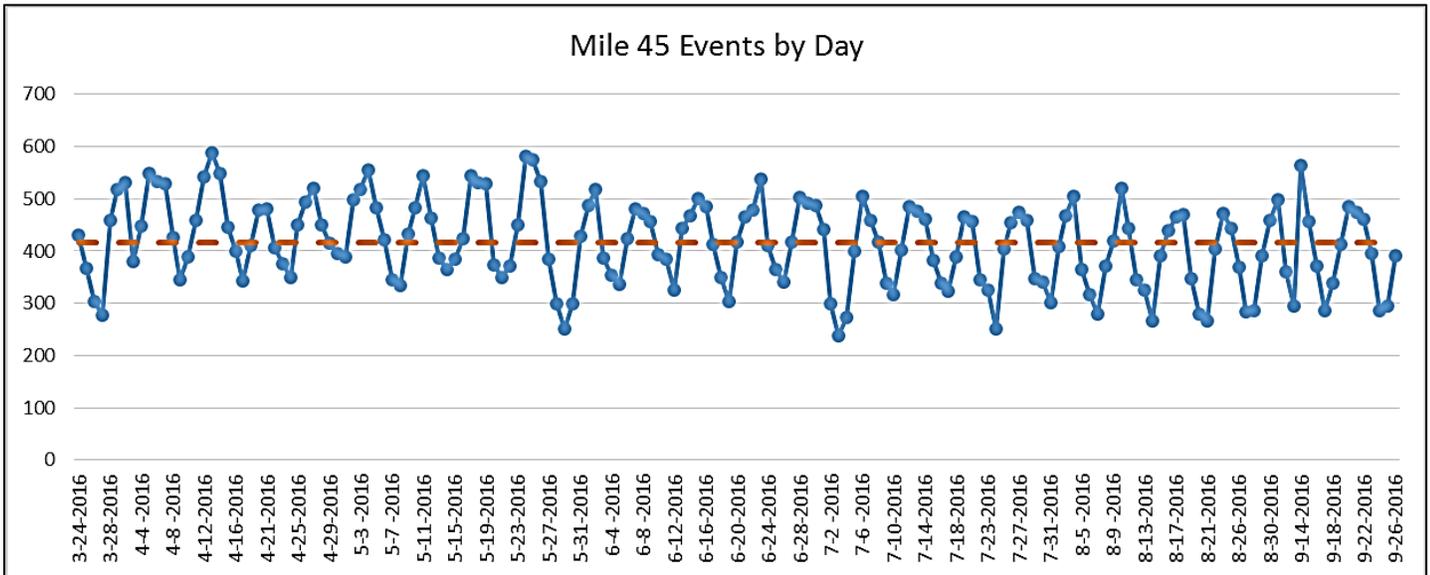
MM45 did not experience any usage anomalies when compared to MM23’s temporary upsurge. MM45’s usage was consistent across the testing period (Figure 27).

Figure 27. Line graph. MM45 daily usage statistics.

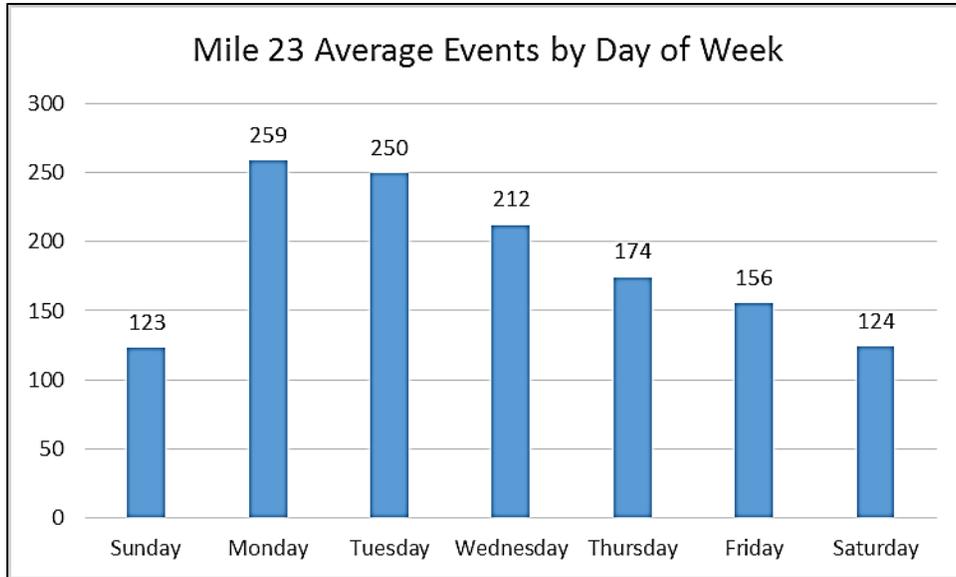
Oscillations in usage over a week occurred across the two parking locations. For both sites, the lower numbers of activities were observed on Sundays. However, the peak day of the week differed between the two sites. Peak usage at MM23 occurred on Mondays, whereas peak usage at MM45 occurred on Wednesdays.

Figure 28. Bar chart. MM23 average events by day of week.

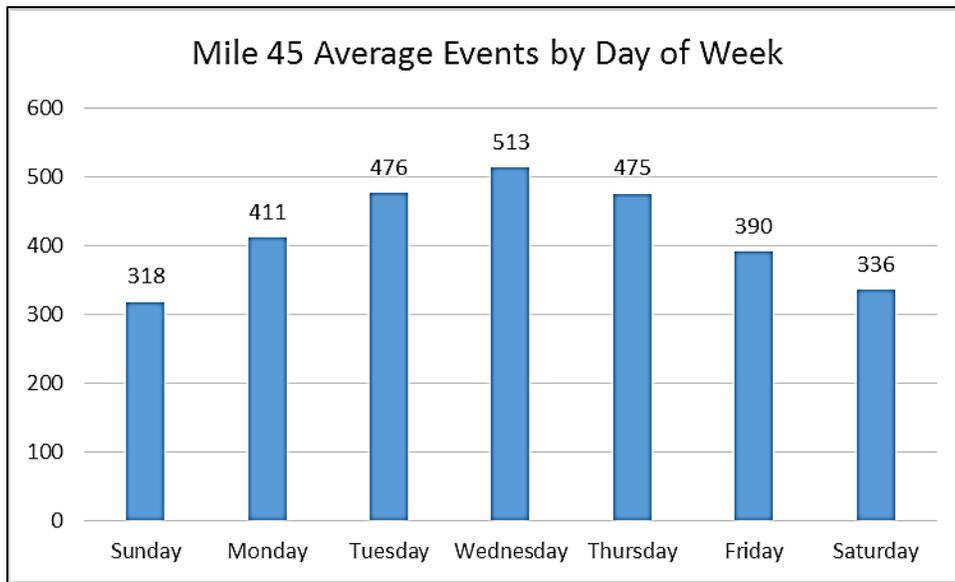
Figure 29. Bar chart. MM45 average events by day of week.

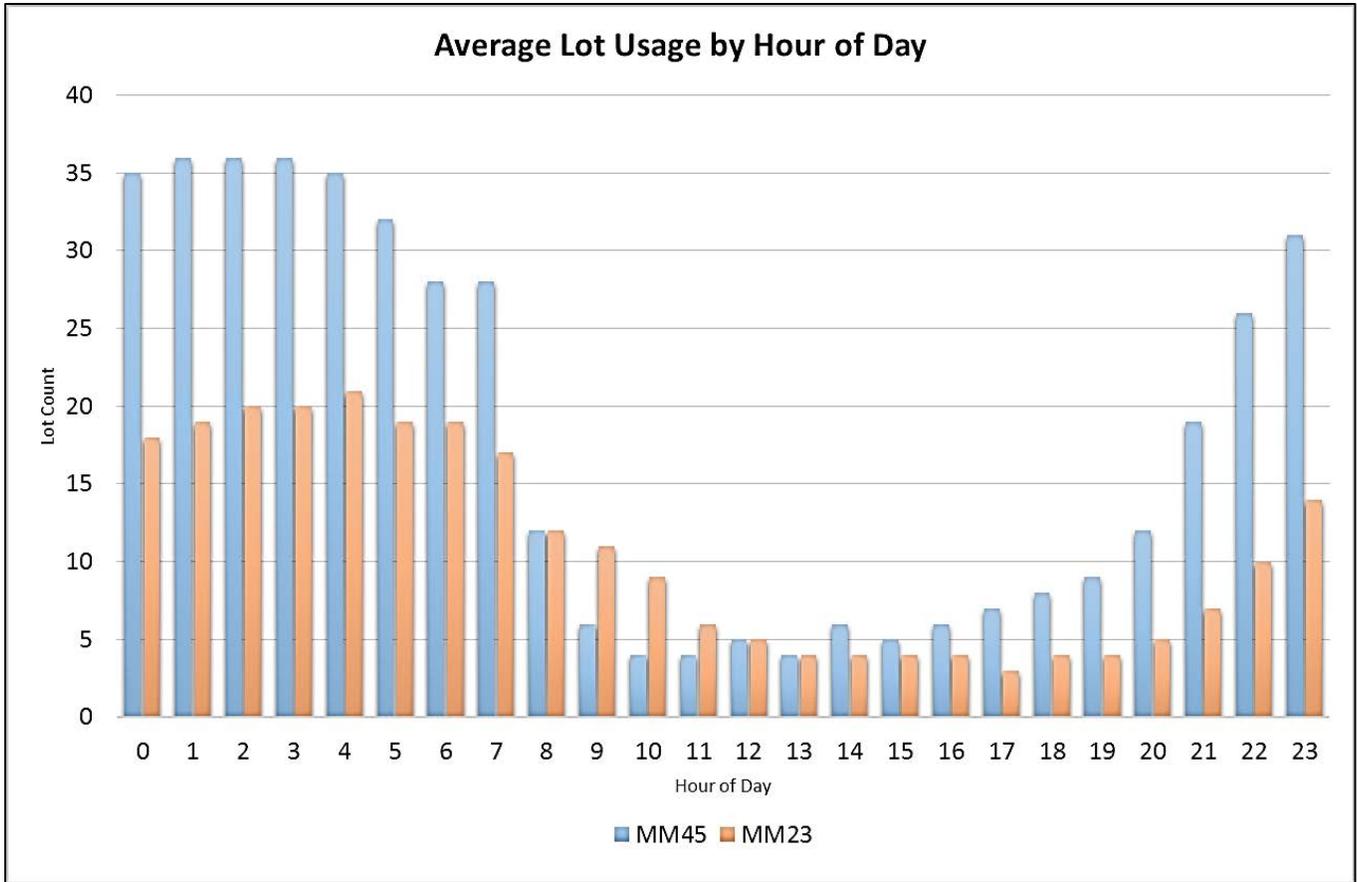
When compared on an hour-by-hour basis, both sites exhibited similar qualities. Peak hours were by far the overnight hours. Presumably, truckers were trying to meet their hours-of-service requirements by using the lots during these overnight hours.

Figure 30. Bar chart. Lot usage by hour of day.

When usage is examined across day of week, MM23 also experienced approximately one-third to one-half of the usage that MM45 did (Figure 30).

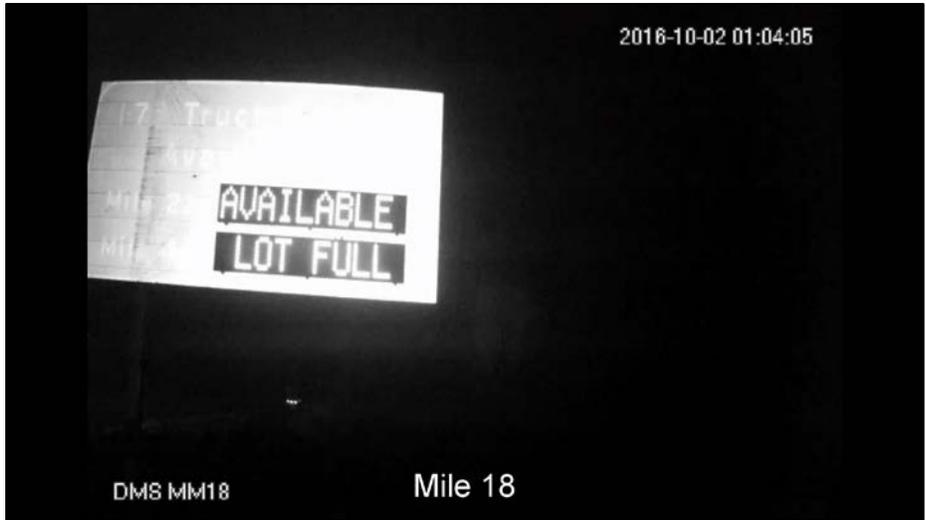
Figure 34. Photograph. Mile 18 DMS selfie camera view.

For an added layer of verification, operators visually verified the status of each DMS through SmartPark's "selfie cam" system. Small, low-resolution cameras were constructed upstream of each DMS and the operators could view these in real time to verify that a sign was broadcasting the appropriate message (see Figure 34, Figure 35, Figure 36, and Figure 37). Operators used these selfie cams during each calibration to verify the sign statuses, which were logged and recorded. There was no instance within the uptime period established in CPR2 where the DMS message on the selfie cams deviated from its reported message on the management site.

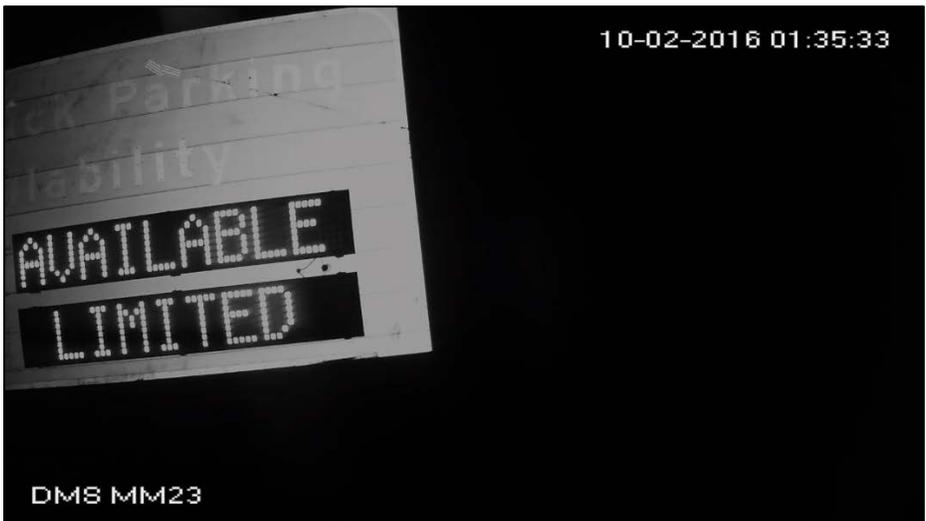
Figure 35. Photograph. Mile 23 DMS selfie camera view.

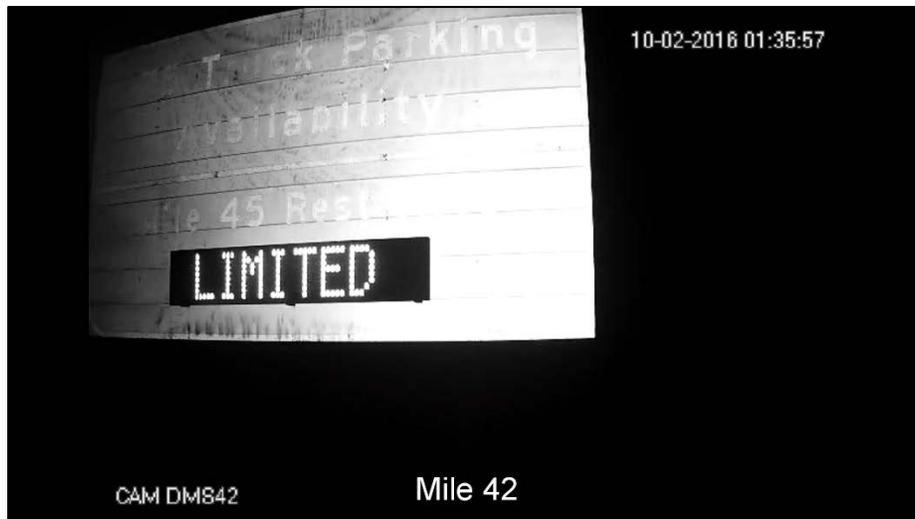
Figure 36. Photograph. Mile 42 DMS selfie camera view.

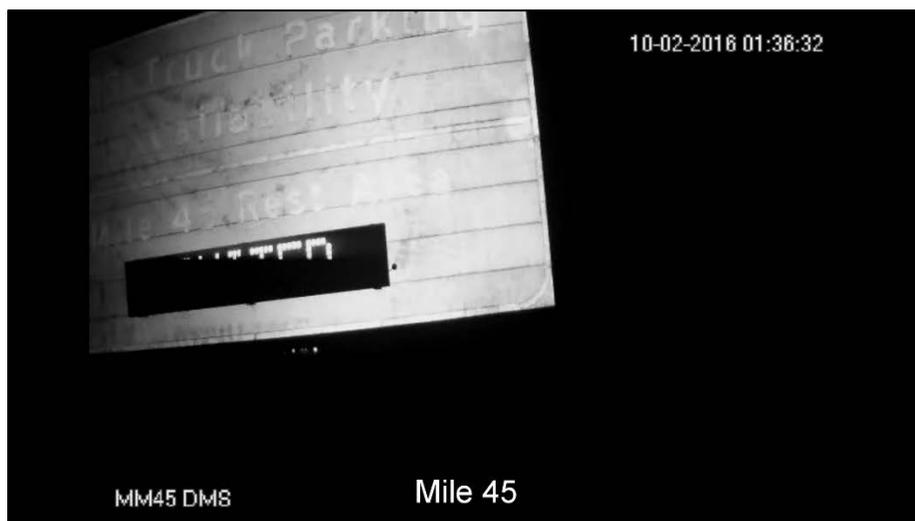
Figure 37. Photograph. Mile 45 DMS selfie camera view.

Figure 37 shows a partial sign display because the refresh rate on this camera was restricted by the bandwidth of the T-1 connection that connected the MM45 facility to the SmartPark WAN. The low bandwidth required the selfie camera to operate at a low refresh rate, making the DMS message appear to be flashing or blinking. The screen capture in Figure 37 shows the sign mid-refresh. However, this does not mean the sign was malfunctioning.
