# **EVALUATION OF 3-D LASER SCANNING EQUIPMENT: 2018 FINAL REPORT**

Research Report No. FHWA-ICT-18-007

**ICT PROJECT R27-45-T1**

**May 2018**

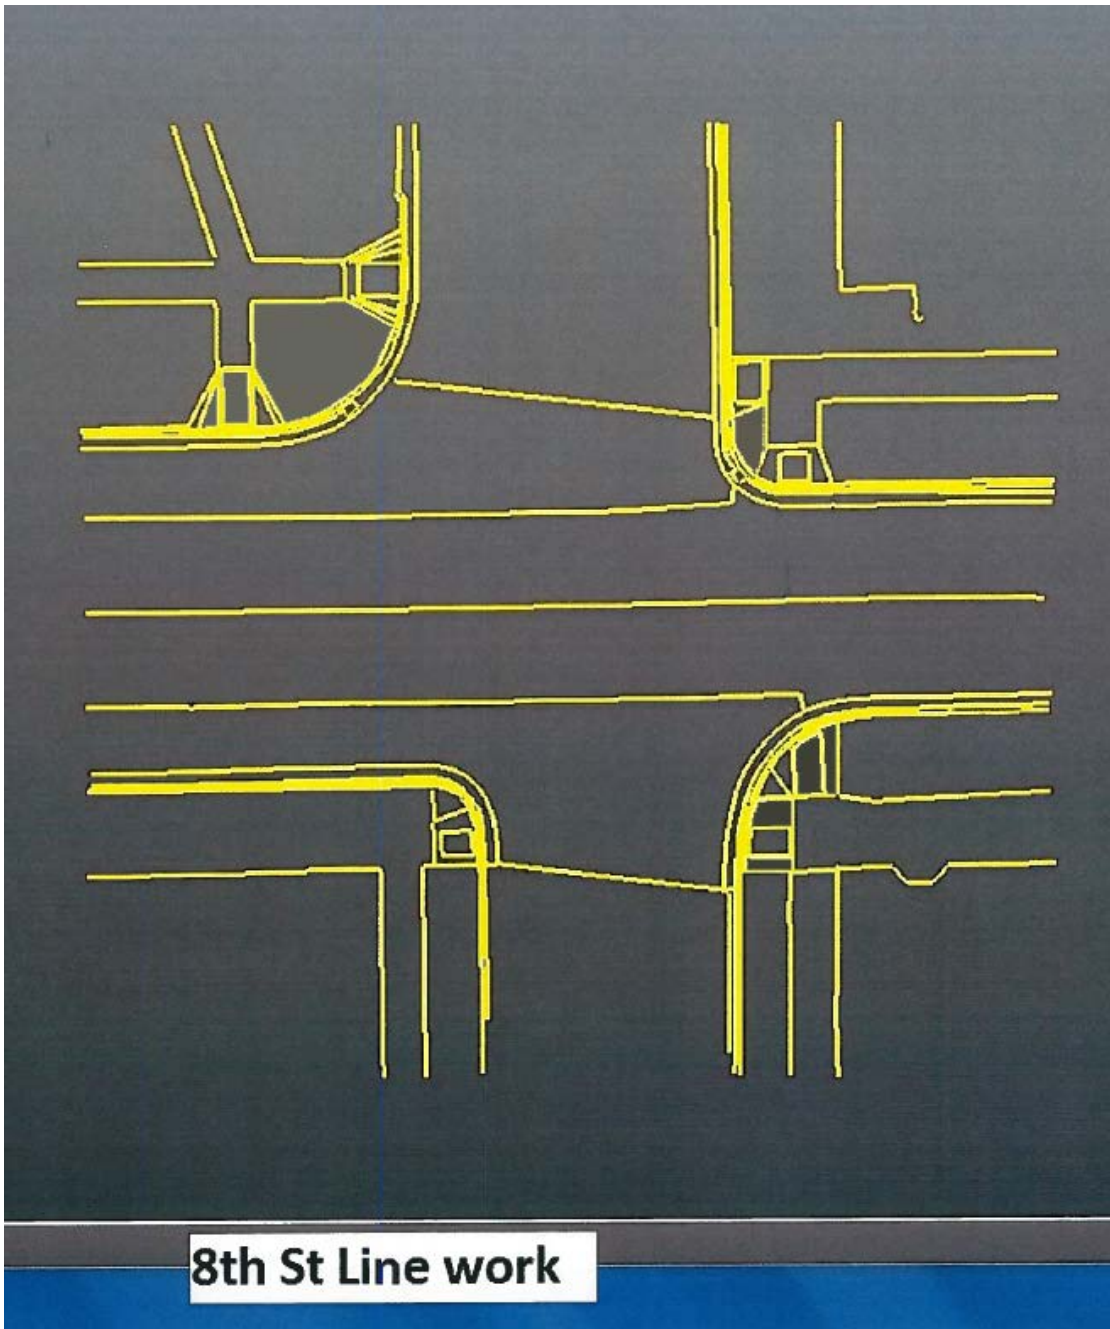
Figure 1. Contract No. 76H11, ADA ramps on US 50, line work for 8th Street generated from laser scanning data.

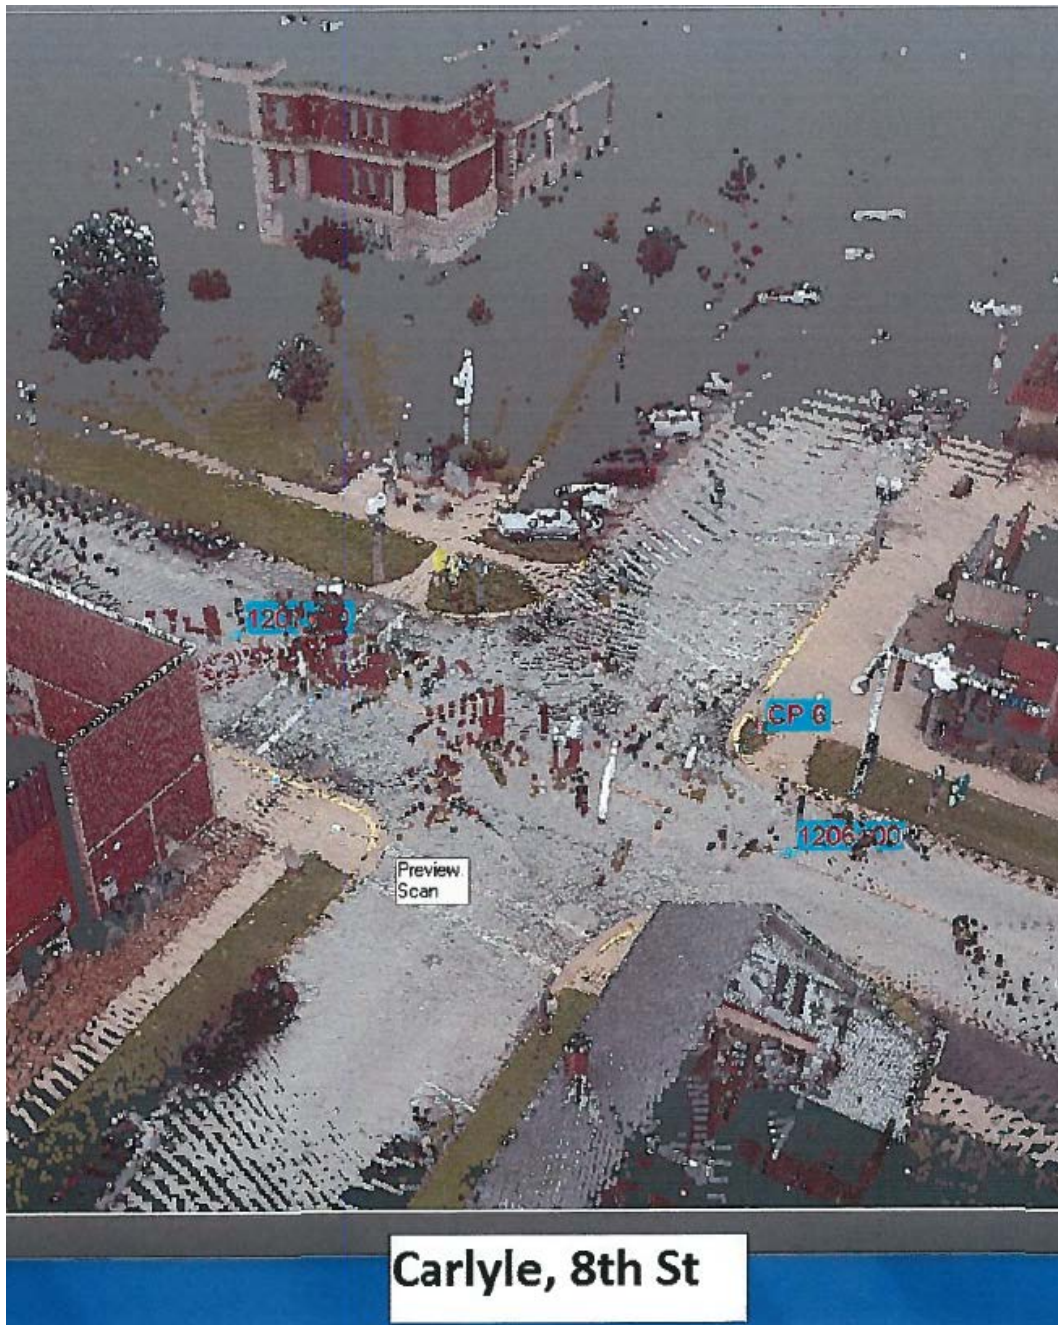
Figure 2. Contract No. 76H11, ADA ramps on US 50, 8th Street intersection generated from laser scanner point cloud with image superimposed.

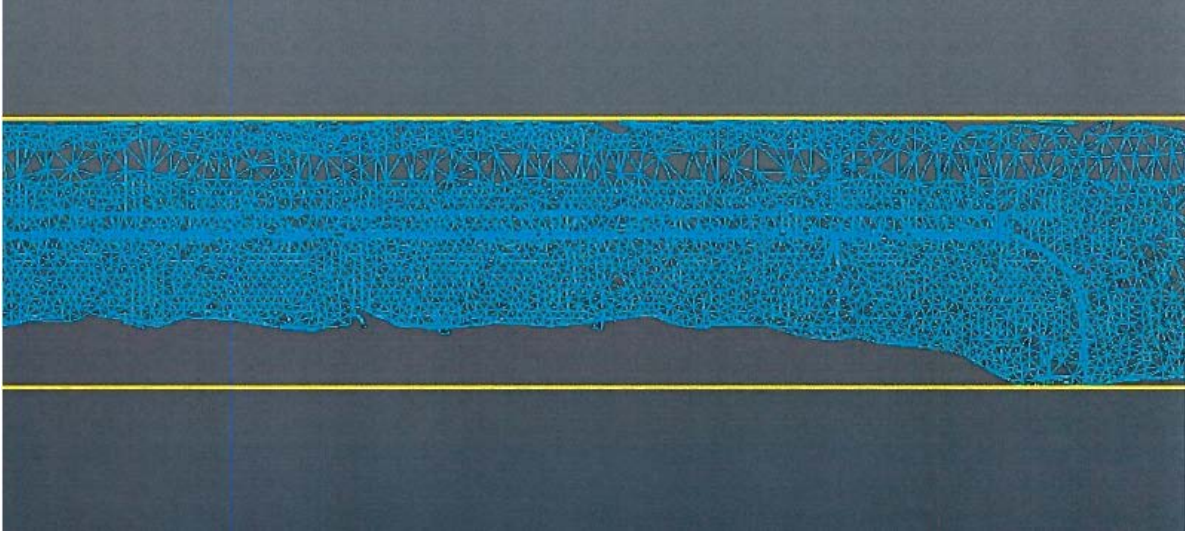
**Figure 3. Contract No. 76J0099, west side of intersection along IL 158 at Plum Hill School Road, TIN model.**

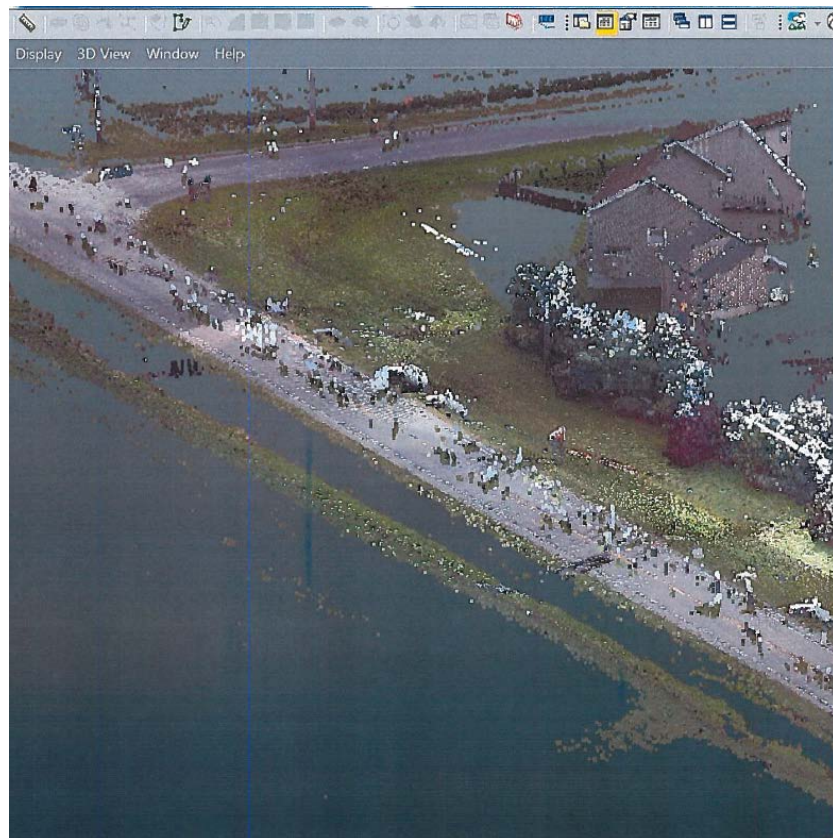
**Figure 4. Contract No. 76J0099, west side of intersection along IL 158 at Plum Hill School Road, laser scanner generated point cloud with image superimposed.**

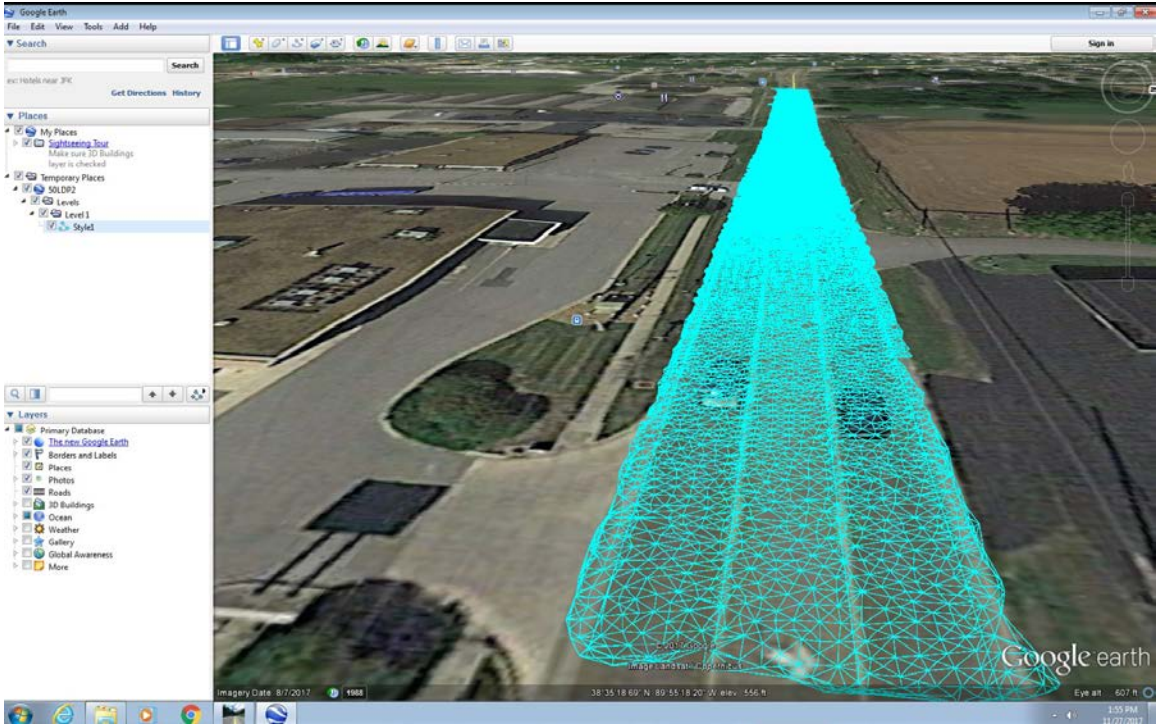
Figure 5. Mine Subsidence US 50 O’Fallon – Google Earth with mesh superimposed.

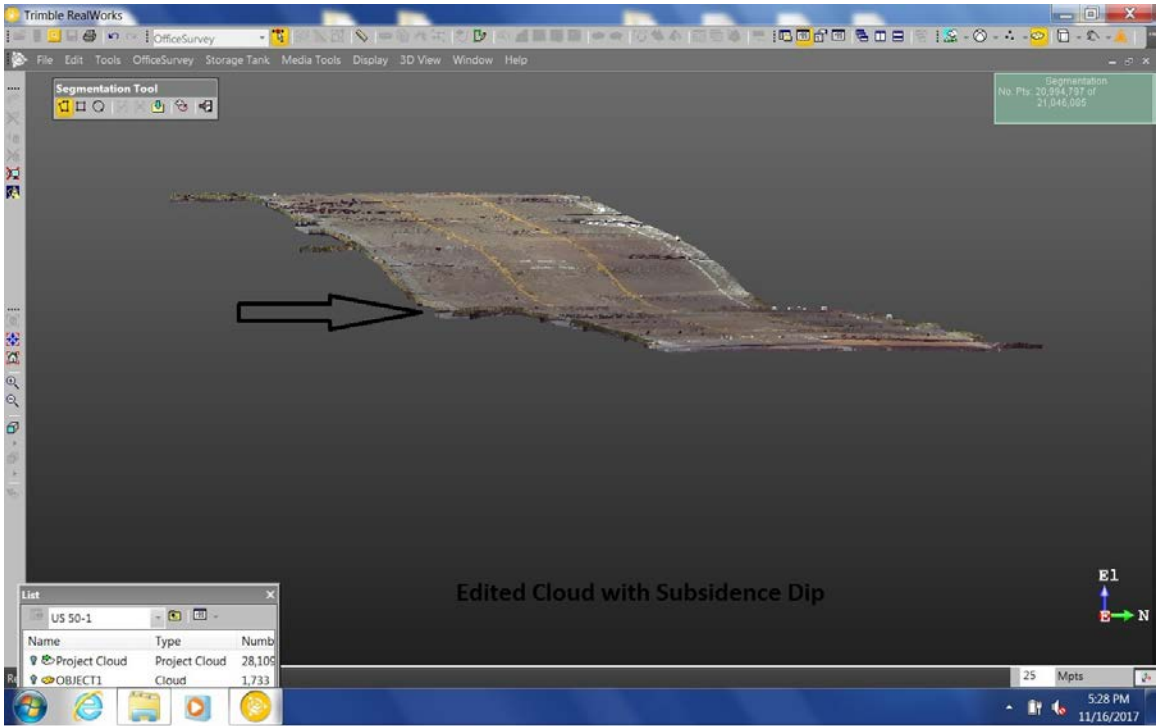
Figure 6. Mine Subsidence US 50 O’Fallon – Laser Scan of problem area.

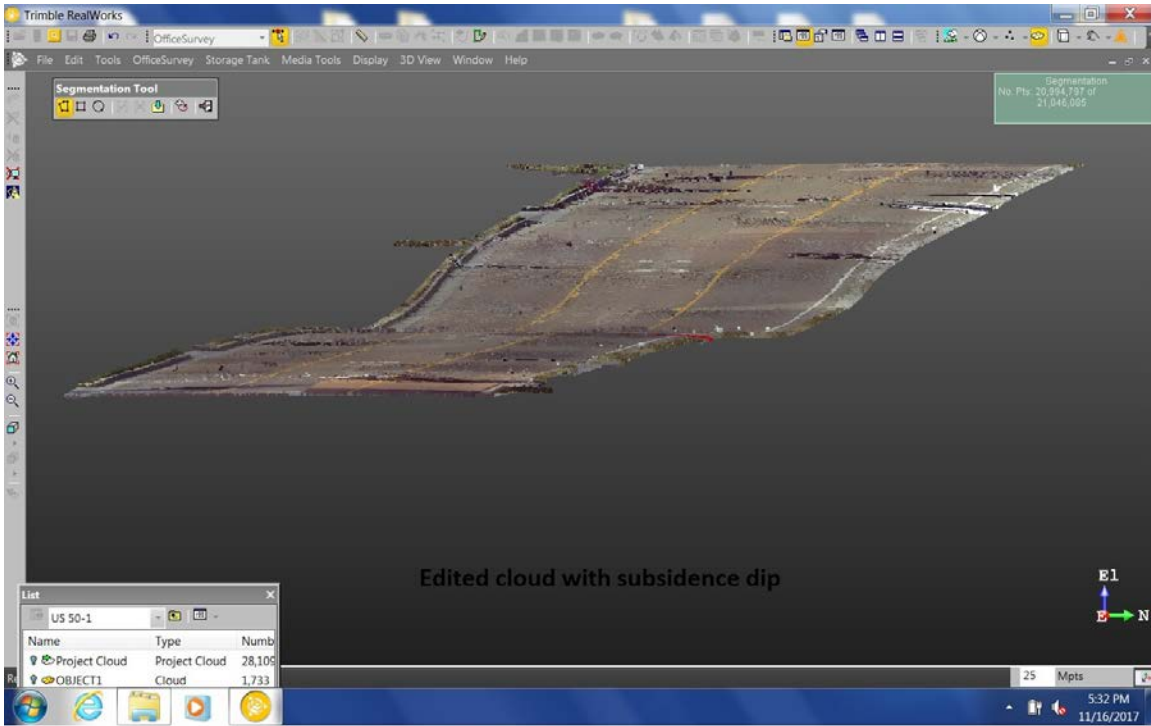
**Figure 7. Mine Subsidence US 50 O'Fallon – Edited cloud data with subsidence dip.**

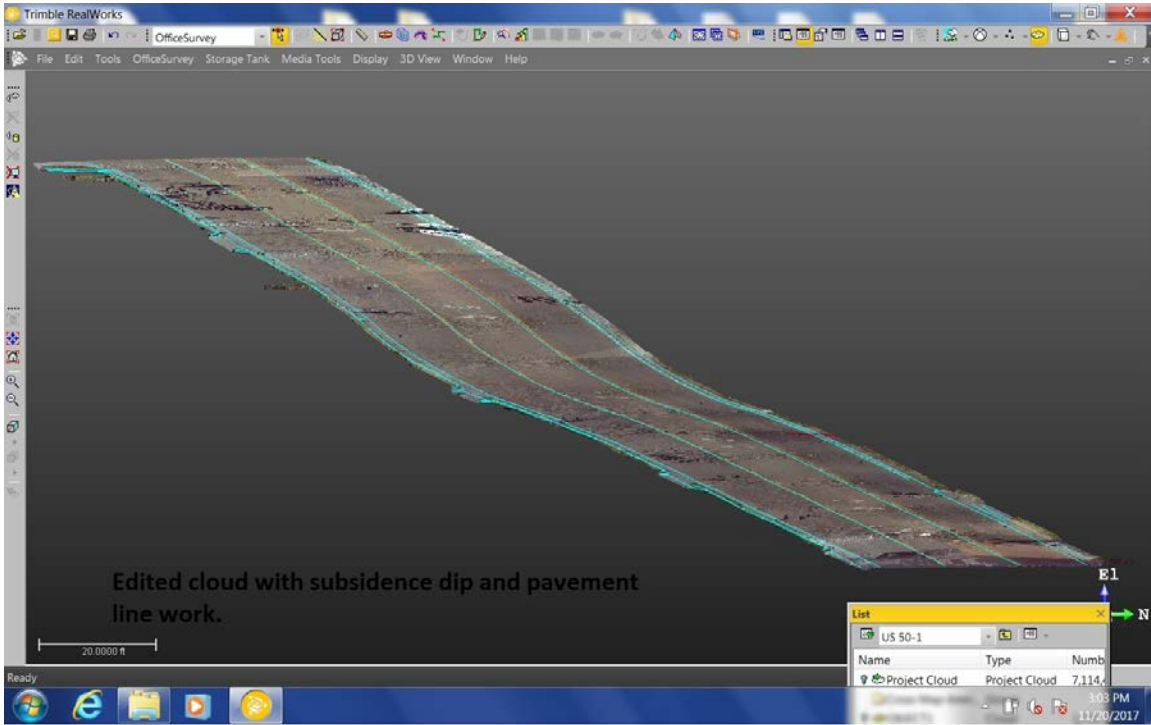
**Figure 8. Mine Subsidence US 50 O'Fallon – Edited cloud data with pavement line work.**

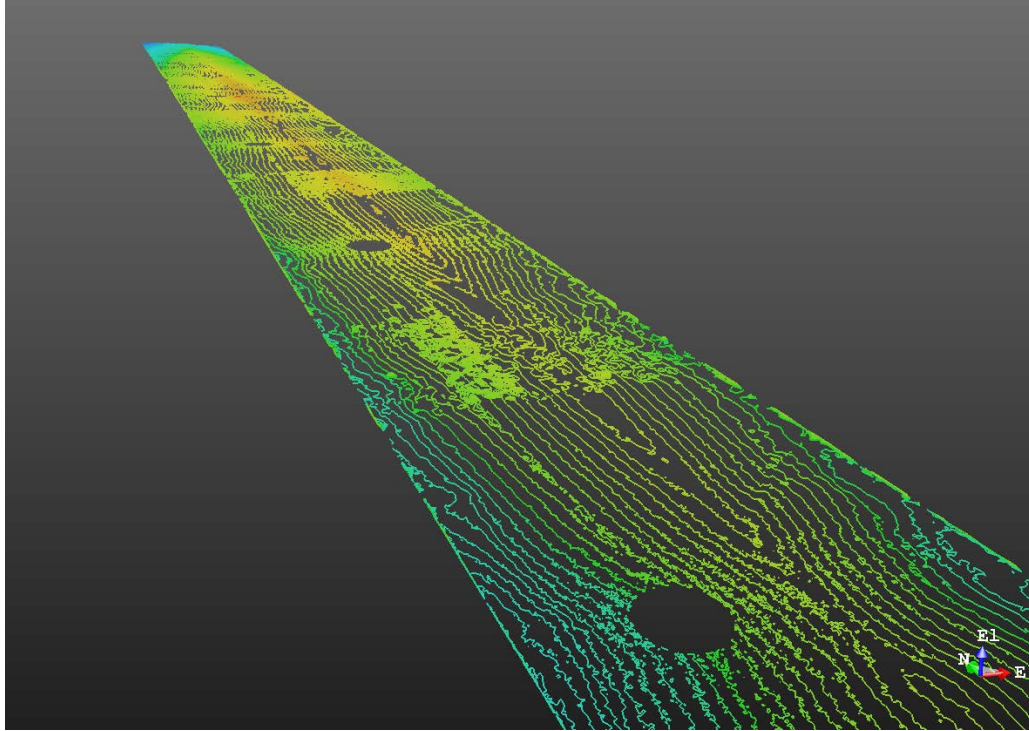
Figure 9. I-57 Bridge over Kankakee River – Cloud data elevation contour lines.

The 3-D laser scanning equipment could create a contour surface map of the bridge decks in 0.02-ft (6 mm) intervals under live traffic. The accuracy of the contour intervals allowed designers to clearly identify the low spots in the bridge deck. Using the traditional survey methods would not have been possible at such high levels of accuracy under live traffic conditions. The traditional survey methods could have been used to achieve the desired accuracy only if both lanes of traffic on each structure were shut down, diverted, or detoured for a long period of time. In addition, a one-person crew could complete the survey in approximately 4 hours, with minimal exposure to traffic hazards.

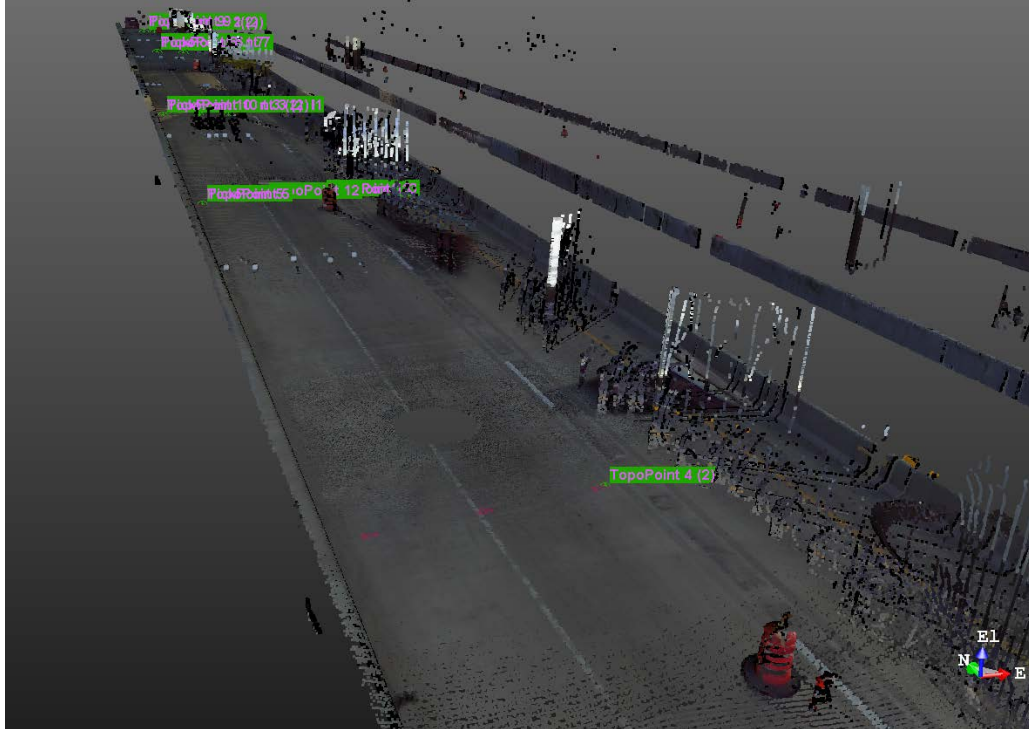
Figure 10. I-57 Bridge over Kankakee River – Laser scan compiled from cloud data.

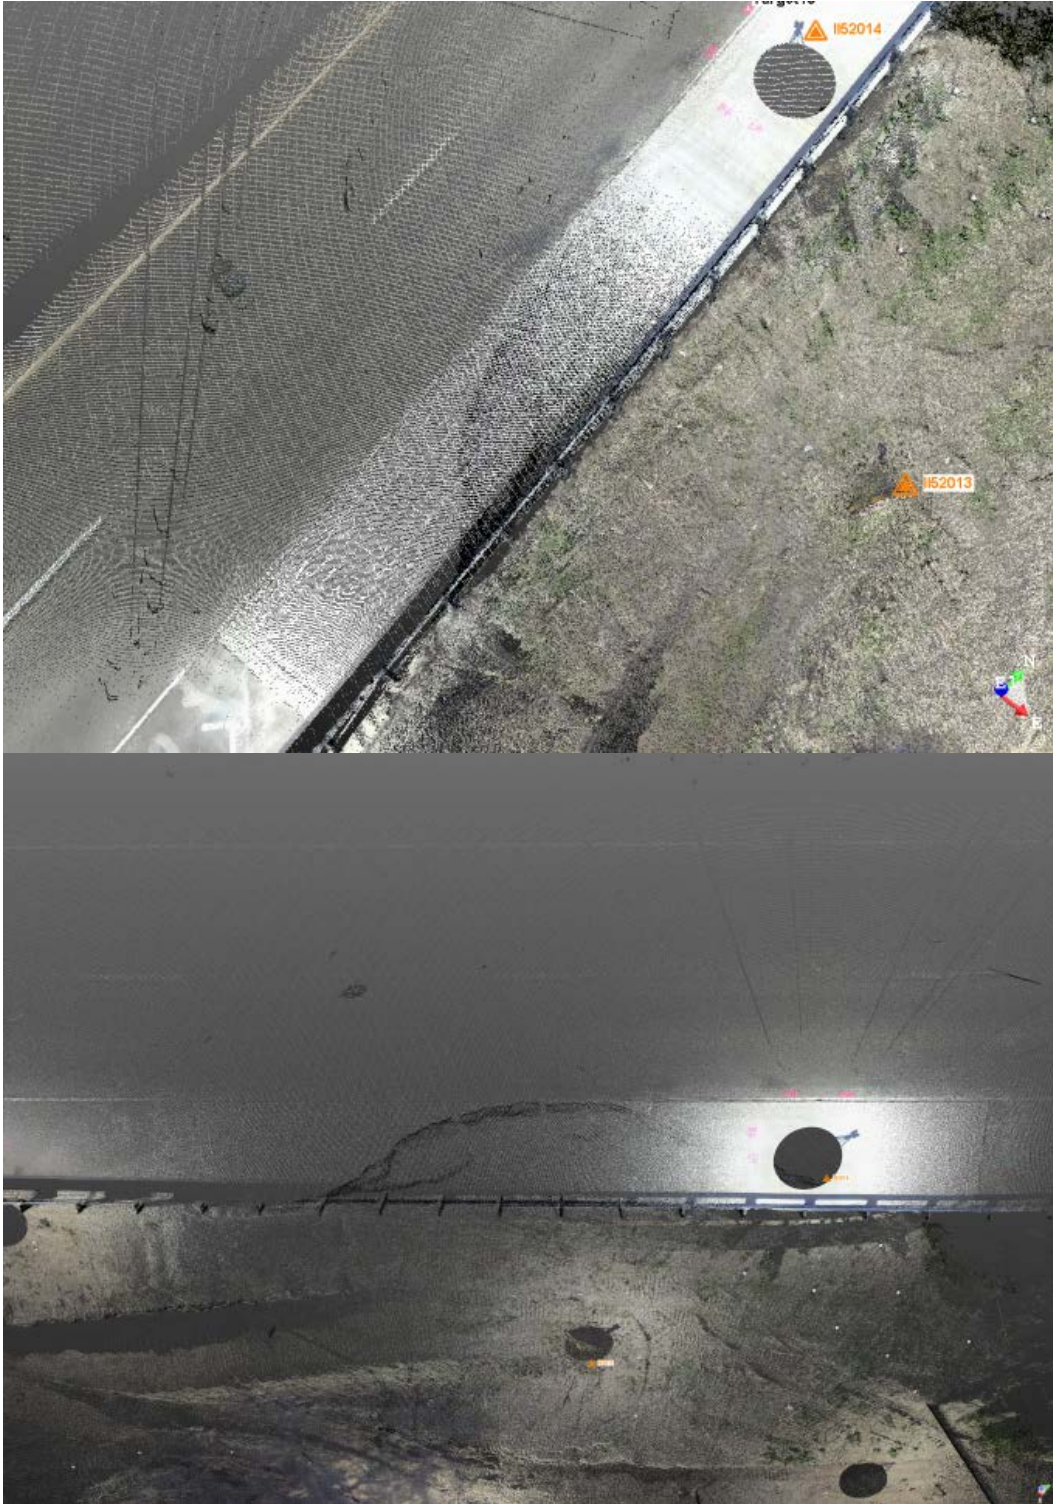
**Figure 11. Route 251 Slope Failure – Shoulder Erosion, laser scanner generated point clouds with images superimposed.**

A section of road along Route 251 was investigated due to subsidence of the pavement. The laser scanning equipment was used to determine the extent of the void caused by slope failure and/or the erosion of the pavement's supporting material. Samples of the documents produced from this work are provided as Figures 11 and 12 in the Appendix.

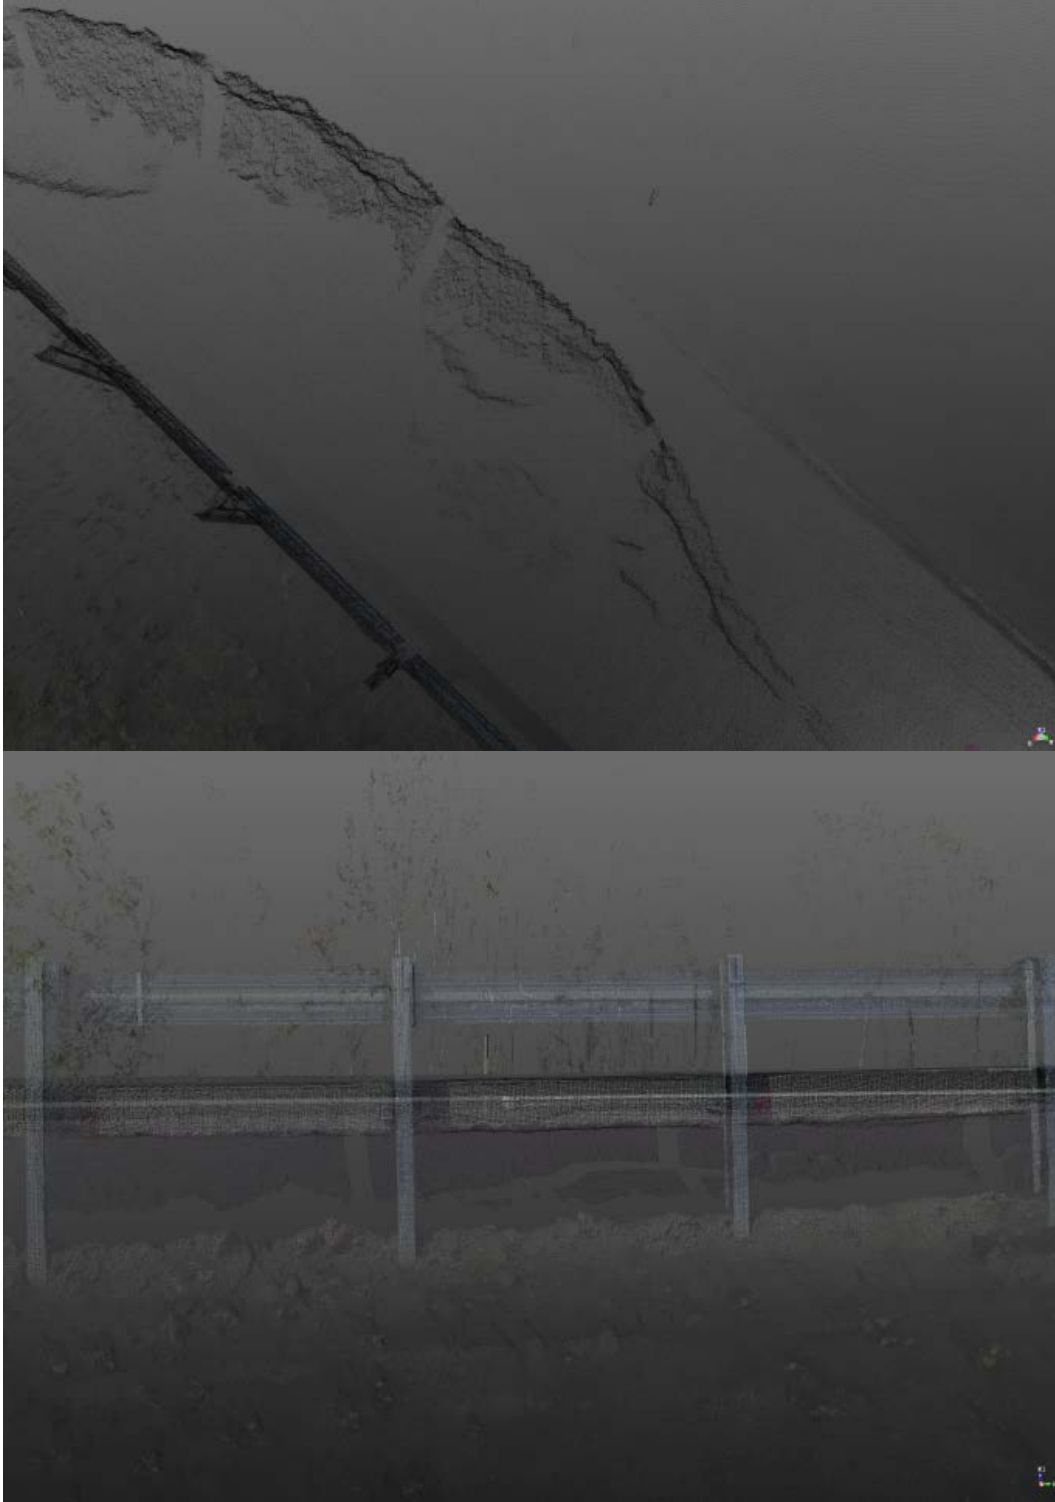
**Figure 12. Route 251 Slope Failure – Shoulder Erosion, laser scanner generated point clouds with images superimposed.**

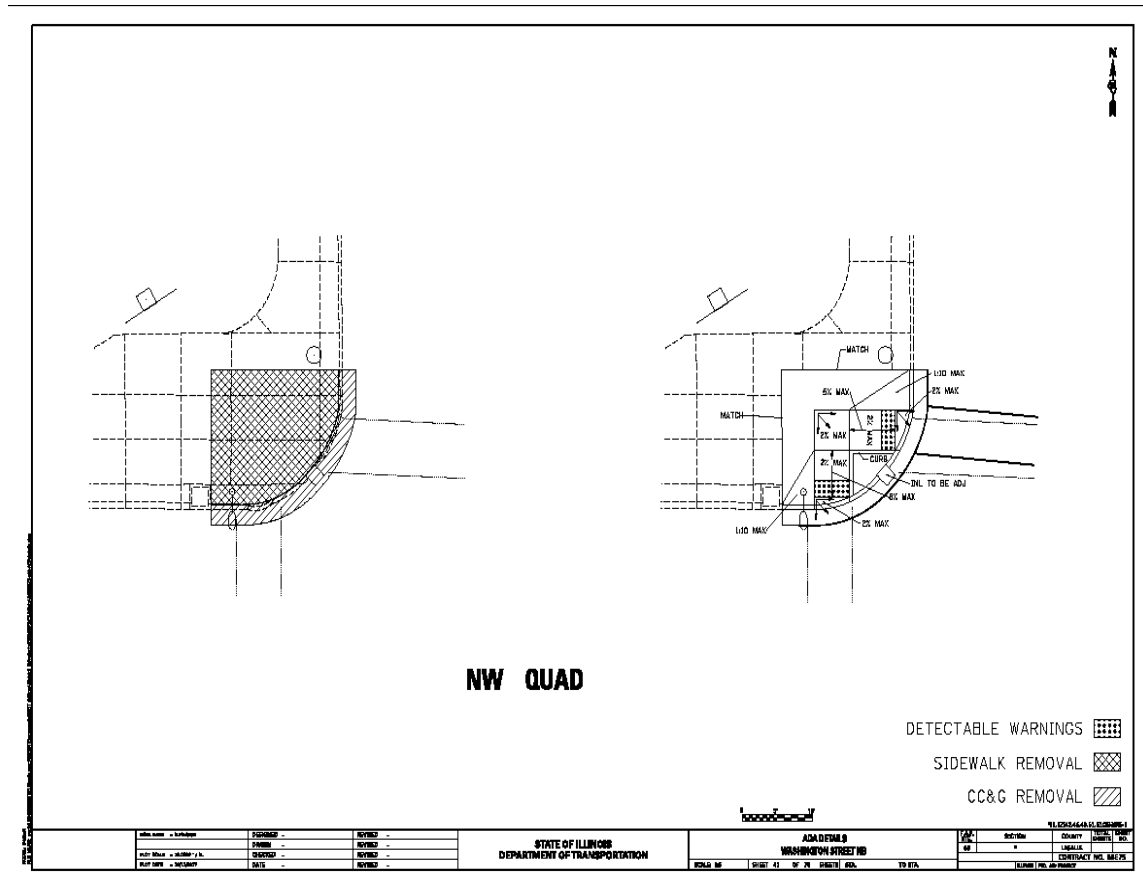
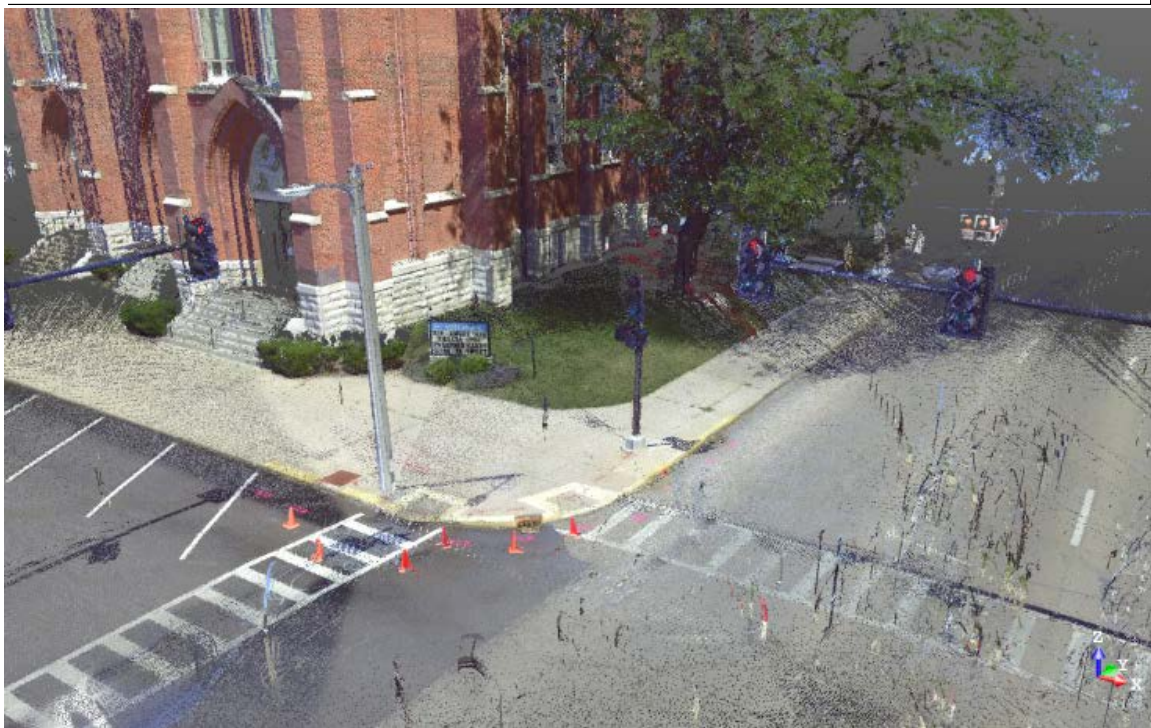
**Figure 13. Engineering Plans – ADA Ramps, laser scanner generated point clouds with images superimposed. Critical Dimensions extracted for engineering plans.**

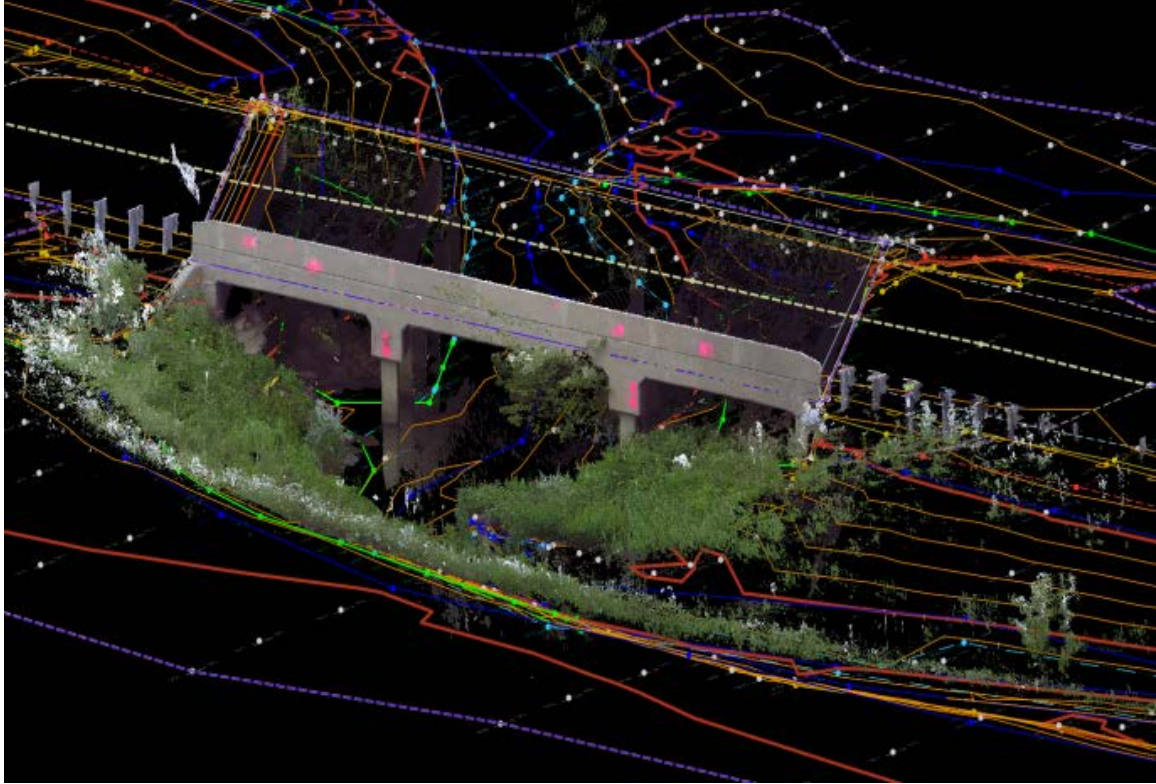
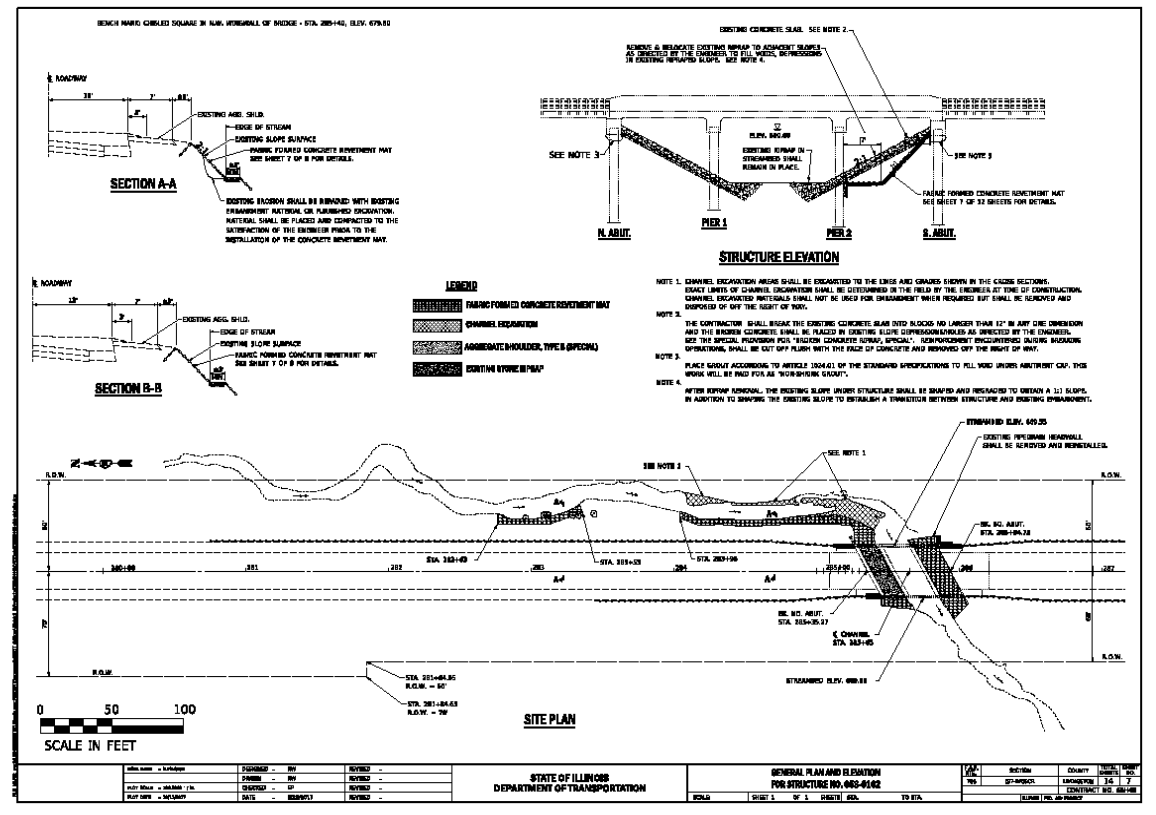
Figure 14. Engineering Plans – Combined TX5 laser scans with conventional surveying to produce engineering plans.

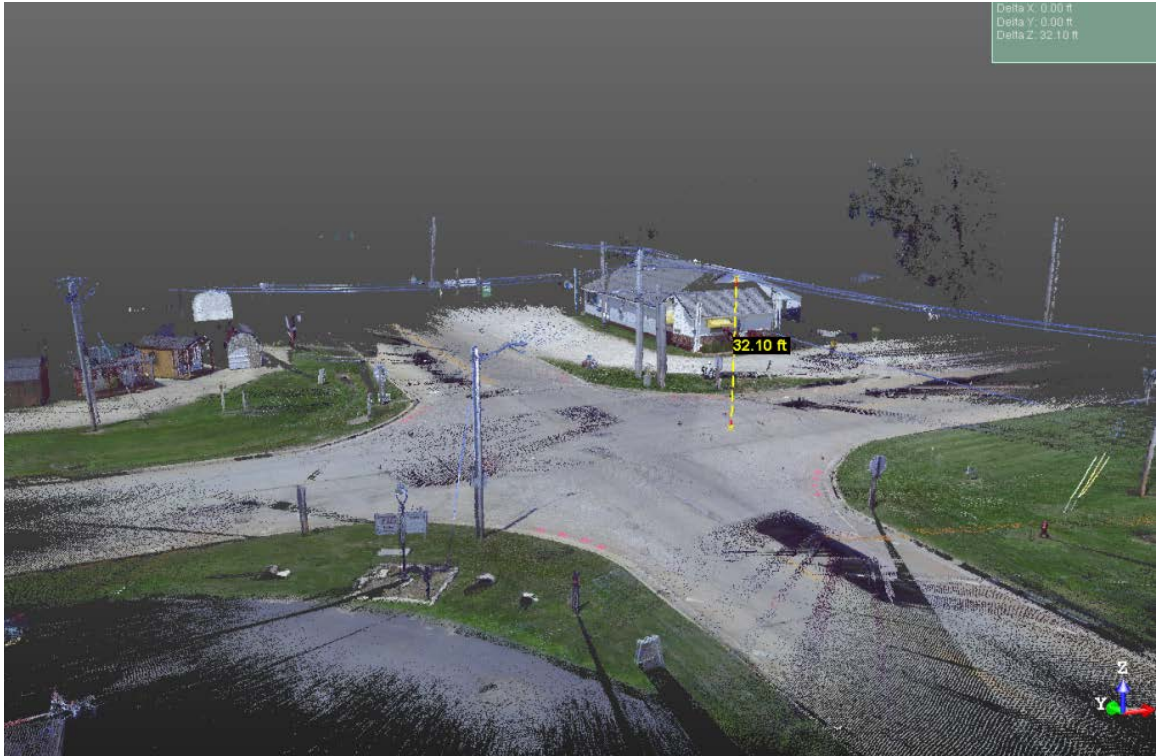
**Figure 16. Route 178 and US 6 intersection, laser scanner generated point cloud with image superimposed. Scanning for utility wire heights for potential conflicts.**

The use of the laser scanning equipment provided a fast and safe method for obtaining the required aerial utility heights that reduced potential risk to employees and reduced potential damage to existing utilities.

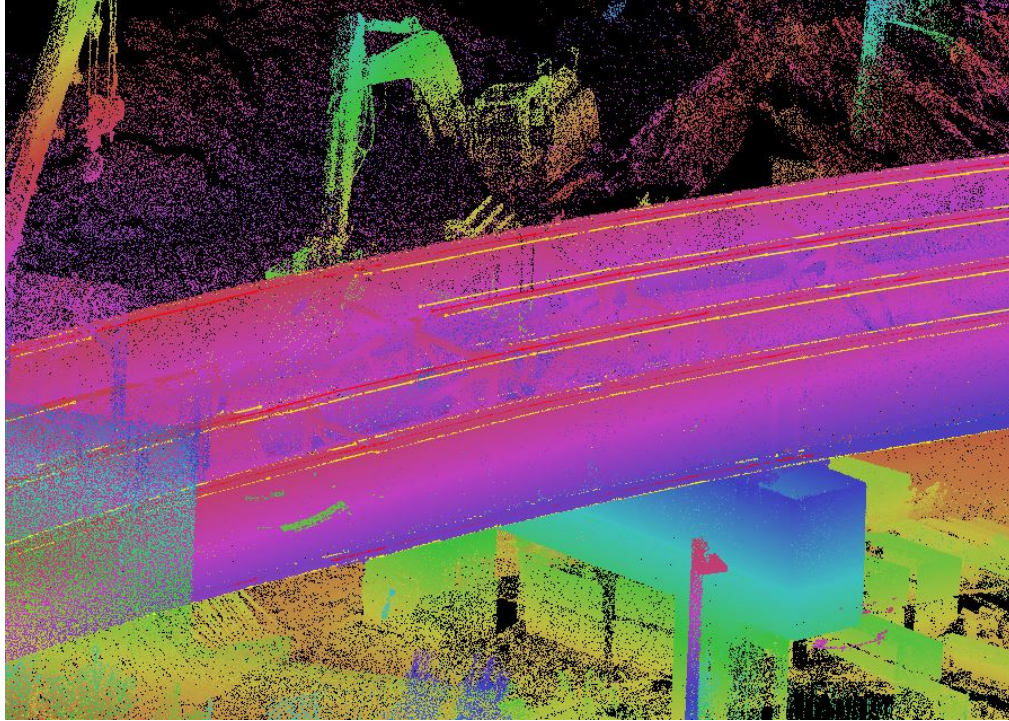
**Figure 17. Van Buren Street Bridge Chicago – Laser scan data combined to show locations of girders.**

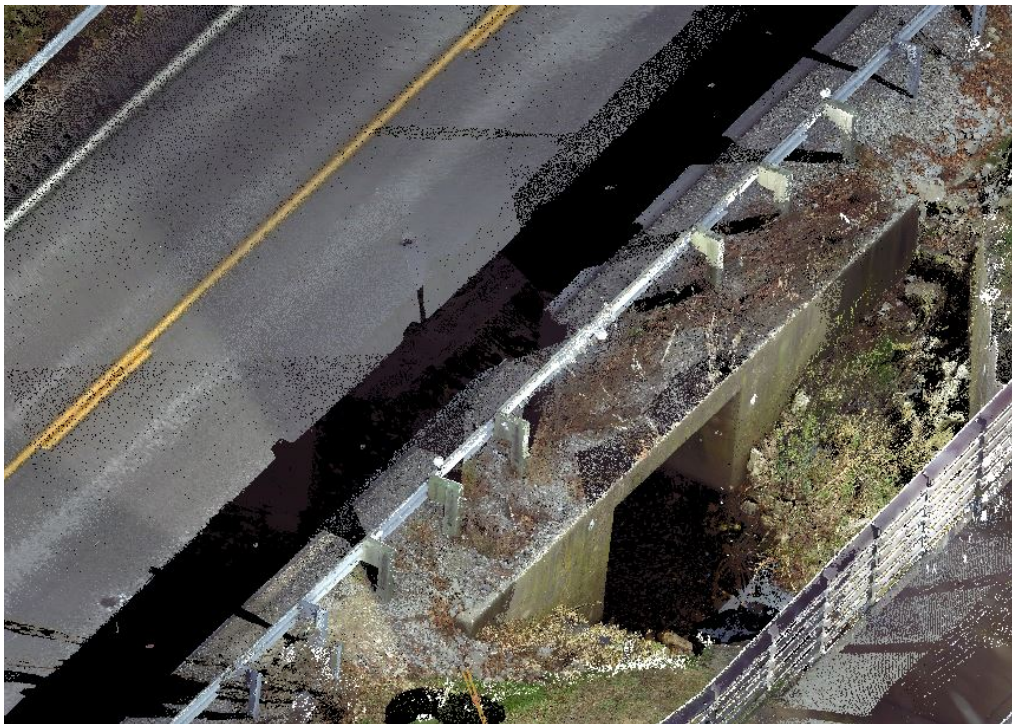
**Figure 18. IL 157 Culvert Replacement – Scan data coupled with scan imagery used to engineer a solution to replacement of the existing culvert.**

A non-typical culvert is located beneath IL Route 157 over a tributary to Silver Creek, in need of replacement at the time of this report. Adjacent to this structure is an old railroad bridge whose wingwalls are within very close proximity of the existing culvert. The old railroad bed was converted to a bike path that passes through Hamel, IL.

The adjacent bike path bridge is not to be disturbed during the replacement of the existing culvert. The initial survey using the total station did not include the data on the location of the adjacent structure. Preliminary design computations called for a structure with wingwalls that would interfere with the adjacent bike path structure. In addition, the design calculations indicated that a more severe skew angle was required that did not appear feasible based on the total station topography

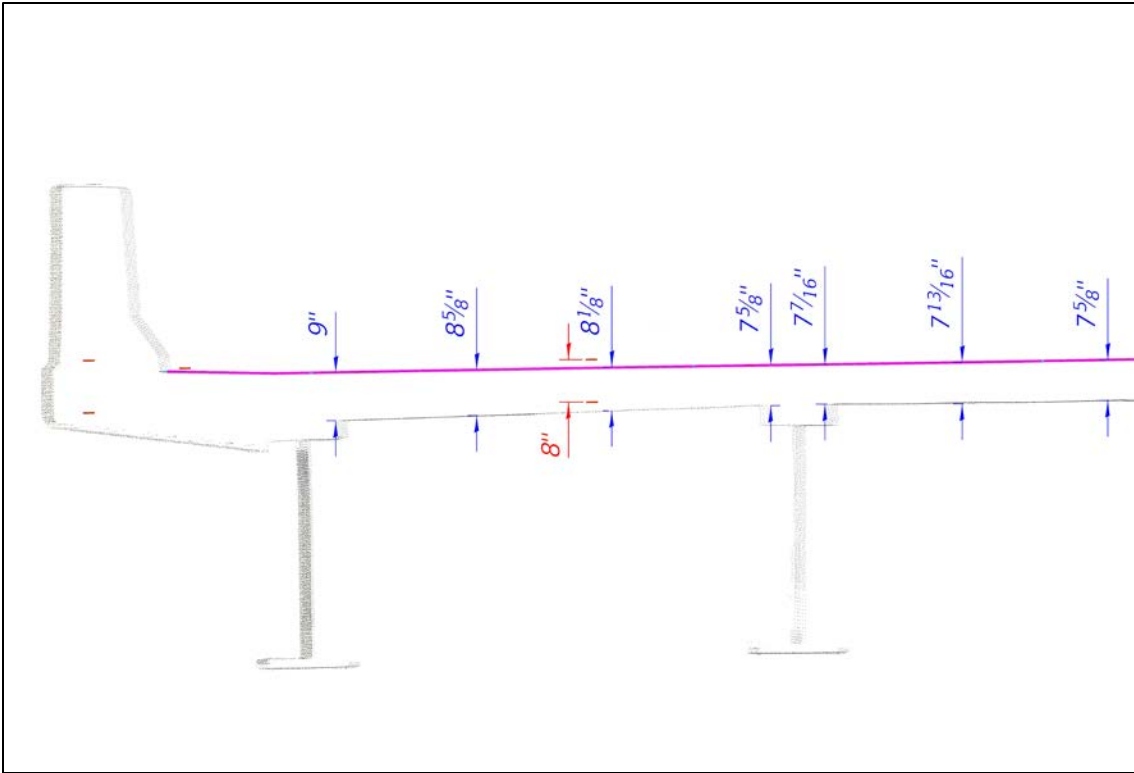
Figure 19. US 51 Bridge Reconstruction – Deck thicknesses measured using laser scanner data.

It is important to determine what happened during construction or if there were errors with the data in the contract plans. To do so, it was decided that both the newly reconstructed bridge and the bridge that was yet to be reconstructed should be scanned and the data subsequently analyzed. Scans from above and below the structures provided the research team with the data to determine the contour of the wearing surface, in addition to other valuable data, such as plumbness of the beams as well as slab thickness. Samples of the documents produced from this work are provided as Figures 19 and 20 in the Appendix.

up to 3 degrees during the deck pour and did not return to a plumb state after the Bidwell machine passed. It was determined that inadequate temporary bracing was used in the three spans of that unit, which allowed the beam movement. The movement of the fascia beams caused the slab to have varying thicknesses. The contract plans called for a uniform deck thickness of 8 inches. However, the actual deck thicknesses varied from about 6.5 to 10 inches, as measured by the laser scanner data.

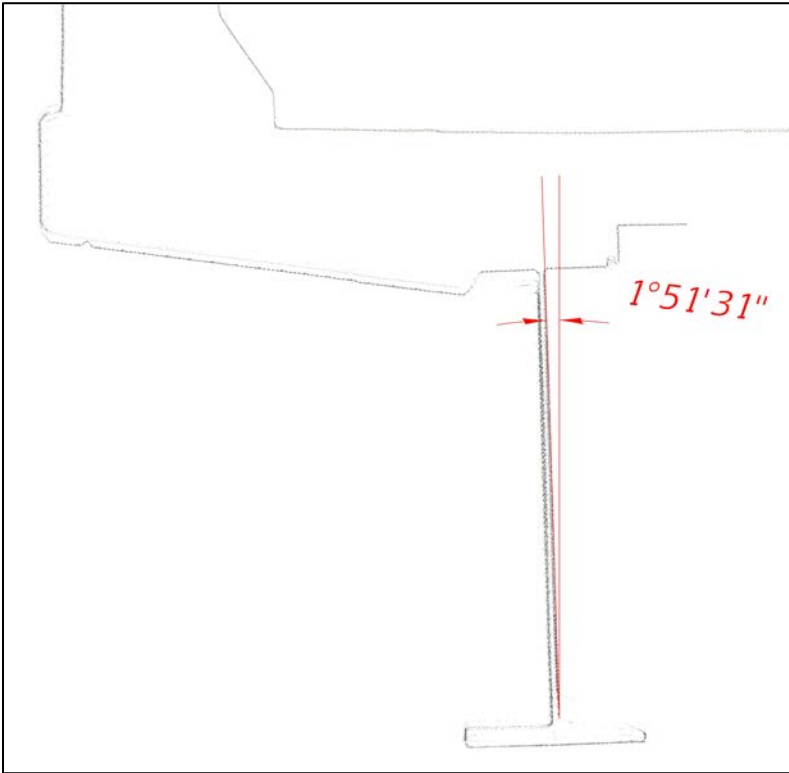
Figure 20. US 51 Bridge Reconstruction – Beam tilt measured with laser scanner data.

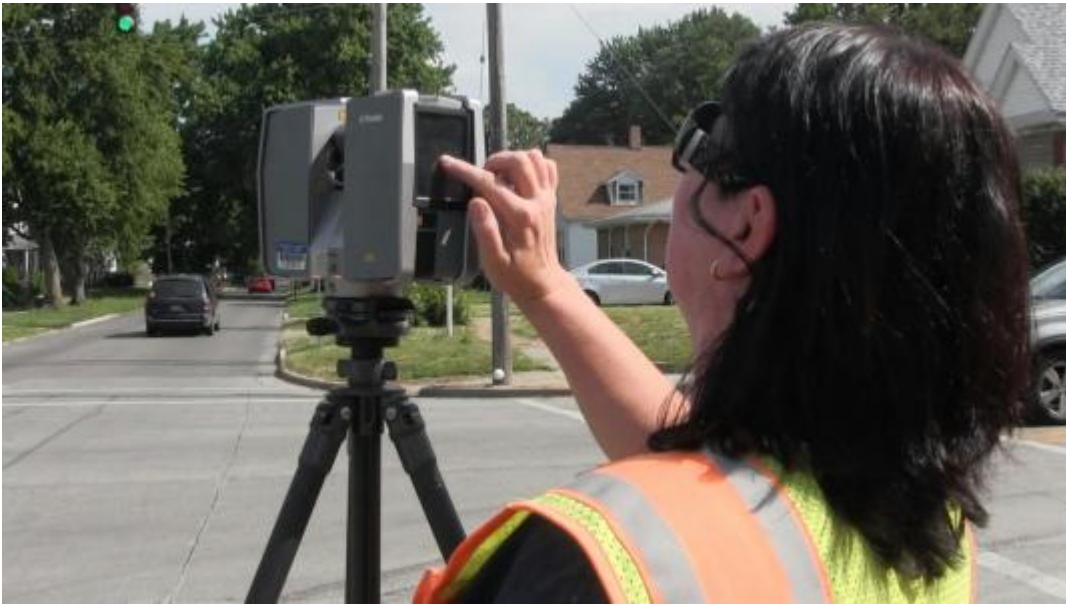
*IDOT survey crew member surveying intersection with 3-D scanner out of the path of live traffic. Photo courtesy of IDOT.*
