# **EVALUATION OF 3-D LASER SCANNING EQUIPMENT: 2018 FINAL REPORT**

Research Report No. FHWA-ICT-18-007

**ICT PROJECT R27-45-T1**

**May 2018**

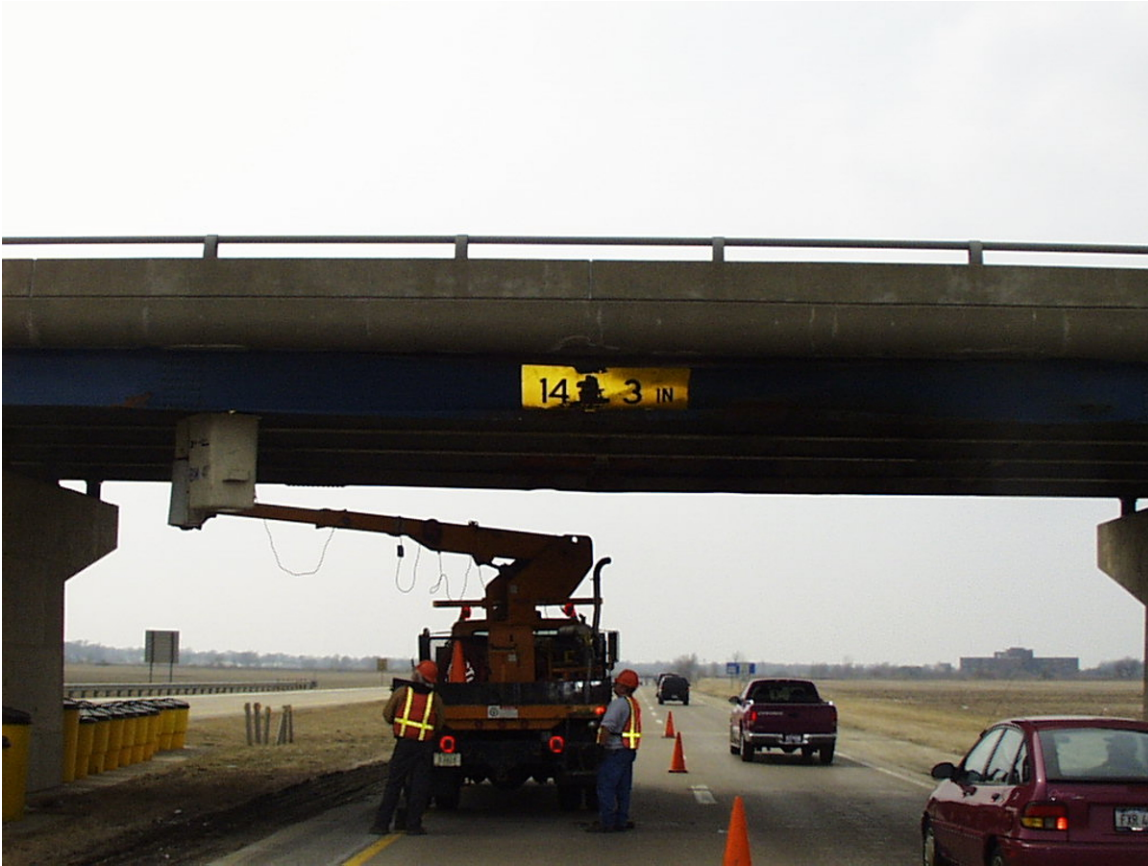
*Photo of IDOT maintenance crews assessing damage to a struck overpass bridge on U.S. 34. Photo courtesy of IDOT.*

Overpass structures are frequently struck by large trucks carrying oversized equipment. As part of this ongoing research project, IDOT’s Central Bureau of Bridges and Structures is utilizing the laser scanning equipment to obtain detailed and accurate scans of multiple overpasses that are frequently struck by vehicular traffic. To date, IDOT has scanned 15 bridge superstructures that are routinely hit by trucks, and are continuously scanning more structures to include in a database of baseline scan information. This information will be used for a comparison of before and after conditions to quantify damage to the structure, determine potential safety issues, and identify repair requirements. Currently, IDOT maintenance crews use bucket trucks and have traffic control set up to measure deflections and damages by hand. Depending on the size of damage and the point of impact, this data collection can take at least two or three working days with a three-person crew.

Because a point cloud is gathered from the scanner, this data can be extrapolated and plotted in the safe environment of an office setting and not hand-measured in the field. These displacement measurements and timely delivery of that data are critical to structural engineers who need to analyze any reduction in structural capacity or adjust posted load ratings to the bridge until repairs can be made.

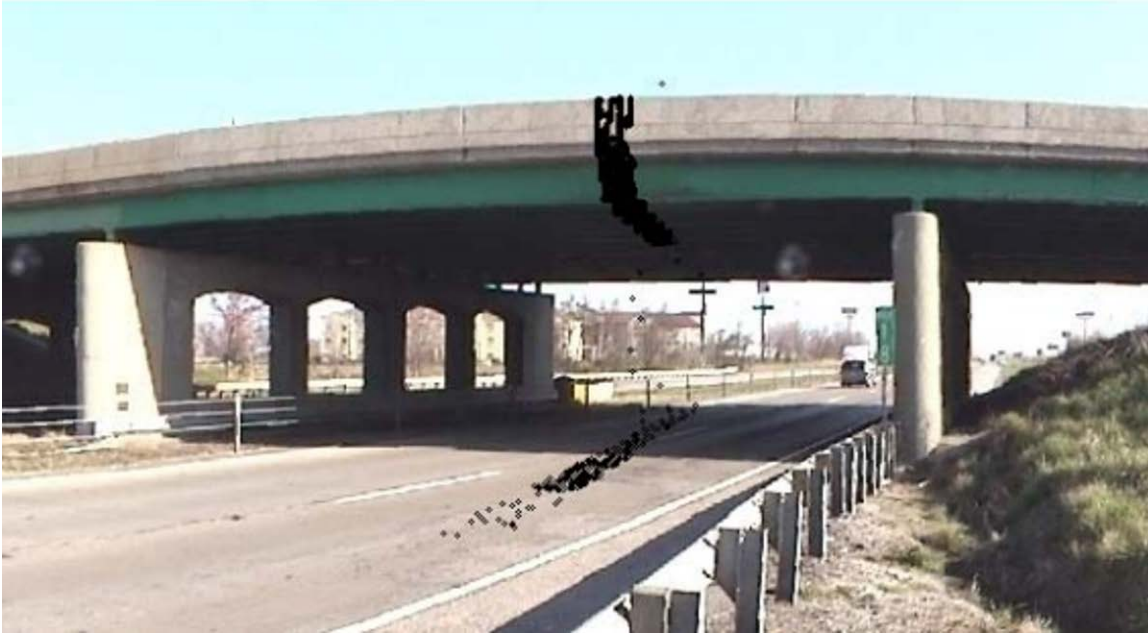
Damaged bridge girder with a 4-ft slice of a point cloud scan. Source: FHWA-ICT-10-068 Report

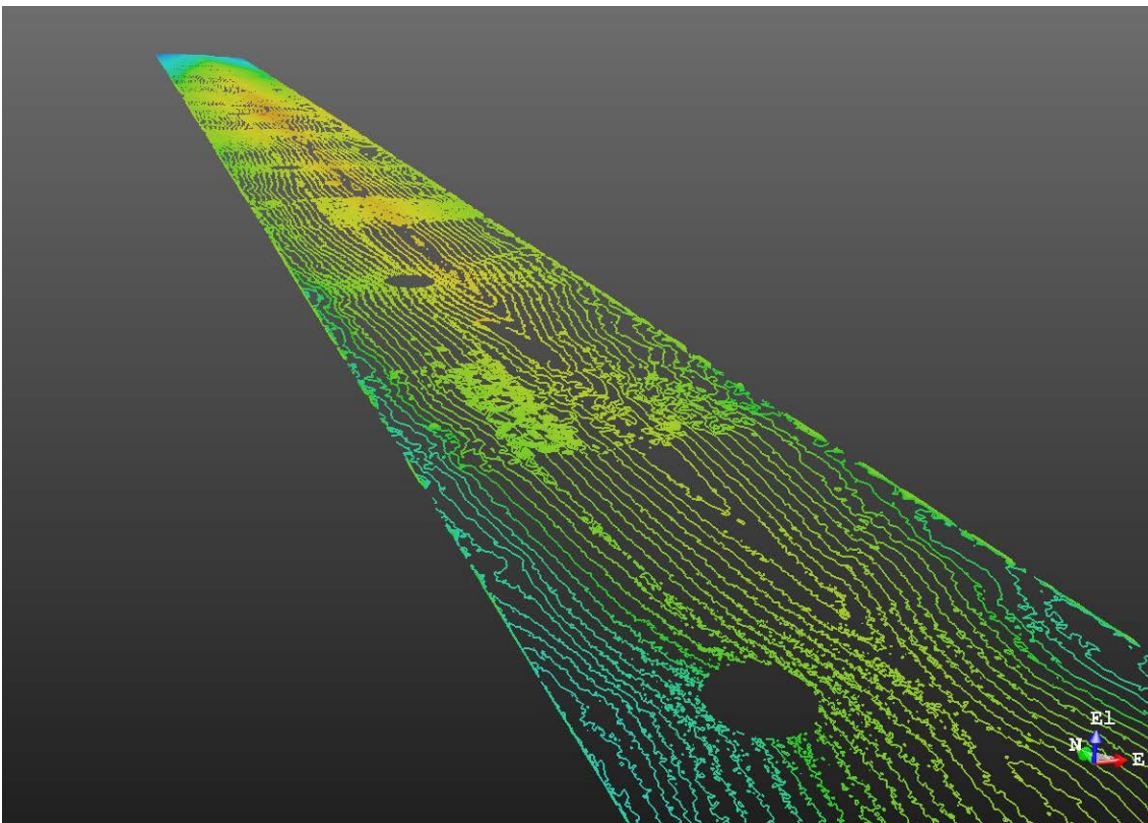
Bridge deck scan of I-57 over Kankakee River. Photo courtesy of IDOT.

The I-57 bridge across the Kankakee River spans 540 ft. and consists of two separate superstructures—one structure for the northbound lanes of traffic, and another structure for the southbound lanes of traffic. After construction, IDOT crews observed that the I-57 bridge deck was experiencing drainage problems and water ponding after rain events. As a result, IDOT designers

The accuracy of the contour intervals allowed designers to clearly identify low spots in the bridge deck. Using traditional surveying methods would not have been possible at such high levels of accuracy under live traffic conditions. Traditional survey methods could only have been used to get the desired accuracy by shutting down both lanes of traffic on each structure, and diverting or detouring traffic for an extended period of time.

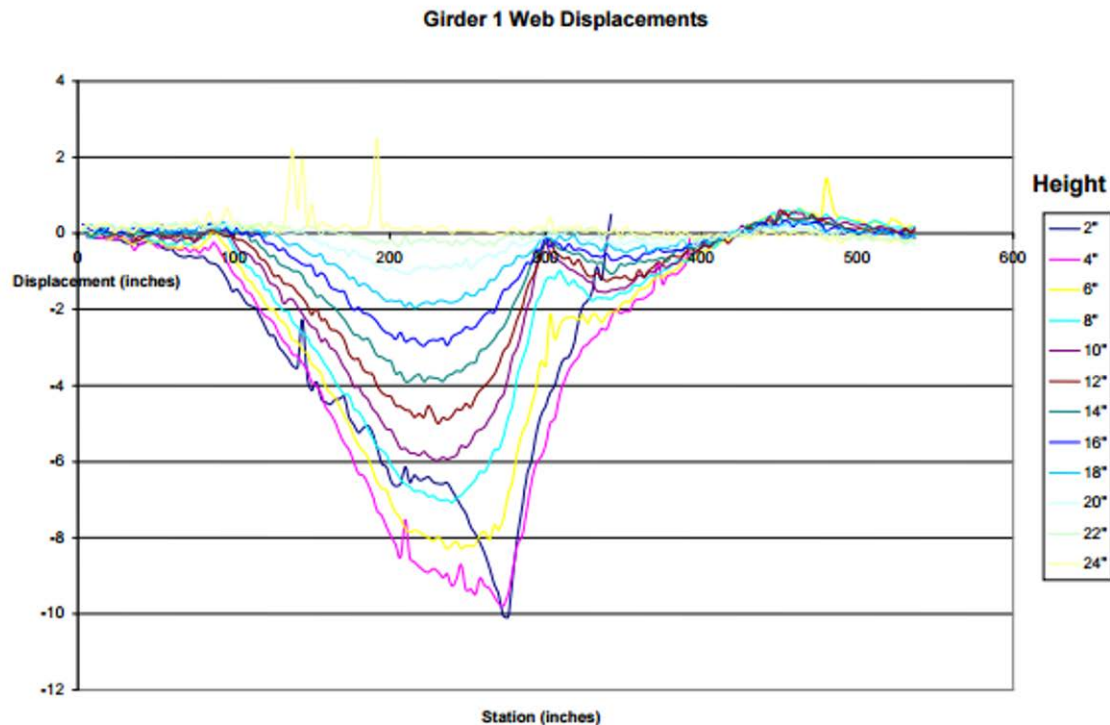
Web displacement curves calculated from point cloud scan. Source: FHWA-ICT-10-068 Report
