# Nontraditional Fog Seals for Asphalt Pavement: Performance on Shoulder Sections in Minnesota

**Eddie N. Johnson, Principal Investigator**  
Minnesota Department of Transportation  
Office of Materials and Road Research

Research Project  
Final Report 2018-18

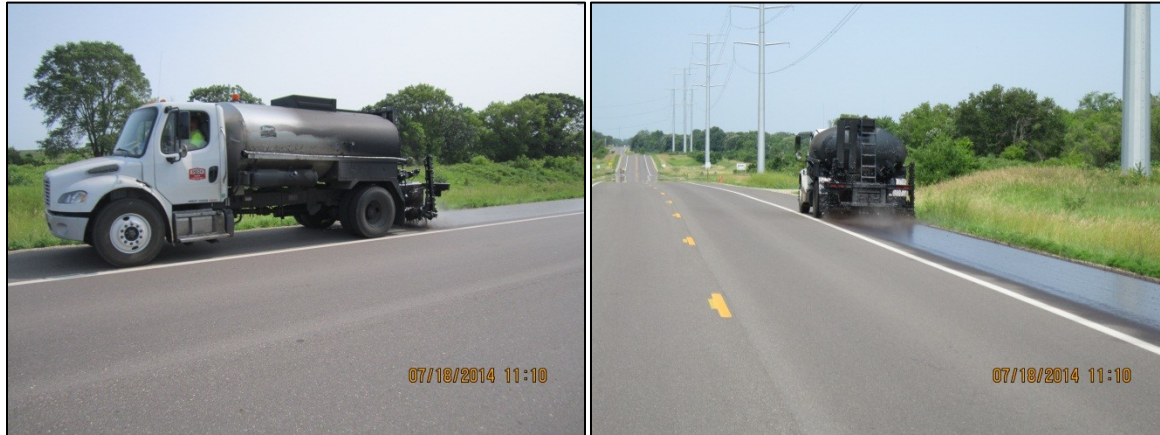
**Figure 3.3 Installation of CSS-1h on Wright CSAH 75 shoulder.**

There were no applications to the existing fog line. No pre-application sweeping was performed. Measurement of application rate was not necessary since the contractor was also performing chip seal work for MnDOT on two nearby projects, and MnDOT inspectors were monitoring the distributor performance.

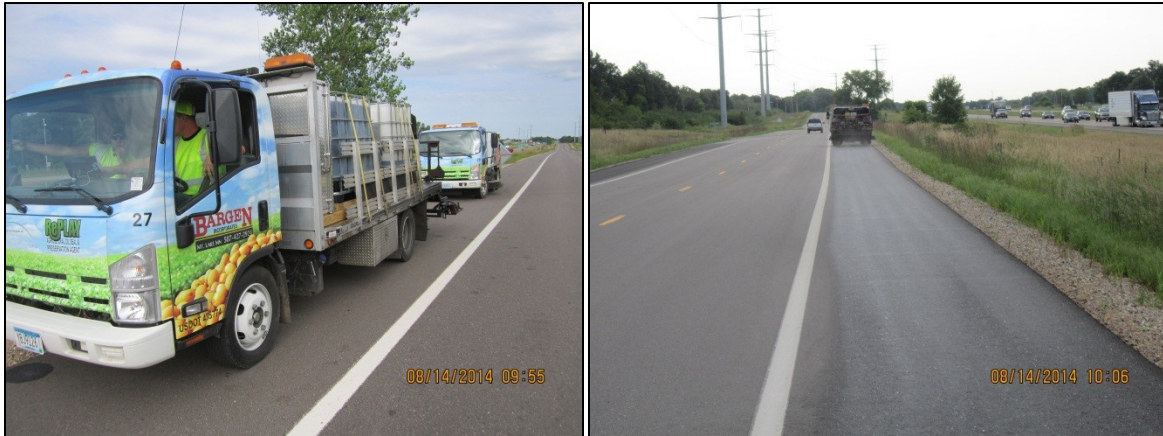
**Figure 3.4 Installation of RePlay™ on Wright CSAH 75 shoulder.**

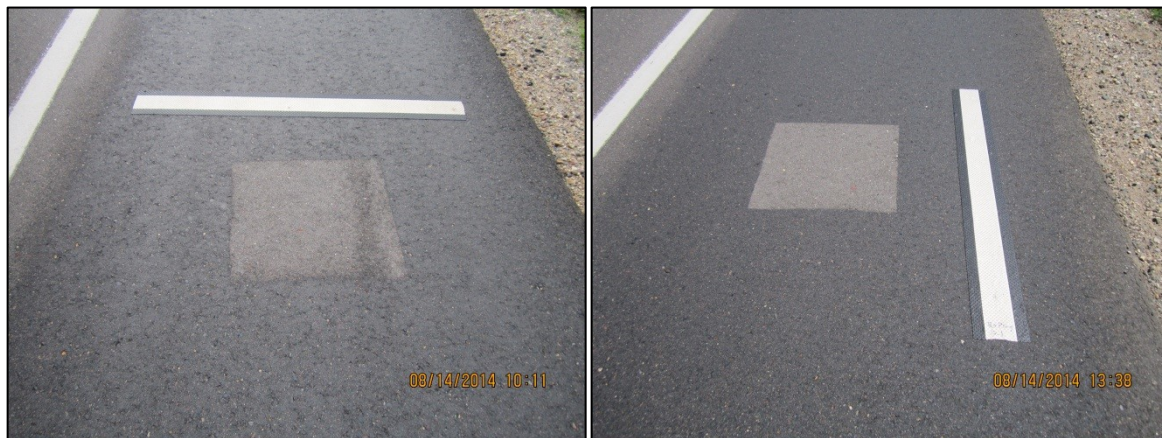
**Figure 3.5 Test setup for monitoring retroreflectivity and application rate; RePlay™.**

Before-After measurements of retroreflectivity were taken on segments of permanent white marking tape. During installation, the tapes were placed in the vicinity the geotextile pads. Figure 3.5 shows the setup after pads had been removed.

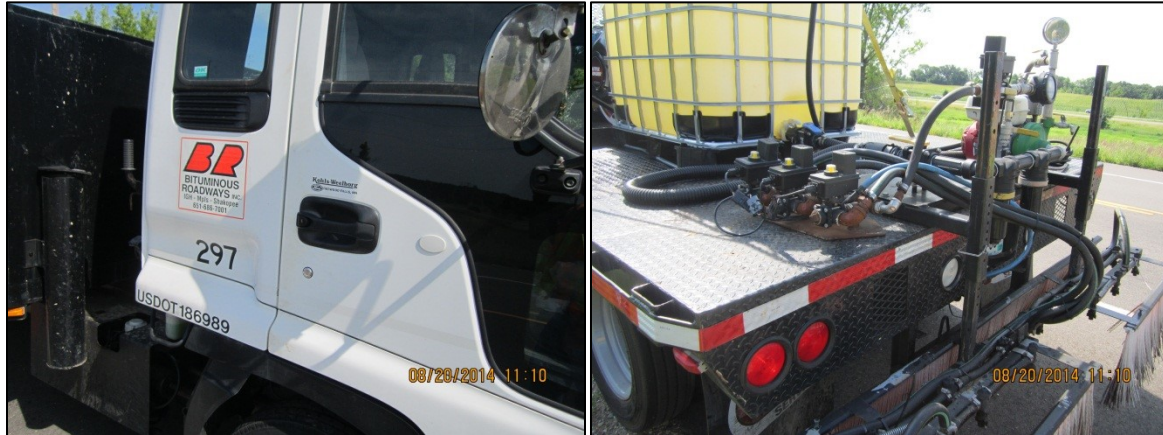
**Figure 3.8 Installation of Biorestor® on Wright CSAH 75 shoulder.**

A distributor truck applied the Biorestor® material at a rate of 0.015 gallons per square yard (Figure 3.8) to 1,338 feet of the eastbound shoulder. A rate of 0.020 gallons per square yard was applied to the following 1,326 feet. A pre-application sweep was performed using a mechanical broom. There were no applications to the existing fog line. Weather was dry and clear, with a light breeze.

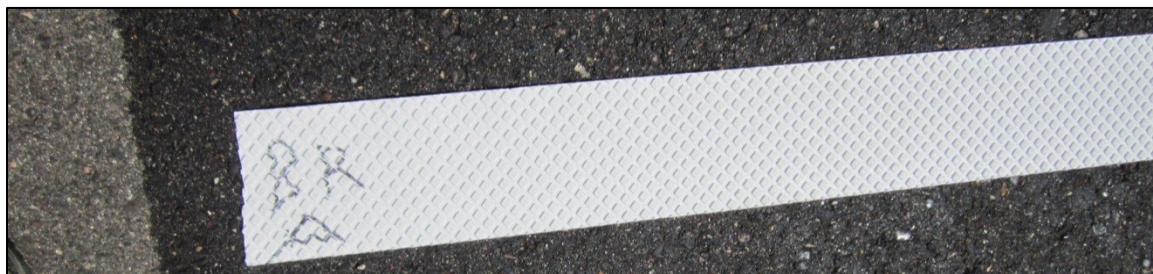
**Figure 3.9 Close-up of transverse striping.**

Before-After measurements of retroreflectivity were taken on segments of permanent white marking tape. During installation the tapes were placed in the vicinity of the nonwoven geotextile pads. Figure 3.9 and Figure 3.10 show the appearance after fog application.

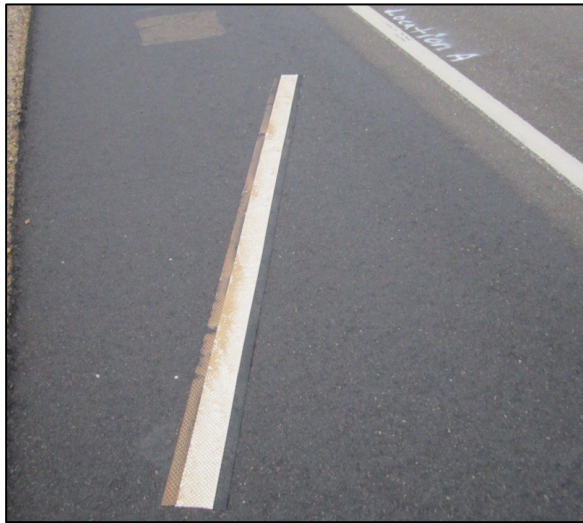
**Figure 3.12** Test setup for monitoring retroreflectivity and application rate; Jointbond®.

Figure 3.12 and Figure 3.13 show the appearance after the fog application.

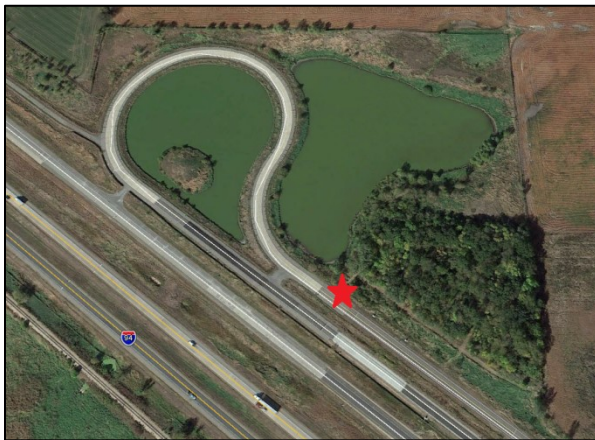
Figure 3.14 Cell 33 Transition at MnROAD (google earth).

A number of traffic marking tapes were treated with fog seal products used during construction of the sections on CSAH 75. The traffic marking tapes were subsequently removed from CSAH 75 and reinstalled on parts of MnROAD Low Volume Road (LVR) Cell 33 (Figure 3.14, Table 3.1). The advantage of the Low Volume Road was the controlled application of traffic. MnROAD LVR traffic was limited to regular repetitions of a five-axle heavy vehicle. The heavy vehicle traffic counts were documented daily.

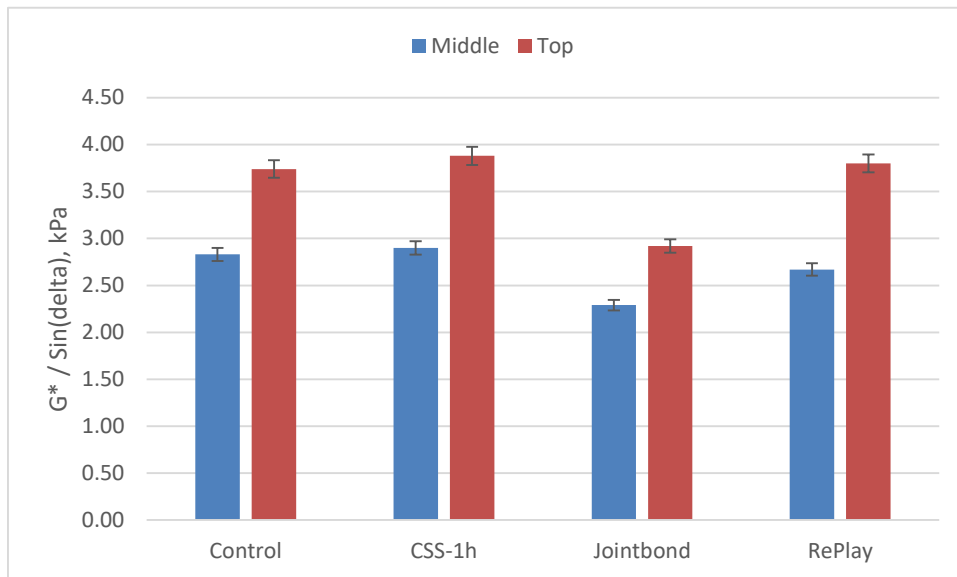
Figure 4.7 DSR results with single operator standard deviation.

Measurements of  $\frac{G^*}{\sin(\delta)}$  from the Jointbond® core top and middle, and RePlay™ middle produced lower values; however they were not below the standard of 1.98 kPa.

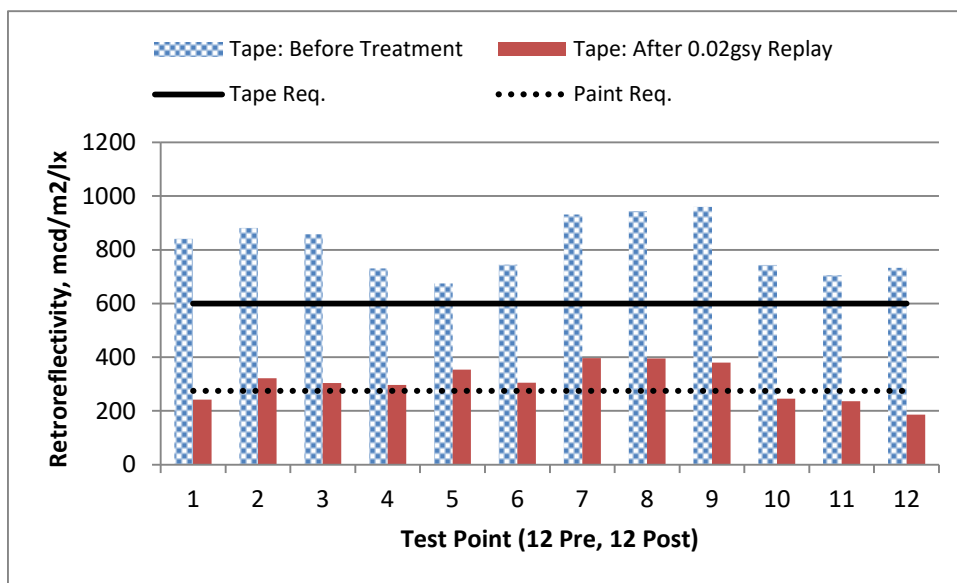
Figure 5.1 Retroreflectivity before/after RePlay™ application.

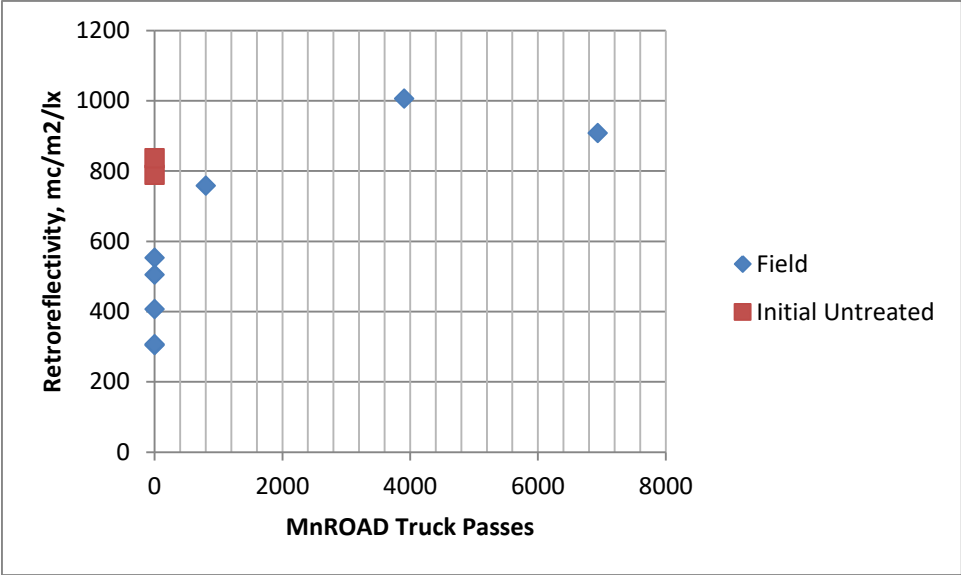
Figure 5.5 Retroreflectivity performance with RePlay™.

- Recovery for the tapes treated with Bioestor® was approximately 1,600 truck passes.
- Recovery for the tapes treated with Jointbond® was approximately 800 truck passes.
- Recovery for the tapes treated with RePlay™ was approximately 1,600 truck passes.
- All sets of tapes and fog materials developed maximum reflectivity at approximately 4,000 truck passes (20,000 tire passes).

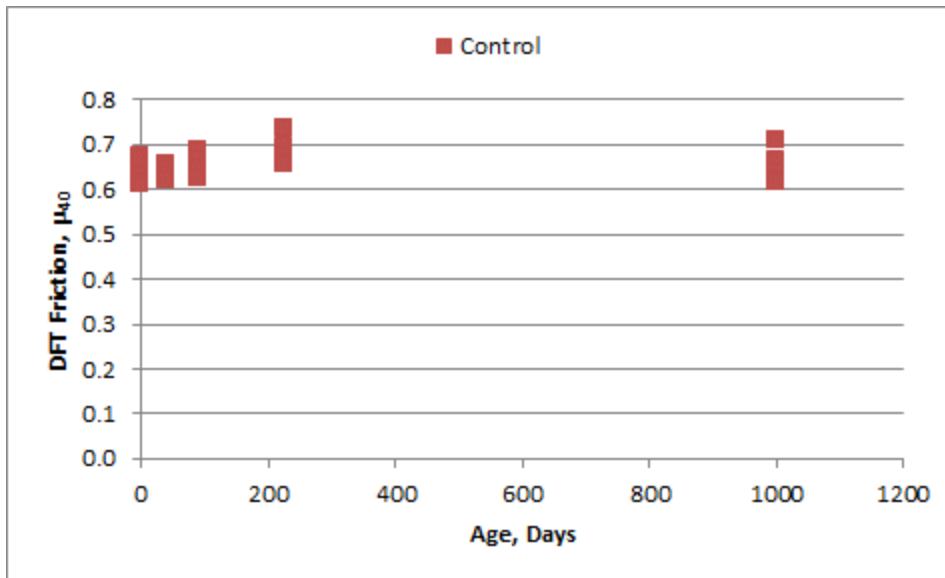
**Figure 5.9 DFT Data from CSAH 75: Control section.**

The Control section  $\mu_{40}$  measurements were stable during the three-year time period (Figure 5.9), with a mere 4.9 percent coefficient of variation and a range between 0.611 and 0.736. Subsequent measurements found that recovery began immediately in all treated test sections, but there was some difference in the rate of recovery between treatment types.

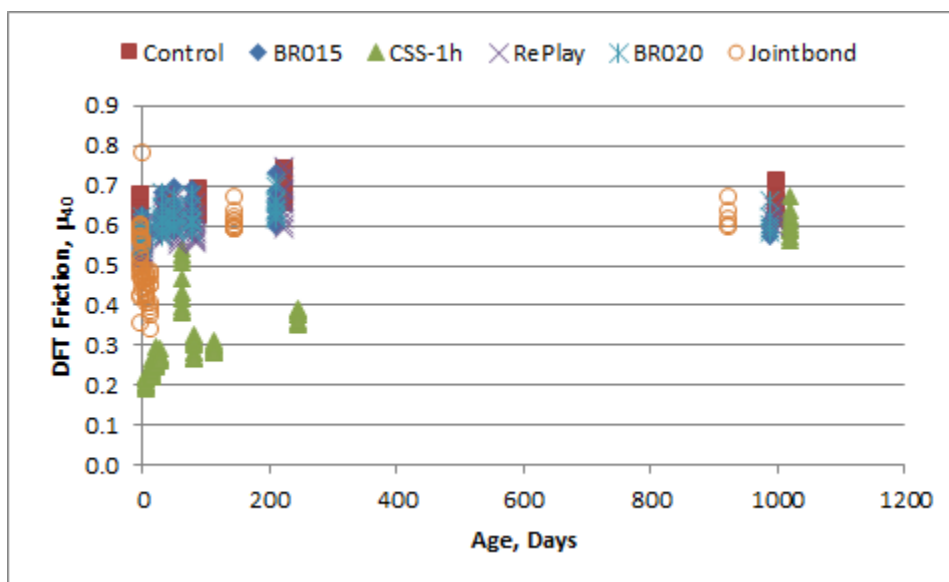
Figure 5.10 DFT Data from CSAH 75: HMA with various fog treatments.

At the conclusion of one year of monitoring the DFT friction performance for all the treatments except diluted CSS-1h had recovered to the level of the untreated control section (Figure 5.10), so subsequent testing was delayed until the next year. Note that the values obtained during Year Three showed all sections had recovered friction performance similar to the Control section.

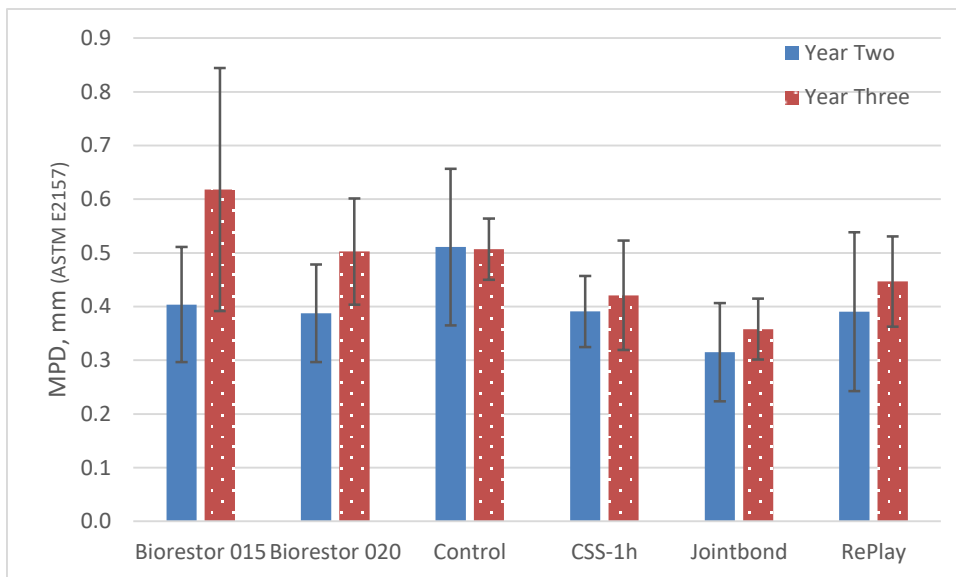
Figure 5.12 Mean Profile Depth by Treatment.

Figure 5.12 presents the MPD averages from Table 5.3. The error bars show the standard deviation for each treatment, and some influence of the spikiness identified in Figure 5.11 can be seen here. The mean values of test section MPD's showed a tendency to increase during the study. Overlapping error bars suggest there was little significance in the differences between mean values.

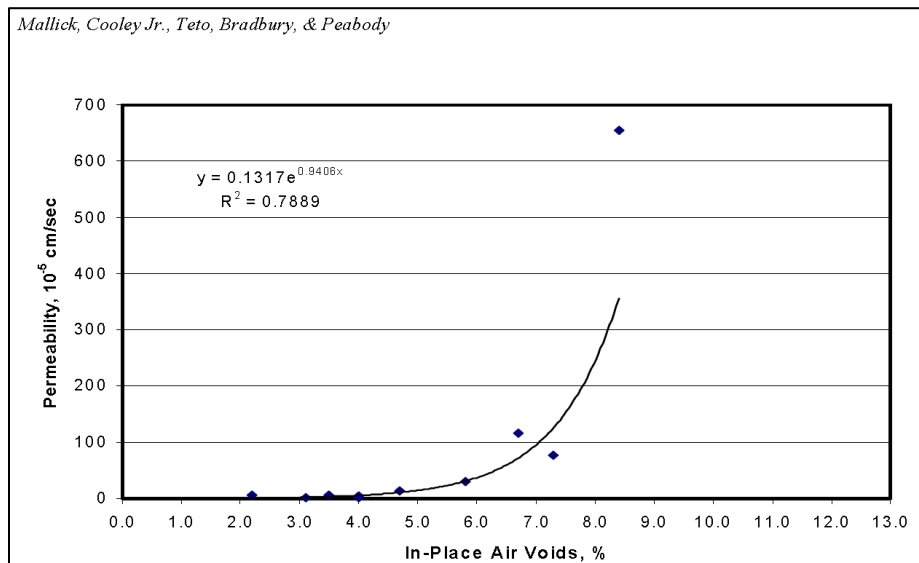
Figure 5.13 Plot of In-Place Air Voids versus Permeability for 12.5mm coarse mix (25).

The following figure shows the expected range of permeability obtained at given air void levels when testing coarse 12.5 mm asphalt mixtures with this equipment. Note that relatively good performance is found in the range below 50 x10<sup>-5</sup> cm/s, corresponding to 6.5 percent air voids.

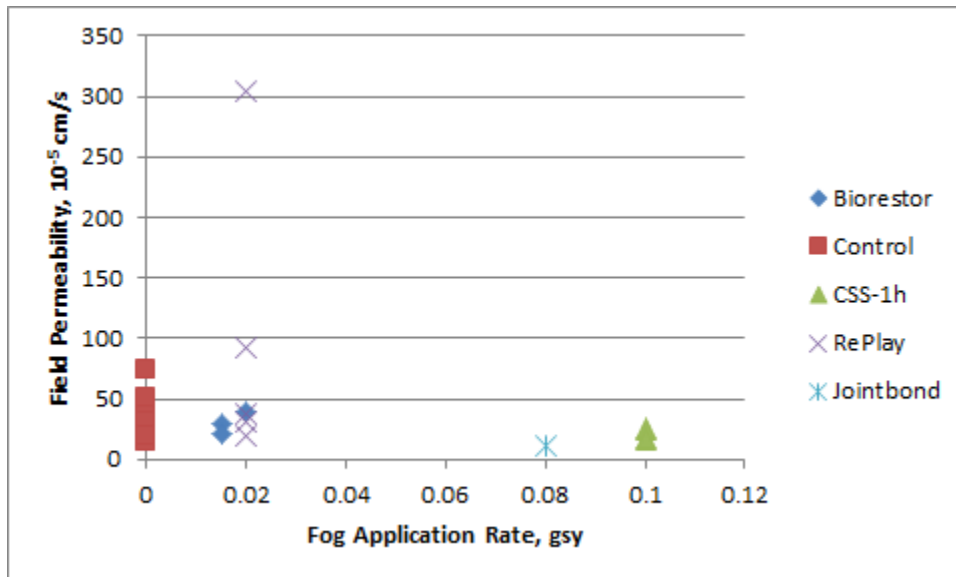
Figure 5.14 Field permeability of Fog sections: Year One.

- A test was performed on the CSS-1h within 1 week of application. Results were obtained without problem.
- A test was performed on the RePlay™ section on the day after application. During removal of the permeameter base the adhesive pulled a ring of asphalt mix from the surface of the pavement, indicating that testing was performed too early. A second test was performed after a cure period of over one month, and no problems were encountered.
- A test was performed on the Biorestor® section after one month. The waiting period was due to the results observed from the other sections. No problems were encountered.
- A test was performed on the Jointbond® section one week after application. No problems were encountered.

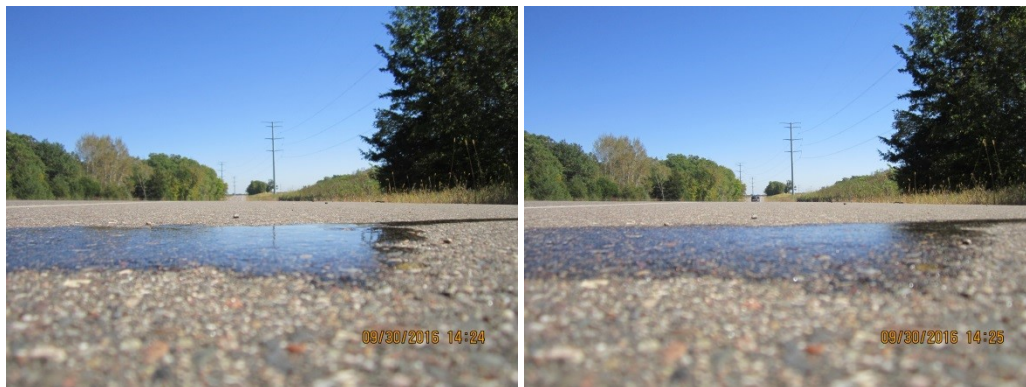
**Figure 5.16 Ponded water soaking into surface texture (left, right).**

Treatment	Applied t=0,	Edge Runoff,	Damp Condition,	Time to Soak,
	hh:mm	hh:mm	hh:mm	minutes
CSS-1h dilute	13:28	13:29	13:41	13
Control (none)	13:38	13:38	13:39	1
Replay	13:52	13:52	13:56	4
Biorestor 0.015	14:14	14:14	14:16	2
Biorestor 0.020	14:23	14:24	14:26	3
Jointbond	14:38	14:38	14:42	4

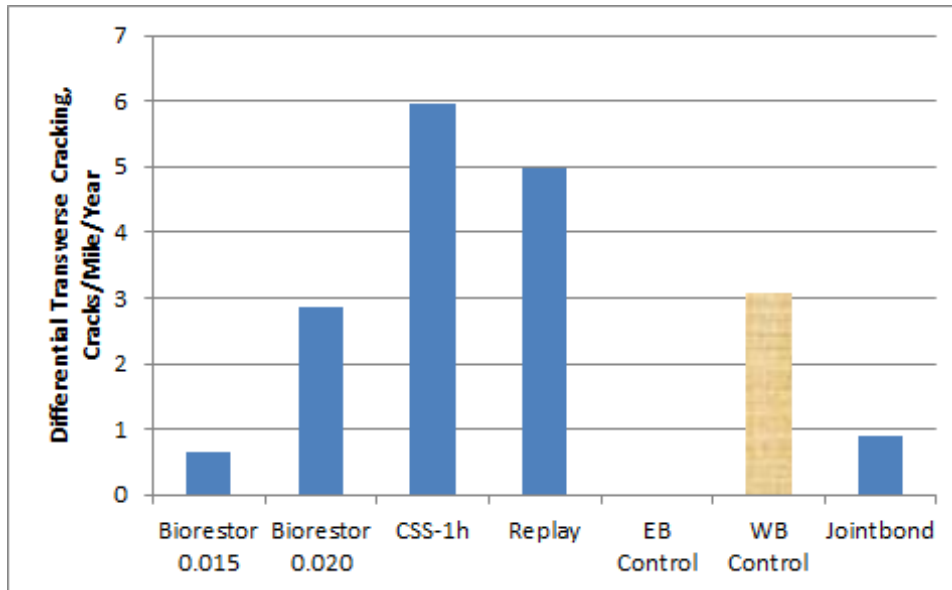
Figure 5.18 Differential Cracking Rates Relative to EB Control.

The cracking rate on each section was compared by fitting linear least squares from the cracking history data to produce slope and intercept values in units of cracks per mile per year. Figure 5.18 is a plot of the difference between those cracking rates when compared to the eastbound control section. The greatest rate difference values occurred in the CSS-1h and RePlay™ sections. Note that the CSS-1h and RePlay™ sections were located in the same mile of roadway.

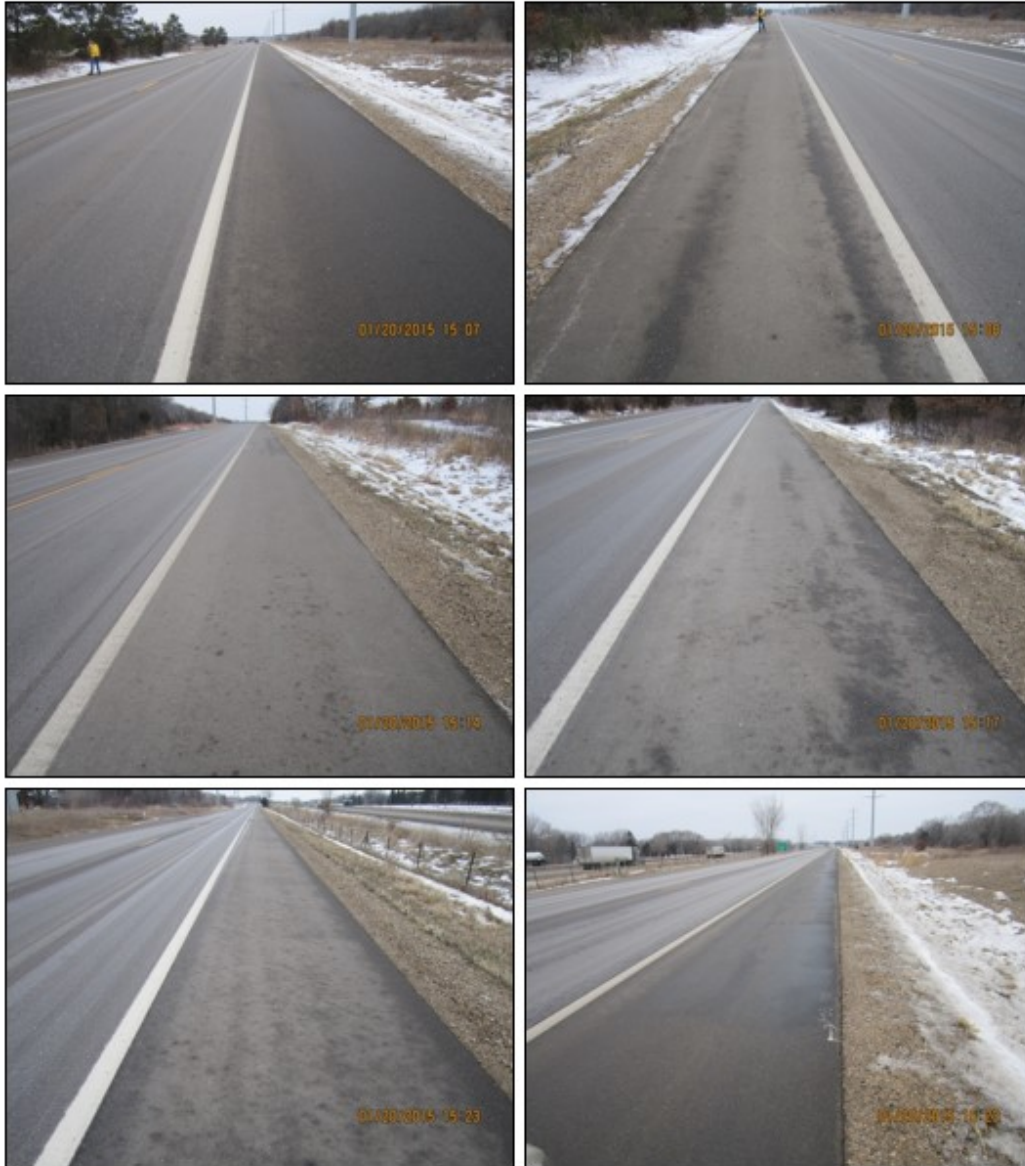
Figure 5.19 Year One wet-condition photos clockwise from upper left: WB Control, Jointbond®, Biorestor® 0.015, CSS-1h, RePlay™, and Biorestor® 0.020.

- The CSS-1h section appeared coated with moisture in the treated area. The surface did not feel slippery for walking, but did feel slippery for turning. In this section the amount of moisture standing on the surface was evidence that the fog seal had prevented moisture intrusion.

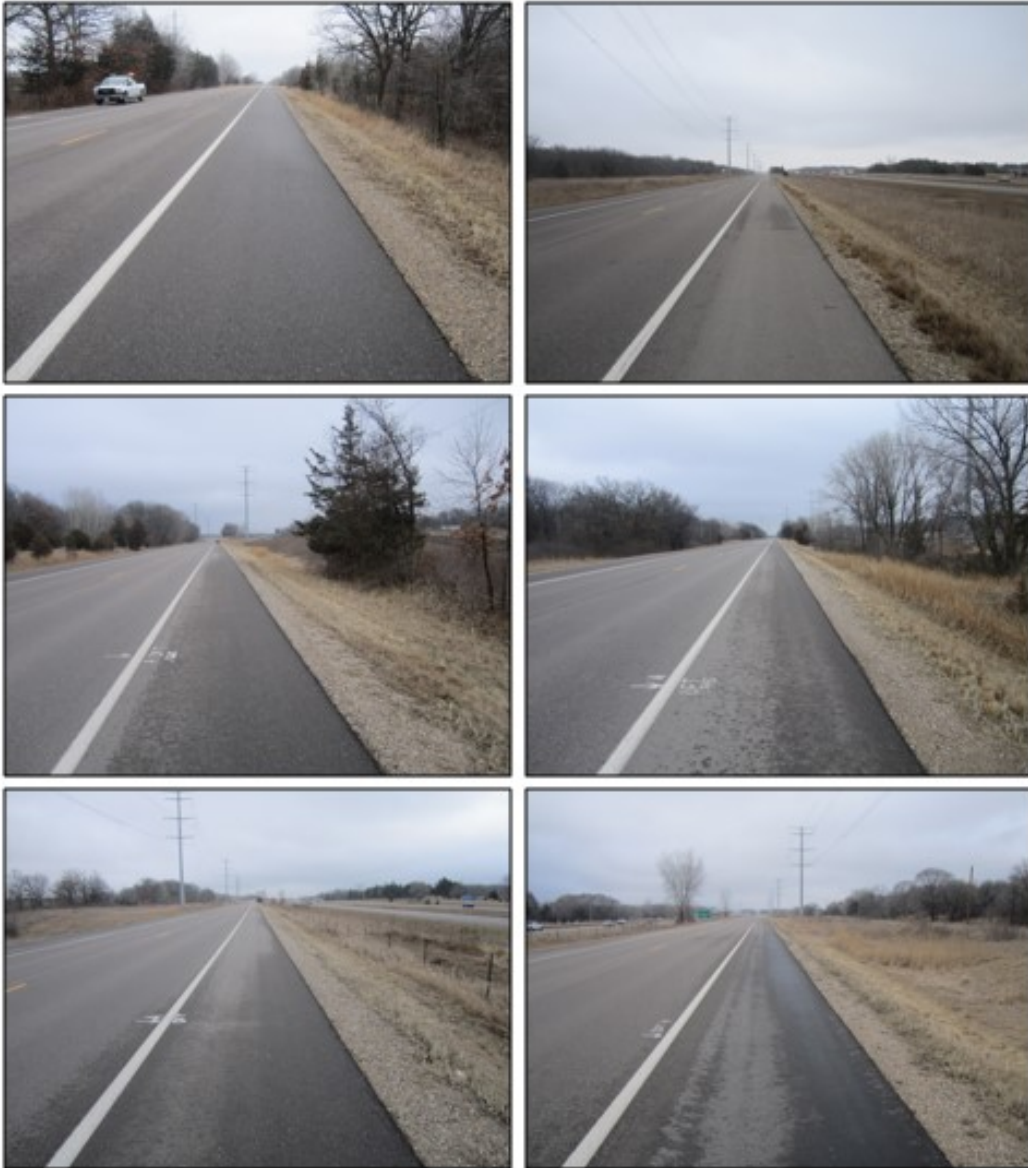
Figure 5.20 Year Two wet-condition photos clockwise from upper left: WB Control, Jointbond®, Biorestor® 0.015, CSS-1h, RePlay™, and Biorestor® 0.020.

- DRY: Bounds of the spray application were visible. The perimeter of the application was less defined, and the color had faded from black to dark gray at this location. The scraping effect of snow plowing was visible at transverse cracks.

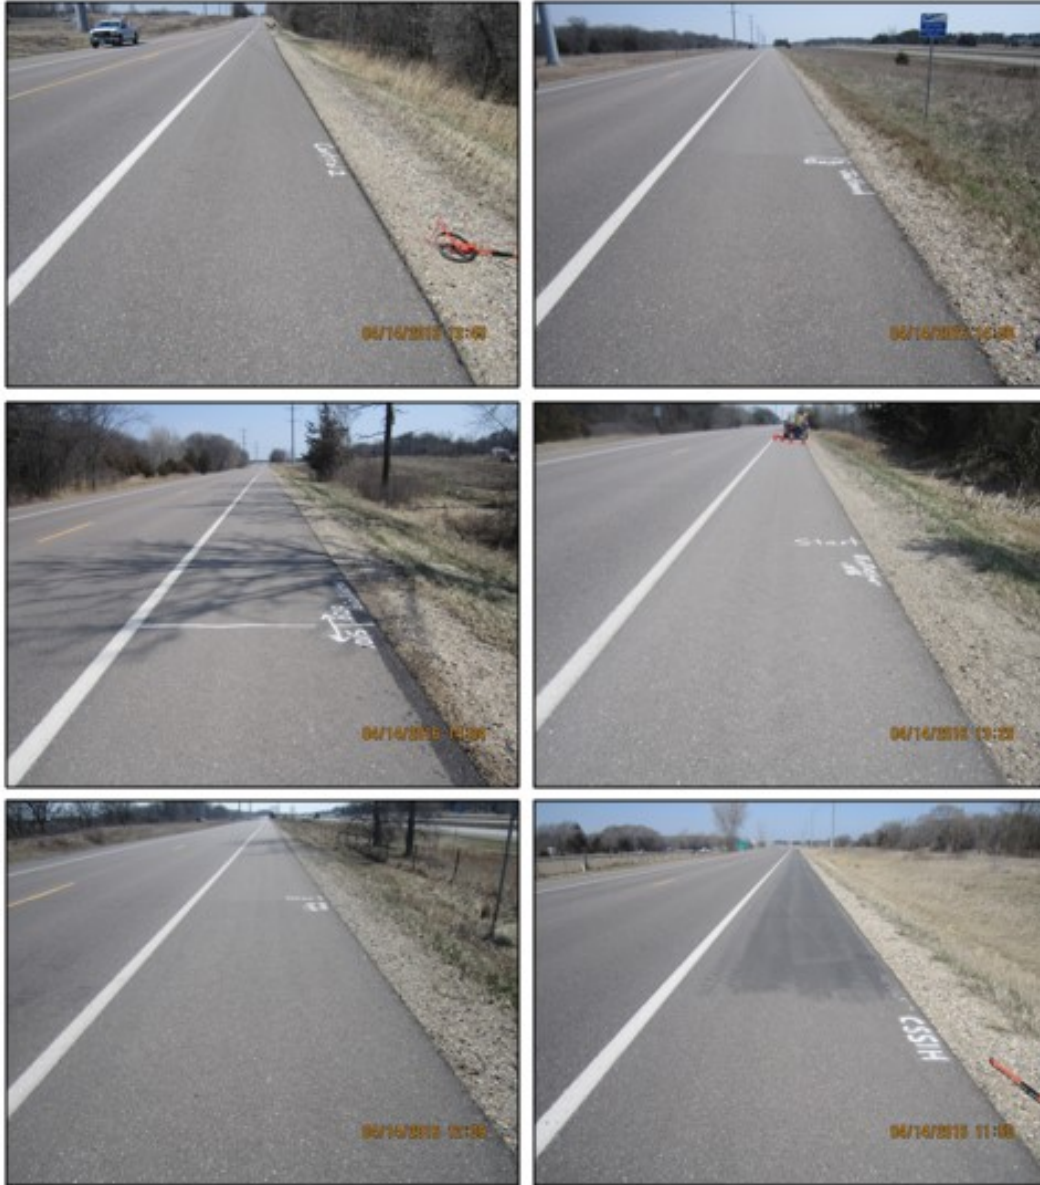
Figure 5.21 Year Two dry-condition photos clockwise from upper left: WB Control, Jointbond®, Biorestor® 0.015, CSS-1h, RePlay™, and Biorestor® 0.020.

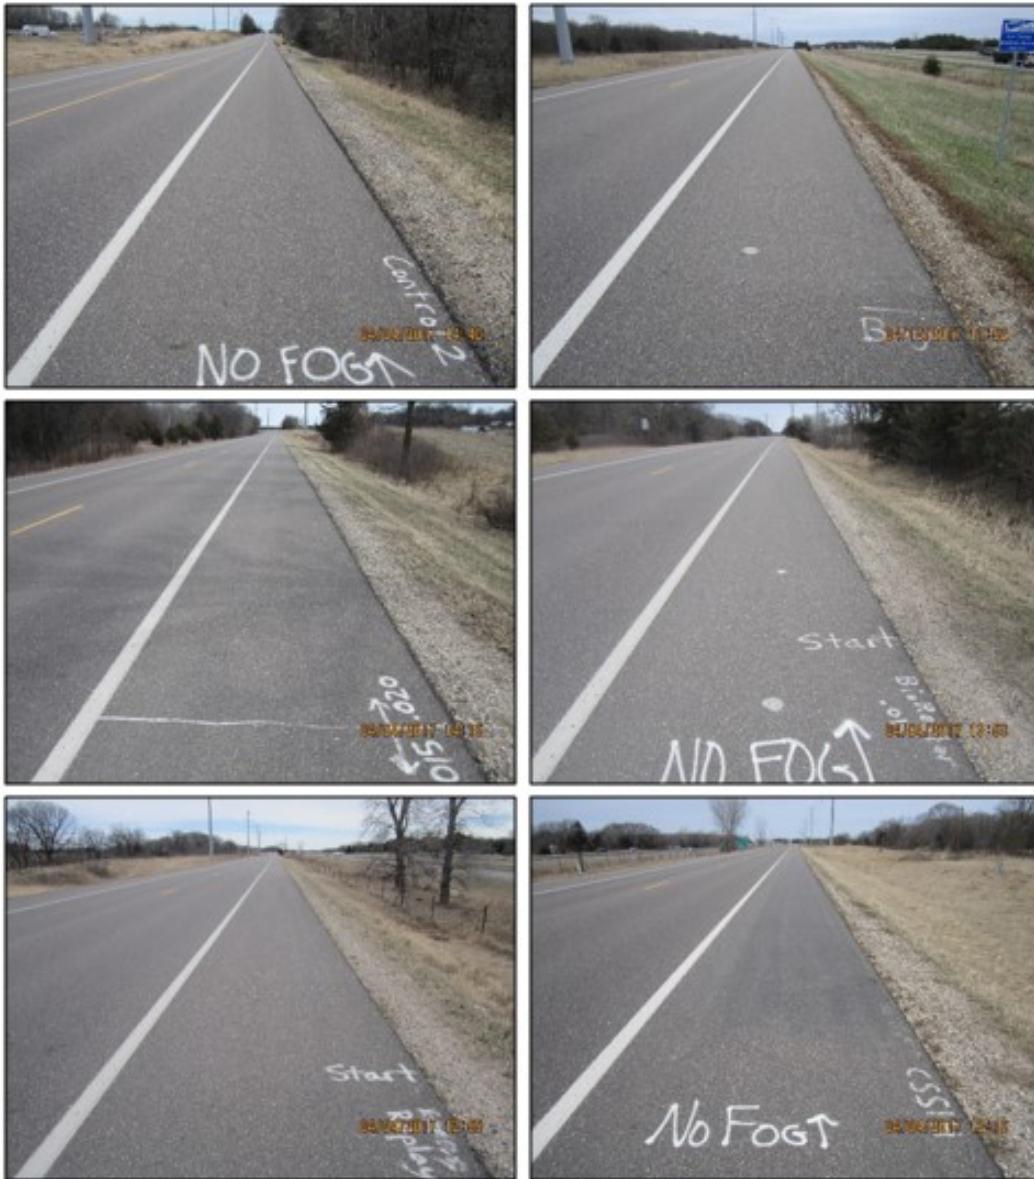
Figure 5.22 Year Three dry-condition photos clockwise from upper left: WB Control, Jointbond®, Biorestor® 0.015, CSS-1h, RePlay™, and Biorestor® 0.020.

- Jointbond® shoulder appeared in good condition. Bounds of the spray application were not visible.
- Biorestor® shoulder appeared in good condition. Bounds of the spray application were not visible.
- RePlay™ shoulder sections were treated from 1-ft outside of the fog line to 1-ft inside the edge of pavement. Bounds of the spray application were not visible.
- CSS-1h shoulder sections were treated from 1-ft outside of the fog line to the edge of pavement. Bounds of the spray application were visible. The perimeter of the application was less defined than during prior inspections, and the color had faded from black to dark gray at this location. Some plow scraping was apparent, especially at transverse cracks

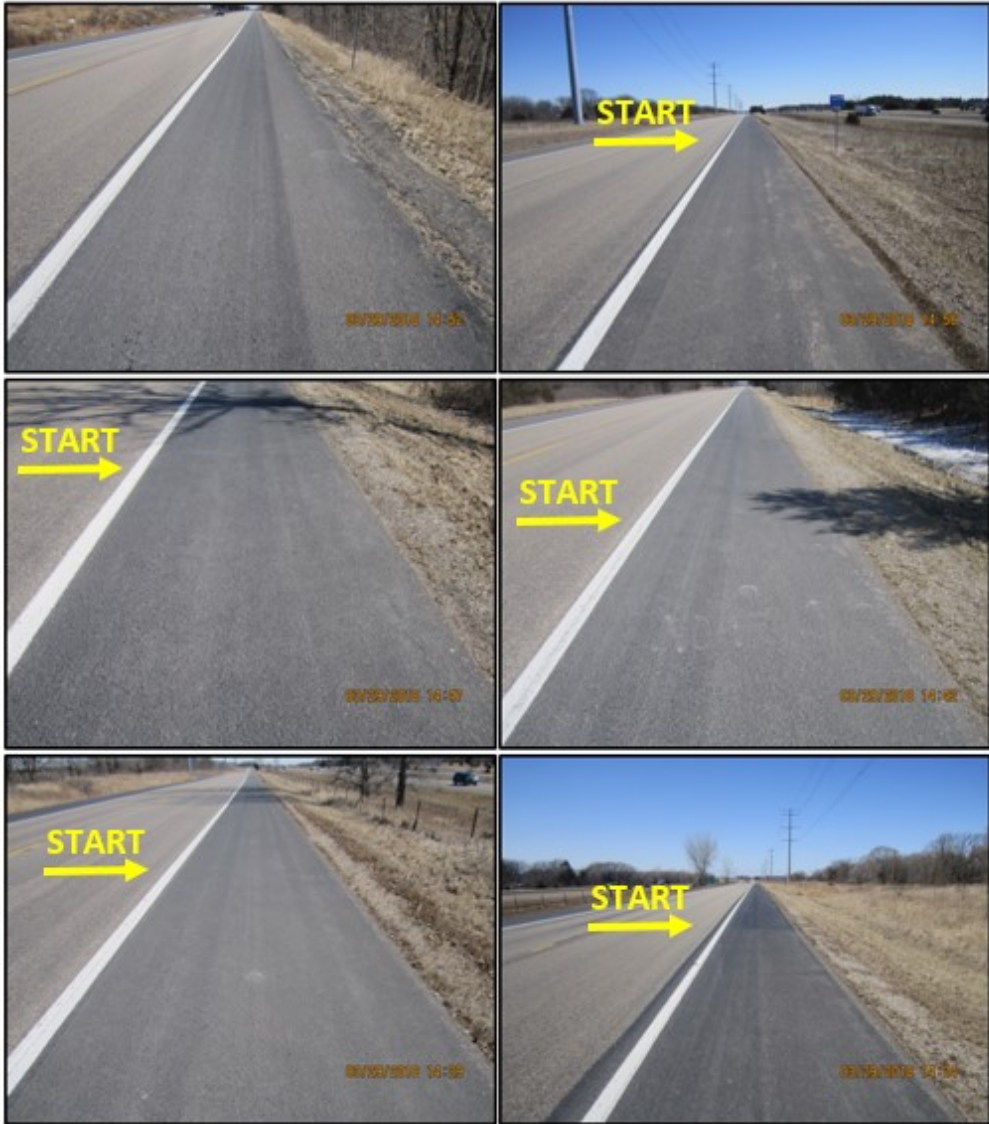
Figure 5.23 Year Four following routine fog seal, condition photos clockwise from upper left: WB Control, Jointbond®, Biorestor® 0.015, CSS-1h, RePlay™, and Biorestor® 0.020.

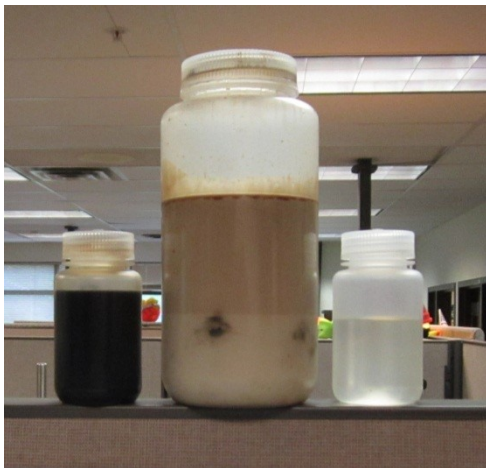
**ITEM 3 – Photo of (left to right) RePlay™, Jointbond®, and Biorestor® field samples.**
