Evaluation of Innovative Approaches to Curve Delineation for Two-Lane Rural Roads

Final Report VTRC 18-R25

June 2018
VTRC 18-R25

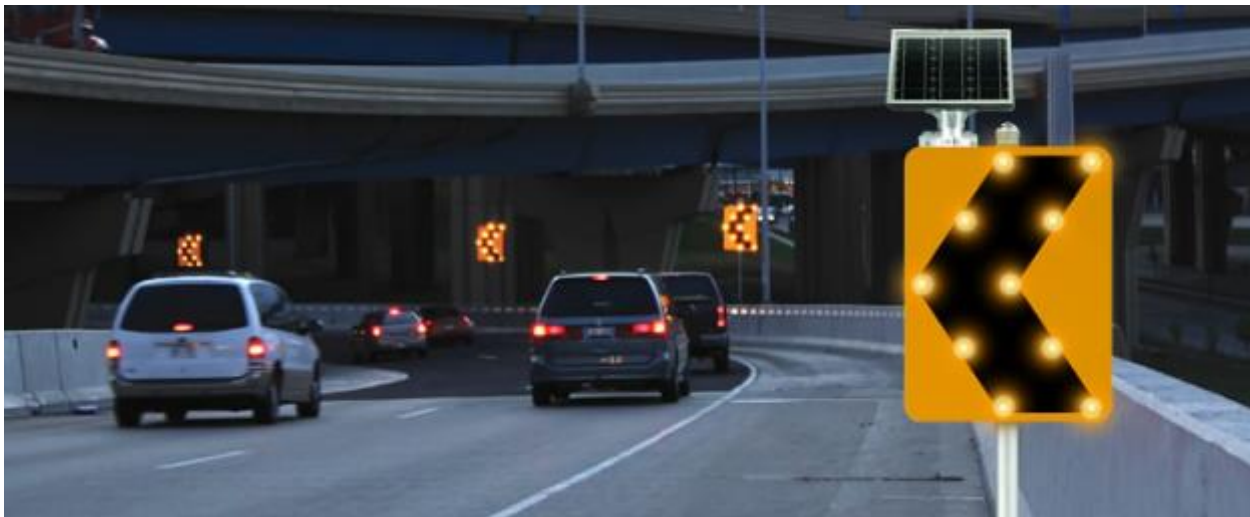
Figure 4. Promotional image of BlinkerChevron system

Sequentially flashing chevrons were added to curve 2. This was a BlinkerChevron dynamic curve warning and guidance system purchased from Traffic & Parking Control Company (TAPCO). This solar powered system used radar to detect oncoming vehicles, which then activated the LEDs embedded in each sign in sequence using wireless communication (Figure 4). The sign used 3M diamond grade cubed (DG3) sheeting.

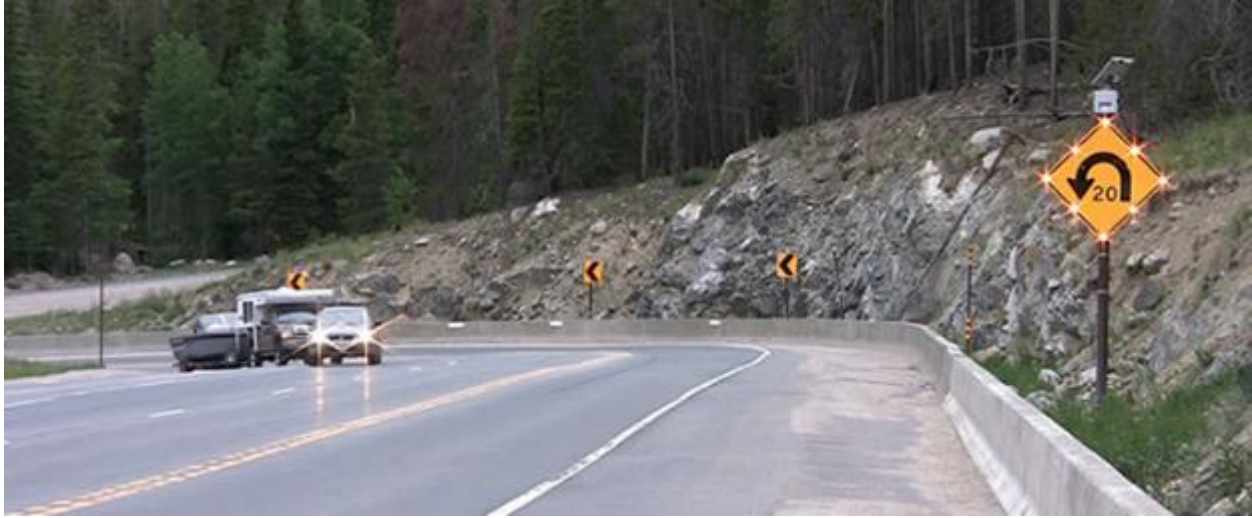
Figure 5. Promotional image of a BlinkerSign

A blinking curve warning sign was added to curve 3. This was a BlinkerSign curve warning sign purchased from TAPCO. This solar powered system used radar to detect oncoming vehicles, which then activated the LEDs embedded in the sign (Figure 5). The sign used 3M diamond grade cubed (DG3) sheeting.

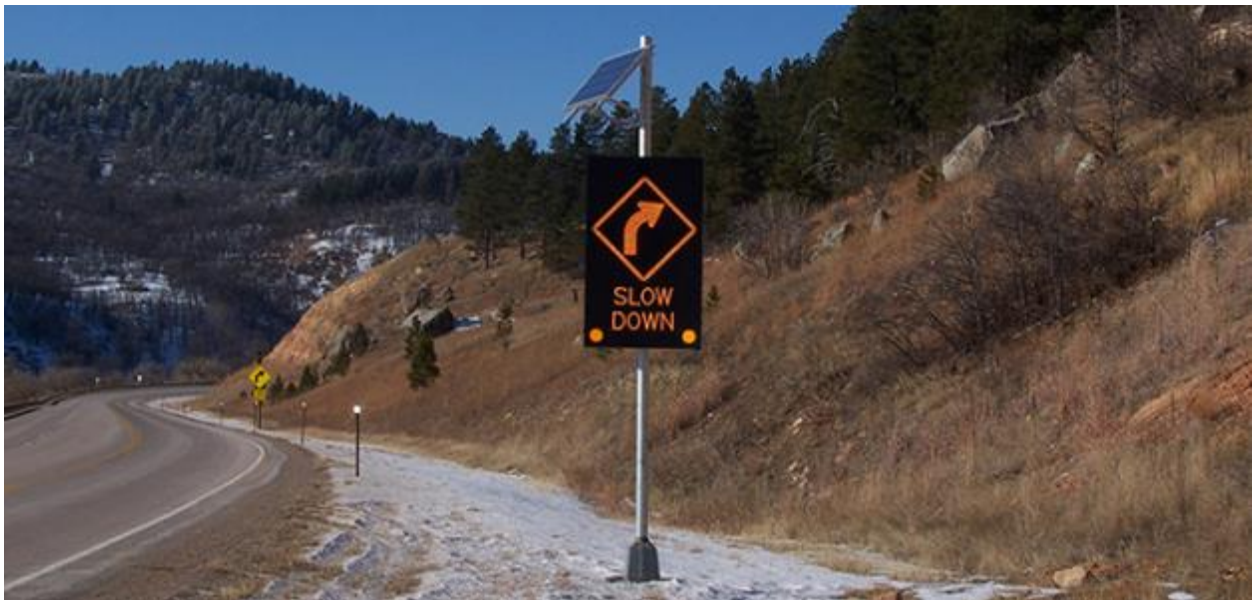
Figure 6. Promotional image of a dynamic curve warning sign

A dynamic curve warning sign (DCWS) was added to curves 5 and 8. This was a vehicle activated traffic calming system (VATCS) purchased from Unipart Dorman. This solar-powered system used radar to measure the speeds of oncoming vehicles. When a vehicle was detected exceeding the advisory speed, a curve sign and a “SLOW DOWN” message appeared on the sign, as well as four flashing circles in each corner of the sign (Figure 6).

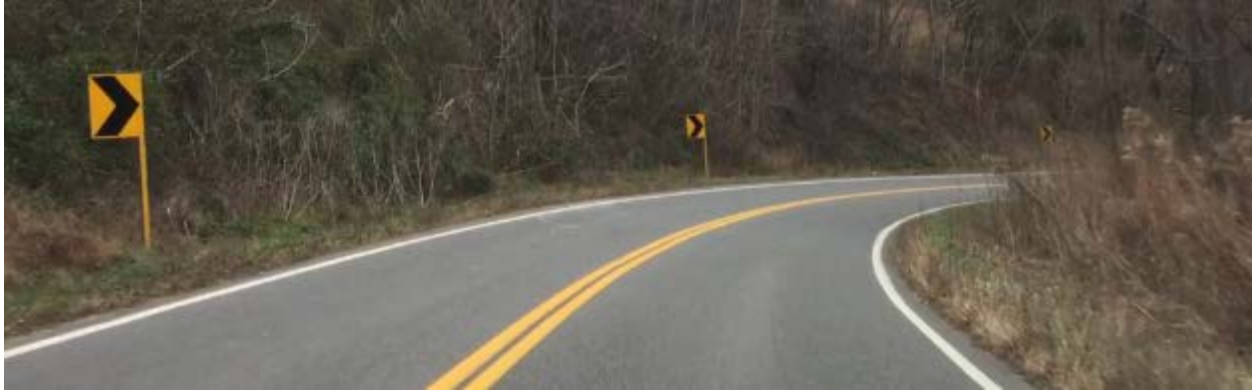
Figure 8. Curve 1 treatment – retroreflective material on chevron posts

The existing treatments for curve 1 consisted of a curve warning sign (CWS), and several chevrons. The new treatment consisted of adding retroreflective material to the posts of the existing chevrons (Figure 8). This was a bidirectional treatment (two chevrons per post). The distance from the point of curvature to the first chevron was approximately 42ft in the inner lane, and 23ft in the outer lane. The ANOVA results of the human-factors study are shown in Table 5. Due to the large number of analyses, only the P values are shown. Values in boldface indicate significant results ($p < 0.05$).

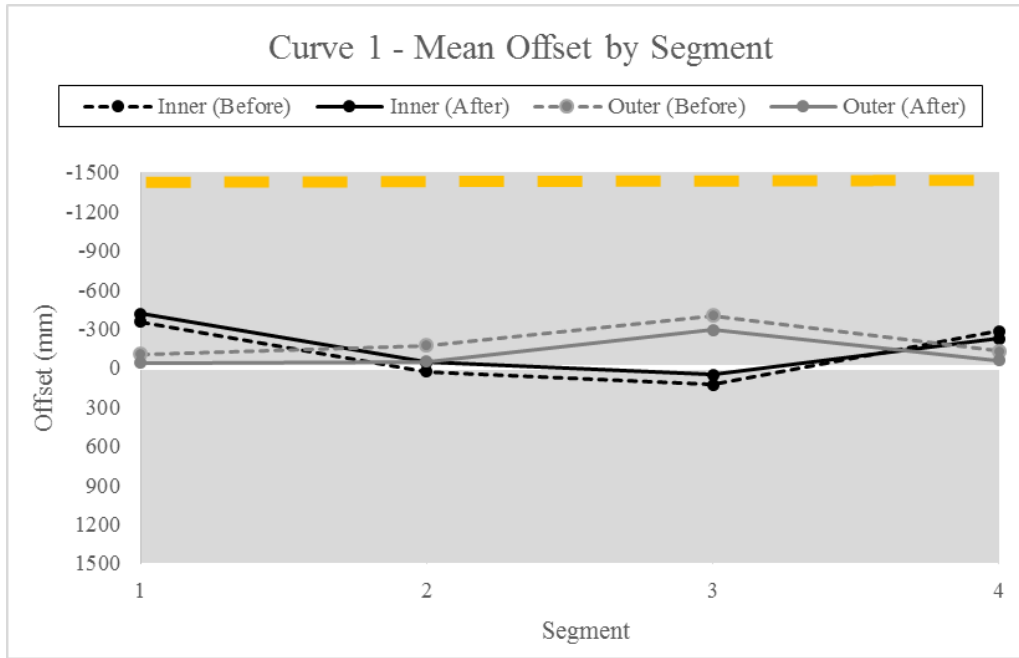
Figure 10. Curve 1 - Mean offset by segment

The treatment caused a slight shift in offset toward the outside of the curve for both lanes; the offset for the inner lane shifted slightly to the left in all but one segment, while it shifted slightly to the right for the outer lane in all segments. The changes were small, however, with the largest difference (127 mm) occurring in segment 2 for the outer lane.

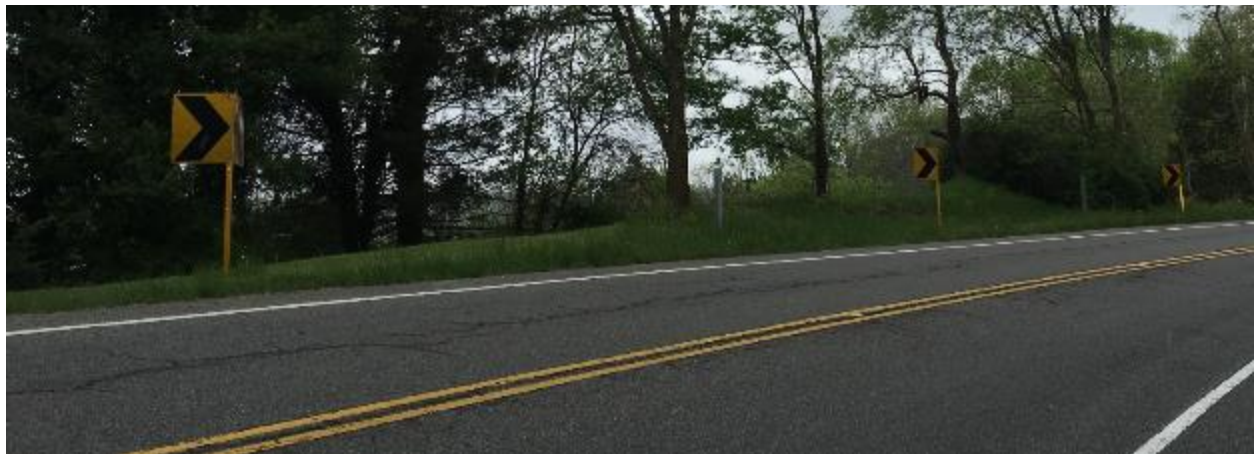
Figure 13. Curve 9 treatment – retroreflective chevron posts

The existing treatments for curve 9 consisted of a CWS, and several chevrons. The new treatment consisted of adding retroreflective material to the posts of the existing chevrons (Figure 13). The treatment was visible from both directions. The distance from the point of curvature to the first chevron was approximately 180ft for both lanes. This curve was not included in the human-factors data because it was located on a different roadway than the other curves. The ANOVA results for the observational study are shown in Table 8. Values in boldface indicate significant results ($p < 0.05$).

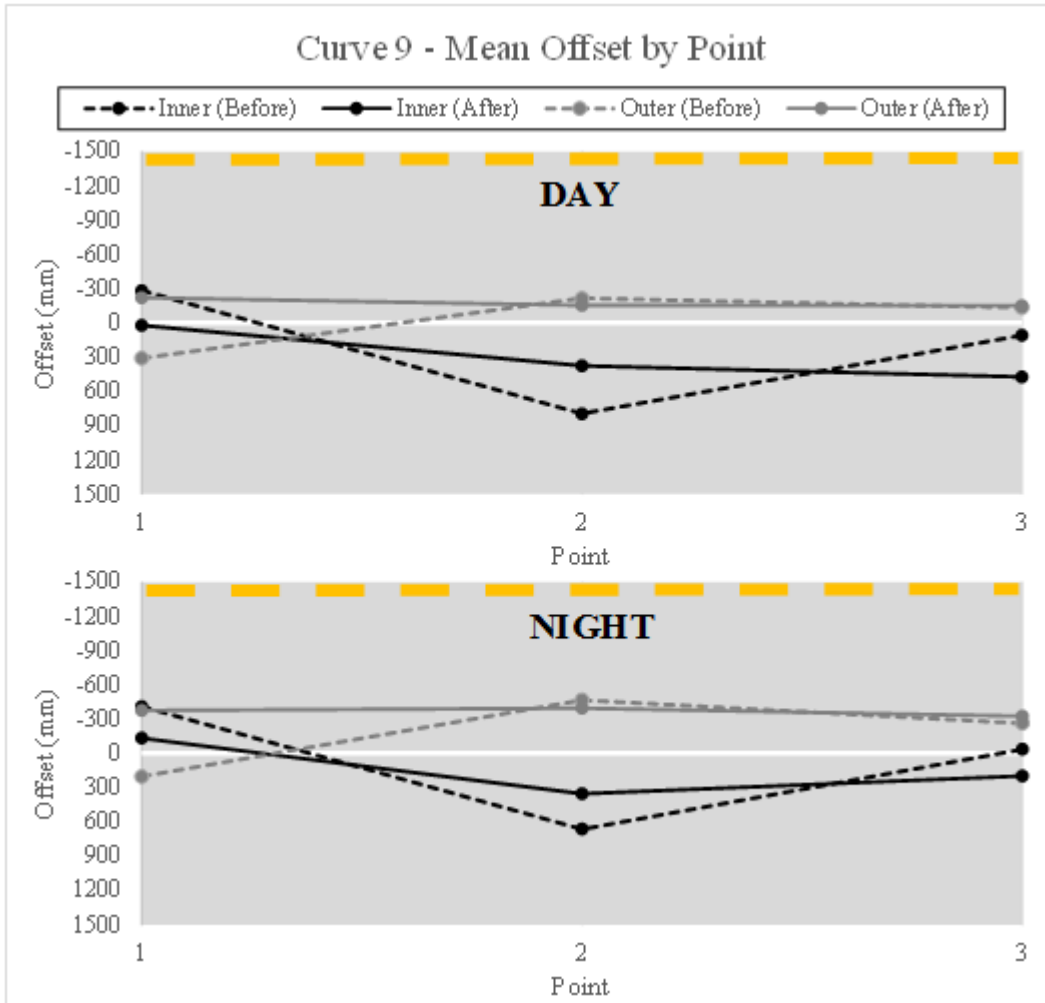
Figure 15. Curve 9 - Mean offset by point

For the inner lane, the mean offset was closer to the center of the lane at points 1 and 2 following the installation of the reflective posts, but was slightly further from center at point 3. For traffic in the outer lane, the offset was shifted left at point 1, but virtually unchanged at points 2 and 3. The mean offset for both lanes was more consistent through the curve following the installation of the reflective posts.

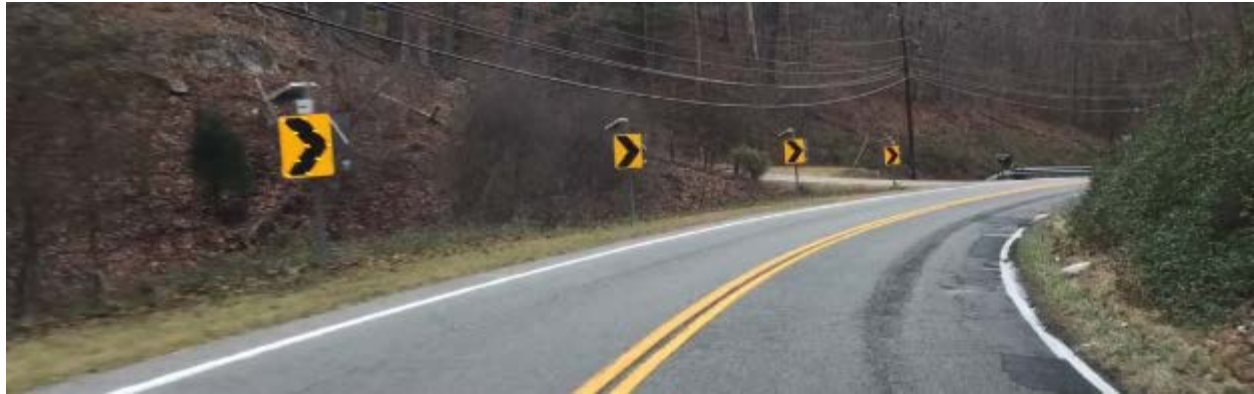
Figure 16. Curve 2 treatment – sequentially flashing chevrons

There was no existing treatment for curve 2 other than a Winding Road sign upstream of the curve. The new treatment consisted of four chevron signs with LEDs around the perimeter of the chevrons that flashed in sequence when an approaching vehicle was detected by radar (Figure 16). This treatment was bidirectional. The distance from the point of curvature to the first chevron was approximately 30ft for both lanes. The ANOVA results for the human-factors study are shown in Table 10. Values in boldface indicate significant results ($p < 0.05$).

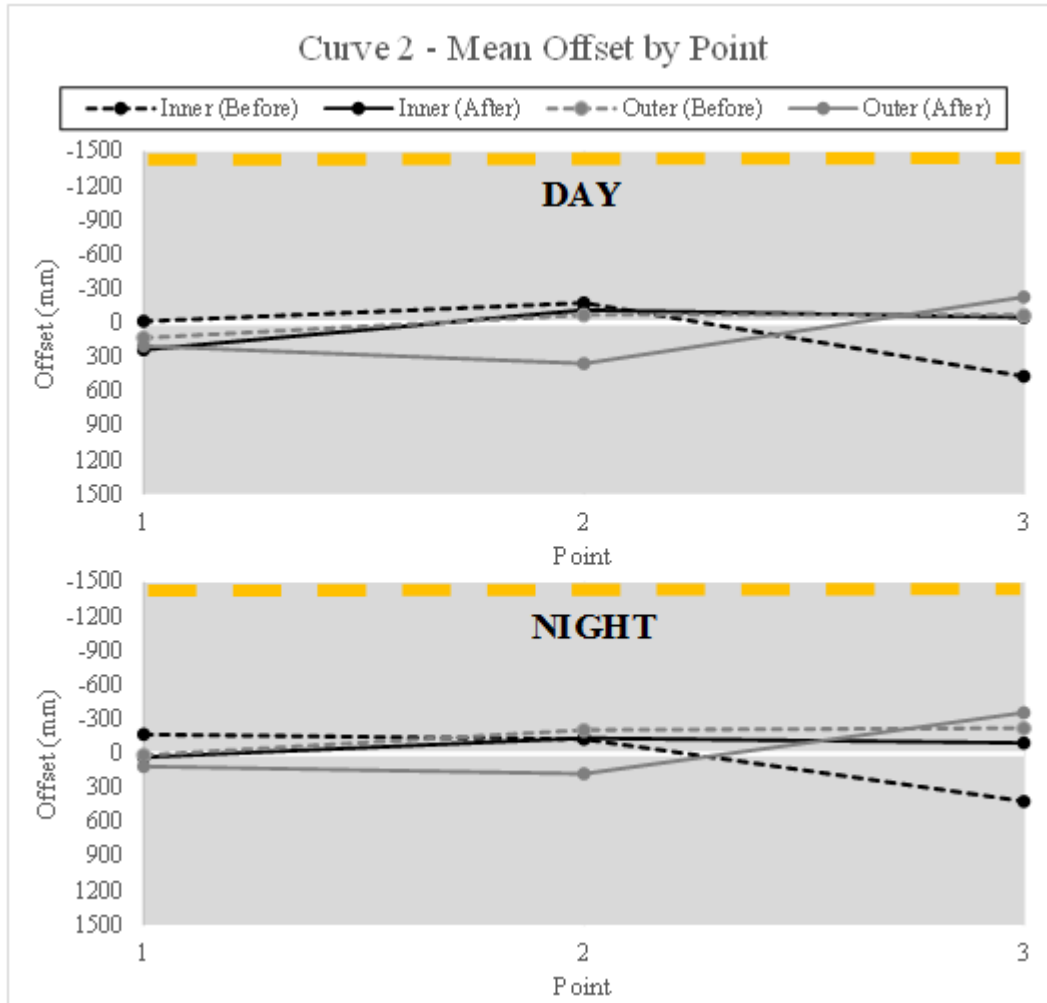
Figure 20. Curve 2 - Mean offset by point

For traffic in the inner lane, the mean offset shifted much closer to the center at point 3 in both daytime and nighttime conditions (Figure 20). Although some of the changes at points 1 and 2 were significant, the differences were very small. The mean offset for traffic in the outer lane shifted further away from the center (toward the right) at point 2, and then further back toward the left at point 3. The sequential chevrons tended to make the offset more consistent for the inner lane traffic, but less consistent for the outer lane traffic.

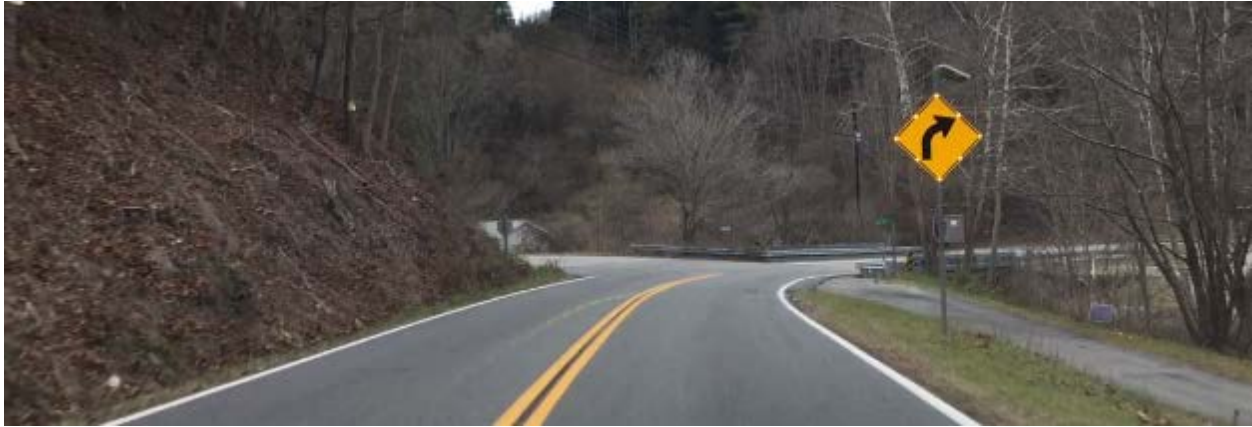
Figure 21. Curve 3 treatment – blinking curve warning sign

There was no existing treatment for curve 3 other than a winding road sign upstream of the curve. The new treatment was a blinking curve warning sign which had LEDs embedded around the perimeter of the sign (Figure 21). When an approaching vehicle was detected, the LEDs would blink continuously. This treatment was only visible from one approach, so only traffic in the inner lane of the curve saw the sign. The distance from the point of curvature to the sign was approximately 50ft. The ANOVA results of the human-factors study are shown in Table 13. Values in boldface indicate significant results ($p < 0.05$).

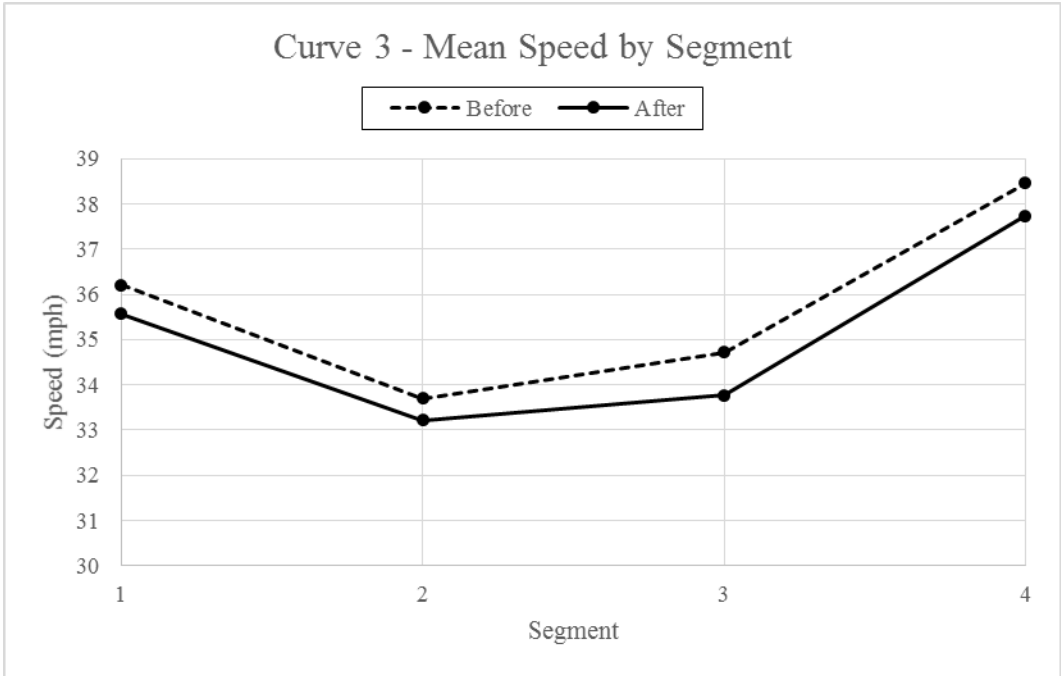
Figure 22. Curve 3 - Mean speed by segment

The mean speed for participants was reduced slightly after the installation of the blinking CWS (Figure 22). However, the difference was only significant in segments 3 and 4 (-1 mph and -0.7 mph, respectively).

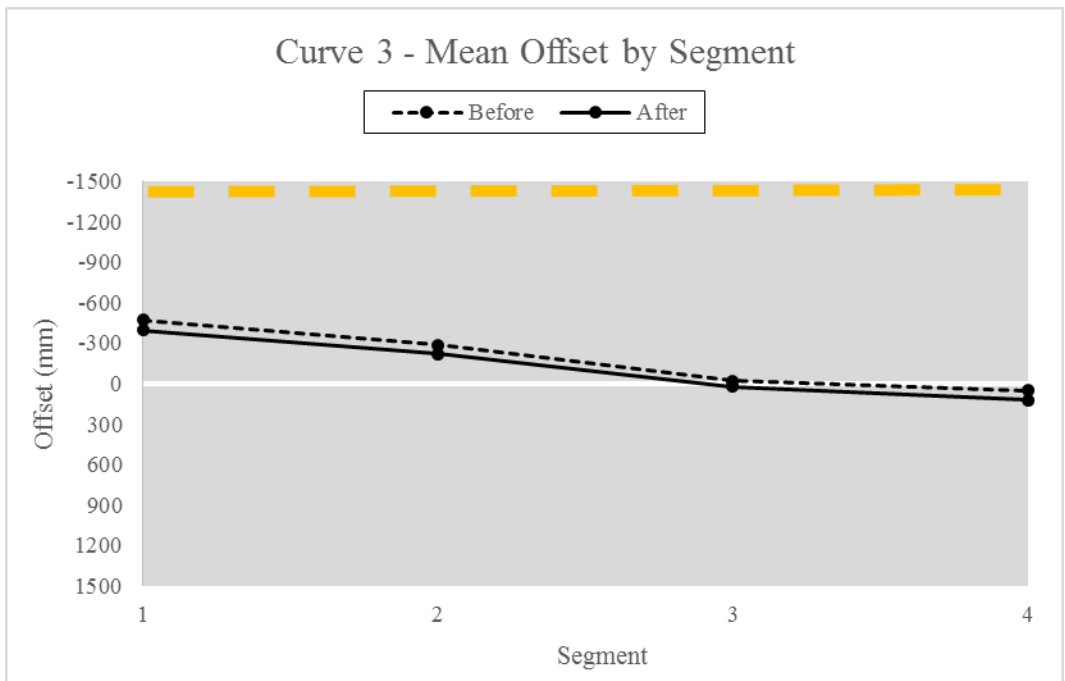
Figure 23. Curve 3 - Mean offset by segment

While the treatment did have a significant effect on the mean offset in segment 2, the difference was only 66 mm (Figure 23). This difference is likely not practically significant, in that the offset is virtually the same, and it would not likely have any impact on the safety of the curve.

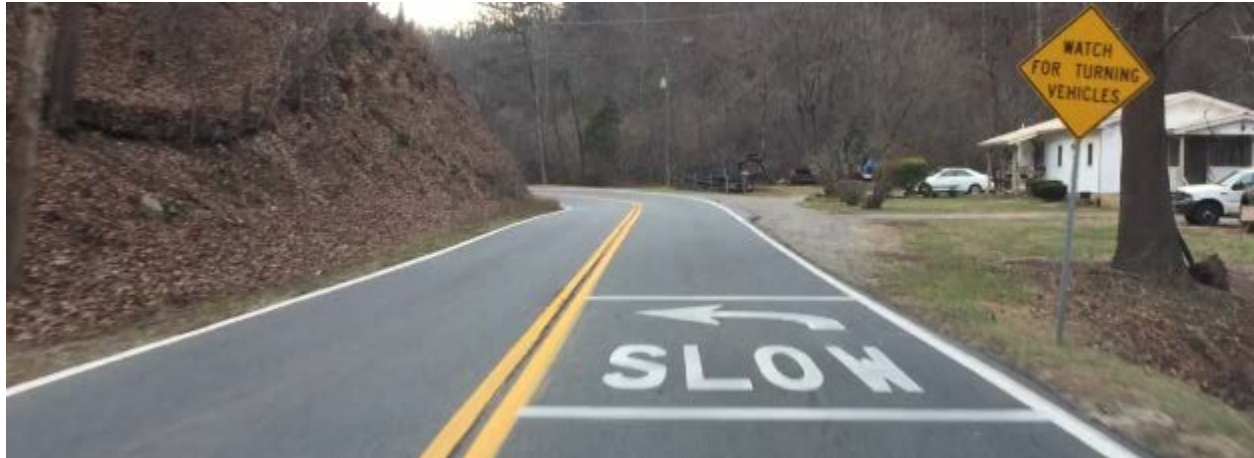
Figure 26. Curve 4 treatment – on-pavement signage

There was no existing treatment for curve 4 other than a winding road sign upstream of the curve. The new treatment consisted of on-pavement signage which included a curved arrow and the word “SLOW” (Figure 26). The treatment was applied in the approach for both sides of the curve. The distance from the OPS to the point of curvature was approximately 167ft in the outer lane, and 115ft in the inner lane. The ANOVA results for the human-factors study are shown in Table 16. Values in boldface indicate significant results ($p < 0.05$).

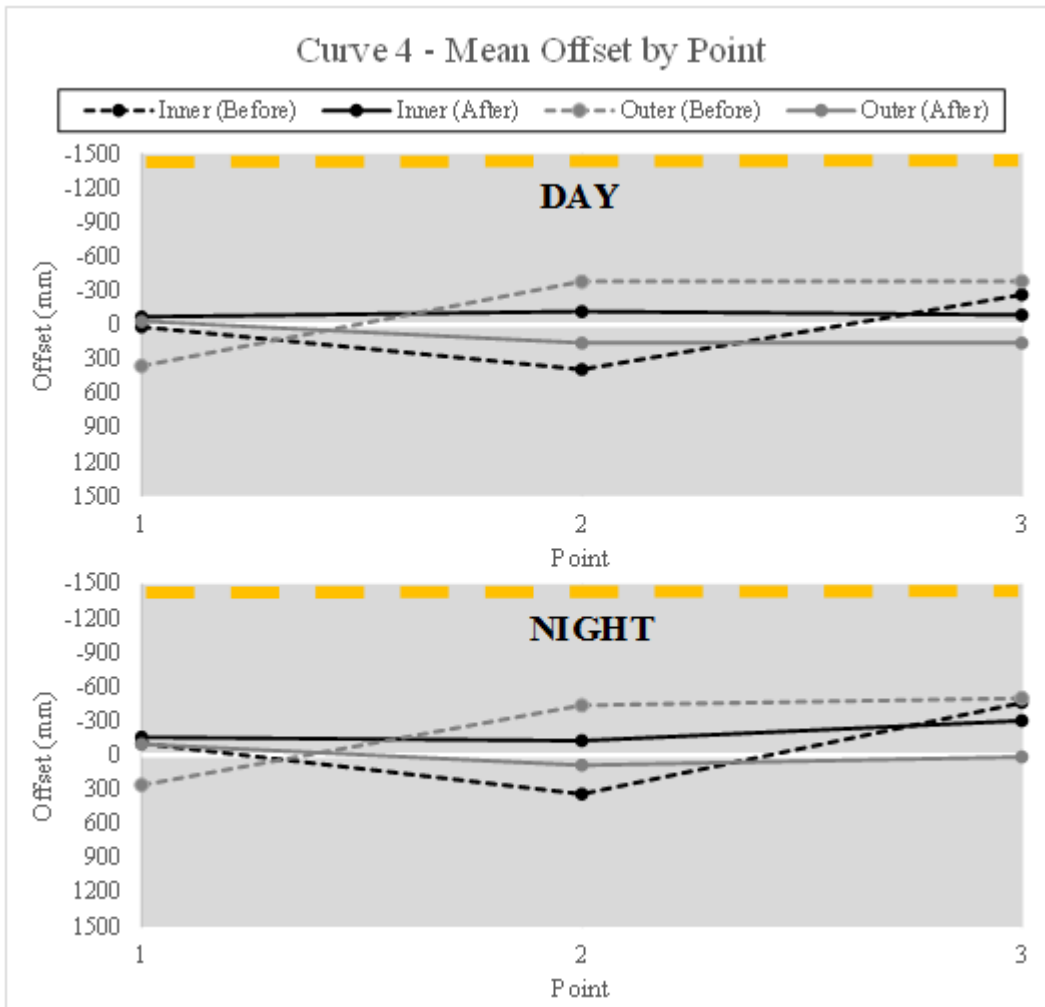
Figure 30. Curve 4 - Mean offset by point

After the installation of the on-pavement signage, the mean offset tended to be closer to the center of the lane for both the inner and outer lanes across day and night conditions (Figure 30). The offset was also more consistent, changing very little from point to point.

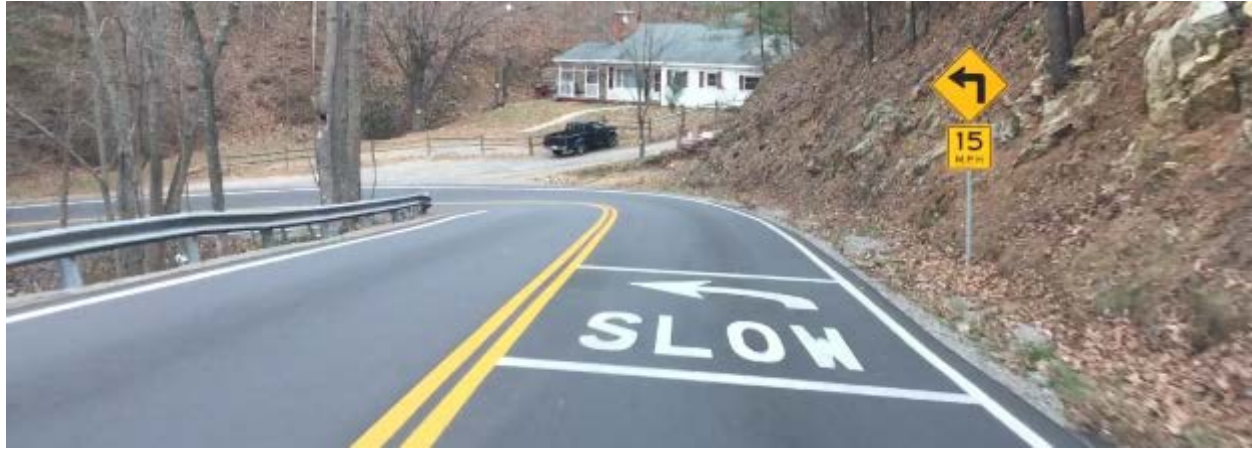
Figure 31. Curve 7 treatment – on-pavement signage

The existing treatments for curve 7 included a CWS on each end of the curve. The new treatment consisted of on-pavement signage which included a curved arrow and the word “SLOW” (Figure 16). The same treatment was applied to both sides of the curve. The distance from the OPS to the point of curvature was approximately 236ft in the inner lane, and 95ft in the outer lane. The ANOVA results for the human-factors study are shown in Table 19. Values in boldface indicate significant results ($p < 0.05$).

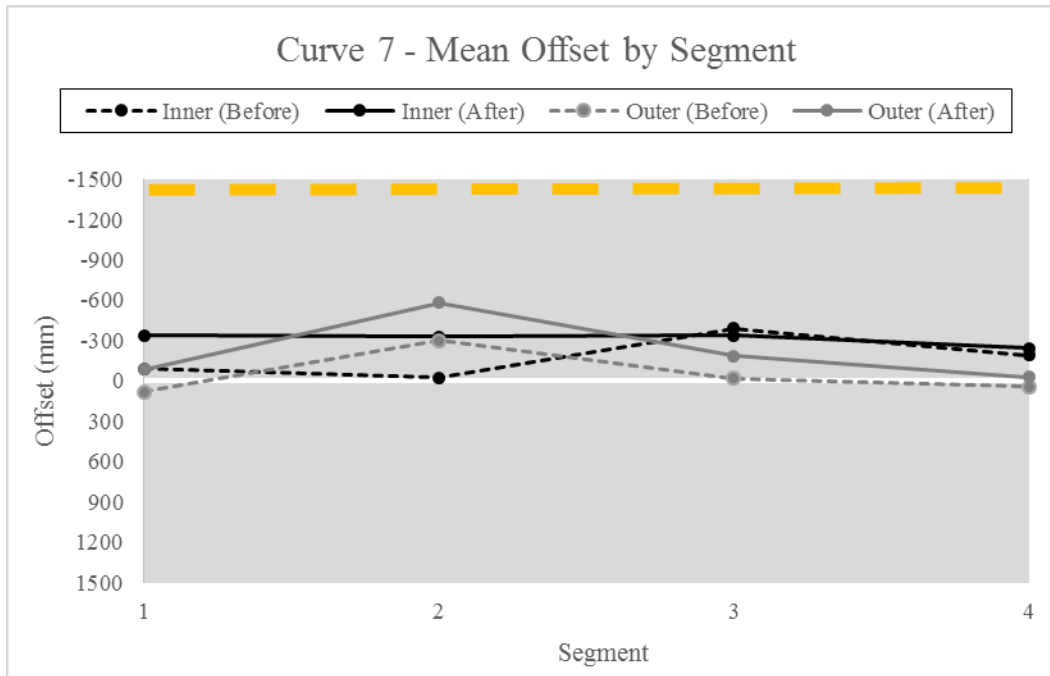
Figure 32. Curve 7 - Mean offset by segment

The treatment did not have a significant effect on speed in this curve. Significant effects were found for offset in segment 1 of both lanes. The mean offset shifted 245 mm to the left for participants in the inner lane, and 163 mm to the left for participants in the outer lane (Figure 32). There were larger differences in the mean offset in segment 2; however, these were not statistically significant.

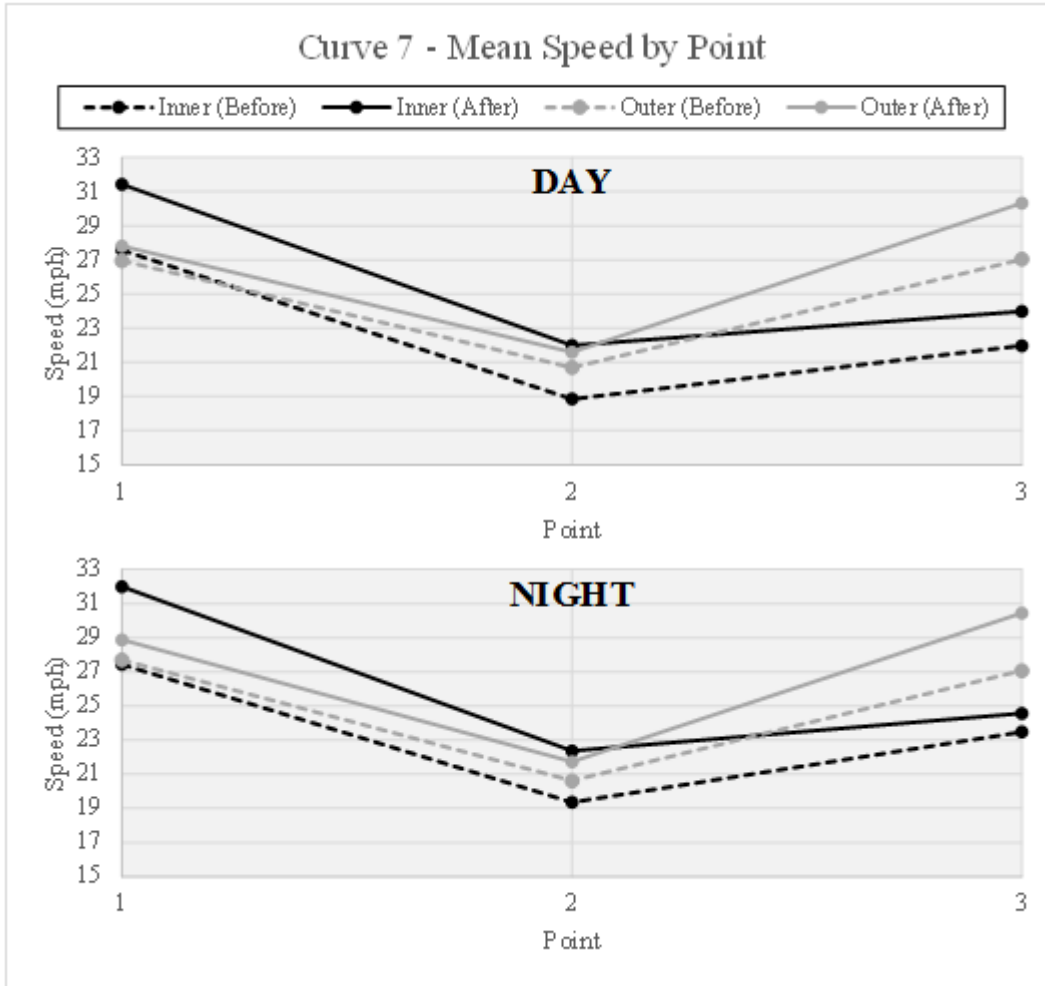
Figure 33. Curve 7 - Mean speed by point

The mean speed increased at all points for both lanes, in both day and night conditions (Figure 33). Across all points, and day and night conditions, the average increase in speed was 2.9 mph for the inner lane, and 1.8 mph for the outer lane.

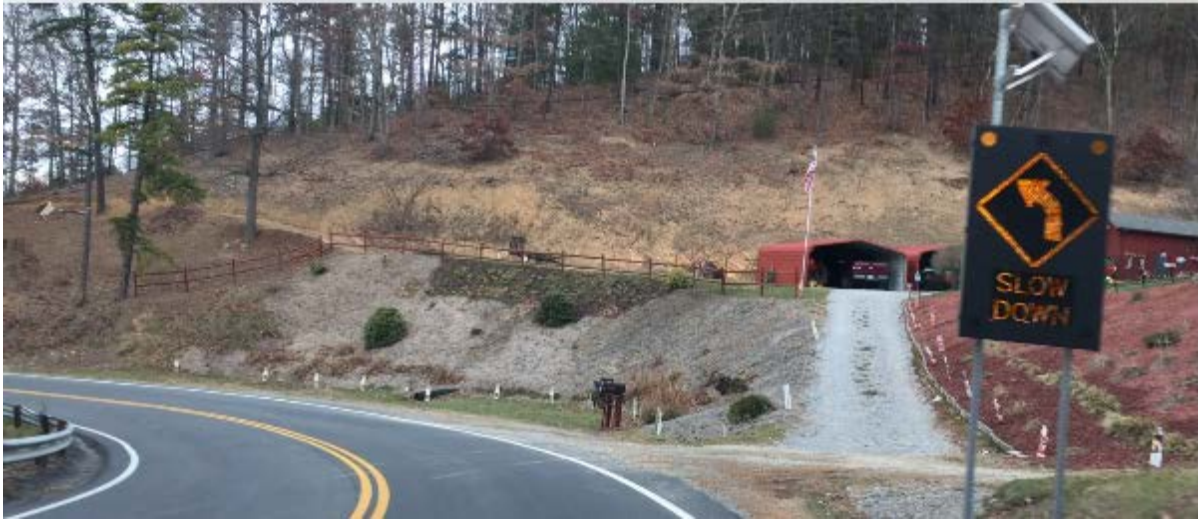
Figure 35. Curve 5 treatment – dynamic curve warning sign

There was no existing treatment for curve 5 other than a winding road sign located upstream of the curve. The new treatment consisted of a DCWS which activated when a vehicle was detected driving faster than the advisory speed. When activated, the sign consisted of two flashing dots, a curve sign, and a “SLOW DOWN” message (Figure 35). This treatment was only applied to one side of the curve, so it was only visible for vehicles travelling in the outer lane. The distance from the point of curvature to the sign was approximately 20ft. The ANOVA results for the human-factors study are shown in Table 22. Values in boldface indicate significant results ($p < 0.05$).

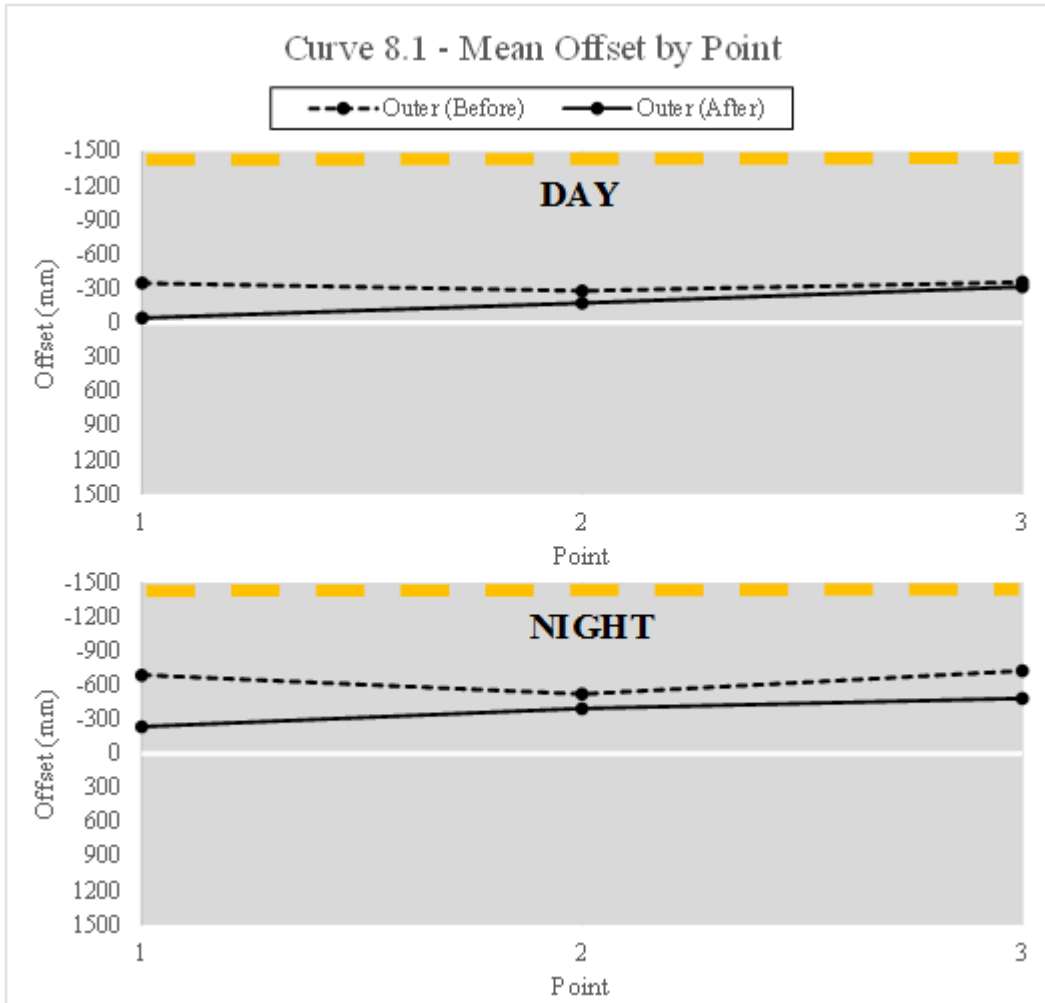
Figure 41. Curve 8.1 - Mean offset by point

The addition of the DCWS caused the mean offset to shift closer to the center of the lane for both day and night conditions, though the offset was closest to the center during the day (Figure 41). The offset was also consistent throughout the curve for each condition, with very little change from point to point.
