# **Salt Brine Blending to Optimize Deicing and Anti-Icing Performance and Cost Effectiveness: Phase III**

Center for Transportation Research and Implementation  
Minnesota State University, Mankato

Research Project  
Final Report 2017-45

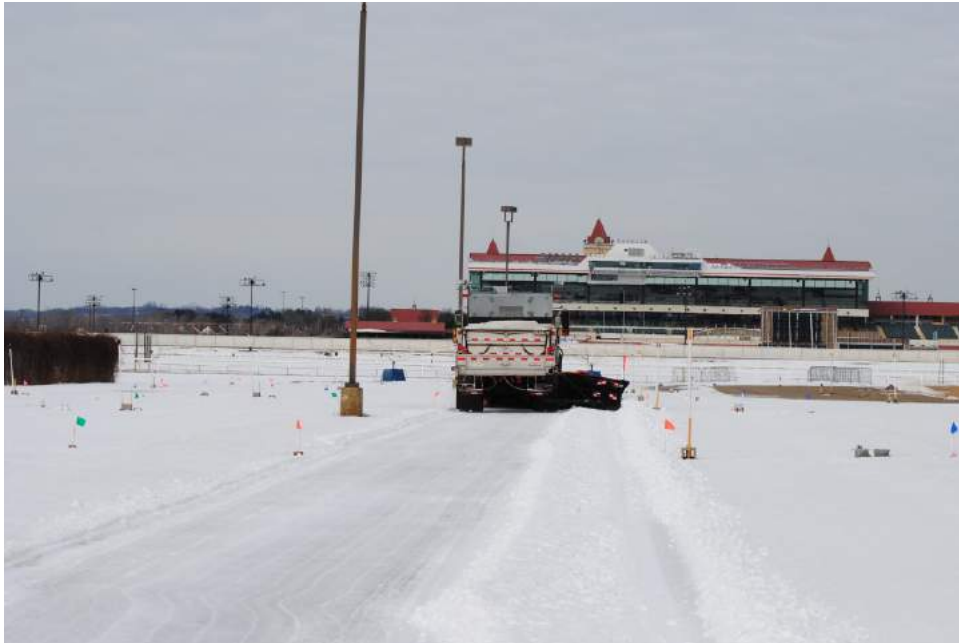
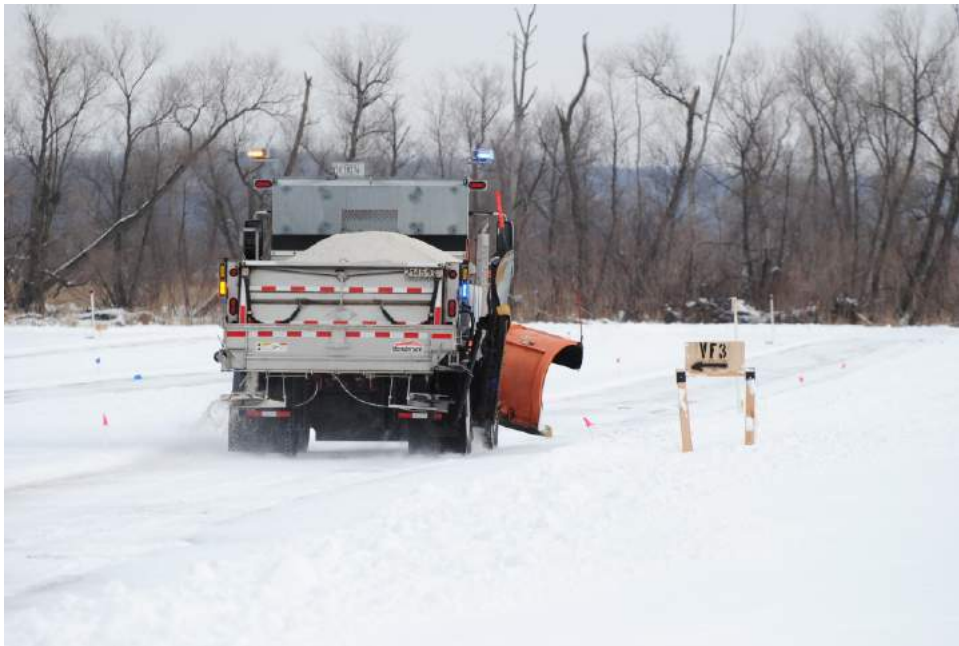
Figure 1 Test areas: Canterbury Park (top) and ValleyFair! (bottom).

- Canterbury Park, 1100 Canterbury Road; in the stable area parking lot on the south side of the facility, adjacent to 12<sup>th</sup> Avenue East and 0.3 mile west of Canterbury Road South.
- ValleyFair!, One Valley Fair Drive; in the back (north) parking lot on the north east corner of the facility, located north of TH 101 about 2.5 miles west of US 169.

Shakopee was targeted for project field sites to provide locations accessible both to researchers from Minnesota State, Mankato and maintenance personnel of MnDOT Metro District, with potential for additional access by maintenance personnel of other nearby MnDOT Districts or volunteer municipal or county departments of public works. Pavement lanes were set up in Shakopee at two locations with large parking lots not typically used during winter months:

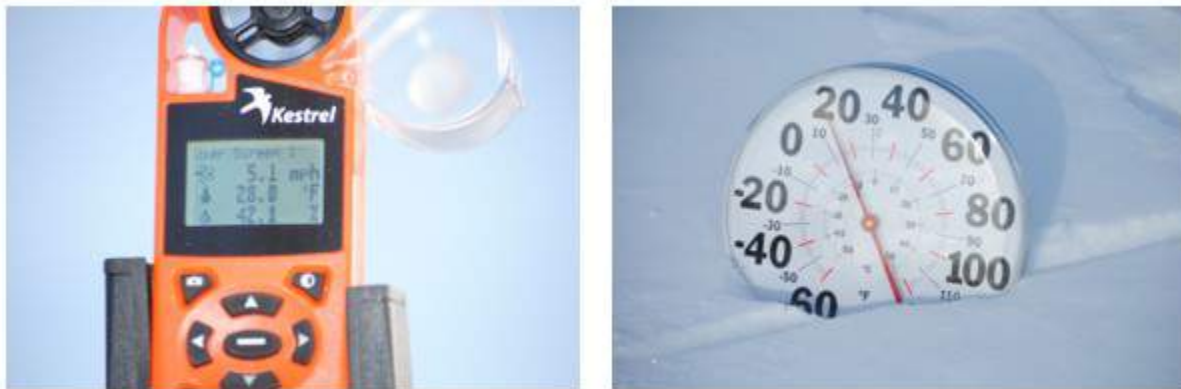
**Figure 2 Weather monitoring tools: handheld weather station; dial thermometer.**

A Kestrel 4000 handheld weather station (Nielsen-Kellerman, Boothwyn, PA), capable of determining temperature, relative humidity, dew point and wind speed, was used to determine conditions during field operations (Figure 2a). A dial thermometer (Figure 2b) was used for illustration and photographic documentation, but was not considered sufficiently accurate to represent field conditions. Weather measurements were primarily made using National Weather Service data obtained from Flying Cloud Airport, Eden Prairie, Minnesota, approximately 2 miles north of either field site (documentation during 2015-16 was from a paid subscription to WeatherSpark.com).

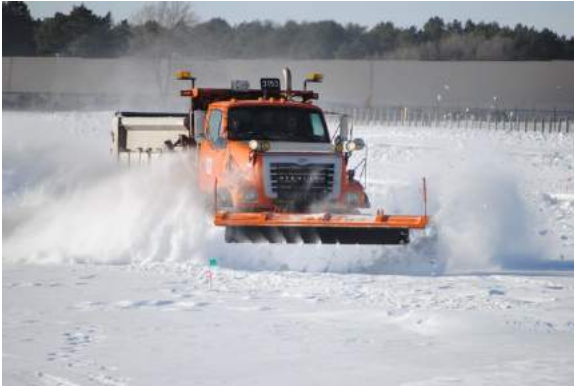
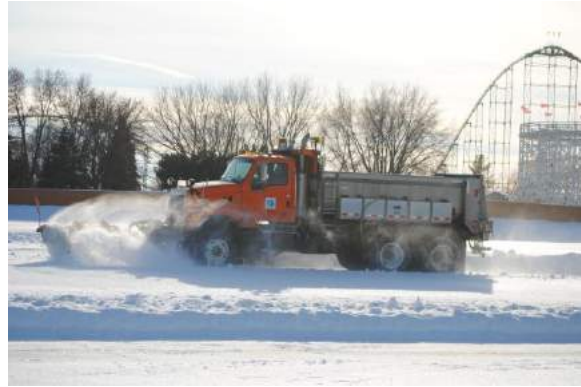
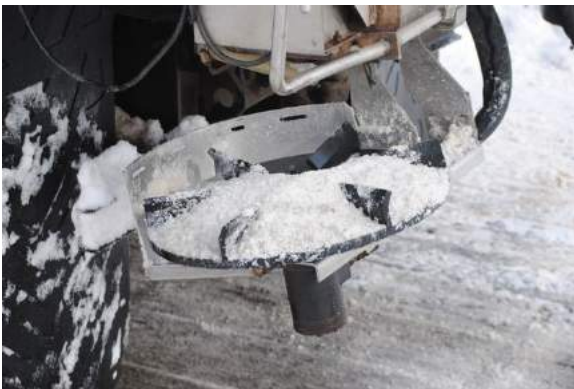
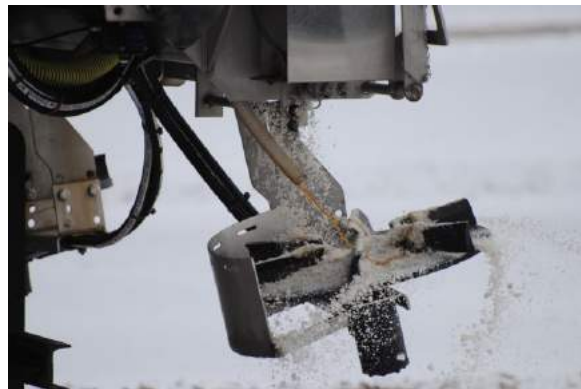
a) MnDOT tandem axle dump truck with front and right wing plows engaged.

b) MnDOT truck with saddle tanks for prewet fluid.

c) Salt distributor behind left rear wheel (not in motion/not being fed deicer at time of photo).

d) Prewet flow and deicer drop onto salt distributor (in motion at time of photo).

**Figure 4 Plow and deicer equipment on a MnDOT truck used for this study.**

Typical highway speed distribution equipment was a 2006 Sterling tandem axle, automatic transmission dump truck with front, right wing and underbody plows (Figure 4a). Side mounted (saddle) tanks were used to carry brine materials used for prewetting granular deicer (Figure 4b). A transverse auger was mounted in the rear of the dump body to feed deicer either to the left or right chute. Granular deicer was maintained in contact with the auger by frequent plow body raising such that the granular deicer would shift to the back of the plow body where the auger was located. Deicer would fall through the chute to a distributor (spinner) plate (Figure 4c). Prewet was poured via gravity onto the granular deicer when on the distributor plate (Figure 4d). The distributor plate rotated when the truck was in forward motion, spreading deicer rather than having a straight drop (Figure 5). Note that Metro District deicer application equipment on board trucks was calibrated at the start of the 2015-16 season, according to the maintenance staff.

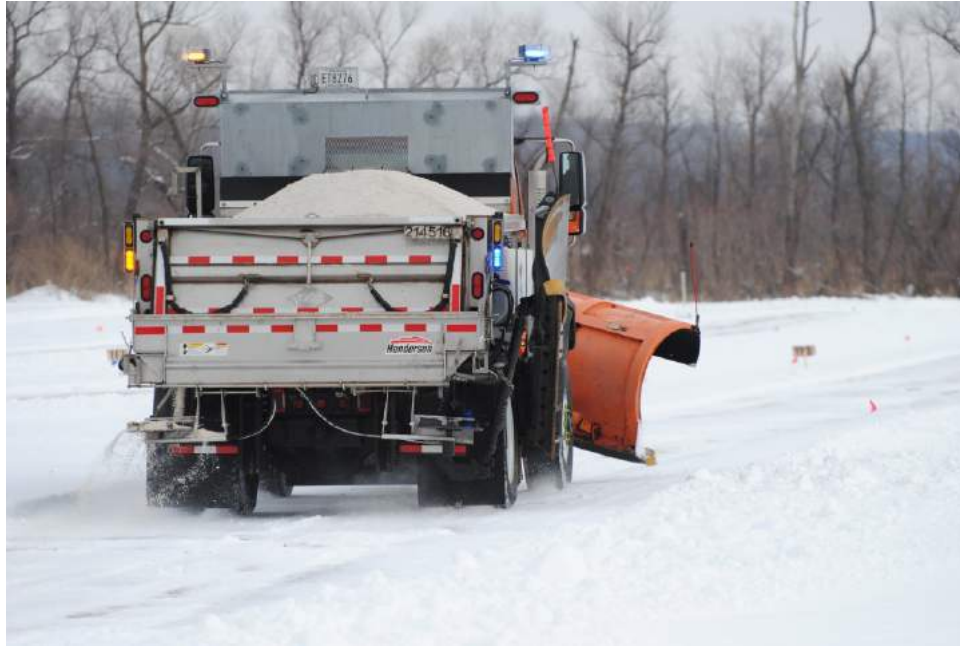
**Figure 5 MnDOT truck spreading deicer off left rear while moving forward on a lane where plowing was done previously by another truck.**

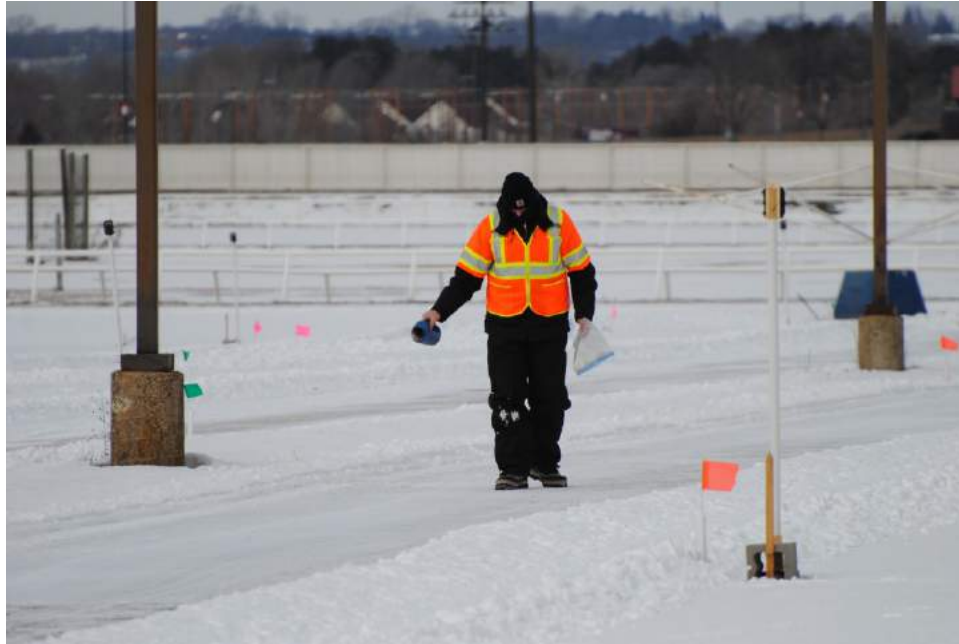
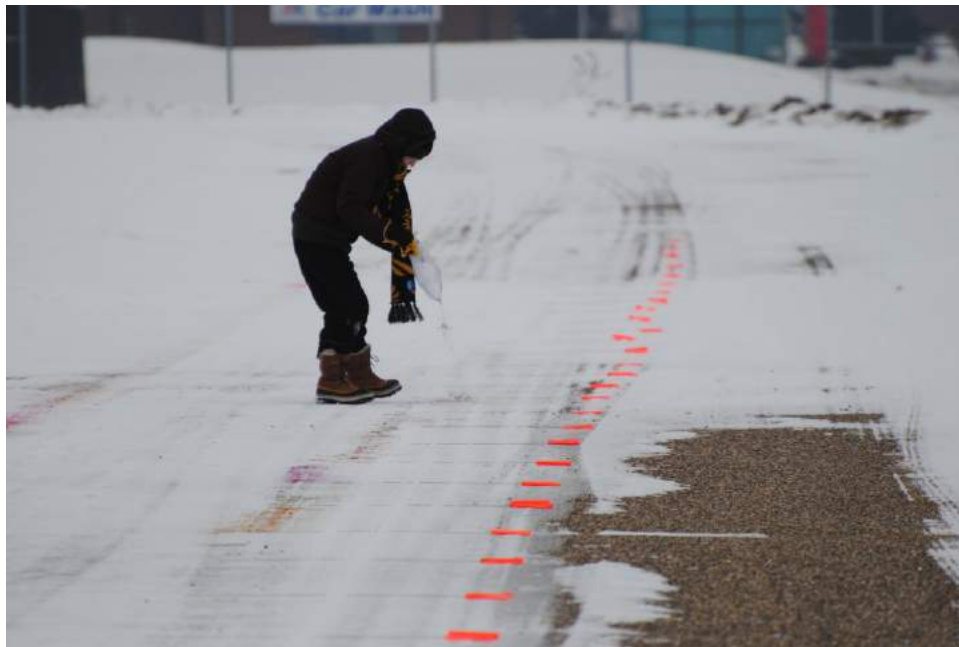
**Figure 6 Distribution of deicer on marked areas: full lane width treatment (top); and compacted wheel track treatment (bottom).**

Hand application of deicers was done by a researcher on foot shaking out deicer over a premeasured and marked area, either a 53 ft lane length (i.e., 1% of a lane mile) or a 5 ft long compacted wheel track (Figure 6). For the full lane width treatment, distribution was through a plastic shaker with a wide top that had holes in it. For the compacted wheel track, distribution was out of a small polyethylene bag. Premeasured amounts of deicer, massed in the laboratory and brought to the test facility in a polyethylene bag, were treated with a measured amount of a prewet (if needed) just prior to distribution (Figure 7).

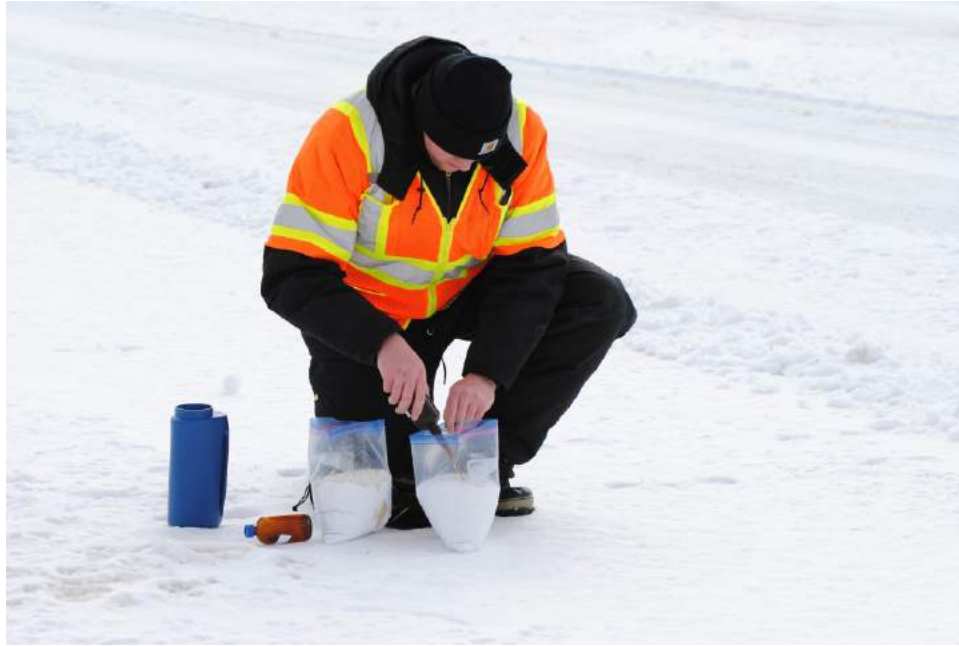
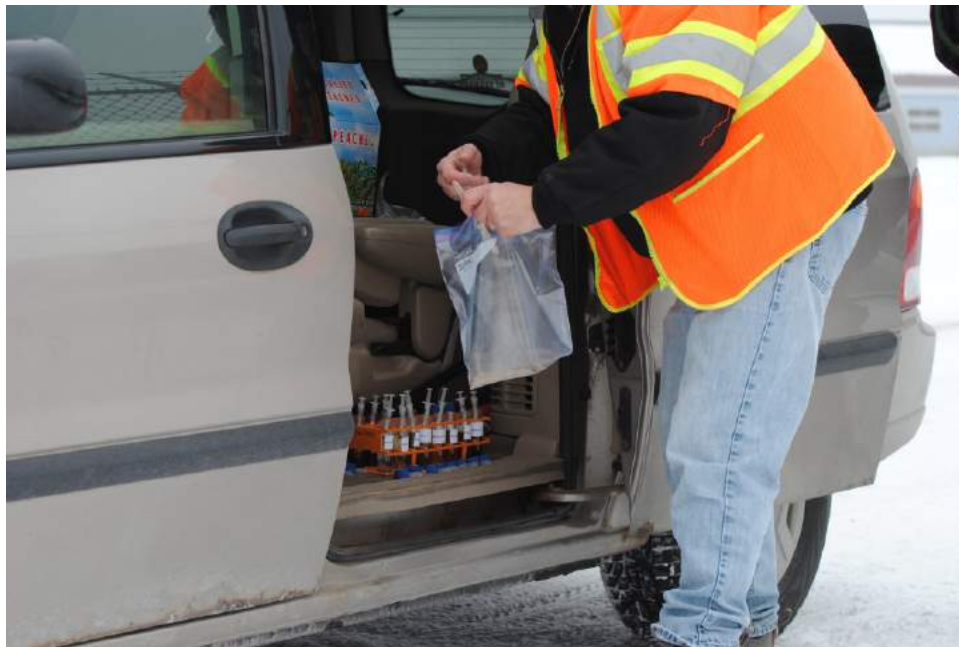
**Figure 7 Application of prewet to premeasured amount of deicer: full lane width treatment using a 500 mL bottle as container of premeasured prewet (top); and compacted wheel track treatment using a 3 mL disposable syringe to field-measured the amount of prewet**

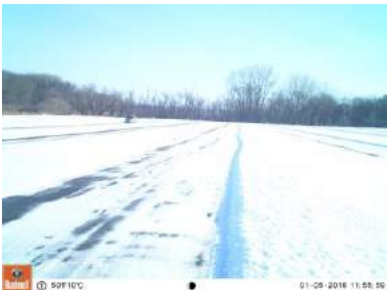
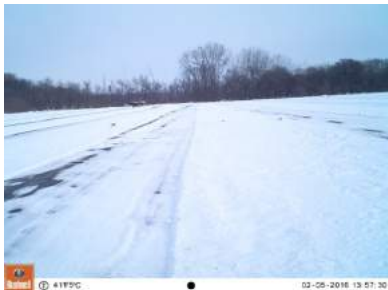
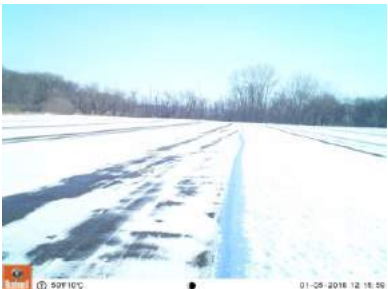
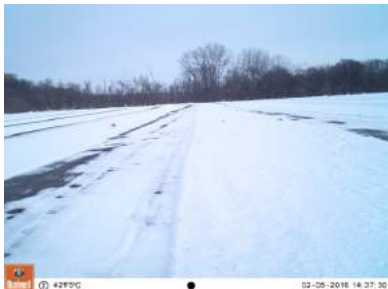
**Table 10 Comparison of deicing over two times and two temperatures.**

(Appendix B and Table 10). Slight openings of pavement can be seen at 10 minutes after application at both temperatures. Enlargement of the open pavement can be observed occurring at 20 minutes after application in both temperatures, and the wheel lanes under the rock salt distribution point is mostly ice free. By 60 minutes after application, a broad area of the lane is open and exposed, with the warmer (28° F) temperature having a moderately larger open area than the colder (22° F) temperature day, matching the behavior expected with a higher ice melt capacity at the warmer temperature.

| Time after deicer application | 28°F<br>(1/05/2016) | 22°F<br>(2/05/2016) |
|---|---|---|
| Notes: Deicer application of 600 lbs/LM rock salt with 15 gal/ton prewet of RG8 10% (salt brine 90%) applied at the point of distribution. No traffic application on test lanes shown. | | |

The temperature and melt time behavior of these two applications suggests that the test conditions of the field evaluation are coherent with and sufficiently model laboratory conditions, validating the experimental approach of this work.

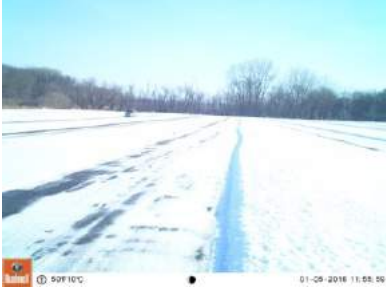
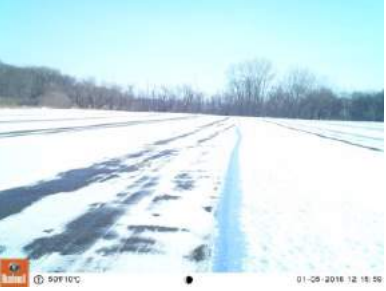
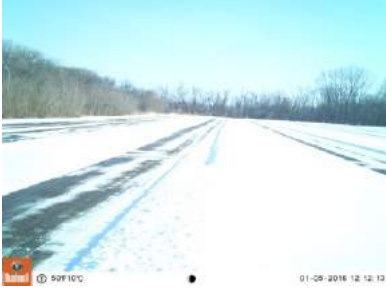
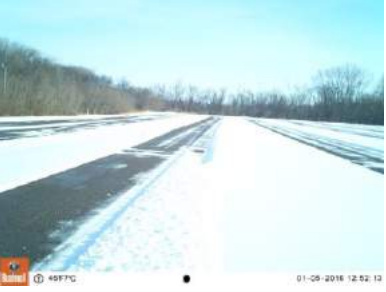
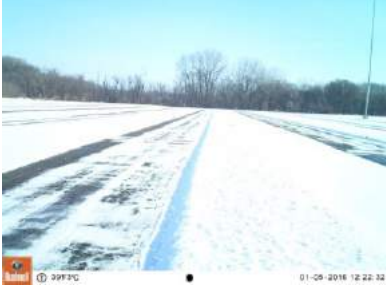
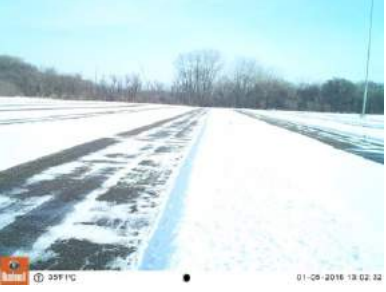
**Table 12 Comparison of deicing over two times by traffic application; January 5, 2016 at 28°F**

Results for no traffic, car traffic, and truck traffic are summarized in Table 12 for January 5<sup>th</sup> at 28° F and Table 13 for February 5<sup>th</sup> at 22° F, at 20 minutes and 60 minutes after traffic completion as these times appear best representative of the melting process for the test temperatures. At 28° F, both truck traffic at three passes and car traffic at five passes substantially increase the melting compared to the no traffic condition. At 22° F, the improvement is less dramatic but can still be seen. Twenty-minute results show larger initial openings and more open area connectivity, while sixty-minute results show broad areas of melting relating to the tire track areas and subsequent down-gradient drainage.

| Lane and traffic condition | 20 minutes after traffic application | 60 minutes after traffic application |
|---|---|---|
| <p>Notes: Deicer application of 600 lbs/LM rock salt with 15 gal/ton prewet of RG8 10% (salt brine 90%) applied at the point of distribution.</p> | | |

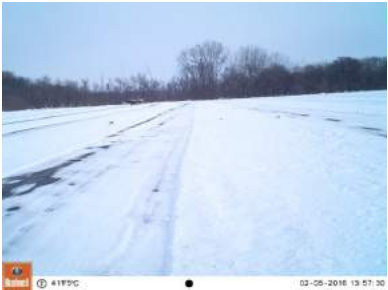
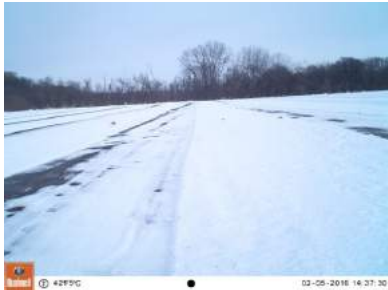
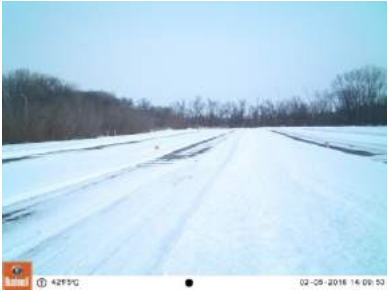
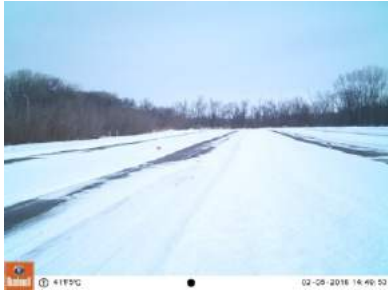
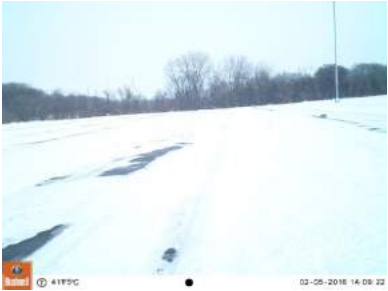
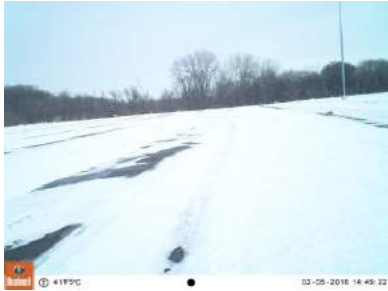
**Table 13 Comparison of deicing over two times by traffic application; February 5, 2016 at 22°F**

| Lane and traffic condition | 20 minutes after traffic application | 60 minutes after traffic application |
|---|---|---|
| Notes: Deicer application of 600 lbs/LM rock salt with 15 gal/ton prewet of RG8 10% (salt brine 90%) applied at the point of distribution. | | |

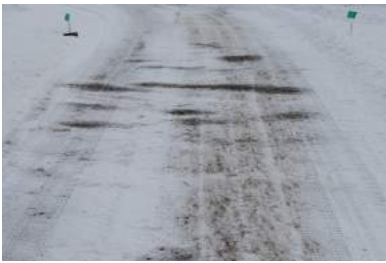
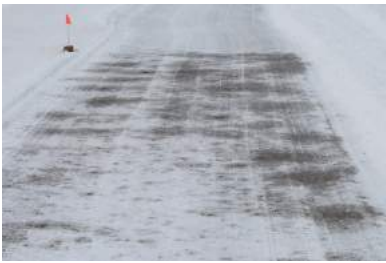
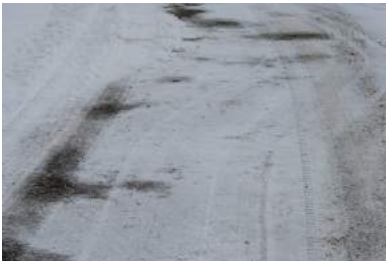
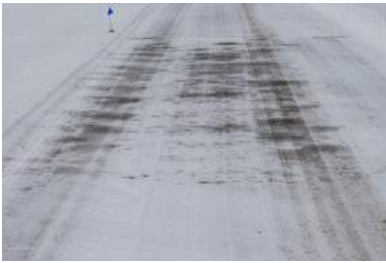
**Table 15 Comparison of deicing by rock salt over conditions of prewetting and traffic; February 11, 2016 at 11°F**

Prewet is reportedly applied to solid deicer to bring about a quicker initiation of melting and to hold the deicer onto the roadway surface during windy conditions. Prewet effects were evaluated by comparing sections of pavement treated with prewetted (RG8 10% at 15 gal/ton) solid deicer to sections of pavement treated with plain solid deicer with both no traffic and traffic (five passes of a car). Deicer was hand-applied by distribution from a shaker across a full lane-width and along a defined lane distance to approximate a 600 lb/LM treatment rate. The tests were performed February 11<sup>th</sup> at 11° F temperature under an overcast sky.

| Traffic Condition | No Prewet Applied | Prewet Applied |
|---|---|---|
| Notes: Deicer application of 600 lbs/LM rock salt with 15 gal/ton prewet of RG8 10% (salt brine 90%) applied at the point of hand distribution. Photographs taken approximately 60 minutes after deicer and traffic application. | | |

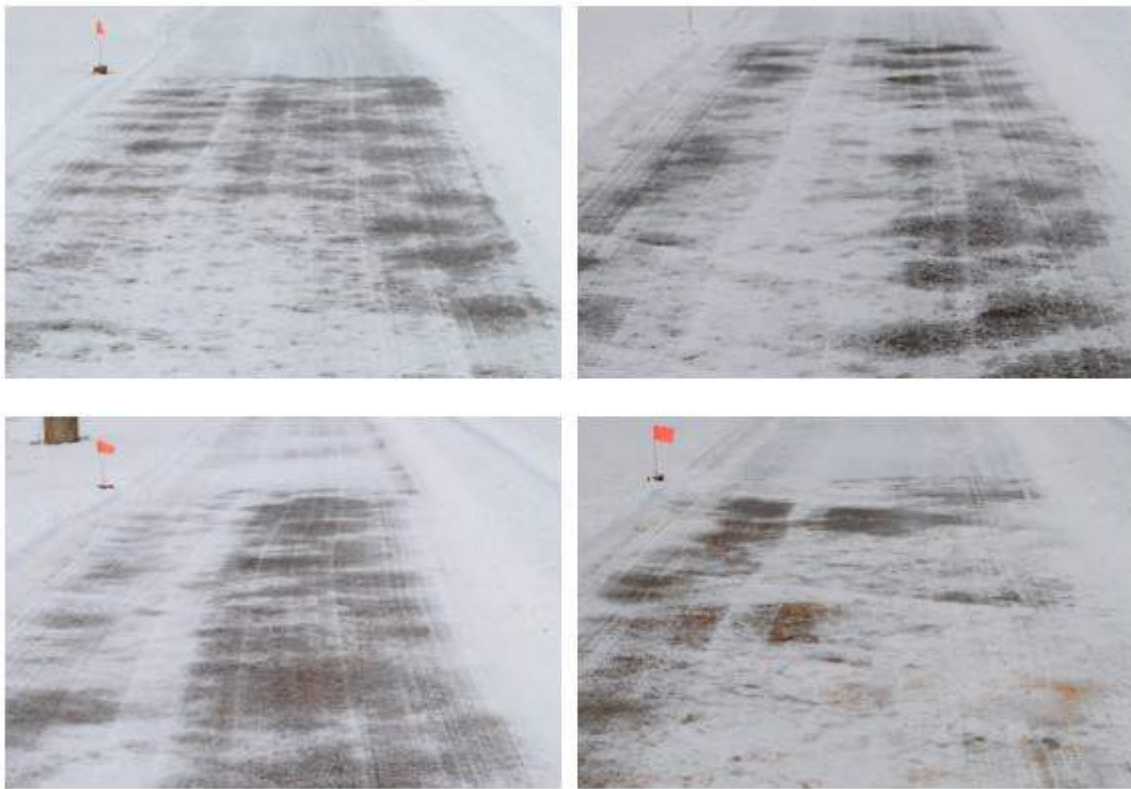
**Figure 8 Pavements treated at 600 lbs/LM of different deicer solids with 15 gal/ton prewet of RG8 10% (90% salt brine) applied at the point of hand distribution: rock salt (top left), magnesium chloride (top right), calcium chloride (bottom left), and Ice Slice**

No matter the material and the associated activity, prewet appears to improve the melt activity shown by the amount of area with undercutting on the test section (comparing Figures 11 and 12). Contrasts of the materials demonstrate much less difference, in spite of the range of ice melt capacities from rock salt to the other materials.

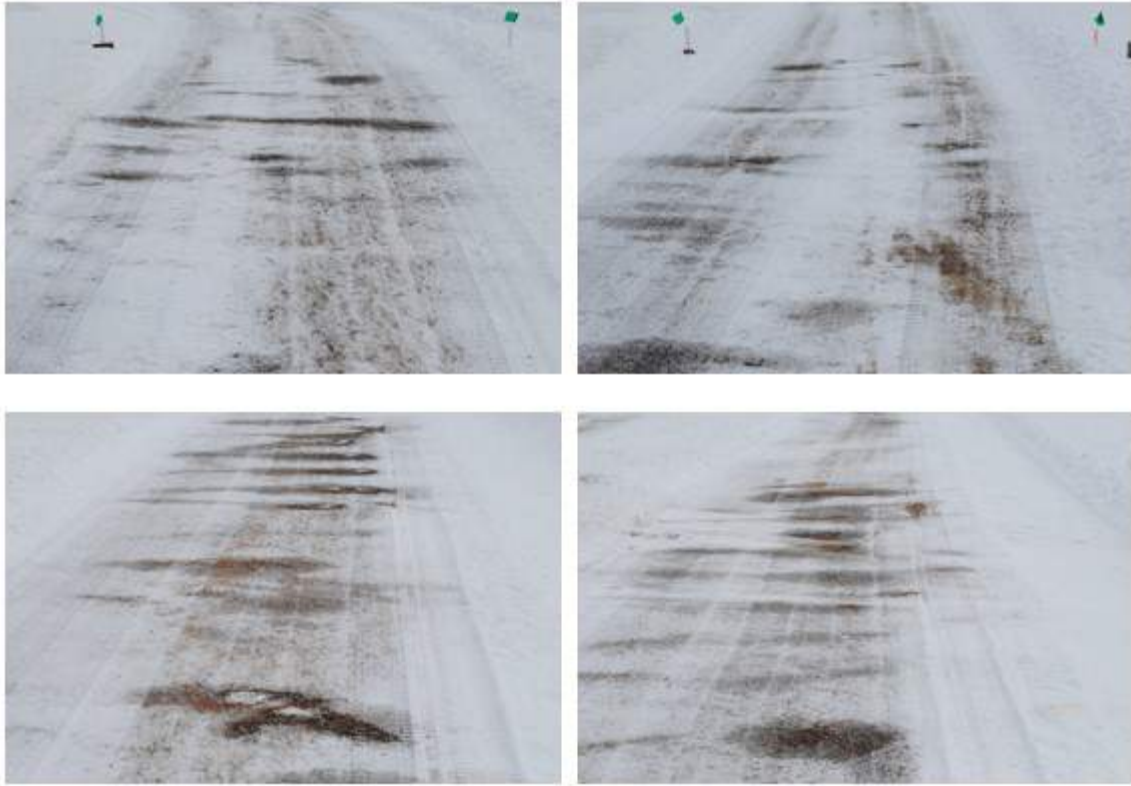
**Figure 9 Pavements treated at 600 lbs/LM of different deicer solids with no prewet: rock salt (top left), magnesium chloride (top right), calcium chloride (bottom left), and Ice Slicer (bottom right). No traffic application. Photographs taken approximately 60**

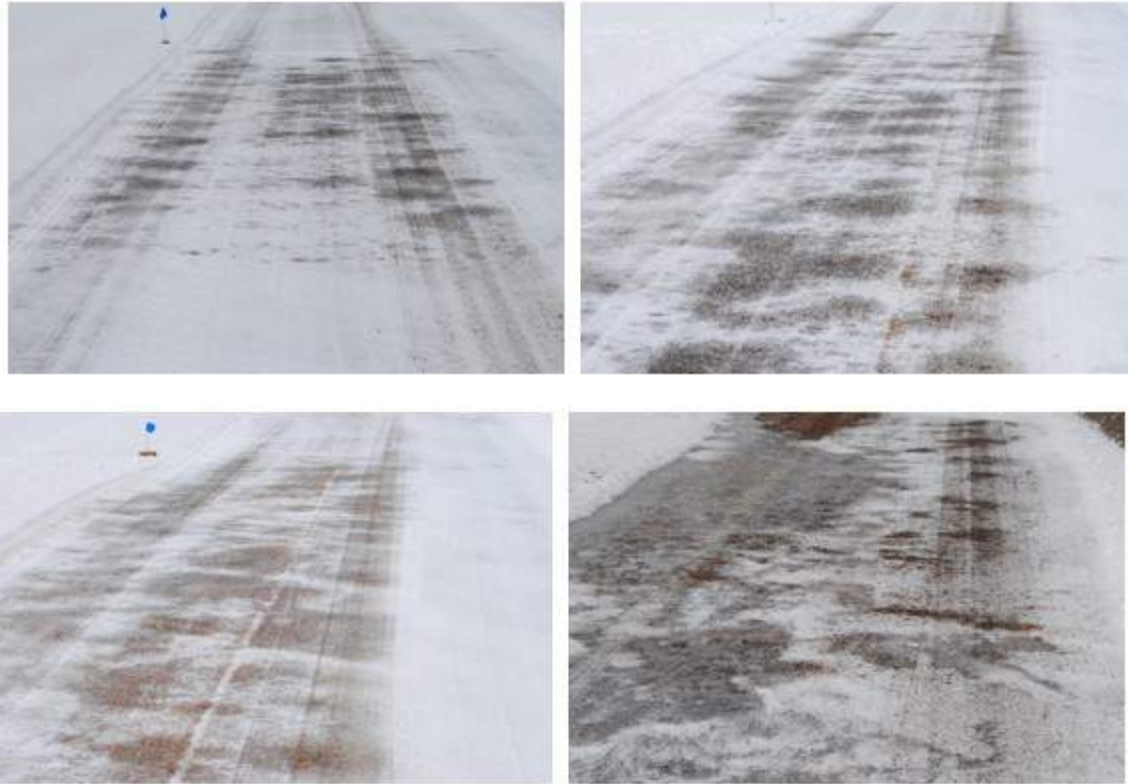
**Figure 10 Pavements treated at 600 lbs/LM of different deicer solids with 15 gal/ton prewet of RG8 10% (90% salt brine) applied at the point of hand distribution: rock salt (top left), magnesium chloride (top right), calcium chloride (bottom left), and Ice Slice**

Because ice melt capacity degrades with lower temperature, solar effects causing warming of deicer materials could have a substantial benefit to deicing operations. Open pavements are typically observed to be about 10° F warmer than the surrounding compacted snow, when exposed to midday sun on a clear day. If the sun could similarly warm the individual deicer grains, if dark in color, either naturally or because of an applied prewet, deicing could perhaps occur at the ice melt capacity of the temperature of the warmed grain rather than the temperature of the snowpack.

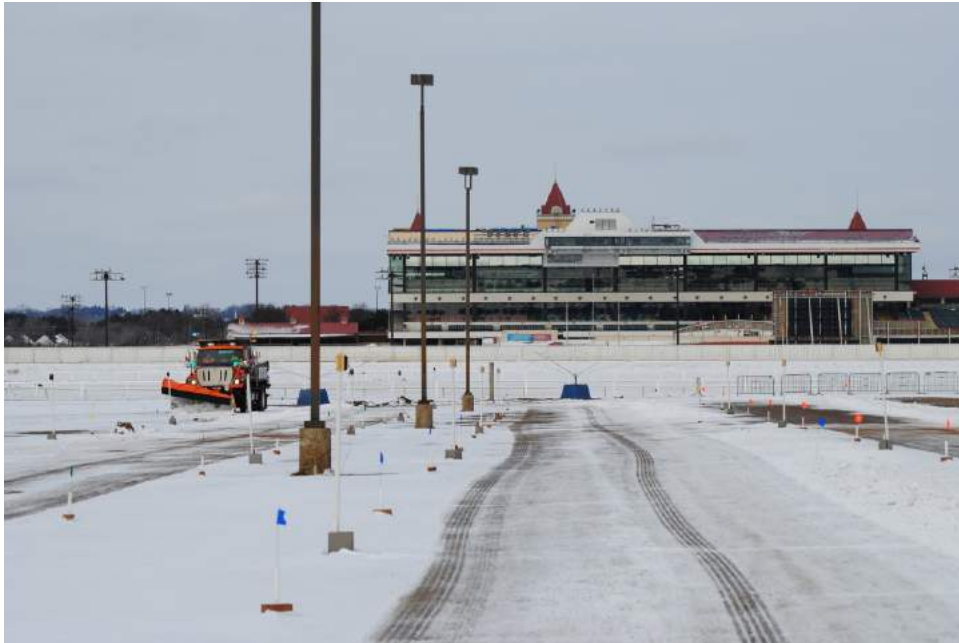
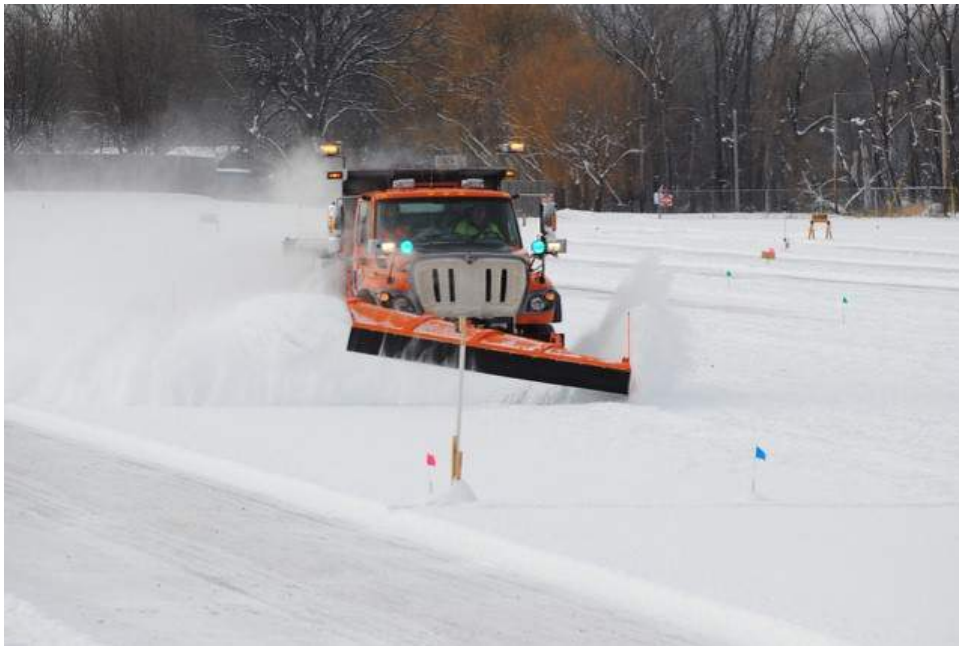
**Figure 11 Test areas: Canterbury Park (top) and ValleyFair! (bottom).**

- Canterbury Park, 1100 Canterbury Road; in the stable area parking lot on the south side of the facility, adjacent to 12<sup>th</sup> Avenue East and 0.3 mile west of Canterbury Road South.
- ValleyFair!, One Valley Fair Drive; in the back (north) parking lot on the north east corner of the facility, located north of TH 101 about 2.5 miles west of US 169.

Access agreements were negotiated and agreed upon during early November, 2016. Prior to a lasting snowfall, researchers with support from MnDOT Metro District maintenance staff performed pavement surveys to locate and document surface discontinuities that could either interfere with or be damaged by plowing. Test lanes were configured to avoid such discontinuities. Lane marking was done with pin flags of various colors; colors were assigned to designate the sides of individual lanes. Pin flags were anchored through 6 in x 3 in x 2 in “sewer” (hollow core) bricks to 8 in x 8 in x ¾ in wooden plates and stabilized by 1 ft lengths of ¾ in diameter Schedule 40 PVC pipe. Anchoring was done to prevent penetration of the pavement by the flags yet maintain the flags in spite of winter winds. Initial lane cuts were made December 12<sup>th</sup>; afterwards flags were reset on measured locations to represent 100-ft stationing along both sides of each lane.

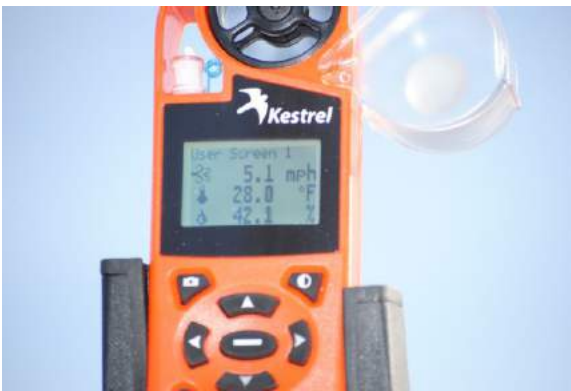
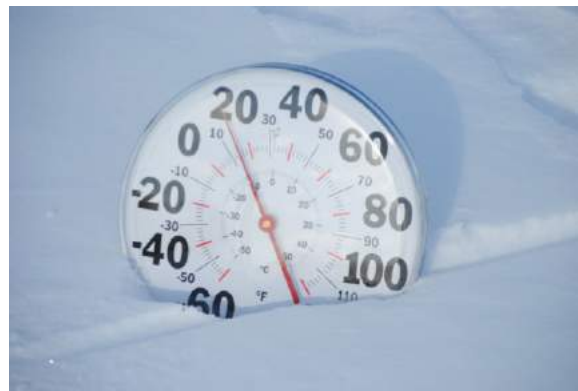
**Figure 12 Weather monitoring tools: handheld weather station; dial thermometer.**

A Kestrel 4000 handheld weather station (Nielsen-Kellerman, Boothwyn, PA), capable of determining temperature, relative humidity, dew point and wind speed, was used to determine conditions during field operations (Figure 12a). A dial thermometer (Figure 12b) was used for illustration and photographic documentation, but was not considered sufficiently accurate to represent field conditions. Weather measurements were augmented with documentation from a paid subscription to WeatherSpark.com, used for interpreting National Weather Service data obtained from Flying Cloud Airport, Eden Prairie, Minnesota, approximately 2 miles north of either field site.

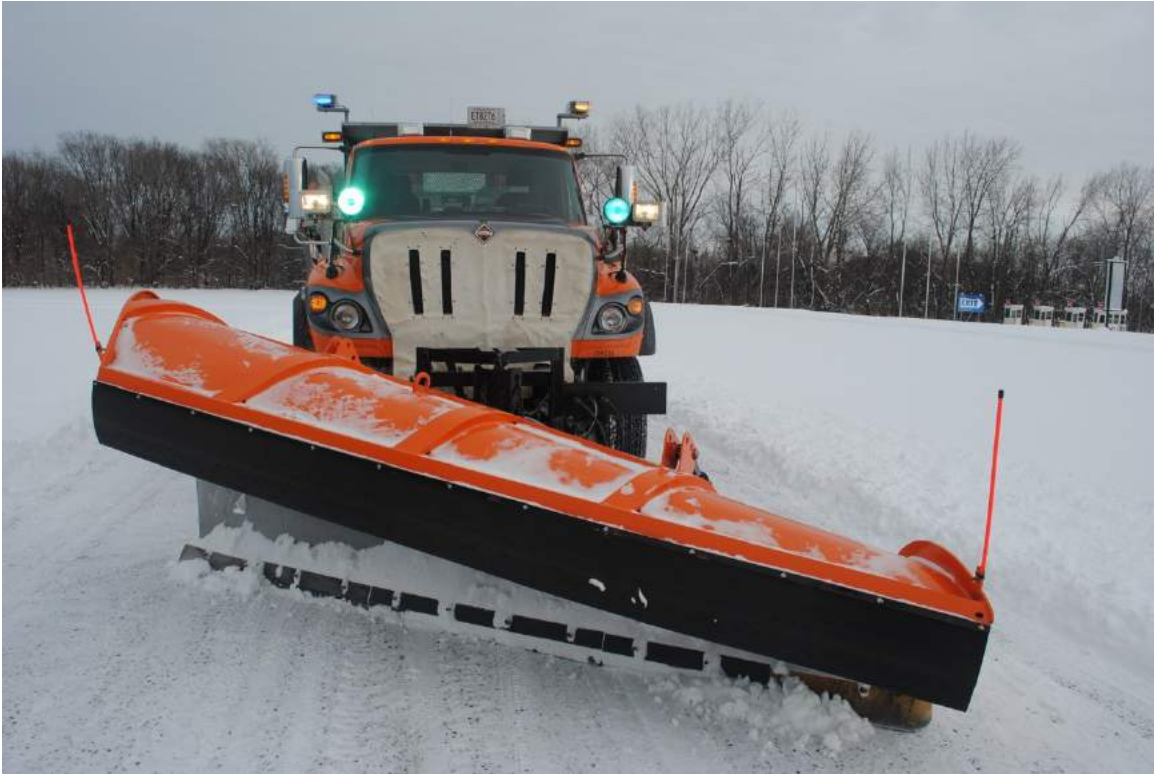
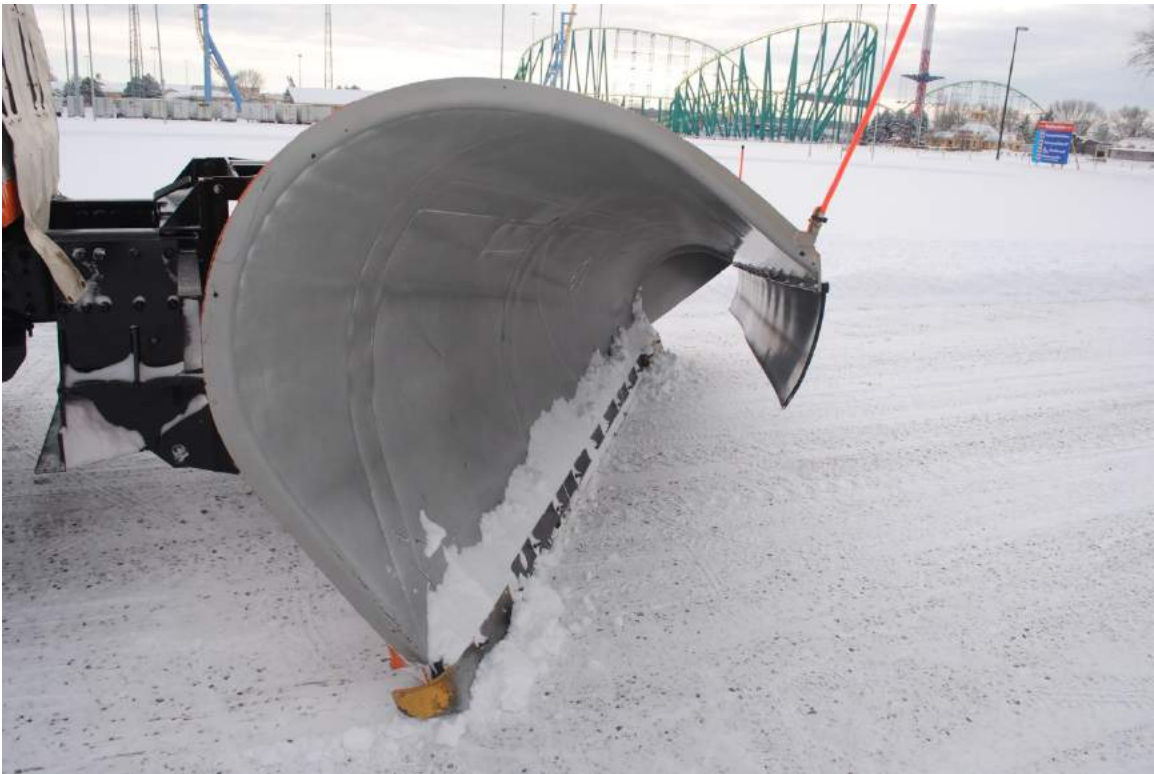
Figure 13 Plow and truck used for testing on December 12, 2016 (from MnDOT Chaska Truck Station).

Plow evaluations are included in Appendix E; weather of plow evaluation days is included in Appendix A. Two events were studied in detail. First, nine plow trucks of different cutting edges and configurations were supplied by Carver County Department of Public Works for testing at ValleyFair! on February 5, 2016 (Table 33). Second, a single plow truck was used for testing at ValleyFair! on December 12, 2016, configured as a single tandem axel dump truck with a one way Falls plow that had a Joma cutting edge installed (Figure 13). Three different operation speeds were used on each of three lanes, with the goal of evaluating the influence of speed and the variability across similar plow runs.

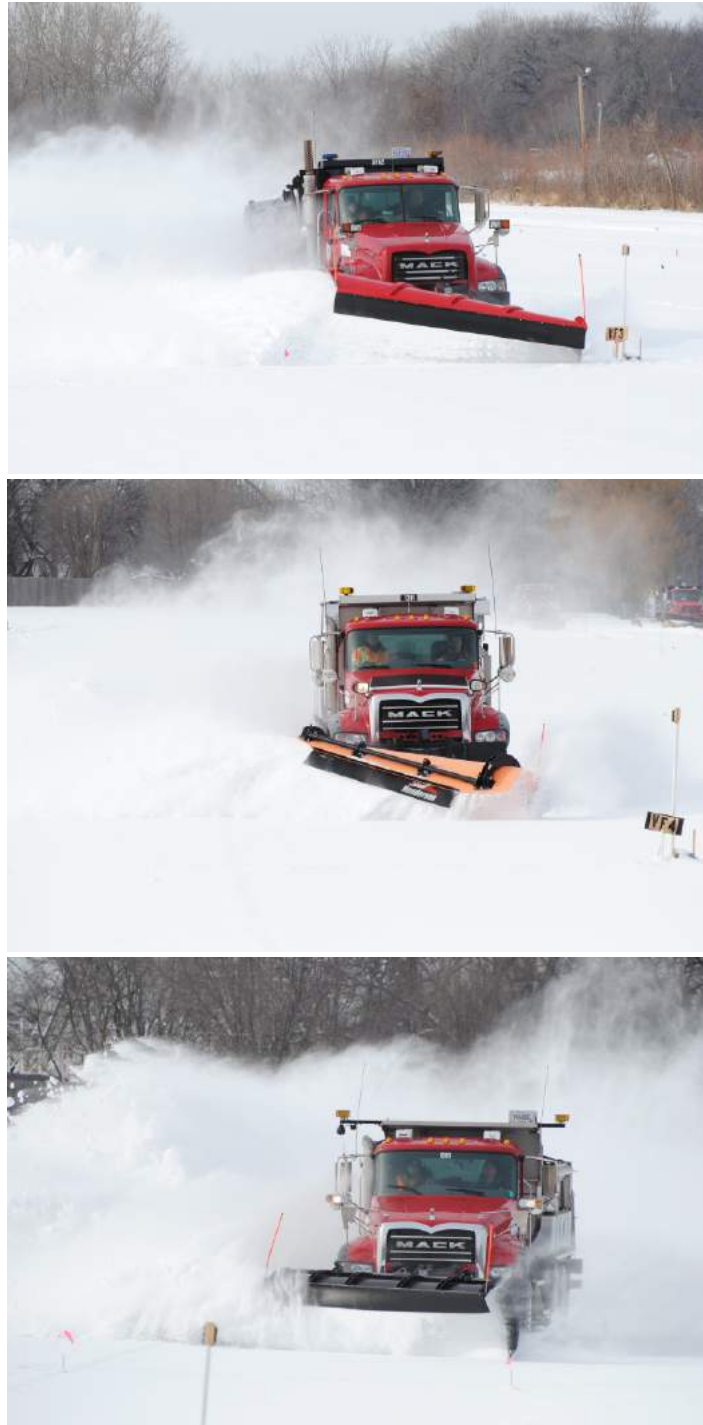
Figure 14 Comparison of one-way (top; VF3), poly (flex, center; VF4), and dozer (bottom; VF5) plows.

differences in the cut. Even less differences were observed with the compaction left after the plow traveled over the residual amount, as the low moisture content of the snow exhibited very little tendency to compact.

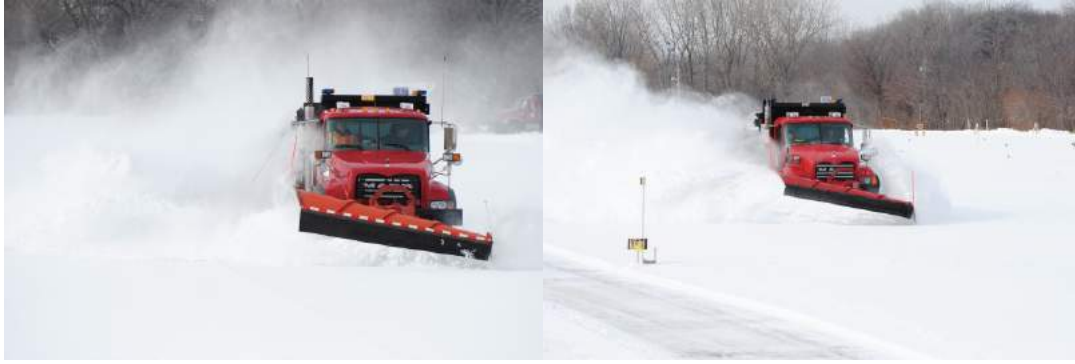
**Figure 15 Comparison of one-way plows with differing cast and cloud characteristics: low, tight cast with moderate clouding (left; VF7); and broad, moderately high cast with thick, opaque clouding (right; VF6).**

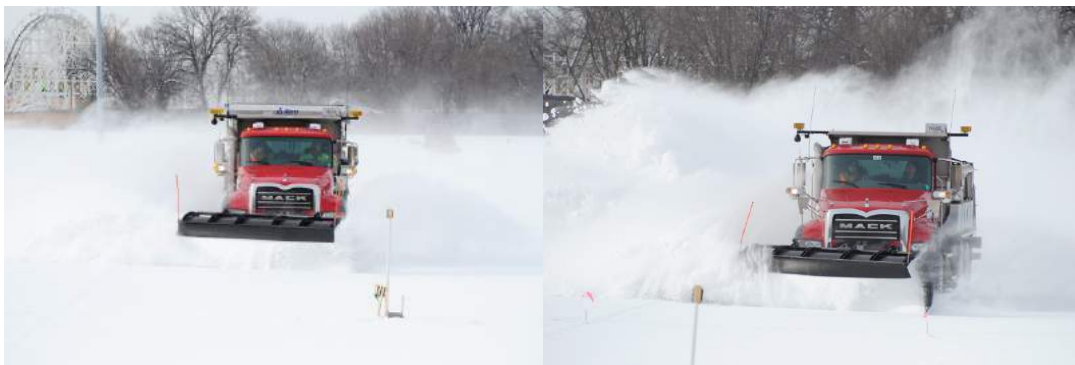
**Figure 16 Comparison of dozer plows with differing cast and cloud characteristics: low, tight cast with little clouding (left; VF8); and broad, turbulent cast with widespread, thick clouding (right; VF5).**

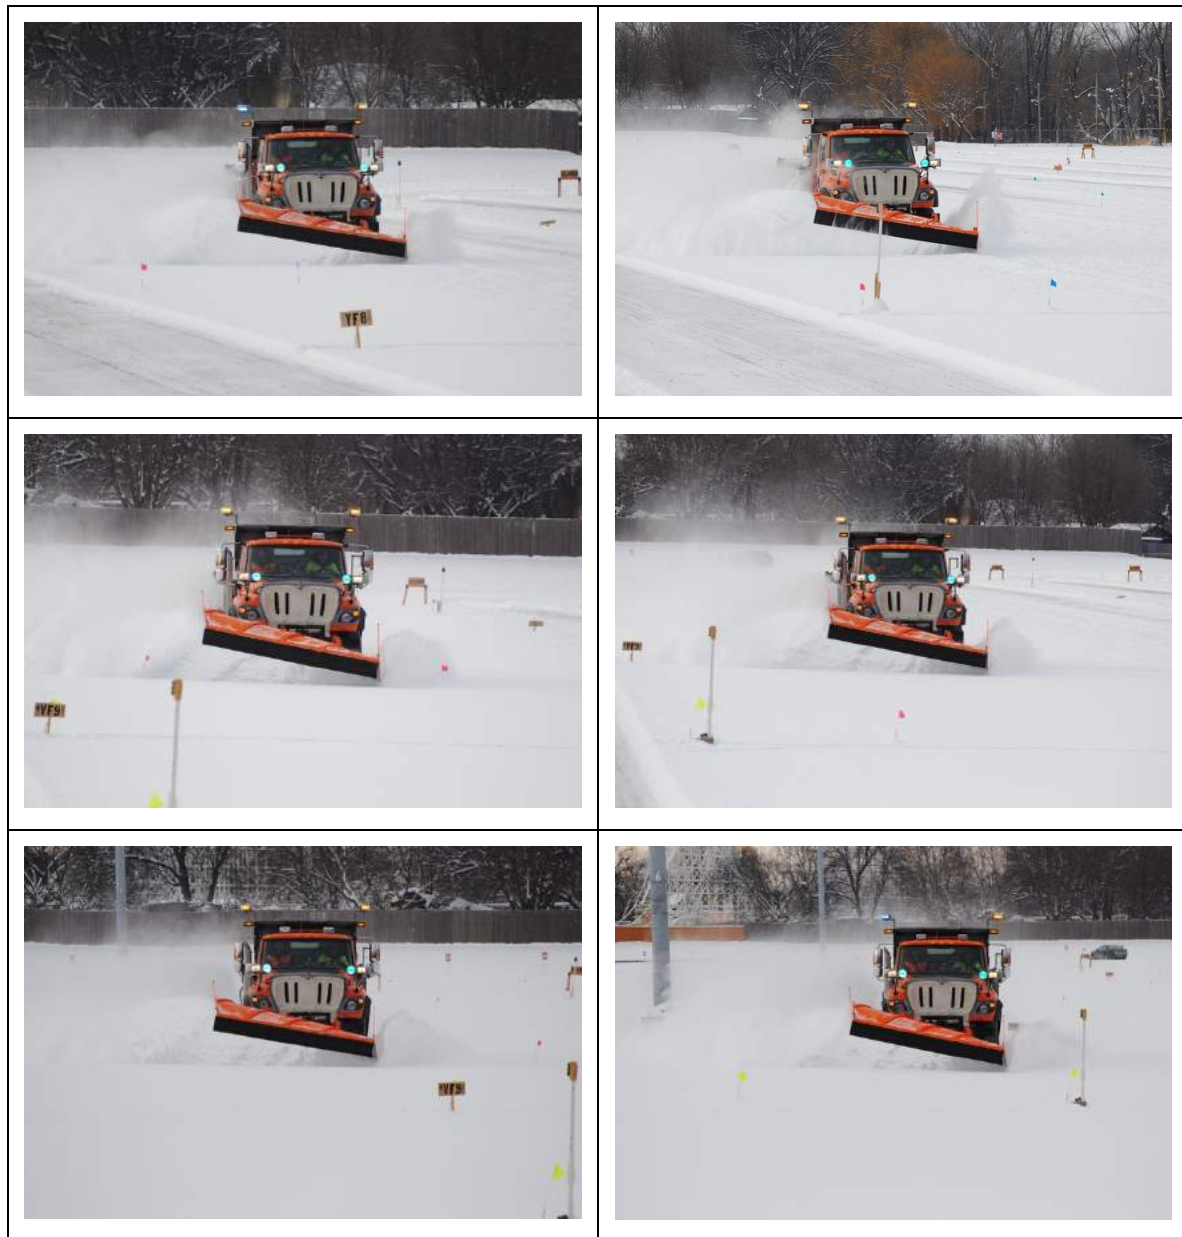
**Table 37 Evaluation of replication: two photos each of three lanes plowed at the same speed. Lanes shown are Valley Fair 1 (top), 2 (middle) and 3 (bottom), all plowed at 30 mph.**

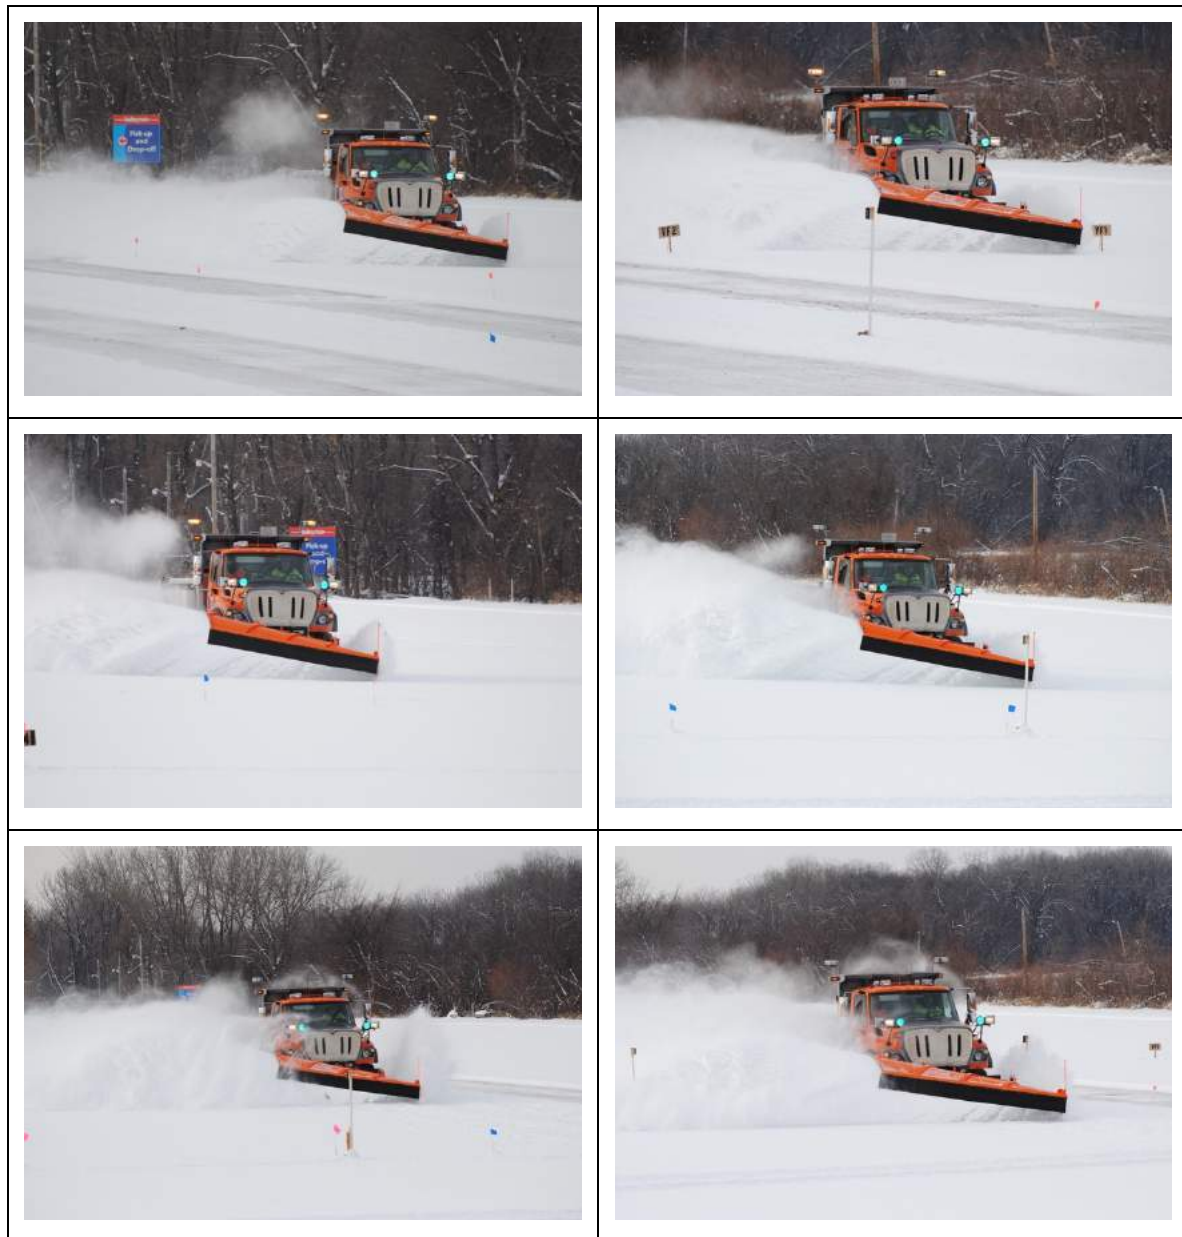
**Table 38 Evaluation of replication: two photos each of three lanes plowed at the same speed. Lanes shown are Valley Fair 4 (top), 5 (middle) and 6 (bottom), all plowed at 35 mph.**
