# **Salt Brine Blending to Optimize Deicing and Anti-Icing Performance and Cost Effectiveness: Phase III**

Center for Transportation Research and Implementation  
Minnesota State University, Mankato

Research Project  
Final Report 2017-45

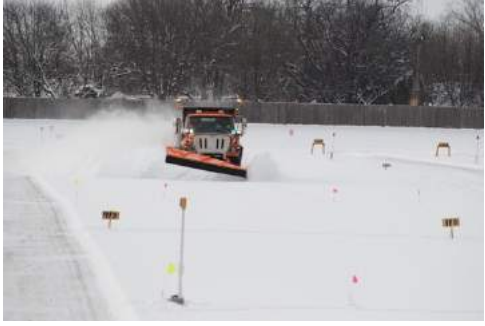
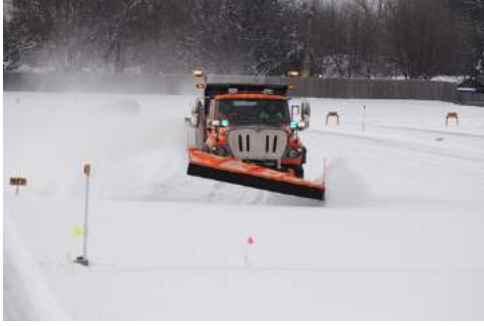
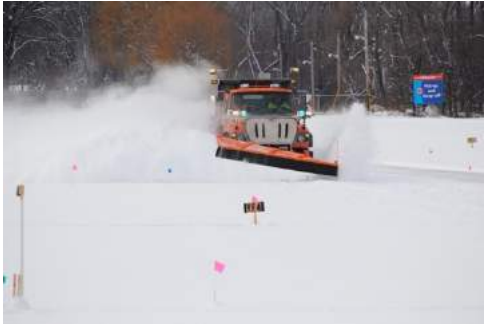
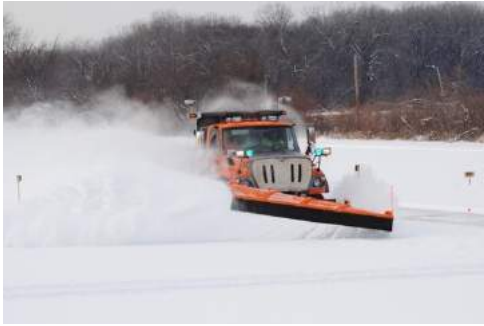
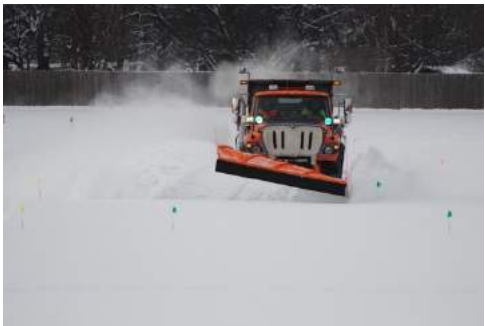
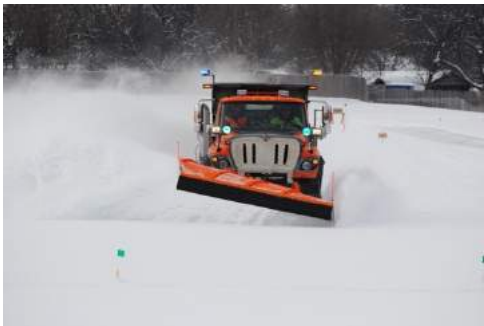
**Table 39 Comparison of plowing at different speeds of the same truck and plow.**

| VF Lane 8,<br>25 mph speed | | |
| VF Lane 3,<br>30 mph speed | | |
| VF Lane 5,<br>35 mph speed | | |

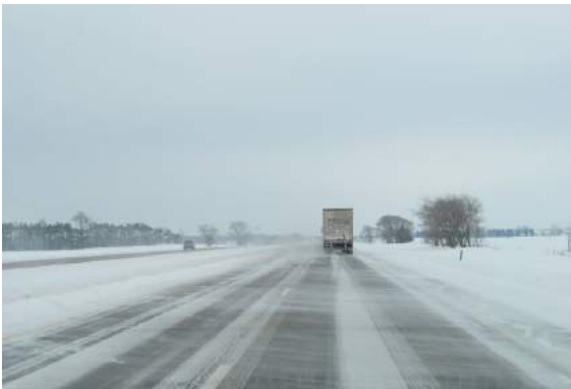
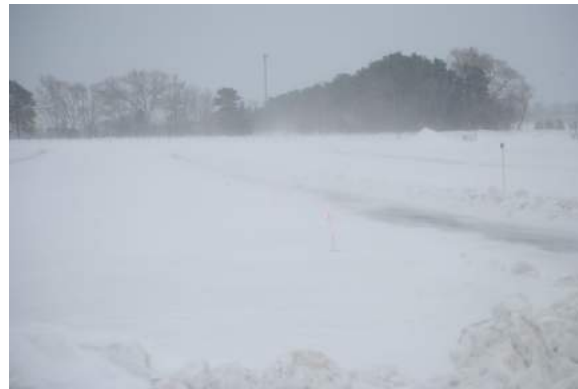
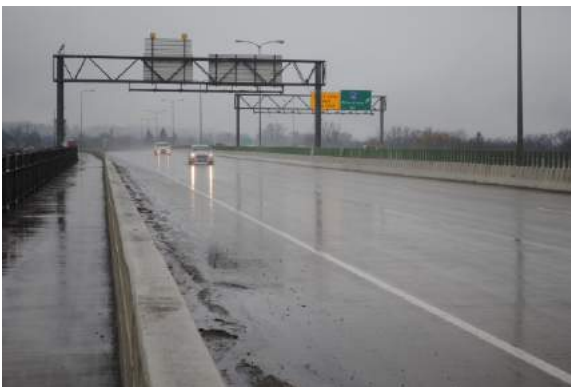
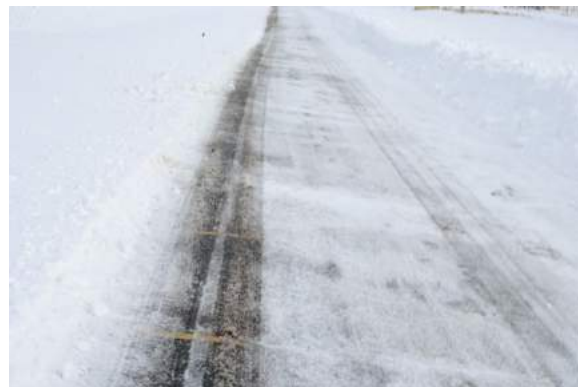
**Figure 17 Winter conditions conducive to ice buildup on roadways.**

One technique of winter maintenance operations that has shown great promise is anti-icing, the pre-storm placement of deicer brine to clear pavement done to limit or prevent formation of icing on a roadway. Whether due to wind blown snow, ice fog, freezing rain, or simply wet snow becoming packed (Figure 17), anti-icing has been found to reduce formation and build up. However, winter maintenance operations have often found it difficult to mobilize the anti-icing application trucks, either because of labor shortages prior to a storm (resting crews before potential long shifts) or limited procurement of the anti-icing brine application equipment (Figure 18). Application of sodium chloride (rock salt) brine at typical rates between 10 and 30 gallons per lane mile (gal/LM) also provides a significant deicer material savings, as with a brine saturation of 23% concentration this rate calculates to 20 to 60 lb/LM, about 1/20<sup>th</sup> of the typical deicer application rate during a snow event.

a) Wind blown snow

b) Ice fog

c) Freezing rain

d) Wet snow becoming packed

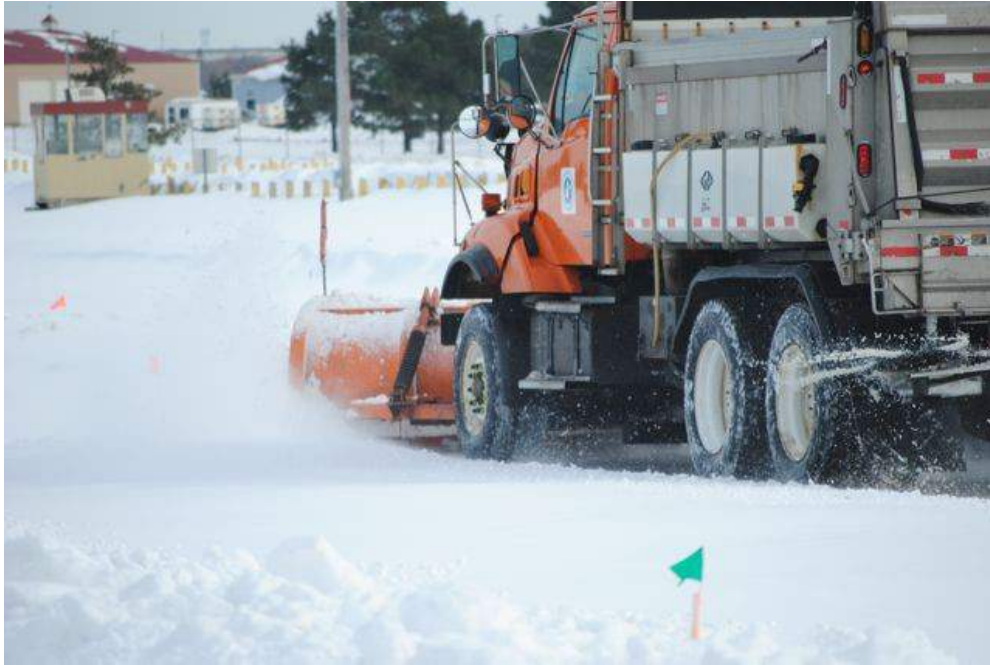
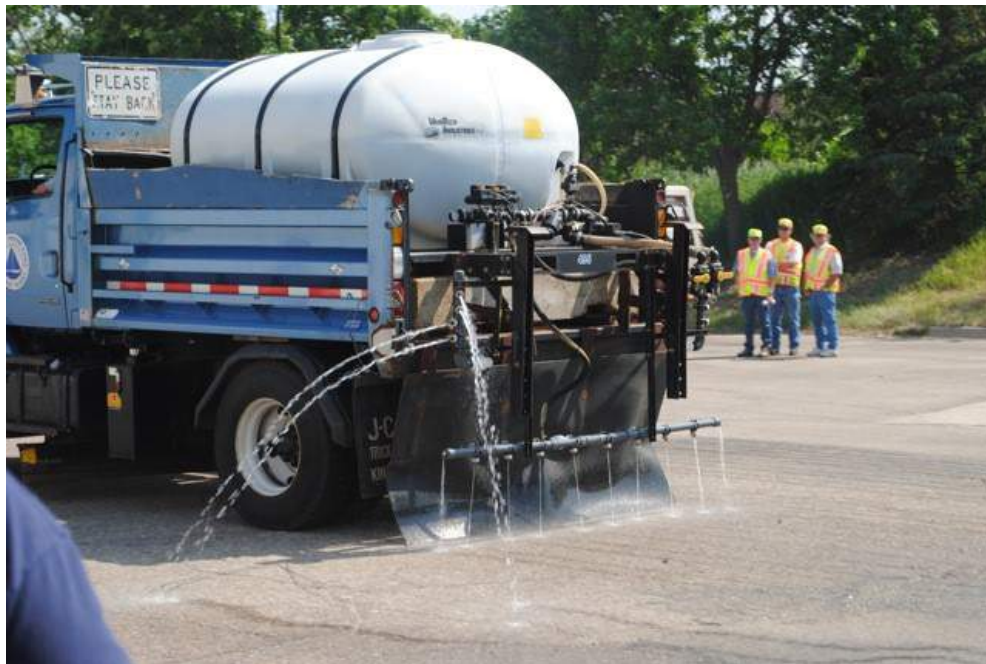
**Figure 18 Deicer and anti-icer application equipment.**

a) MndOT truck spreading solid deicer with prewet off left rear.

b) Brine application truck during demonstration (non-winter day).

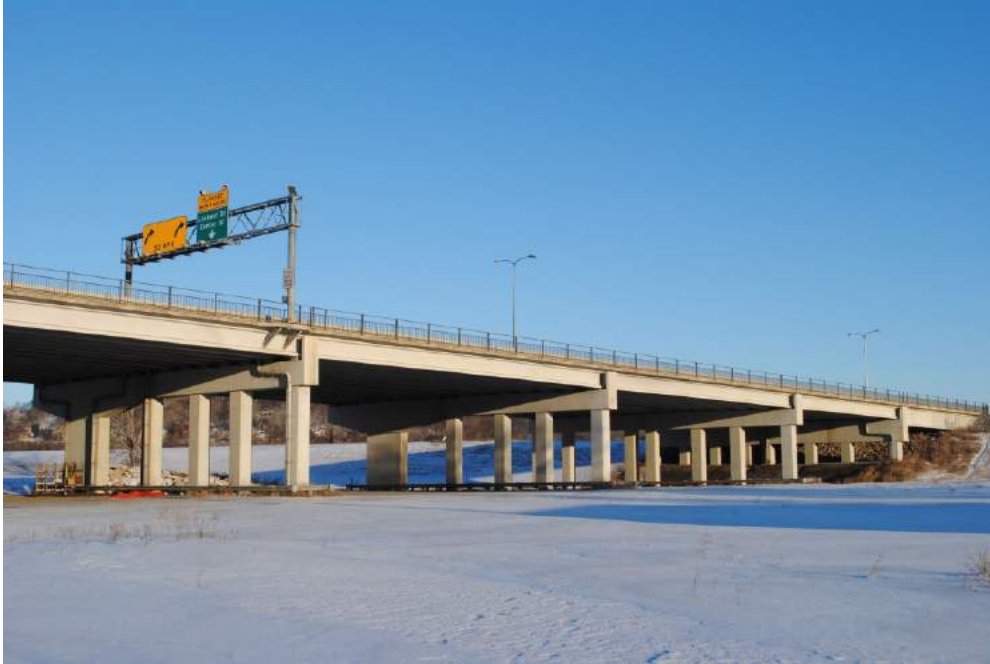
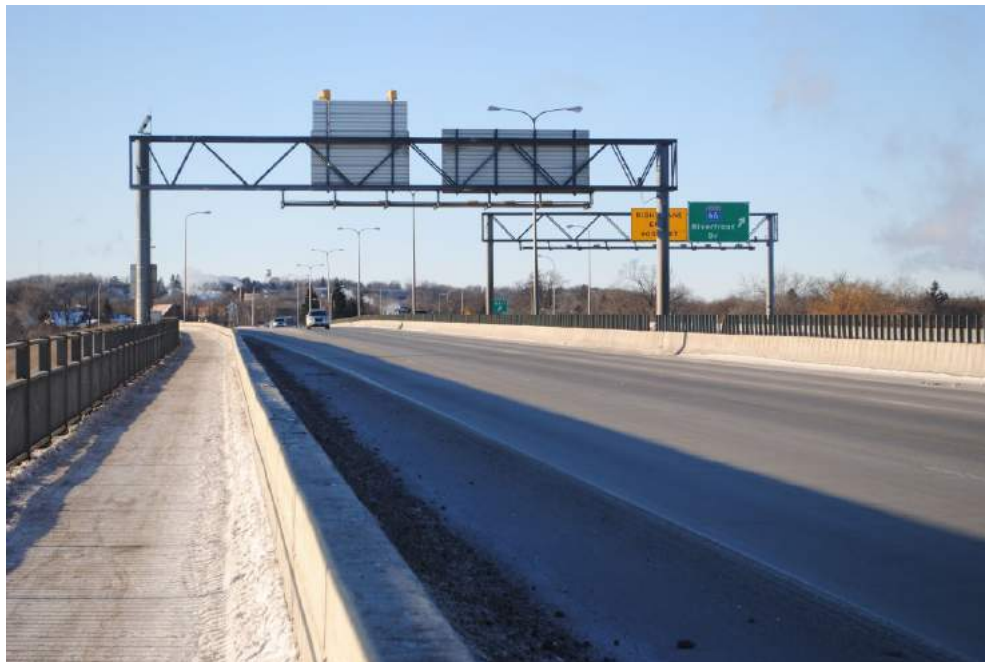
**Figure 19 North Star Bridge, US 169 over the Minnesota River at Mankato, Minnesota.**

a) Side view, view west.

b) Northbound lanes, view south.

Pavement areas were defined by the contributing drainage area of individual scupper collection points on an elevated section of US 169 in Mankato, Minnesota (Figure 19), part of the Minnesota River crossing. This location was selected because: (1) the elevated highway is an active highway with known anti-icing and deicing procedures; (2) the drainage system is easy to access from below, with no exposure to highway traffic nor any potential confined space entry as can occur with catch basins; and, (3) weather at this location was both sufficiently wintry and well defined through use of the National Oceanic and Atmospheric Agency (NOAA) weather system coverage.

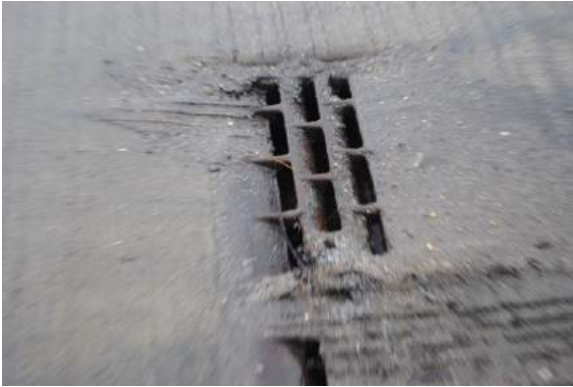
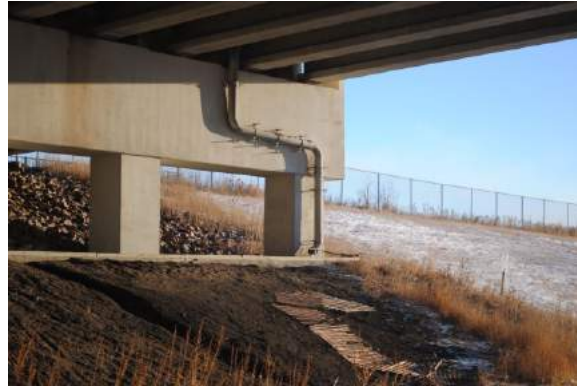
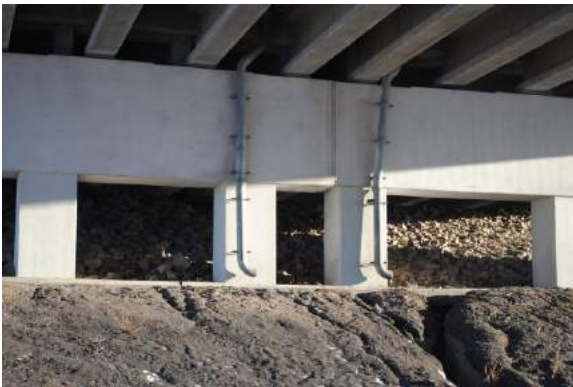
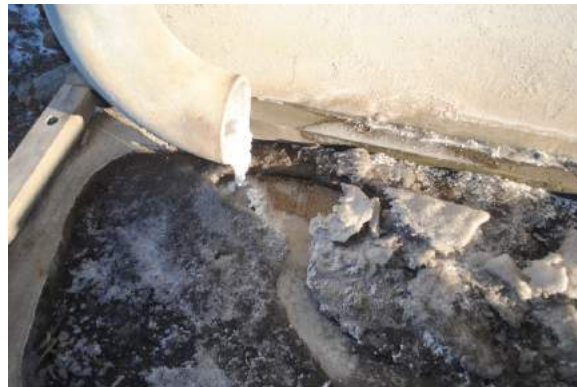
a) Scupper.

b) Down chute piping, outside lane.

c) Down chute piping, inside lanes.

d) Outlet to concrete drainage gutter.

Two sets of four scupper/down chute drainage features were selected for study, shown on Figure 21 and detailed in Table 40. The two sets are replicates, draining adjacent areas with the same traffic and thermal conditions. Each set of four scuppers represents four distinct areas of the bridge: northbound right lane, ramp and shoulder; northbound left lane with shoulder; southbound left lane with shoulder; and southbound right lane, ramp and shoulder. They are denoted in that order as Locations A to D and E to H for the north and south sets, respectively. As viewed from the ground level, the north set is along the Minnesota River flood protection levee and the south set is near to Sibley Avenue.

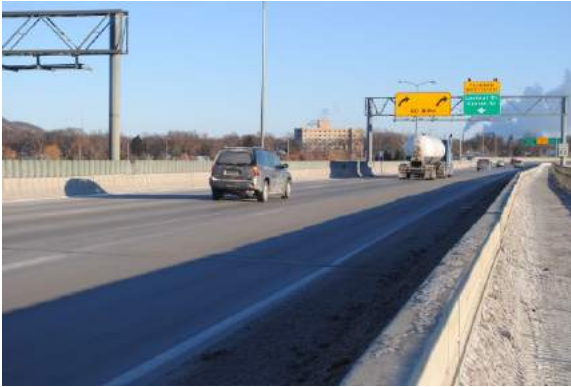
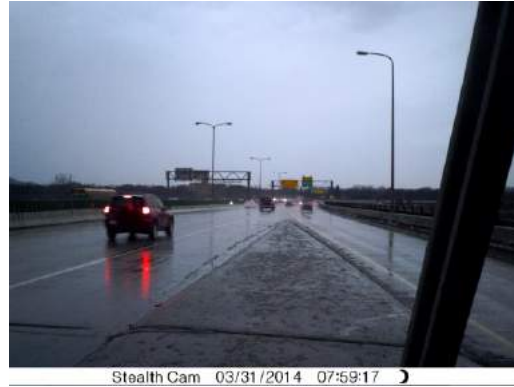
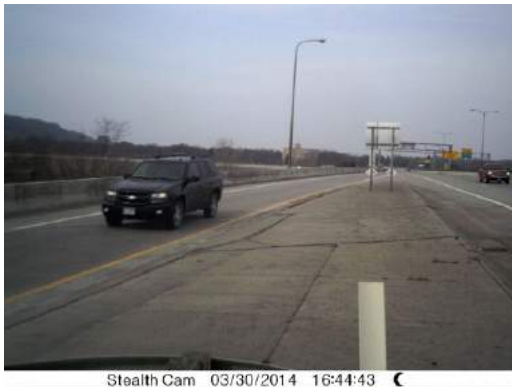
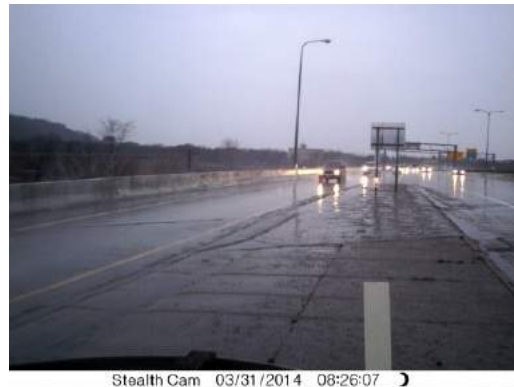
**Figure 22 Traffic on the North Star Bridge.**

a) Northbound – cold day.

b) Northbound – rain day.

c) Southbound – dry day.

d) Southbound – rain day.

It may be noted that the heavy commercial (truck) proportion is about 7.5% of the total traffic. Figure 22 provides several views of traffic on the bridge.

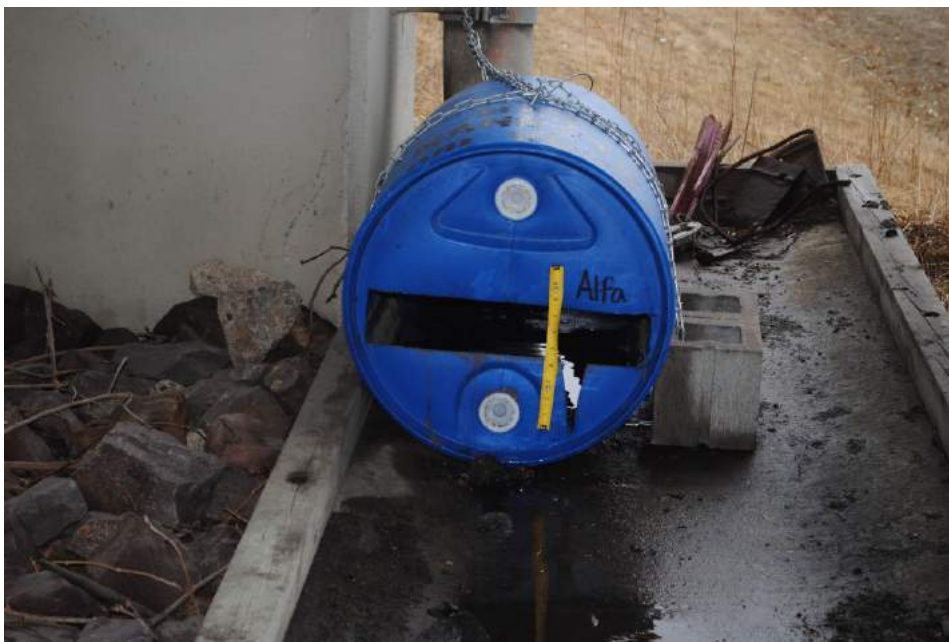
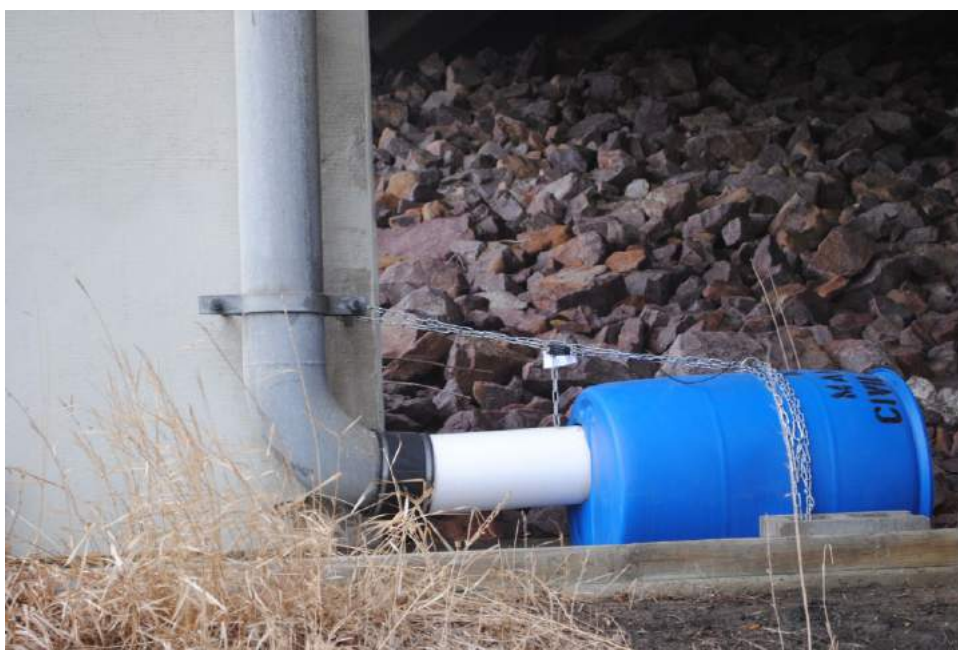
**Figure 23 Flow through cells**

a) End view showing plastic drum with V-notch weir, broad weir, manual measurement tape, leveling chain/concrete masonry unit, and security chain.

b) Side view showing down chute piping, boot, PVC stub, plastic drum, leveling chain/concrete masonry unit, and security chain.

Because of the potential for ice to damage the pressure transducer within the Leveloggers, when temperatures were expected to be consistently below 20°F, flow through cells were taken out of the drainage pathway and locked in place adjacent to the drainage gutter and down chute (Note: extreme pressures on several Leveloggers were observed during the February 29 to March 7<sup>th</sup>, 2016 time period, due to subfreezing temperatures creating ice around the Levelogger pressure membranes; flow through cells had not been removed during this period as temperatures had been forecast to remain above 20°F; the ice formation was likely due to drainage water not having significant chloride content to cause freeze point depression).

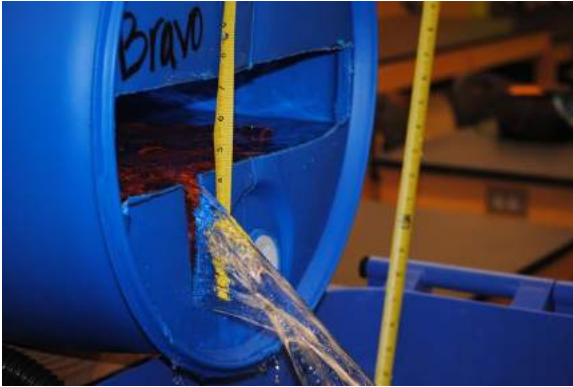
a) Flow through V-notch weir into receiving sump.

b) Measurement of water level at known flow.

**Figure 24 Calibration of flow measurement in weirs of plastic drum.**

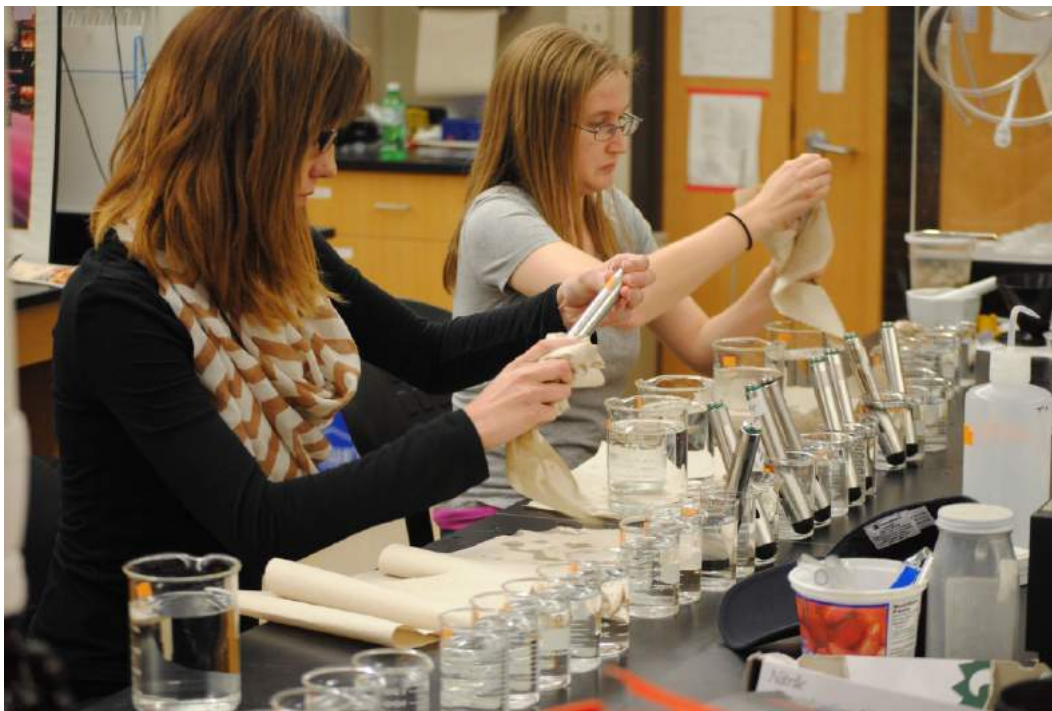
**Figure 25 Calibration of conductivity measurement in ten total data loggers (Levelloggers). Solutions of various concentrations contained in beakers. Levelloggers being rinsed with deionized water and toweled dry between placement in solutions.**

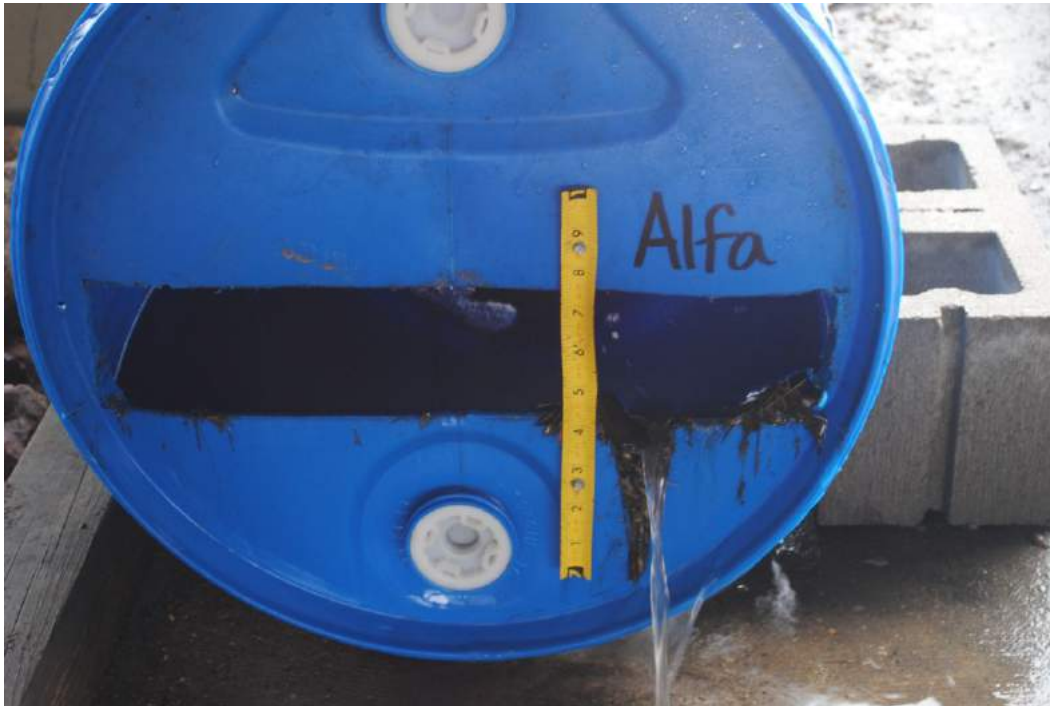
Figure 26 Debris clog at Location A, March 27, 2014.

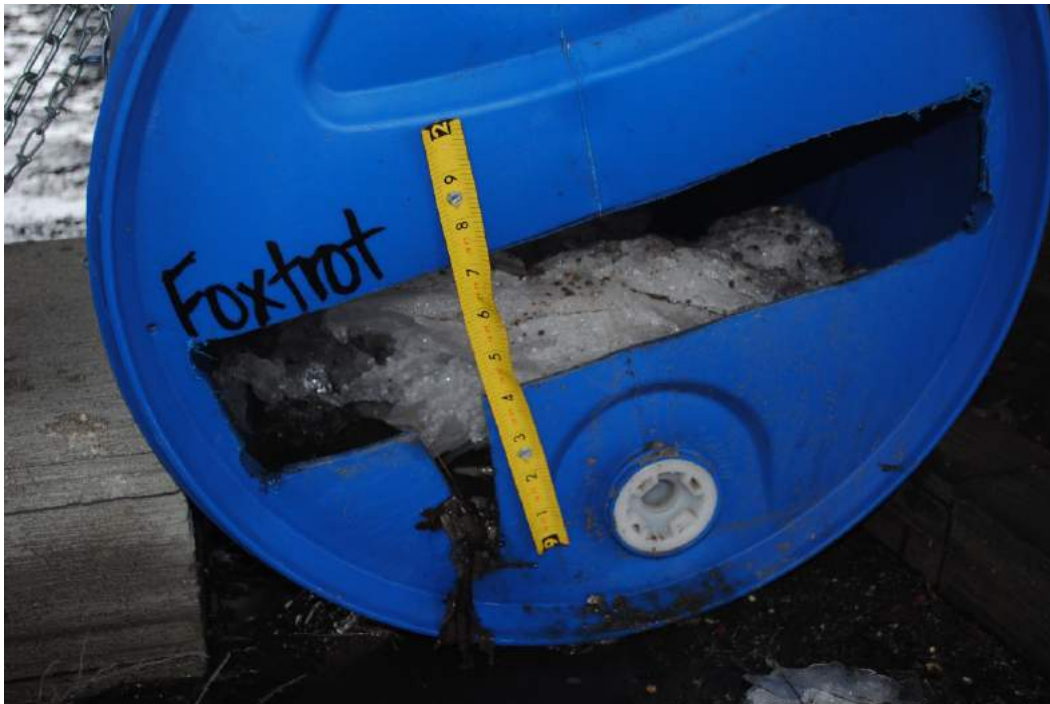
a) March 27, 2014, Location F, ice level above broad weir.

b) April 3, 2014, Location F, debris and ice damming flow through V-notch weir.

Field conditions were documented through photography using two different camera systems. Handheld, high resolution photographs were taken using a Nikon D3000 camera with a 55-300 mm telephoto lens, occasionally alternating with a 20-55 mm wide angle lens. Additional handheld photographs were taken with an Apple iPhone 5 camera. Time-lapse photographs were attempted, but two camera installations were vandalized and the cameras stolen so time-lapse photography was discontinued.

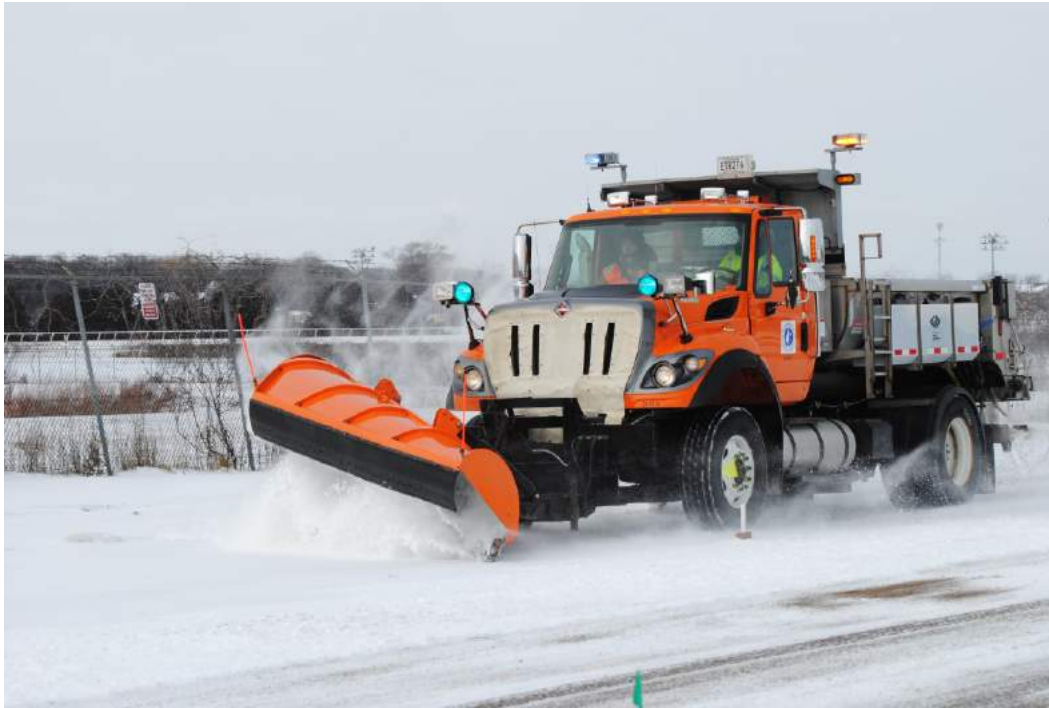
**Figure 28 Typical MnDOT winter maintenance truck, circa 2016, outfitted with front, right wing and underbody plows, brine saddle tanks and rear deicer distribution system.**

Plowing and deicer spreading (distribution) were done by maintenance personnel from MnDOT District 7 Headquarters location in Mankato. Typical equipment was a Sterling tandem axle, automatic transmission dump truck with front, right wing and underbody plows (Figure 28). Side mounted (saddle) tanks were used to carry brine materials used for prewetting granular deicer. Typical deicer material applied was rock salt pretreated with calcium chloride at a rate of 6 gal/ton then prewet at 15 gal/ton with 10% RG8 - 90% salt brine (sodium chloride, 23.3%, in tap water). Application typically is off the left rear corner of an application truck, so placed to use traffic for pavement distribution. Based on discussion with maintenance personnel, the North Star Bridge was treated with deicer at about 400 lb/LM as an anti-icing treatment prior to storm events if the pavement temperature is below freezing, plus application of 200 – 800 lb/LM during storm event plowing. Application rates were automatically adjusted for vehicle speed.

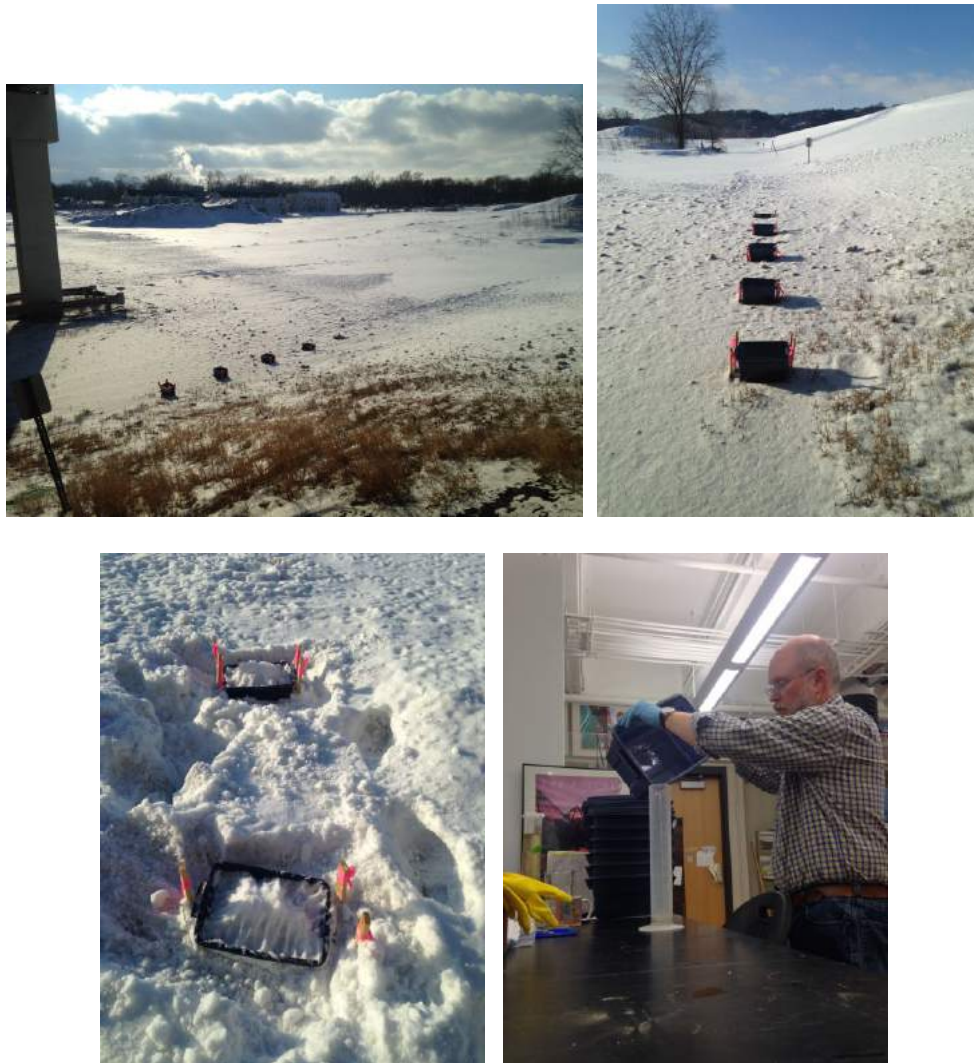
29, top left and top right). Snow cast by the plowing effort was caught along with the storm precipitation (bottom left); captured precipitation was melted then measured for volume and salinity (bottom right).

Figure 29 Plow cast experiment for the storm of February 3, 2016.

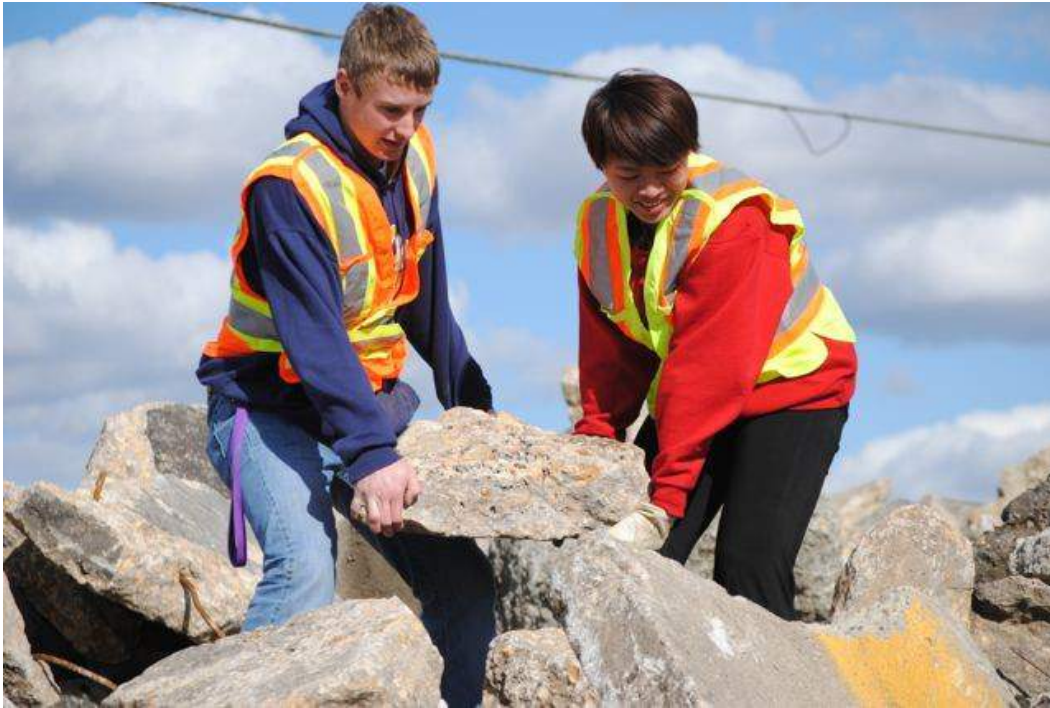
**Figure 30 Pavement specimen collection, CSAH 17 project.**

Pavement samples were obtained from Blue Earth County and the City of Mankato, rather than MnDOT, as by the time this research work had been authorized, excavated state highway pavements had been removed from maintenance and construction operations (pavements are typically ground or crushed in preparations for material reuse). Figure 30 shows student workers collecting a concrete pavement sample.

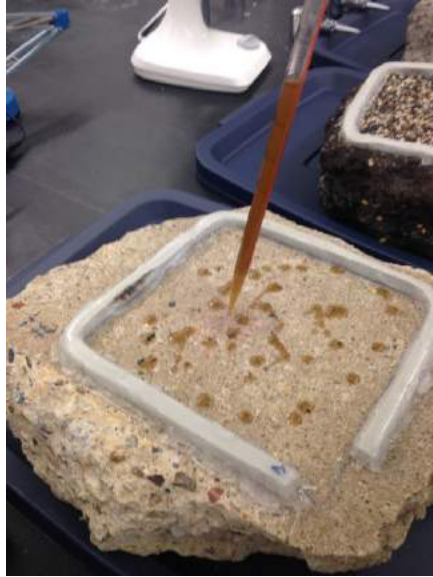
**Figure 31 Anti-icer application to defined pavement area.**

Deicers were evenly distributed over the pavement section as 10 mL volumes from a transfer pipet (Figure 31).
