Report no. CM 2018-01

Prepared by Construction and Materials
Division Pavements Section
Missouri Department of Transportation

May 2018

Missouri's Bond Strength Investigation

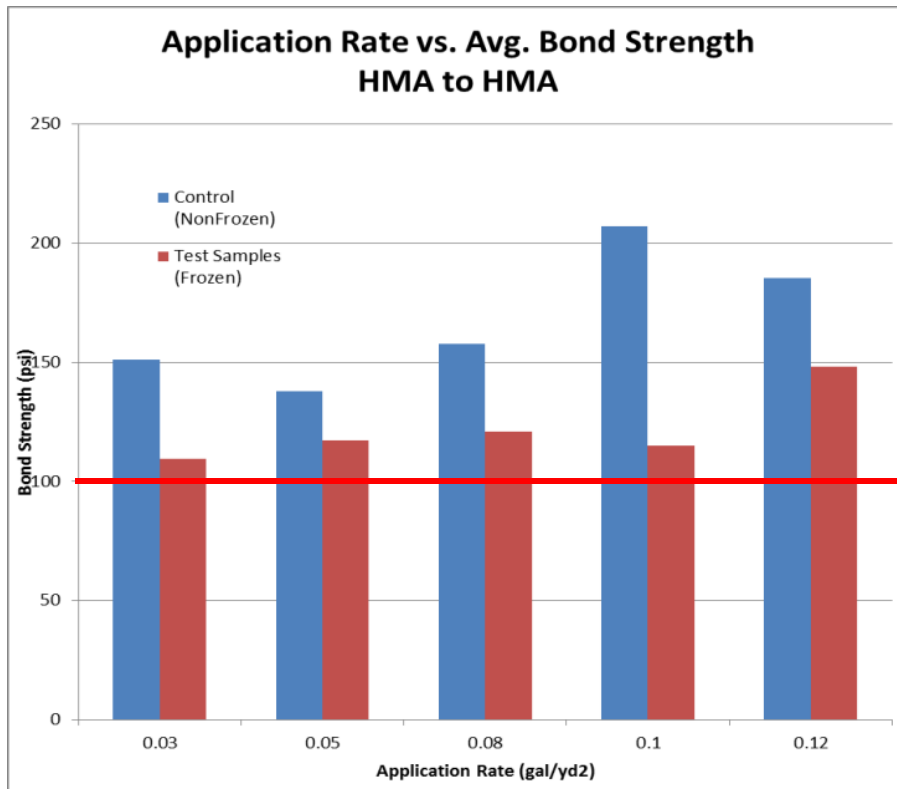
Figure 2.2 Laboratory Study HMA to HMA Bond Strength Results

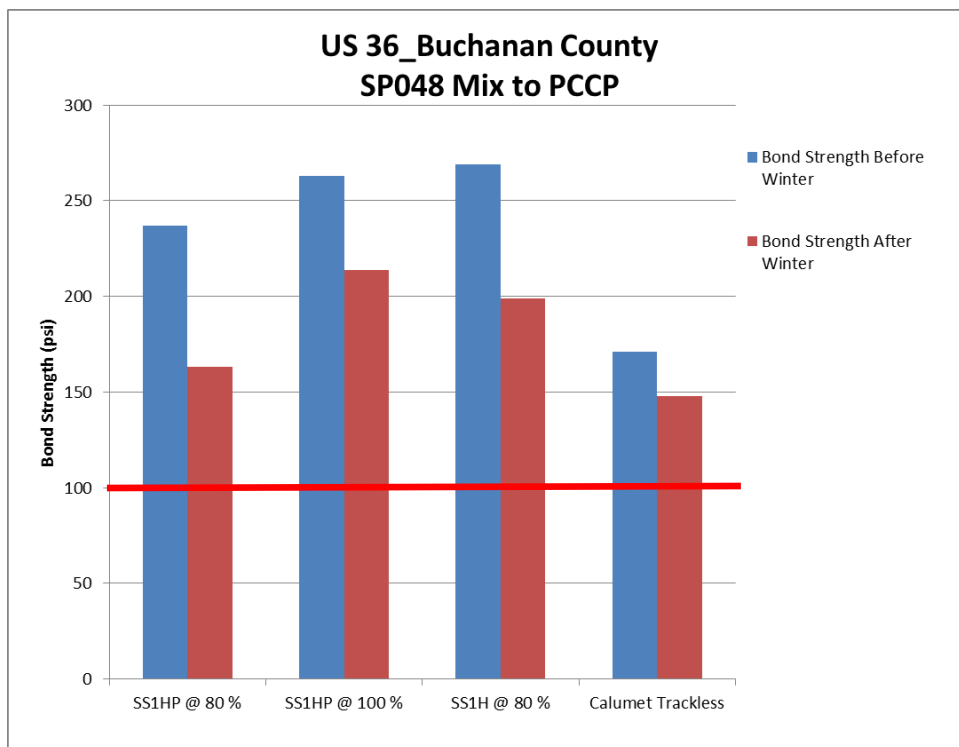
Figure 3.3 US 36 Bond Strength Results (HMA to PCCP)

The primary lifts to be tested for bond strength were the HMA/PCCP interface and the next lift between the HMA/HMA interfaces. The third lift of HMA/HMA interface was also tested, but the results were erroneous and are not shown. It is believed that this lift may have been damaged during the coring and testing of the bond strength of the other lifts. Table 3-1 lists the average bond strength from the roadway before and after the 2013/2014 winter months, while Figure 3.3 and Figure 3.4 graphically show the results. Based upon the field results, the following conclusions can be made.

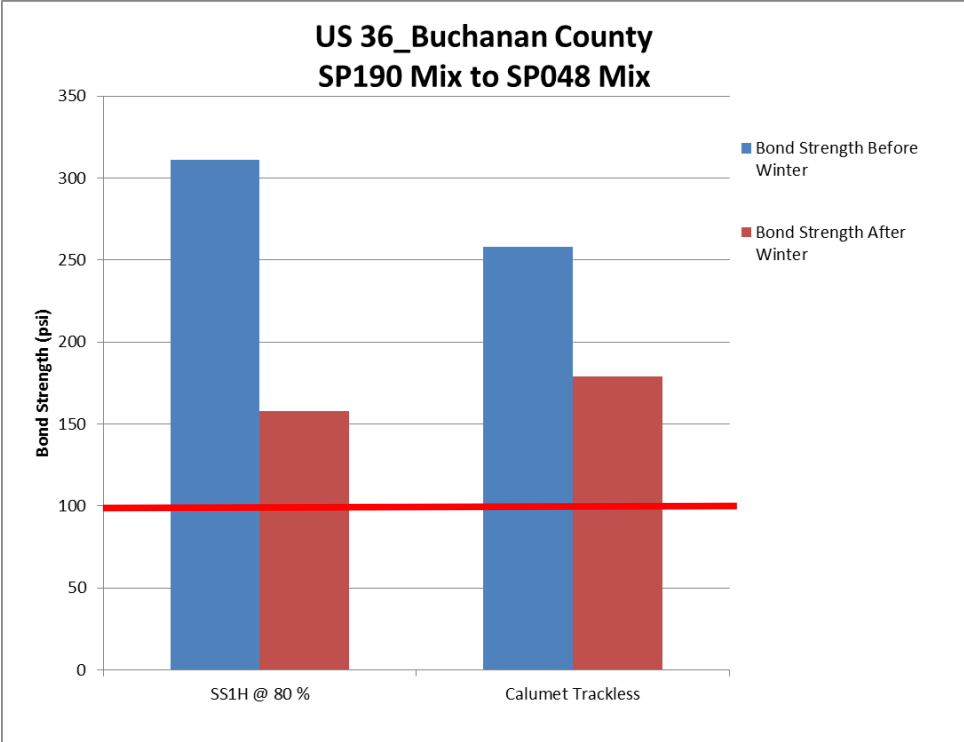
Figure 3.4 US 36 Bond Strength Results (HMA to HMA)

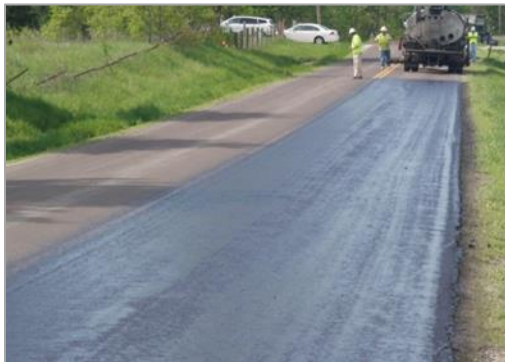
Figure 4.1 0.06 gal/yd² Tack Coverage

The scope of this project consisted of placing a 1-inch surface level course on the roadway. The existing surface was composed of a chip seal surface with multiple cold mix patches. This project required a minimum of 0.08 gal/yd² for the tack coat application rate. A couple of issues were encountered during this project. One issue is that the existing chip seal surface already had some residual asphalt available, which made the 0.08 gal/yd² application rate excessive. The contractor reported having issues with the paver sliding and difficulty in pulling up grades. MoDOT agreed to reduce the rate to 0.06 gal/yd² to alleviate this issue and this rate appeared to uniformly cover the existing surface as illustrated in Figure 4.1. The second issue with this project is that the tack coat was tracking off the roadway. Due to the two-lane route with sharp curves, the contractor was unable to apply tack for a long distance. Also, the trucks were driving on the tacked surface within minutes after the tack was applied. Figure 4.2 illustrates the tacked surface just prior to the paver.

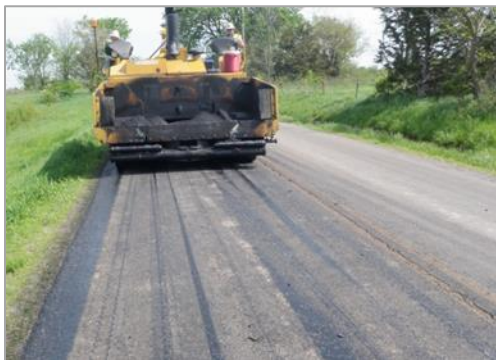
Figure 4.2 Tack Tracking Off Roadway

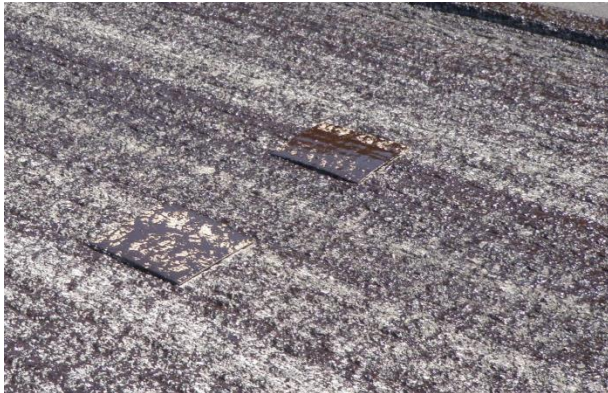
Figure 4.4 Inadequate Tack

The scope of this project consisted of coldmilling ½-inch of the existing pavement and placing 1 ¾-inch bituminous plant mixture over the coldmilled surface. This project also required a minimum tack application rate of 0.08 gal/yd². Two issues documented on this project were that the amount of tack was inadequate and did not uniformly cover the coldmilled surface, and that the undiluted tack was not spraying uniformly across the surface of the roadway. These two issues, depicted below in Figure 4.4 and Figure 4.5, show the inadequate coverage and the inconsistent spray on the cardboard pieces. The inconsistency of the tack application was also reflected in the bond strength results which ranged from 93 psi to 255 psi.

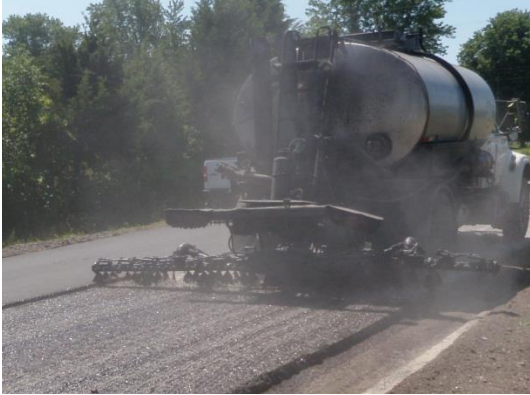
Figure 4.5 Inconsistent Spray

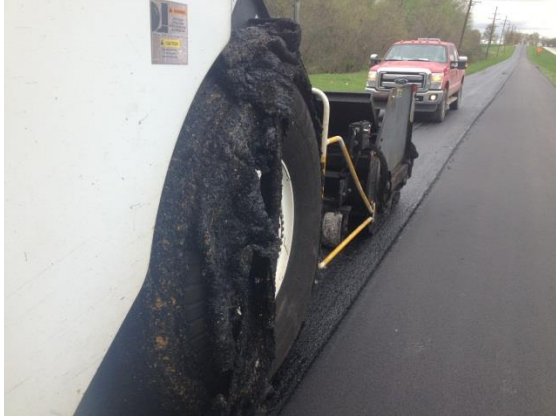
Figure 4.7 Polymer Tack Build Up (2)

The scope of this project consisted of a two lift asphalt overlay consisting of SuperPave mixtures that was intended to add structure to a deficient roadway. This project required a polymer tack coat to be used in which a SS1HP was selected at the 0.08 gal/yd² application rate. The pictures below (Figure 4.6 and Figure 4.7) illustrate the constructability issues with the use of polymers that sometimes occurs.

All tack coat application procedures were determined to be acceptable. The exact cause of the extraordinary build up on tires and the paver was not determined, other than the roadway was paved early in the spring during cooler temperatures.
