Frequency and Potential Severity of Red Light Running in Anchorage – Phase II

Prof. Osama Abaza, PhD., C. Eng.

University of Alaska Anchorage

December 2017

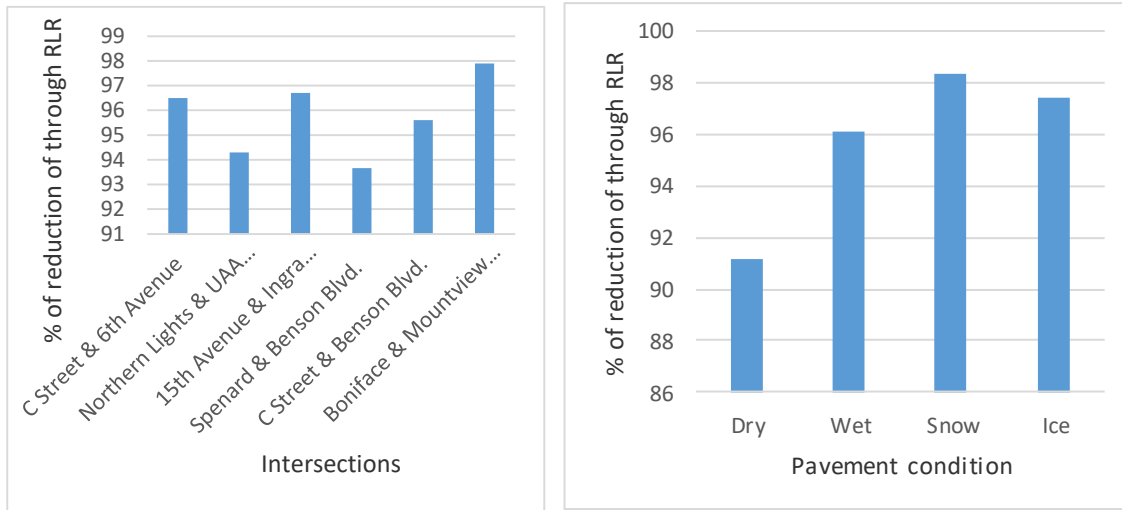
Figure 2.6 shows that with a 2-second increase in the yellow/red interval, more than 90% theoretical reduction in RLR might be observed at all the study intersections. An appreciable number of intersections would experience more than a 95% RLR theoretical reduction in through movement. At a 95% confidence interval, RLR violations on wet, snowy, and icy pavement would be reduced as well. More than a 90% theoretical reduction in RLR violations might be expected on dry pavement. A decrease of more than 80% in overall violations might be achieved. A detailed analysis on this countermeasure are provided in Appendix B.

Figure 2.6: Percentage of reduction of through-movement RLR at respective intersections as well as pavement condition with an increase of 2 seconds in the yellow/red period.

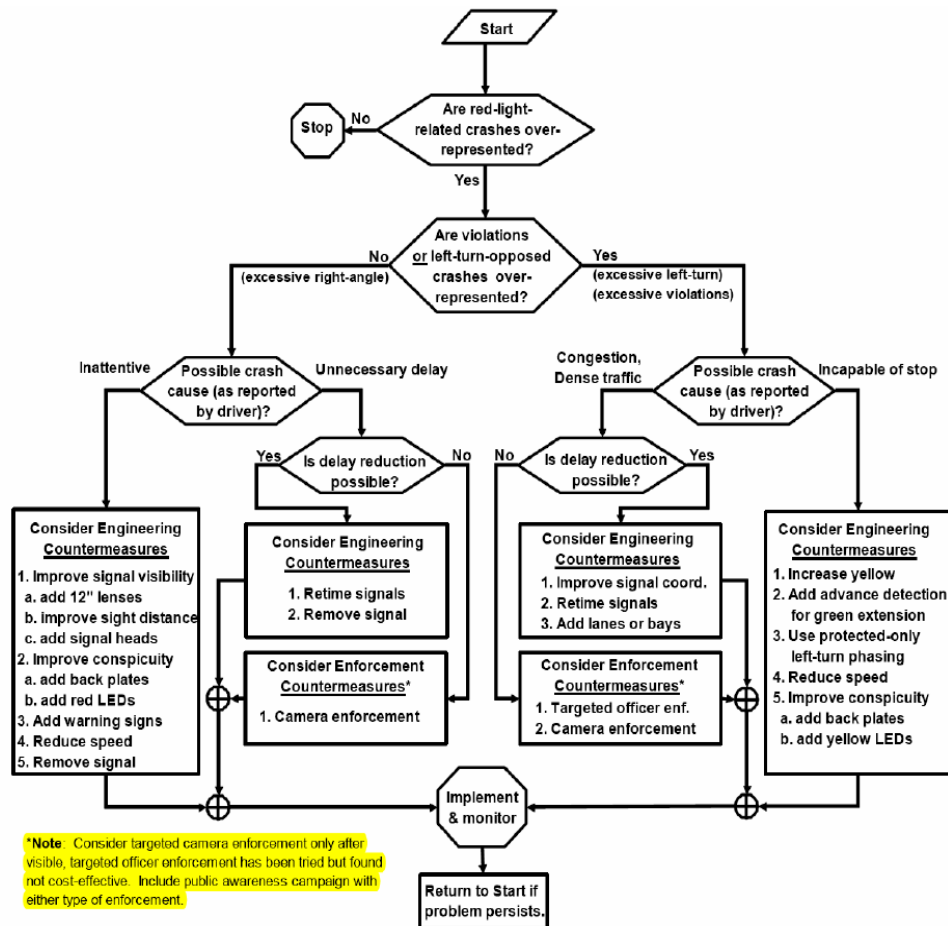
Figure A1: Flow chart of red light running countermeasures.

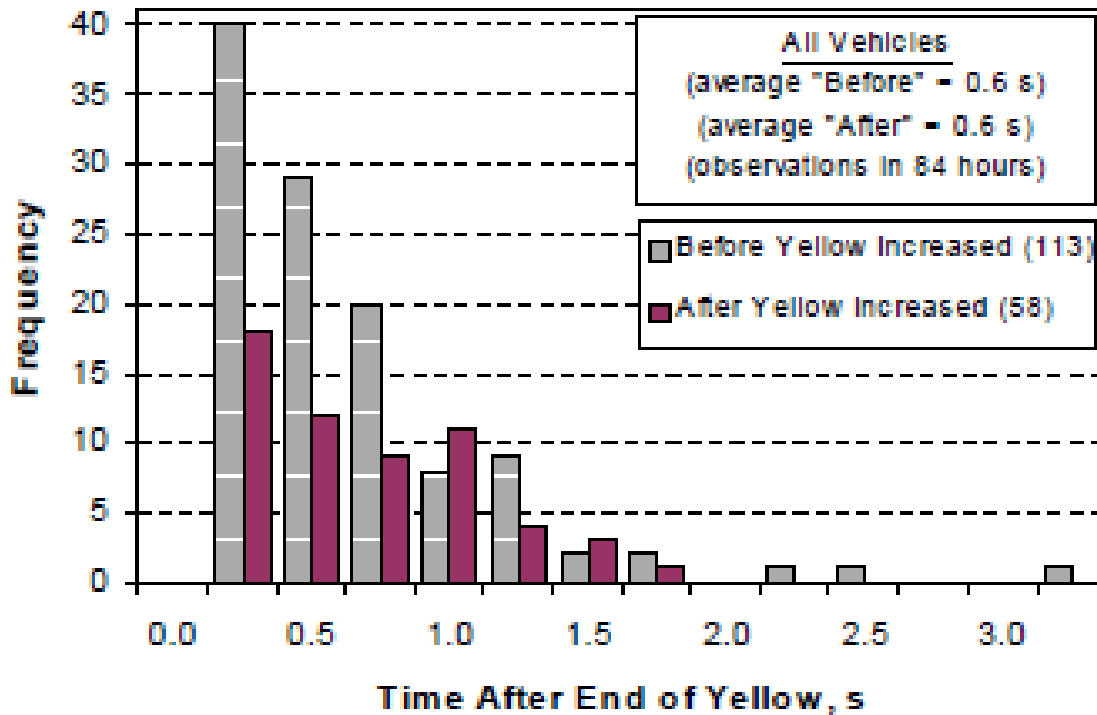
Bonneson et al (2004) reported a before-and-after study of the effect of increasing the yellow interval duration of a light cycle in relation to the frequency of RLR violations. The study took place at 10 intersections in 5 cities in Texas. Data used in the yellow interval study included 3,370 signal cycles at 8 of the intersection approaches. Data analysis indicated a 50% reduction in RLR violations (see Figure A2). Although red light violations were reduced, the effects on red light-related crashes were more modest, as drivers adapted to the increase in the yellow phase duration.

Figure A2: Effect of an increase in yellow interval duration on the frequency of RLR.

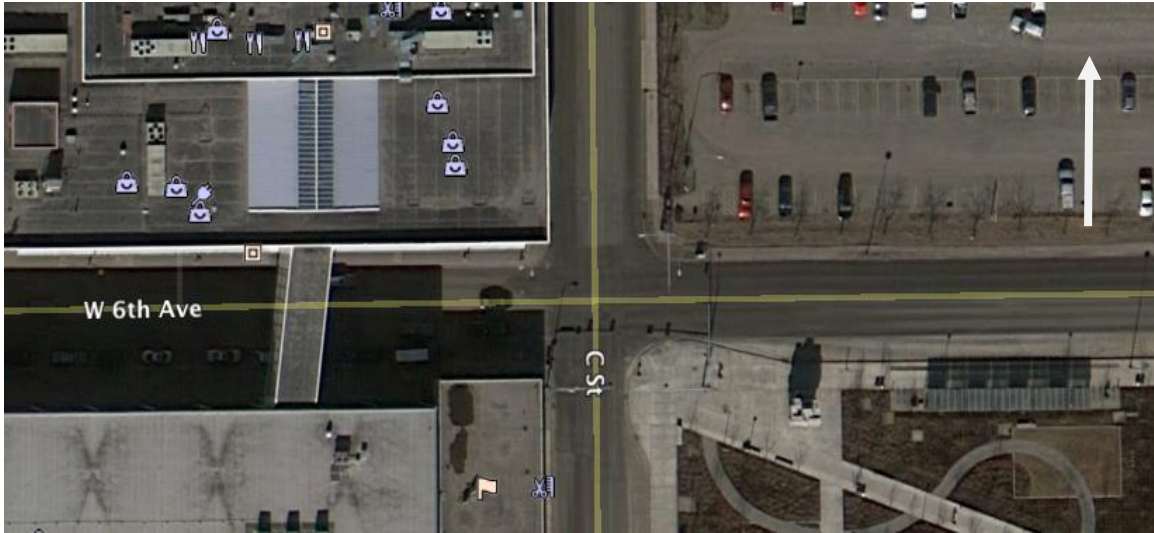
Figure B1: C Street and 6th Avenue intersection (Source: Google Earth).

The intersection of C Street and 6th Avenue is located in downtown Anchorage. This multilane two-way signalized intersection experiences high traffic volumes. An image of this intersection is provided in Figure B1. Sight distance of the approach, especially for southbound traffic, is obstructed by a building on the corner. Because the intersection is located in a densely populated area of the city, sight distance is hard to achieve. As a result, limited sight distance contributes to RLR crashes at the intersection.

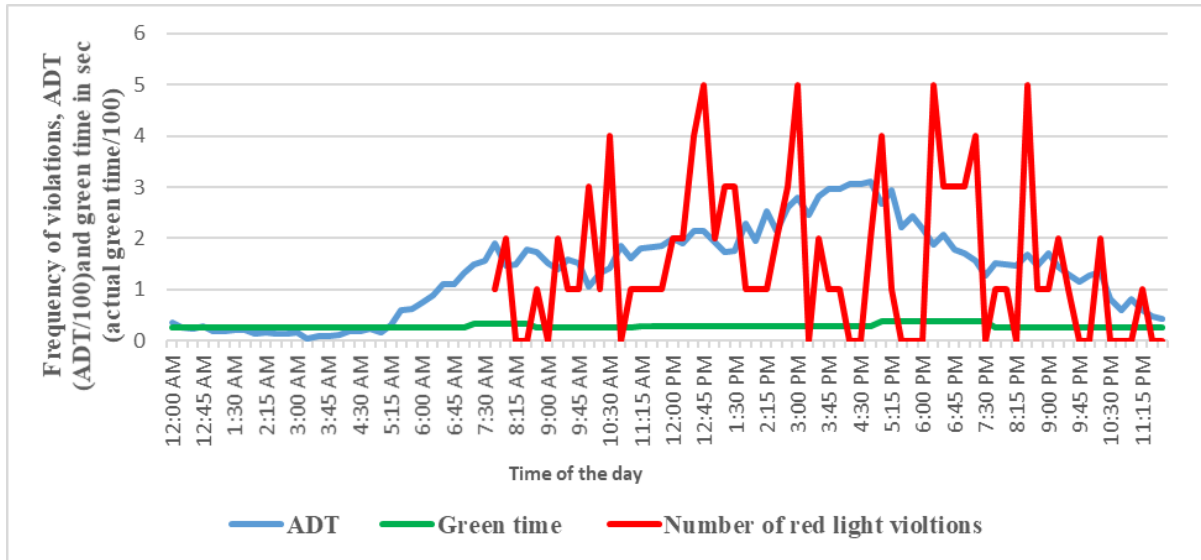
Figure B6: Frequency of red light violations, ADT, and green time sequence throughout a day for dry pavement conditions at C and 6th Avenue intersection.

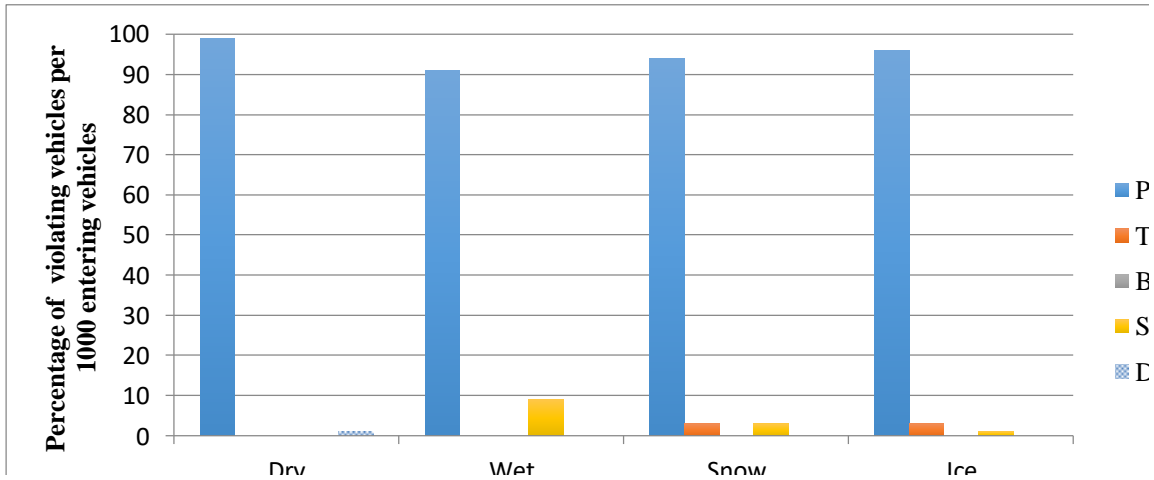
Figure B22: Percentage of red light violations based on vehicle mix for different pavement conditions 15th Avenue and Ingra Street.

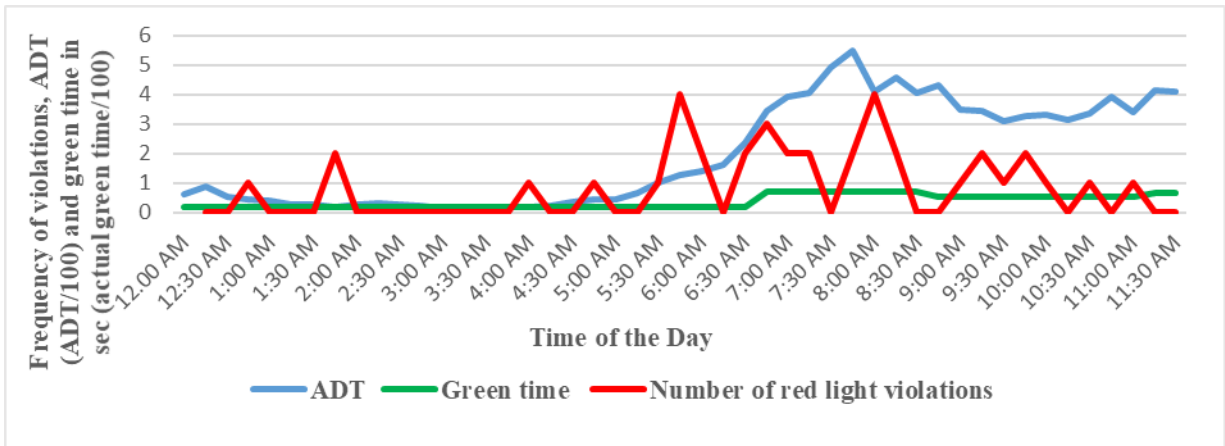
Figure B24: Frequency of red light violations, ADT, and green time sequence throughout a day for wet pavement conditions 15th Avenue and Ingra Street.

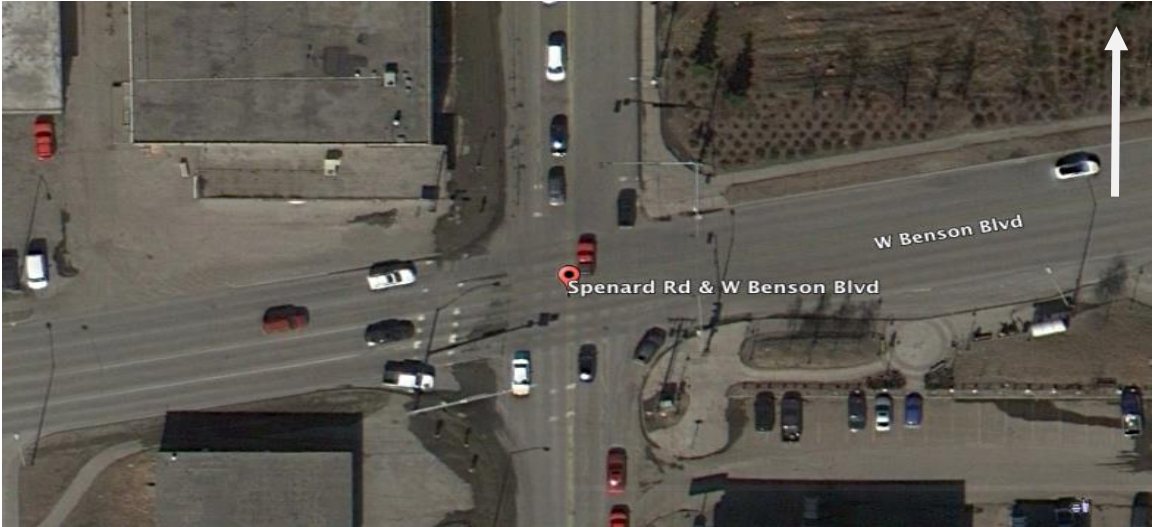
Figure B26: Aerial view of Spenard Rd, and Benson Blvd, (Source: Google Earth).

The intersection of Spenard Road and Benson Boulevard is an 80° angle intersection of two-way and one-way roads with sufficient sight distance, as shown in Figure B26. At this intersection, while violation rates during dry and snowy conditions are similar (about 3 per 1000 entering vehicles), there are more than twice as many violations during icy conditions, as shown in Figure B27. This trend is due to various reasons. On dry pavement, drivers are better able to predict when they will be able to stop, so their violation rates are lower. On snowy pavement, the violation rates are lower, since drivers expect to drive at a lower speed to avoid running a red light. In icy conditions, however, predicting how a car will react is more difficult for drivers, so they may find it harder to stop on time, causing them to run the light more often.

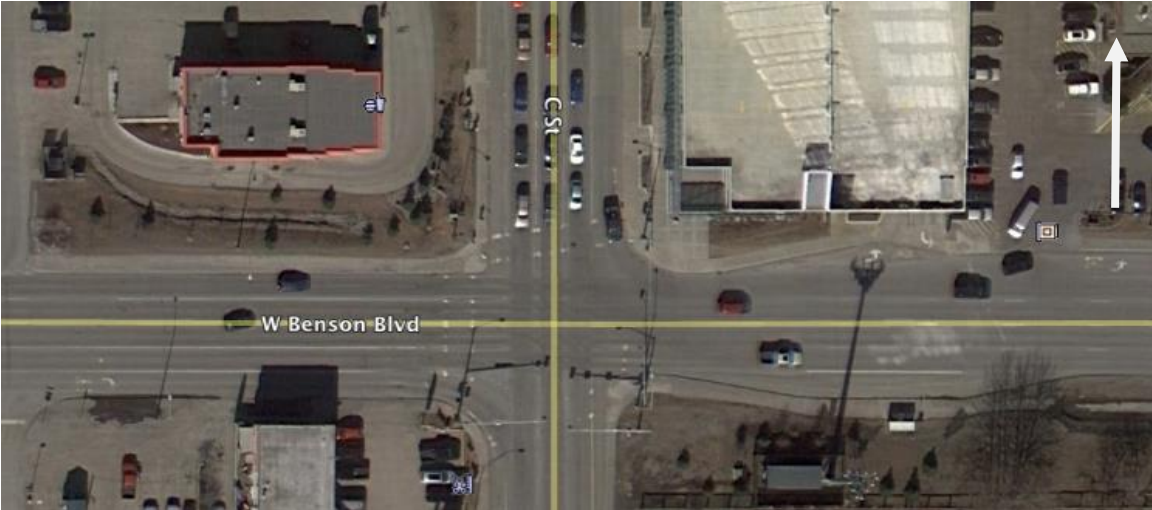
Figure B34: Aerial view of C Street and Benson Blvd intersection (Source: Goggle Earth).

C Street and Benson Boulevard is an intersection of two one-way roads with relatively high traffic volume and limited sight distance at its northeast corner (see Figure B34).

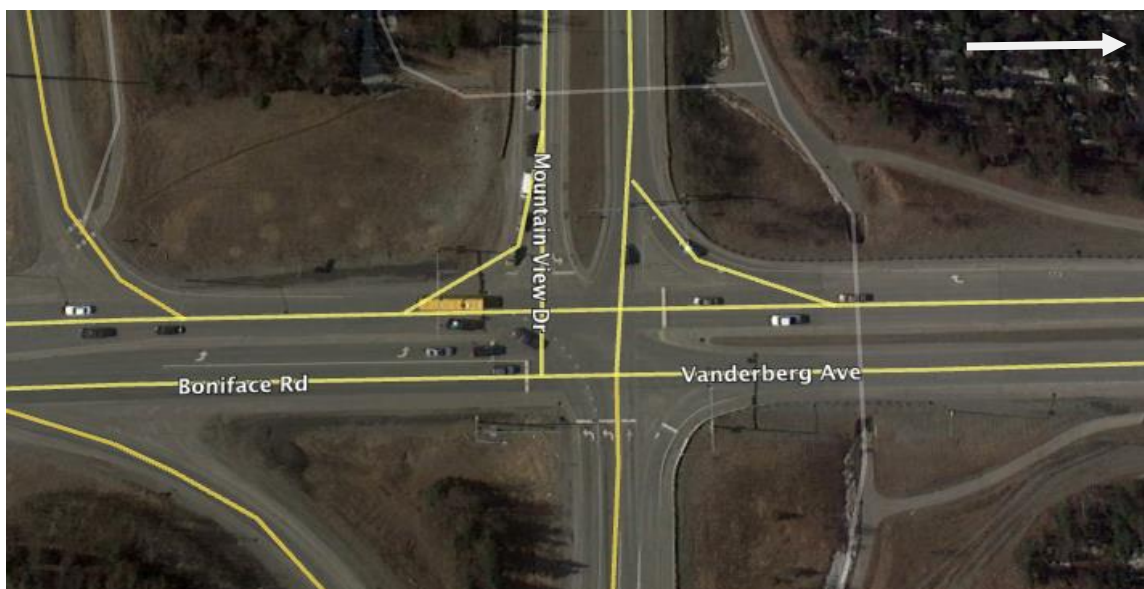
Figure B42: Aerial view of Boniface Parkway and Mountain View Drive intersection (Source: Goggle Earth).

The intersection of Boniface Parkway and Mountain View Drive is located on a highway off-ramp with a multilane road. A median exists where taking a left from the off-ramp to the divided high-traffic-volume road (see Figure B42, bottom center of image, which shows the case when turning left onto Boniface Road). Straight from the off-ramp is a two-way undivided road, and to the right is the entry to a military base. The relatively unique geometry of this intersection may play a large role in RLR violations that occur here. Sight distance is sufficient all around the intersection.

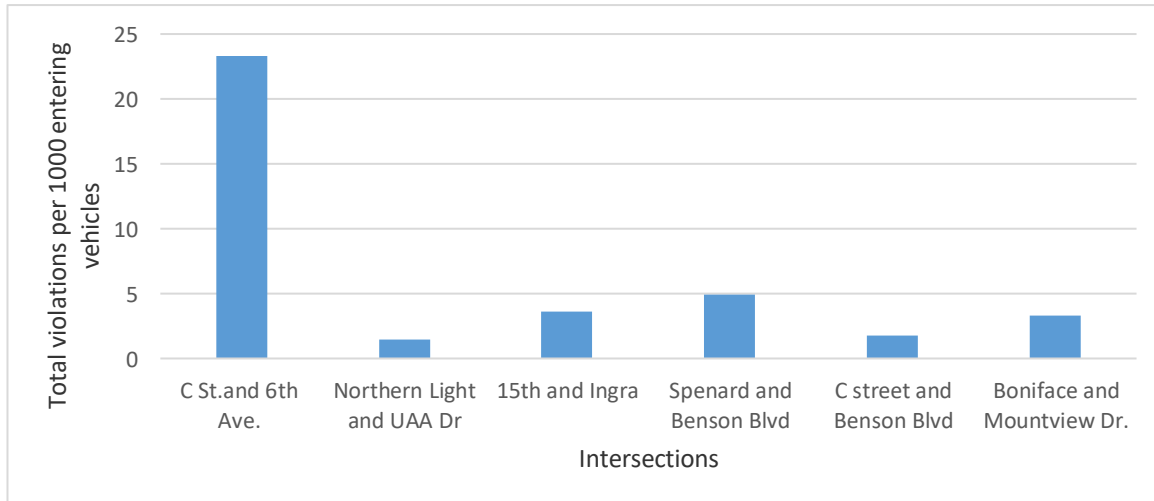
Figure B48: Frequency of red light violations per 1000 entering vehicles in different intersections.

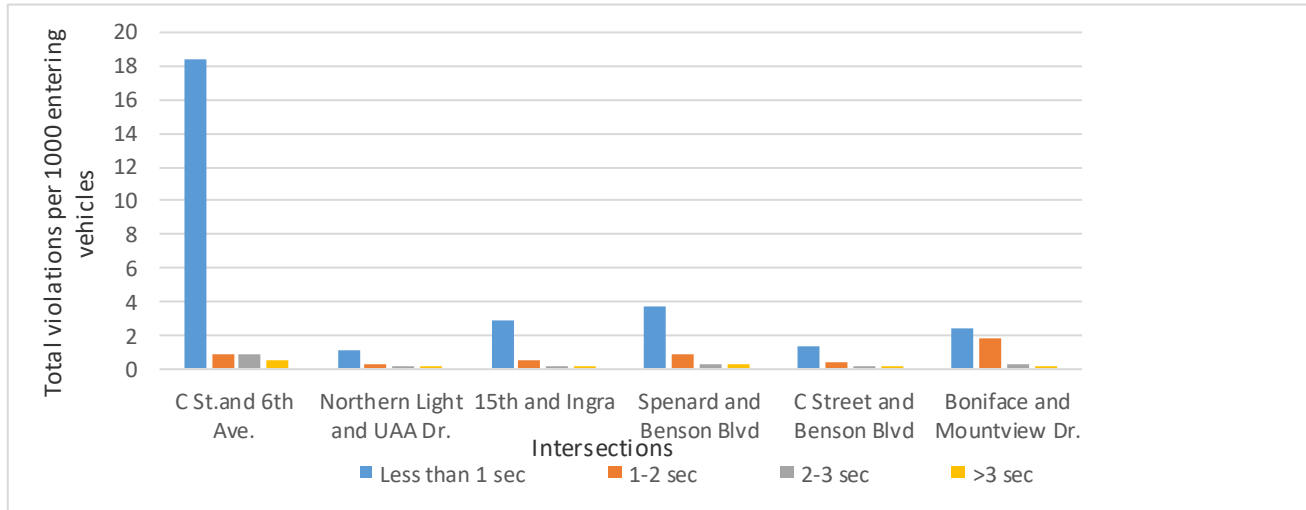
Figure B50: Frequency of red light violations based on severity type for different intersections.
