# **Development of a Hybrid Laser Arc Welding System for Pipeline Construction**

Reference: 6166.FR01 (Rev. 00)  
Date: September 8, 2010

September 8, 2010

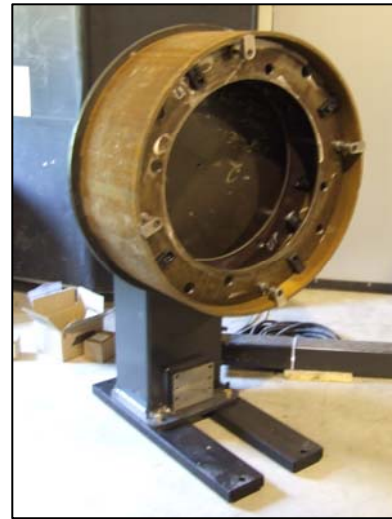
**Figure 6.1: Robotic Test Set-up for Plate and Pipe Welding**

Installation of a new ABB robotic platform was completed including the addition of an integrated rotational fixture. In addition, fixtures and mounting hardware for out-of-position 1G welding of pipe sections were fabricated and installed for lab trials. Figure 6.1 shows a solid model and actual test set-up of the robotic system used in the flat plate and pipe welding procedure development phases.

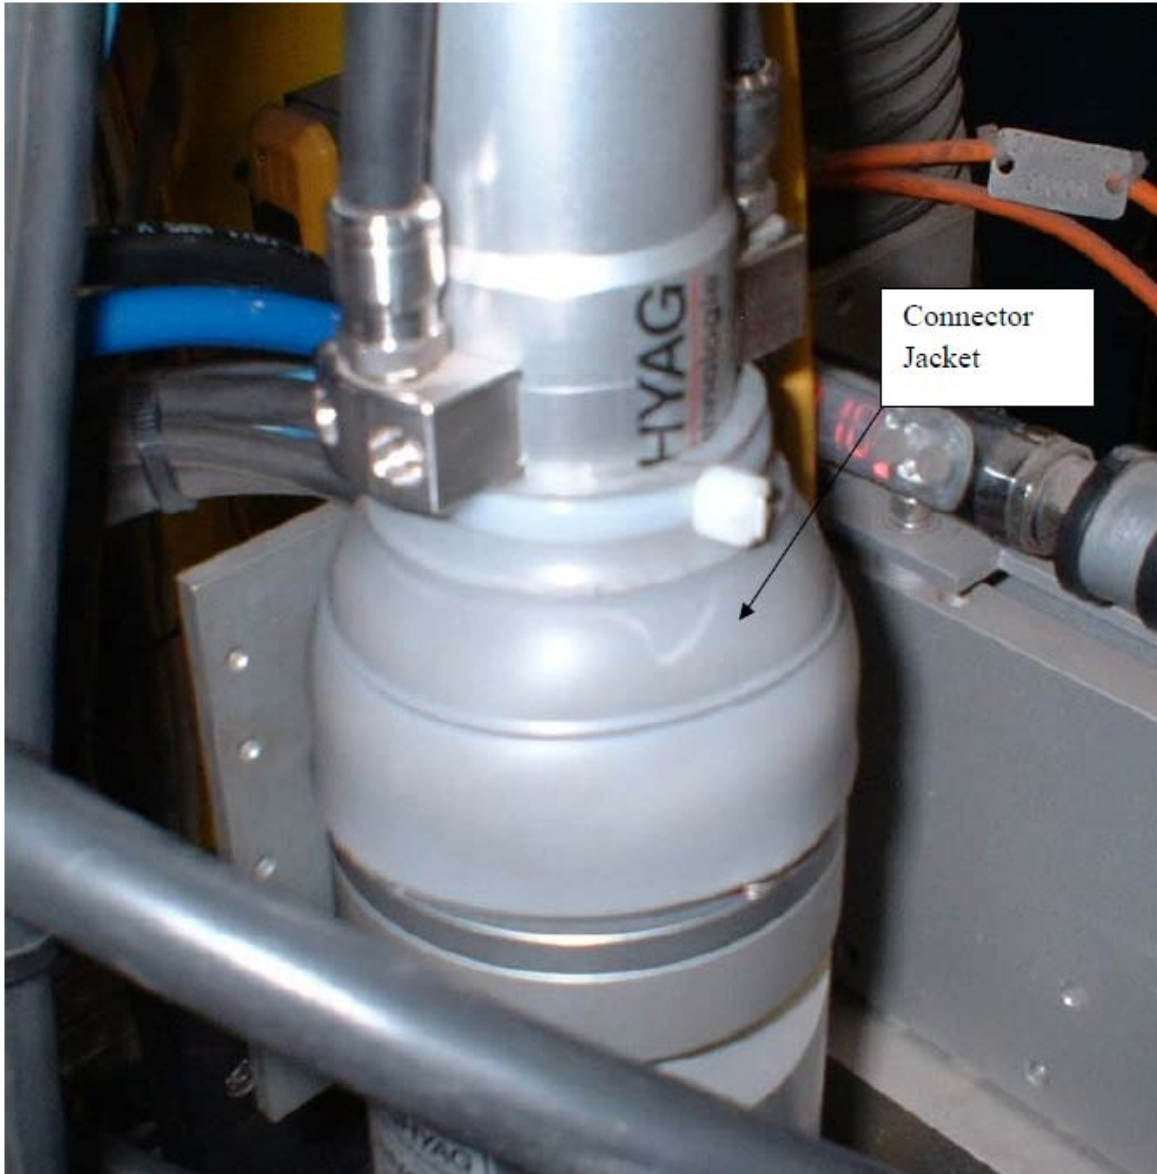
**Figure 6.9: ESAB Water-Resistant Jacket**

ESAB believes the fibre optic cable could be operated at these temperatures if it is housed in an insulated flexible conduit, with heating/cooling lines to maintain the operating temperature between 5°C and 30°C. ESAB had also developed a water-resistant jacket that can be installed on the fibre optic connector. Figure 6.9 shows an example of this jacket.

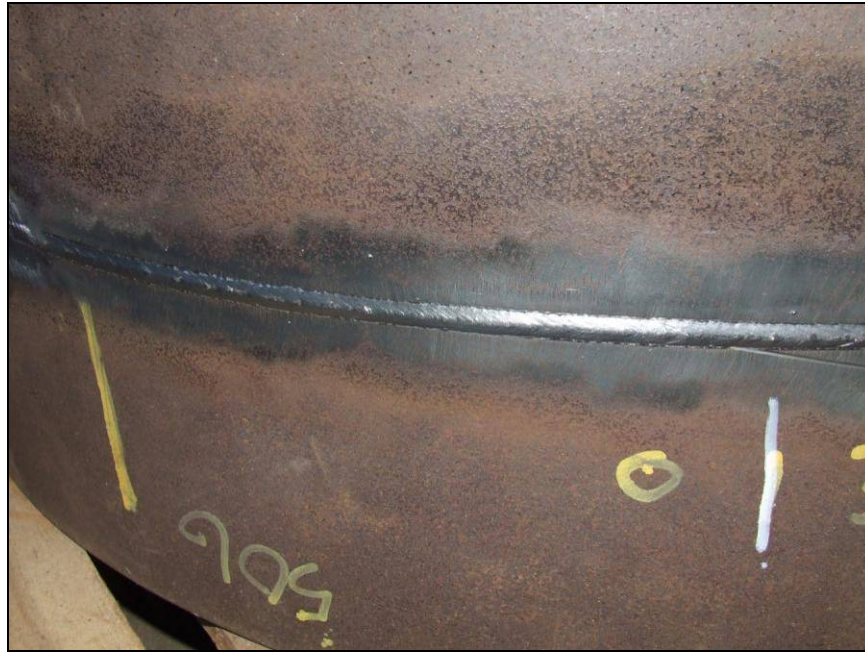
**Figure 6.35: Typical Face Bead Profile for X80**

The appearance of the root and cap passes for the X80 and X100 welds are shown in Figure 6.35 to Figure 6.38.

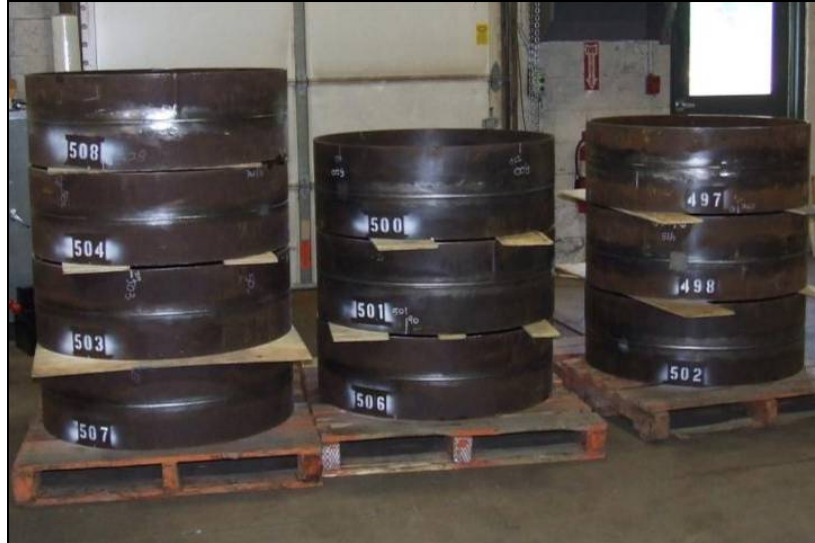
**Figure 6.39: Ten Pipe Sections Manufactured for Testing (Pipe Samples 498 to 508)**

A total of ten welded pipe sections were fabricated to be subjected to a series of mechanical testing and investigations (see Figure 6.39).

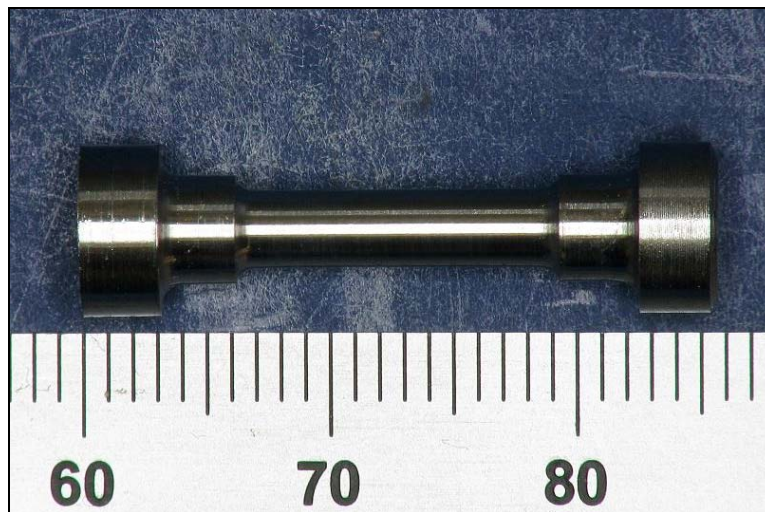
**Figure 6.44: Machine Hounsfield Specimen**

Two tensile specimen types were produced for testing. The sample geometry included strip tensile (Figure 6.43) and Hounsfield tensile specimen (Figure 6.44) types. The aim was to extract all weld metal tensile coupons from pipe numbers 503 and 507 (X80) and pipe numbers 500 and 502 (X100).

Approximately 25 mm (1 inch) lengths of X100 weld were sectioned from the 11:30 and 1:30 clock positions. The extracted coupons were then machined to a smooth finish and were then etched with 10 percent nital (see Figure 6.47). The cross hair mark visible in this image was used to indicate where the centre of the round bar specimen should be located during the EDM extraction process. The arrow in Figure 6.43(b) also indicates the centre of the round bar specimen. From these extracted round bars, 3 mm diameter Hounsfield specimens were then machined, as shown in Figure 6.44.

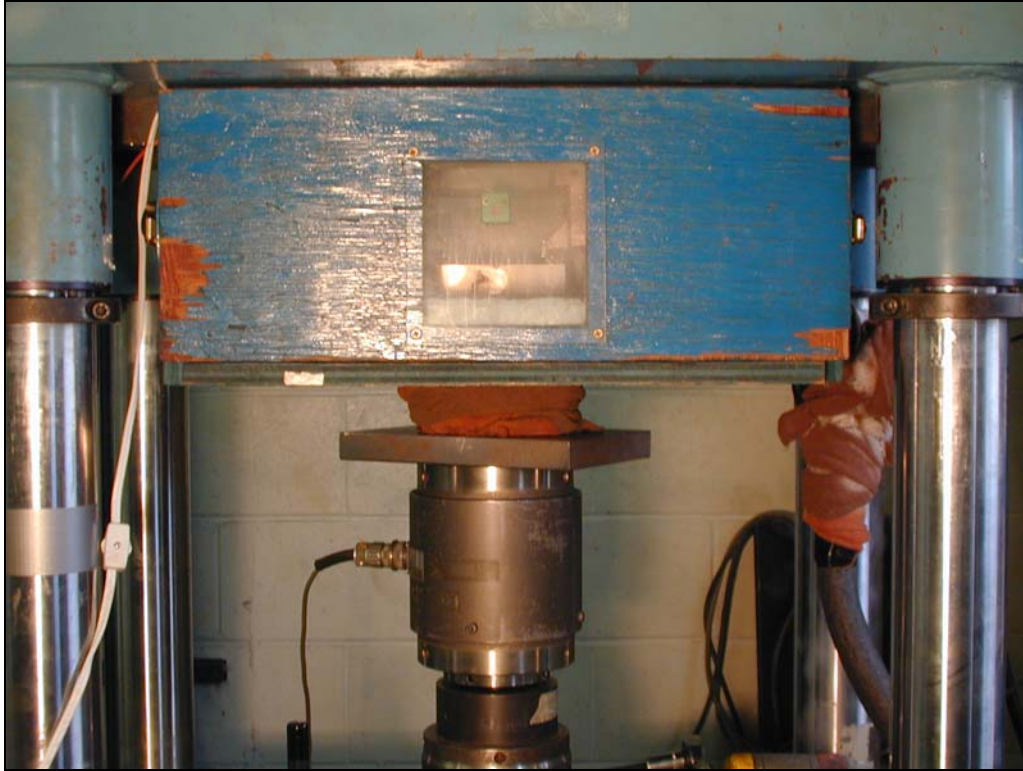
**Figure 6.87: CTOD Test Set up**

The specimens were enclosed in a chamber (as shown in Figure 6.87) and cooled by liquid nitrogen to the required temperature. Temperature control was maintained using a thermocouple attached to the specimen. After the temperature had stabilized for a minimum period that is determined from specimen thickness, they were loaded at a quasi-static rate ( $\sim 1.3MPa\sqrt{m} s^{-1}$ ). The load and the clip gauge displacements were digitally acquired for the duration of the test. The test was ended when a fracture instability event was detected from the load-CMOD curve or a maximum load plateau was reached and surpassed.

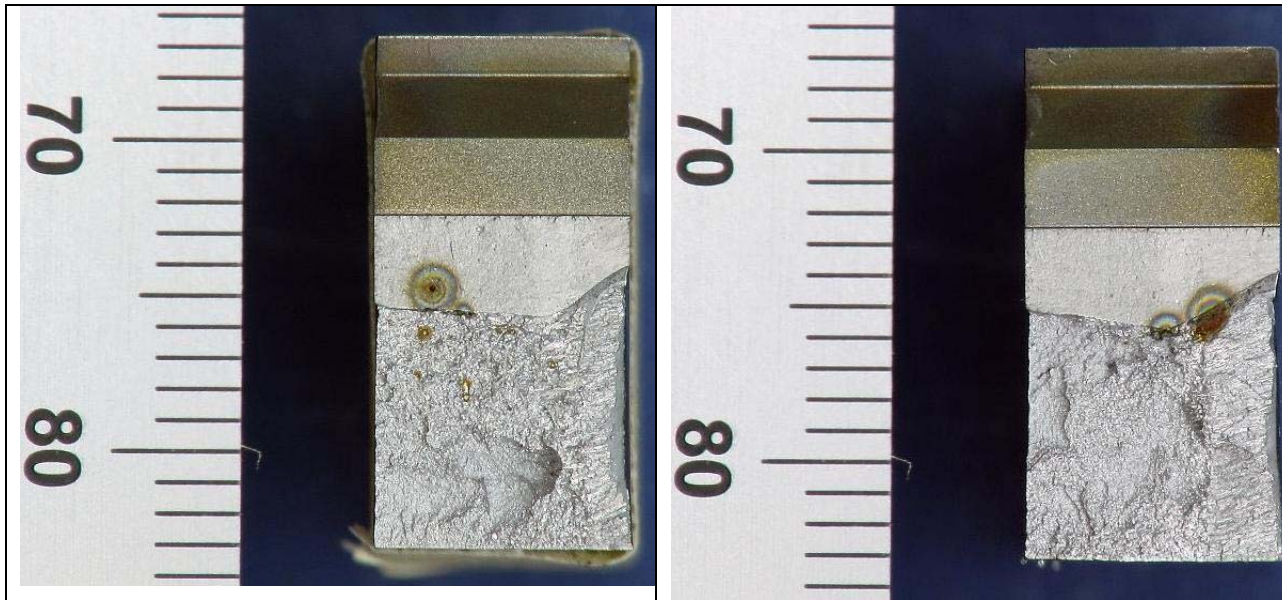
**Figure 6.88: Fracture Surface of Specimens 3W (left) and 6W (right) from X80 Pipe Weld**

The load-CMOD curves for specimens 12W and 6W from X80 pipe weld displayed only minor load drops but need to be called a  $\delta_u$  type following the procedure described in the previous section. However, it is not clear if the load drops were a result of the regions associated with discolouration at the fatigue crack front. By contrast, the specimen from the 3 o'clock location produced an “unstable” crack extension with a significant load drop that was audible. The fractures for specimens 3W and 6W from X80 pipe weld is presented in Figure 6.88 and the corresponding load-CMOD curves are in Figure 6.89. The remaining CTOD results of this set all produced ductile (upper shelf) behaviour as indicated by  $\delta_m$  type.

Pop-in events are a result of a cleavage fracture occurrence recorded by a load drop and CMOD increase followed by a subsequent increase in load beyond the load at which the pop-in event occurred. A good example of the fracture face and the corresponding load-CMOD plot is presented in Figure 6.98. In the fracture face the ductile tear is clearly visible and occurred during subsequent loading after the pop-in event. The fatigue crack profile in this example is typical of the improvement that was obtained with regard to crack front straightness as a result of lateral compression before pre-cracking (compare with Figure 6.88).

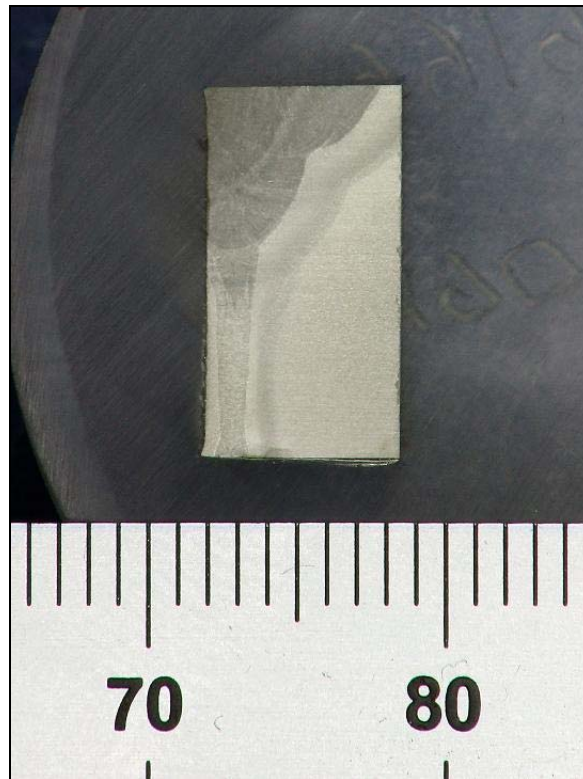
**Figure 6.103: Macrographs of Specimen 6-H1**

The fracture face in Figure 6.101 shows a dull region below the fatigue crack that is most likely to have caused the load drop displayed in the load-CMOD plot. Note that this is a gradual load drop and occurred without any audible sound and is, therefore, not typical of a brittle (cleavage) fracture. By contrast, the load-CMOD behaviour in Figure 6.103 is typical of a brittle event and corresponding sudden drop in load. The stretch zone at the root of the fatigue crack and a very small thumb nail extension before the cleavage fracture is categorized as a  $\delta_u$  type. Post test metallography carried out on specimen 6H-1 showed the fatigue crack to be in the HAZ (see Figure 6.103).
