Report # MATC-KU: 246

Repair of Skewed Steel Bridges Damaged by Distortion-Induced Fatigue

Final Report: Repair of Skewed Steel Bridges Damaged by Distortion-Induced Fatigue

Dec 2014

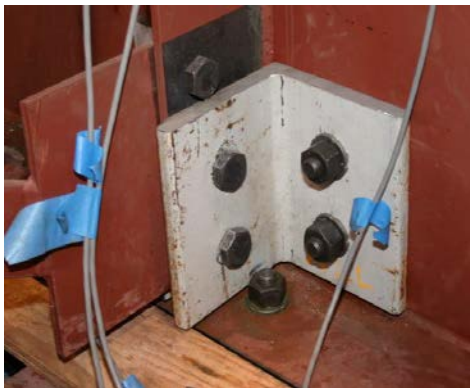
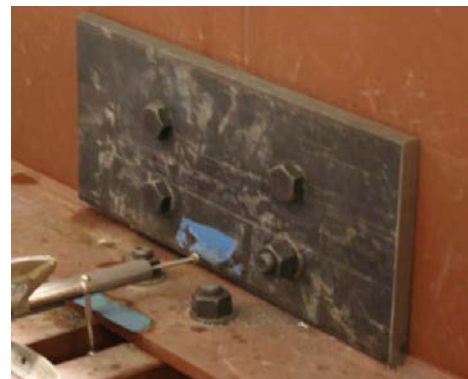
Figure 1-3: Angles-with-plate retrofit (Alemdar et al. 2014a; 2014b)

Developed at the University of Kansas, the angles-with-plates retrofit has shown its potential in repairing straight girder-to-crossframe connections (Alemdar et al. 2014a, 2014b; Hartman et al. 2013; Bennett et al. 2014). As shown in Figure 1-3, the angles-with-plate retrofit provides connection between the stiffener and the girder web, instead of connecting the flange and the stiffener. The retrofit consists two steel angles and a backing plate for an exterior connection, and four angles for an interior connection. The angles connect the stiffener to the girder web, while the backing plate distributes the load across a broad area of the web, such that stresses are no longer concentrated in a small region. The good performance of the angles-with-plate retrofit on straight girder-to-crossframe connections established in prior testing is one of the motivations for investigating its performance in skewed connections.

(a) Angle

(b) Backing plate

Many studies have been aimed at developing new stiffening techniques, but methods that rely on bolting are generally accepted to be the best option to guarantee the efficacy of the attachments. Traditionally, attachments are provided between the flange and the stiffener, but to do so, the concrete deck must be removed to drill bolt holes through the steel flanges when cracking is in the top web-gap. The difficulty involved with removing the concrete deck gives rise to the need to develop an alternative method (Bennett et al. 2014). The angles-with-plate retrofit is a stiffening method that does not require removing the concrete deck.

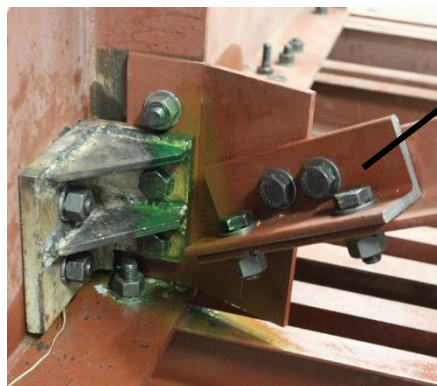
The angle bolted
to repair the crack
on the crossframe

Figure 3-2: Crack on 20-deg. skewed crossframe 697,000 cycles into Trial 20-2, and the bolted steel angle used to repair it

The crossframe was not considered to be sensitive to fatigue since crossframe cracking has rarely been reported. However, unexpectedly, the crossframe failed four times in Trial 20-2. 697,000 cycles into Trial 20-2, the actuator displacement interlock was triggered. After inspecting, a crack was observed at the junction of the crossframe angle and the bottom gusset plate. As presented in Figure 3-2, when it was observed, the crack had already cut through the vertical leg of the angle. The exact time of the crack initiation was unknown. However, initiation occurred near this cycle count since the girder had been inspected just 22,000 cycles earlier and the crack was not observed. After the crack was detected, a steel angle was bolted as a retrofit on the damaged crossframe, as shown in Figure 3-2. However, it was not able to provide enough stiffness and was unable to stop the crack growth. The crack propagated through the remainder of the crossframe member in less than 100,000 cycles.

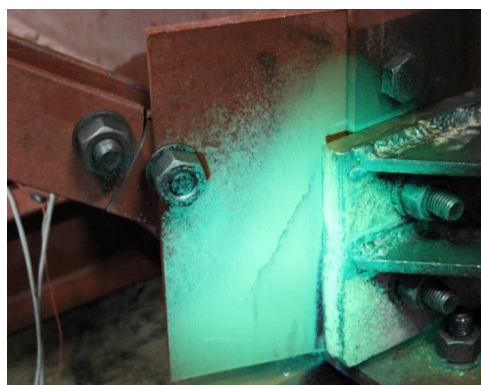
Figure 3-3: Cracks on 20-deg. skewed crossframe 775,000 cycles into Trial 2

775,000 cycles into Trial 20-2, a large crack was observed on the bottom gusset plate of the crossframe (Figure 3-3). The crack propagated along the crossframe angle-to-gusset plate weld.

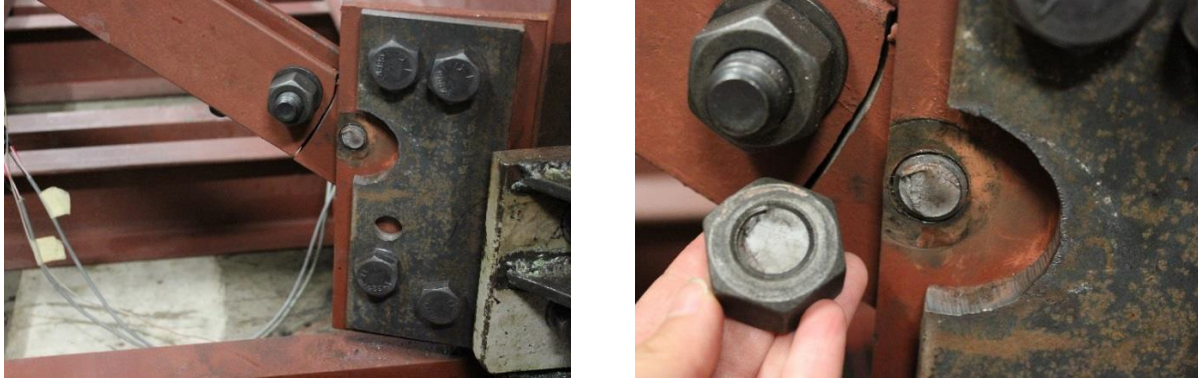
Figure 3-4: Shear failure of the bolt connecting the steel angle and crossframe

A plate was then attached to the cracked gusset plate so that test could continue. 875,000 cycles into Trial 20-2, a bolt on the steel angle used to repair the crack on the crossframe failed in shear, as shown in Figure 3-4. When it was noticed, the bolt had already failed entirely. The crack on the gusset plate continued growing and extended beyond the attached plate. The test continued after replacing the bolt and plate. However, after 22,000 cycles (897,000 cycles into Trial 2), the bolt failed again at the same location.

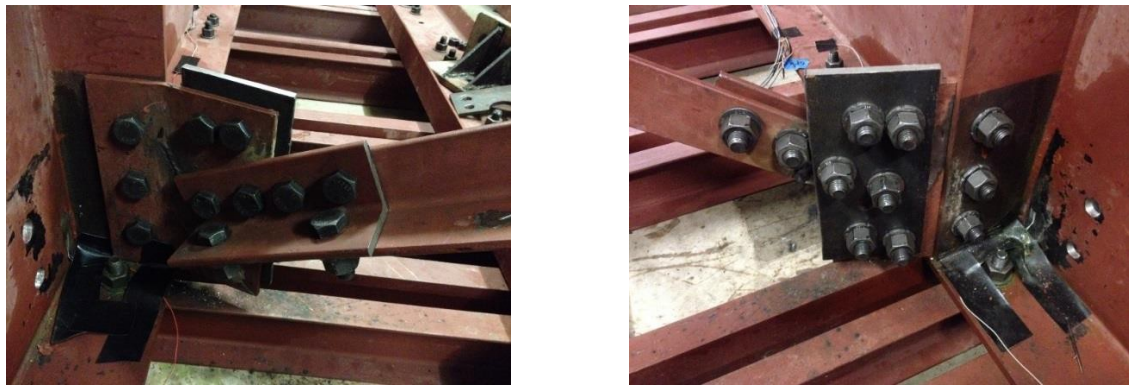
Figure 3-5: Crossframe after re-welding and repair

As presented in Figure 3-5, a decision was made to grind/weld the cracks on the crossframe, as well as to bolt the angle and the plate, and more bolts were added on the crossframe retrofit angle. The test continued, and no more problems occurred in the crossframe for the remainder of the test.

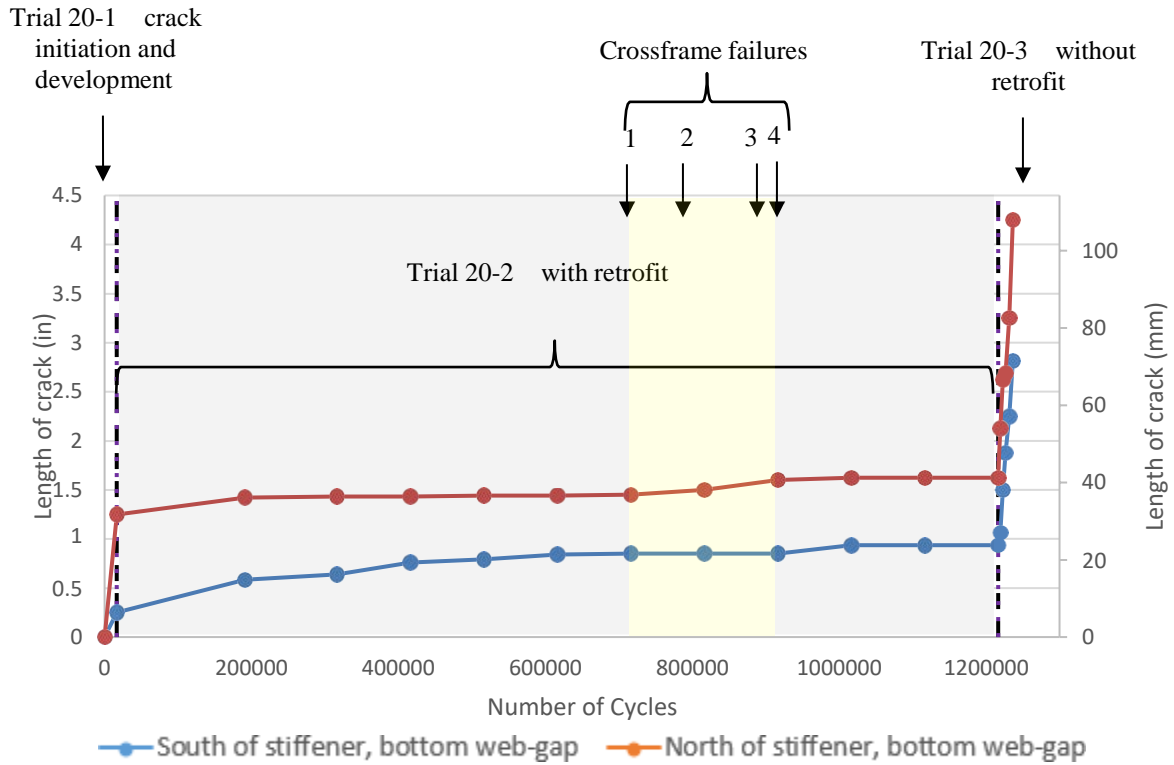
Figure 3-6: Crack propagation vs. number of applied cycles for 20-deg. skewed specimen

Figure 3-6 depicts the propagation of the bottom web-gap crack versus the number of applied cycles. In the retrofitted trial, the growth rates were extremely small compared with the rates in the unretrofitted trials. In the unretrofitted trials, the crack growth rates in the south bottom and north bottom web-gap regions were 58.2 and 106.2 in. per million cycles, respectively, while in the retrofitted trials, the crack growth rates were only 0.6 and 0.3 in. per one million cycles.

Explained below, the notations 1, 2, 3, and 4 in Figure 3-6 corresponded to the four failures of the crossframe.

1. A crack was observed at the junction of the crossframe angle and the bottom gusset plate.
A steel angle was bolted on the crossframe to repair the damage.
2. A large crack was observed on the gusset plate of the crossframe along the weld connecting the crossframe angle to the gusset plate. A plate was then bolted to the gusset plate to strengthen it.
3. The bolt used to repair the damaged crossframe angle cracked in shear. The broken bolt was replaced with a new one.

4. The bolt used to repair the damaged crossframe failed. A decision was made to grind/weld the cracks on the crossframe as well as to bolt the angle and the plate. More bolts were added to strengthen the connection.

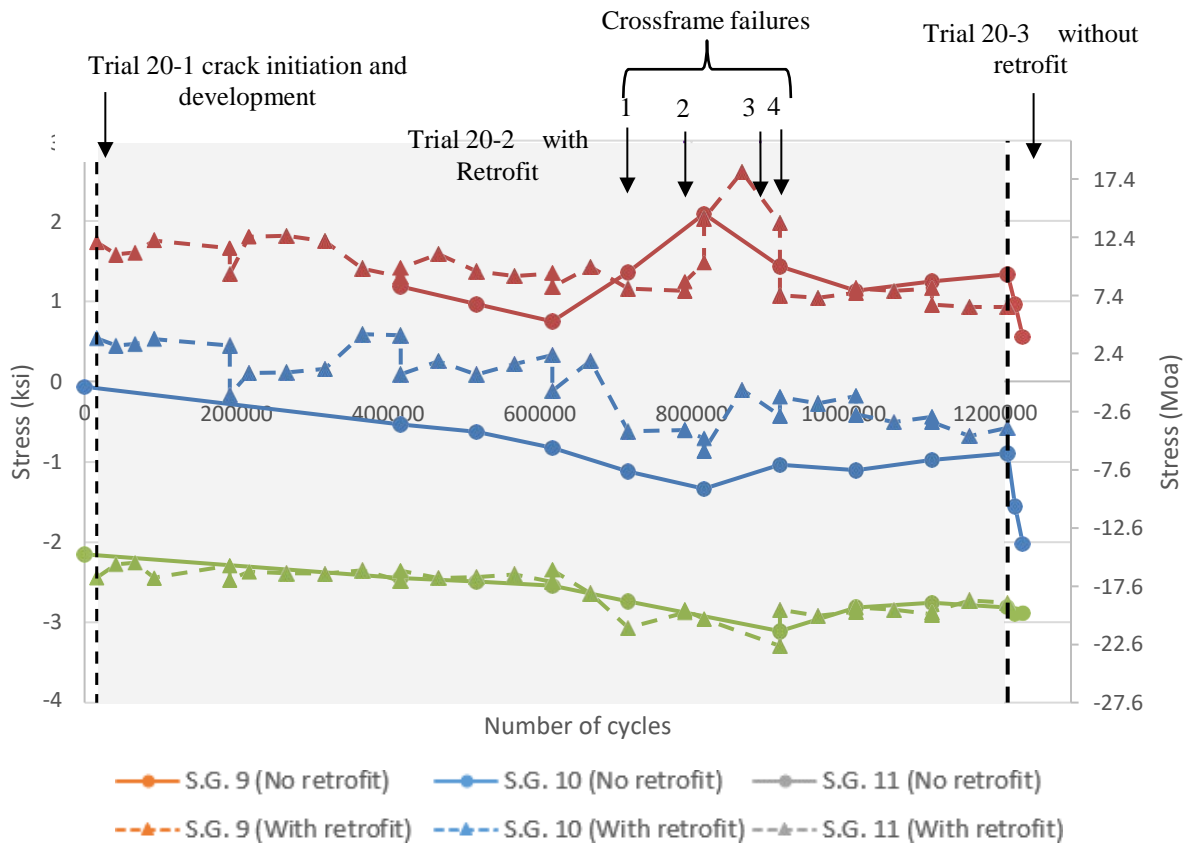
Figure 3-9: Stresses measured by strain gages placed on crossframe at 6 kip actuator force for 20-deg. skewed specimen

Figure 3-8 and Figure 3-9 present the strain gage readings at 6 kip of actuator force. The strain gage data were recorded during the intermittent monotonic tests. In Trial 20-2, the retrofit was removed every 100,000 cycles to examine the crack length. At that time, the readings made without the retrofit in place were recorded. The strain gages were fragile, especially those underneath the retrofit. That is why only a few of the gages on the lower part of the girder web were available for measurement after retrofitting.

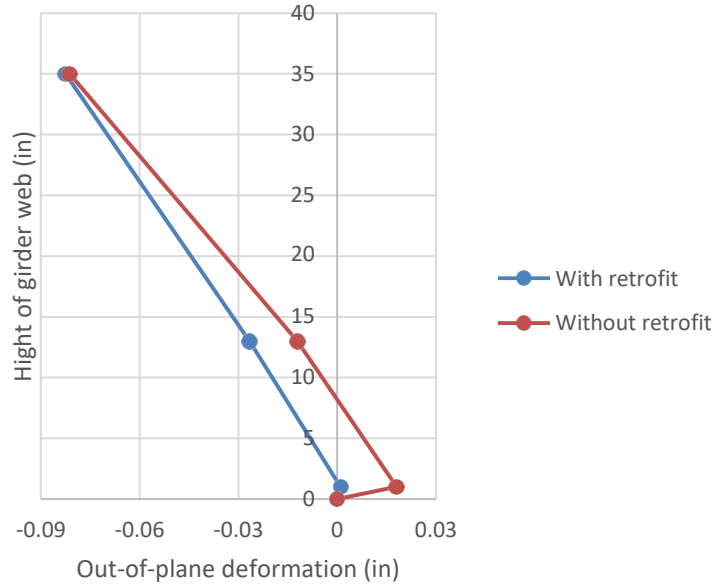
Figure 3-10: LVDT readings for 6 kip of actuator force for 20-deg. skewed specimen

The LVDT placements are shown in Figure 2-5. Figure 3-10 shows that the retrofit significantly reduced local deformations in the web-gap region. LVDT 1, located 1 in. above the bottom flange, showed a 94% decrease in out-of-plane deformations after retrofitting.

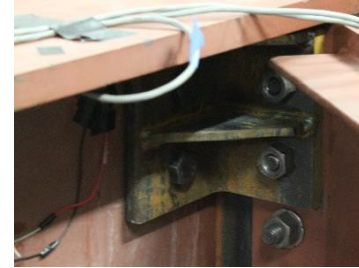
(c) Retrofit angle at top web-gap

Figure 4-2: Photographs of 40-deg. skewed specimen with angles-with-plate retrofit installed

In this test, the angles-with-plate retrofits were installed in both the top and the bottom web-gap, since cracks were found in both of the two regions. The angles-with-plate retrofit used in this test had the same dimensions as the retrofit used in the 20-deg. skewed test. Figure 4-2 presents the photographs of the 40-deg. skewed specimen and test set-up.
