FINAL REPORT ~ FHWA-OK-17-01

# DEVELOPMENT OF AN ASPHALT PAVEMENT TEST FACILITY AT THE OSU UNMANNED AERIAL VEHICLE FACILITY

Oklahoma State University

March 2017

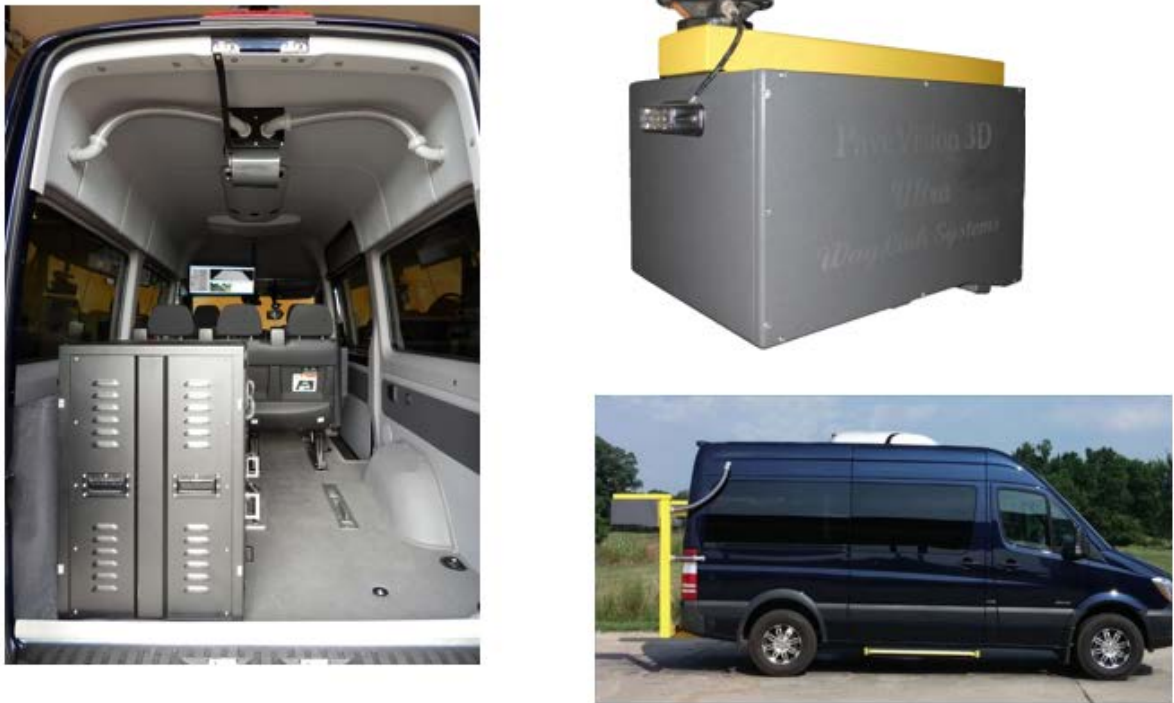
**Figure 2.1. PaveVision3D Ultra**

The PaveVision3D laser imaging system has evolved into a sophisticated system to conduct full lane data collection on roadways at highway speeds up to 60mph (96.5 km/h) at 1mm resolution (Wang, 2011). Figure 2.1 demonstrates the Digital Highway Data Vehicle (DHDV) equipped with PaveVision3D Ultra, which is able to acquire both 3D laser imaging intensity and range data from pavement surfaces through two separate sets of sensors. Recently, two 3D high resolution digital accelerometers have been installed on the system, capable of reporting compensated pavement surface profiles and generating roughness indices. The collected data are saved by image frames with the dimension of 2,048 mm in length and 4,096 mm in width. In summary, the 1mm 3D pavement surface data can be used for:

- Comprehensive evaluation of surface distresses: automatic and interactive cracking detection and classification based on various cracking protocols;
- Profiling: transverse for rutting and longitudinal for roughness (Boeing Bump Index and International Roughness Index);
- Safety analysis: including macro-texture in term of mean profile depth (MPD) and mean texture depth (MTD), hydroplaning prediction, and grooving identification and evaluation;
- Roadway geometry: including horizontal curve, longitudinal grade and cross slope.

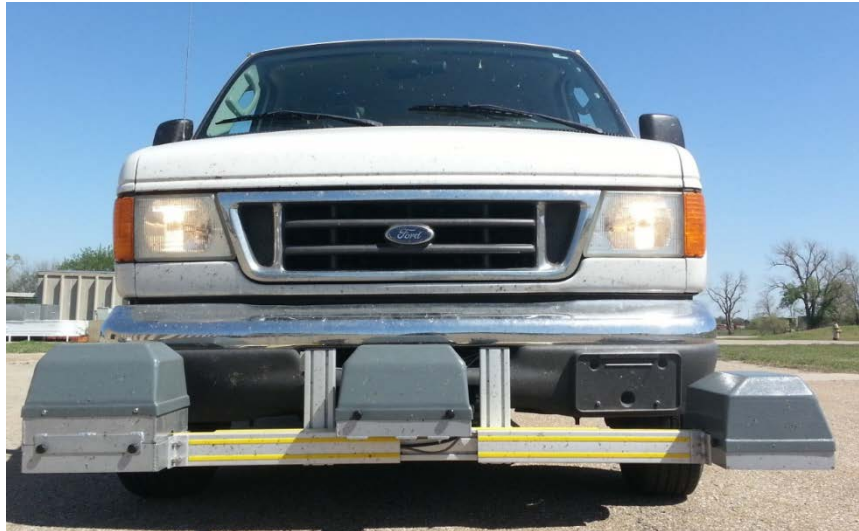
**Figure 2.2 AMES 8300 Survey Pro Profiler**

- Capable of collecting measurements at speeds between 25 and 65 mph
- Laser height sensor with a range of 180 mm and a resolution of 0.045 mm
- Horizontal distance measured with an optical encoder that has a resolution of 1.2 mm

- Pavement elevation sampling rate 62,500 samples per second
- Profile wavelength down to 0.5 mm

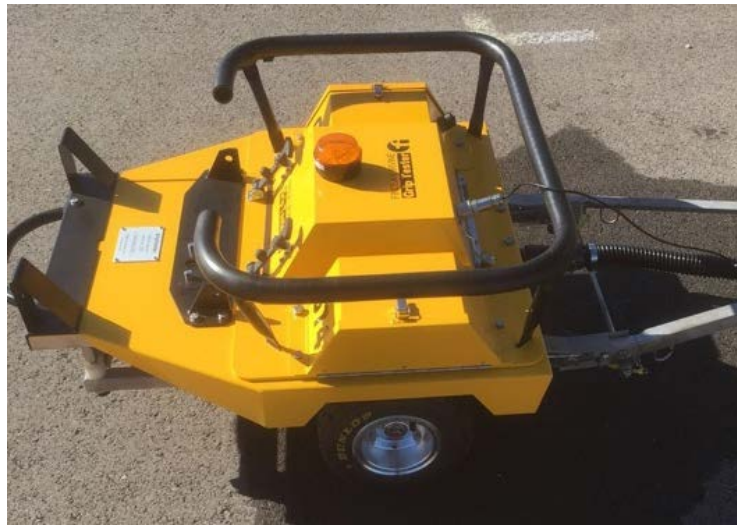
**Figure 2.5. Grip Tester**

Grip tester has been used in recent years by FHWA on many demonstration projects in the United State. It is designed to continuously measure the longitudinal friction along the wheel path operating around the critical slip of an ABS at highway speed across the entire stretch of a road with much lower water consumption, which can provide greater detail about spatial variability and be an ideal option for project and network level friction management. The device has the capability to test at highway speeds (60 mph/100 kph) as well as low speeds (20 mph/32 kph) using a

constant water film thickness. The collected data are recorded in 3-ft (0.9 m) intervals by default and can be adjusted by the user. It follows ASTM E274 - 11 "Standard Test Method for Skid Resistance of Paved Surfaces Using a Full-Scale Tire".

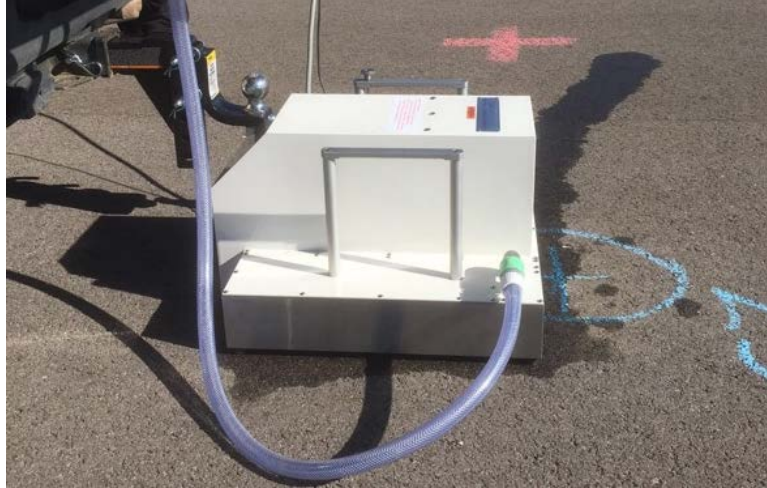
**Figure 2.6. Dynamic Friction Tester (DFT)**

This portable instrument is able to measure dynamic coefficient of friction in accordance with the ASTM E1911 specification. DFT has been widely used in friction measurements under various conditions to measure the speed dependency of pavement friction by measuring frictions at various speeds.

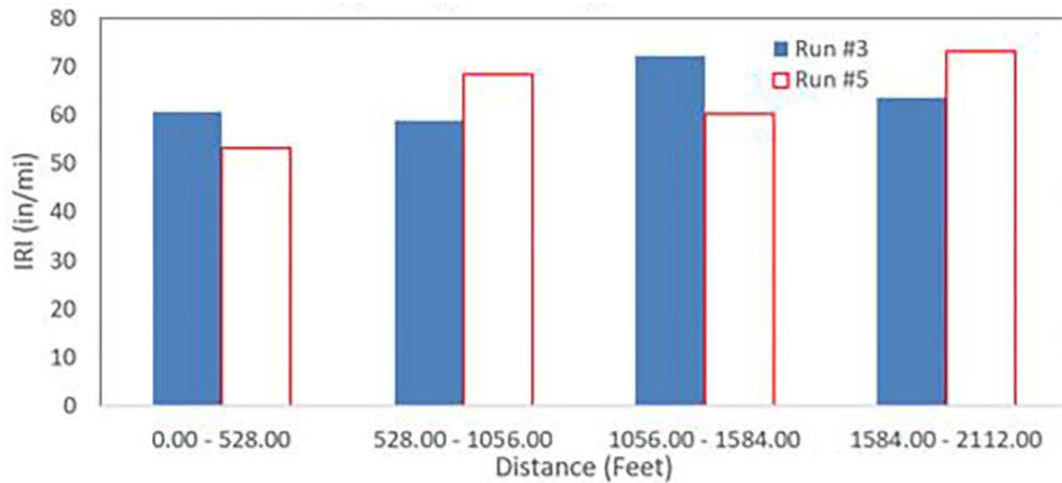
**Figure 3.4. Runway Longitudinal Roughness**

Two longitudinal profiles are collected on the airport runway. In total there are 57 in. of height difference along the entire runway with an average longitudinal grade of 0.2%. It should be noted that approximately 300ft of the runway (from 850 ft to 1150 ft) has a close to zero longitudinal slope. International Roughness Index (IRI) is subsequently calculated at 528 ft interval (0.1 miles) from the two longitudinal profile data to evaluate runway roughness condition and the IRI results are plotted in Figure 3.4. The average IRI values are 63.9 in/mi for Run #3, and 63.7 in/mi for Run #5.

In addition, eleven transverse profiles are collected at an interval of 200ft. The centerline of the runway is on average 4.5 in. higher than the two edges with an approximately transverse slope of 1.25%.

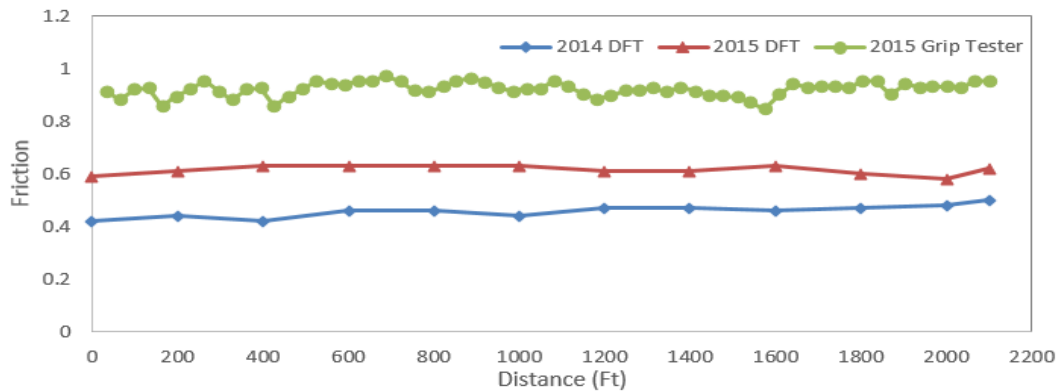
**Figure 3.5. Runway Friction Results**

The eleven DFT measurements along the two paths are provided in Table 3.1 and plotted in Figure 3.5. It should be noted that the DFT friction numbers measured

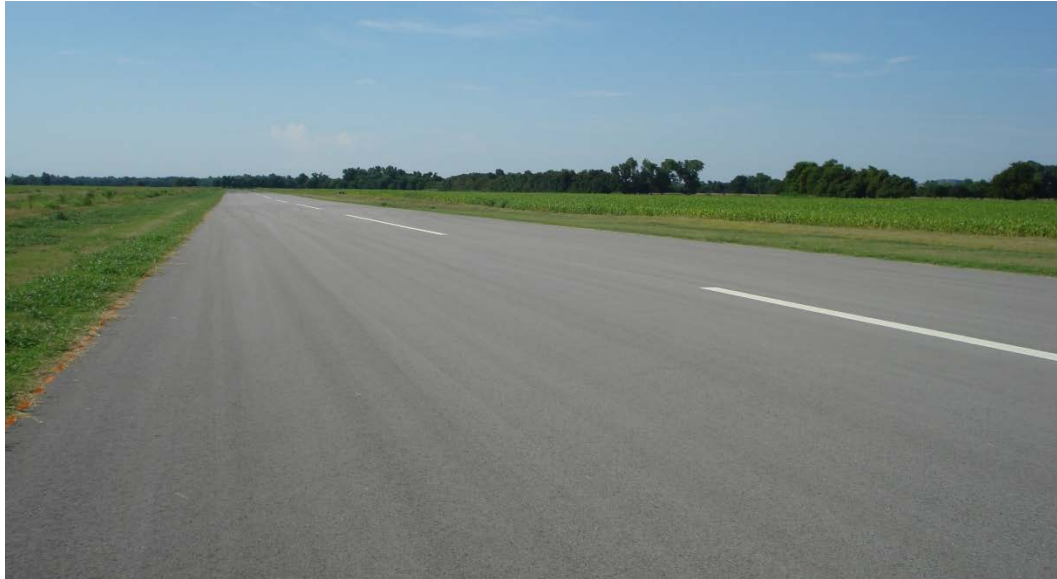
**Figure 5.1. Existing Runway at OSU's UAV Facility**

According to the original construction plans, the existing runway is approximately 2,200 feet long and runs north to south. The pavement section consists of four inches of a Type B mix placed on six inches of aggregate base. It is believed a separator fabric was placed on top of the prepared subgrade prior to placing the aggregate base. The paved section of the runway is 60 feet wide with a 1.5% crown. The runway has a 1.5% cross-slope extending from the centerline of the runway in both directions to the edge of the paved runway and then extends another 30 feet, at the same slope, to drainage ditches that extend the full length of the runway on both sides. This 30 foot wide section is covered in grass. The aggregate base extends approximately 12 to 18 inches beyond the edge of the paved runway but does not extend to the surface. Soil was placed over the extended aggregate base. In other words, the paved runway is built in a “bath-tub” section with

any water that enters the aggregate base having no quick way to exit the pavement section as the drainage ditch is 30 feet away. Figure 5.1 shows the existing runway. The drainage ditches along the sides of the runway are not visible in the photo.

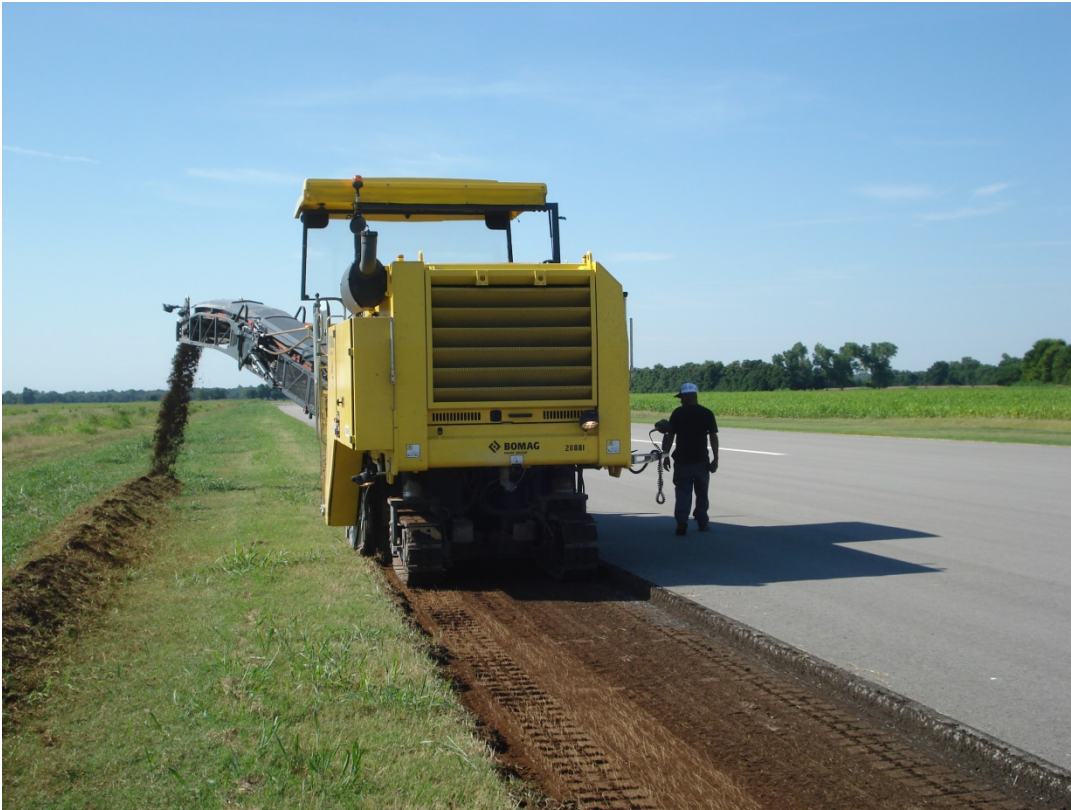
**Figure 6.1. Cold Planer Excavating Material for Shoulder Placement**

As previously described, the existing runway consisted of four inches of a Type B mix placed on six inches of compacted aggregate base. The aggregate base extended approximately 12 to 18 inches beyond the edge of the paved runway. A clay soil with grass vegetation growing on top extended over the aggregate base to the edge of the paved runway. The contractor chose to use a cold planer (milling machine) to excavate the shoulder area to the required four-inch depth and 1.5% cross-slope. Even though construction occurred on August 23, 2016, the material excavated was moist and occasionally came up in chunks. Figure 6.1 shows the cold planer excavating the material to the required depth and cross-slope.

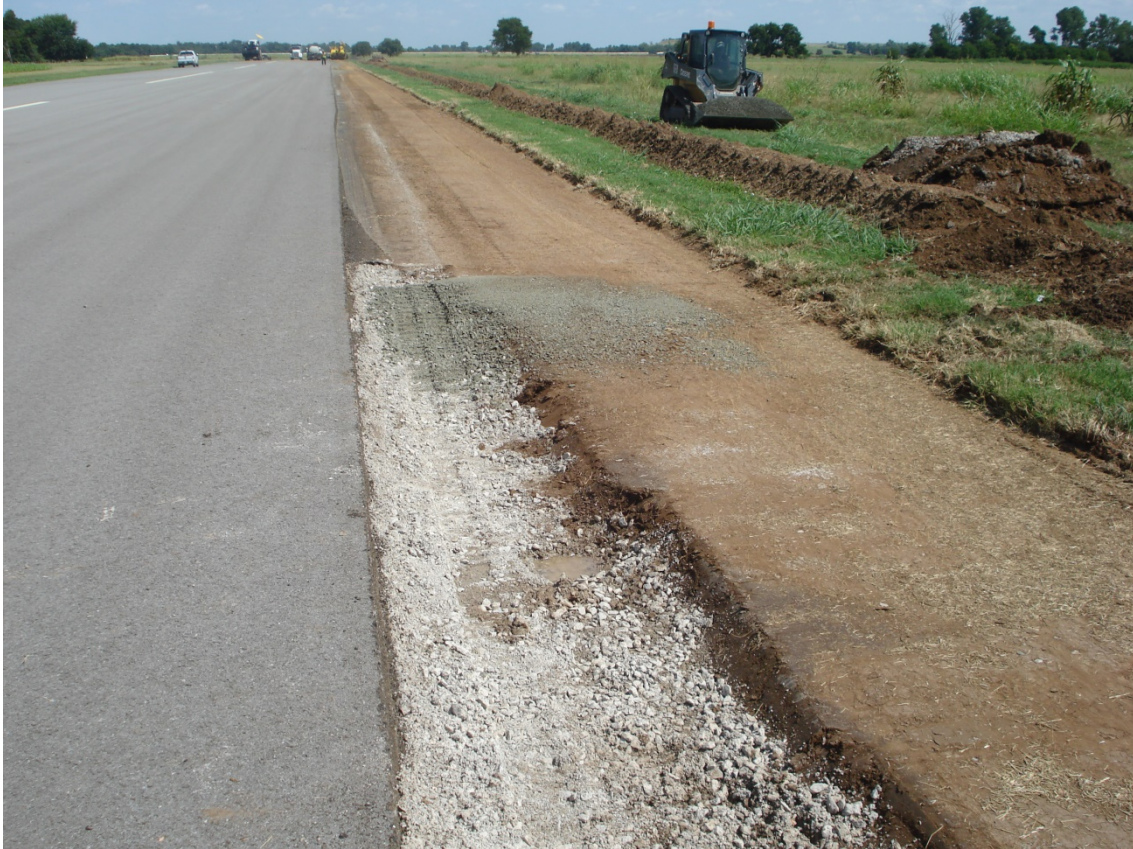
**Figure 6.2. Over Excavation Area Filled With Crusher Run Material**

Placement of the asphalt shoulder mixes occurred on August 26, 2016. Rain fell on the site late on the 25<sup>th</sup>. Prior to beginning paving operations the subgrade was proof rolled with a pneumatic roller. No areas of pumping subgrade were noted but there were several areas of standing water in the excavation. The contractor chose to over excavate these areas and fill the excavation in with 3/4 inch crusher run material as shown in figure 6.2. The crusher run material was compacted with a steel-wheel roller.

It was beyond the scope of this project to determine the exact cause of the pumping of the subgrade. It did rain on the site the night before paving and several wet spots were noted at the edge of the runway. These areas were over excavated by the contractor and replaced with crusher run material at his own expense. It should be noted that pumping did not occur during proof rolling of the subgrade or during compaction of the crusher run material in the over excavated areas. No pumping or distortion of the ground was noted between the road and the north end of the runway where all the haul trucks entered the site.

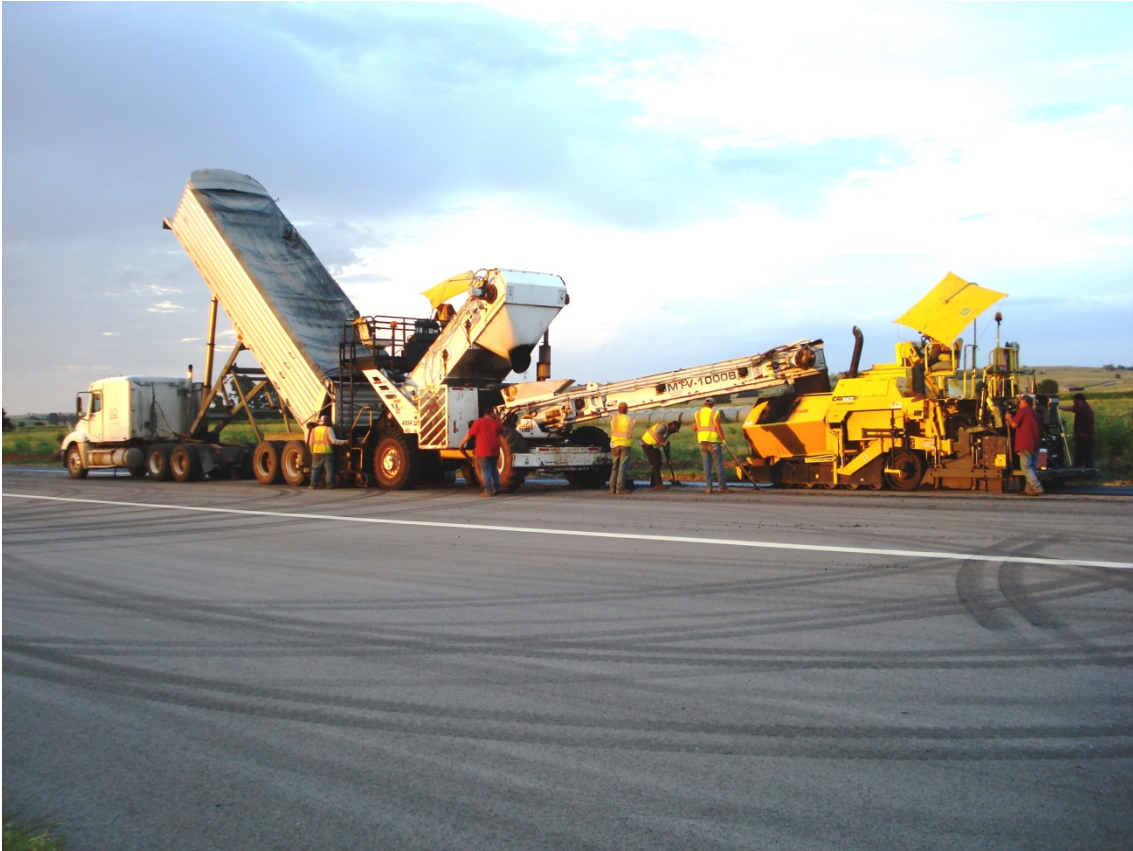
**Figure 6.3. Paving Train Placing Shoulder Mix**

All nuclear density testing used to establish the rolling patterns indicated adequate compaction was being achieved. Results were not reported by CEC as it was intended to come back and cut cores on the completed pavement. Due to the pumping of the subgrade it was later decided by the PI and ODOT to forgo coring of the mixes. A shuttle buggy was used to transfer the mix from the haul trucks to the paver hopper, keeping all unnecessary construction traffic off the subgrade. It should be noted that all haul trucks drove over unpaved ground for a considerable distance to reach the north end of the runway. No pumping or distortion of the ground north of the runway was noted during or after completion of the paving operations. Figure 6.3 shows the paving train used to construct the paved shoulder.

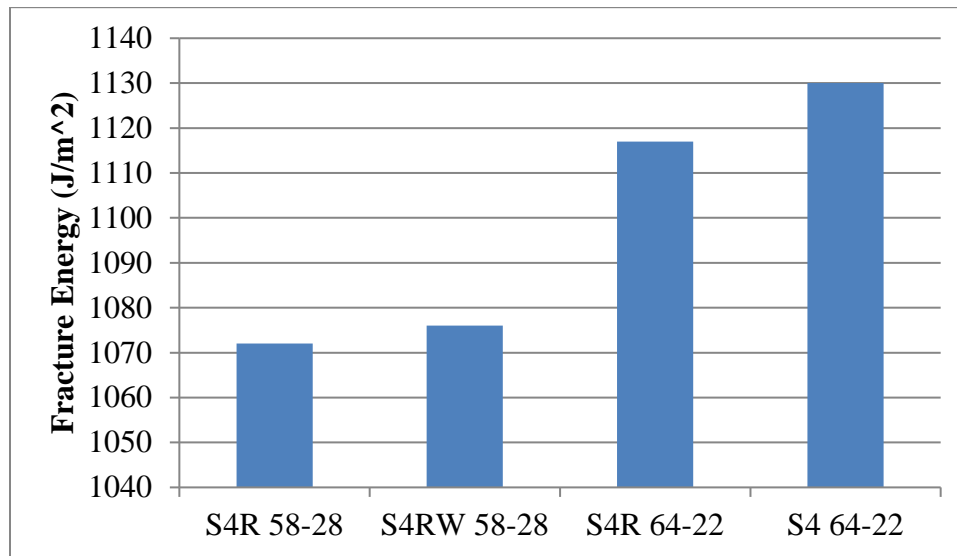
**Figure 7.4. SCB Fracture Energy**

According to AASHTO TP 124 (AASHTO, 2015b), a mixture's calculated fracture energy indicates its overall capacity to resist cracking related damage. A mixture with higher fracture energy should be able to better resist stresses and have higher damage resistance. A study by Illinois (Al-Qadi, 2015) was not able to satisfactorily correlate fracture energy with observed performance. However, the general trend of higher fracture being associated with less pavement cracking was observed. The results of the SCB fracture energy tests are shown in figure 7.4.

As shown in figure 7.4, the evaluated mixtures were ranked from highest to lowest fracture energy as the S-4 PG64 mix, the S-4 R PG64 mix, the W S-4 R PG58 mix and the S-4 R PG58 mix. It was expected that the S-4 PG64 mix would have the highest fracture energy, due to the lack of RAP in the mix. However, it was expected that the PG58 mixes would have more fracture energy and better cracking resistance than the S-4 R PG64 mix. It should be noted that the Illinois study (Al-

Qadi, 2015) reported that fracture energy did not correlate to field performance as well as Flexibility Index.
