Final Project Report

| Project Title: EXTERNAL PIPELINE COATING INTEGRITY- One Year Extension | | |
| DOT PHMSA Advances Coatings R&D Contract # DTPH56-06-T-000022 | | |

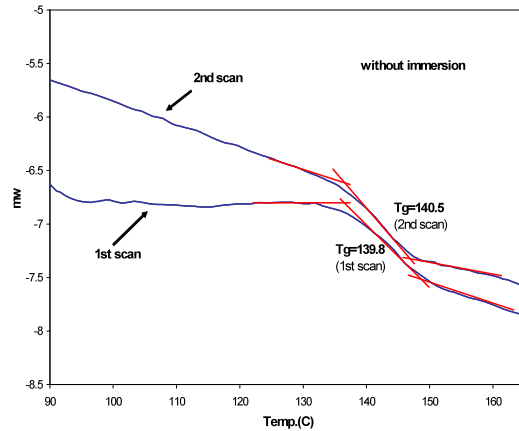
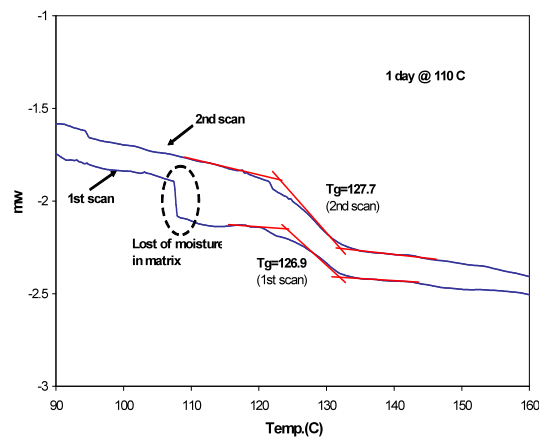
The DSC curves of FBE from System 1-2 were shown in Figure 4.1-5. The T_g of the FBE material shows a significant drop from about 140°C to 126°C with only 1 day of immersion at 110°C. The DSC curves of FBE for System 1-3 show that after changing the post-cure time, the T_g of FBE exhibits a less drop from 140°C to 134°C with 1 day of immersion at 110°C and to 136°C with 1 day of immersion at 95°C, respectively.

Figure 4.1-5. DSC curves of FBE of System 1-2: a) virgin sample and b) 1 day water immersion at 110°C.

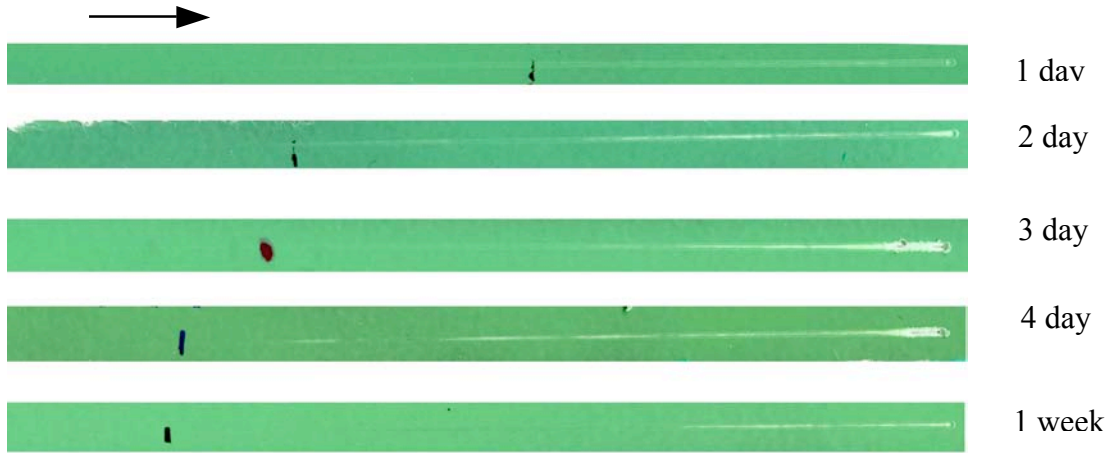
Scanned images of coating scratches for three systems with various coating thicknesses with an immersion time of up to two weeks at a water temperature of 95°C are shown in Figures 4.1-6 to 4.1-8. The observed locations of the onset of debonding were marked for comparison.

Figure 4.1-6: Scratch test results for coating System 2-1 (DFT = 4mils) after water immersion at 95°C. A normal load range of 1-95N was applied.

With coating delamination found on all the tested samples, the size of the delamination area and its onset location are quite different. Those differences are believed to be due to the thicker coating, which delays the water permeation and immersion degradation. At the same time, the thicker coating also requires a higher load to achieve similar stress levels to induce the debonding.

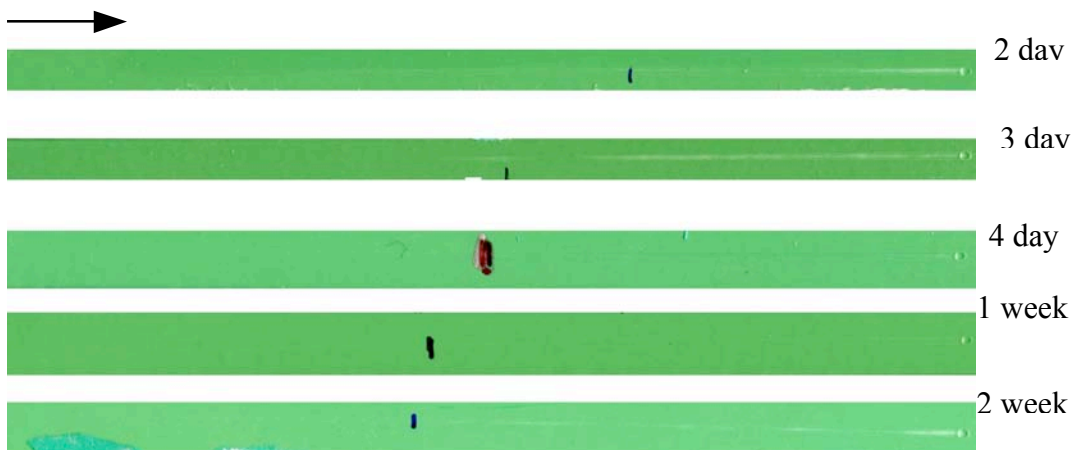
Figure 4.1-8: Scratch test results for coating System 2-3 (DFT = 12mils) after water immersion at 95°C. A normal load range of 1-95N was applied.

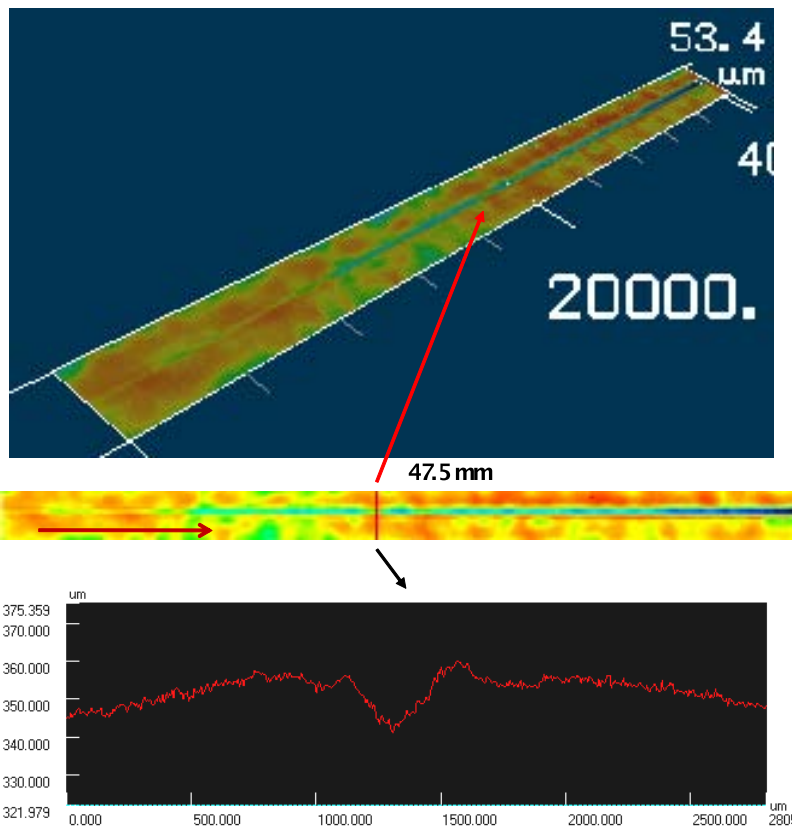
A typical image of the rusted scratch sample is shown in Figure 4.1-9. Here, the beginning point and the shape of rusted area give a good hint where the onset debonding happens. A typical LSCM three-dimensional image of the surface profile of a scratched sample is shown in Figure 4.1-10 for System 2-1 after three days of water immersion. The bulging of the scratch path can be readily observed from both the three-dimensional and the cross sectional profile of the scratch groove to identify the initial point of coating debonding.

Figure 4.1-10: Onset coating debonding detection by LSCM for System 2-1 after three days of water immersion.

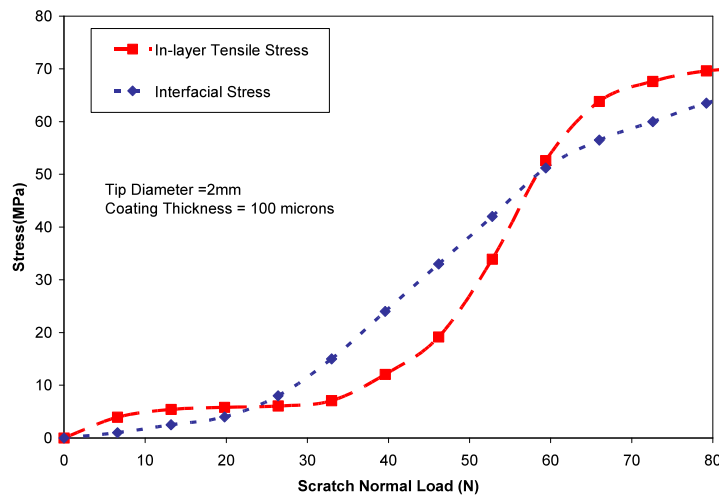
The material properties for the FEM modeling are shown in Table 4.1-2. The occurrence of transverse crack and adhesive delamination depends on the coating ductility, adhesive strength, the ratios of E_c/E_s , σ_{yc}/σ_{ys} , and the coating thickness. Figure 4.1-14 shows the change of the debonding stress and the in-layer tensile stress as a function of the increasing normal load of scratch.

Figure 4.1-14. Interfacial Debonding Stress vs. In-layer Tensile Stress as a Function of Applied Scratch Normal Load.

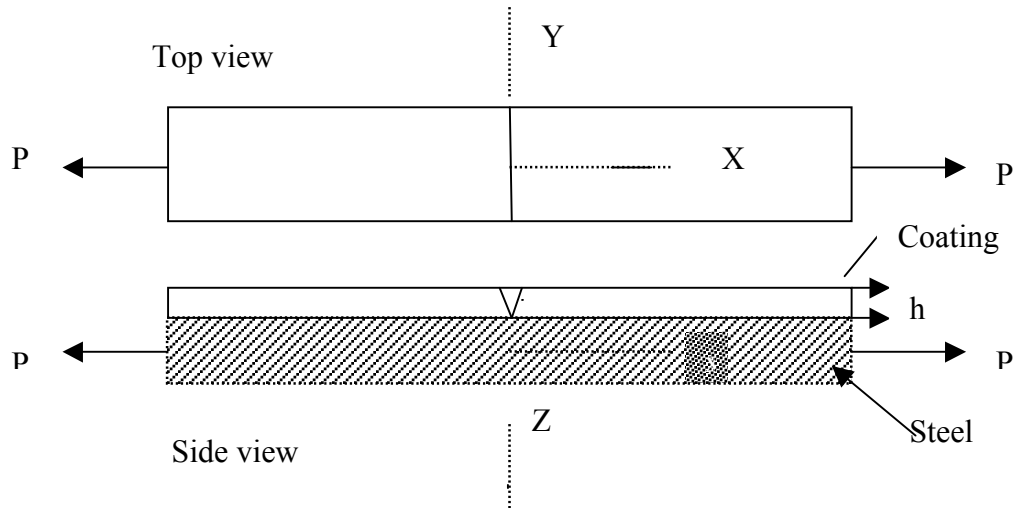
We assume that the coating is isotropic to act in a linear elastic fashion. A linear elastic assumption is made for the substrate.

Figure 4.2-1 Notched Coating Adhesion Specimen.

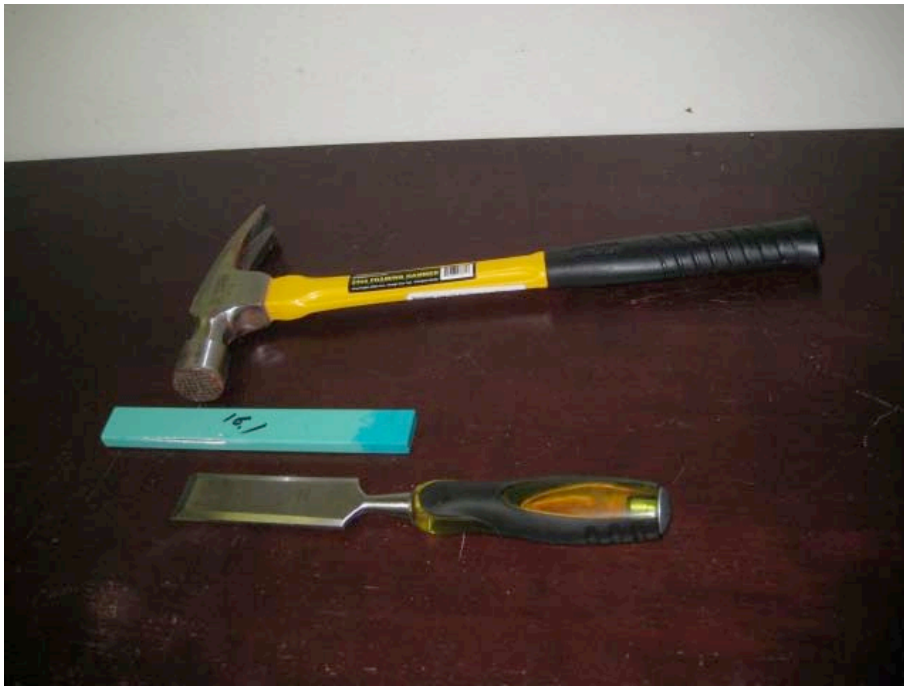
After the specimen has been environmentally aged or conditioned, a notch is introduced into the coating layer to sever the coating. Firstly, use of a chisel to hit the coating surface with a hammer to generate a coating-steel interfacial precrack. The setup is shown in Figure 4.2-2. A concomitant coating debonding can also occur at the edge of the indenter and extend for a

Figure 4.2-2 NCA Test Setup to Generate a Precrack.

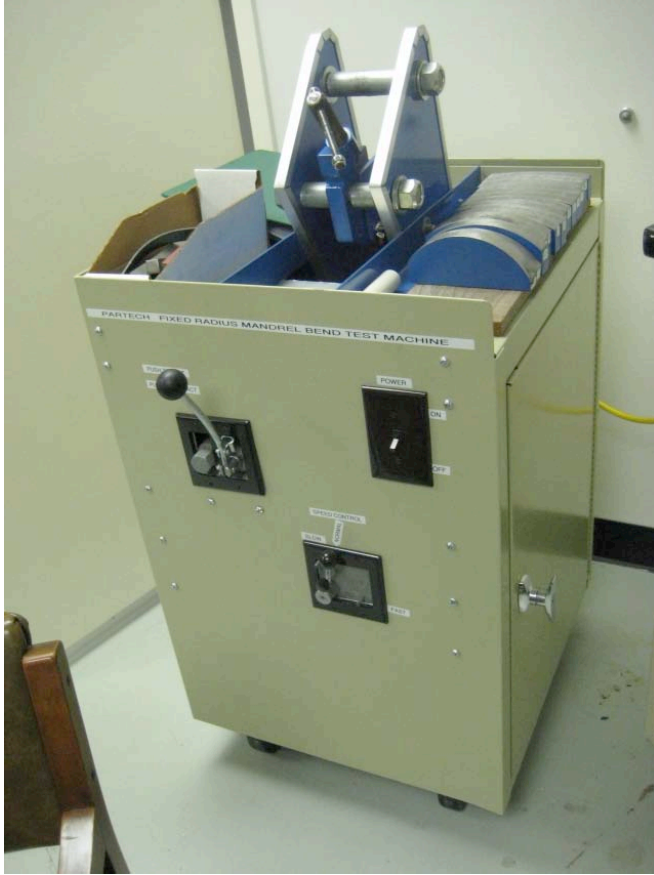
The specimen is loaded in bending by a fixed radii mandrel bending tester. The critical strain at which the debond starts to propagate is recorded. The debonding can be observed from the side of the specimen after each bending testing. The critical strain is defined as the strain where the initial debond begins to propagate. The primary concern when performing the NCA test is consistently determining the initial debonding stage. This determination is a source of experimental error since it depends on the reactions and discretion of the experimenter.

Figure 4.2-3 Fixed Radii Mandrel Bending Machine.

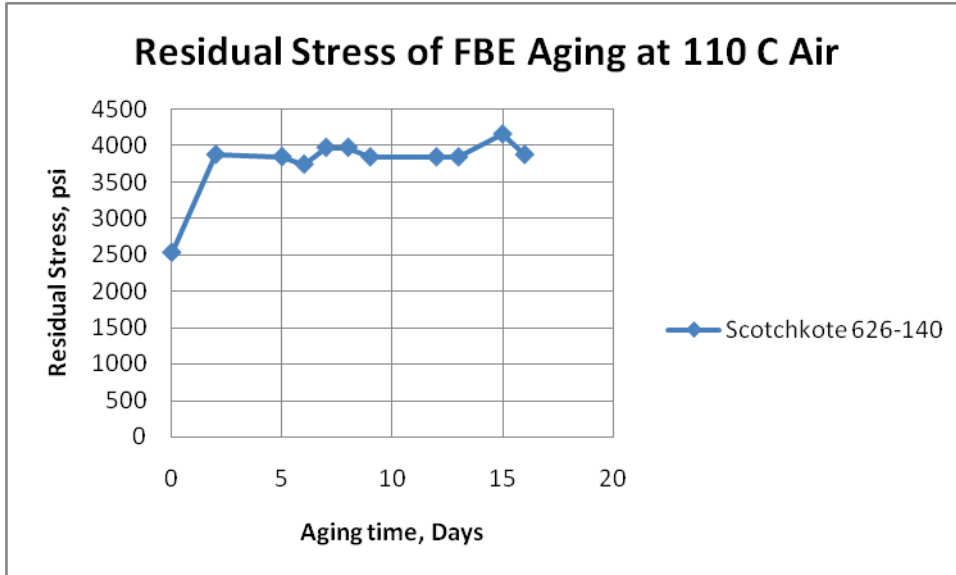
Residual stress in the FBE immersed in water or aging in 110 °C air will be relaxed or increase due to dimensional swelling or shrinkage. The FBE coated steel shim is aged in 110 °C oven and RT water. We monitor the radius of curvature and calculate the residual stress. The residual stress for the FBE aged at 110 °C increases in less two days to its highest value of around 4,000 psi. The CTE is $5.0 \times 10^{-5} / ^\circ\text{C}$ for the dry FBE sample. This is the true CTE for the FBE without the effect of water absorption in ambient condition. The lower value of CTE measured on the FBE sample, which has absorbed equilibrium amount of water at RT. When we measure the CTE, the FBE is heated with a constant heating rate. When the FBE sample is heated, the FBE expands, but also loses water. Therefore, the CTE value for the RT conditioned sample is lower than the CTE for the dry sample at 110 °C. The residual stress after aging at 110 °C is approximately 4000 psi, as shown in Figure 4.2.5.

Figure 4.2-5 Residual Stress of Scotchkote 626-140 Aging at 110 °C Air.

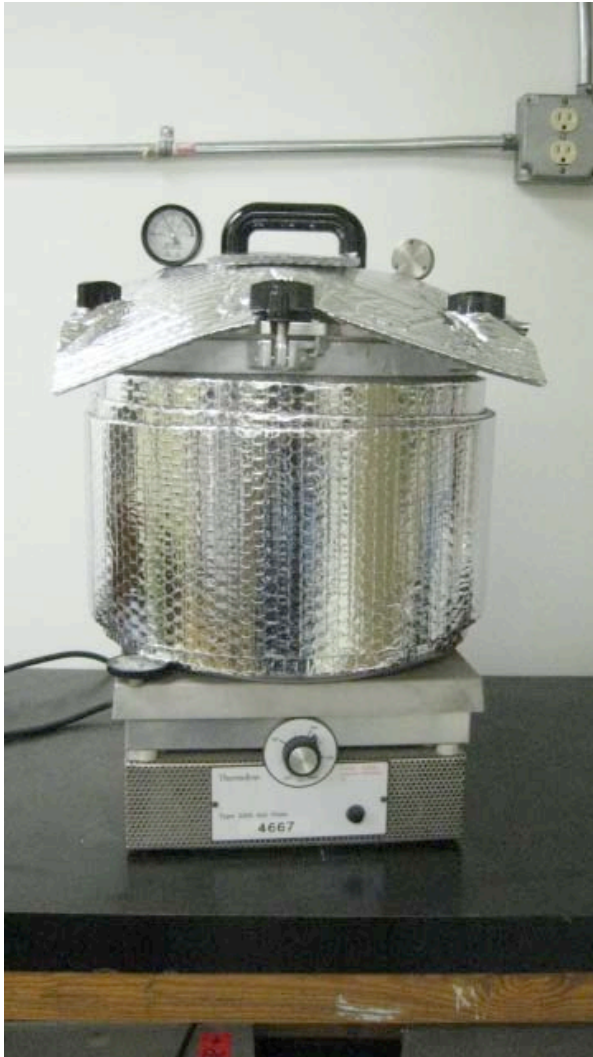
Figure 4-2.6 110 °C Water Immersion of FBE Samples in an Aluminum Autoclave.

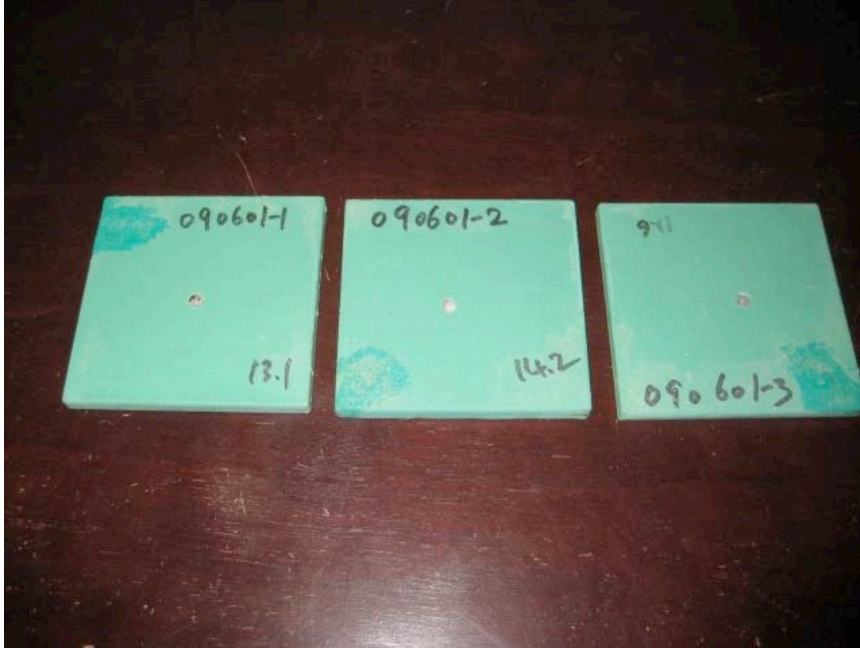
No disbondment can be detected after 12 weeks water immersion in 95 °C water, as shown in Figure 4-3.1. Zero wet disbondment was also observed on the three panels for 103 days immersion at 110 °C, as shown in Figure 4-3.2. No blisters are observed on all panels.

Figure 4.3-1 Wet Disbondment after 12 weeks 95 °C water immersion.

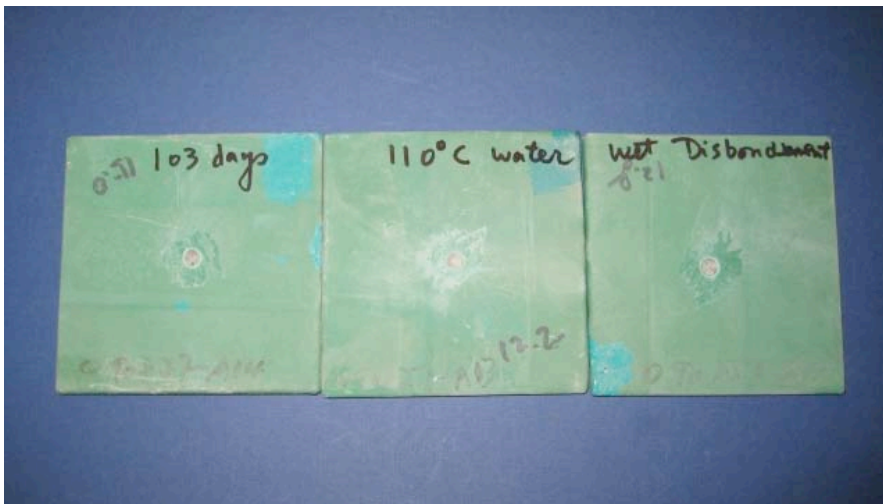
Figure 4.3-2 Wet Disbondment after 103 days 110 °C water immersion.

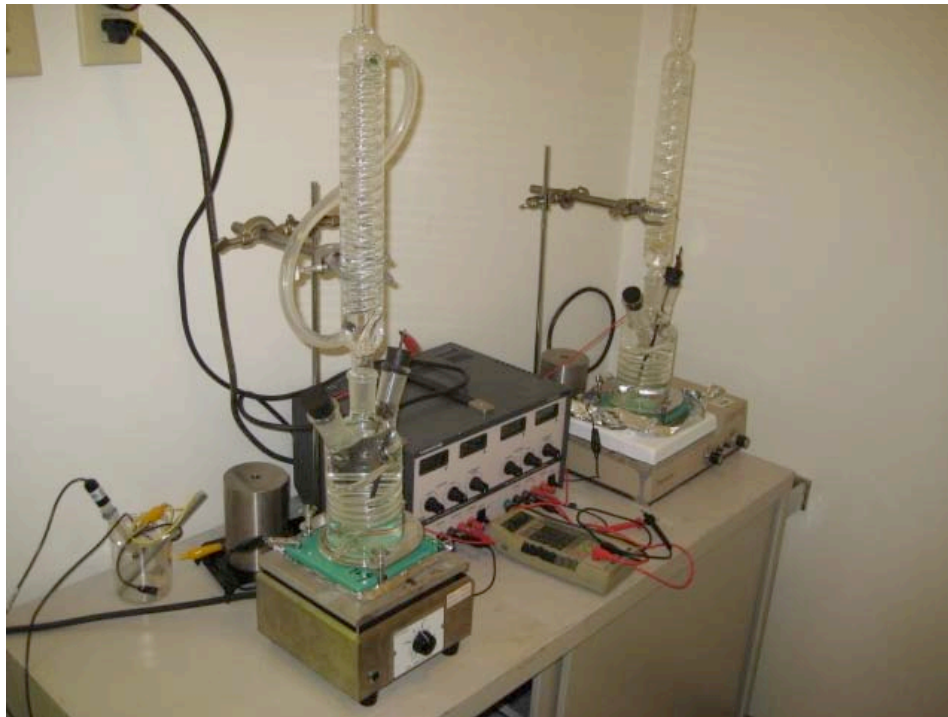
The CD test setup is shown in Figure 4.4-1. The original test setup is from 3M and ShawCor.

Figure 4.4-1 Cathodic Disbondment Test Setup for 95 °C and 110 °C.

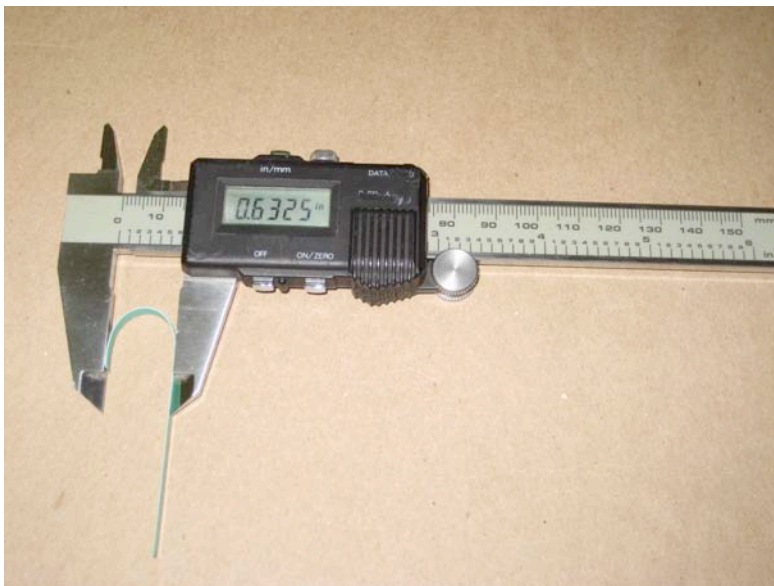
The coating material flexibility can be measured by caliper bending of free coating in accordance with ASTM B490- Standard Practice for “Micrometer Bend Test for Ductility of Electrodeposits”. The experimental method for the caliper bending of free films, as shown in Figure 5.1.

Figure 5.1. Caliper Bending of Free Films.

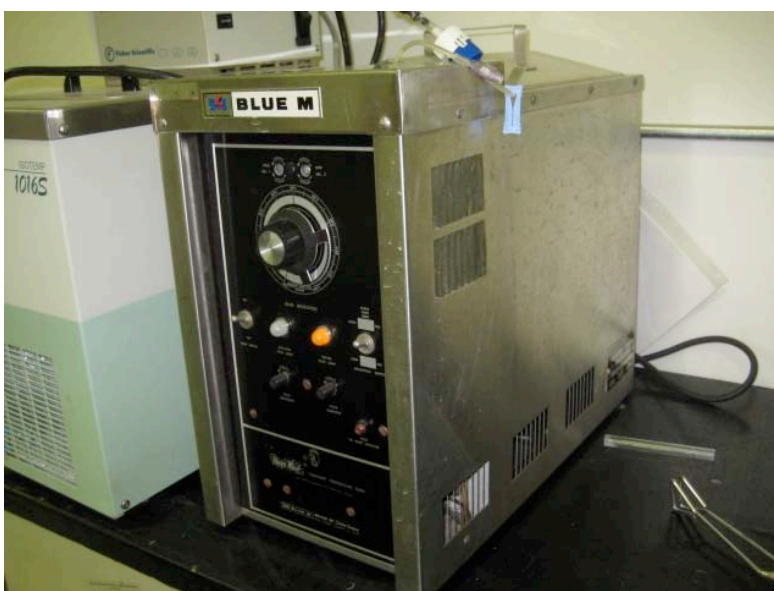
Dry air aging at 110 °C was done in an oven. Hygrothermal aging at 95 °C was done in a Blue M water bath as shown in Figure 5.2. Hygrothermal aging at 110 °C was done with an ACE Pressure Glass tube, as shown in Figure 5.3 and the tube was filled with tap water and strip film samples in a 110 °C oven.

Figure 5.2. Hygrothermal Aging of Coating Samples at 95 °C Water.

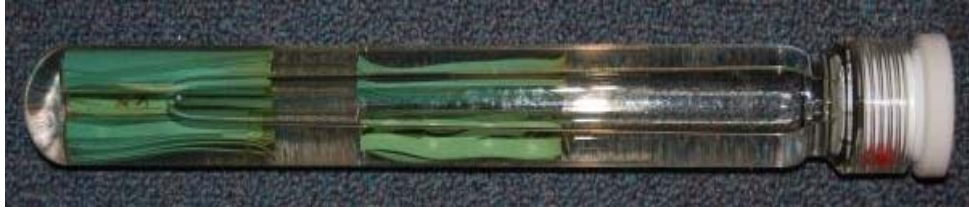
Figure 5.3. Hygrothermal Aging in a Pressure Glass Tube in 110 °C oven.

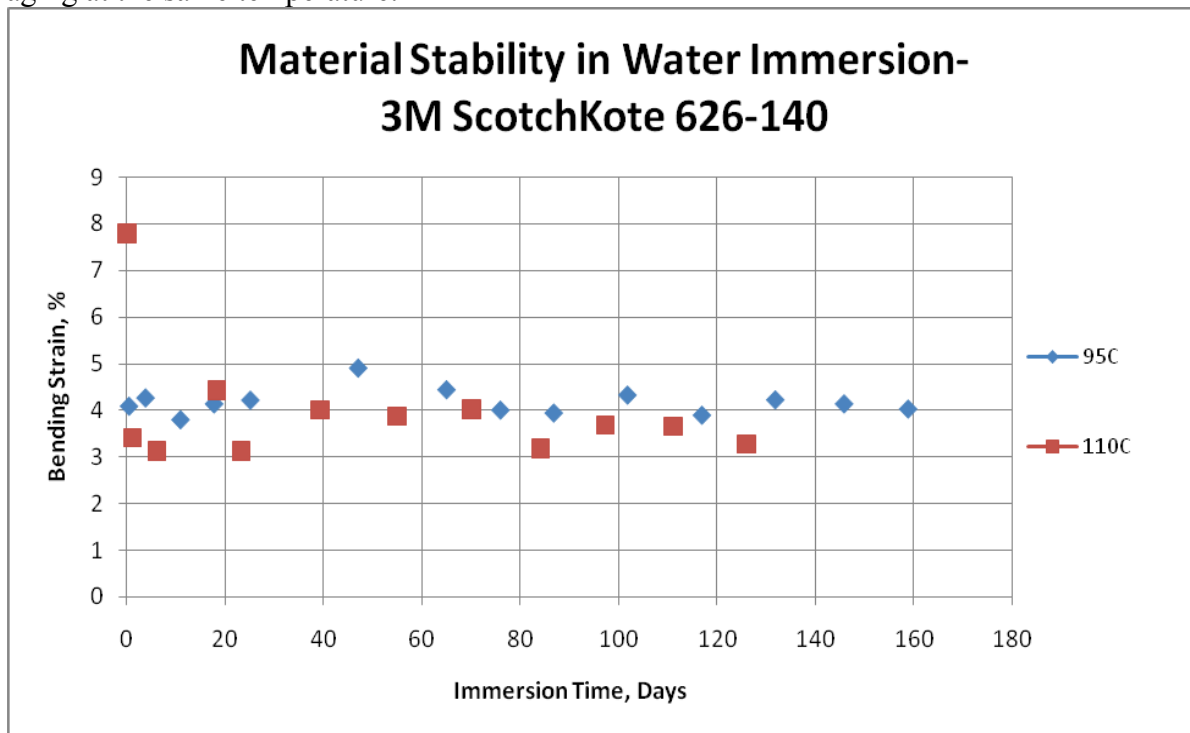
The bending strain results for 95 and 110 °C water immersion are shown in Figure 5.4. The FBE flexibility drops very fast in an early stage and seems to reach a plateau afterwards in 95 °C water immersion. For the 110 °C water immersion, the FBE seems also reaching a plateau with a slightly lower retention bending strain.

Figure 5.4 Material Stability in 95 and 110 °C Water.

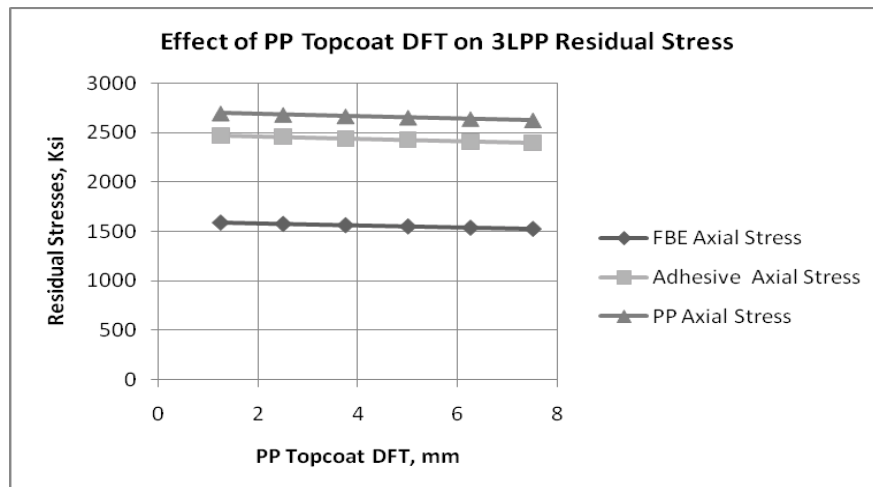
ID=12 inch, Wall thickness=0.25 inch, FBE DFT = 10 mil, PE Adhesive DFT = 10 mil

Figure 6-1 Residual Stresses in 3LPP.

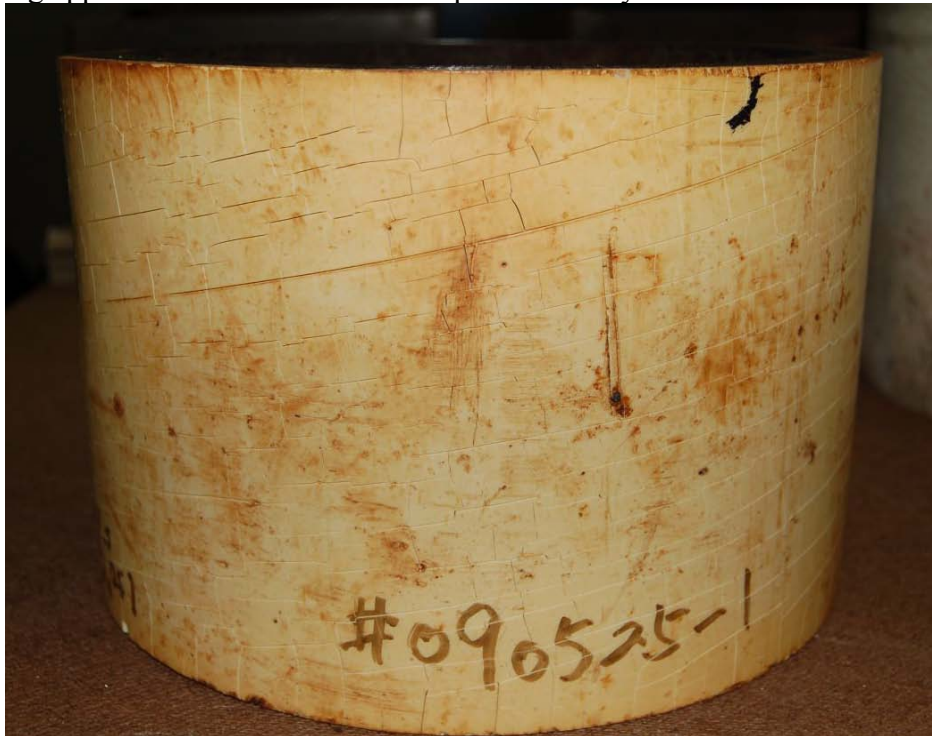
Figure 6-3 Cracking of Thermally Aged 3LPP, at 150 °C for 1,000 hr + 1 wk.
In addition to spiral cracking, transverse cracking is also observed.
