Acoustic Emission Monitoring on Fiber Reinforced Bridge Panels

1 Report No. FHWA-KS-16-05	2 Government Accession No.	3 Recipient Catalog No.	
4 Title and Subtitle Acoustic Emission Monitoring on Fiber Reinforced Bridge Panels		5 Report Date July 2016	
		6 Performing Organization Code	
7 Author(s) James Christopher Flannigan, Youqi Wang, Ph.D.		7 Performing Organization Report No.	
9 Performing Organization Name and Address Kansas State University Department of Mechanical and Nuclear Engineering 3002 Rathbone Hall Manhattan, KS 66506		10 Work Unit No. (TRAIS)	
		11 Contract or Grant No. C1644	
12 Sponsoring Agency Name and Address Kansas Department of Transportation Bureau of Research 2300 SW Van Buren Topeka, Kansas 66611-1195		13 Type of Report and Period Covered Final Report July 2006–June 2012	
		14 Sponsoring Agency Code RE-0452-01	
15 Supplementary Notes For more information write to address in block 9.			
<p>Two fiber-reinforced polymer (FRP) bridge deck specimens were analyzed by means of acoustic emission (AE) monitoring during loading cycles performed at various locations on the composite sandwich panels' surfaces. These panels were subjected to loads that were intended t

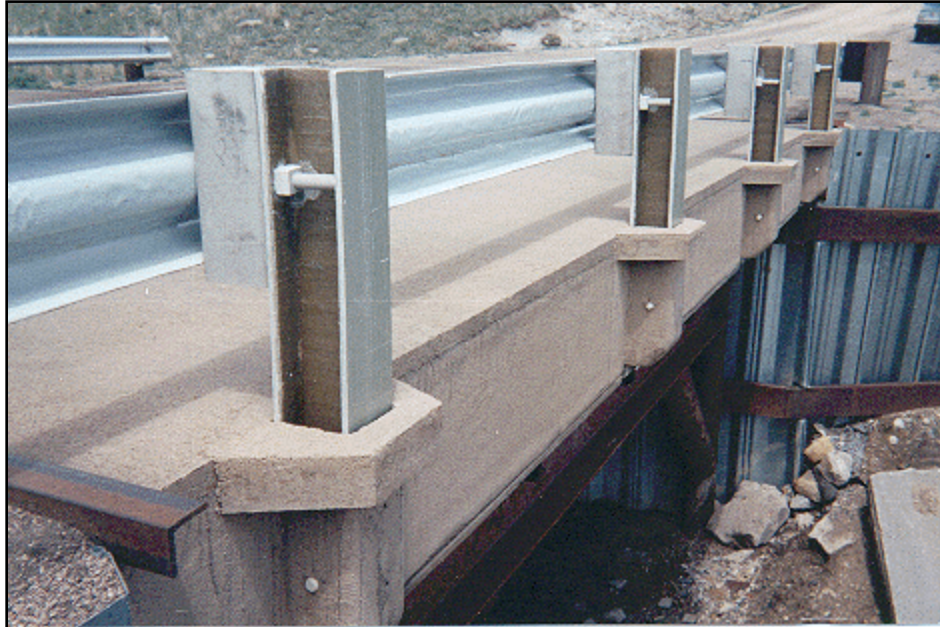
Figure 1.1: No-Name Creek FRP Bridge
Source: Kansas Structural Composites, Inc. (2007)

The first FRP bridge in the United States, and first in the western hemisphere to allow free flows of two-lane traffic, was built by Kansas Structural Composites Inc. (KSCI) in 1996 to cross No-Name Creek near Russell, Kansas. While not technically the first bridge of its kind, the advancements in design and the material's relatively new type of construction won it overwhelming praise from a variety of sources. Organizations ranging from the scientific community to the media broadcasters quickly praised it as one of the biggest advancements of its kind in several years. The accolades included the awarding of both "Best of Market" and the prestigious "Counterpoise Grand Design Award" from the International Composite Expo held in

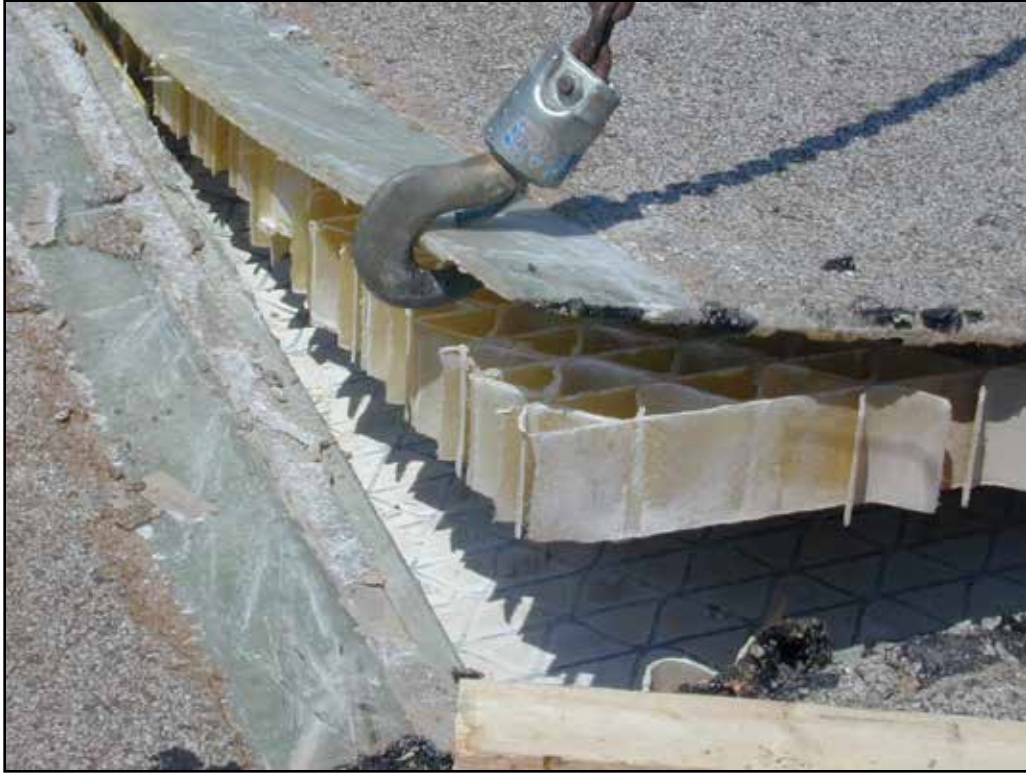
Figure 1.2: Material Delamination in Bridge Panel

Due to the possibility of the material experiencing fiber breakage or delamination, it was decided that a system should be developed to monitor FRP bridges to evaluate the potential failure of components or bond lines. A method was sought to help understand the failure mechanisms experienced by the panels when critical loads are reached. From this information, it might be possible to determine where and when a failure would occur based on sudden events and changes that happen prior to a critical break. The use of non-destructive tests (NDTs) offered highly attractive options as they would allow for monitoring of the structure while allowing the bridge to be in use. The technique decided on was acoustic emissions (AE) monitoring. This will take advantage of the sound created when a fiber breaks, layers delaminate, or other types of failures occur in most composite materials before larger failures occur. Use of this method would not require a person to be constantly present to monitor the site, and the analyzing itself can be carried out in a variety of ways, including periodic testing or continuous monitoring, allowing year-round analysis of acoustic signals and development of possible warning signs of failure.

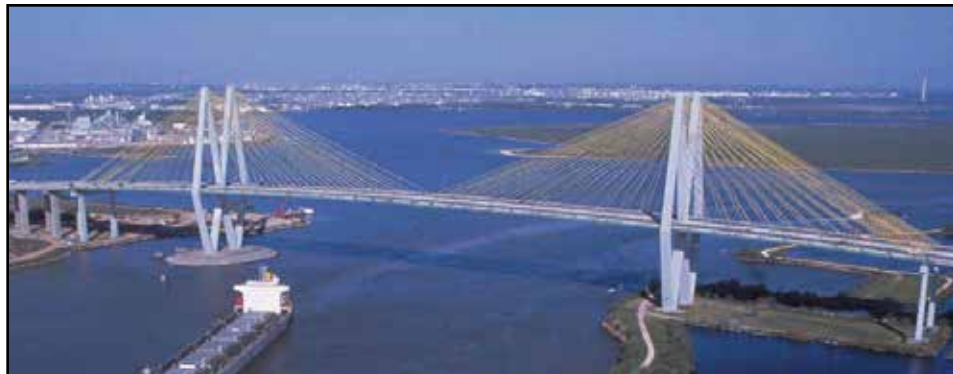
Figure 2.2: Fred Hartman Bridge

The Texas Department of Transportation (TxDOT) applies AE sensors to many of its bridges, including the Fred Hartman Bridge, shown in Figure 2.2. The bridge was officially opened in 1995, and is responsible for carrying State Highway 146 over the Houston Ship Channel. However, it was soon discovered that large oscillations occur on the stay-cables, and through visual inspection it was determined that the cables were creating cracks in the welds between the fixture holding the cables and the rest of the superstructure. In order to monitor the situation, it was decided that a fatigue examination of an AE device with four sensors, supplemented by strain gauge monitoring, would be conducted at the Ferguson Lab at the University of Texas on a similar cable specimen (Kowalik, n.d.).

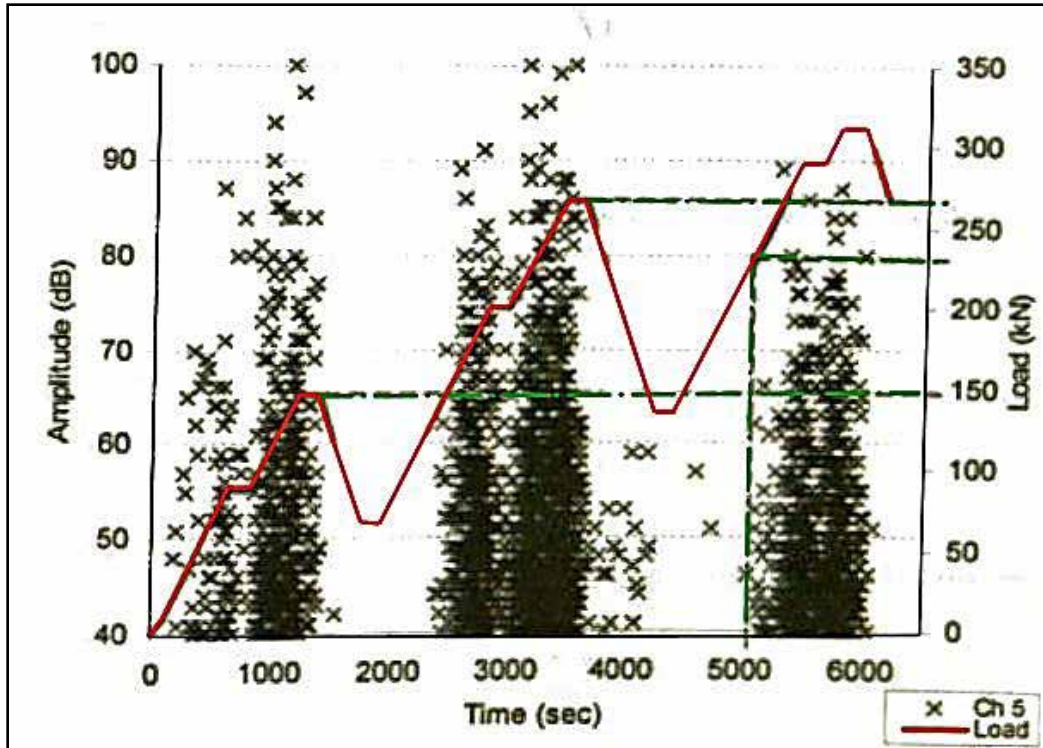
Figure 3.1: Load Application in Keiser Effect Analysis

To do this, a set of five sensors were attached to a series of panels, widths varying between 6 and 30 inches, during bending tests that included failure examinations. Two sensors were attached to the top, two on the sides, and one on the bottom during each testing session. The tests consisted of an application and partial removal of load at the center of the beam by use of an I-beam oriented perpendicular to the panel length. The early examinations had to do in part with determining the Felicity Ratio, the value corresponding to the Kaiser Effect in the FRP panels. The Kaiser Effect is a trend related to acoustic emission, where the acoustics are recorded during load application and partial removal. When the force is reapplied, the acoustic readings do not initially commence. The emissions do not occur until a particular stress is obtained at some fraction of the originally applied load's maximum value. A general graph of the loading cycle used during this analysis is shown in Figure 3.1.

From examining the Keiser Effect, it was demonstrated that the emissions recorded occurred when the loads were being increased and occurred more often after the previous maximum loading peak was approached. This outcome would be expected, as an increase in the load would infer an increase in the stress of the panel, as well as the fibers and matrix within it. In order for the material to remain unbroken, it would have to be able to support a stress equal to that experienced in earlier peaks, and would therefore not fracture until a higher load was applied.

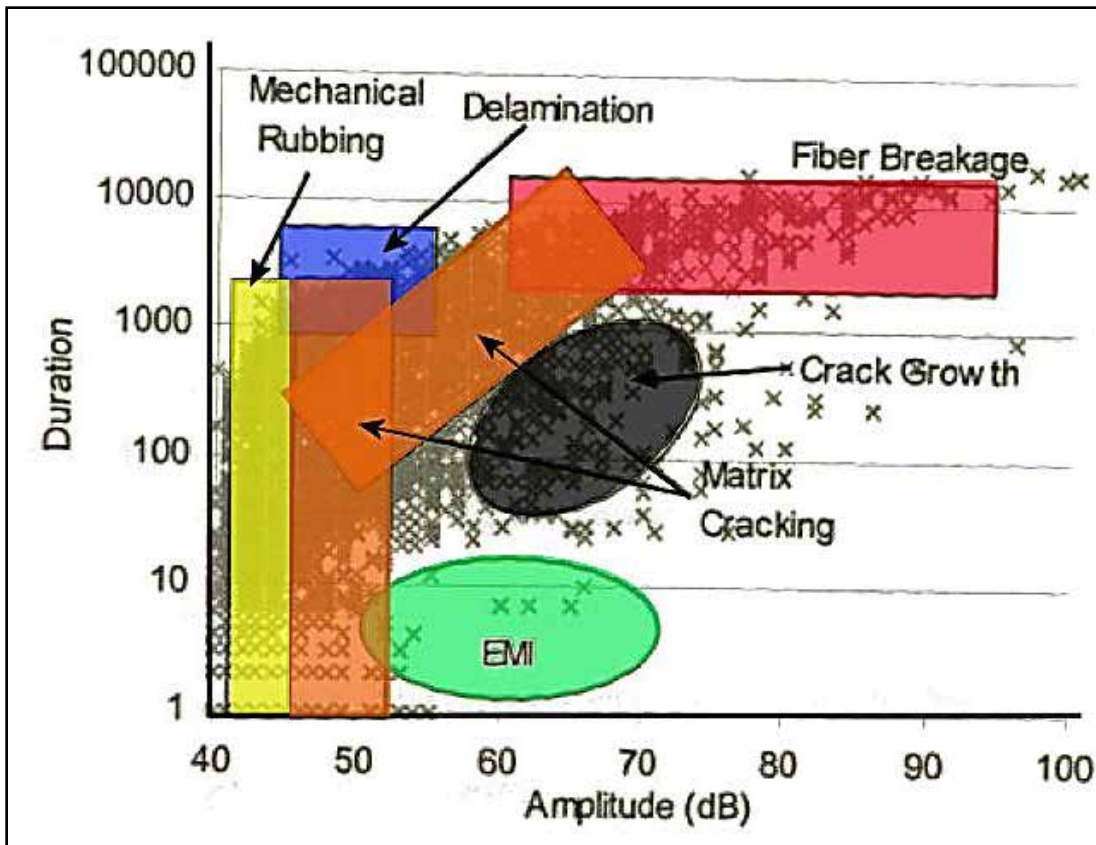
Figure 3.2: Cross Plot of Duration versus Amplitude

The second analysis performed has to do with the ability to determine what properties are related to and occur during a panel's failure. Gostautas concluded that a graph of zones could be used to aide in the classification of the type of failure being seen during the analyses, but several of these areas overlap making it difficult to classify all failures into a specific type. A general layout of the Amplitude-Duration Zone chart is shown in Figure 3.2.

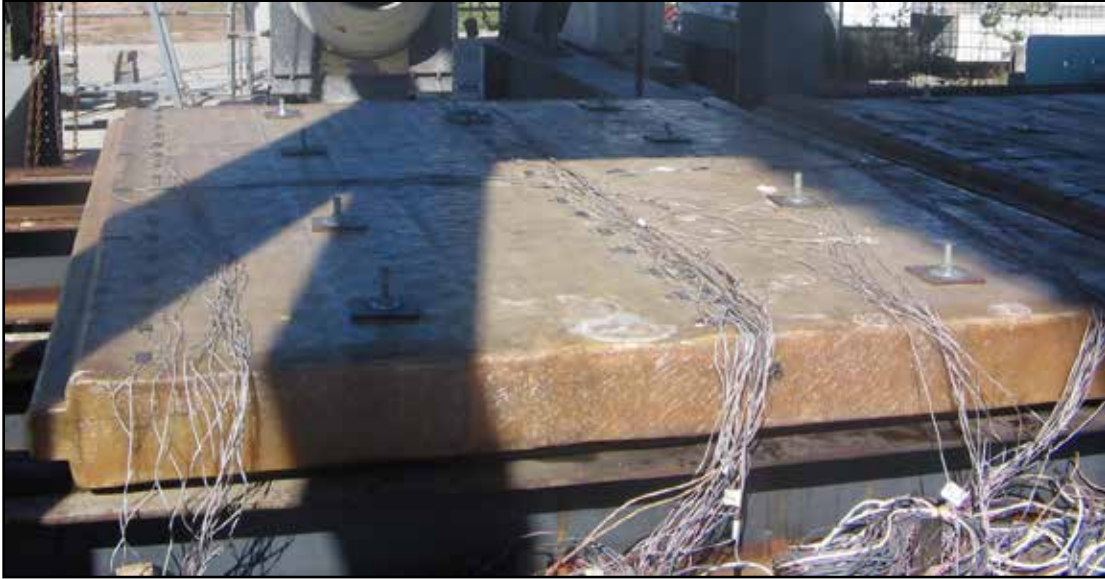
Figure 3.4: Panel-A on Testing Platform

Three FRP bridge deck panels were built by Kansas Structural Composites, Inc., designated Panel-A, Panel-B, and Panel-C for the purposes of this report. Each is comprised of a mostly hollow 74-inch-long \times 102-inch-wide \times 6-inch-deep structure made of glass fiber-epoxy material designed by the Kansas Structural Composites after stage one activities were completed. This design consists of three layers of plates laid up to create a sinusoidal wave and stacked upon one another with a flat layer of fiber between them. The structure was then wrapped in chopped-strand mat and the epoxy resin was allowed to harden; the resulting plates have a ridged cross section but are capable of tolerating applied bending forces. Throughout the tests discussed, Panel-A was monitored at all times to some degree, while Panel-B was monitored only during instances in which interaction between two panels was being observed. Panel-C was not used in this research at all and was held in reserve in case massive failure occurred in Panel-A or Panel-B or as a reaction panel for constraint to the other panels. Panel-A can be seen in Figure 3.4.

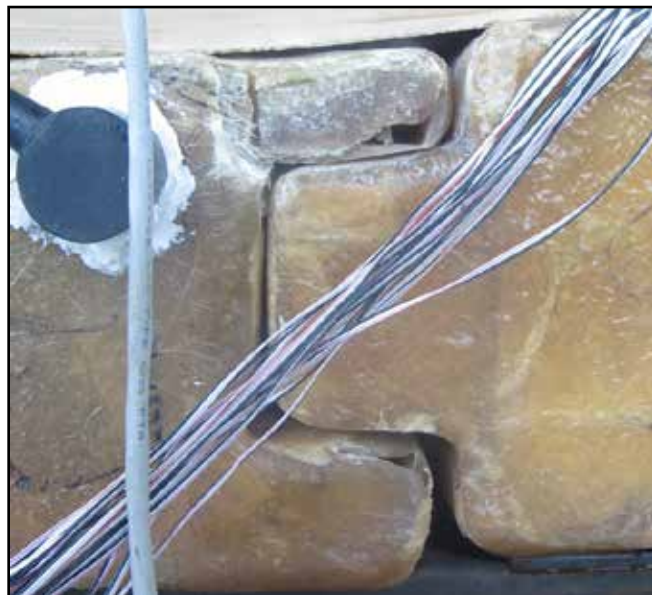
Figure 3.5: Close-Up of Lip-and-Groove Connection Between Two Panels

The overall structure of the panels was designed to allow bending forces to exist without damaging it to failure under regular loading cycles. To help create added strength to the bridge structure, when used in series the decks will be interlocked with one another by use of tongue-and-groove connections on either end of the structure as shown in Figure 3.5.

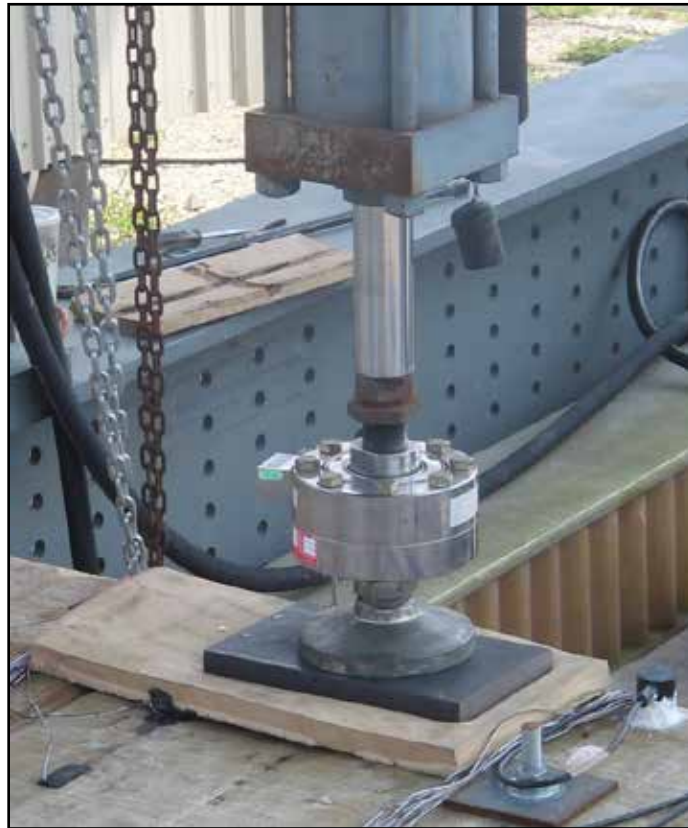
Figure 3.7: Pneumatic Cylinder and Distribution Pad

the most likely source will come from the point at which the plate is being exerted onto the panel, giving more accurate results if the plate is smaller. The items used to produce the direct force can be seen in Figure 3.7.

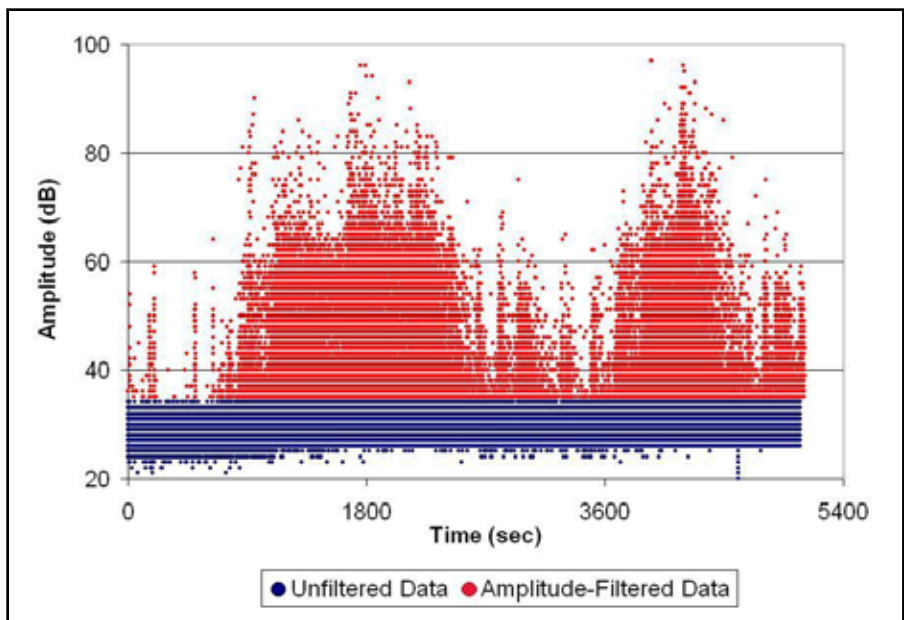
Figure 3.10: 35 Decibel Amplitude Filter Comparison

A comparison of the data before and after the filter application can be seen in Figure 3.10. The use of this single filter had a large effect on the file size as well as the data plots. The original data file was 32 MB for a test lasting just under 1.5 hours. With the filter applied, the data file was reduced to only 2.42 MB, roughly 8.5% of the original file size. Also the characteristics of the data changes during increased loading occurrences were still present after application of the filter.

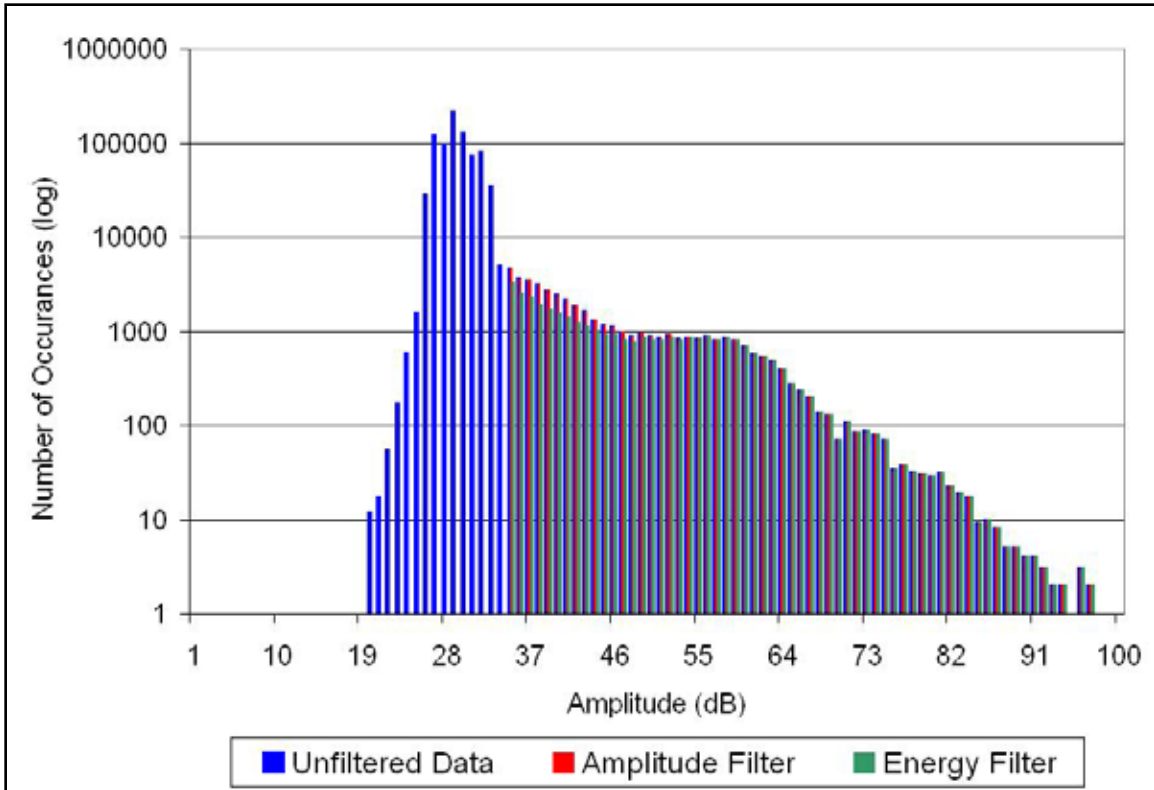
Figure 3.14: Change in Hit Number by Applying 35-Amplitude and 60-Energy Filters

A hit occurrence chart can be seen in Figure 3.14. There are a large number of points located below the 35 dB mark on the chart, appearing between 10 and 100 times more often than the rest of the hit values. By applying the 60-Energy Filter the data decrease appears to be on the lower end of the remaining amplitude data points. There seems to be a small hump of data between the 35 and 48 dB values remaining, and a majority of the second filter takes the data out of that section only.

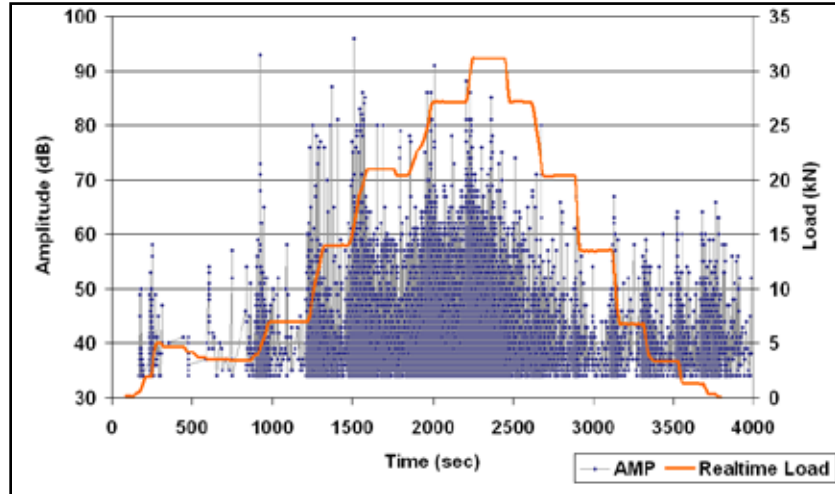
Figure 3.15: Initial Test, Amplitude with Force Overlay

load increases, the amount of AE data created appears to increase in both the magnitude and amount of hits.

It is also reasonable and shown in the figure that when a larger load is obtained, the AE activity occurs without a significant drop. This is most likely due to continuous fiber breakage and resin cracking; as the load is applied, the initial weaker fibers within the structure will break along with weak spots in the resin. This breaking of materials creates an increase in the amount of stress being experienced in the remaining local structure; these pieces then fail as their ultimate stress values are surpassed, creating more stress for the material, and the cycle continues. This scenario can also be seen in the values of energy and signal strength charts included in Figure 3.16 and Figure 3.17. These properties experience a greater amount of variation in their values, and need to be displayed on a logarithmic scale in order to get a greater understanding of the information.

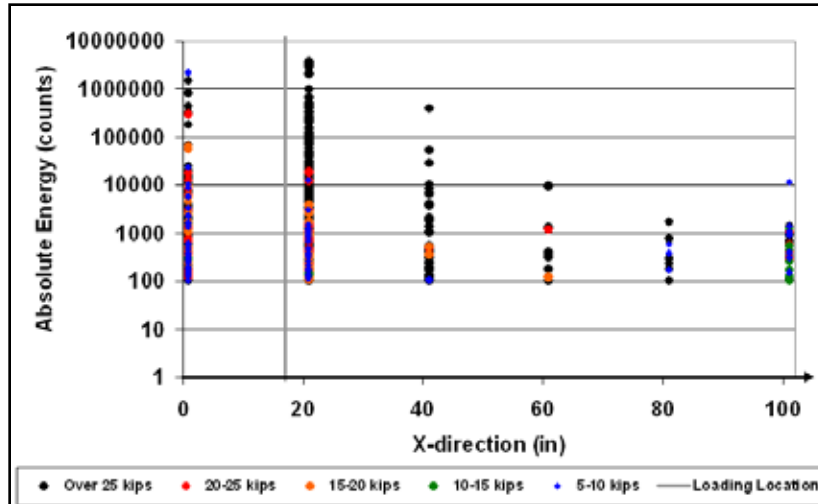
Figure 3.19: Absolute Energy Values Across Sensor Array 1

The first analysis was conducted to determine what effect the loading amount has on the properties of each sensor. In Figure 3.19, it can be seen in general that as the force value increases, the magnitude of the absolute energy also increases in each of the sensors. As would be expected, the sensors near the loading zone show an increased magnitude in relation to the other sensors, causing a peak response to occur around the sensor located at the 21-inch mark, S5.

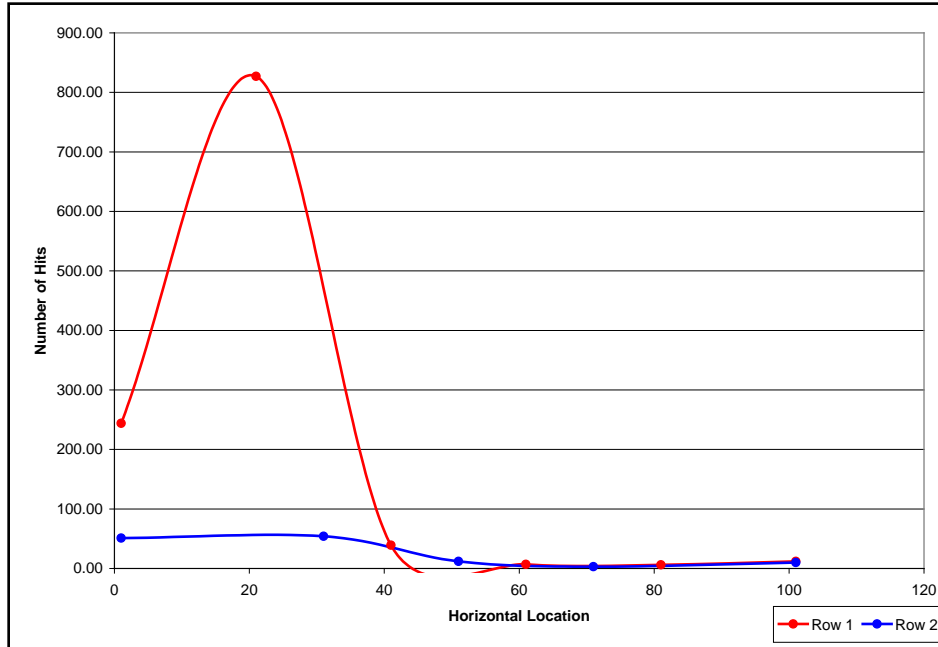
A further analysis of this technique shows that the number of hits recorded by each array is significantly different with Array 1 having a larger amount overall.

Figure 3.26: Number of Hits Across Sensor Array 1 and 2

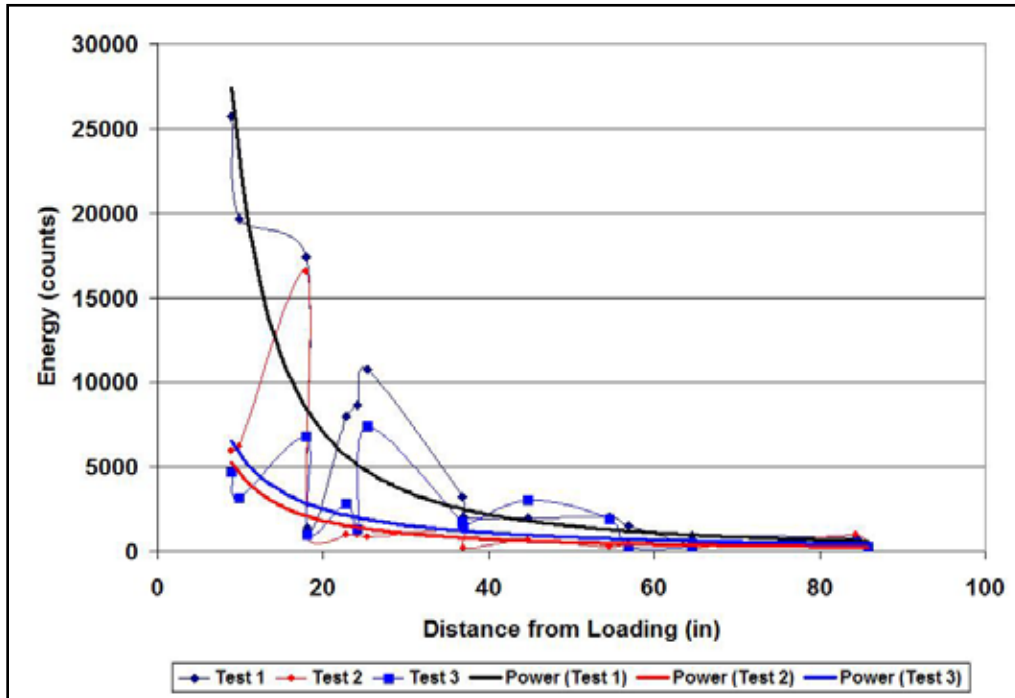
Figure 3.27: Average Absolute Energy Plotted at Various Sensor Distances

The property that shows the greatest difference between distance points is that of the absolute energy as plotted in Figure 3.27. In this figure, we can see the decrease in magnitude as the distances increase. In this case the best plot was found to be that of a “Power Trend-line,” which is not all that surprising as a great deal of acoustic properties have an inverted second-order relationship with regards to distance from the source. It appears in the case of AE in an FRP panel the relationship is no different, as that general trend exists here as well.

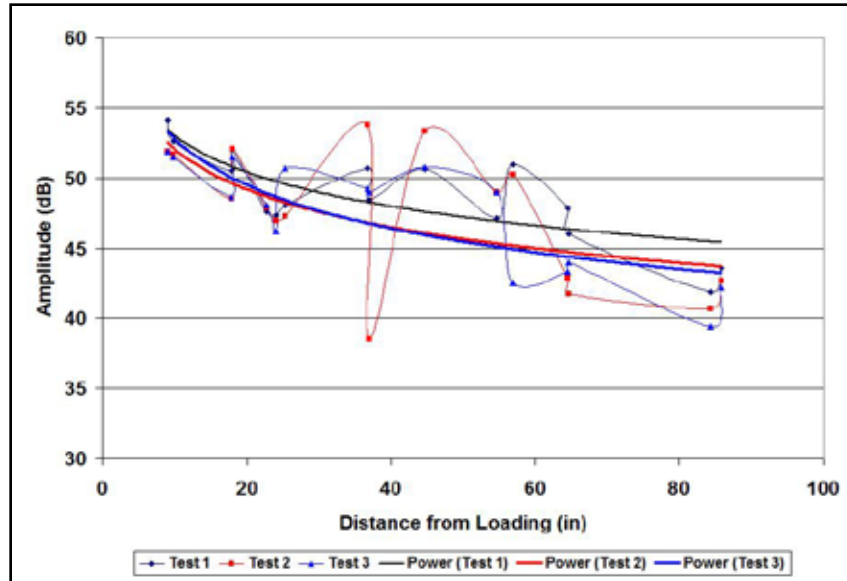
Figure 3.28: Amplitude Plotted at Various Sensor Distances

The next property examined is that of the amplitude data. From Figure 3.28 we can see that a similar trend is experienced as that in the energy plot in Figure 3.27.

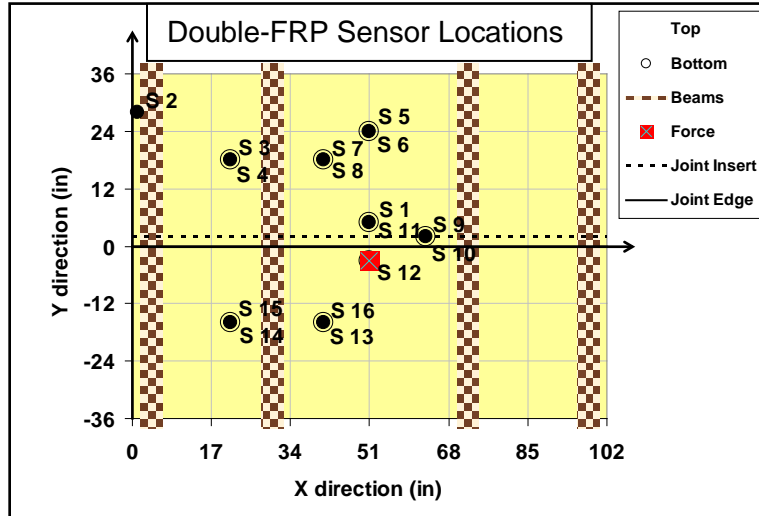
Figure 3.29: Degrading Signal Sensor Arrangement

while Panel-A records data from the transfer of the acoustic signal across the joint. The sensor layout designed and used for this analysis is shown in Figure 3.29.

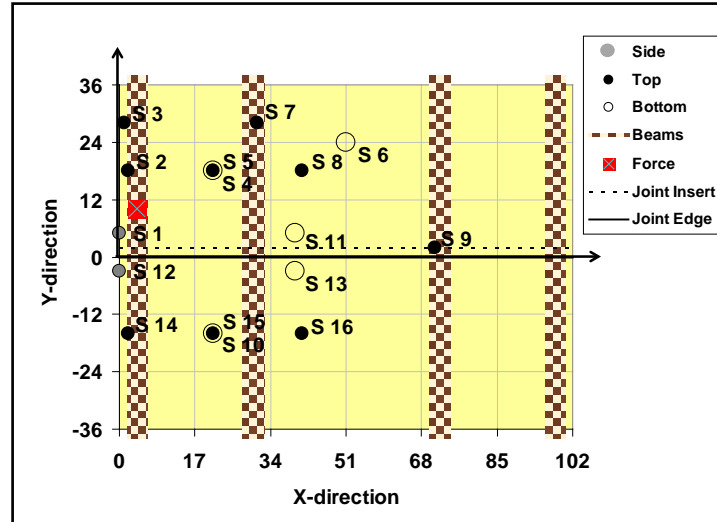
Figure 3.34: Signal Transfer Sensor Arrangement

located on separate panels, as shown in Figure 3.34. By this method, a general profile should become apparent as to how well the acoustic data transfers from one panel to the other.

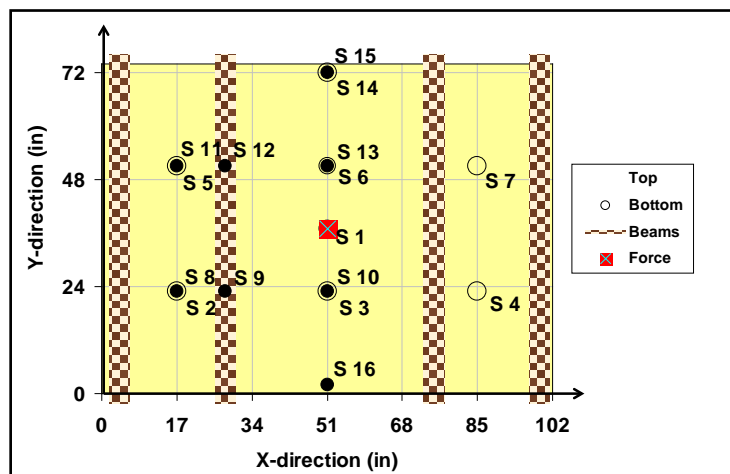
Figure 3.39: Final Sensor Location Layout

A force was being applied to the center of the panel at locations on and between beams located horizontally from the force application point designated in Figure 3.39, which is placed at the location where the failure occurred. The two preceding tests occurred centered over Beams 2 and 3, respectively, but no information was recorded that hinted at the upcoming failure. In fact, there is very little acoustic data at all from the test over Beam 2, even without using the signal strength and energy filters. The test from Beam 3 contained more data but not as much as in earlier tests, indicating that even in this analysis very little occurred in regards to acoustically significant events. After the failure occurred, an earlier test was reexamined to determine if any earlier signals were present to signal the oncoming event.

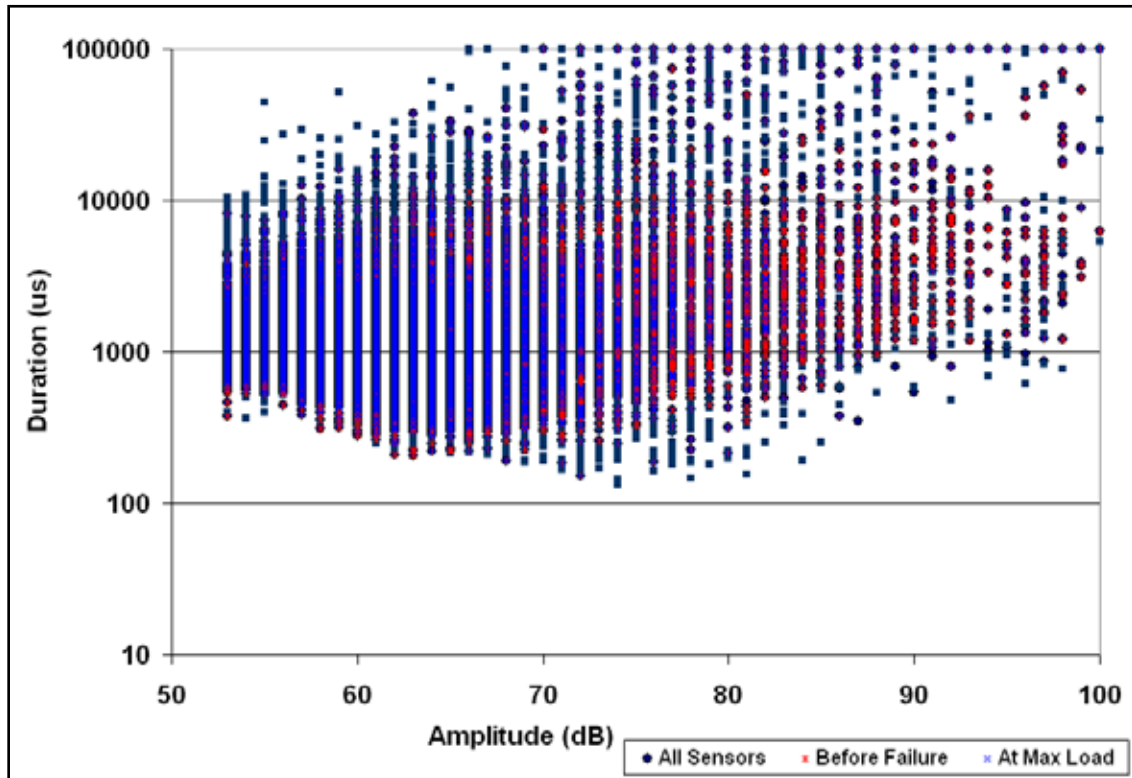
Figure 3.46: Pre- and Post-Failure Duration-Amplitude Plot of the Failure Test
