Development of an Eco-Friendly, Cost-Effective Biogrout for Concrete Crack Repair

Final Report
September 2016

Sponsored by
Midwest Transportation Center
U.S. Department of Transportation
Office of the Assistant Secretary for
Research and Technology

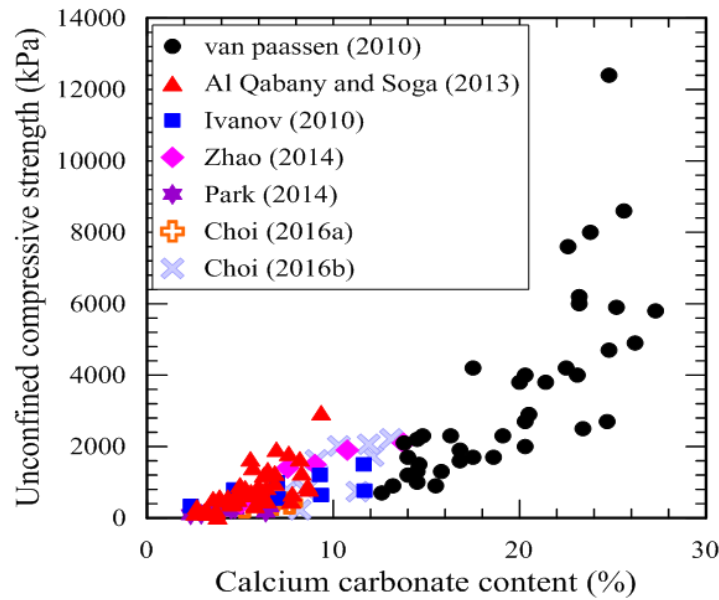
Figure 2. Effect of CaCO_3 content on the UCS of MICP-treated sand

Figure 2 summarizes the relationship between CaCO_3 content and UCS based on the results reported in the above reviewed literature.

As seen in Figure 2, the UCS of biocemented sand increases linearly with CaCO_3 content when CaCO_3 content is lower than 15% and increases exponentially when CaCO_3 content is higher than 15%. This suggests that genetic CaCO_3 content plays a very important role in the engineering properties of biocemented materials.

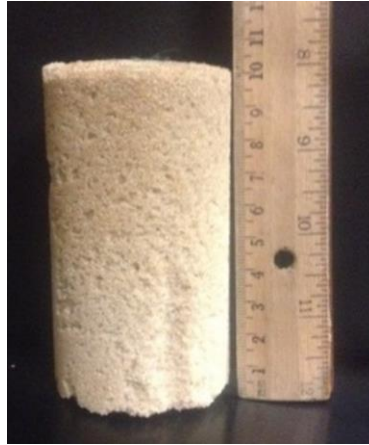
Figure 6. Cemented sand after MICP treatment

After 10 days of MICP treatment, the samples were washed with distilled water, the plastic cylinder molds were removed from the samples, and the samples were washed with water again. Figure 6 shows the cemented sample after washing.

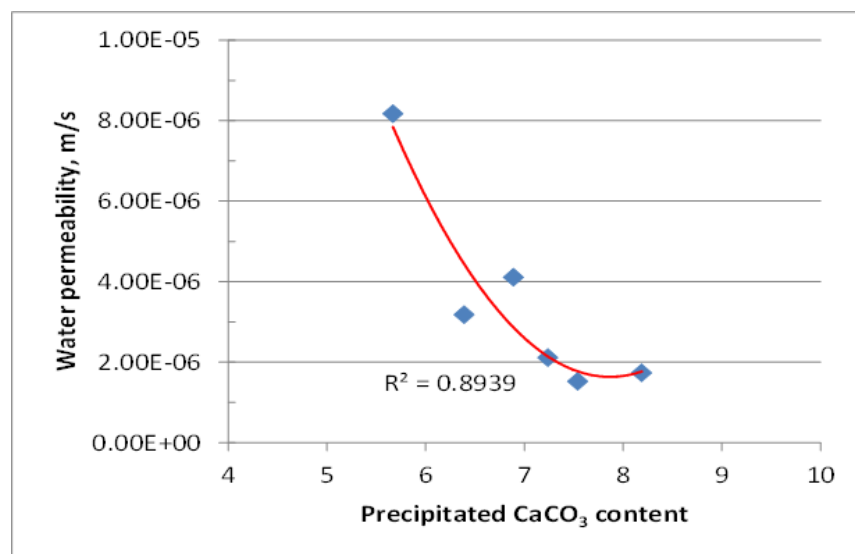
Figure 7. Effect of CaCO₃ content on permeability of biocemented sand

Permeability tests were performed on six sand cylinder samples before and after MICP tests. Before the MICP treatment, the permeability of the uncemented sand was approximately 1E-4 m/s. After the 10-day MICP treatment, the water permeability values of the biocemented sand ranged from 8.17E-6 to 1.52E-6 m/s, depending upon the CaCO₃ content of the samples. The CaCO₃ content of the samples ranged from 5.67 to 8.19%. As shown in Figure 7, permeability decreased with the CaCO₃ content of the samples, which is consistent with findings by other researchers (Chu et al. 2013 and Choi et al. 2016b).

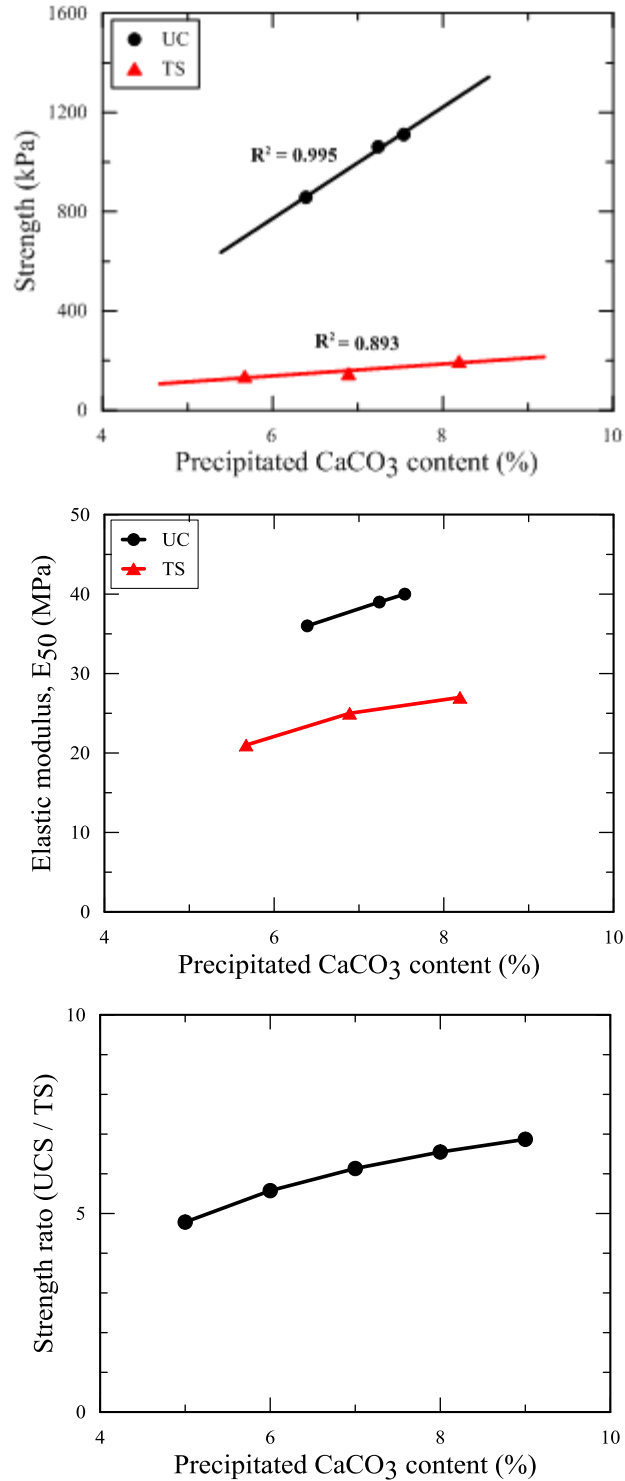
Figure 9. Physio-mechanical properties of biocemented sand showing UCS (top), TS (middle), and UCS/TS ratio (bottom)

Figure 9 illustrates the relationships between mechanical properties (UCS, TS, and E_{50}) and the CaCO_3 content of the samples tested in the present study.

The top graph in Figure 9 shows that both UCS and TS increased linearly with CaCO₃ content, which is also consistent with previous studies (Park et al. 2014, Whiffin et al. 2007, and Al

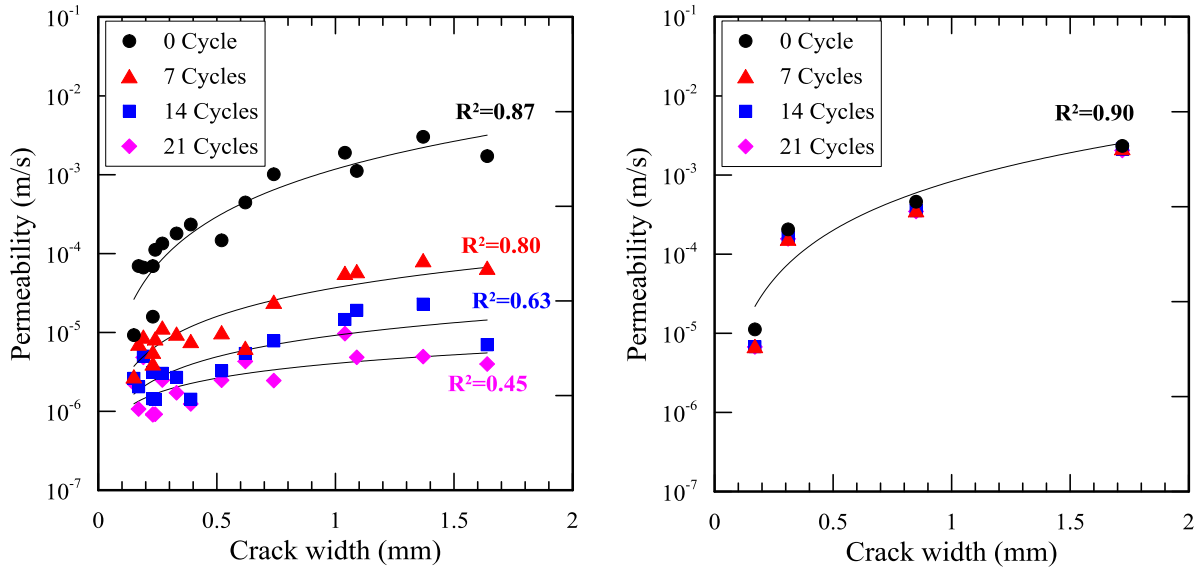
Figure 19. Effect of initial crack size on permeability of mortar samples after MICP treatment (left) and water treatment (right)

Figure 19 illustrates water permeability of cracked mortar samples subjected to different cycles of MICP and water treatment.

The graph on the left generally shows permeability of the mortar samples polynomial increased with their average crack widths. As the initial crack width was about 2 mm, the mortar without treatment had a permeability value of about $8.0E-5$, which is consistent with measurements by other researchers (Wang et al. 1997 and Van Tittelboom et al. 2010).

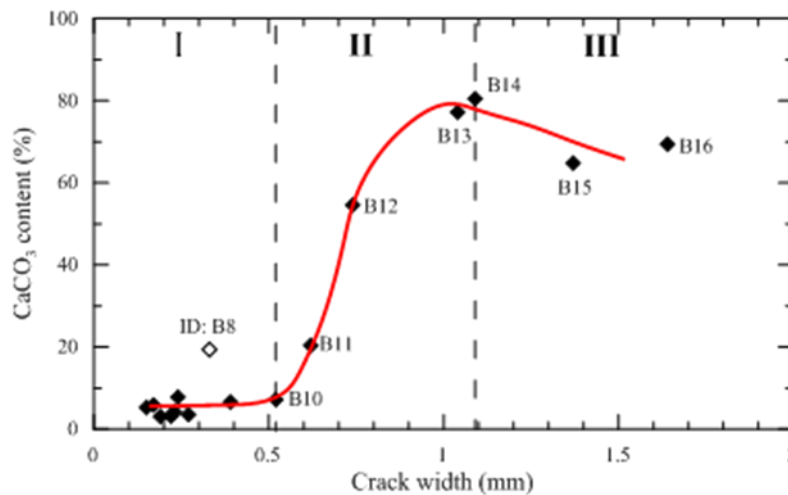
Figure 22. Relationship between crack width and precipitated CaCO_3 content

Figure 22 shows the relationship between crack width and precipitated CaCO_3 content on the crack surface.

In Region I (average crack width < 0.52 mm), CaCO_3 content on the crack surface was very low and fluctuated around 5% (varying from 3.2 to 7.8%). This suggested that only a small amount of the chemical and bacteria solutions got into those small cracks and performed the MICP process there. In Region II (0.52 mm \leq average crack width ≤ 1.1 mm), CaCO_3 content on the crack surface increased with the crack width (up to approximately 80%). This indicated that MICP was more effective for cracks within this size range. In Region III (average crack width > 1.1 mm), CaCO_3 content on the crack surface started decreasing slightly with the crack width.

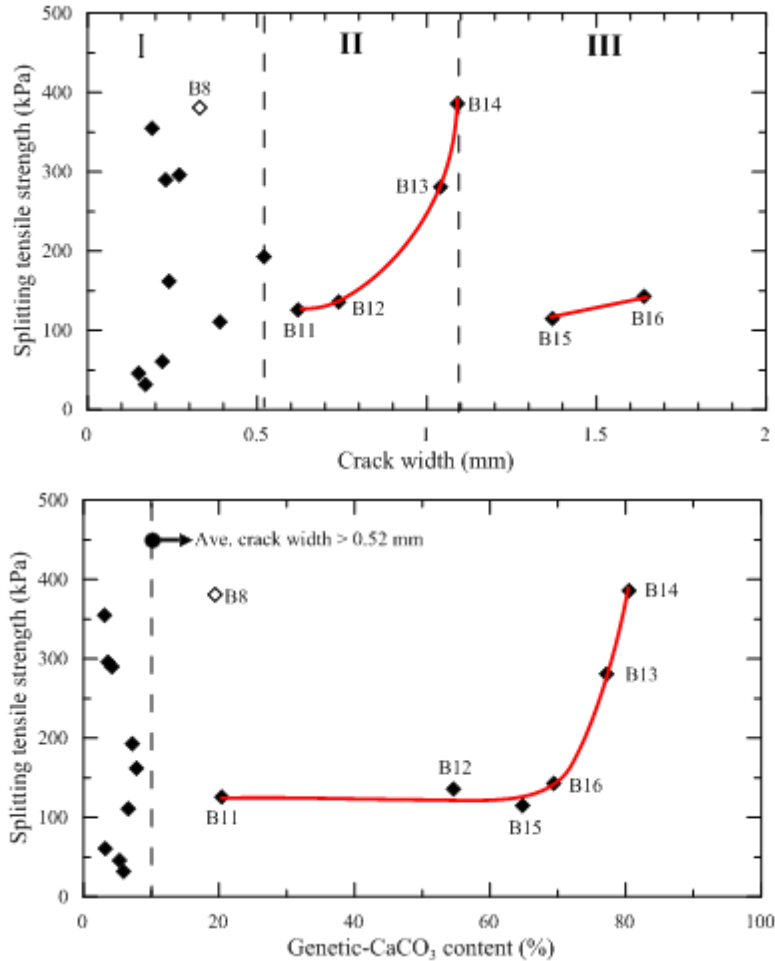
Figure 23. Relationship between tensile strength and CaCO₃ content (top) and initial average crack width (bottom)

Figure 23 shows the relationship between TS and precipitated CaCO_3 content/initial average crack width.

The top graph in Figure 23 shows that in the small crack region (Region I), some samples regain relatively high TS (up to 386 kPa) while others had very low TS (32 kPa) after the MICP repair. This might happen for several reasons: (1) some samples might not split totally, and their uncracked portion might carry some loads during the splitting tests; (2) since the crack widths of the samples were very small, or their two cracked surfaces are close together, a little precipitated CaCO₃ in the cracks might generate a high adhesion on the cracked surfaces, which helped the splitting resistance; and (3) after a few MICP cycles, the precipitated CaCO₃ quickly sealed the small crack on the top of the cylinder samples and prevented UPB and urea/CaCl₂ solutions from easily penetrating into the internal cracks, thus increasing the variation in the effectiveness of the MICP repair, which resulted in inconsistent TS test results. In the large crack region (Region III), the TS of the MICP-repaired samples were relatively low, probably due to the insufficient CaCO₃ bridging the cracks. It appeared that MICP was more efficient for repair of mortar cracks with a size ranging from 0.5 to 1.1 mm (Region II).
