Pavement Roughness Measurement Using Android Smartphones: Case Study of Missouri Roads and Airports

Final Report Prepared for Missouri Department of Transportation
August 2018

Project TR201709

Report cmr18-010

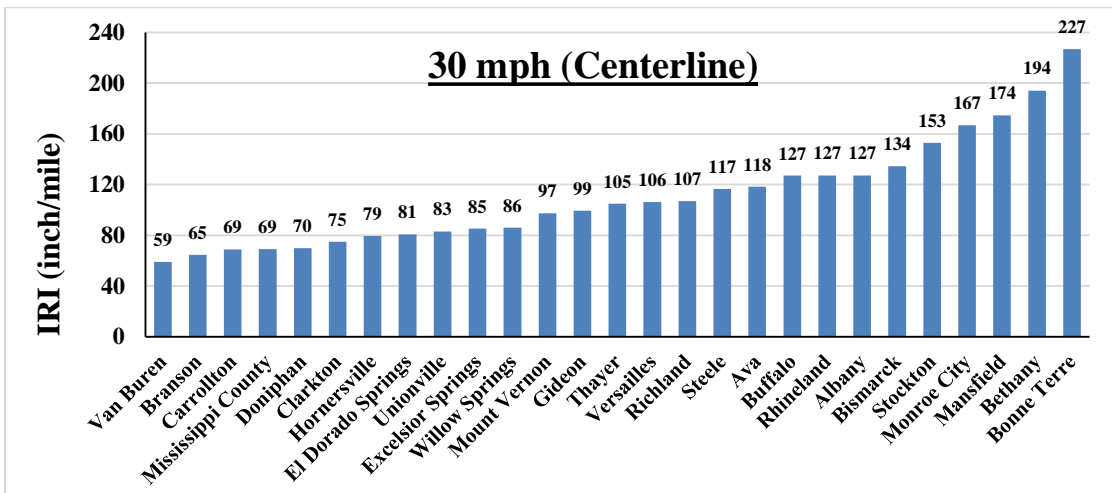
Figure ES.1. Ranking of airports based on their pavement roughness for 30 mph speed

Figures ES.1 and ES.2 show the ranking of the airports based on their pavement roughness for 30 and 40 mph speeds, respectively. It was observed that the IRI values ranged from 47 to 280 for the airfield pavements. Among the investigated airports, Bollinger-Crass Memorial Airport in Van Buren with an average IRI equal to 59 inch/mile was found to be in very good condition. Bonne Terre Municipal Airport pavement was found to have the highest roughness, with an average IRI of 227 inch/mile on the centerline lane. The remaining airports were classified as follows with respect to pavement condition assessed via the smartphone app: 10 airports in good condition, 13 airports in fair condition, and 2 airports in poor condition.

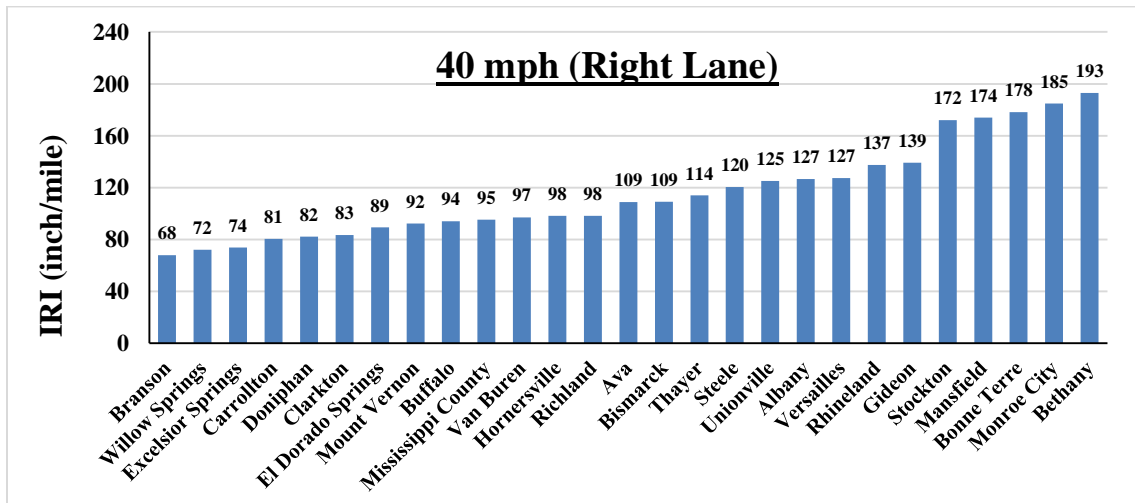
Figure ES.2. Ranking of airports based on their pavement roughness for 40 mph speed

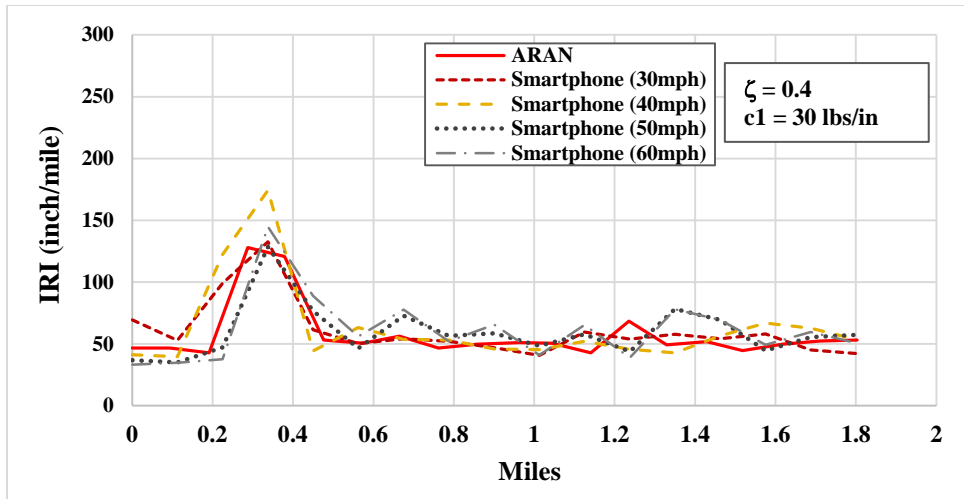
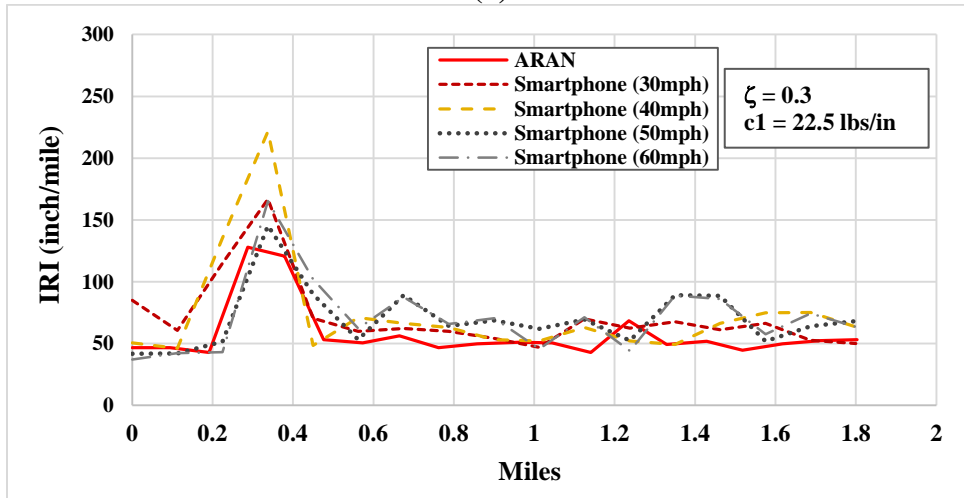
Figure 2.4. Estimated average IRI values for different damping ratios on I-70 W (Log 113 - 115)

First, the model was calibrated using the data collected for a part of these sections (Log 126 -129 and Log 113 -115) for different damping ratios. The calibration results for Logs 126 to 129 and Logs 113 to 115 are shown in Figures 2.3 and 2.4, respectively. As seen in these figures, the averaged IRI values measured by smartphone are in good agreement with the ARAN measured IRI for different speeds. Also, the smartphone results for 50 mph speed seemed to have a better match with ARAN data for the starting logs compared to those for other speeds. Moreover, the best results were obtained for $\zeta = 0.4$ ($c_1 = 30$ lbs/in (5261 Ns/m)) (Figures 2.3 and 2.4(a)).

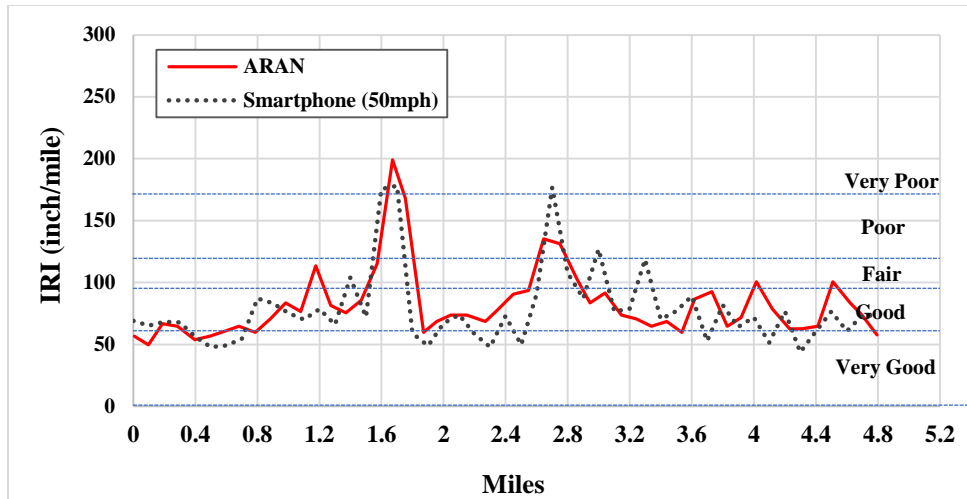
Figure 2.5. Validation study for I-70 W (Log 126 -131) for optimal damping ratio

Figures 2.5 and 2.6 present the final validation results for Logs 126 to 131 and Logs 113 to 118, respectively. It can be observed from these figures that the accuracy of the smartphone-based IRI predictions are quite acceptable, specifically for I-70 W (Log 126 -131). The smartphone-based roughness system was also assessed in terms of its ability to classify pavement according to MAP-21 criteria. MAP-21 requires the States to provide pavement IRI data for every 0.1-mile pavement section for the Interstate and Non-Interstate highway systems annually and biannually, respectively (AASHTO 2013). Pavement ride quality can be categorized into five groups (U.S. Department of Transportation 2000), as shown in Table 2.2. Figures 2.5 and 2.6 show these pavement ride quality levels relative to the IRI values measured from ARAN and the smartphone application. The vertical axis has been labeled according to MAP-21 smoothness criteria threshold values. As can be seen in Figures 2.5 and 2.6, the smartphone based-IRI assessment system developed herein was able to categorize pavement condition based on roughness accurately for most of the pavement sections between Logs 126 to 131 and Logs 113 to 118.

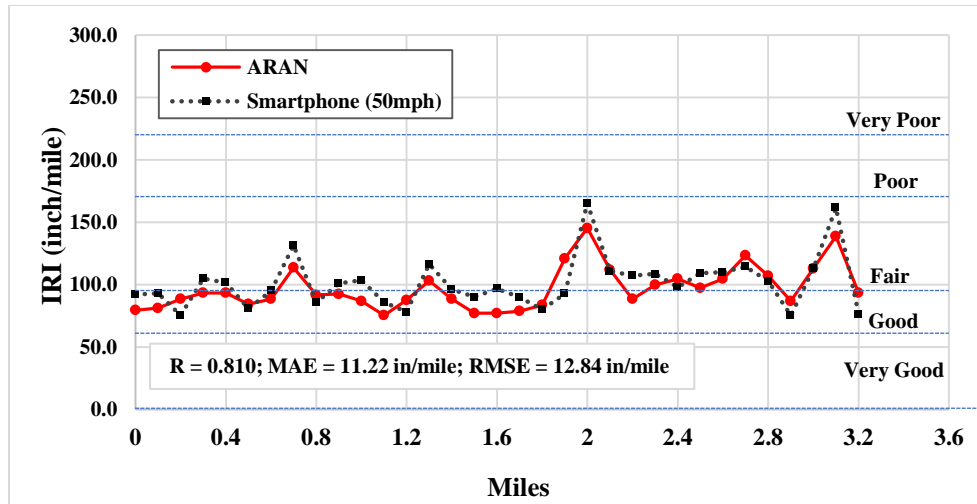
Figure 3.2. Smartphone calibration on MO-10 E (Log 40.449-43.74)

calculated at speed of 50 mph (80 km/hr). Therefore, the test runs were conducted at the same speed. Figure 3.2 shows the ARAN and smartphone data that were used for the calibration. The vehicle suspension and smartphone parameter settings from the calibration are shown in Table 3.1. The smartphone parameters shown in Table 3.1 were used during the data collection process for each of the 27 Missouri airports in this study.

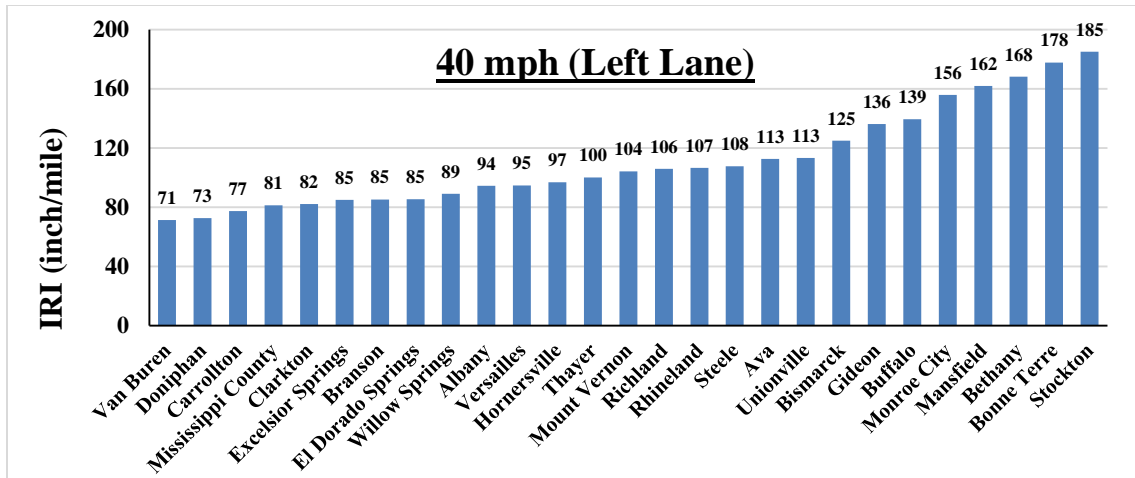
Figure 3.4. Ranking of airports based on their pavement roughness for 40 mph speed

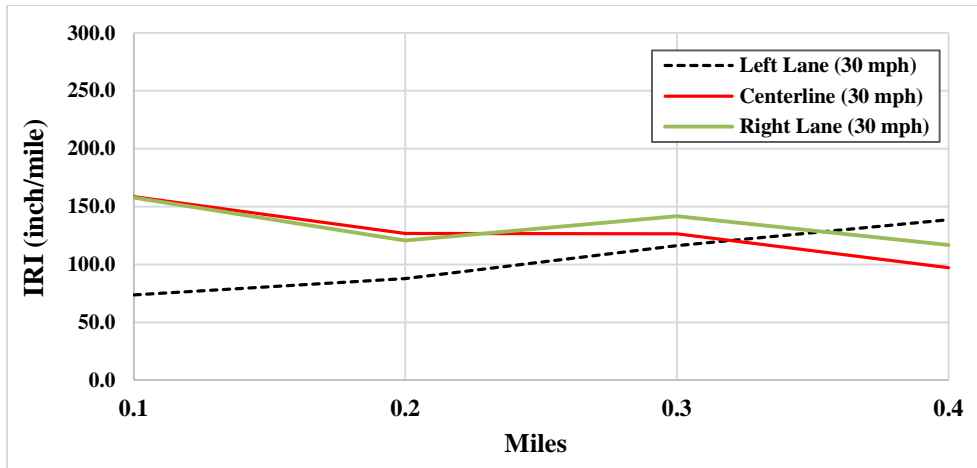
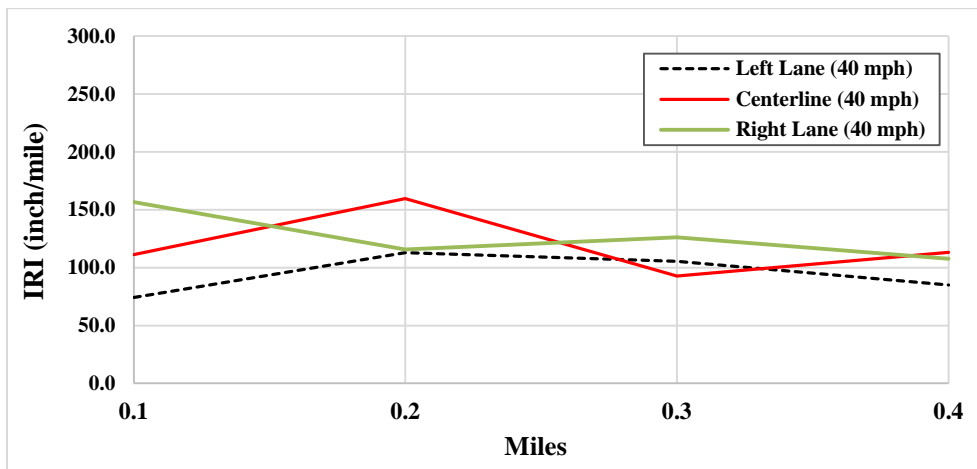
Figure A.2. Plot showing the estimated IRI values for Albany Municipal Airport: (a) 30 mph (b) 40 mph
