ACCIDENT REDUCTION FACTORS RELATING TO MOOSE-VEHICLE COLLISION CRASH TYPES

Prepared by:
Osama A. Abaza, C.Eng., Ph.D. and Colleen C. Moran, P.E.
University of Alaska Anchorage

May 2018

Prepared for:
Alaska Department of Transportation & Public Facilities
Statewide Research Office
3132 Channel Drive
Juneau, AK 99801-7898

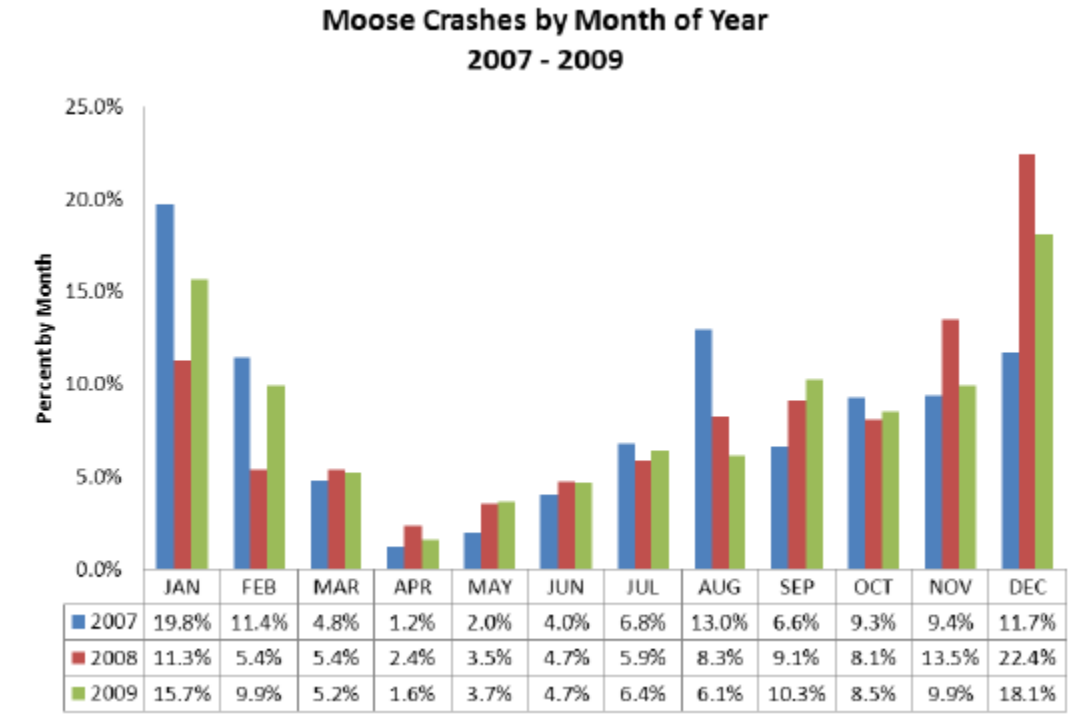
Figure 2 - Moose Crashes by Month of Year 2007 – 2009

It has been determined that the greatest number of animal collisions occurs during early morning hours (4:00 to 6:00 a.m.) and the evening hours (6:00 to 11:00 p.m.). Collisions with animal are more frequent at night, with occurrences ranging from 68% to 85% (Highway Safety Information System, 1995). During 2009 in Alaska, 64.7% of moose collisions occurred in darkness or in reduced light conditions (DOT&PF, 2012). In addition to daily peak movements, moose have seasonal migration patterns with spring-peaks, spring-dips, and summer-dips. Moose-vehicle collisions have a seasonal cyclic component, with the majority of collisions occurring from May to October, which is linked to the peak movement times of moose. Figure 2 shows moose crashes on Alaska roadways by month with the lowest number in April and the rates increasing into the winter months. In Alaska, the highest number of moose related crashes occurred in January and December (DOT&PF, 2012). Sweanor and Sandegren found that moose winter range is significantly smaller in winter than summer (1989). With moose movement smaller in range in winter months and moose crashes highest in winter months may reflect that moose are foraging closer to roadways, using roadways for ease of travel, or moose are forced out of other areas due to snow depth changes.

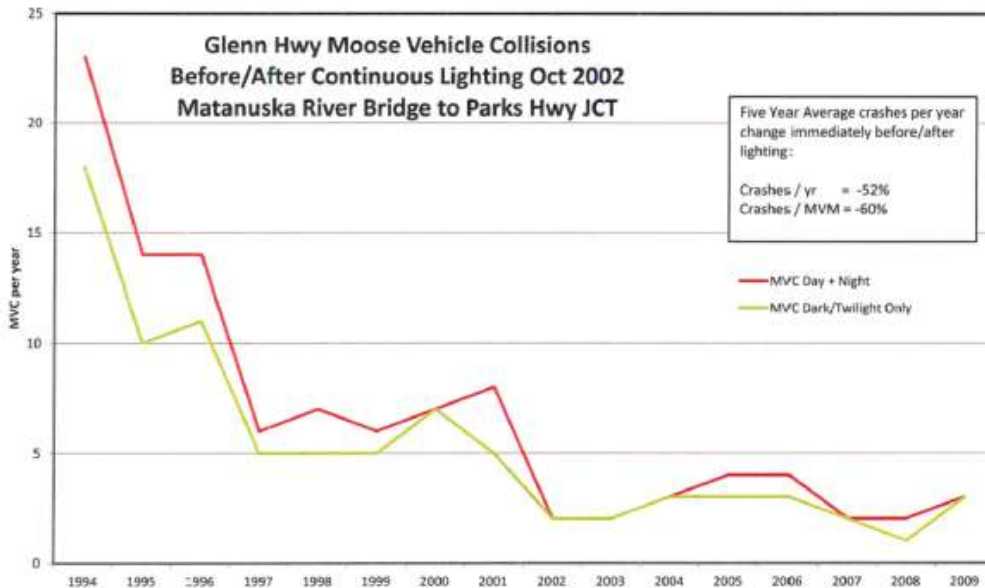
Figure 4 - Glenn Highway Moose vehicle Collisions Before and After Construction of Continuous Lighting – Matanuska River Bridge to Parks Highway Junction (Hayflats)

The DOT&PF also studied the Glenn Highway at the Hayflats, Matanuska River Bridge to the Parks Highway Junction. Continuous lighting was installed on this corridor in October of 2002. Figure 4 shows the results of the study. The five-year average per year dropped by over 50% after the installation of continuous lighting.

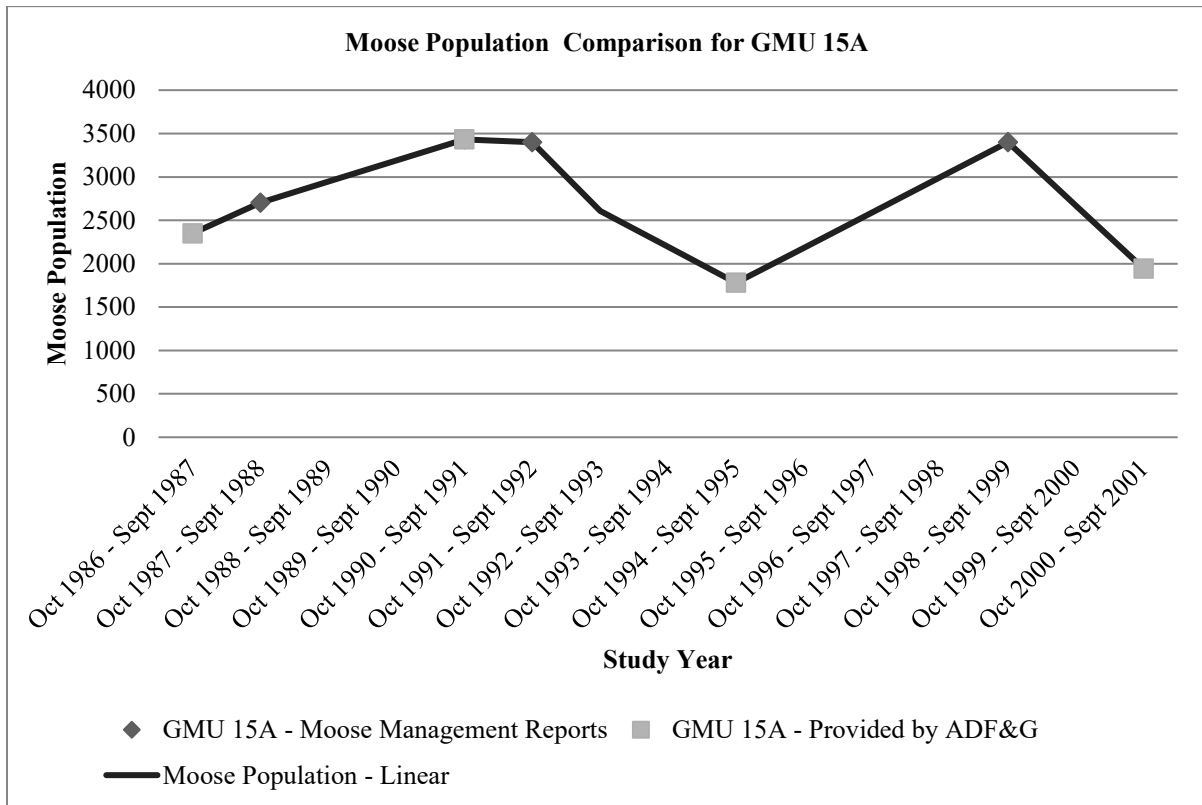
Figure 6 – Moose-Population Comparison for GMU 15A

The Sterling Highway MP 82.0–93.72 project is located in GMU 15A. Moose population information for GMU 15A was gathered from ADF&G Moose Management Reports; additional information was provided by ADF&G. Linear population interpolations were conducted to estimate moose population for years when population surveys were not conducted, as shown in Figure 6.

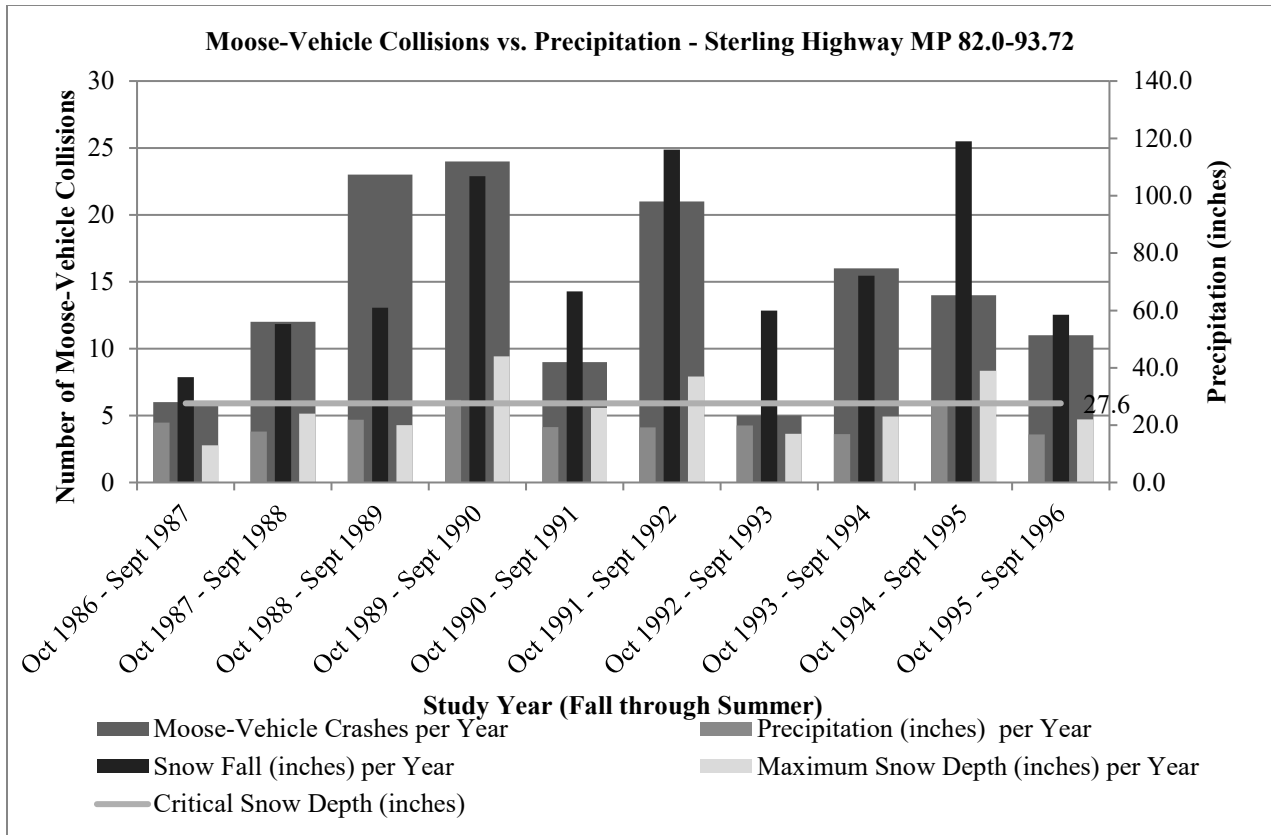
Figure 7 – Moose-Vehicle Collisions vs. Precipitation

Figure 9. Precipitation and snow depth are in harmony, since years of high precipitation yield high snowfall and snow depth, and therefore have a similar relationship with MVCs. Figure 6 and Figure 8 are graphs of the same data in ascending order, from lowest number to highest number of MVCs. Although the overall rising trend is similar between snow depth and MVCs and between snowfall and MVCs, these graphs indicate no direct connection between the two. The highest collision years were not the highest snowfall or maximum snow depth years, so other factors are contributing to MVCs. The lowest dip in MVCs occurred the second year of post-project completion.

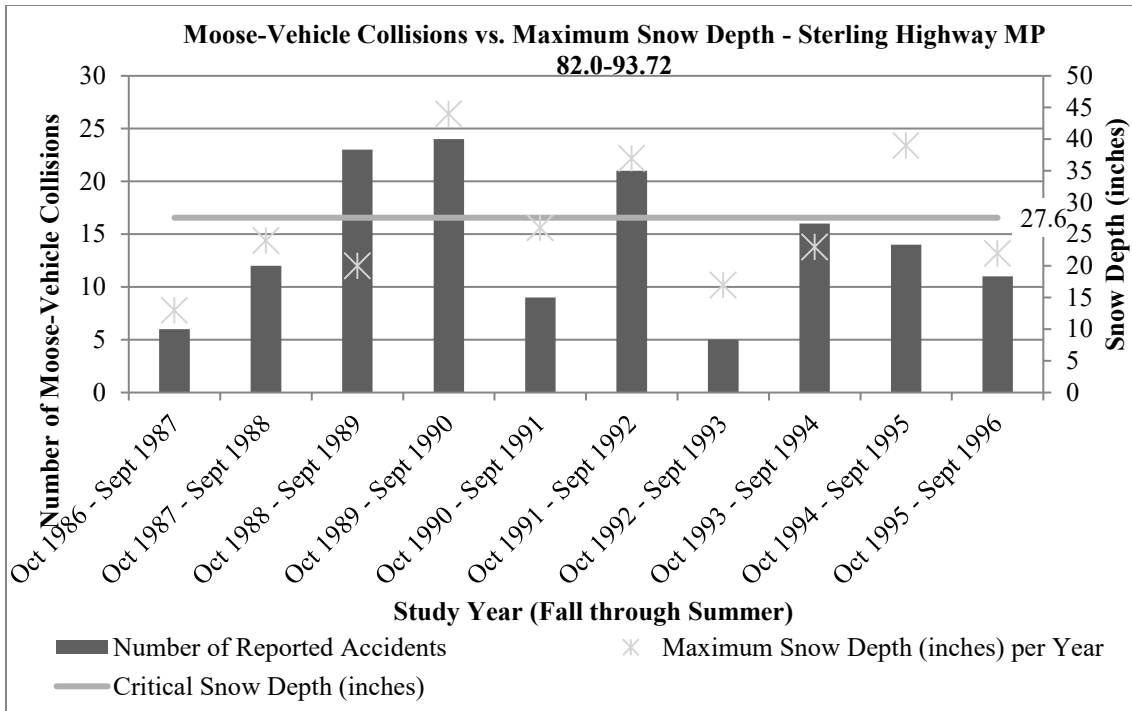
Figure 8 – Moose-Vehicle Collisions vs. Maximum Snow Depth

the same trend per year as maximum snow depth and snowfall, as depicted in Figure 8 and

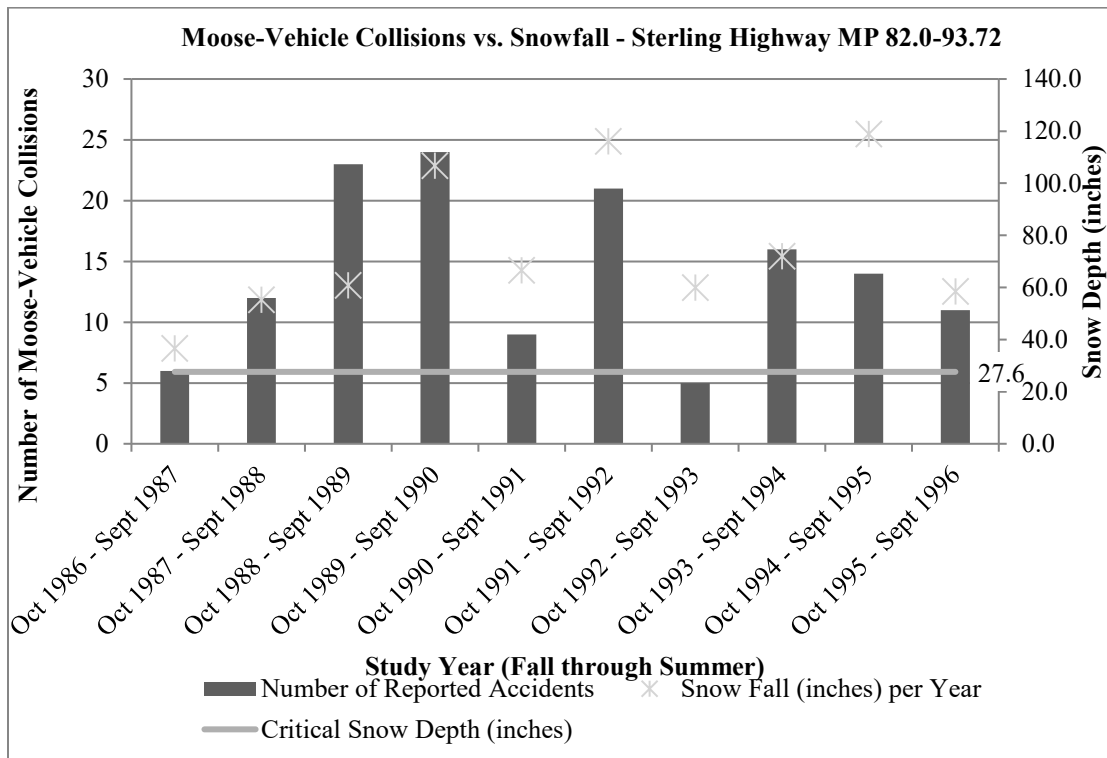
Figure 9 – Moose-Vehicle Collisions vs. Snowfall

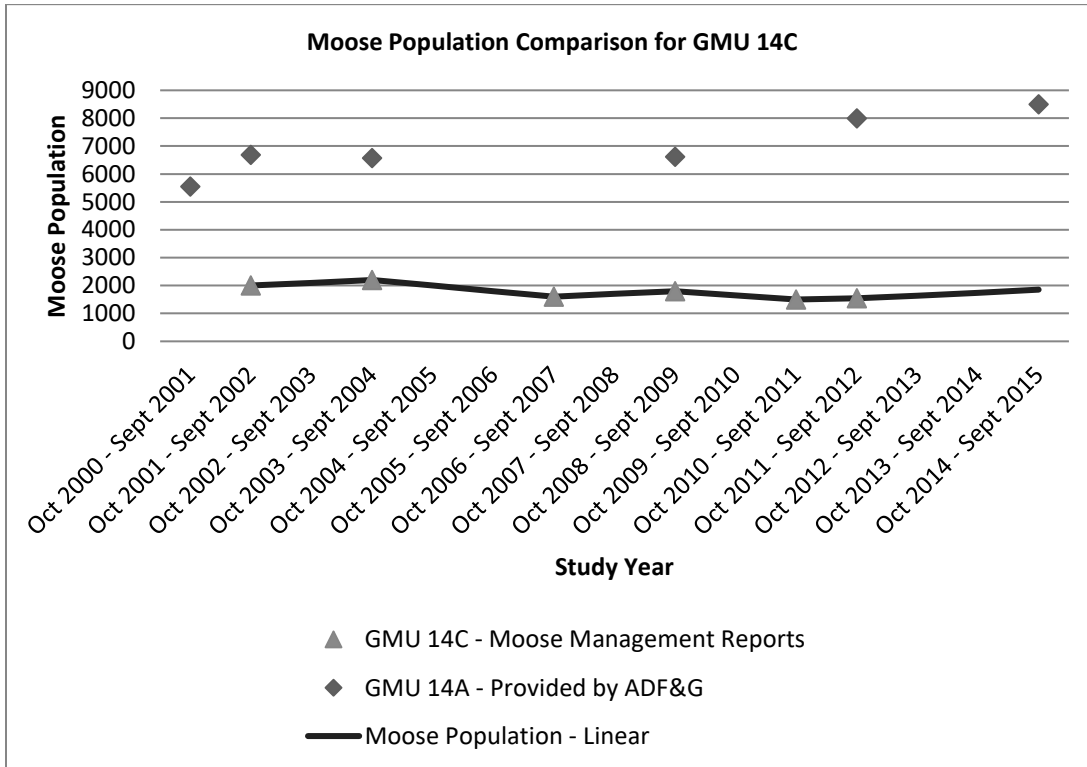
Figure 10 – Moose Population Comparison for GMU 14C

The Glenn Highway MP 12.082–16.5 project is located in GMU 14C. Moose population information for GMU 14C was gathered from ADF&G Moose Management Reports, and additional information was provided by ADF&G. Moose population trends from GMU 14A provided by ADF&G were used to estimate moose population for years when population surveys were not conducted using linear interpolation, as shown in Figure 10.

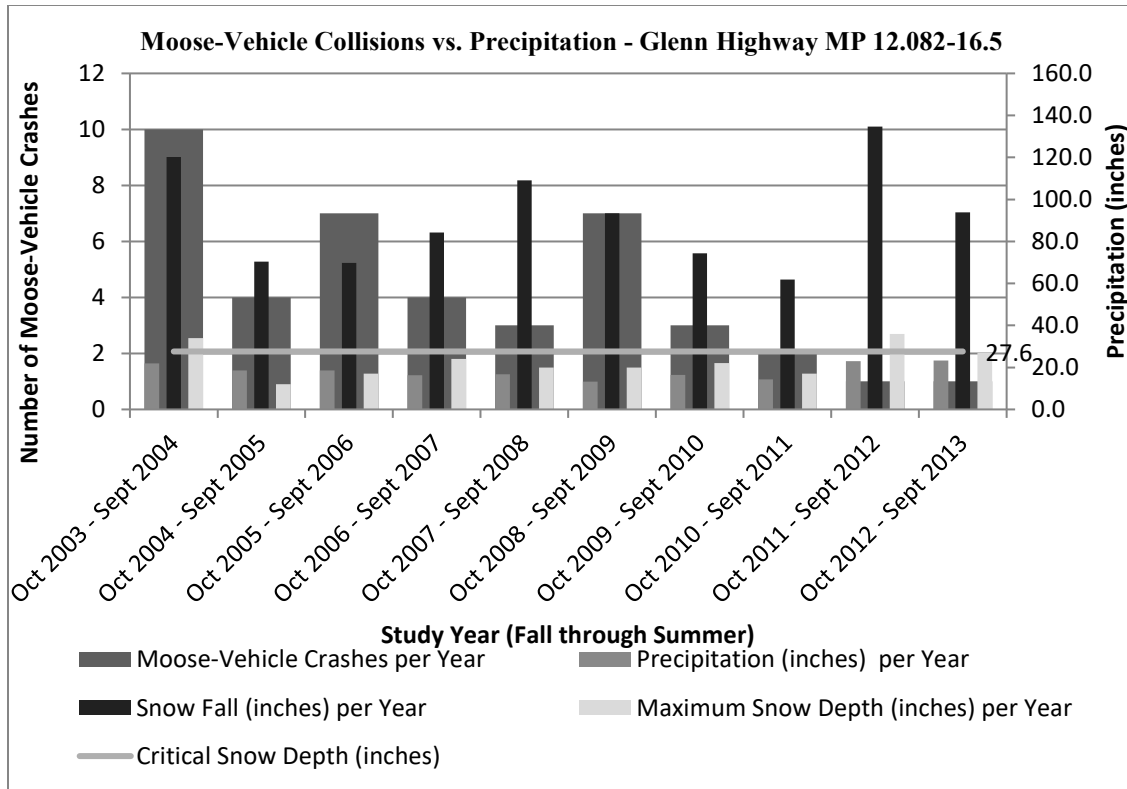
Figure 11 – Moose-Vehicle Collisions vs. Precipitation

The linear moose population estimate and the precipitation data were charted to compare data trends (see Figure 11–13). Figure 11 shows that the number of reported MVCs does not appear to have any sort of pattern related to the recorded precipitation information. The study years with the highest snowfall and maximum snow depth are paired with years of high and low reported MVCs, as depicted in Figure 13. A peak in MVCs occurred the first year after construction completion, although there appears to be a trend of reduced MVCs after construction, with the lowest dip in MVCs occurring 4 and 5 years post-project completion.

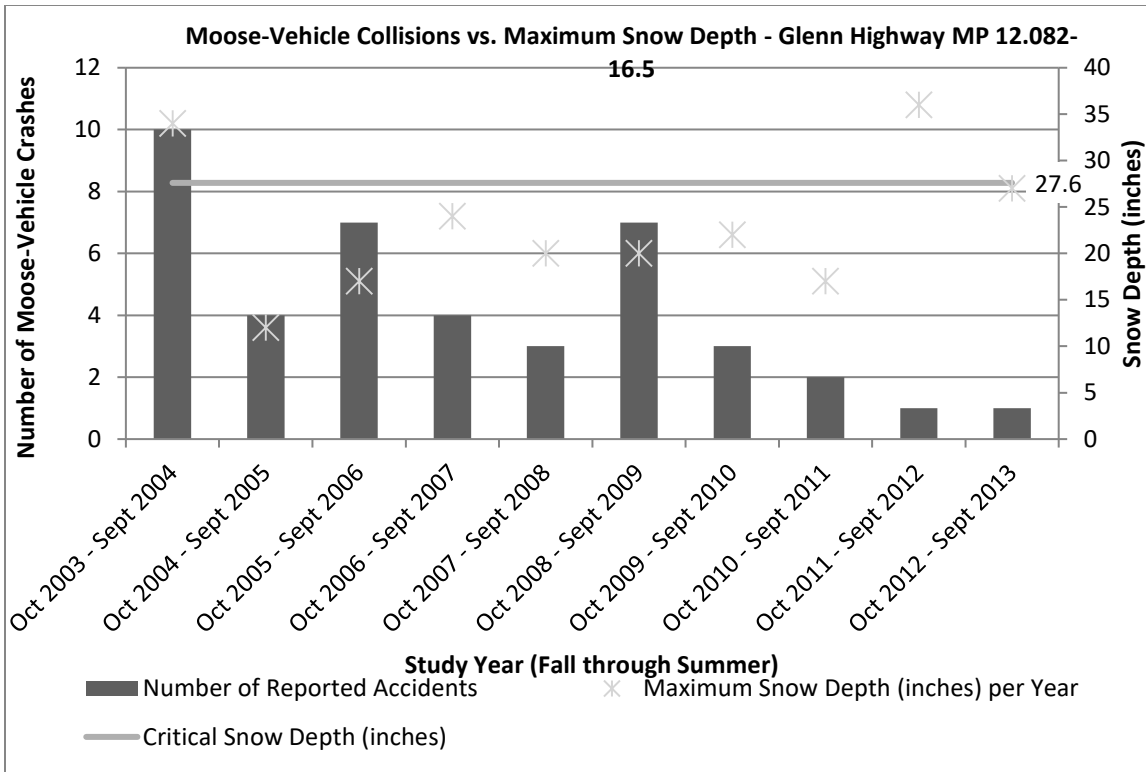
Figure 12 – Moose-Vehicle Collisions vs. Maximum Snow Depth

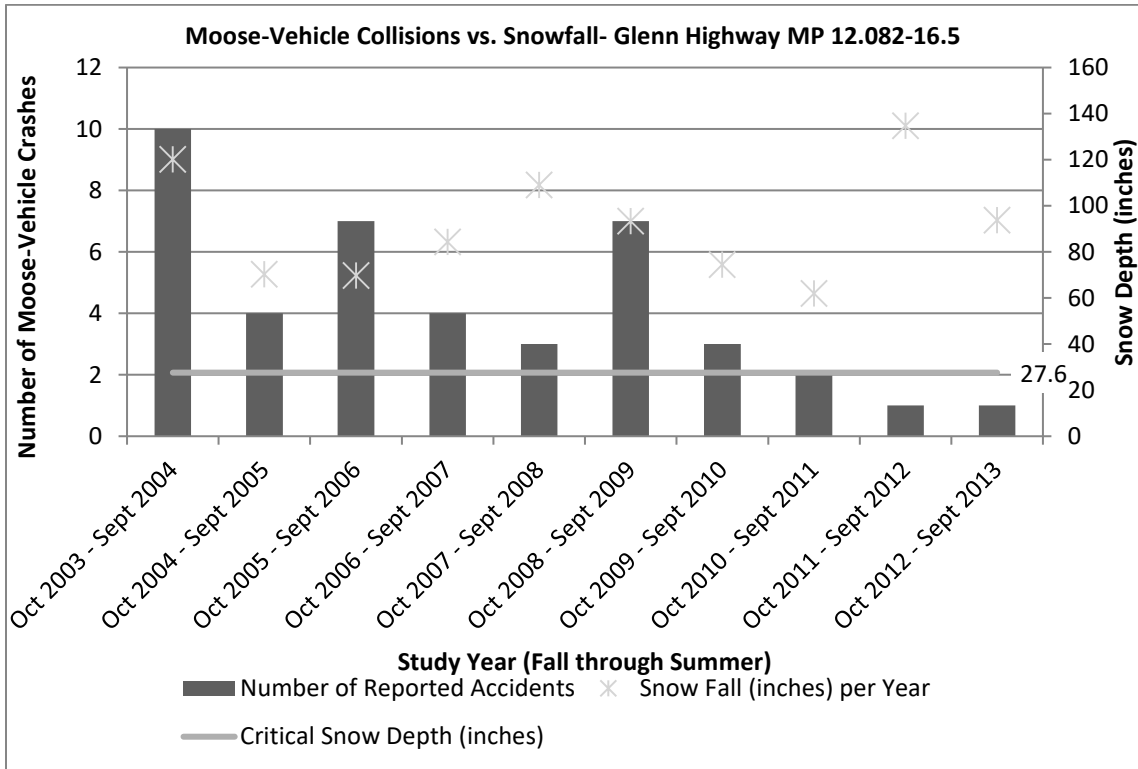
Figure 13 – Moose-Vehicle Collisions vs. Snowfall

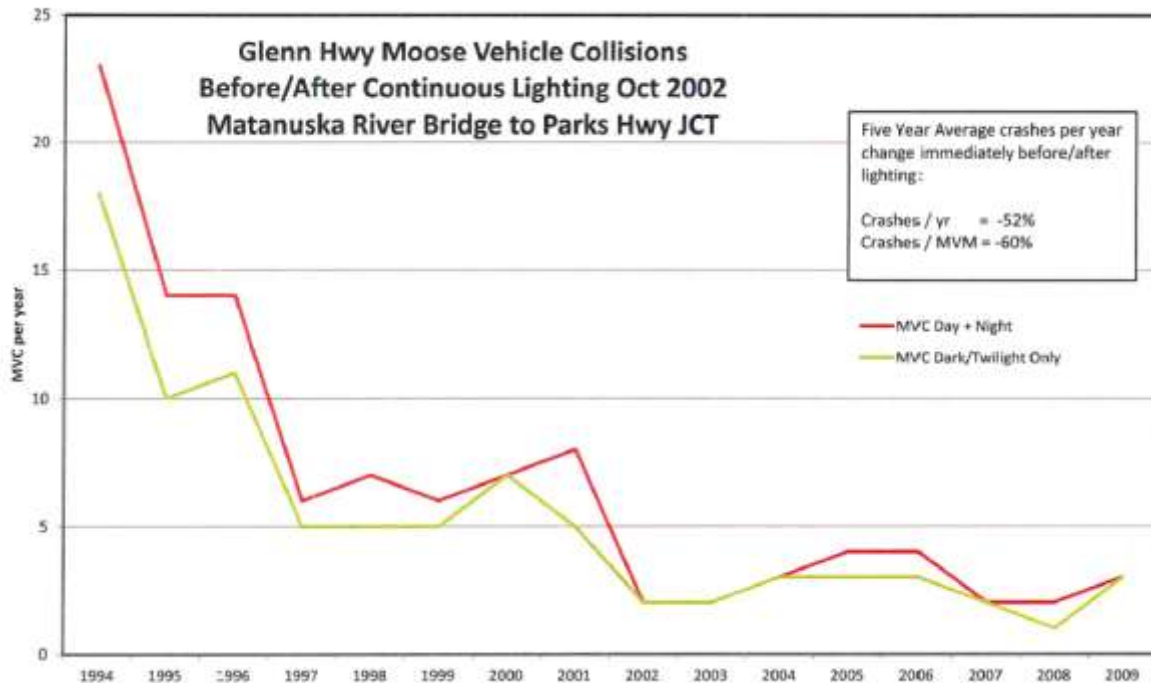
Figure A15 - Glenn Highway Moose vehicle Collisions Before and After Construction of Continuous Lighting – Matanuska River Bridge to Parks Highway Junction (Hayflats)

The DOT&PF also studied the Glenn Highway at the Hayflats, Matanuska River Bridge to the Parks Highway Junction. Continuous lighting was installed on this corridor in October of 2002. Figure A15 shows the results of the study. The five year average per year dropped by over 50% after the installation of continuous lighting.

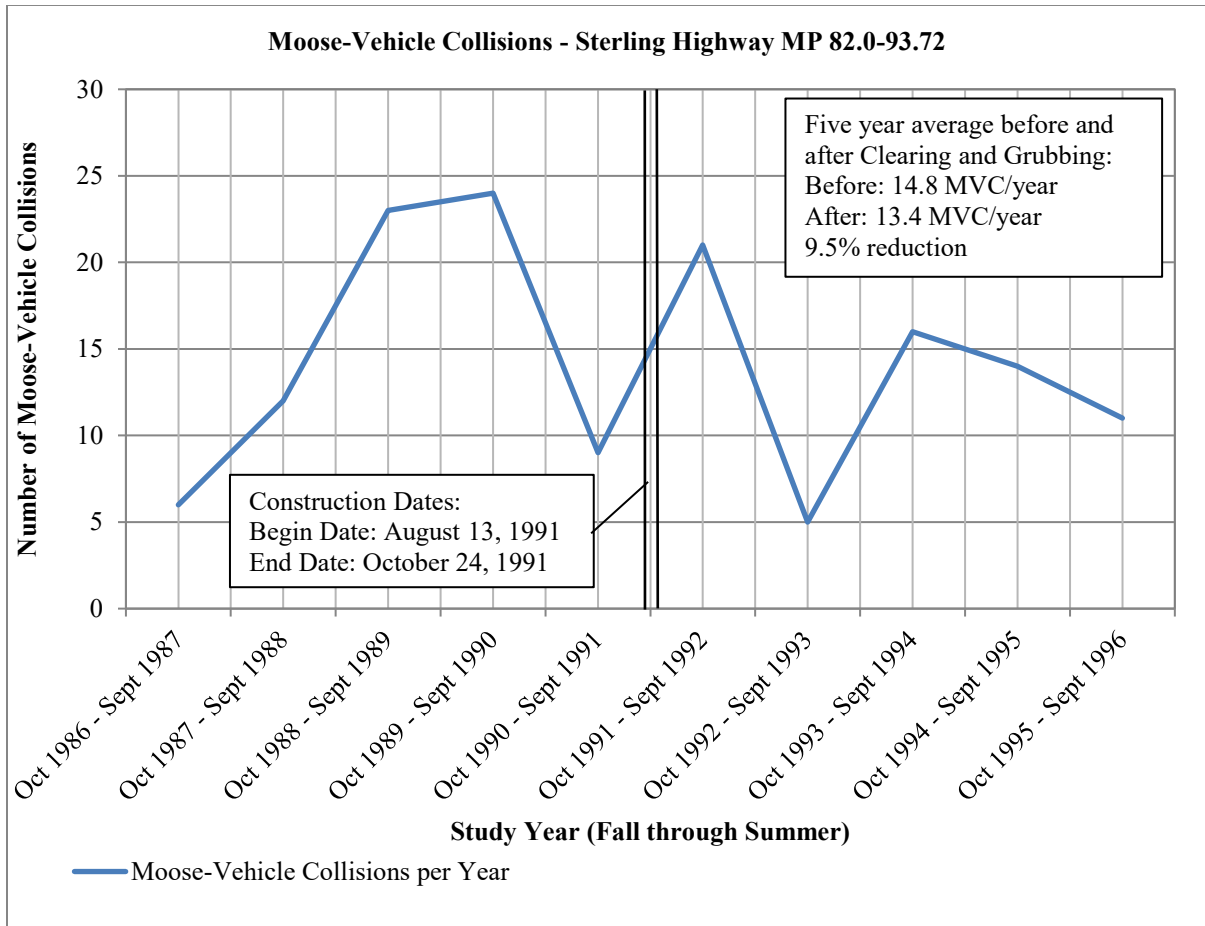
Figure C1 – Moose-Vehicle Collisions - Sterling Highway MP 82.0-93.72

The following figures, Figure C1 through C10, show the number of moose-vehicle collisions reported for each study year by project. Also shown are the construction dates and five year averages before and after the mitigation measure was constructed.

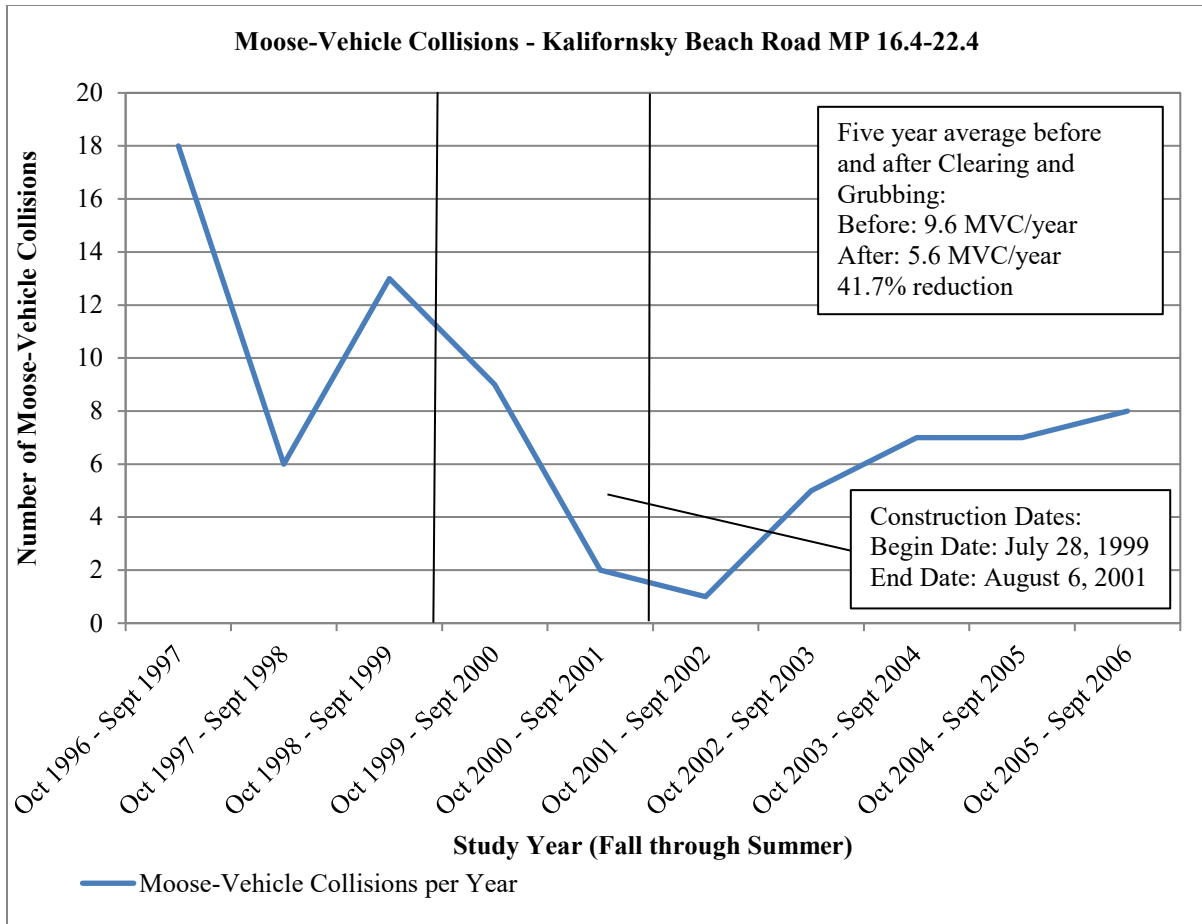
Figure C2 – Moose-Vehicle Collisions - Kalifornsky Beach Road MP 16.4-22.4

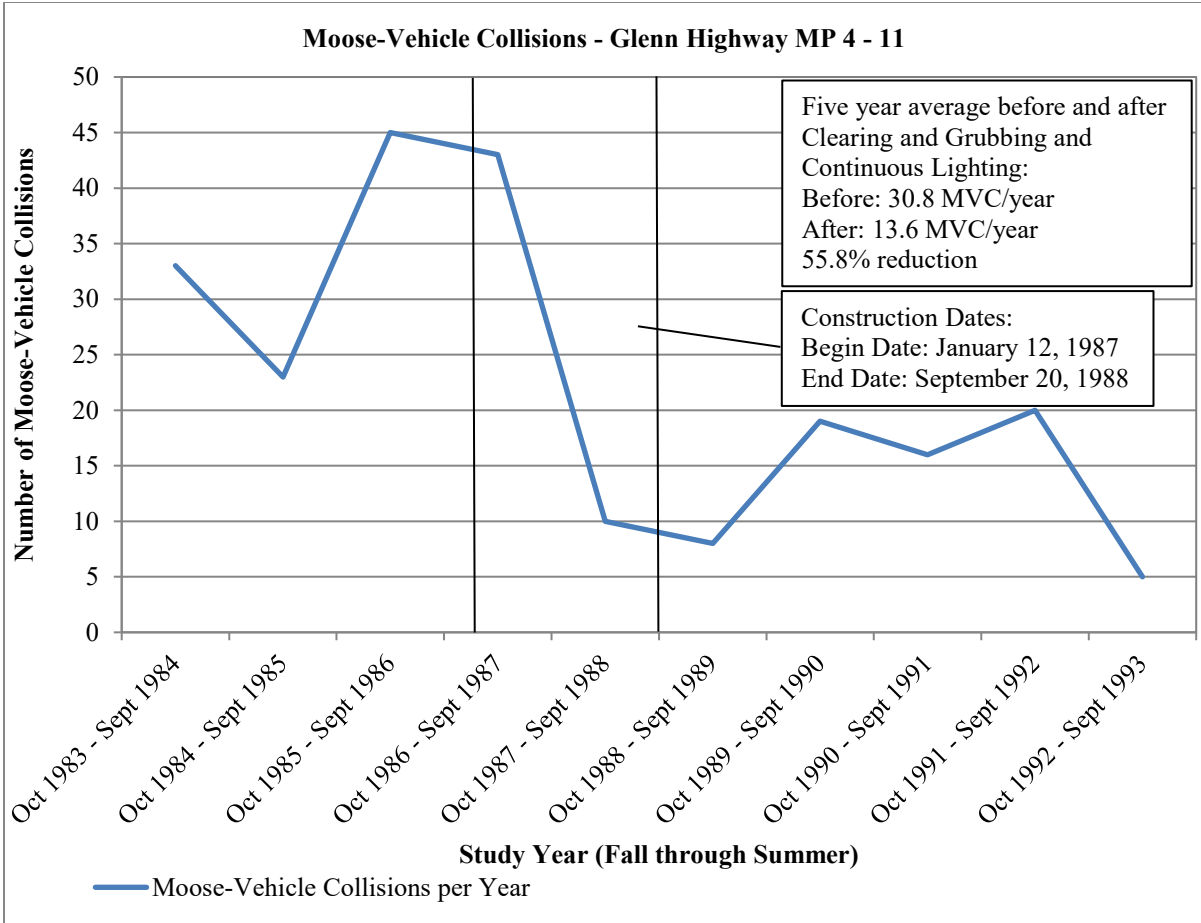
Figure C3 – Moose-Vehicle Collisions - Glenn Highway MP 4 - 11

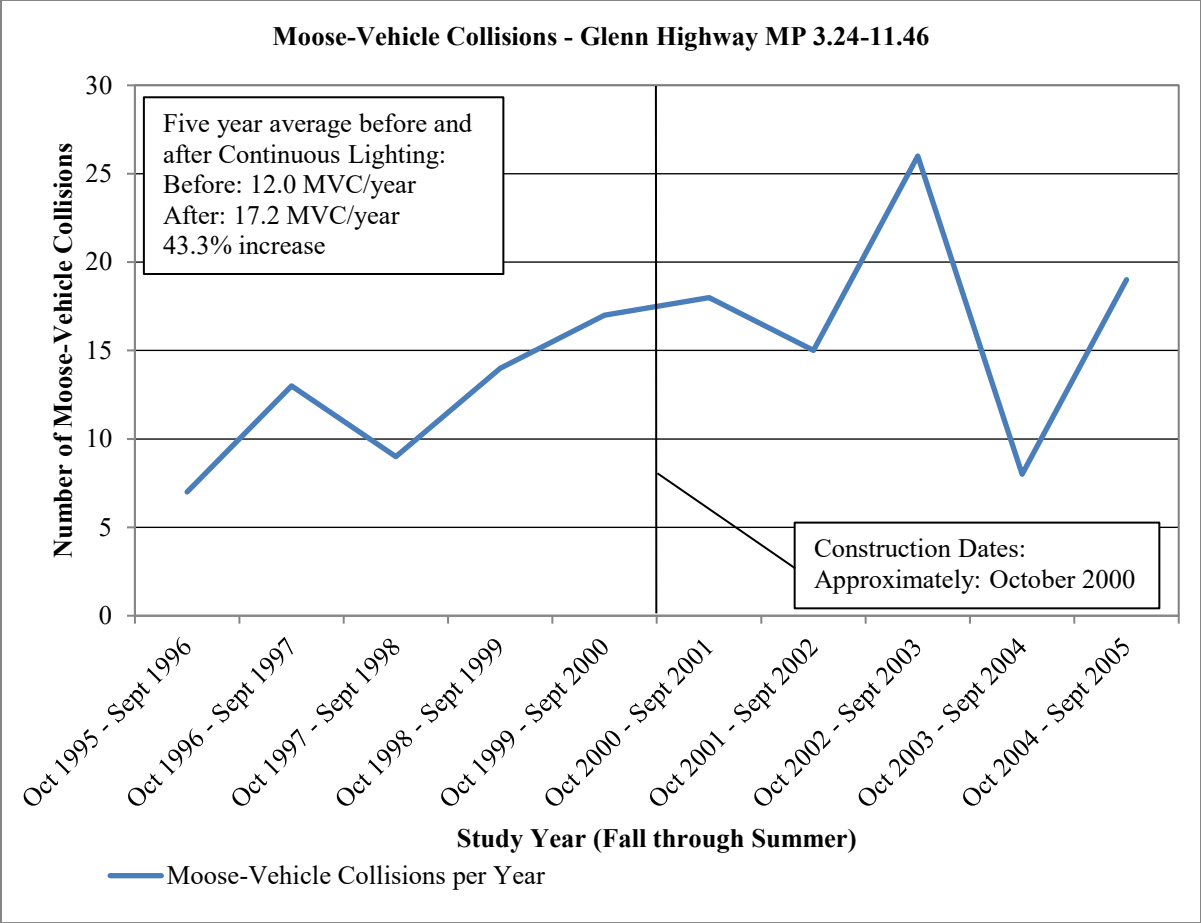
Figure C4 – Moose-Vehicle Collisions - Glenn Highway MP 3.24-11.46

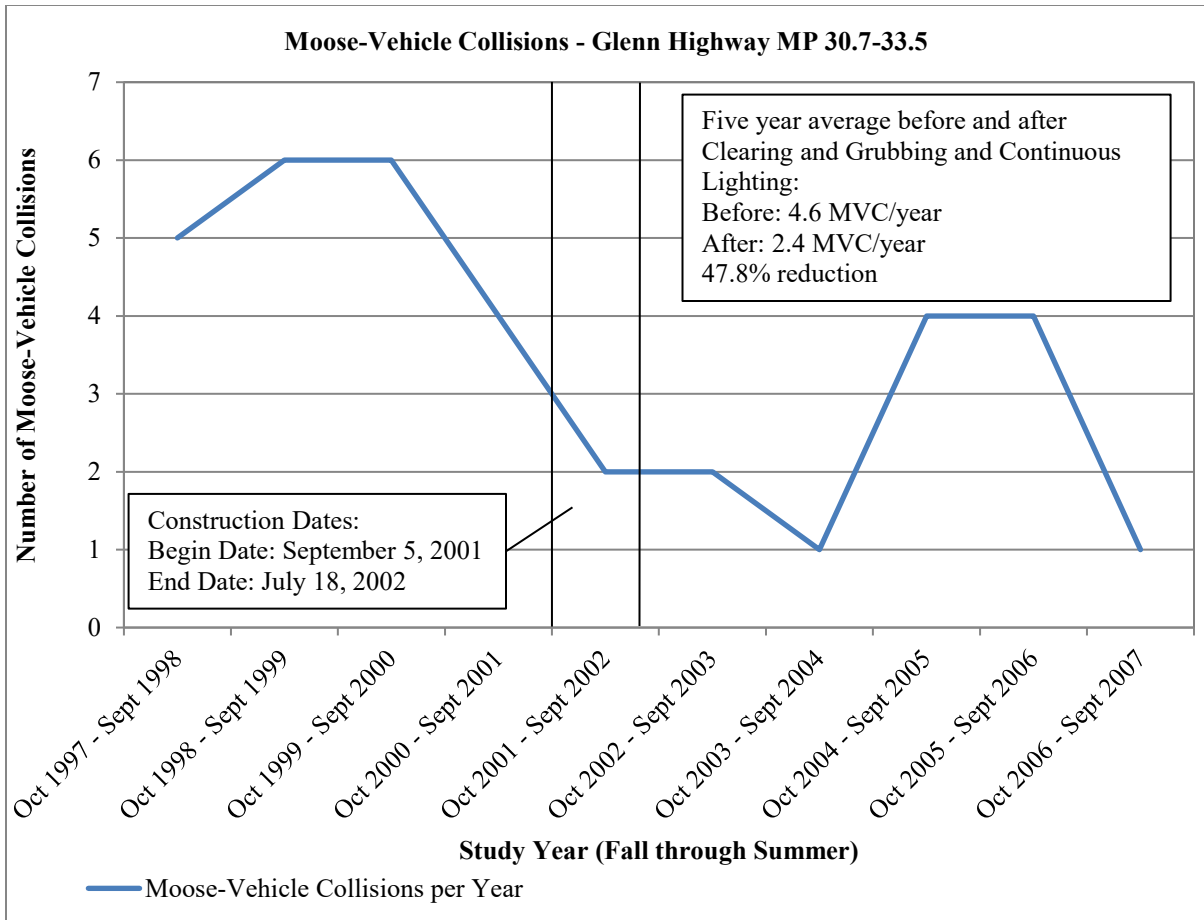
Figure C5 – Moose-Vehicle Collisions - Glenn Highway MP 30.7-33.5

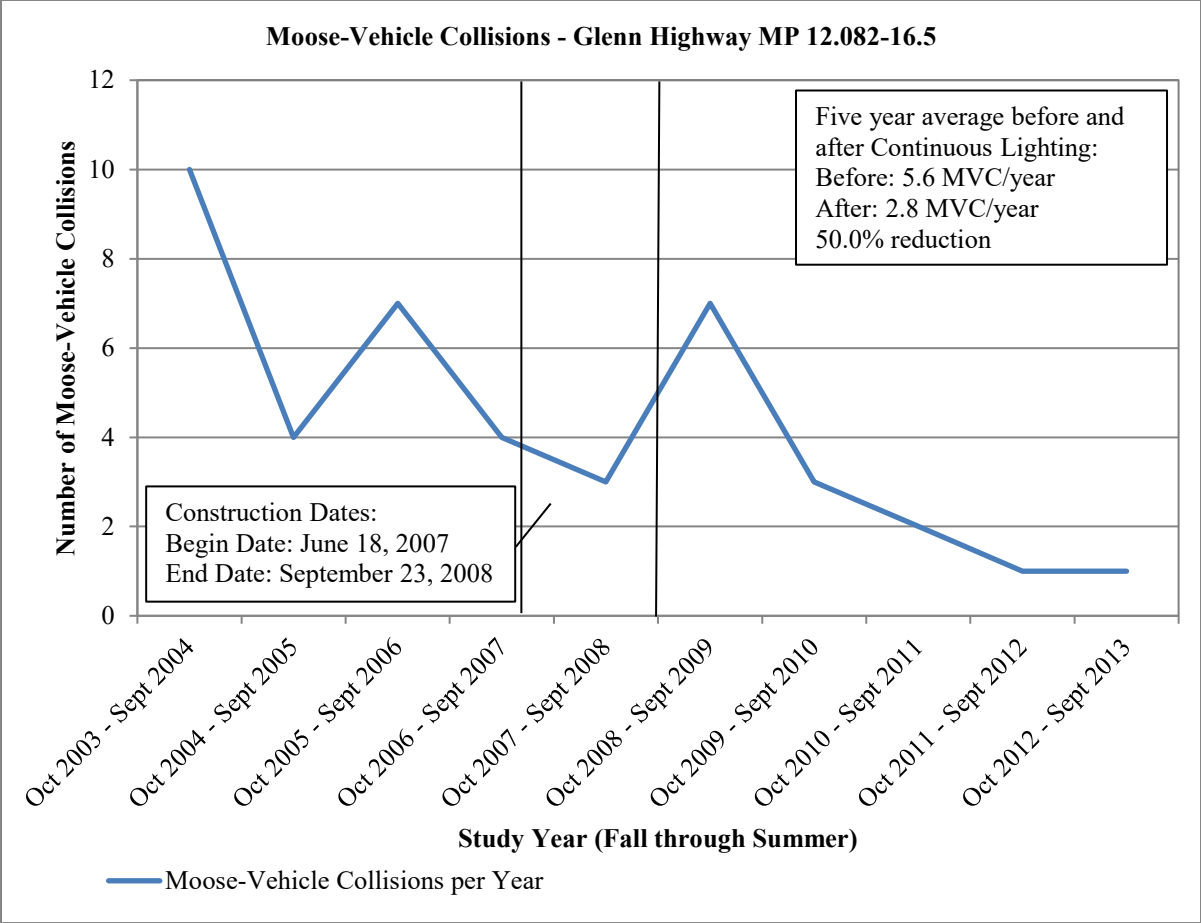
Figure C6 – Moose-Vehicle Collisions - Glenn Highway MP 12.082-16.5

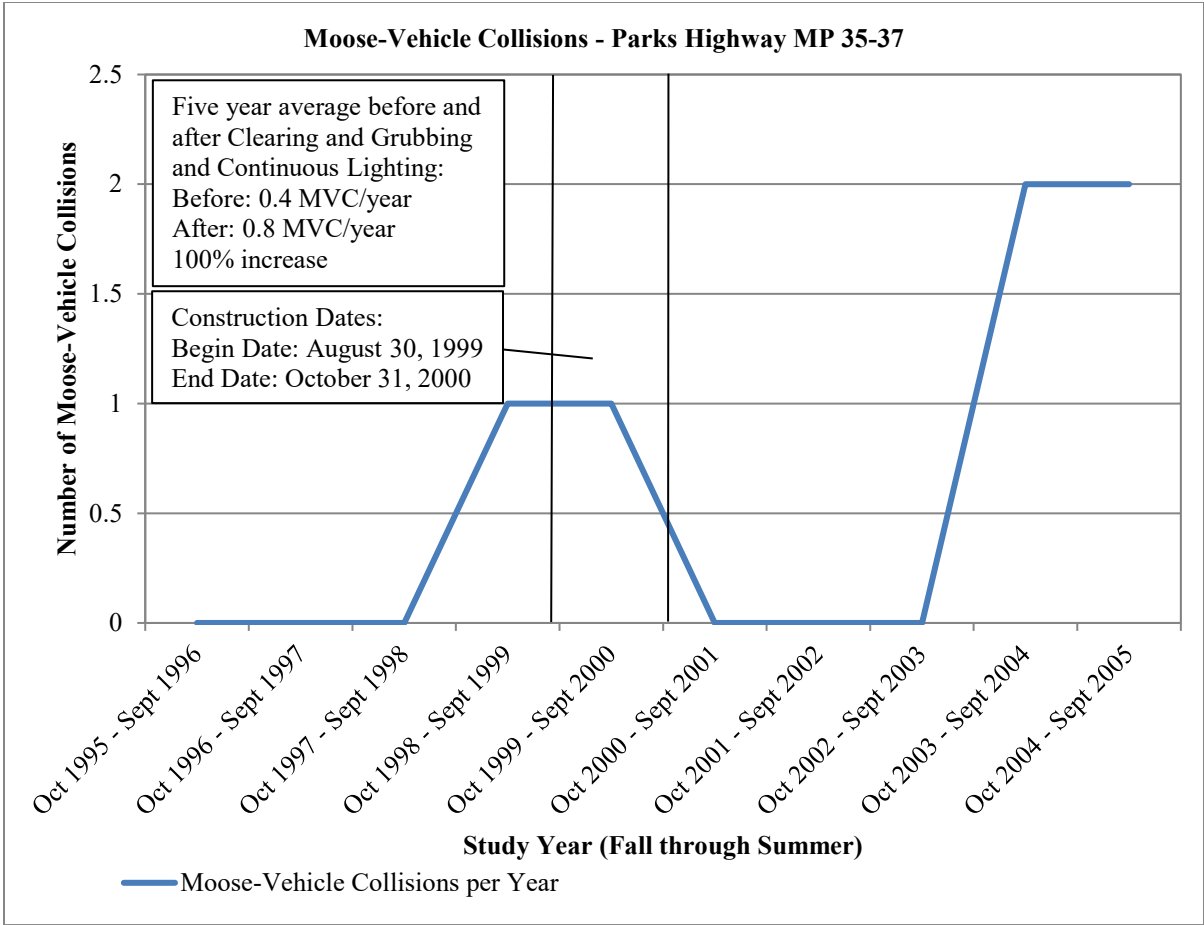
Figure C7 – Moose-Vehicle Collisions - Parks Highway MP 35-37

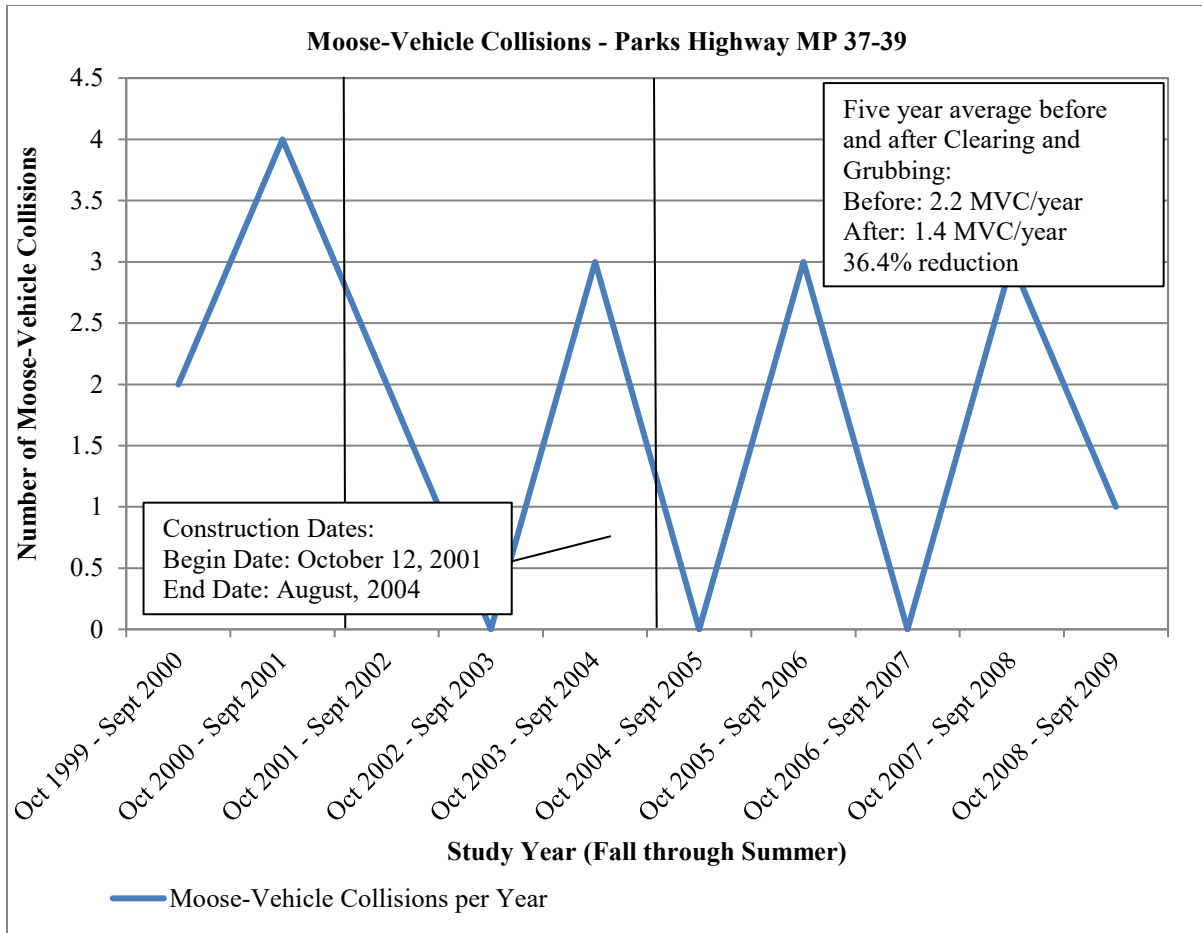
Figure C8 – Moose-Vehicle Collisions - Parks Highway MP 37-39

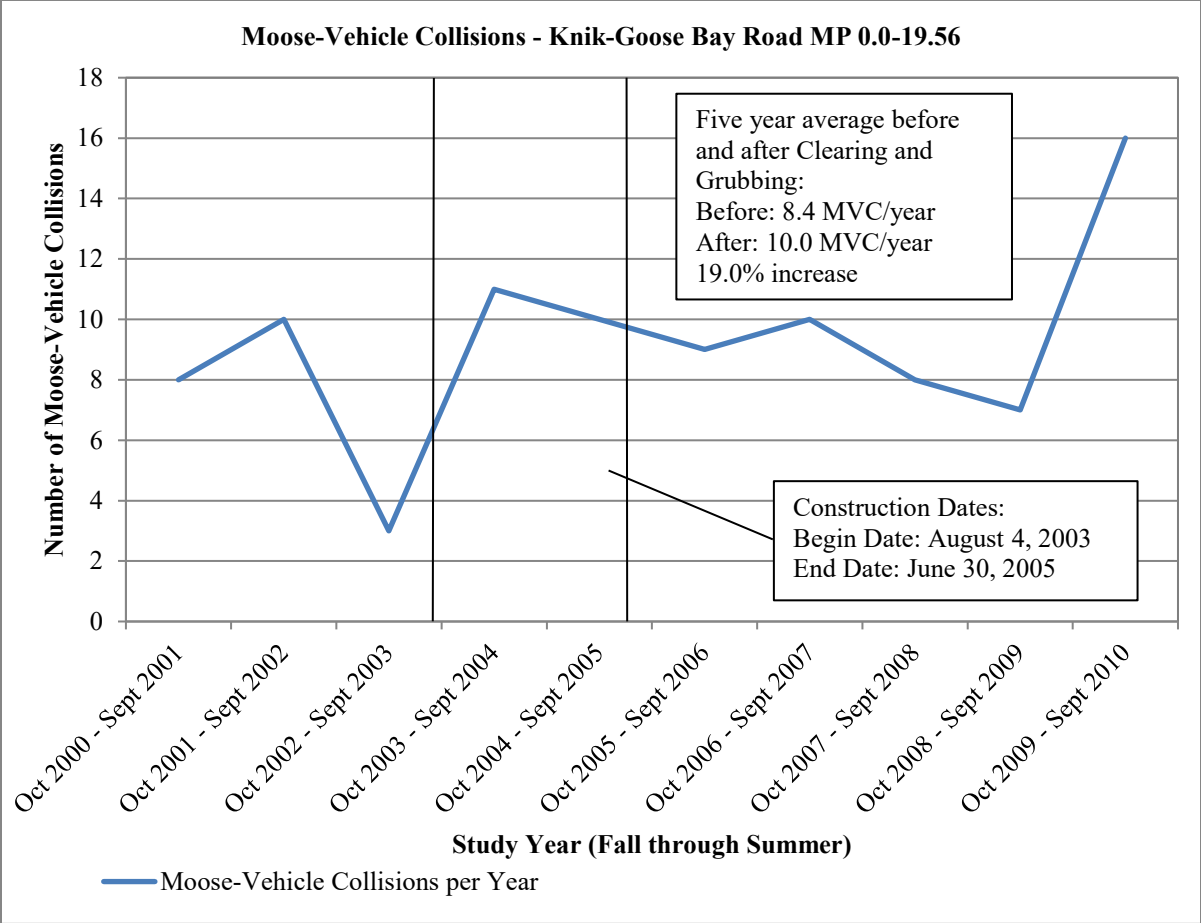
Figure C10 – Moose-Vehicle Collisions - Knik-Goose Bay Road MP 0.0-19.56
