Final Report

Effectiveness of Stationary Police Vehicles with Blue Lights in Freeway Work Zones

March 2018

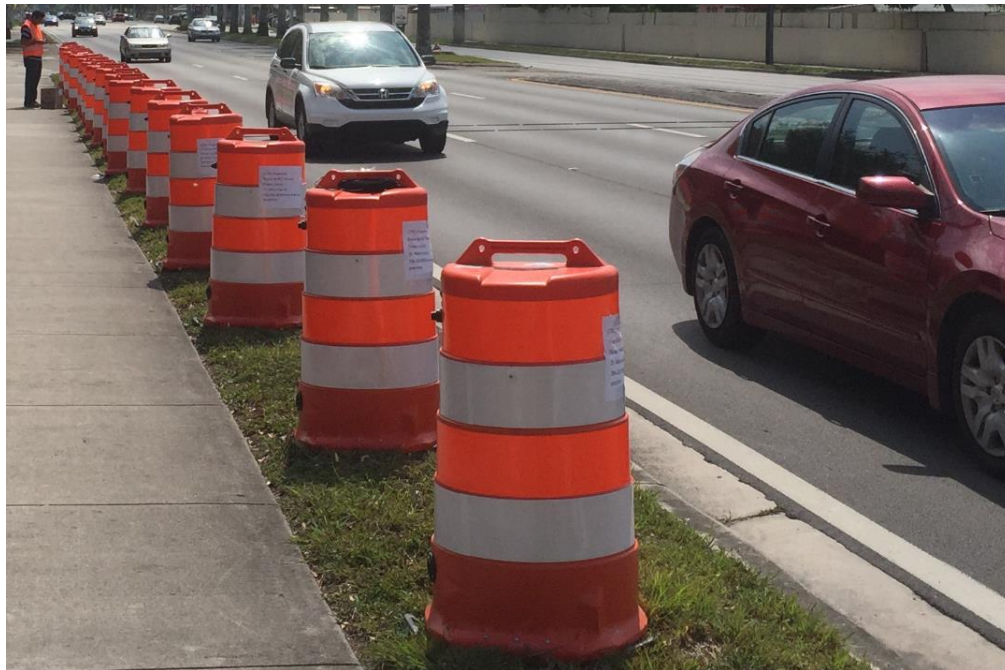
As shown in Figure 2-2, the setup of the test involved placing iCones side-by-side at the location with a pneumatic road tube setup. The setup was situated at a mid-block location on West Flagler Street between Woman Park Drive and SW 103rd Court (see Figure 2-3). The test was successfully completed on April 27, 2017, with speed data collected from both iCones and the road tubes from 11:00 am to 3:00 pm, for a total of four hours. During the entire test period, traffic was free-flow, and was not affected by any vehicle queue.

Figure 2-2. iCone and Road Tube Test Setup

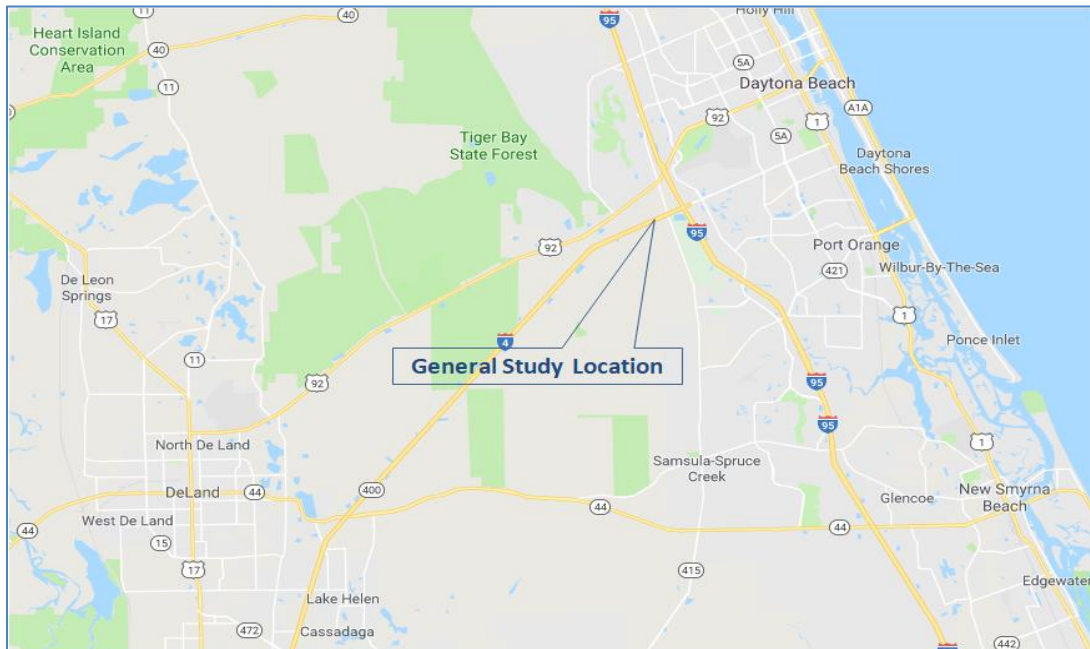
Figure 3-1. General Study Location (Map)

The Daytona Beach study location was part of a major project at the outskirts of City of Daytona Beach to widen I-95 from four to six lanes. The project limits were between north of SR 44 and north of US 92 (International Speedway Boulevard). The project also included the reconstruction of the two interchanges at I-4 and US 92. The specific work zone location selected in this study was located on I-4 eastbound approaching I-95. Figure 3-1 shows the general study location and Figure 3-2 shows the study project limits.

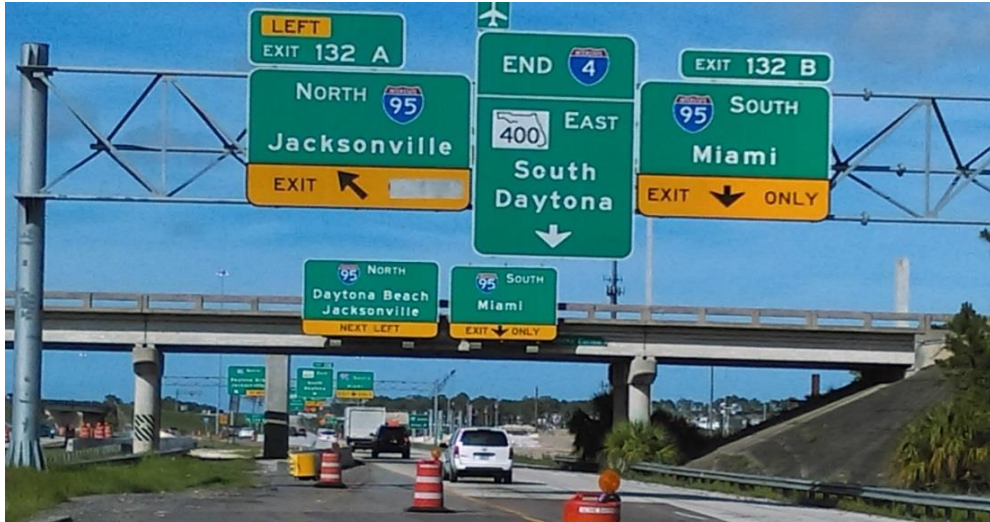
Figure 3-4. Directional Signs on I-4 Eastbound Approaching I-95 Interchange

The study location included a taper transition followed by a full left-lane closure that extended through both the southbound and northbound ramps to I-95, as well as straight ahead to a local arterial street where I-4 ended (see Figure 3-4). The study location also included a 1.9-mile section upstream of the work zone to capture the vehicle speeds before they entered the work zone. The speed limit was 70 mph upstream of the work zone and 65 mph within the work zone. The entire study area was completely dark with no streetlights.

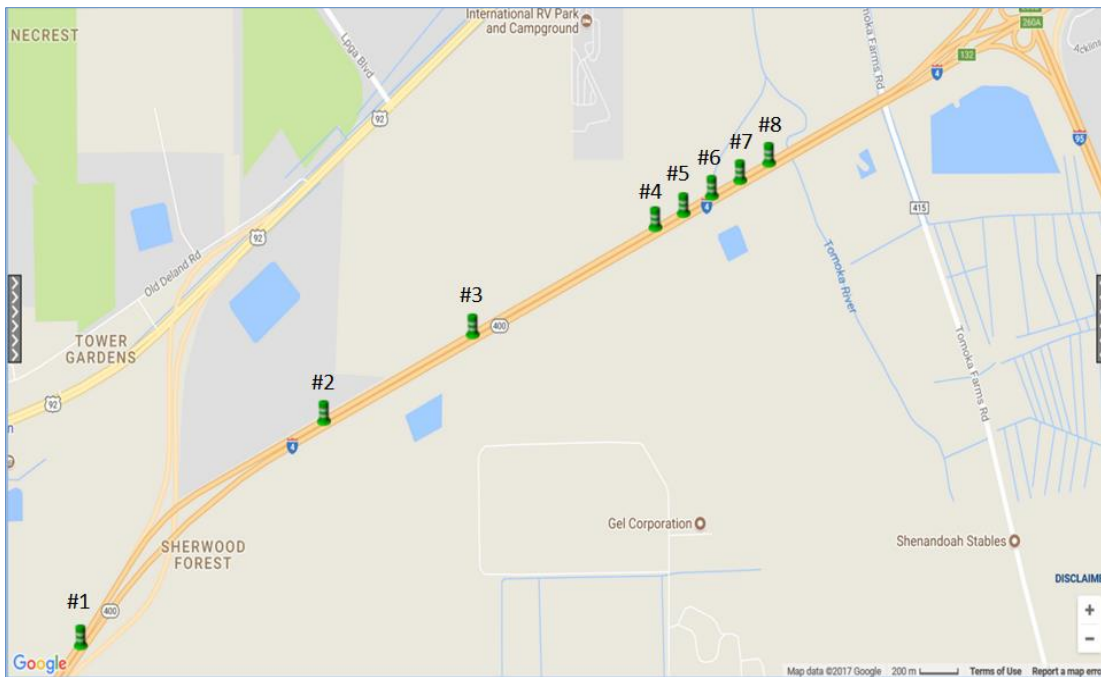
Figure 3-5. iCone Locations for Speed Data Collection

Among the eight iCones used, iCones #1 to #3 were located upstream of the work zone and iCones #4 to #8 were located within the work zone. More specifically:

- iCone #4 was located within the taper transition zone, which measured about 1,100 feet.
- iCone #5 was located at the beginning of the full lane closure.
- iCones #6 to #8 were additional iCones along the work zone.
- iCones #4 to #8 were spaced 500 feet from each other, for a total distance of about 0.5 miles. A larger spacing was not used as vehicles were observed to slow down as they got closer to the I-95 interchange area.

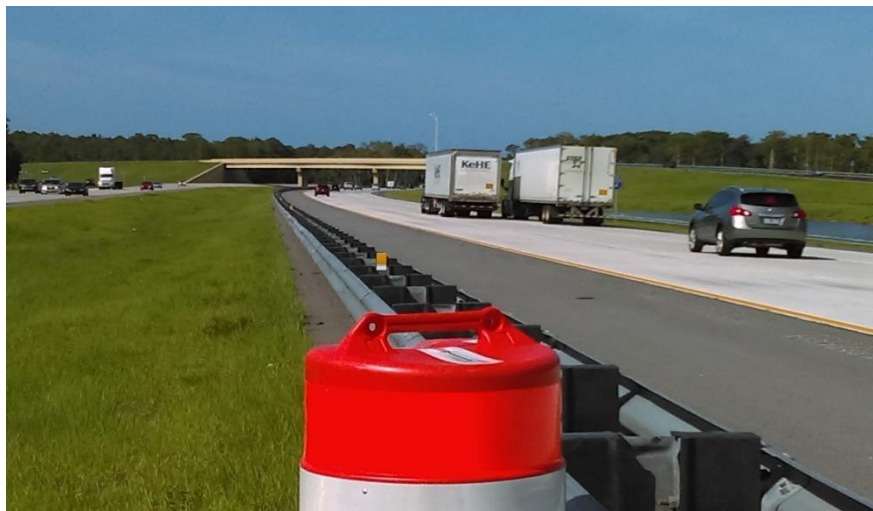
- iCone #1 was located before a horizontal curve (see Figure 3-6). At this location, drivers were not able to see the police vehicle with blue lights, ensuring that their speeds would not be affected by the police vehicle. As the horizontal curve was relatively straight, its impact on the vehicle speeds was expected to be negligible.

Figure 3-6. iCone #1 Located Ahead of the Curve (and Upstream of Work Zone)

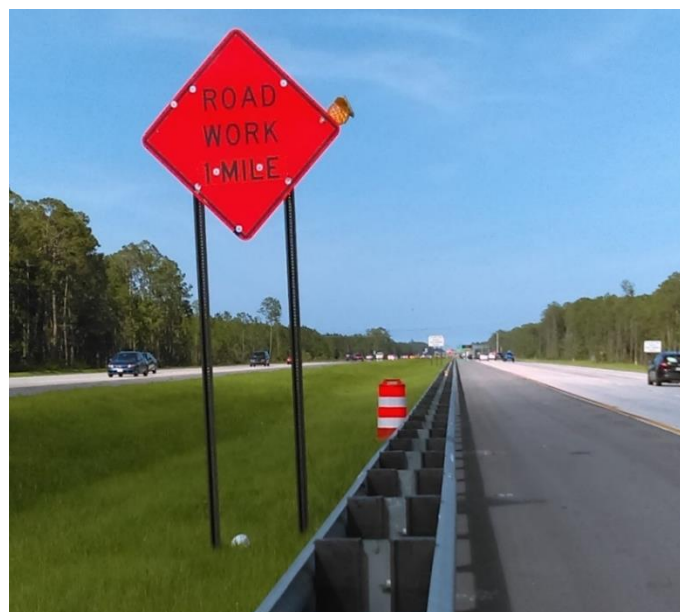
- iCone #2 was located at the “ROAD WORK 1 MILE” warning sign. At this location, drivers were able to see the police vehicle with blue lights relatively clearly (see Figure 3-7).

Figure 3-7. iCone #2 at “ROAD WORK 1 MILE” Sign

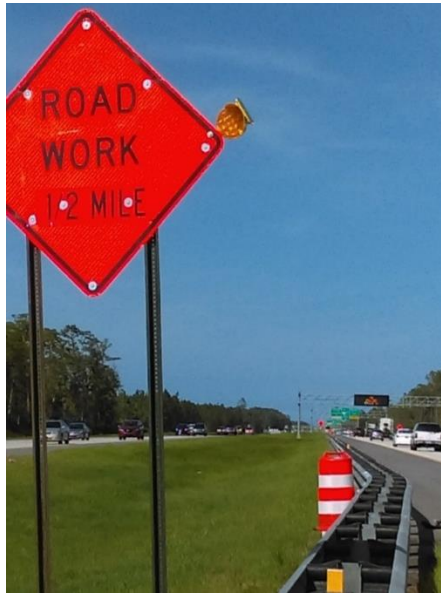
- iCone #3 was located at the “ROAD WORK ½ MILE” warning sign (see Figure 3-8). At this location, drivers were able to see the police vehicle with blue lights clearly.

Figure 3-8. iCone #3 at “ROAD WORK ½ MILE” Sign

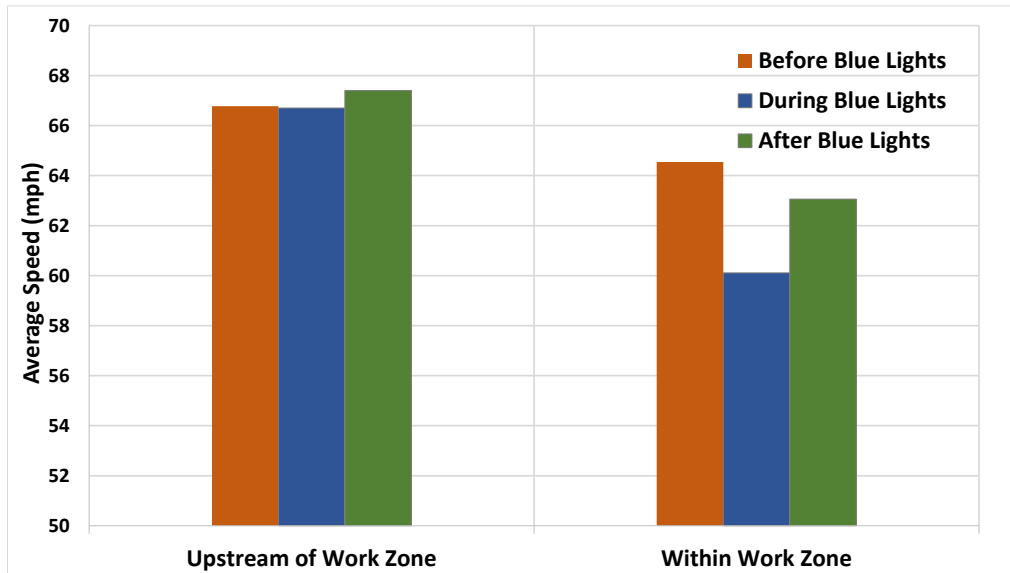
Figure 3-11 plots the overall average speeds for each evaluation period for iCones upstream of the work zone and iCones within the work zone.

Figure 3-11. Overall Average Speeds Upstream of and within Work Zone

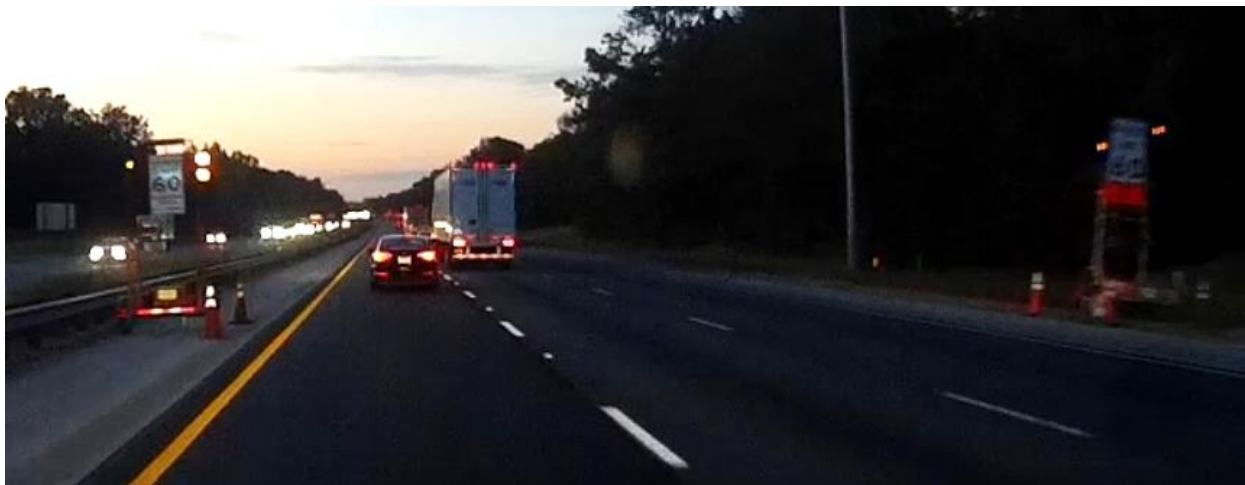
Figure 4-3. Reduced Work Zone Speed Limit Warning Sign

The selected construction project was a fast-moving asphalt milling and resurfacing project located on I-75 at the outskirts of City of Gainesville (see Figure 4-1). As shown in Figure 4-2, the project limits ran between south of SR 121 (SW Williston Rd) and south of SR 222 (NW 39 Ave). The section of the I-75 had three lanes in each direction and the total distance was 6.5 miles. The section included three major interchanges that pass over the W. Newberry Road to the north, the SW Williston Road to the south, and the SW Archer Road in between. As a result of these overpasses, there were three minor crest vertical curves that were not expected to significantly affect the truck speeds. As can be seen in Figure 4-2, the section was relatively straight, thus the vehicle speeds were not affected by horizontal curves. The regular speed limit on the section was 70 mph and was temporarily reduced to 60 mph during construction (see Figure 4-3).

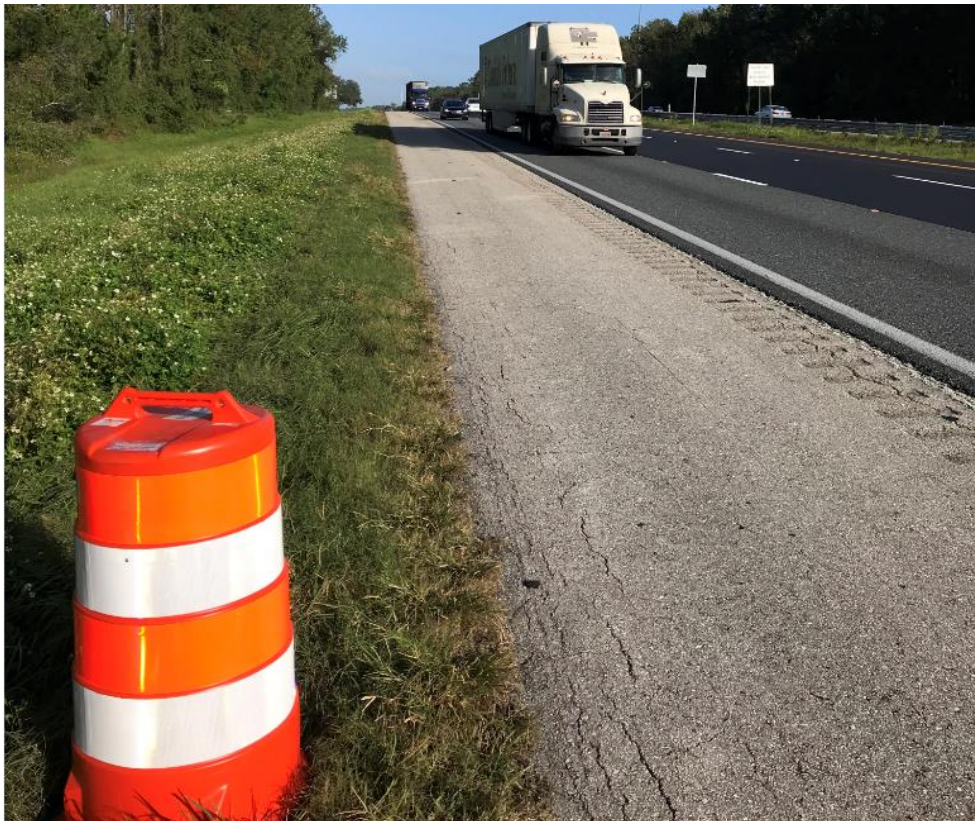
As the work zone locations varied each day, the actual locations of the iCones for each day were adjusted (i.e., moved slightly upstream or downstream) as needed, in order to avoid: (1) vertical curve slopes where the average speeds, especially of the trucks, could be affected; (2) acceleration and deceleration lanes where the average speeds could be affected by those of the merging and diverging vehicles. The actual iCone locations used for each of the night closures for which data were collected are given in Appendix A. For the entire study, all iCones were placed near the outside shoulder (see Figure 4-5 for an example) next to the open travel lane.

Figure 4-5. iCones Placed Next to the Outside Shoulder

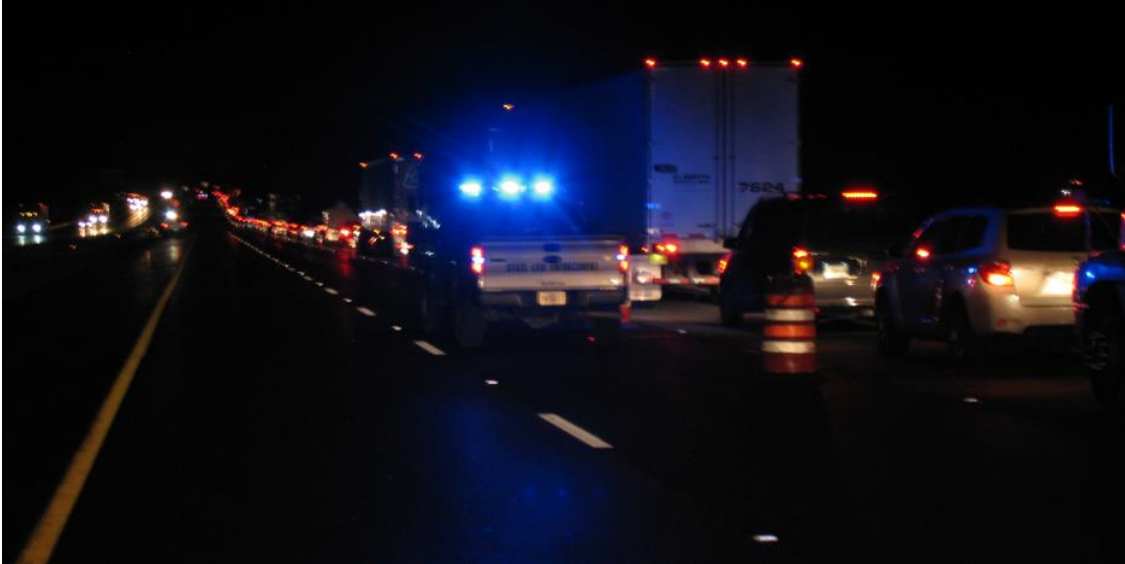
Figure 4-6. Florida Fish and Wildlife Conservation Commission (FWC) Vehicle with Blue Lights

The first of the two video cameras was set up at iCone #4 located at the beginning of the full closure (2-lane or 2.5-lane). This was also the location where the vehicles with blue lights were parked. The vehicles used in this study were from the Florida Fish and Wildlife Conservation Commission (FWC) and displayed only blue lights (see Figure 4-6). This particular video camera served four main purposes: (1) captured the parked vehicle with blue lights and helped to keep a record of the exact time periods that blue lights were present, (2) determined the congestion level in order to identify the uncongested periods for analysis, (3) determined the period when construction ended, and (4) determined the truck percentages and lane use distribution (for the one night closure with two lanes open, see Table 4-1).

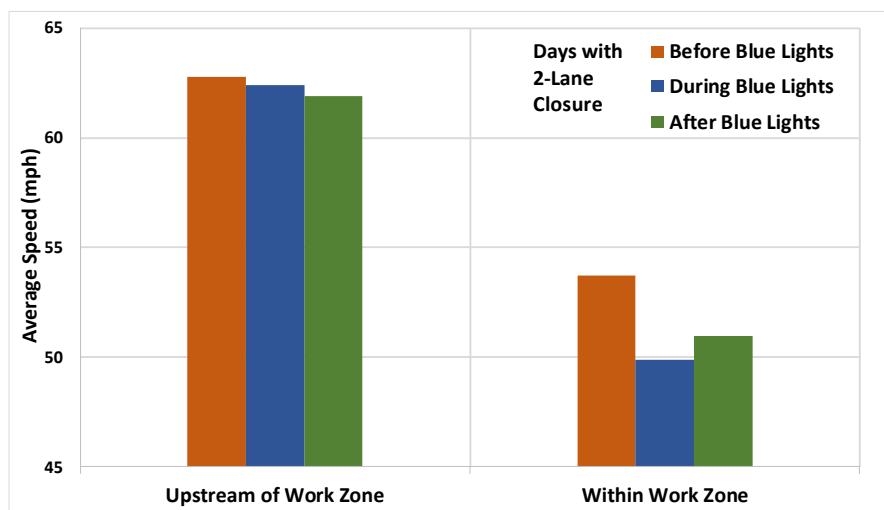
Figures 4-10 and 4-11 show the overall average speeds upstream of and within work zone for each of the three evaluation periods for 2-lane and 2.5 lane closures, respectively.

Figure 4-10. Overall Average Speeds Upstream of & within Work Zone for 2-Lane Closure
