Report No. FHWA-KS-03-5
FINAL REPORT

DAYLIGHTED DRAINABLE BASE RESEARCH

KANSAS DEPARTMENT OF TRANSPORTATION

Division of Operations
Bureau of Materials and Research

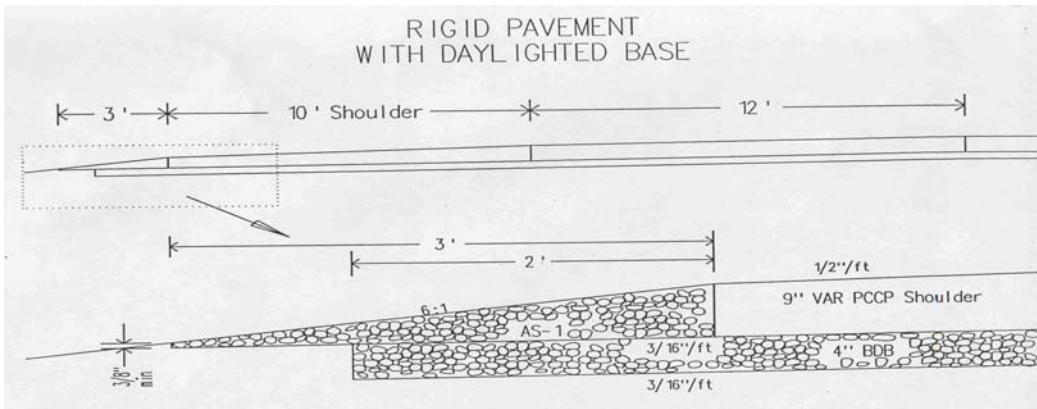
FIGURE 1

The original “daylighted” section detail that was submitted to FHWA, Federal Highway Administration, is shown in Figure 1. The section consisted of drainable base construction two feet beyond the pavement edge and a three-foot wide rock wedge over the base and adjacent to the shoulder pavement. The rock wedge was to be dense graded to reduce erosion and prevent water infiltration into the drainage layer. Water from the drainable base was to be removed by evaporation and transpiration.

This section would not rapidly remove water from the pavement structure. KDOT’s observation of in-place systems indicated that few outlet pipes drain appreciable quantities of water. It was further observed that pipes on flat slopes generally resulted in plugged to partially plugged conditions. This daylighted section had a continuous path for water egress. On flat grades the primary drainage component is the direction of the pavement cross slope. This design resulted in a short flow path. The water concentrates at the edge of the shoulder, away from the traffic loading, until it dissipates. This proposal was rejected by FHWA because it did not provide for positive drainage and could have problems associated with water ponding on the lime treated sub-grade.

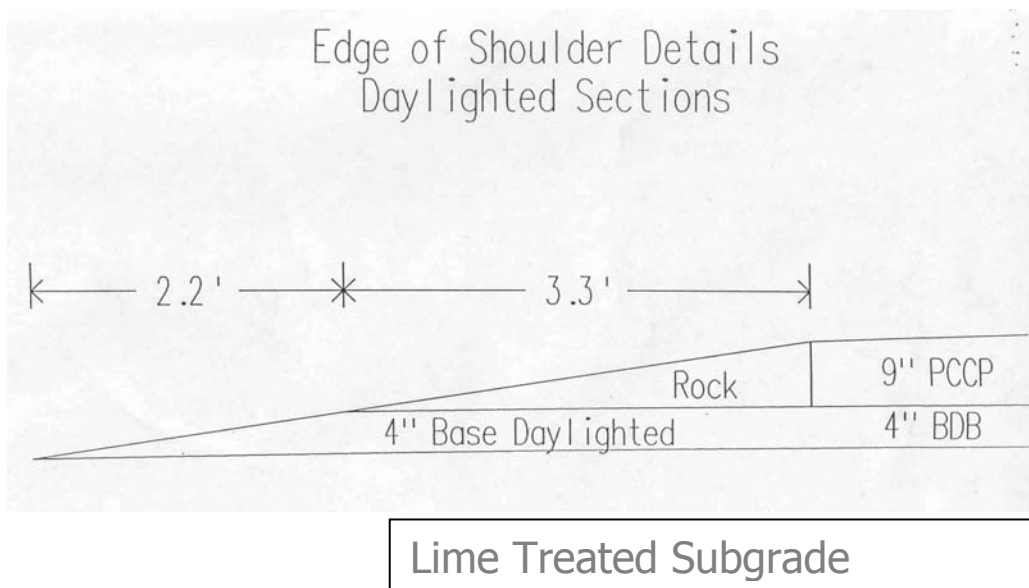
FIGURE 2

A revision to this original design, illustrated in Figure 2, was submitted in May of 1995. This design extended the bound drainable base material to the shoulder slope providing the positive drainage system desired. Thus the term “daylighted” was applied. The positive drainage was achieved by constructing the lime treated subgrade at a 3/16-inch per foot slope. This method of continuous positive drainage would also prevent the ponding of water on the lime treated subgrade. Aggregate, with minimal fine material, would be used adjacent to the shoulder above the daylighted base material, in lieu of soil, to reduce the infiltration of fine material into the drainable base material.

This design met with FHWA's approval. Test Projects were selected and variations of the design were prepared to be field tested on these Projects.

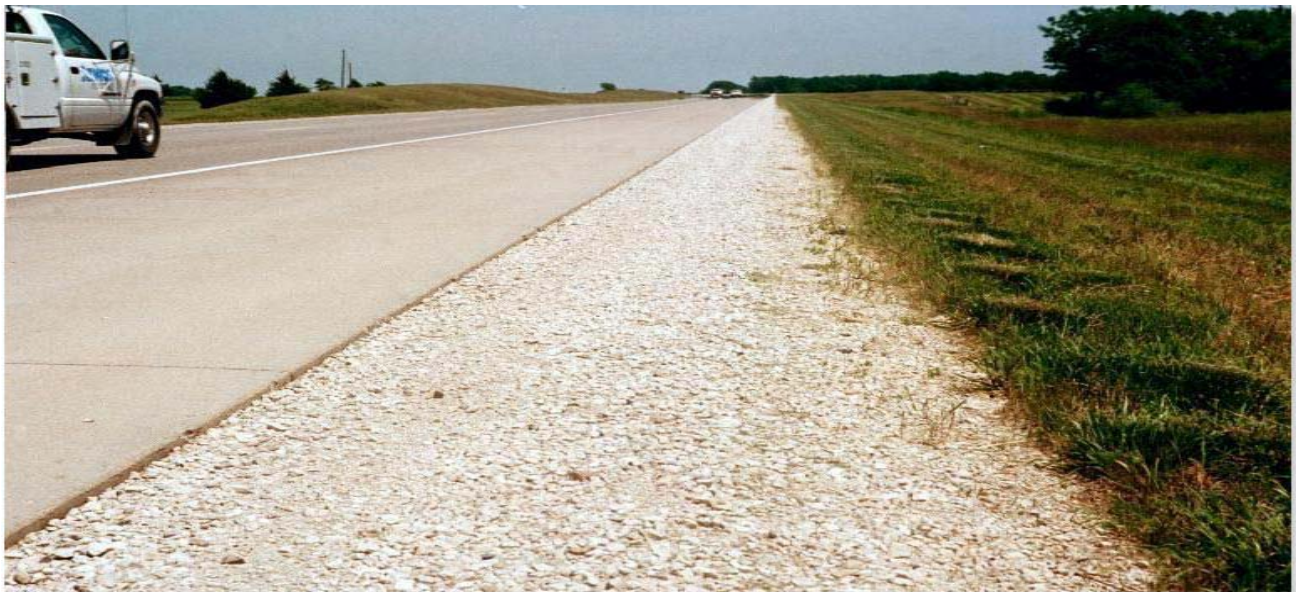
FIGURE 3: Expected aggregate appearance of a daylighted drainable base. This is the right shoulder on US-50 at Station 242+00

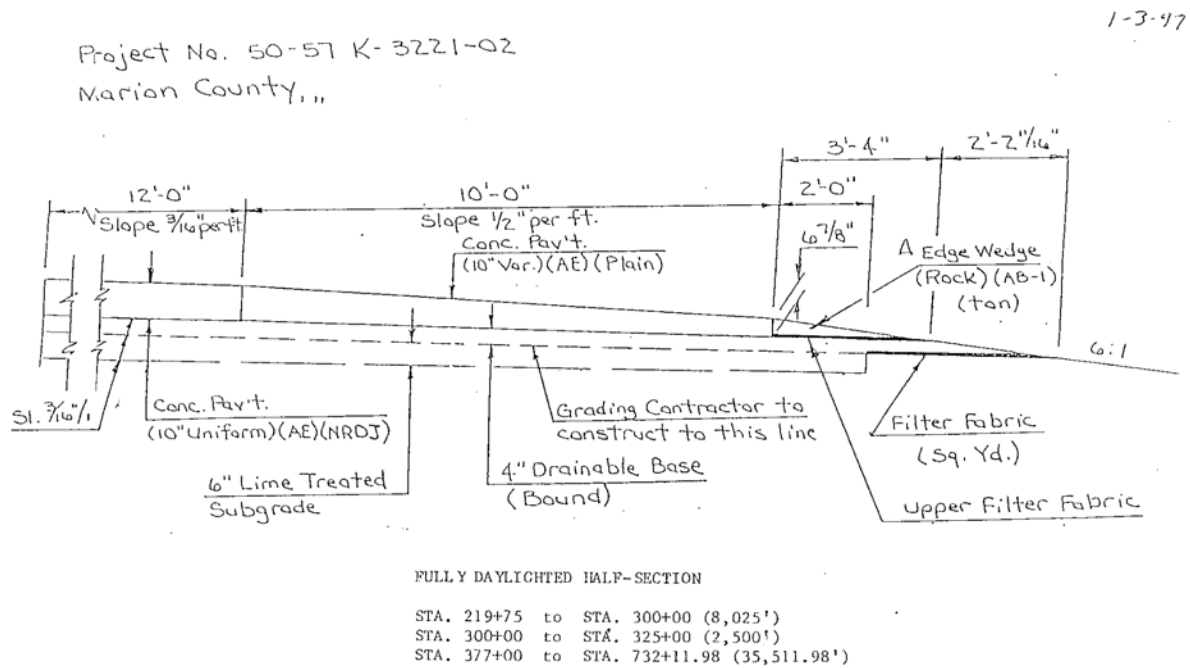
FIGURE 4

As noted above, the US-50 Project tested four different drainage systems. The first was a fully daylighted drainable base section with the cement treated drainable base material carried to the shoulder slope as shown in Figure 4. A filter fabric was placed below and above this drainage layer from the shoulder edge out. This filter fabric was used to prevent infiltration of the

untreated soil from below and the fines from the aggregate wedge above. Aggregate of the AB-1 designation was used in the shoulder wedge. Figures illustrating the other drainage designs being investigated are shown in Appendix C.

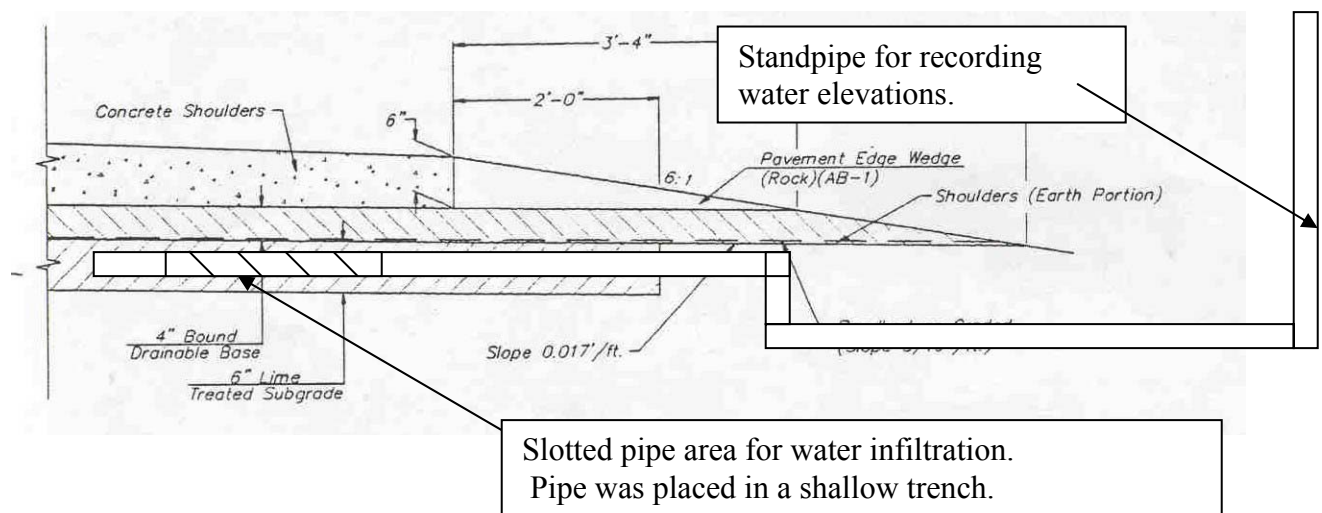
Figure 2

Two types of instrumentation were used to document the performance of the daylighted drainable base. The first was a standpipe system. A standpipe consisted of one-inch diameter pipe with a five foot slotted section. The slotted section was buried at the interface of the base with the lime treated subgrade. The pipe was then extended to the ditch with a vertical standpipe for elevation readings. One of these standpipes was placed at each test section. The standpipe was used to determine the elevation of water in the drainage system. A reading greater than the reference elevation would indicate the presence of standing water in the base drainage system. Conversely, a reading less than the reference elevation would indicate the absence of water in the base. One standpipe was located at each of the stations listed in Table 2. A detail of the standpipe design is shown in Figure 5.

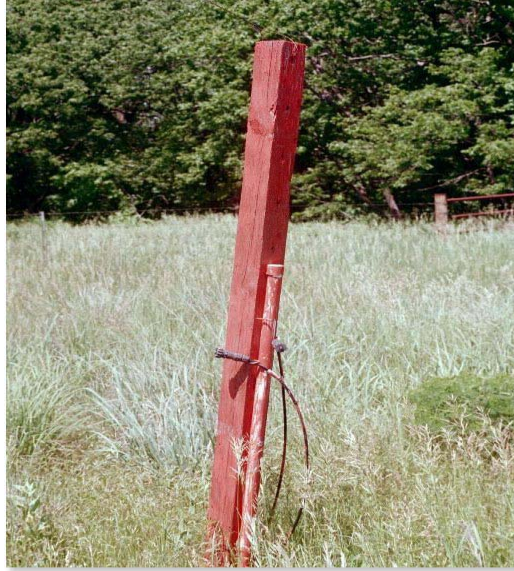
Figure 4

Typical standpipe setup for testing. The PVC tube is the standpipe. The black tubes access the piezometers for reading purposes.

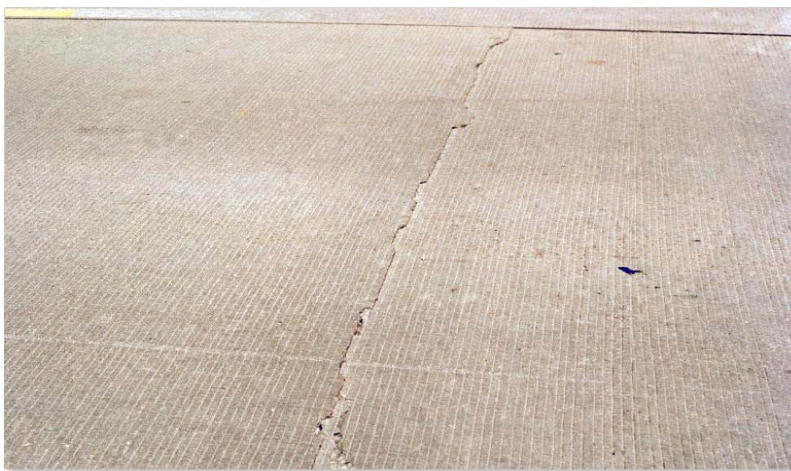
Figure 5

Typical Mid-Panel Crack on the US-50 Project. This one is at Station 339+98.

The US-50 Project has experienced serious distress. See the “Special Pavement Investigation” report by Richard A. Barezinsky, P. E. dated June of 2002. This report indicates the failure of the Lime Treated Subgrade separator layer and its infiltration into the drainable base. This is leaving voids in the subgrade allowing the pavement slab to settle. See the photo in Figure 8 below. Jim Brennan’s report of July 7, 1999 did indicate that all of the test sections were performing as expected except for the section with the bound drainable base wedge prior to this failure of the subgrade.

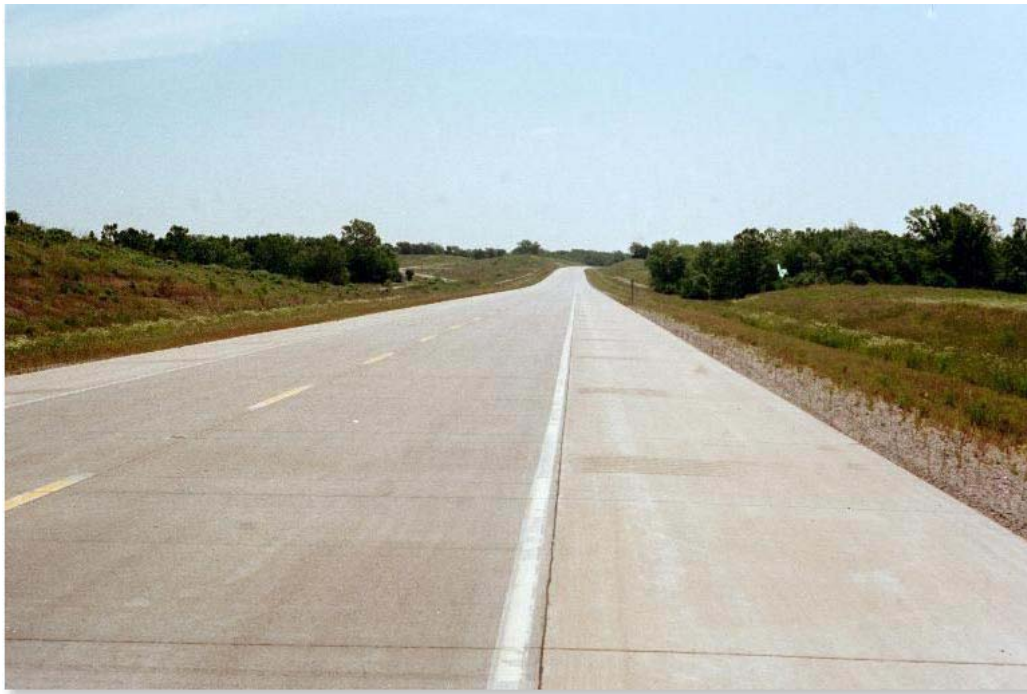
Figure 6

Condition of US-400 at Station 349+95 viewed to the East.

The US-400 Project is still performing in the expected manner. The final readings taken in 2003 indicate the absence of water in the base indicating the daylighted drainable base is functioning. Jim Brennan's July 7, 1999 report indicated similar performance between the partially daylighted system using AS-1 aggregate wedge as the edge drain system with one exception. The edge drain system was plugged initially and required cleaning to perform properly, a typical requirement for edge drain systems. The photos of this project illustrate a vast difference from the US-50 photos as this Lime Treated Sub-grade is still performing as designed.

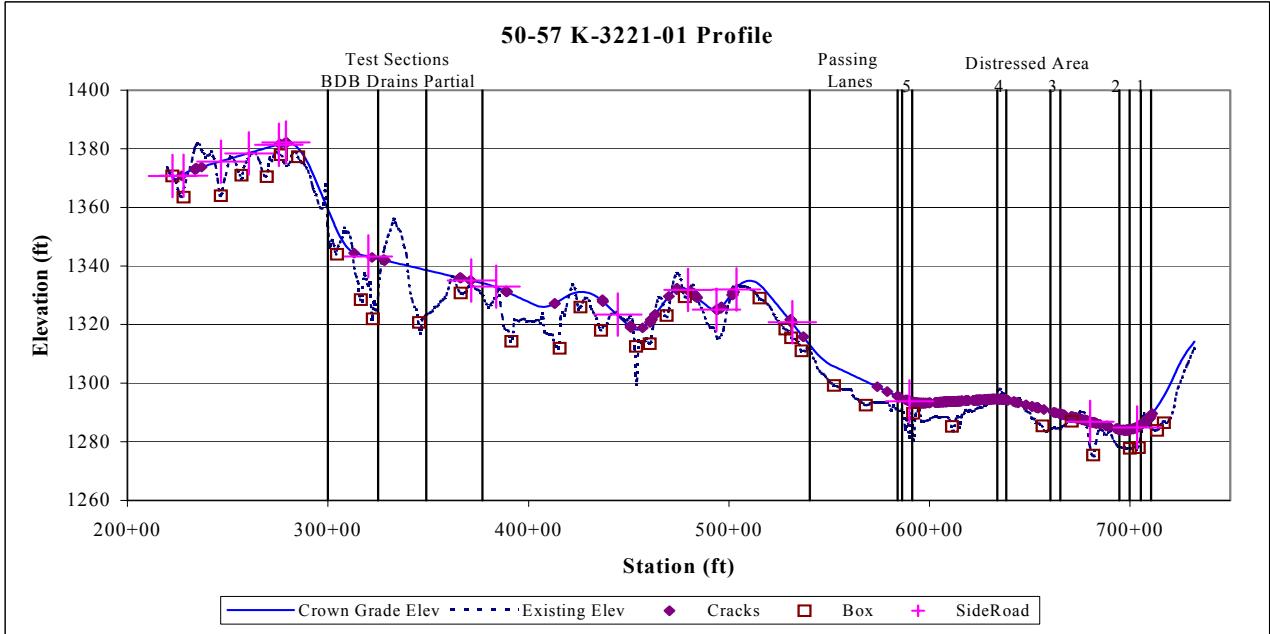
Figure 12
US-50 Profile Indicating Areas of Distress

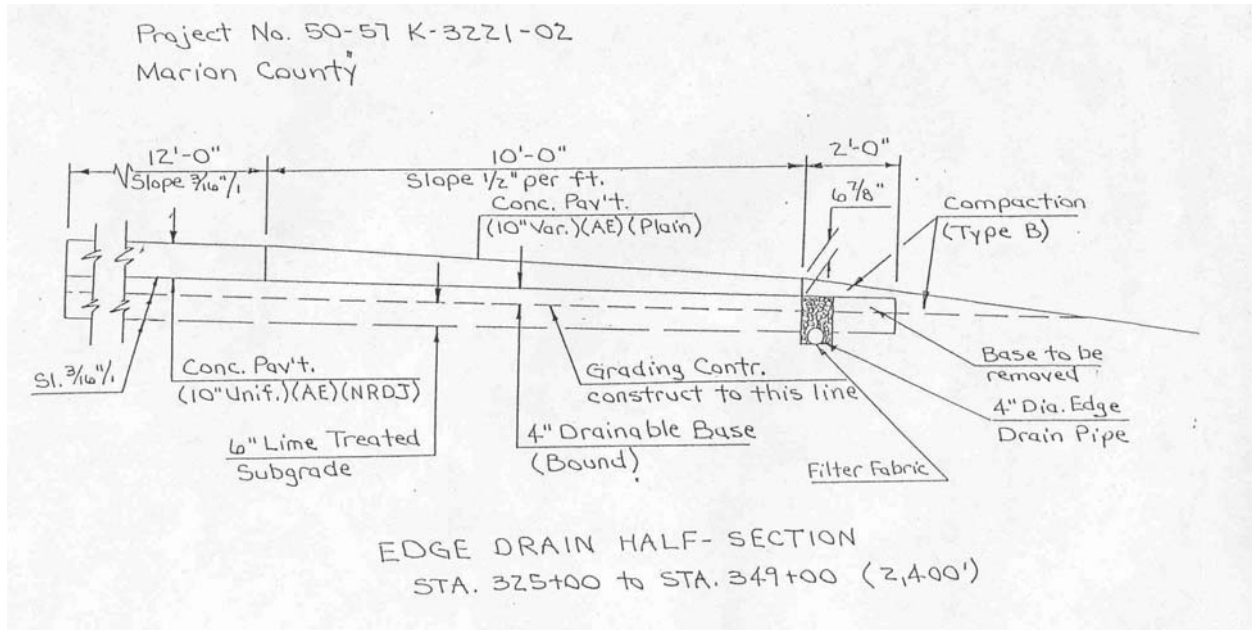
Figure 14

Edge Drain System Design

The second design section was compared to an edge drain system, a partially daylighted section and a fully daylighted system using the bound drainable base aggregate as the shoulder wedge. The edge drain system used the same cement bound drainable base material. This base was connected to a drainage trench at the shoulder. The drainage trench contained a four-inch drainage pipe with a coarse drainage aggregate. The trench was lined with a filter fabric to allow infiltration of water, but to prevent the infiltration on soil particles. This design is illustrated in Appendix C under Figure 14.

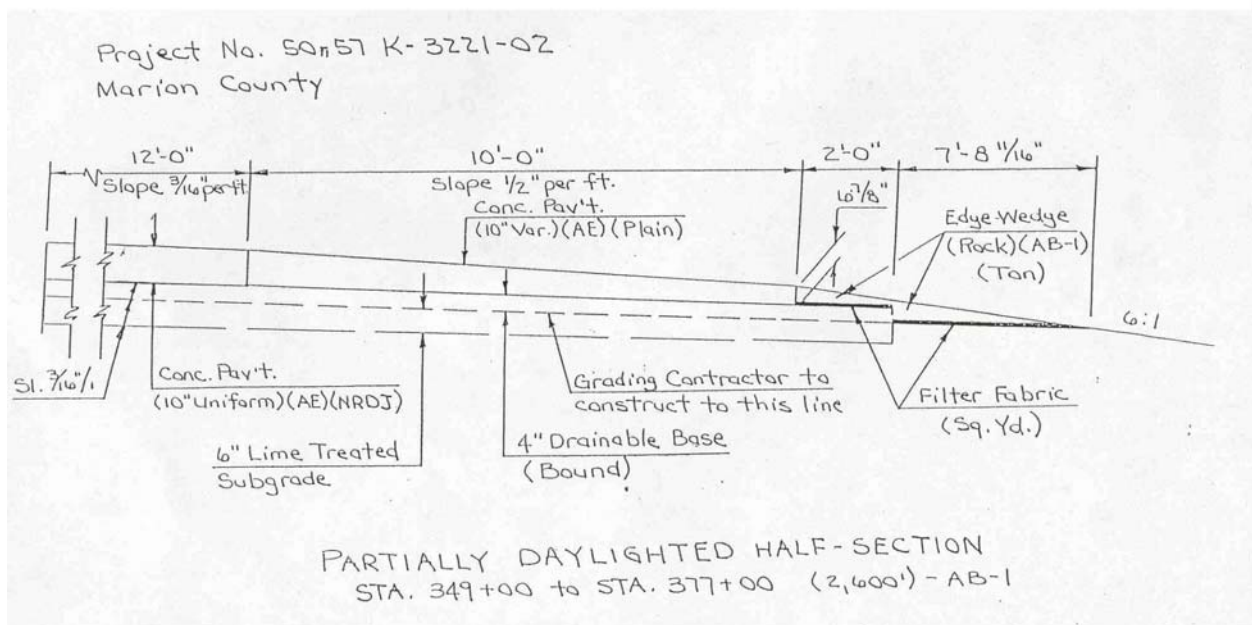
Figure 15

Partially Daylighted Drainable System (AB-1 with Fabric)

The third design section used on the US-50 Project consisted of a partially daylighted section. This design consists of the same cement treated drainable base material. However, in this design the base material is stopped two feet outside of the shoulder. The water would then pass through a shoulder wedge of AB-1 material. This aggregate wedge would give the shoulder slope a more consistent appearance, as only one material would be visible instead of the two materials visible in the fully daylighted section. It is believed that the AB-1 aggregate gradation will allow the egress of moisture. The AB-1 aggregate gradation specification is shown in Table 1 below. This design is shown in Appendix C under Figure 15.

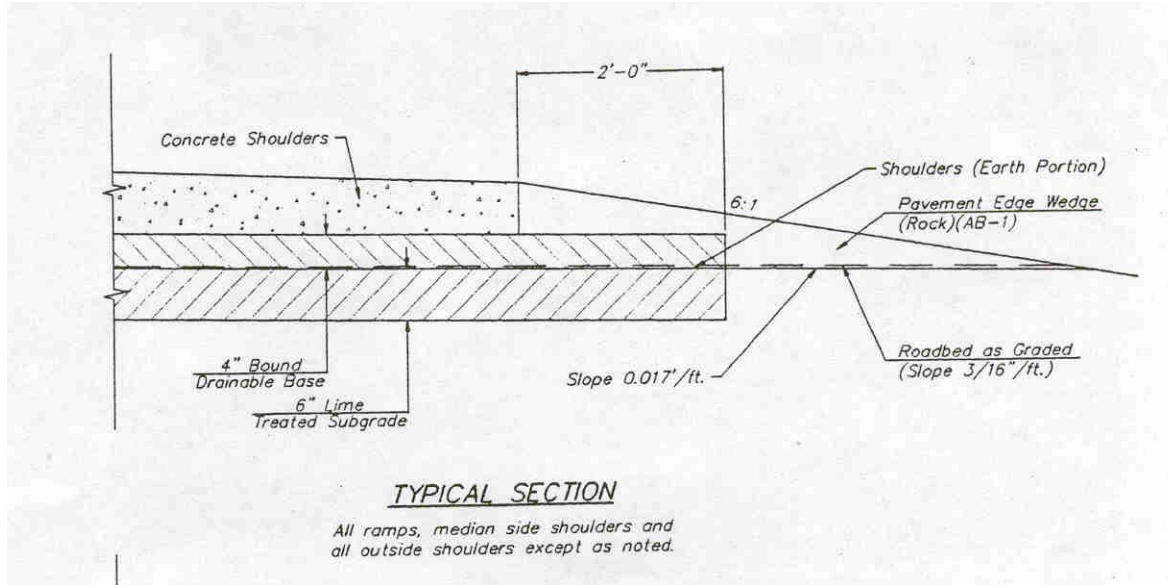
Partially Daylighted System (AB-1 without Fabric)

The US-400 incorporated these four designs and added three additional variations of the partially daylighted section design. These designs modified the partially daylighted design by changing the aggregate used in the wedge. This original design used AB-1 for the wedge material. This material was changed to AS-1 for the section from Station 226+00 to 249+85.25. The wedge material was changed to unbound drainable base aggregate on the left side from Station 101+40 to 126+00. Bound drainable base aggregate was installed on the right side in this same section. The gradations for these aggregates are shown in Table 1. The fourth design section used the original AB-1 material. However, it called for placing a filter fabric over the extended bound drainable base similar to the installation on US-50. These designs are shown in Appendix C as Figure 16 through Figure 18.

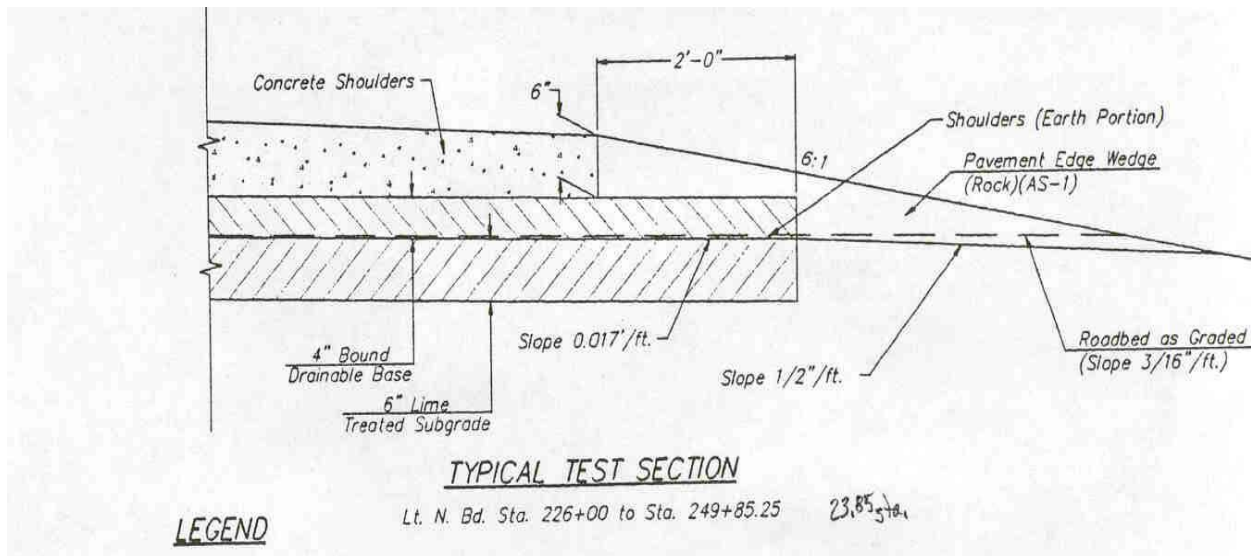
Figure 17

Partially Daylighted Drainable System (AS-1)

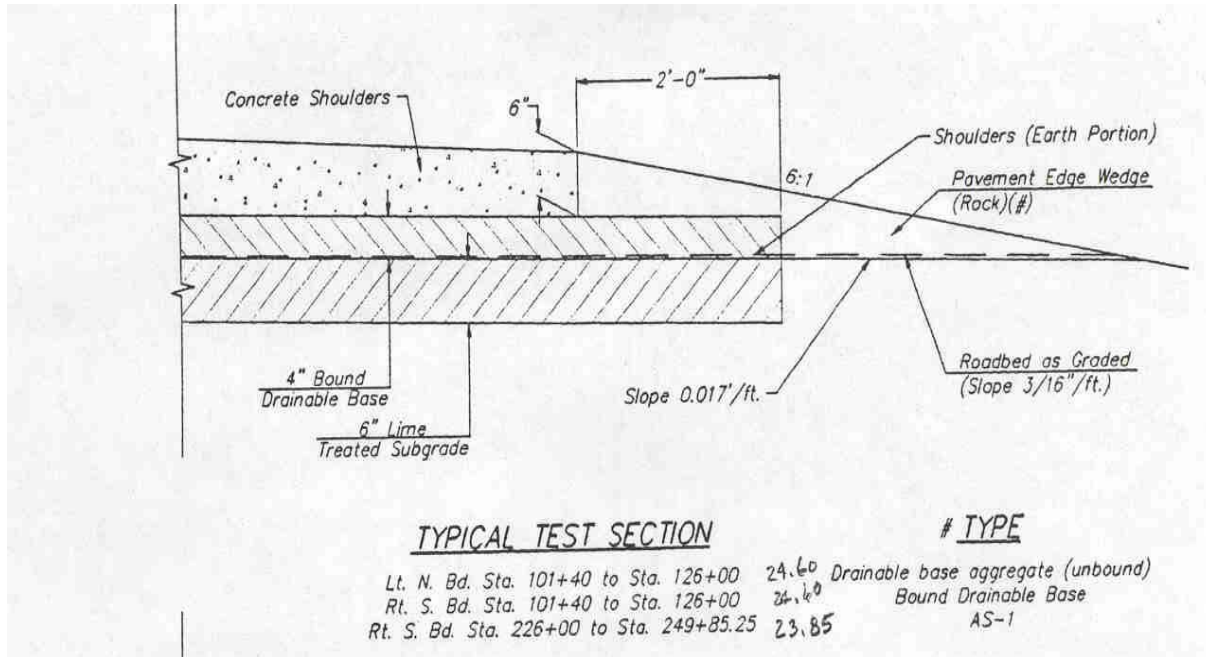
Figure 18

Partially Daylighted Drainable System (BDB)

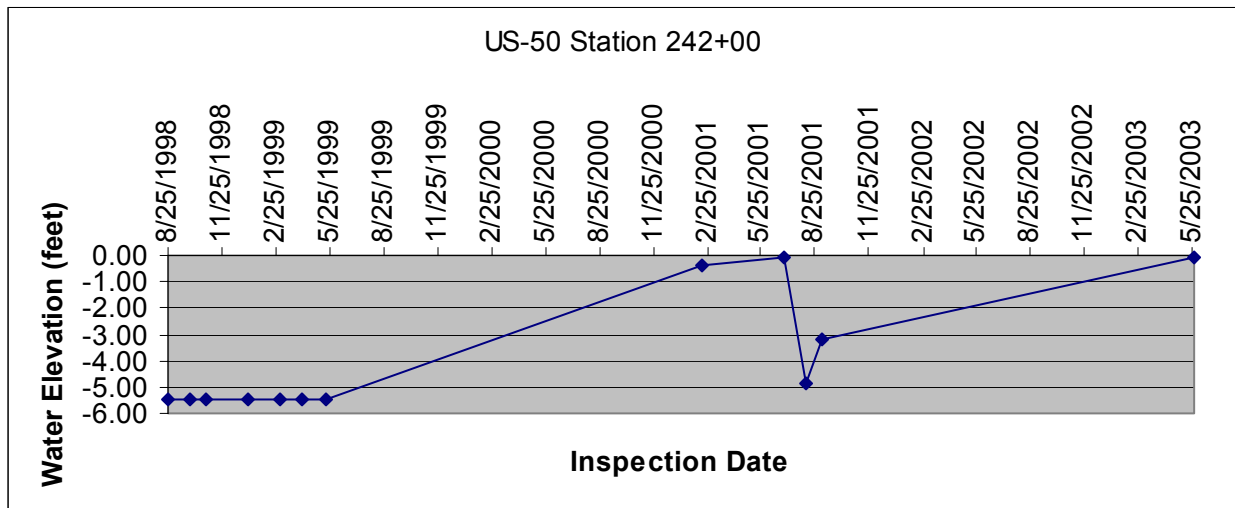
Figure 19

US-50 Station 242+00

Fully Daylighted Bound Drainable Base with AB-1 Rock Shoulder Wedge

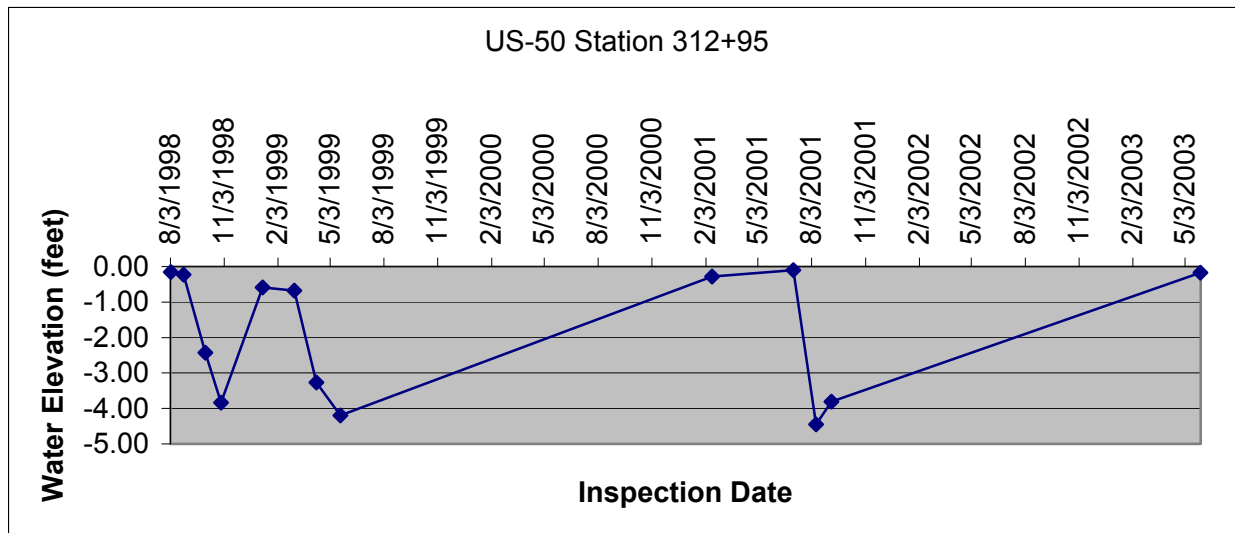
Figure 20

US-50 Station 312+95

Fully Daylighted Bound Drainable Base with Bound Drainable Base Shoulder Wedge

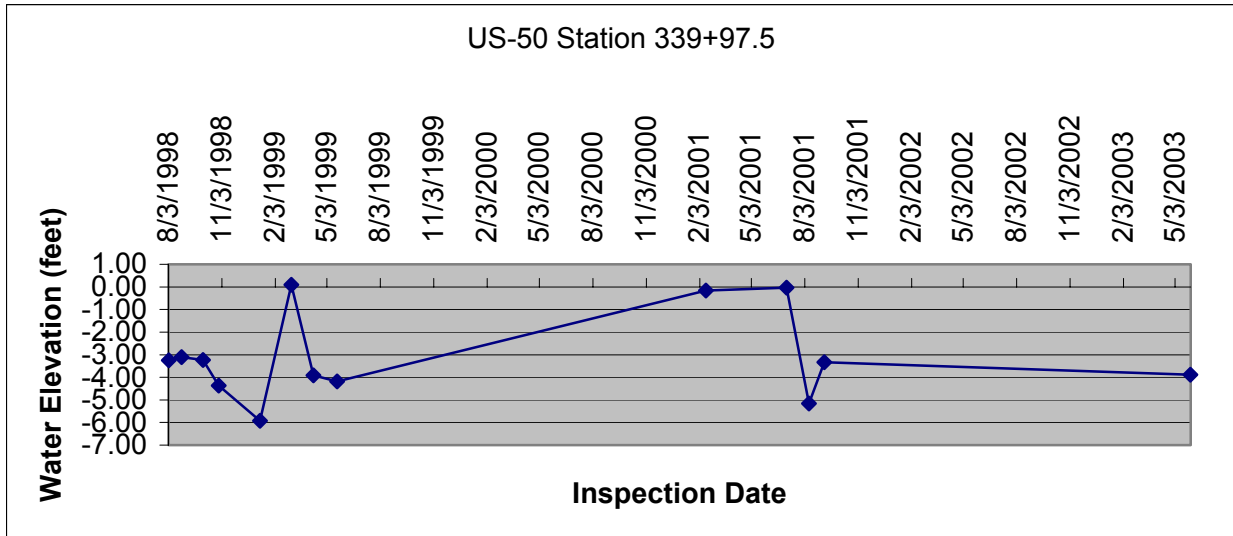
Figure 21

US-50 Station 339+97.5

Bound Drainable Base with Edge Drains

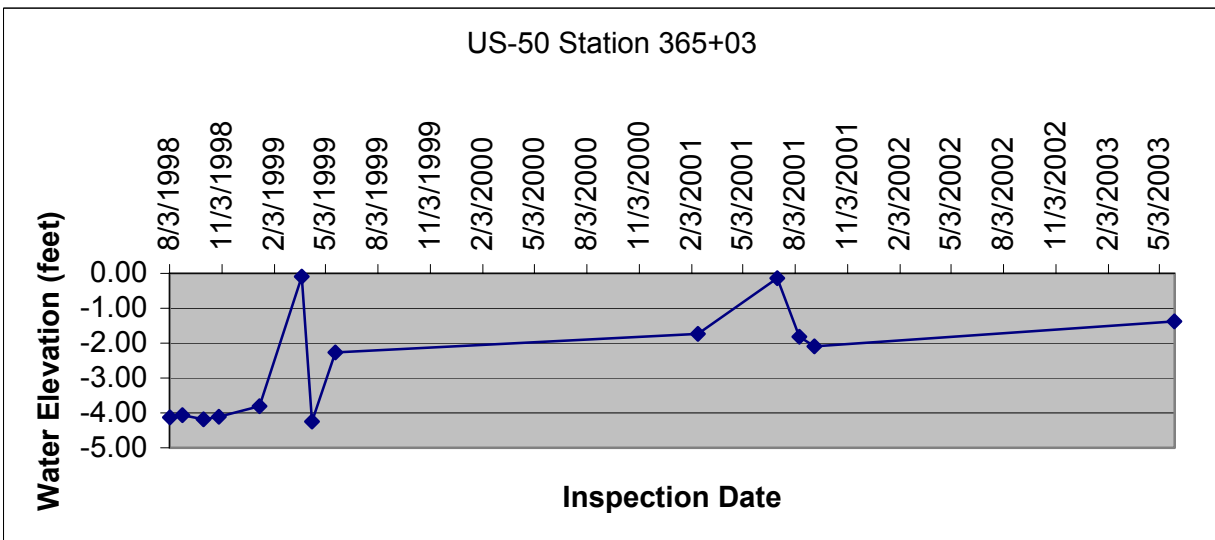
Figure 22

US-50 Station 365+03

Partially Daylighted Bound Drainable Base with AB-1 Shoulder Wedge

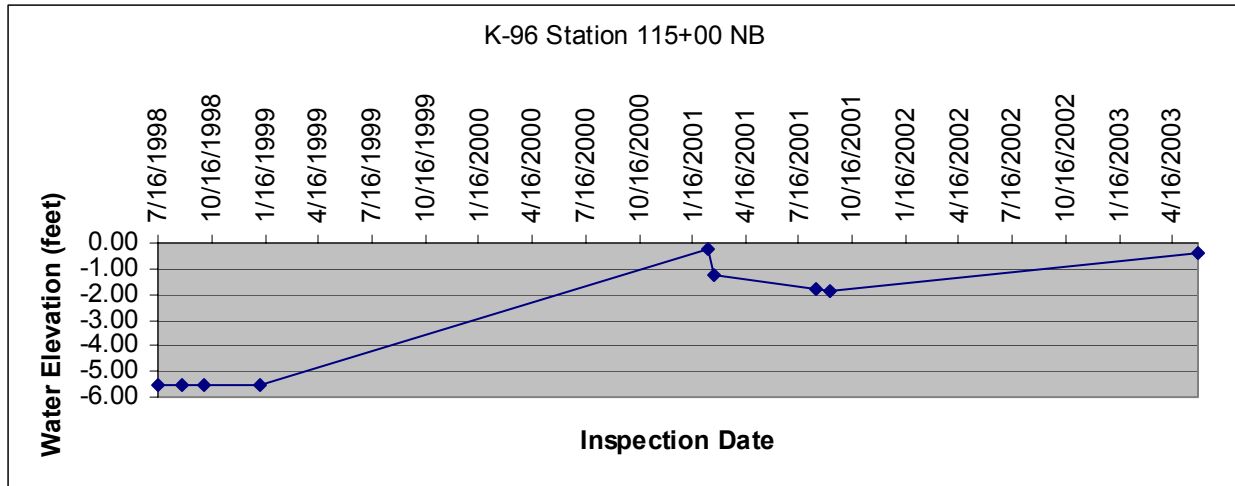
Figure 23

K-96 Station 115+00 Northbound

Partially Daylighted Bound Drainable Base Section with the Wedge Aggregate being Unbound Drainable Base Aggregate

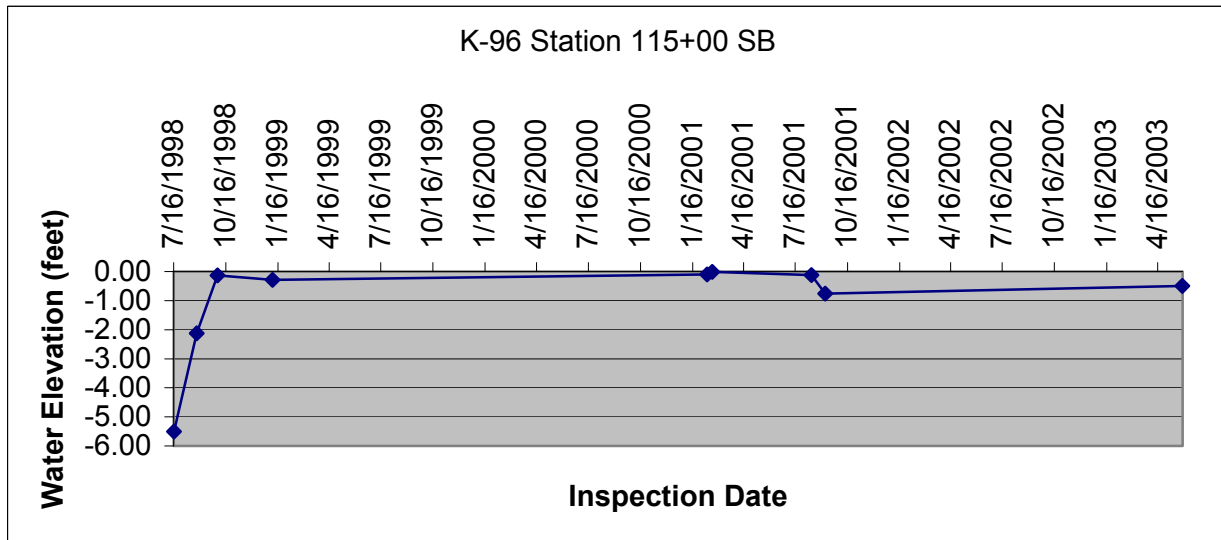
Figure 24

K-96 Station 115+00 Southbound

Partially Daylighted Bound Drainable Base Section with the Wedge Bound Drainable Base

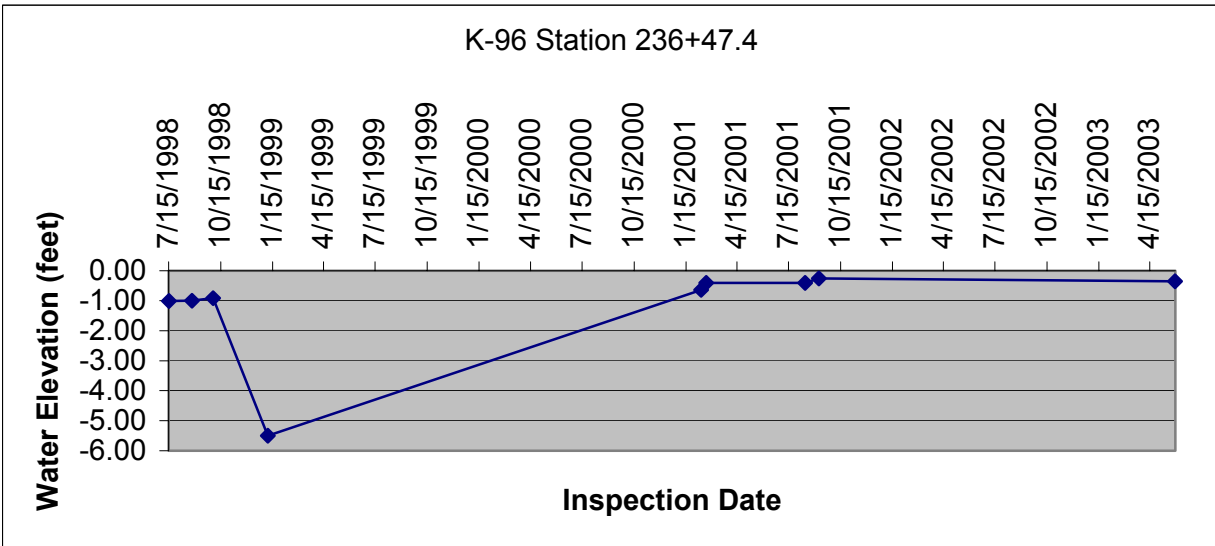
Figure 25

K-96 Station 236+47.4 Northbound

Partially Daylighted Bound Drainable Base Section with the Wedge Aggregate being AS-1

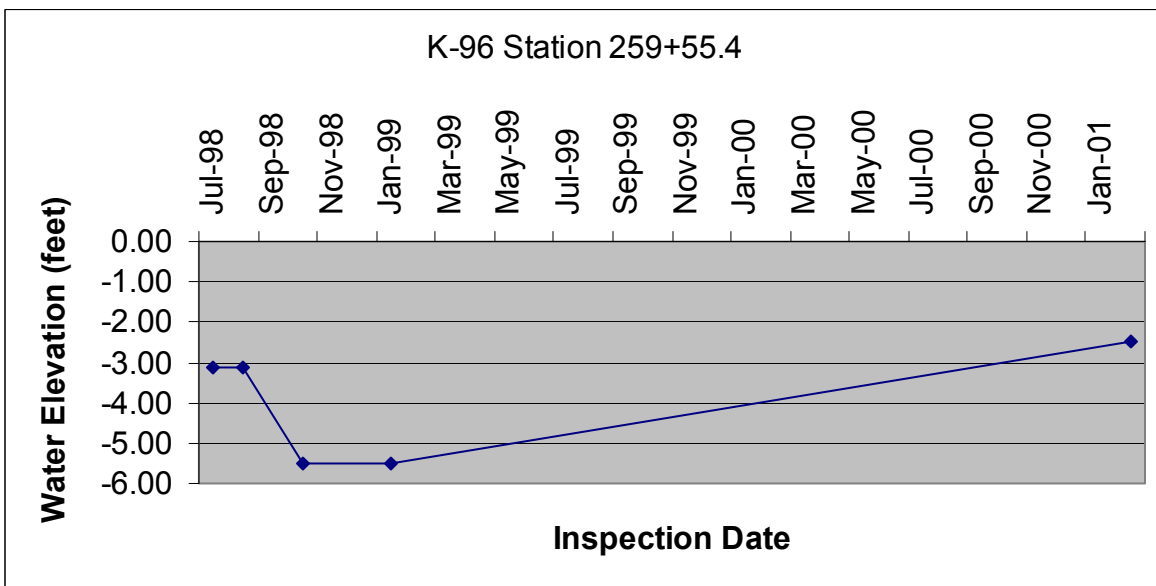
Figure 26

K-96 Station 259+55.4 Northbound (Standpipe Destroyed)

Partially Daylighted Bound Drainable Base Section with the Wedge Aggregate being AB-1

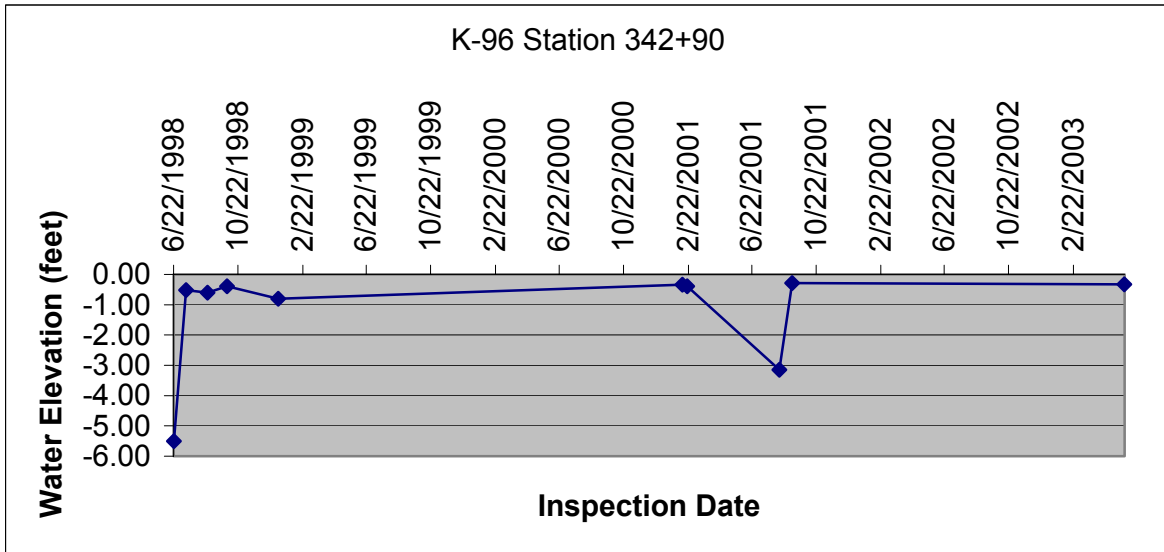
Figure 27

K-96 Station 342+90

Bound Drainable Base with Edge Drain System

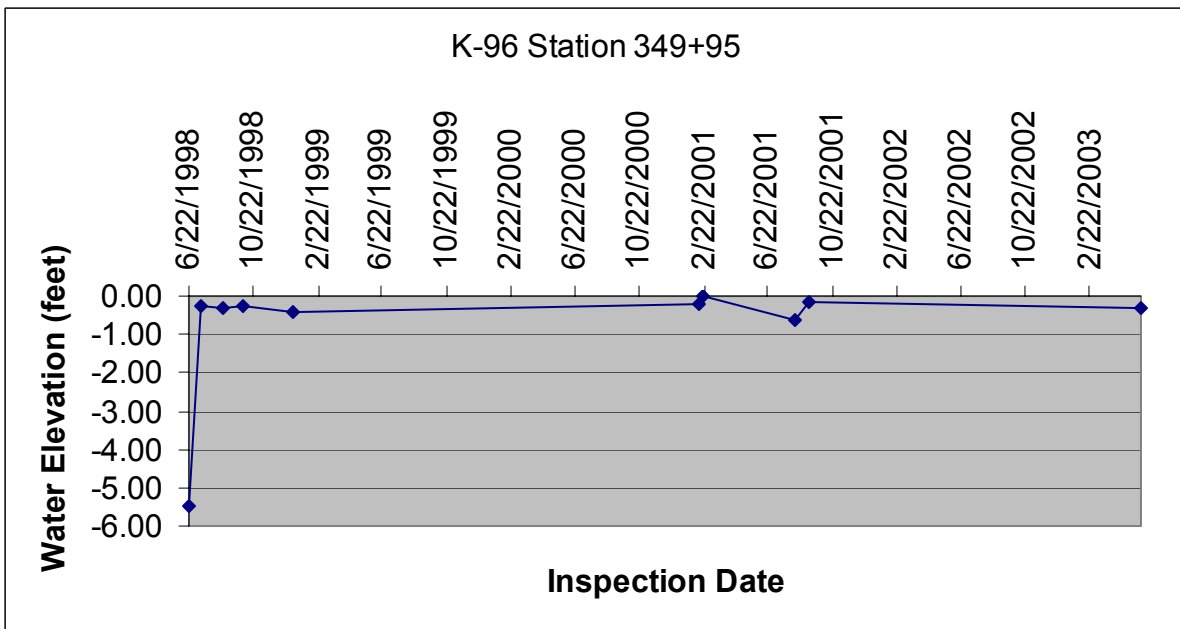
Figure 28

K-96 Station 349+95

Fully Daylighted Bound Drainable Base System
