Report No. KS-03-6  
FINAL REPORT

**FIELD INSTRUMENTATION AND ANALYSIS OF THE  
ARKANSAS RIVER BRIDGE**  
*Bridge No. 96-78-19.11(064)*

SEPTEMBER 2004

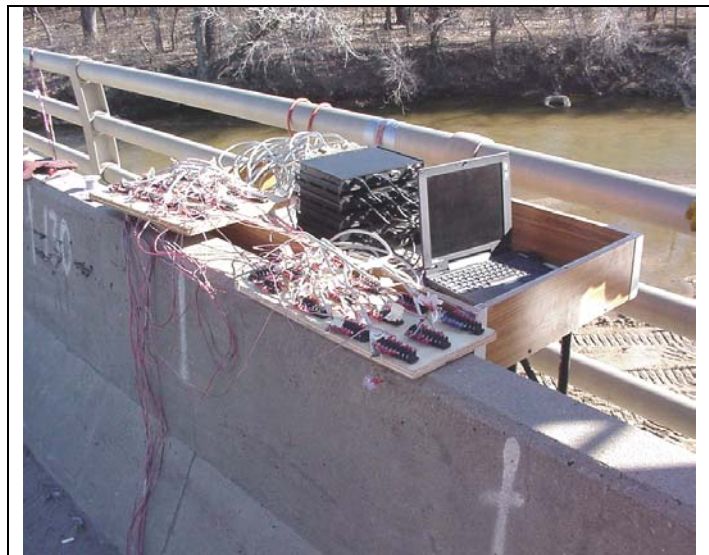
**Figure 2.1.3.1: Instrumentation Setup**

The data acquisition system is composed of a laptop computer, one Wavebook, and three strain gage modules. The laptop is a Dell Latitude CPi. The Wavebook, specified as a WB516 and purchased from Iotech, Inc., is a high-speed Waveform Data Acquisition and Analysis Module. The three strain gage modules, specified as

WBK16/SSH modules, each have eight channels to provide the 24 channels required for testing. Each channel has a cable that runs to a terminal strip. The wires run from the strain gage to a terminal strip with a quarter bridge configuration. Figure 2.1.3.1 shows the entire data acquisition system fully installed in the field.

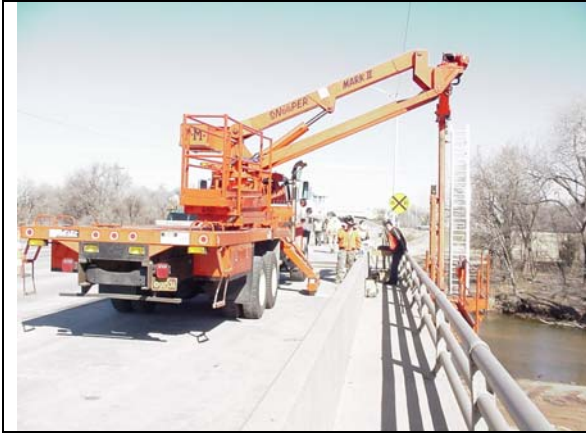
**Figure 2.1.5.1: Mark II Snooper**

In addition to the strain gages and the data acquisition software and hardware, other accessories were required for the instrumental analysis of the Arkansas River Bridge. Some of these accessories included the wires that led from the strain gages to the terminal strips, which are specified by Micro Measurements as 326DFV. The other necessary accessories to properly install the gages onto the bridge will not be discussed because they are assumed to be standard. At the time of installation, the other equipment required included the Mark II snooper and an operator, as shown in Figure 2.1.5.1. A portable generator at the site was also necessary, in addition to hard hats and safety vests for the installers. For loading, two HS15 dump trucks were provided, as shown in Figure 2.1.5.2, with known weights and wheel dimensions. Lamps were required to light the working area and to heat the steel prior to installation.

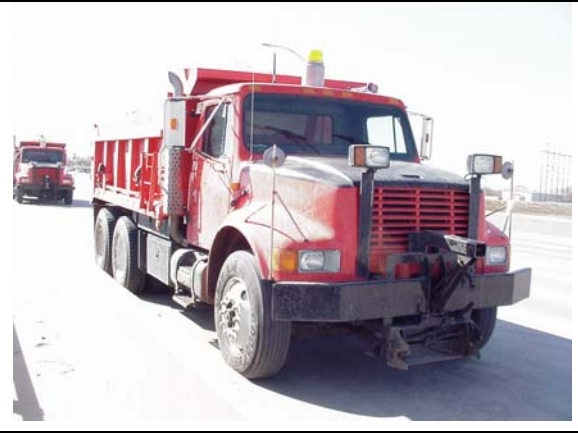
**Picture 2.1.5.2: HS15 Trucks**

For the testing procedure, two HS15 trucks were supplied by KDOT before and after retrofit. The bridge was blocked off from traffic during the testing and all construction work on the bridge was temporarily halted. Before retrofit, 21 loading conditions were applied. After retrofit, seven loading conditions were applied. Each loading condition was executed twice. The trucks drove from south to north and data was recorded at a rate of 200 data points per second to ensure that the peak stresses were captured. For each loading condition, the data recording was initiated just as the front tire of the HS15 truck was running over the expansion joint at pier #5. For prior-to-
